## **Environmental Review for Activity/Project that is Categorically Excluded Subject to Section 58.5**

**Project Name:** PR-CRP-000807: Mejoras a la Plaza Pública de Vieques & PR-CRP-001111: Centro Agrícola de Transformación Social y Comunitario

**Responsible Entity:** Puerto Rico Department of Housing (PRDOH)

**Preparer:** Angel Garcia PE, Sr. Environmental Engineer at AG Environmental PSC

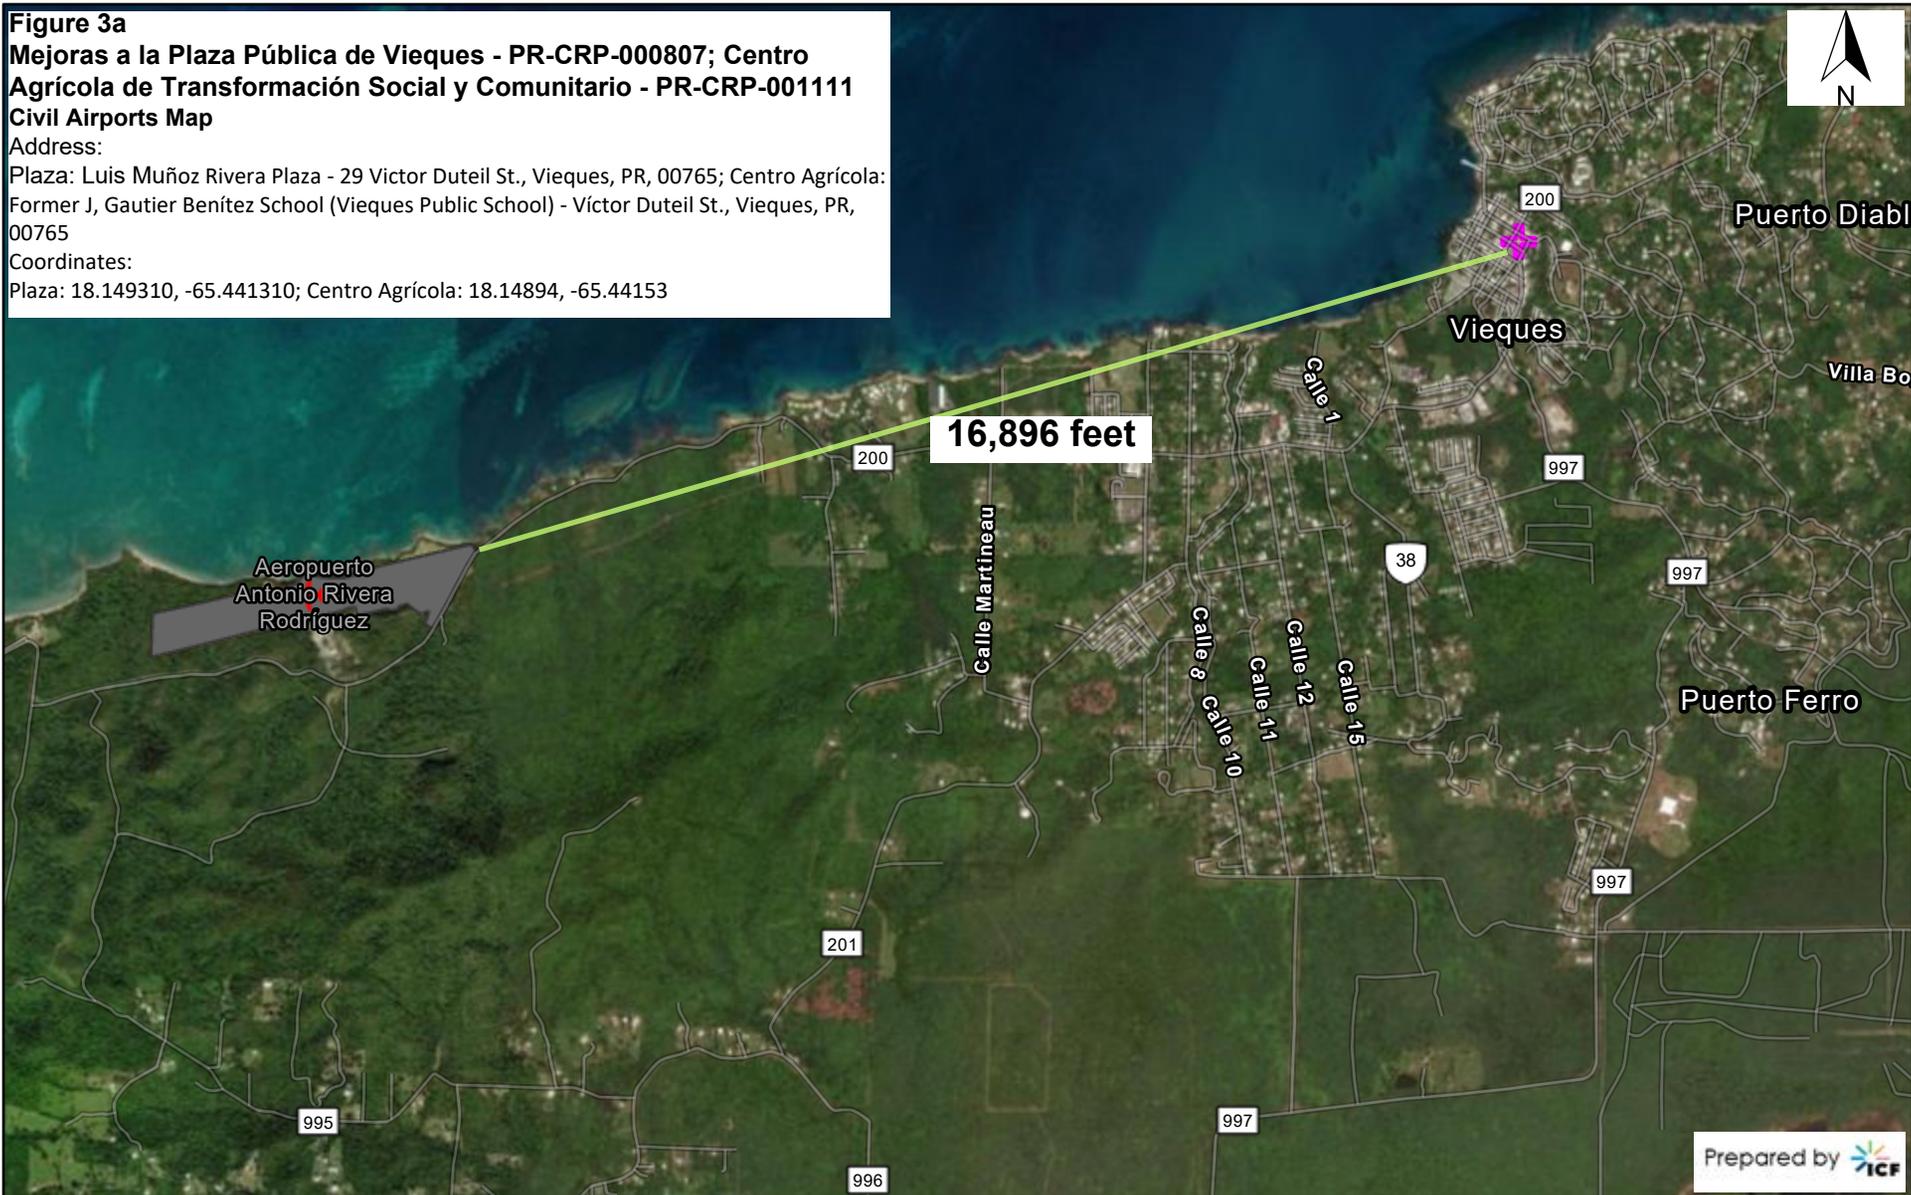
**Figure 3a**  
**Mejoras a la Plaza Pública de Vieques - PR-CRP-000807; Centro**  
**Agrícola de Transformación Social y Comunitario - PR-CRP-001111**  
**Civil Airports Map**  
 Address:  
 Plaza: Luis Muñoz Rivera Plaza - 29 Victor Duteil St., Vieques, PR, 00765; Centro Agrícola:  
 Former J, Gautier Benítez School (Vieques Public School) - Víctor Duteil St., Vieques, PR,  
 00765  
 Coordinates:  
 Plaza: 18.149310, -65.441310; Centro Agrícola: 18.14894, -65.44153

<p><b>Compliance Factors:</b> Statutes, Executive Orders, and Regulations listed at 24 CFR §58.5 and §58.6</p>	<p>Are formal compliance steps or mitigation required?</p>	<p>Compliance determinations</p>
<p><b>STATUTES, EXECUTIVE ORDERS, AND REGULATIONS LISTED AT 24 CFR 50.4 &amp; 58.6</b></p>		
<p><b>Airport Hazards</b>  24 CFR Part 51 Subpart D</p>	<p>Yes    No <input type="checkbox"/>   <input checked="" type="checkbox"/></p>	<p>Vieques is an archipelagic island-municipality located approximately 42,240 feet (8 miles) to the east of the main island of Puerto Rico. The municipality has a civilian airport, the Antonio Rivera Rodríguez Airport (VQS), which is located approximately 3.2 miles (16,896 ft) west of the project site. The closest military airport is Luis Muñoz Marín International Airport (SJU) which is in San Juan, approximately 42.9 miles (226,477 ft) to the northwest of the project site. The SJU facility operates as a joint civil/military airport.</p> <p>The project is not located within 15,000 feet of a military airport, or 2,500 feet of a civilian airport. The projects are in compliance with Airport Hazard requirements.</p> <p>Please refer to <b>Figure 3a and Figure 3b in Appendix A.</b></p>

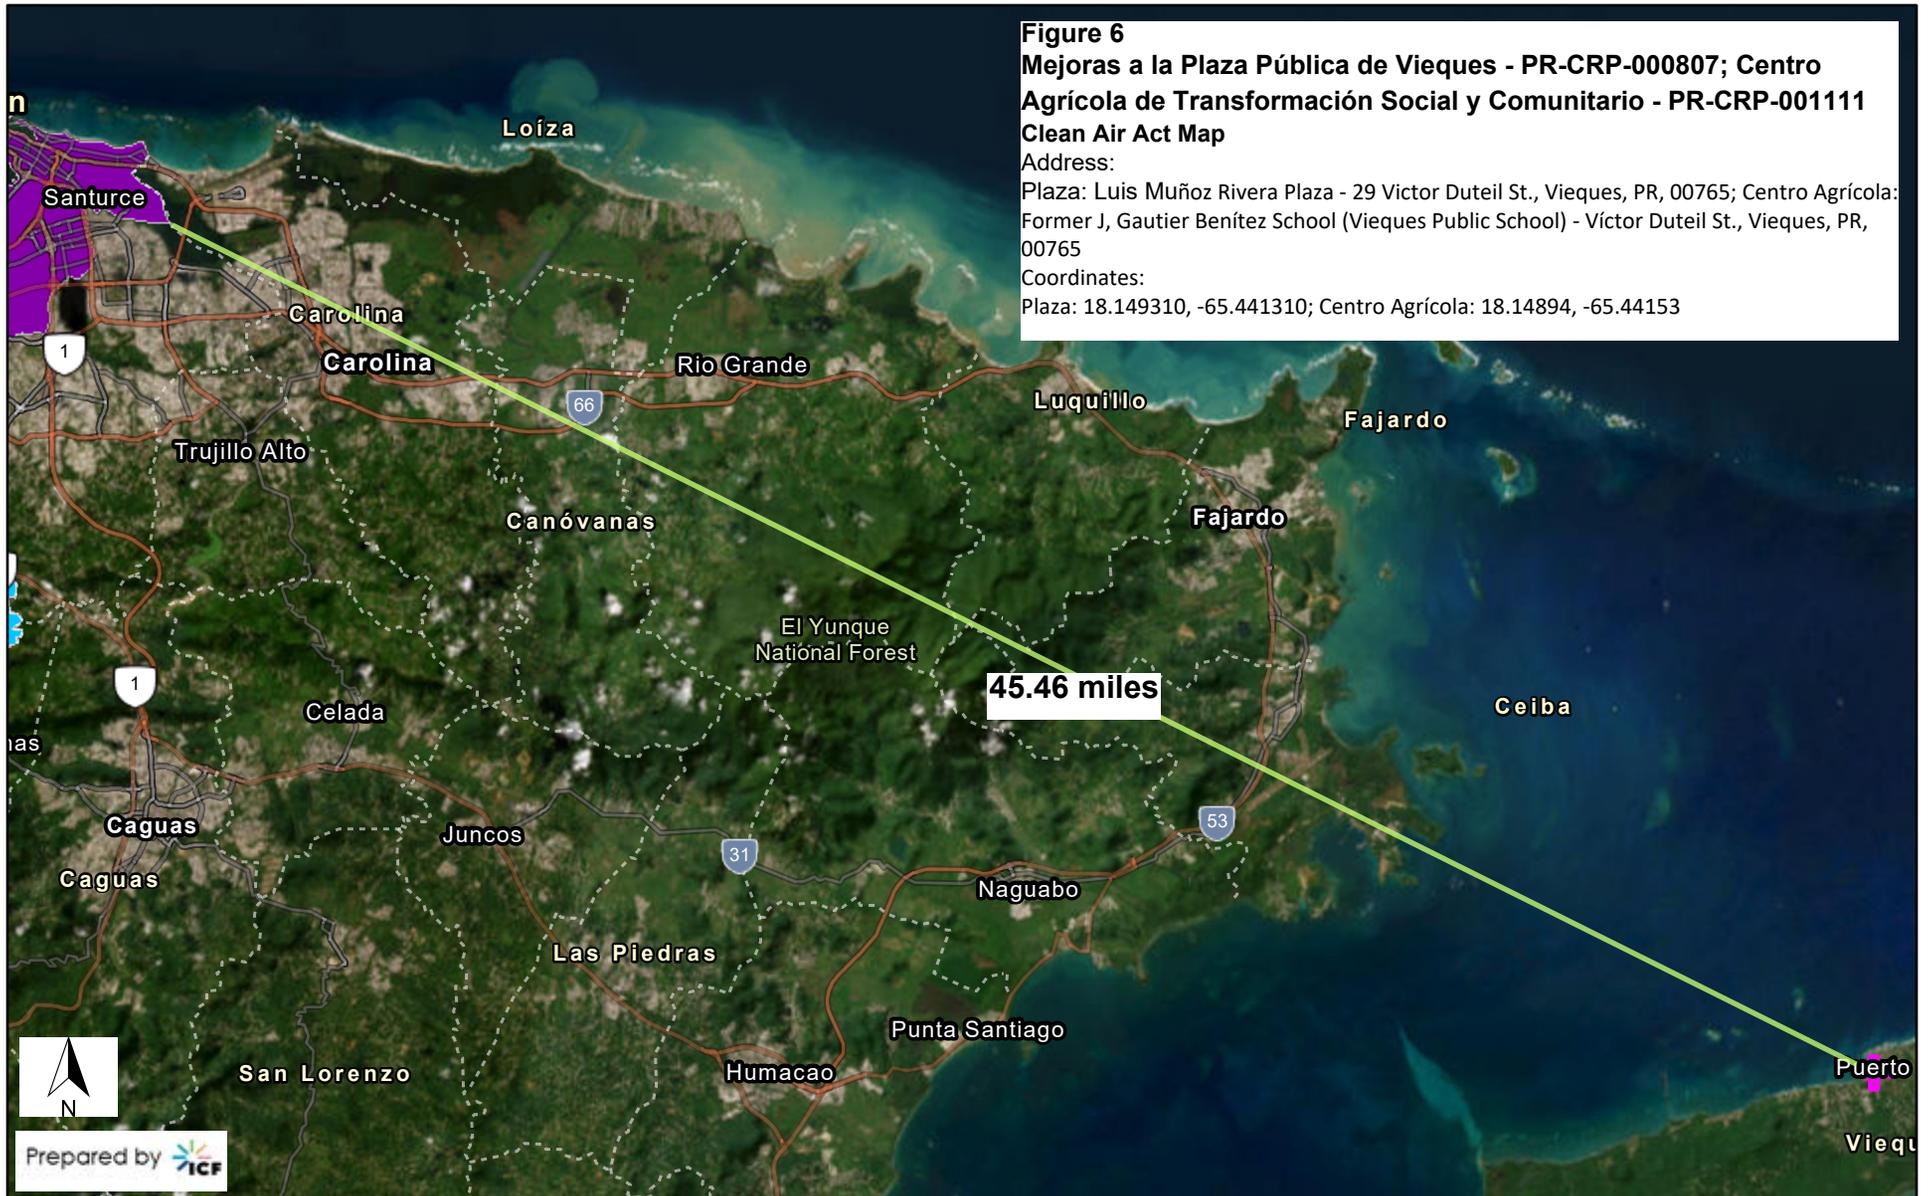
**Figure 6**  
**Mejoras a la Plaza Pública de Vieques - PR-CRP-000807; Centro**  
**Agrícola de Transformación Social y Comunitario - PR-CRP-001111**  
**Clean Air Act Map**  
 Address:  
 Plaza: Luis Muñoz Rivera Plaza - 29 Victor Duteil St., Vieques, PR, 00765; Centro Agrícola:  
 Former J. Gautier Benítez School (Vieques Public School) - Víctor Duteil St., Vieques, PR,  
 00765  
 Coordinates:  
 Plaza: 18.149310, -65.441310; Centro Agrícola: 18.14894, -65.44153

<p><b>Flood Insurance</b></p> <p>Flood Disaster Protection Act of 1973 and National Flood Insurance Reform Act of 1994 [42 USC 4001-4128 and 42 USC 5154a]</p>	<p>Yes    No</p> <p><input type="checkbox"/>   <input checked="" type="checkbox"/></p>	<p>Per Floodplain Insurance Map (FIRM) 72000C1340J effective date November 18, 2009, the project is not located within a flood zone. No flood insurance will be required for the projects and the projects are in compliance with Flood Insurance requirements.</p> <p>Please refer to <b>Figure 5 in Appendix A.</b></p>
<p><b>STATUTES, EXECUTIVE ORDERS, AND REGULATIONS LISTED AT 24 CFR 50.4 &amp; 58.5</b></p>		
<p><b>Clean Air</b></p> <p>Clean Air Act, as amended, particularly section 176(c) &amp; (d); 40 CFR Parts 6, 51, 93</p>	<p>Yes    No</p> <p><input type="checkbox"/>   <input checked="" type="checkbox"/></p>	<p>According to the Environmental Protection Agency's Green Book and the NEPA assist website data, the project site is 45.46 miles (240,025 feet) to the southeast of the nearest nonattainment area. Construction activities may result in unwanted fugitive dust emissions. However, the project is located in an area with attainment status for all criteria pollutants. As such, the project is in compliance with the Clean Air Act. The emissions from the project would not cause any exceedances or violations.</p> <p>The project will include the installation of a new 60-KW emergency-power generator unit with a 48-hour diesel fuel backup capacity. The mechanical power of this unit corresponds to approximately 80 horsepower (HP). This unit is considered a minor, stationary, air emissions source and will require a permit for its construction and operation in compliance with the Puerto Rico Department of Natural and Environmental Resources (DNER). This permit will comply with the Clean Air Act. Thus, the project developer or owner will obtain the necessary permits in compliance with regulations. The location of the unit on the roof of the building will ensure proper dispersion of emissions.</p> <p>See <b>Figure 6</b> and the EPA's Green Book in <b>Appendix J.</b></p>

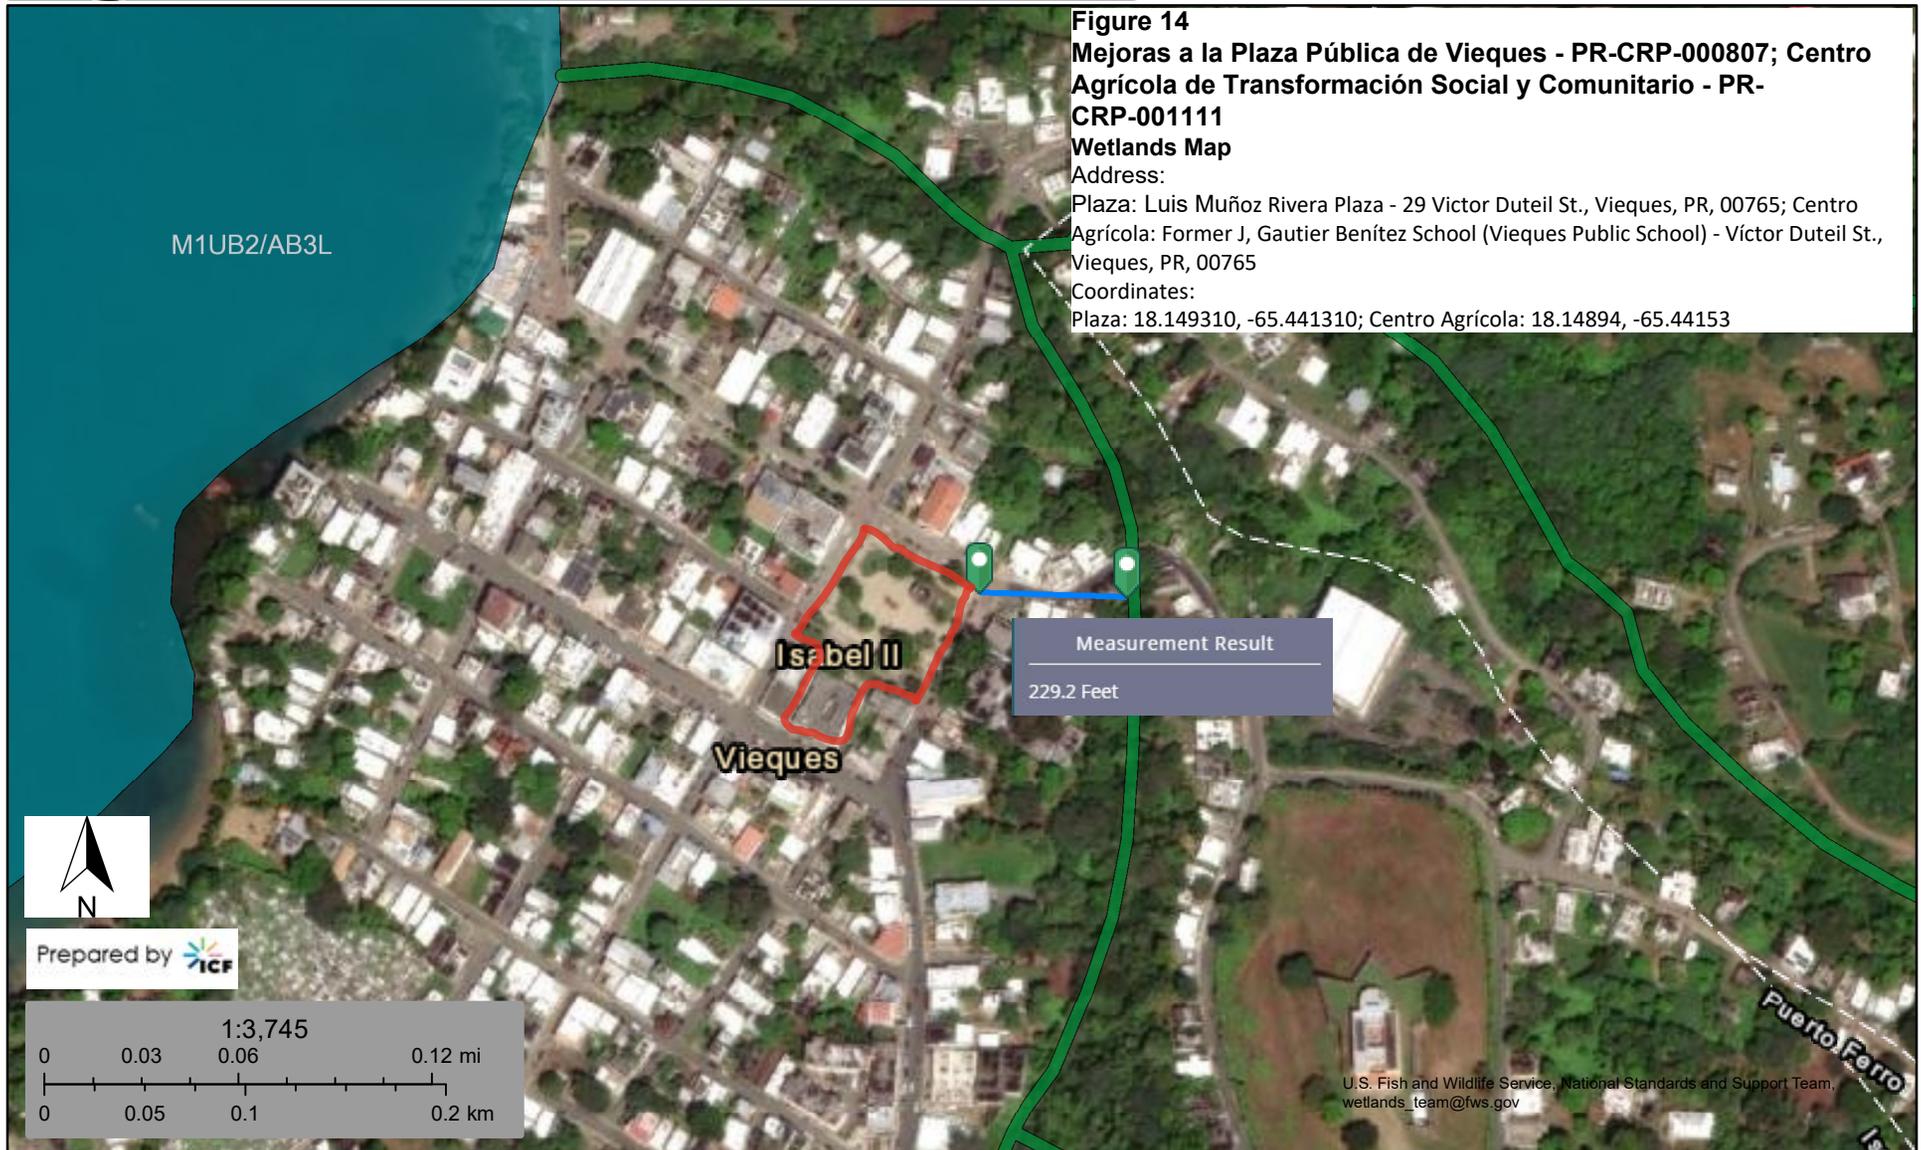
**Figure 14**  
**Mejoras a la Plaza Pública de Vieques - PR-CRP-000807; Centro Agrícola de Transformación Social y Comunitario - PR-CRP-001111**  
**Wetlands Map**  
 Address:  
 Plaza: Luis Muñoz Rivera Plaza - 29 Víctor Duteil St., Vieques, PR, 00765; Centro Agrícola: Former J, Gautier Benítez School (Vieques Public School) - Víctor Duteil St., Vieques, PR, 00765  
 Coordinates:  
 Plaza: 18.149310, -65.441310; Centro Agrícola: 18.14894, -65.44153

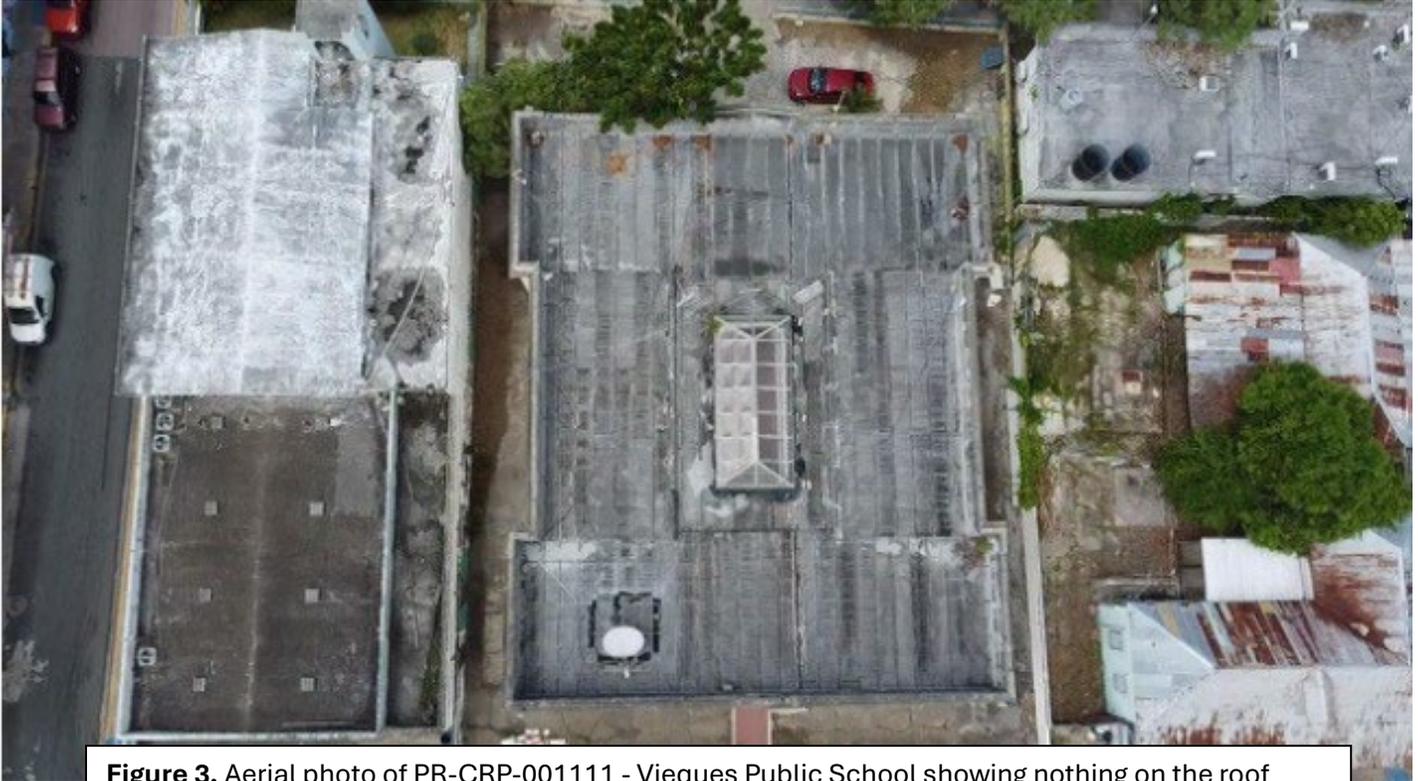
**Figure 3.** Aerial photo of PR-CRP-001111 - Vieques Public School showing nothing on the roof aside from a satellite dish in the southwest corner.

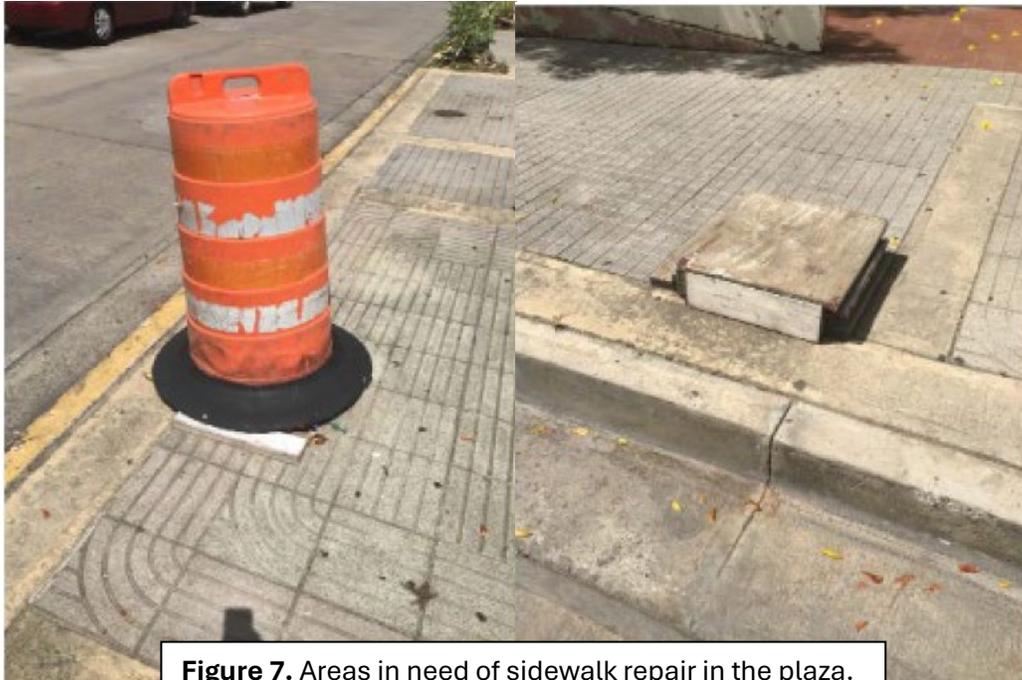
**Figure 7.** Areas in need of sidewalk repair in the plaza.

**Field Inspection:** Field inspection took place on January 19, 2023, by the design team and MARVEL personnel. A follow-up site visit was conducted on April 26, 2023, with a civil and structural engineer. Documentation from these field visits can be found in **Appendix H**. **Appendix C** contains site photos taken during the inspection of PR-CRP-001111 and PR-CRP-000807. No aboveground storage tanks (ASTs), emergency power generators, or other significant on-site infrastructure were observed. The roof of the Vieques Public School was clear of items, except for a satellite dish located in the southwest corner (**Appendix C, Figure 3**). No visible soil stains or signs of hazardous materials were noted during the inspection. In the plaza, examples of areas requiring attention included sidewalk damage and noticeable sinking in the central area, which aligns with the location of the historic underground cistern (**Appendix C, Figures 7 and 10**).

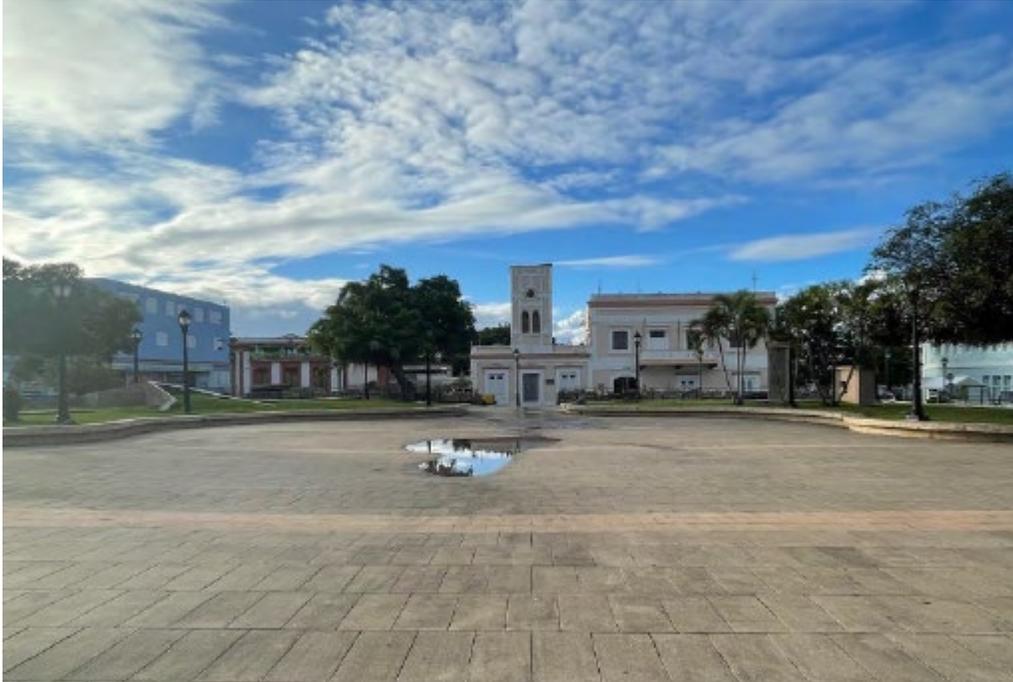
**Figure 10.** View of the central area of the Plaza showing the area that is sinking (historic underground cistern location).

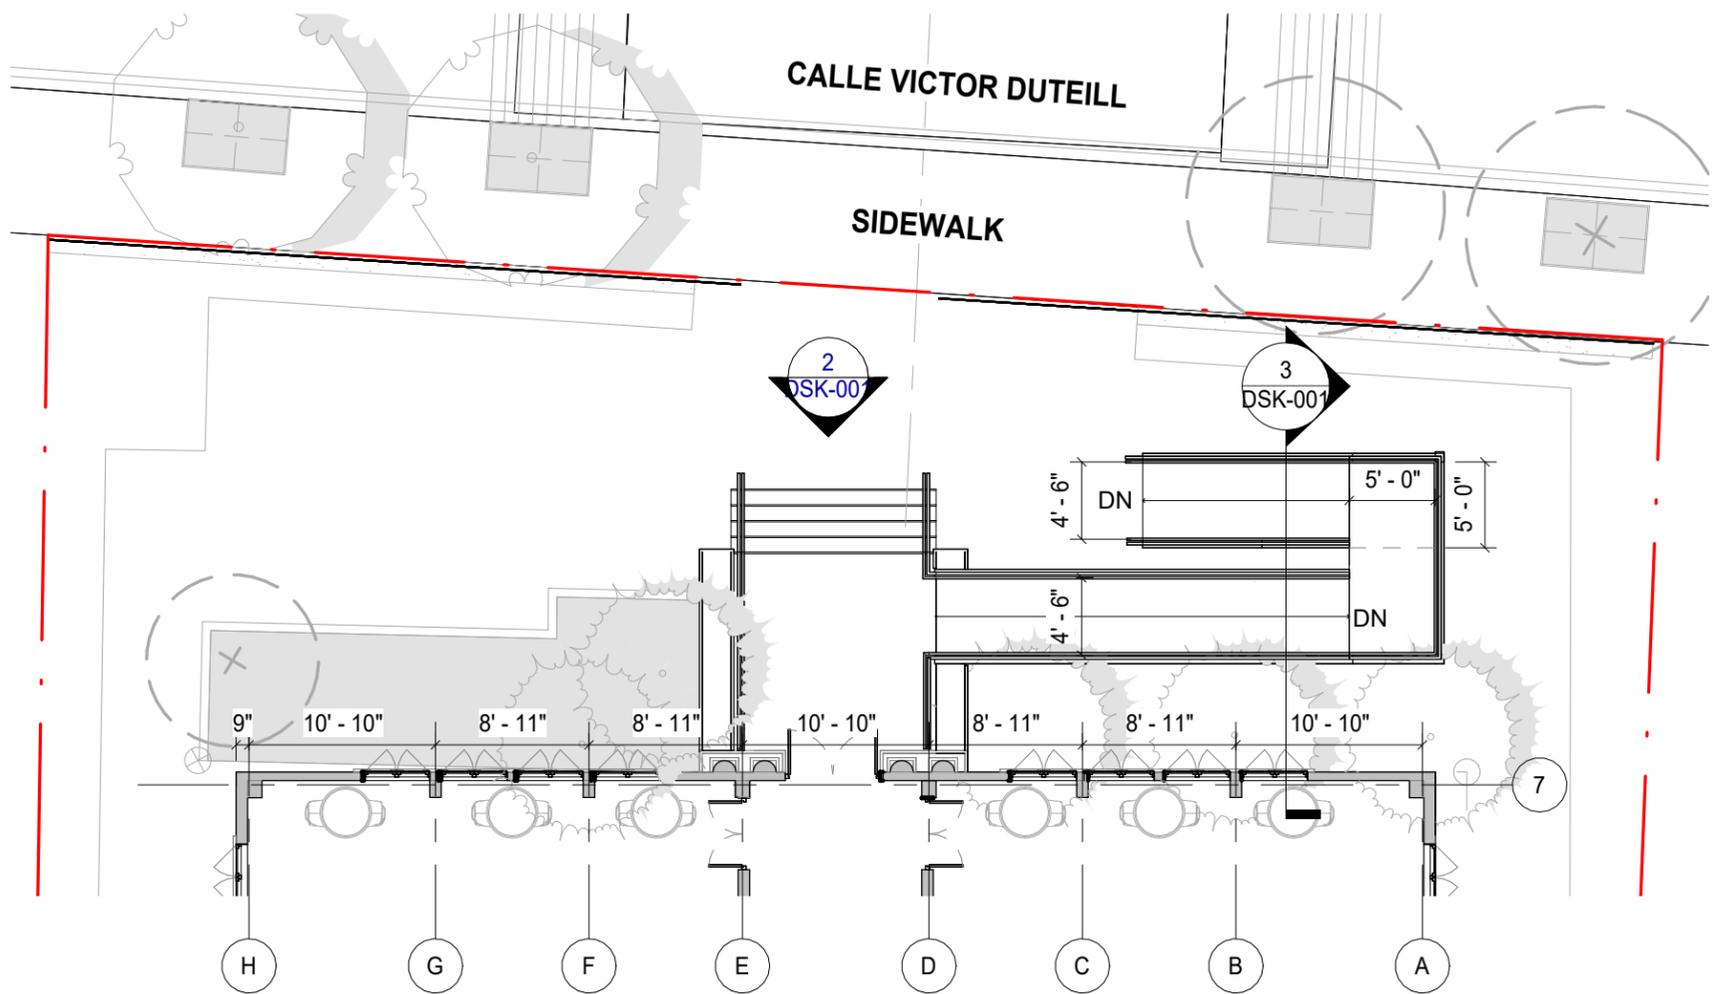
# 1 MAIN ENTRANCE RAMP FLOOR PLAN

3/32" = 1'-0"

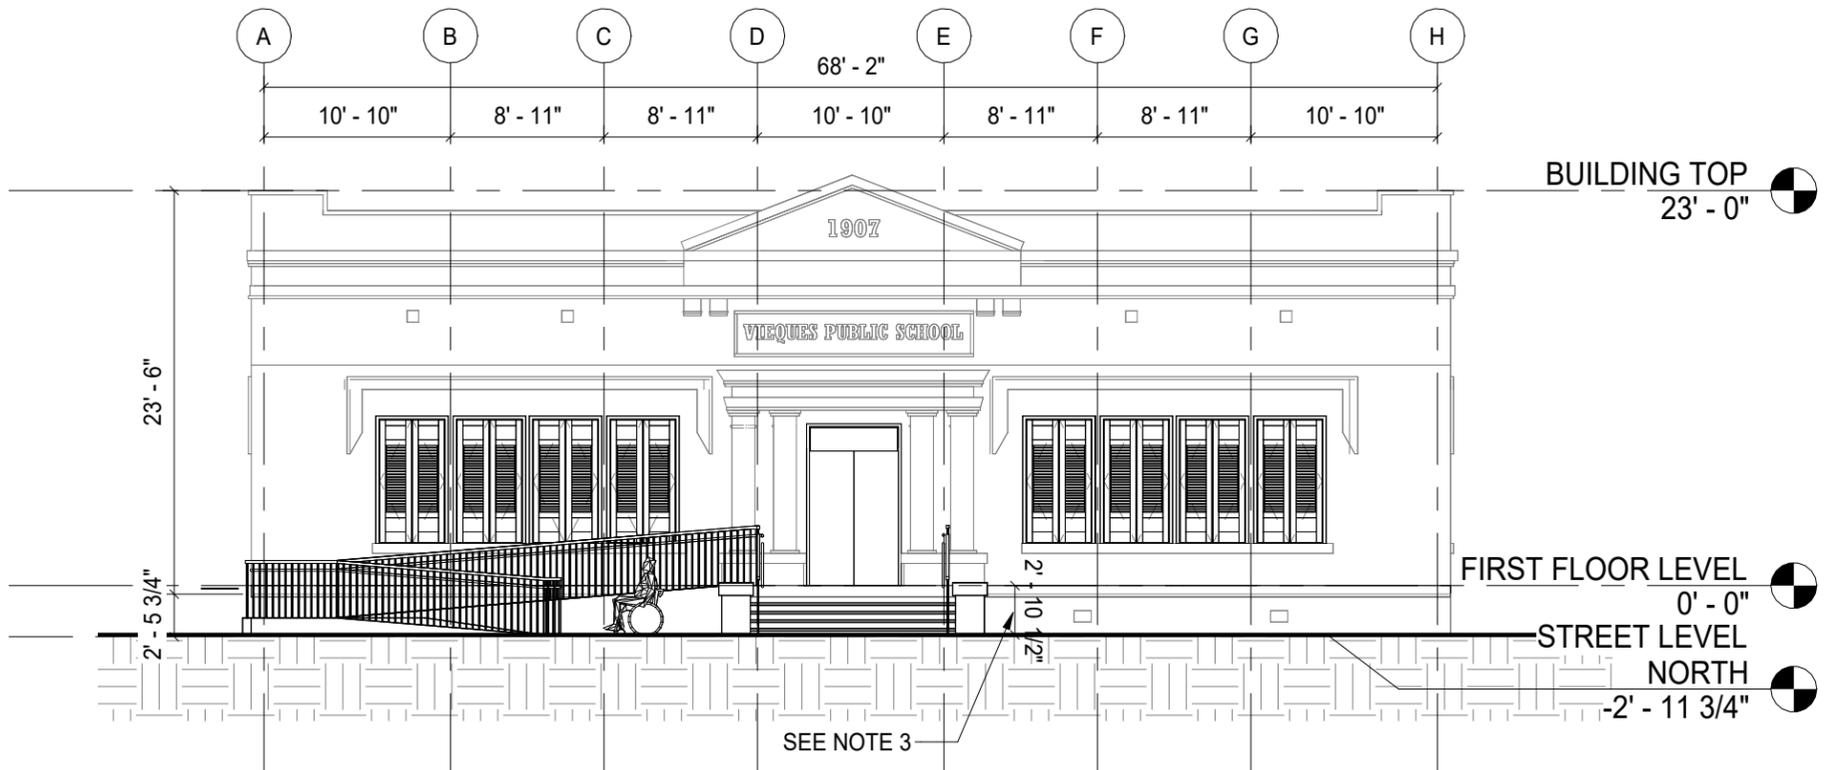
# 2 NORTH ELEVATION - MAIN ENTRANCE RAMP

3/32" = 1'-0"

2. PRBC 2018 - SECTION 1015.4 OPENING LIMITATIONS: Required guards shall not have openings that allow passage of a sphere 4 inches (102 mm) in diameter from the walking surface to the required guard height.

3. PRBC 2018 - SECTION 1015.2 WHERE REQUIRED: Guards shall be located along open-sided walking surfaces, including mezzanines, equipment platforms, aisles, stairs, ramps and landings that are located more than 30 inches (762 mm) measured vertically to the floor or grade below at any point within 36 inches (914 mm) horizontally to the edge of the open side. Guards shall be adequate in strength and attachment in accordance with Section 1607.8.

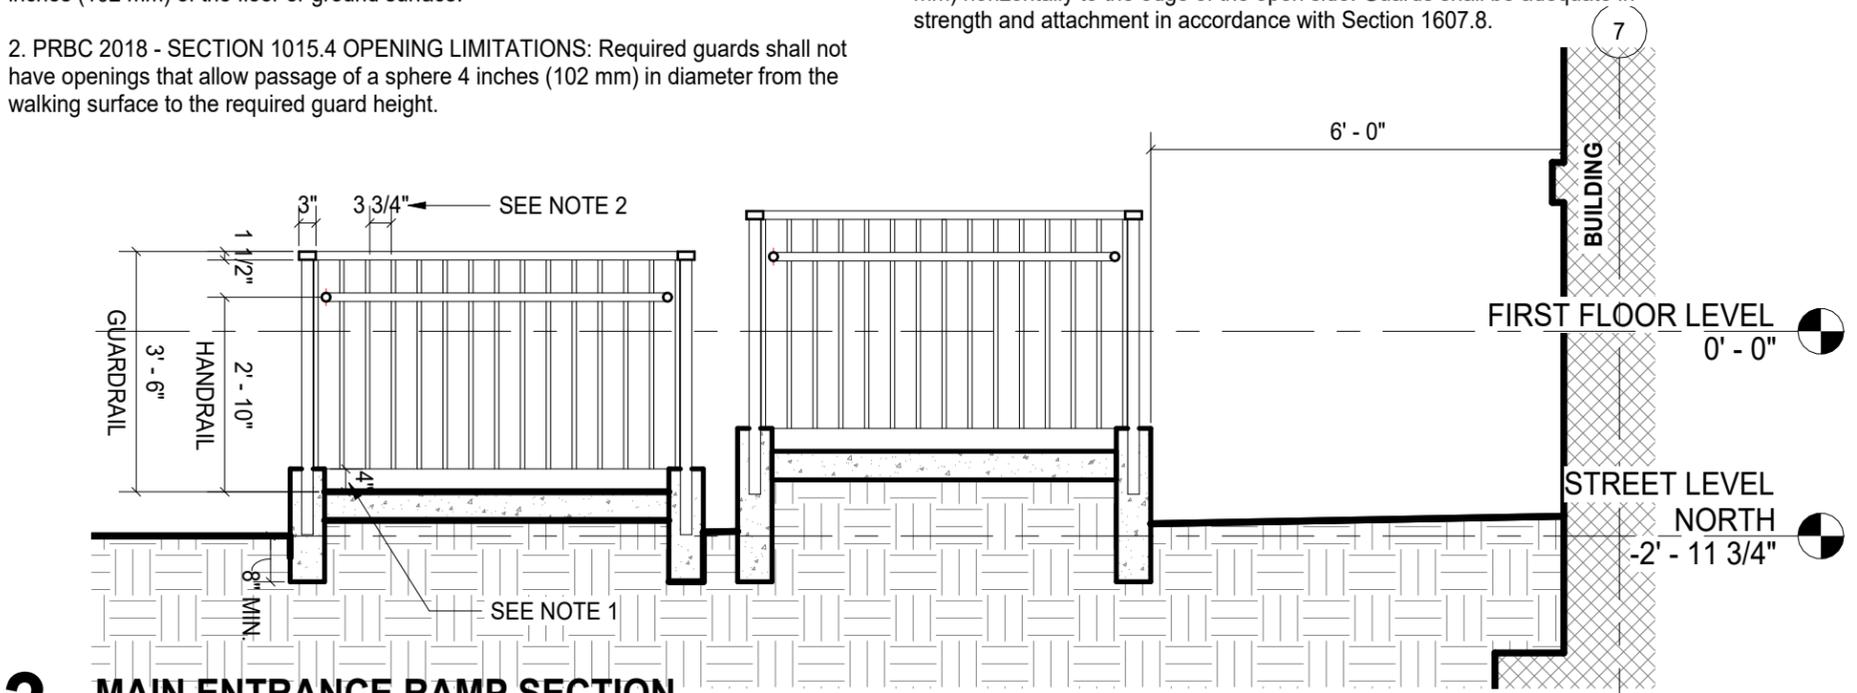
# 3 MAIN ENTRANCE RAMP SECTION

3/8" = 1'-0"

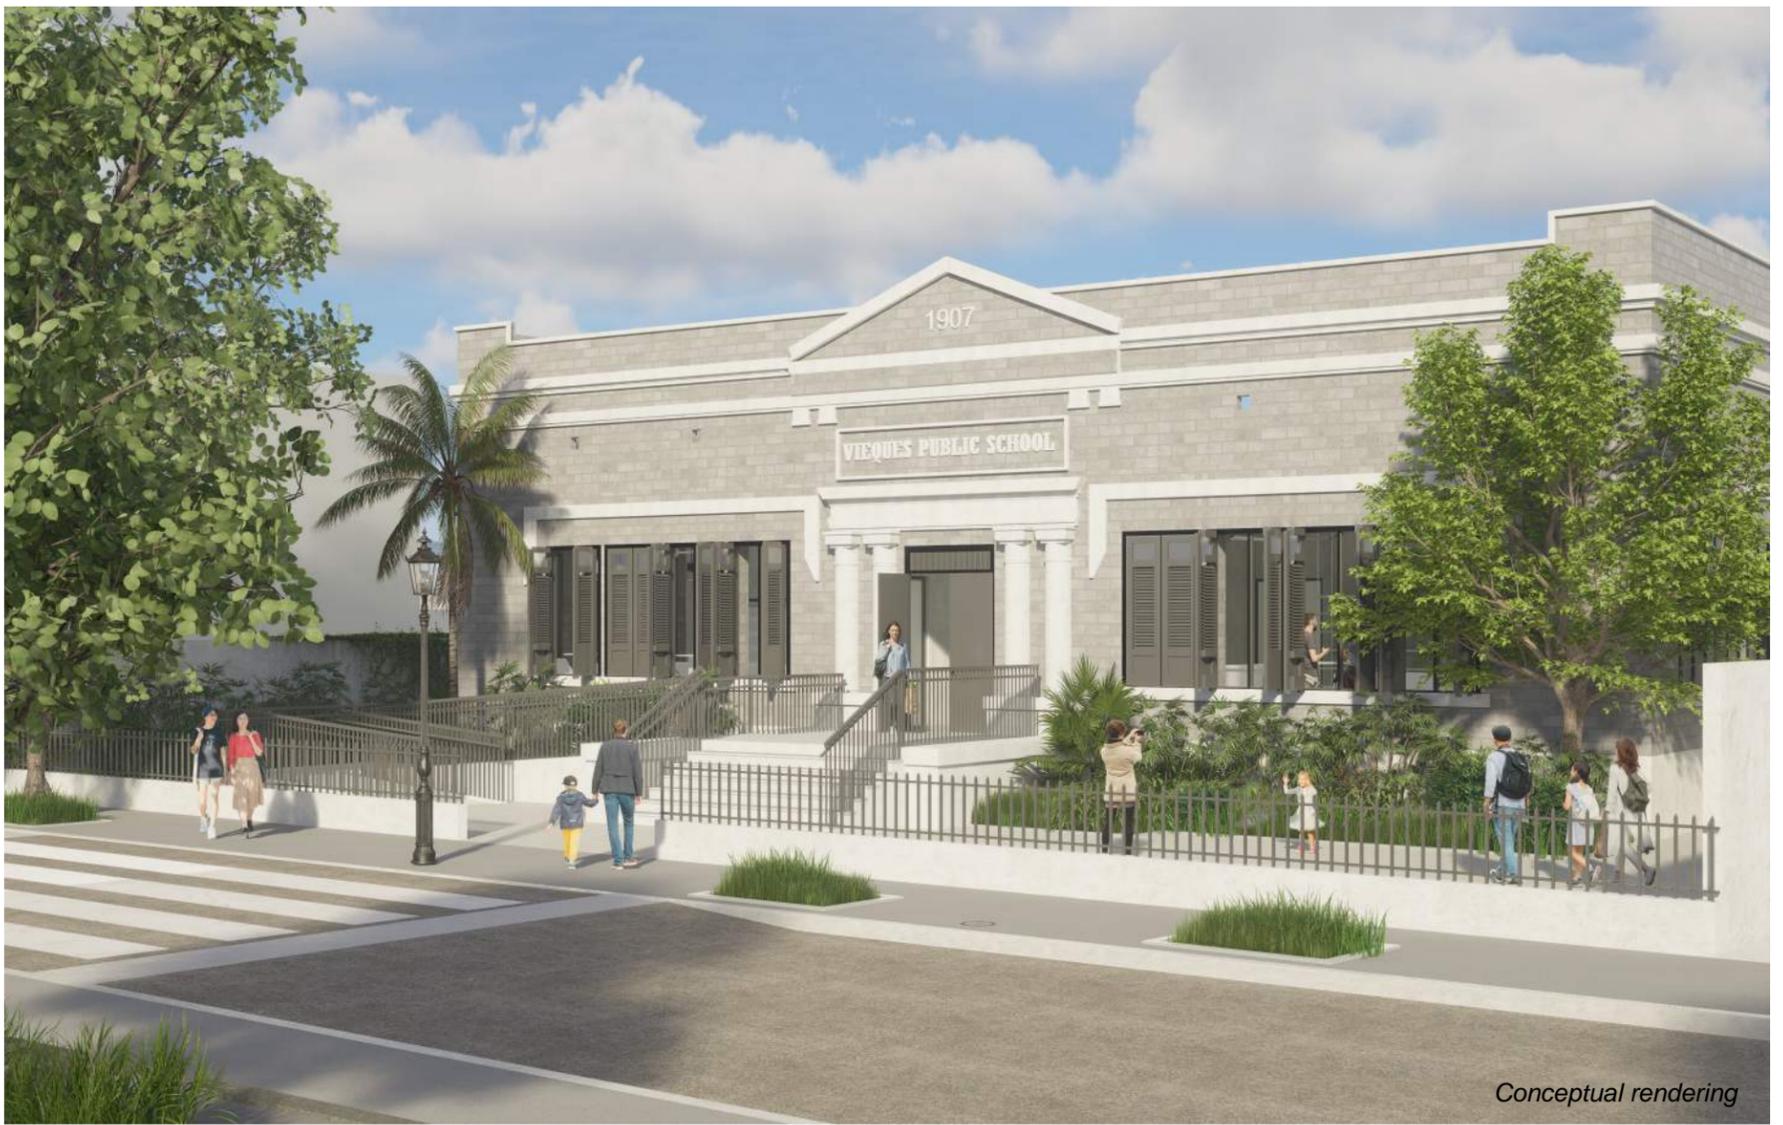
Conceptual rendering

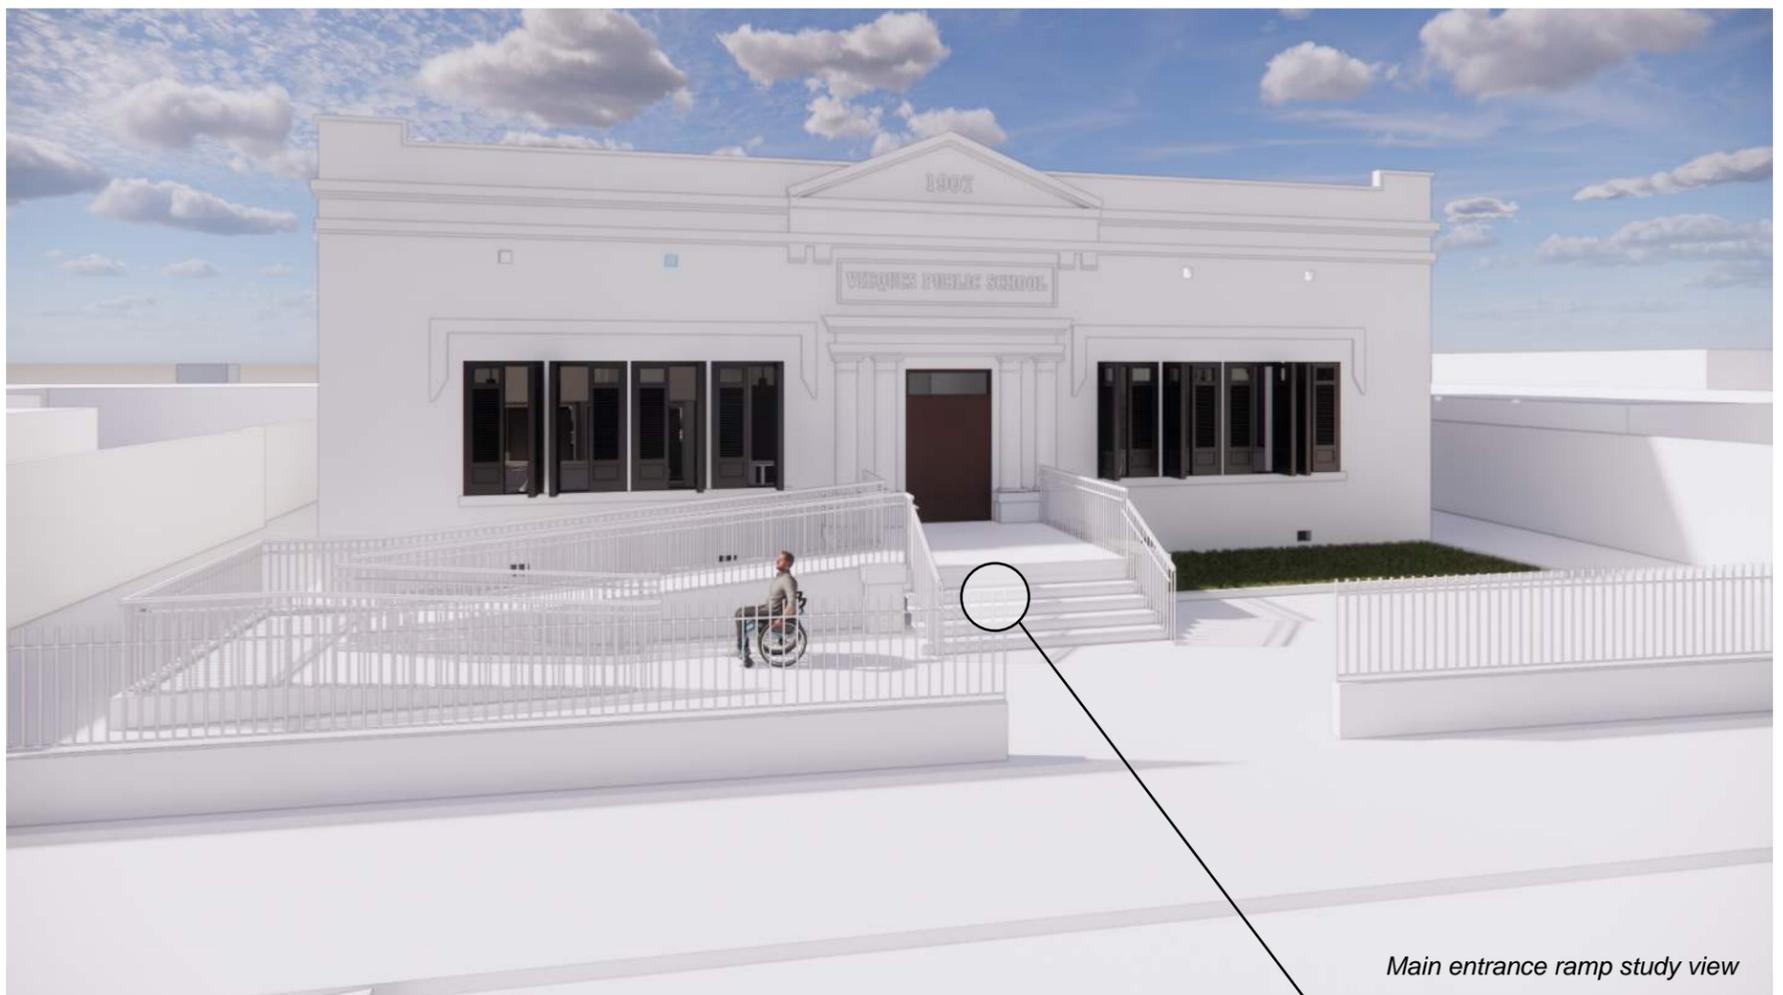
Main entrance ramp study view

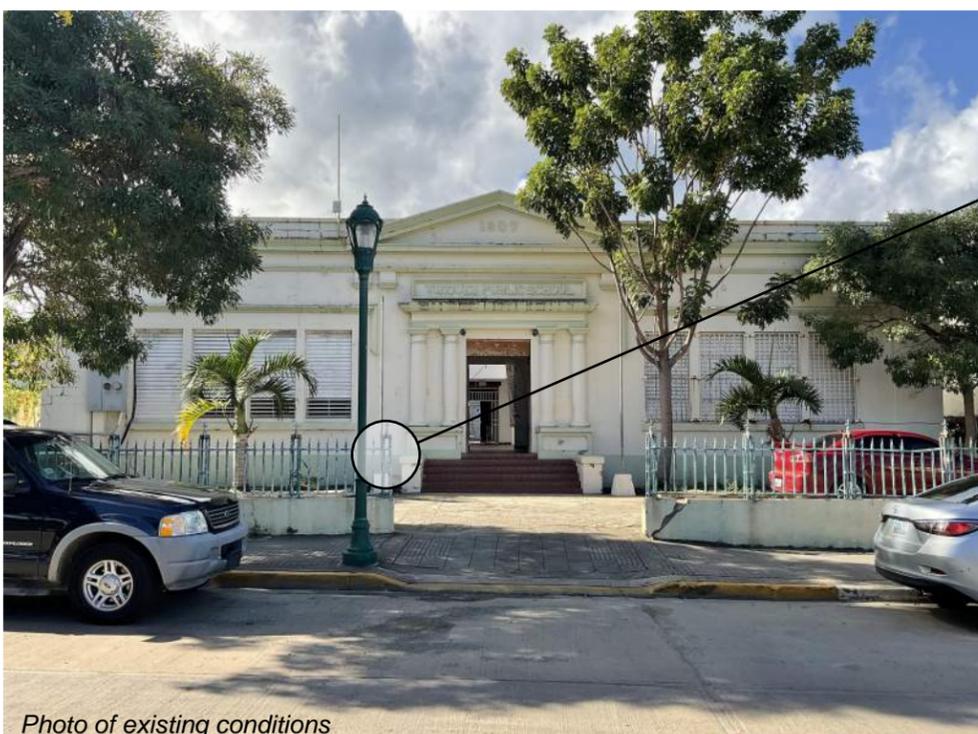
Photo of existing conditions

Historic elements from exterior existing fence to be preserved and restored and incorporated into new fence design.
