## **Environmental Review for Activity/Project that is Categorically Excluded Subject to Section 58.5**

**Project Name:** PR-CRP-000807: Mejoras a la Plaza Pública de Vieques & PR-CRP-001111: Centro Agrícola de Transformación Social y Comunitario

**Responsible Entity:** Puerto Rico Department of Housing (PRDOH)

**Preparer:** Angel Garcia PE, Sr. Environmental Engineer at AG Environmental PSC

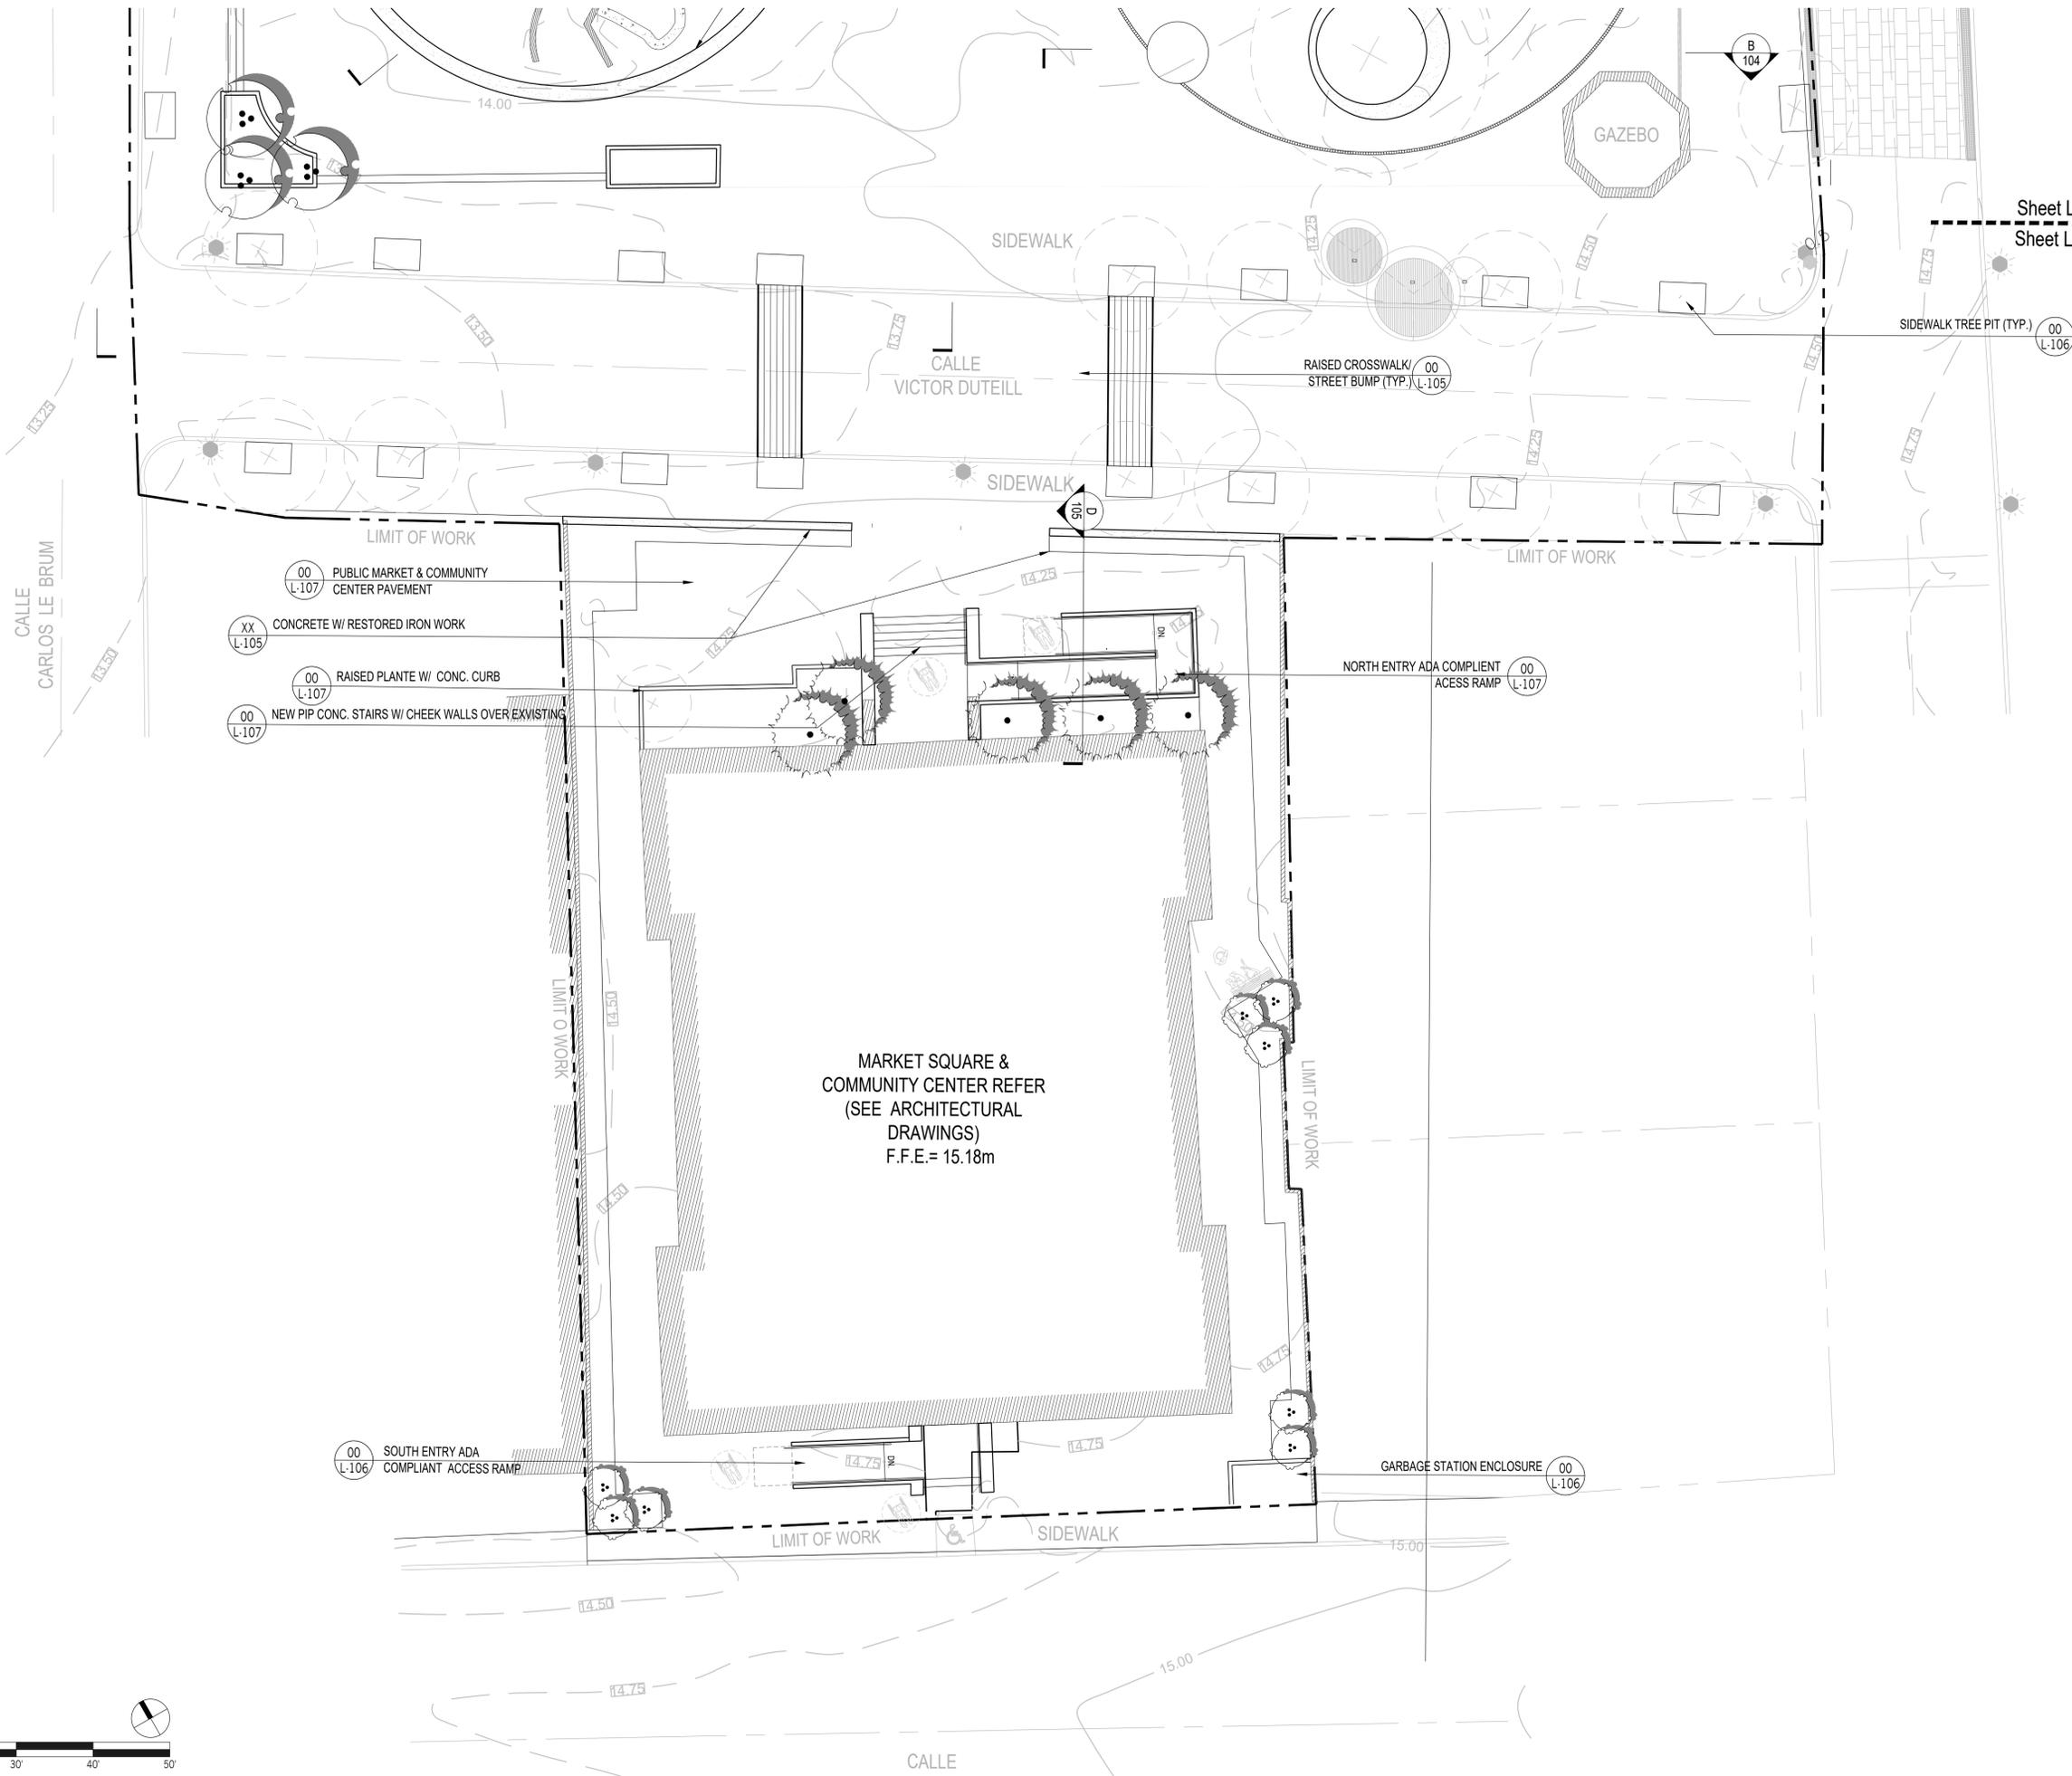
- 00 L-107 PUBLIC MARKET & COMMUNITY CENTER PAVEMENT
- XX L-105 CONCRETE W/ RESTORED IRON WORK
- 00 L-107 RAISED PLANTE W/ CONC. CURB
- 00 L-107 NEW PIP CONC. STAIRS W/ CHEEK WALLS OVER EXISTING

MARKET SQUARE & COMMUNITY CENTER REFER (SEE ARCHITECTURAL DRAWINGS)  
 F.F.E. = 15.18m

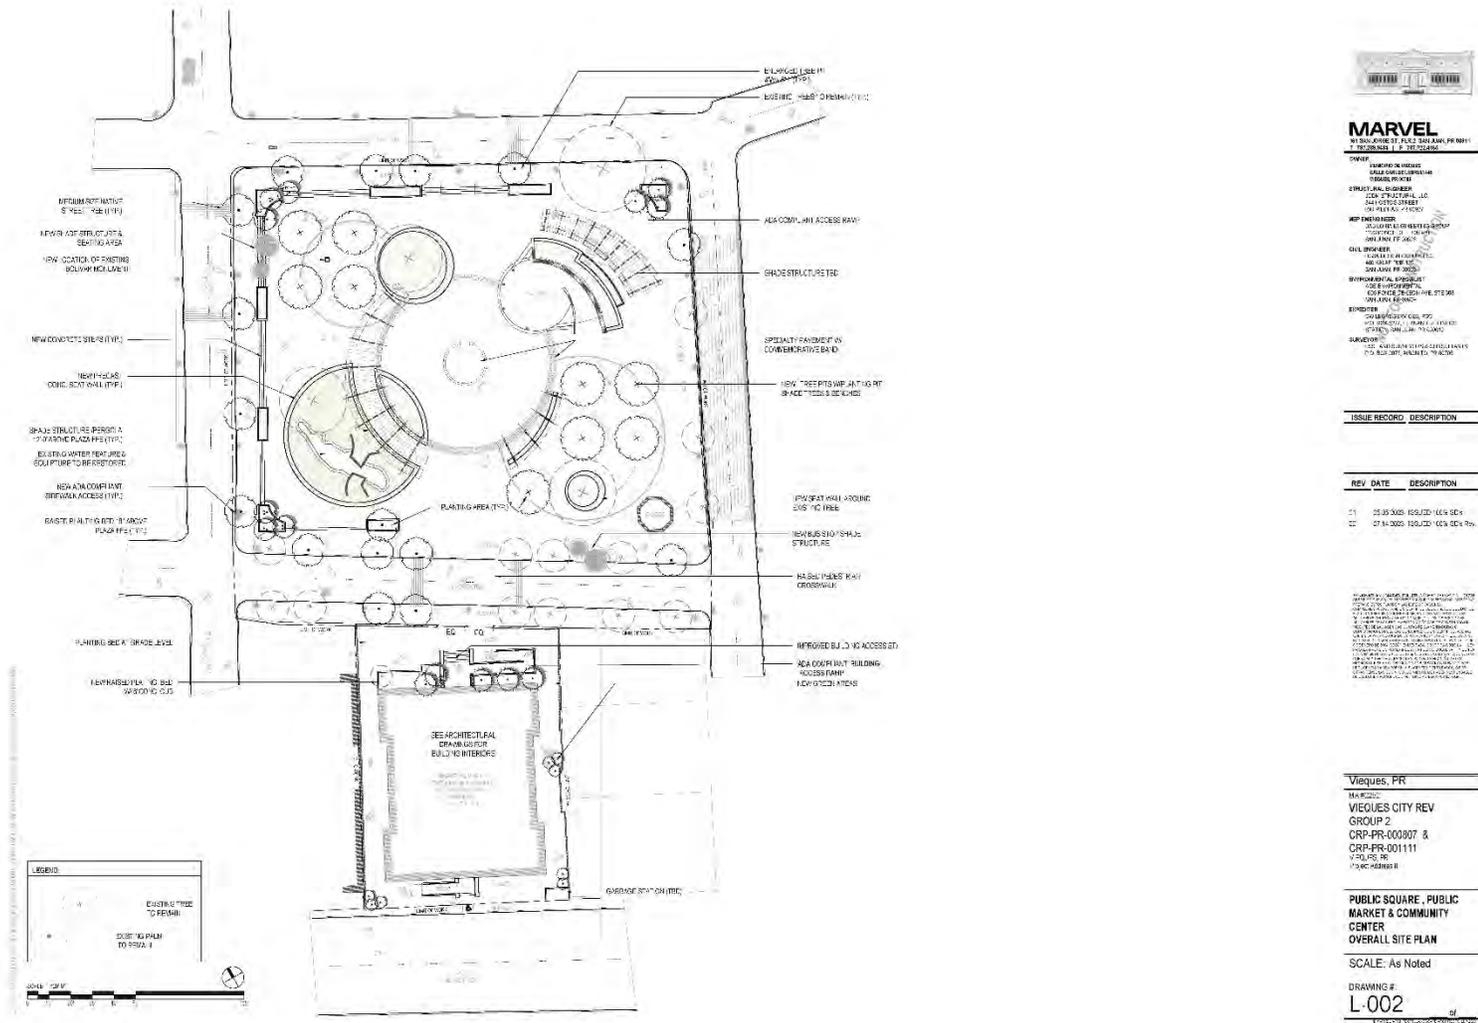
Figure 5 Undertaking General Site Plan

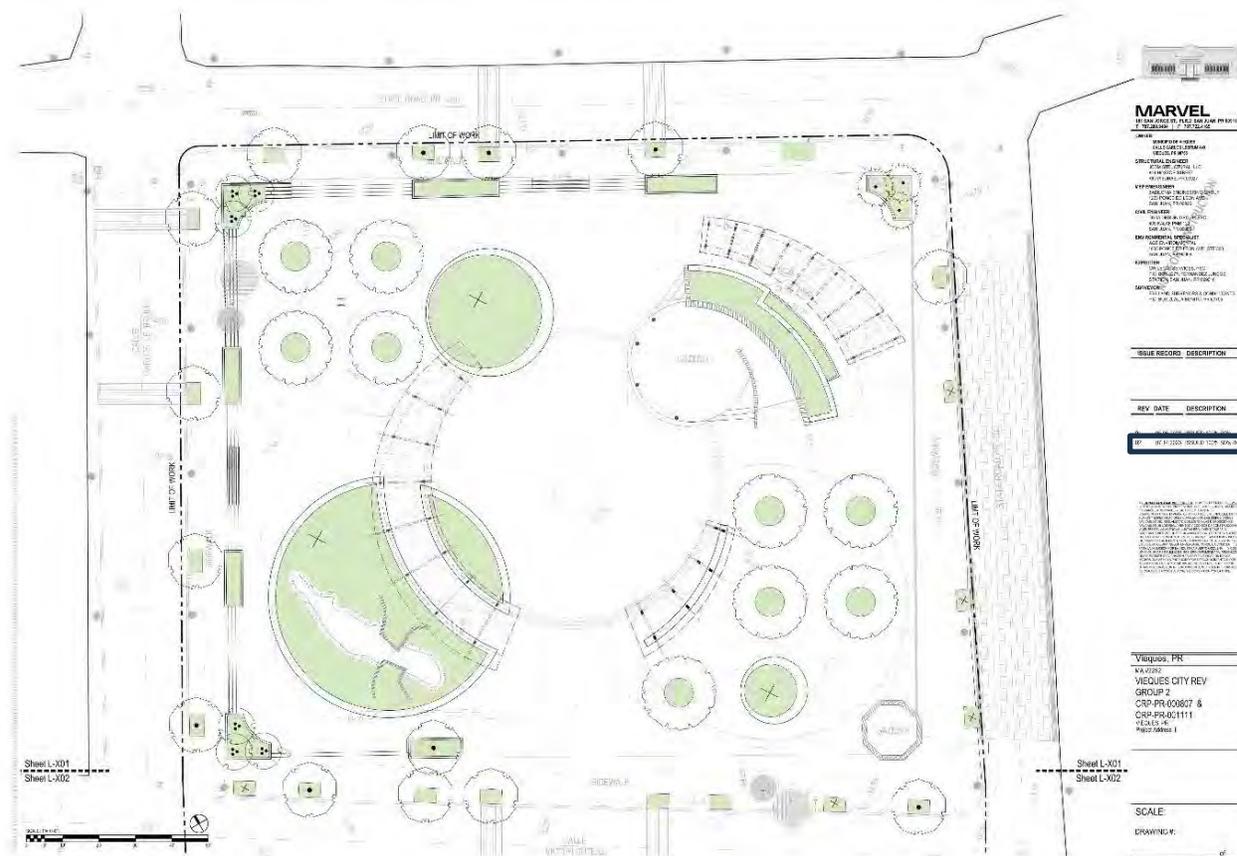
The improvements to the Vieques Public Plaza will require electrical & plumbing adjustments and modifications to restore the existing water feature to its original working conditions and the provision of new electrical outlets, internet services, replacement of outdoor-grade speakers, plumbing and electrical hookups throughout the Plaza, a public Wi-Fi system, new lighting system and urban furniture.

Figure 6 PR-CRP-000807 Vieques Public Plaza, proposed overall site plan.

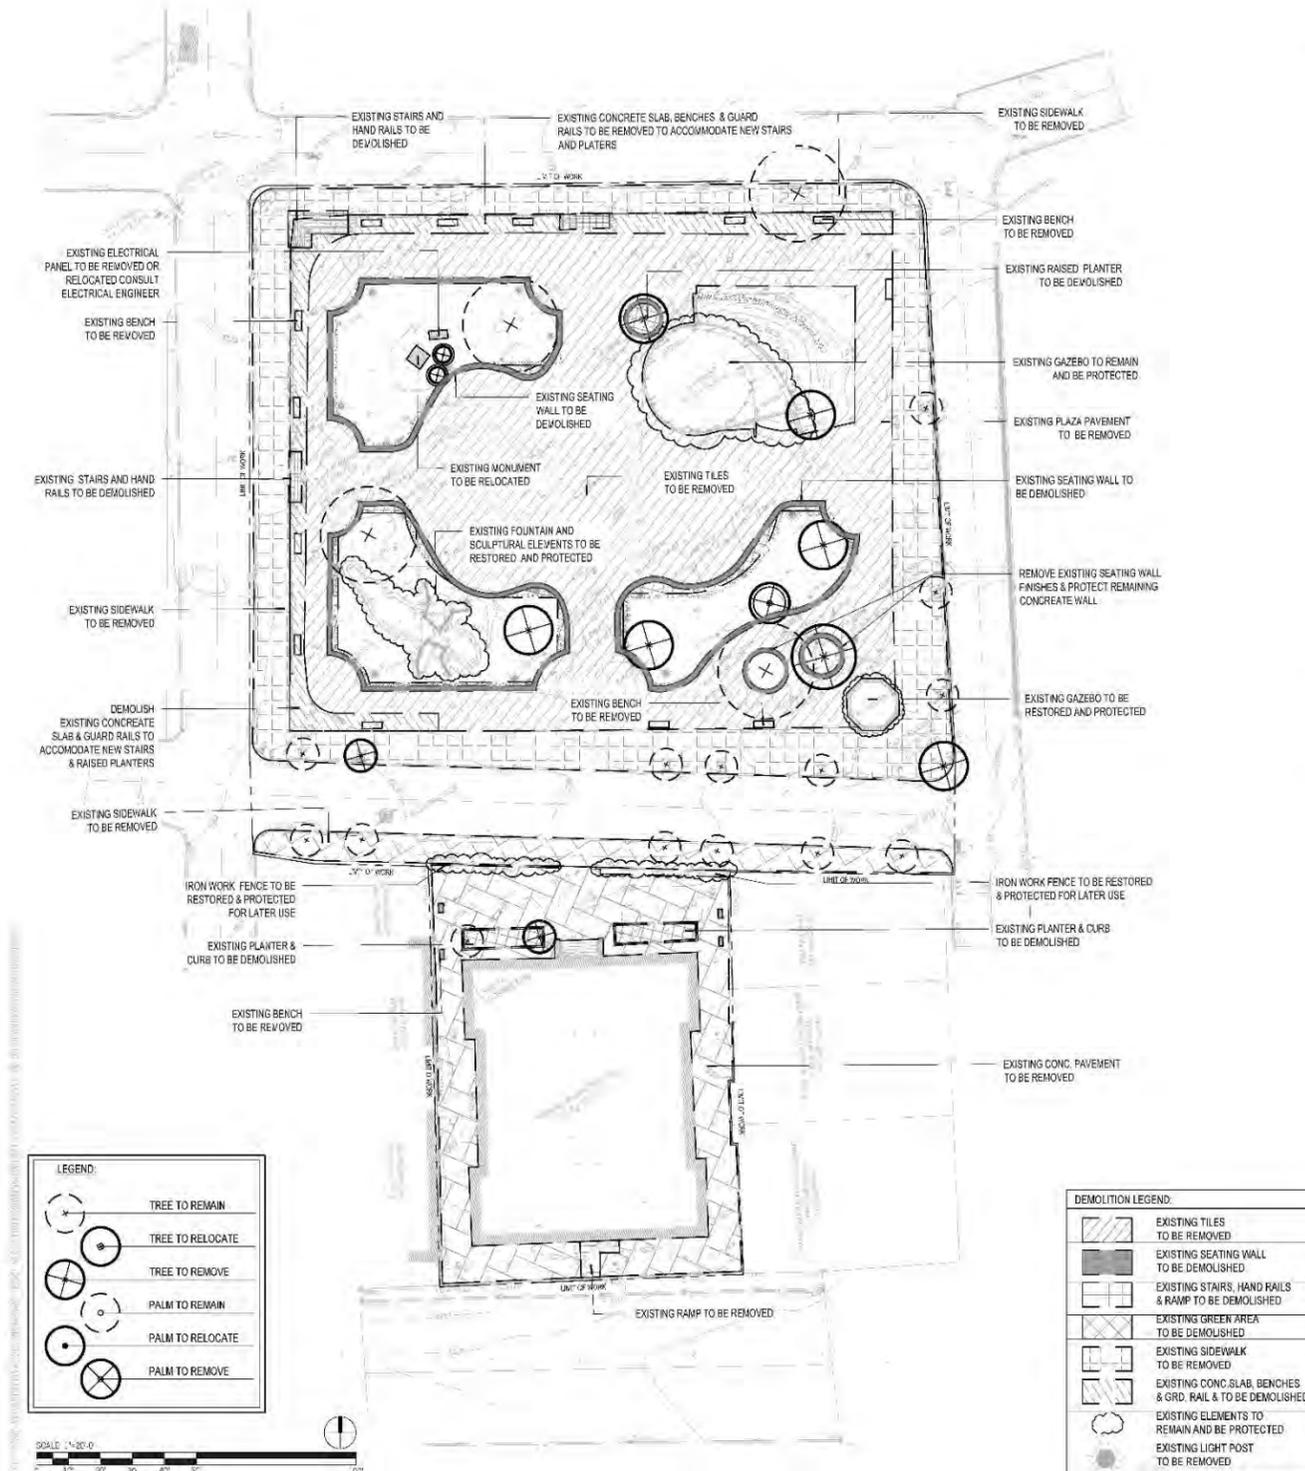
<b>Demolition:</b>			
Existing Wall (Luis Munoz Rivera Street)	1	115 SF x 12"	115
Existing Planter Curb	1	58 SF x 12"	58
<b>New Construction:</b>			
New Raised Planter Wall	1	58 SF x 12"	
New Stairs and ADA Ramp	2	550 SF x 18"	1,193
		245 SF x 18"	
New Tree Pit	2	24 SF x 18"	72
New Concrete Wall and Slab	1	41 SF x 18"	62

Figure 9 General demolition plan for the undertakings (taken from the 30% plans provided)

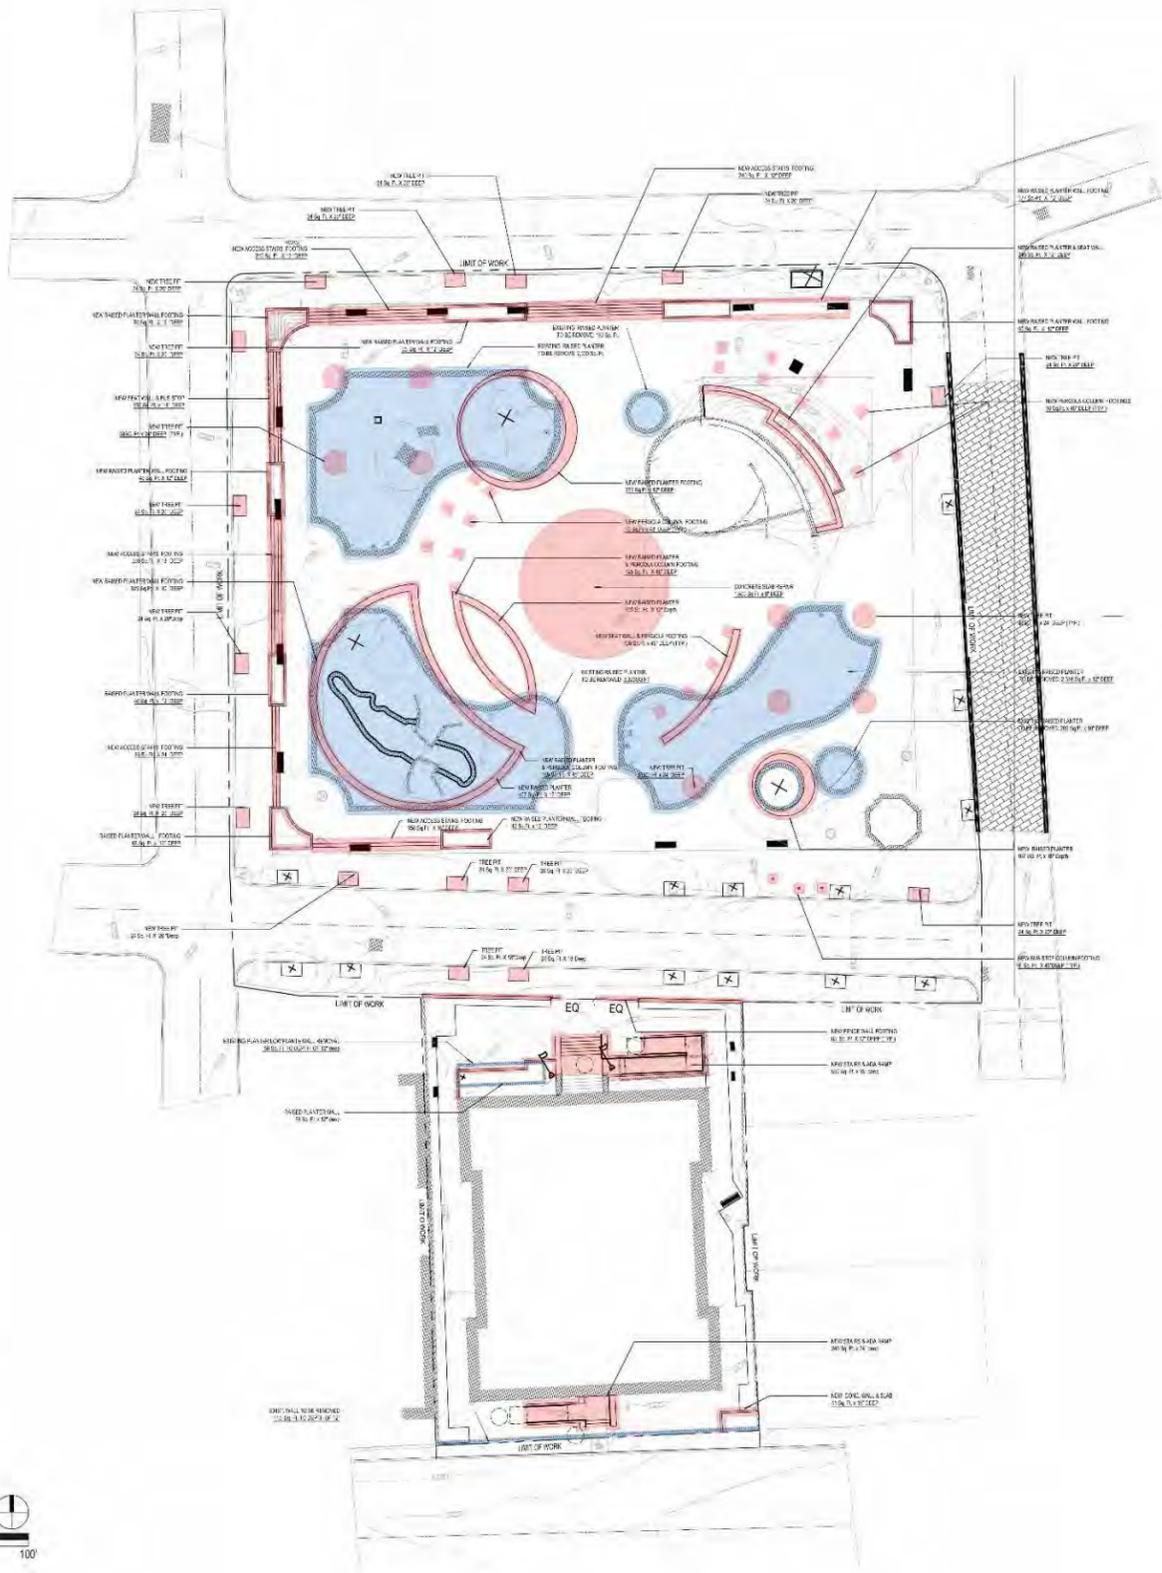
**LEGEND:**  
 GROUND DISTURBANCE ACTIVITIES ASSOCIATED TO PROPOSED DESIGN  
 GROUND DISTURBANCE ACTIVITIES ASSOCIATED TO REMOVAL AND/OR DEMOLITION OF EXISTING ELEMENTS

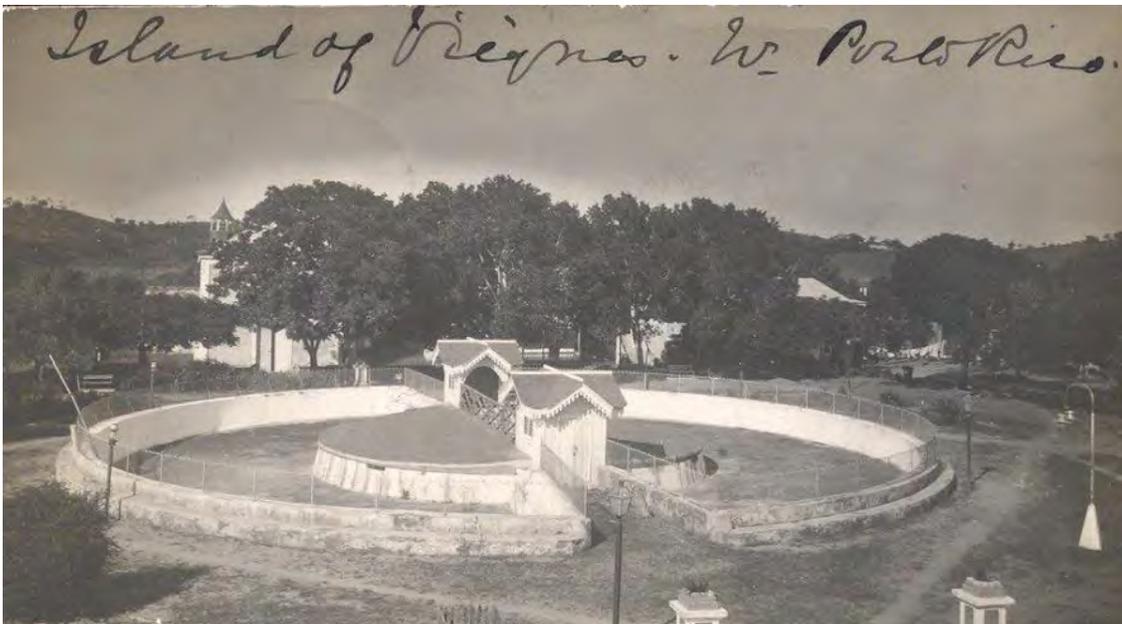
Figure 11 Photo from Rodriguez Archives circa 1909 showing the water well and associated structures.

Plaza with a well-defined in the central area of the "Plaza" . This well is the entrance to the "aljibe" that is located under the square. The cistern structure was built in 1869 and it seems to still be preserved under the Luis Muñoz Rivera Plaza.

Figure 19 Image prepared by the author with the cistern and other features in 1899 based on plan in figure 12. The circle in the middle is the actual cistern, surrounded by the entrances and walls. Those features can be seen in figure 11 photograph.

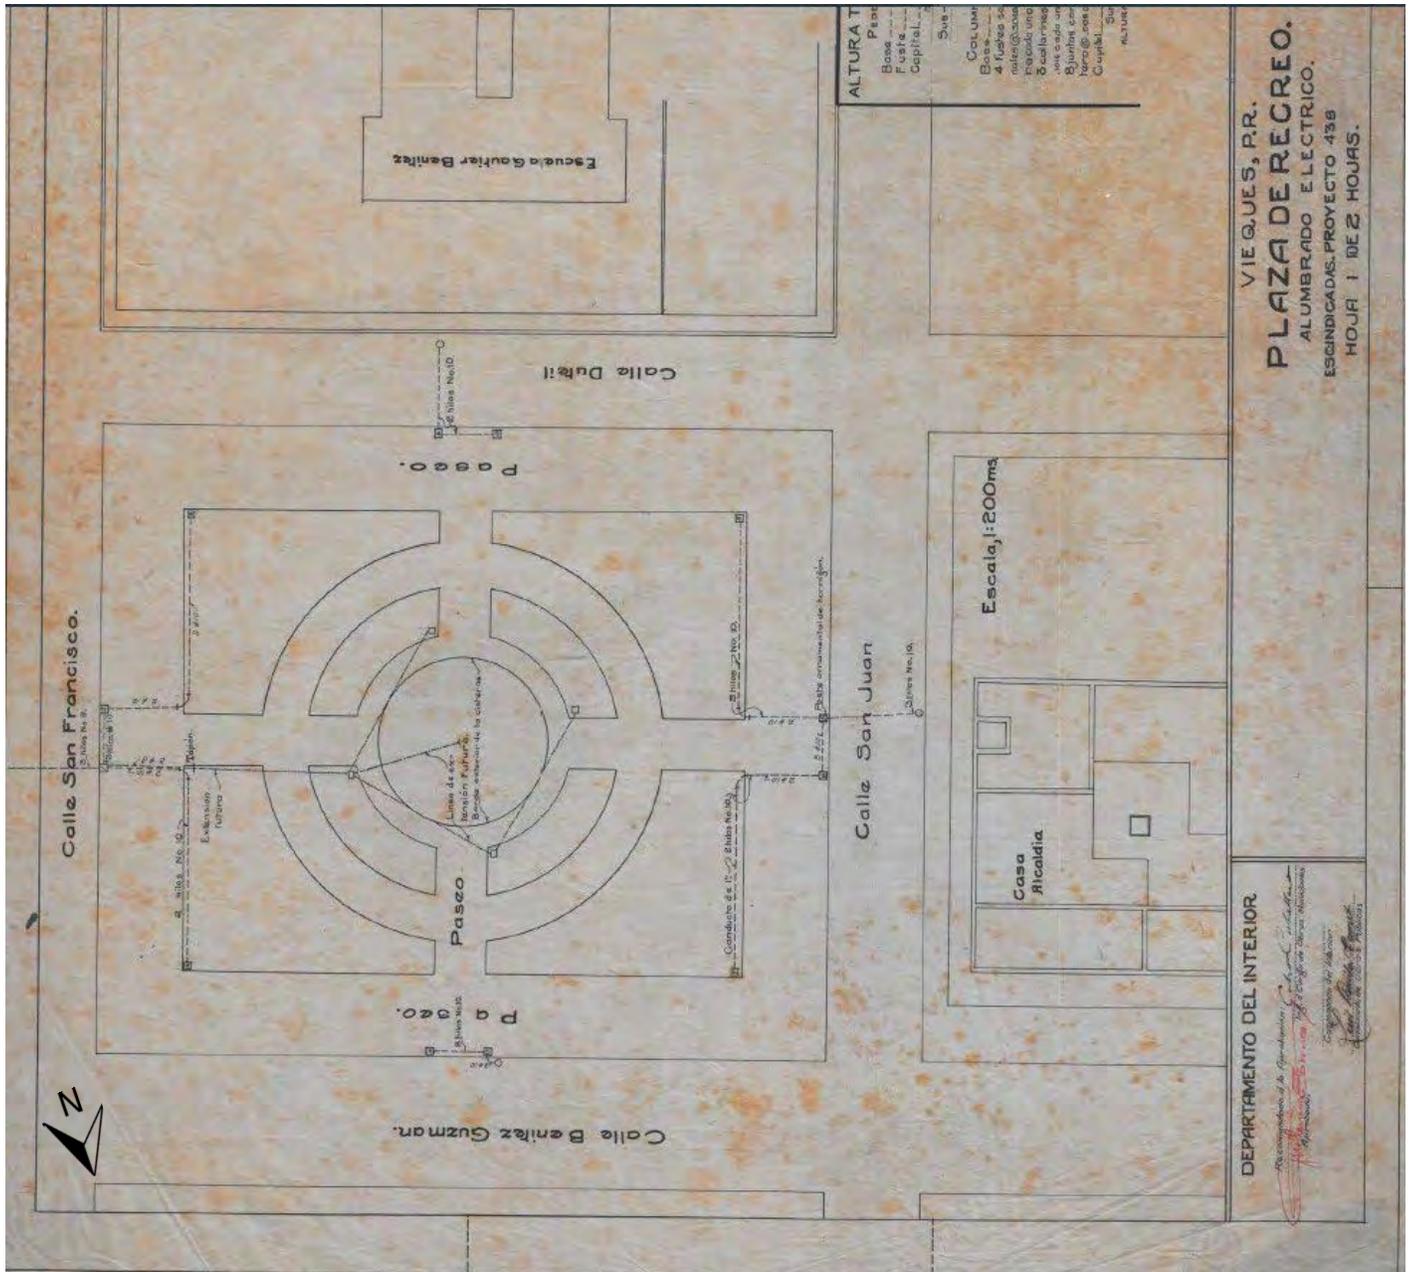
Figure 12 Plan dated 1919 for the lighting to be located in the Muñoz Rivera Townsquare (for Vieques Publica Plaza) it also shows the footprint of the Gautier Benitez School (Vieques Public School). At that moment, the street to the west of the plaza was named San Juan, now it is Carlos Lebron Street. The other streets remain the same.

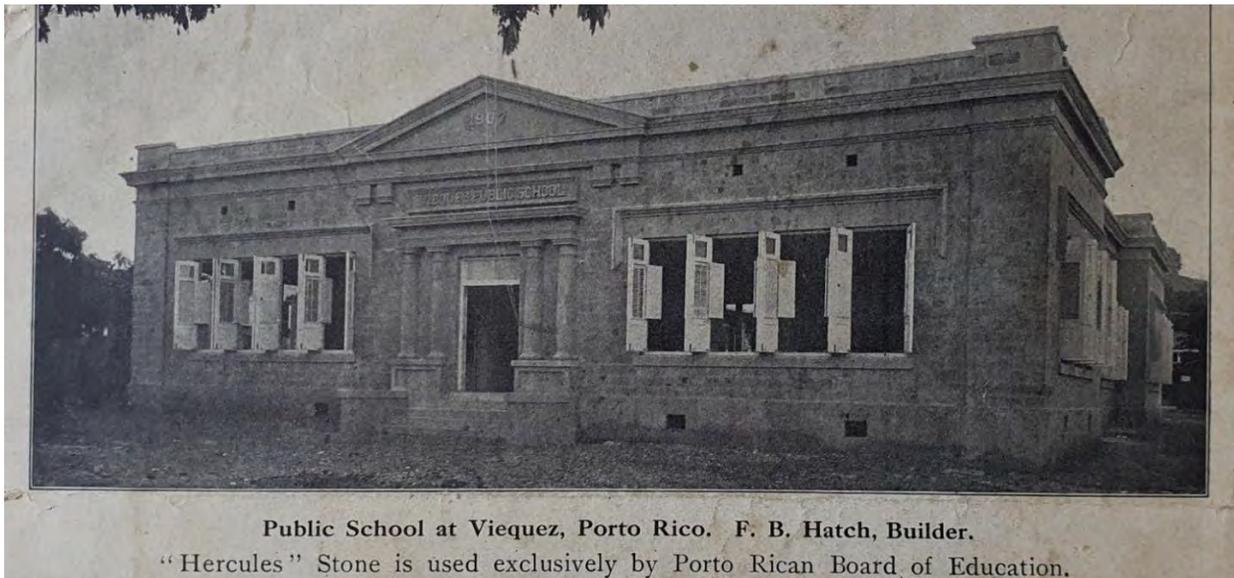
Figure 13 1910 Photo showing Vieques Public School. It can be appreciated that the whole area was removed.

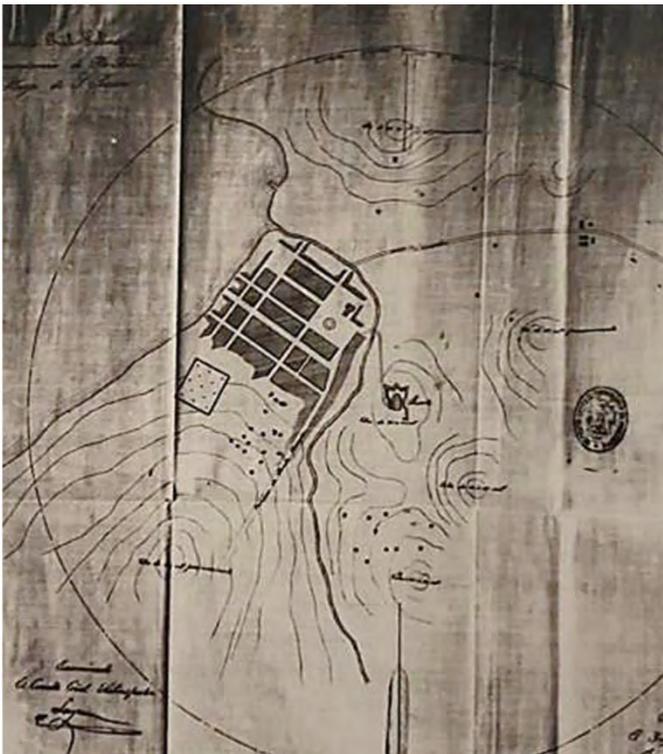
Figure 14- Map dated 1887. It only shows a dot that may be the well.

Based on the information presented by the SOIQ we prepared an analysis of the structures that were in the town square and that were demolished. According to our information the structures were built circa 1844. As we can observe in 1885 and the 1893 maps presented in the images shown in figures 13 and 14, those structures were demolished in the remodeling of the Plaza made in the 1930's. No actual document exists for that demolition was identified. Based on the photo shown in figure 15, dated circa 1940, that shows the Gazebo built in the plaza with the date 1934, we can assume that was the date of construction of that structure.

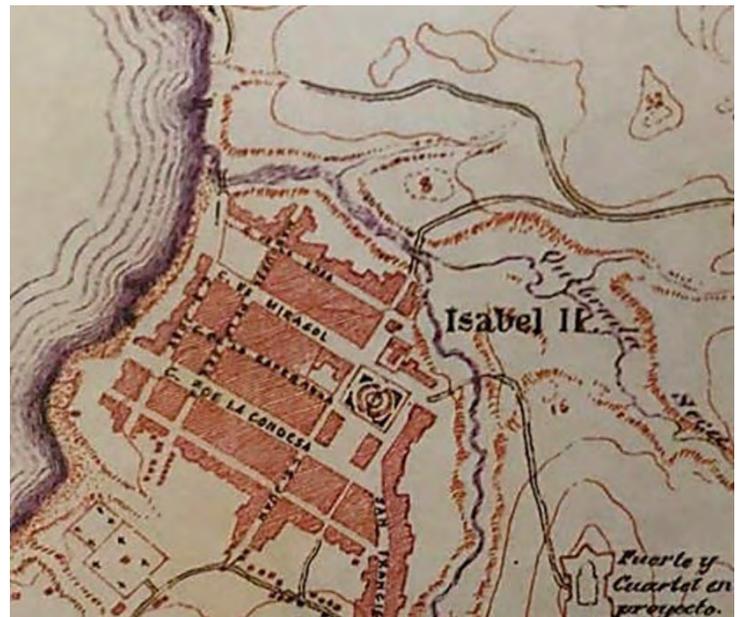
Figure 15 Fragment of the map dated 1893 showing the Isabel Segunda urban center where the plaza and the cistern is clearly identified.

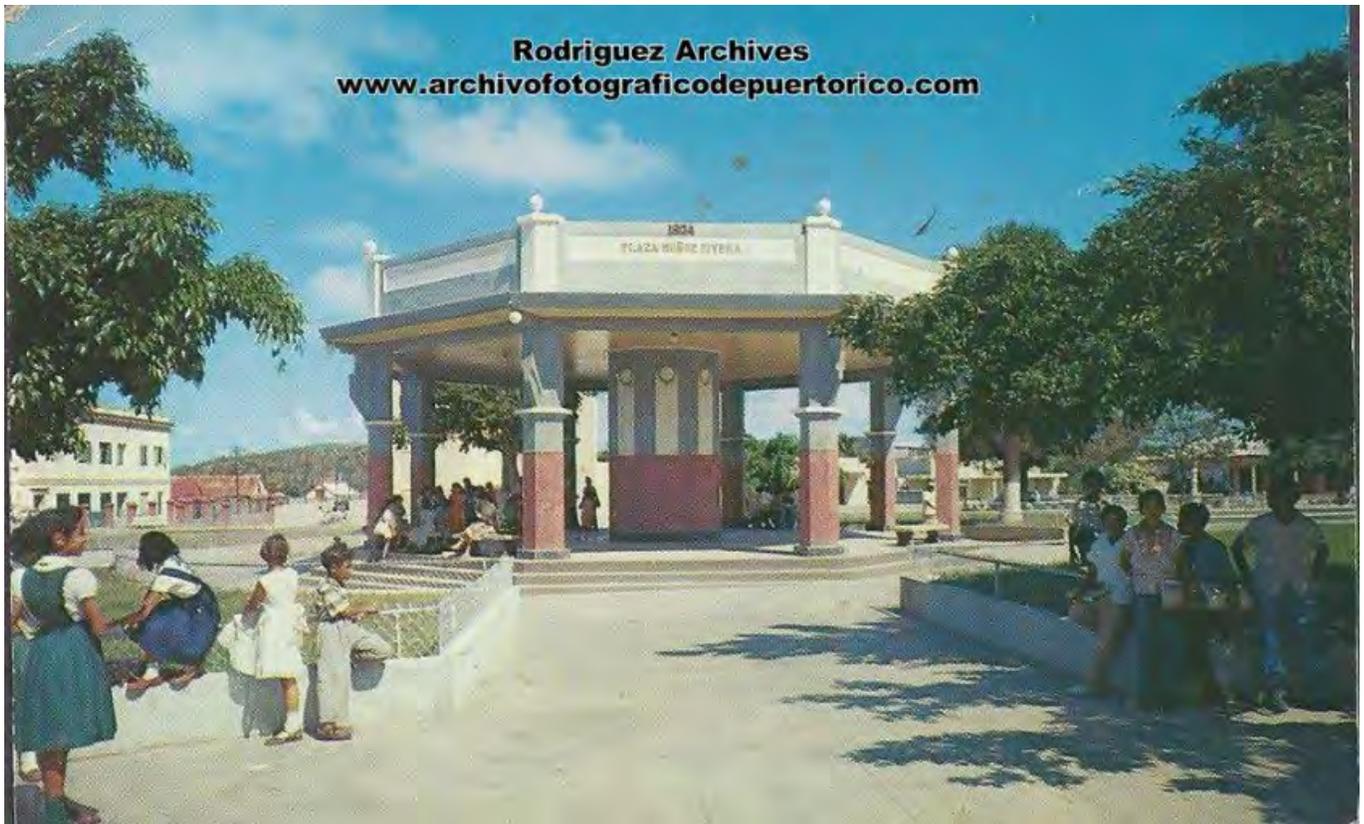
*Figure 16 Photo circa 1950's of the Gazebo where we can observe the 1934 date over the Plaza Muñoz Rivera.*

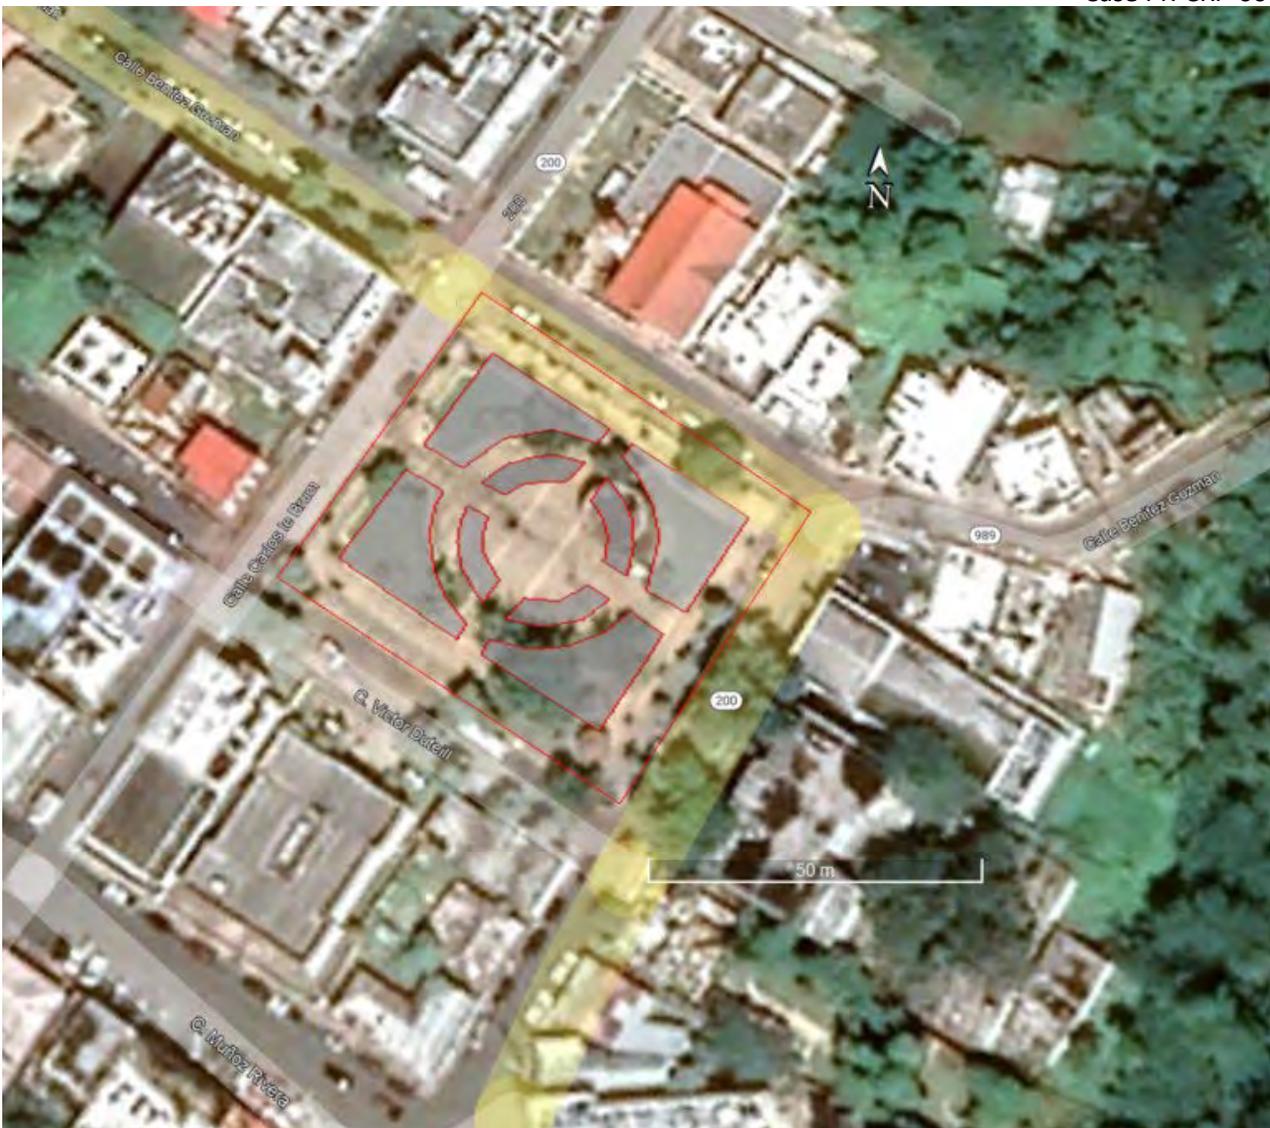
Figure 17 Footprint from the 1899 lighting plan over the 2023 satellite image. We can observe the well associated structures aligned with the planters.

An analysis using the 1899 map of the plaza was prepared. In figure 17 we can see the structures in relation to the Plaza (2019 satellite image) As we can see the structures of the cistern coincide with the footprint of the planters. In an actual photo we can observe this area coincide with the area that is sinking at the center of the plaza (Figure 18).

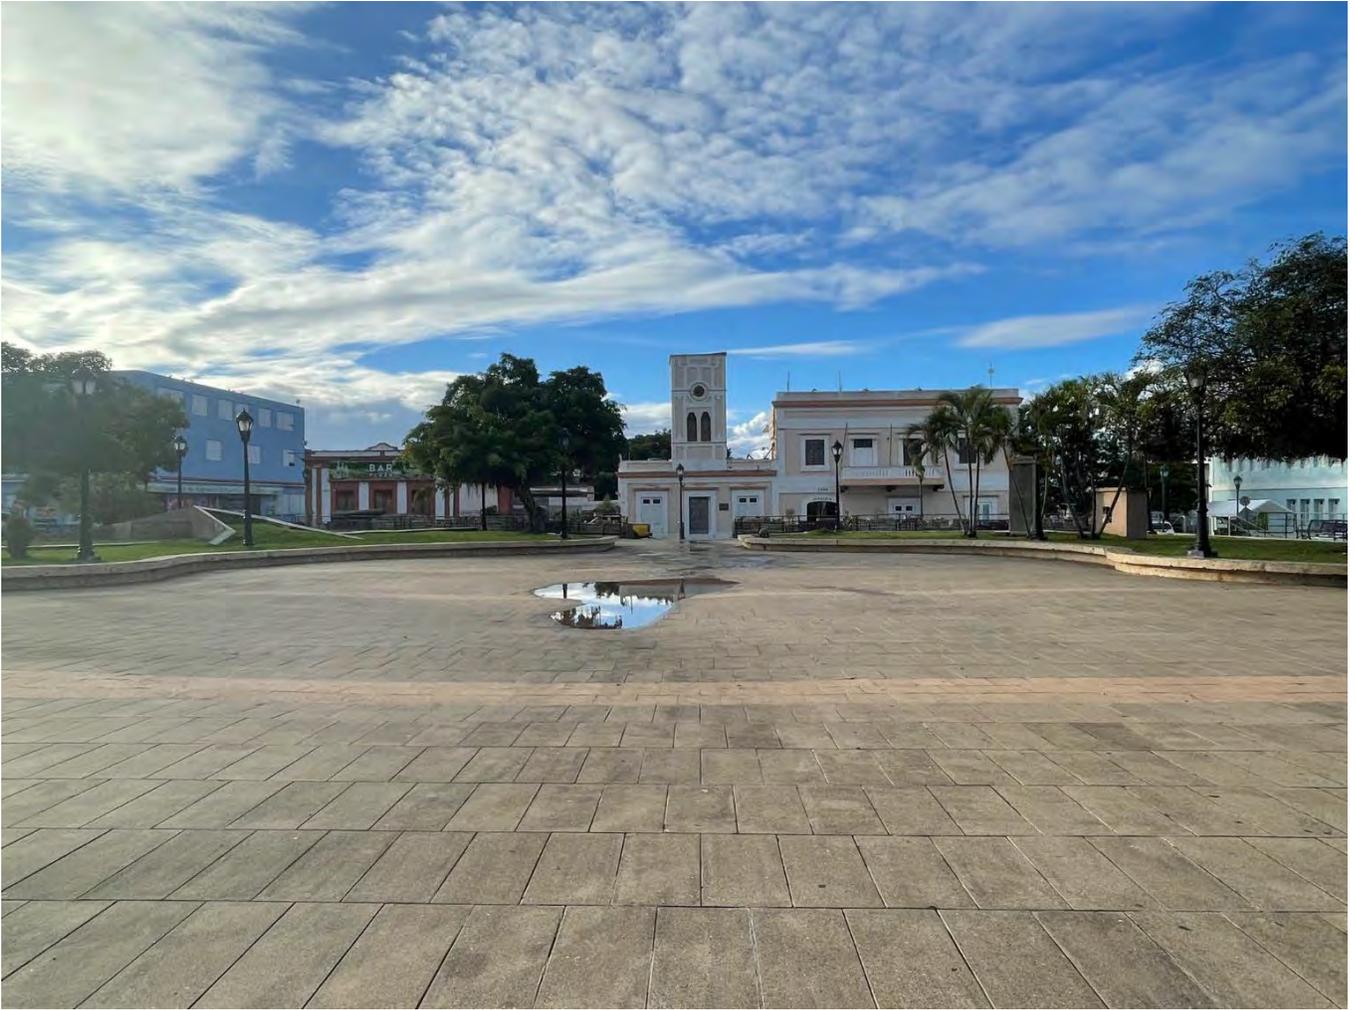
Figure 18 View of the central area of the plaza showing the area that is sinking. According with the 1899 plan this is the area where the cistern was located.

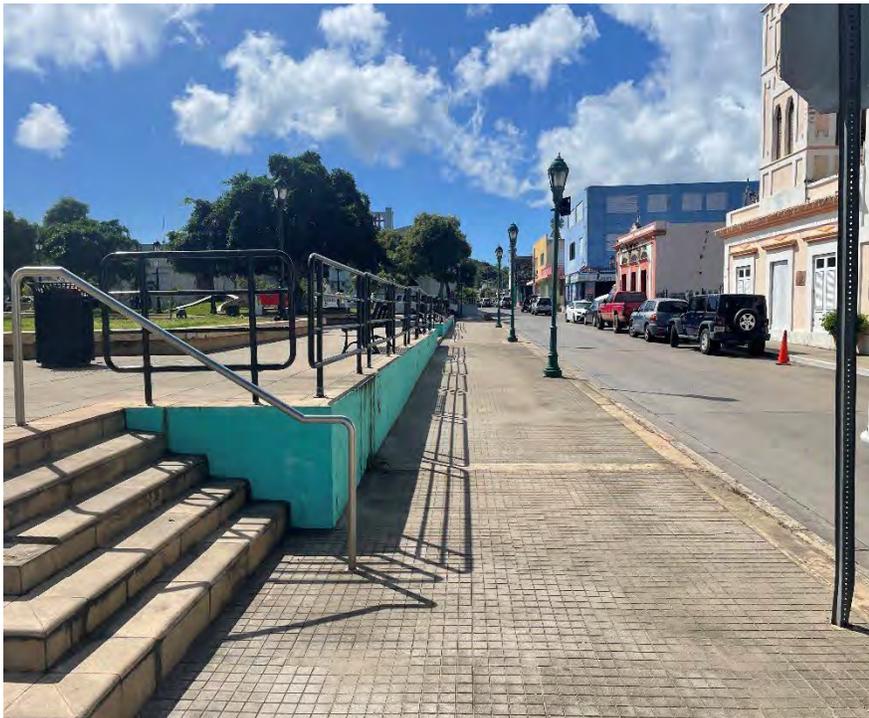
Figure 23 View of the Carlos Lebrum street and plaza (at the left of the photo). The unevenness in the slab is visible compare with the previous photo showing what was filled.

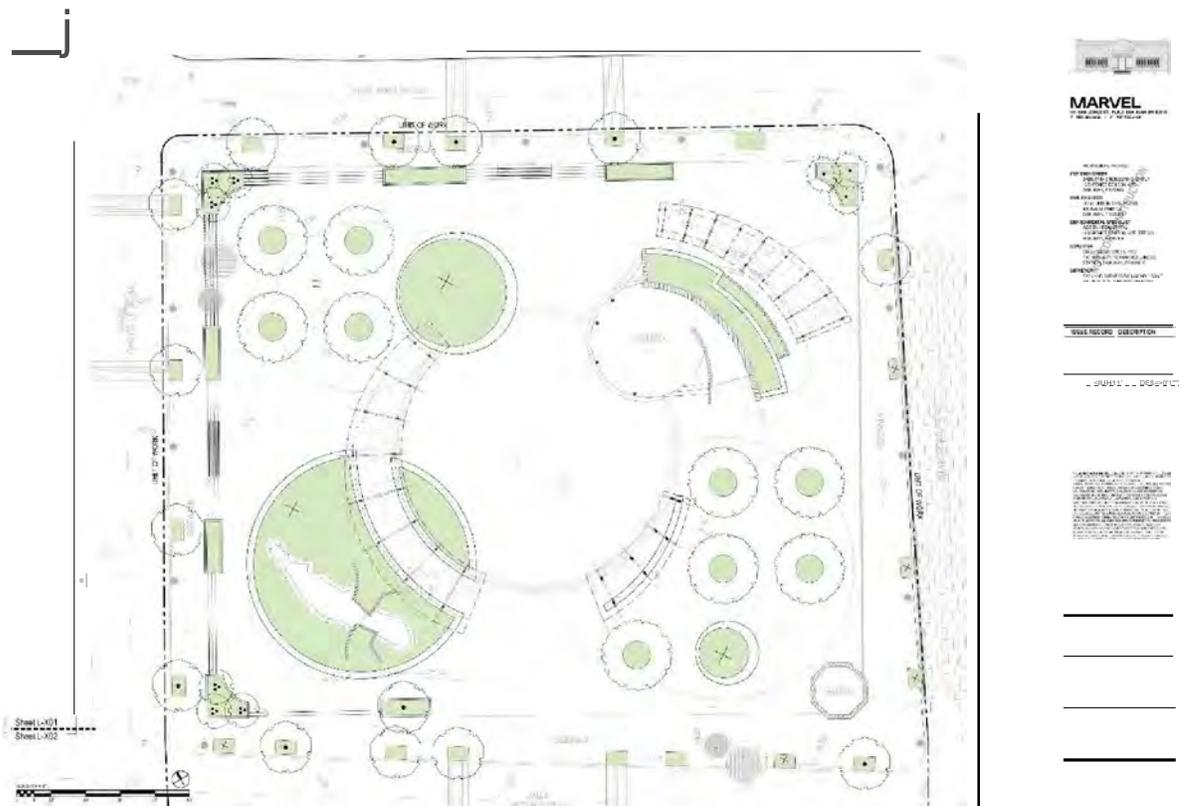
Figure 01. Vieques Public Square Proposed Overall Site Plan

The improvements proposed as part of the City Revitalization Program (See Fig. 01) are focused on bringing the plaza to current standards and expectations for a contemporary public space, addressing damages to its infrastructure, vegetation and urban elements, caused by the passage Hurricanes Irma and María. By enhancing its spatial and environmental qualities, including circulation and accessibility, leisure, and shading areas (through trellis structures and increased vegetation cover), stormwater

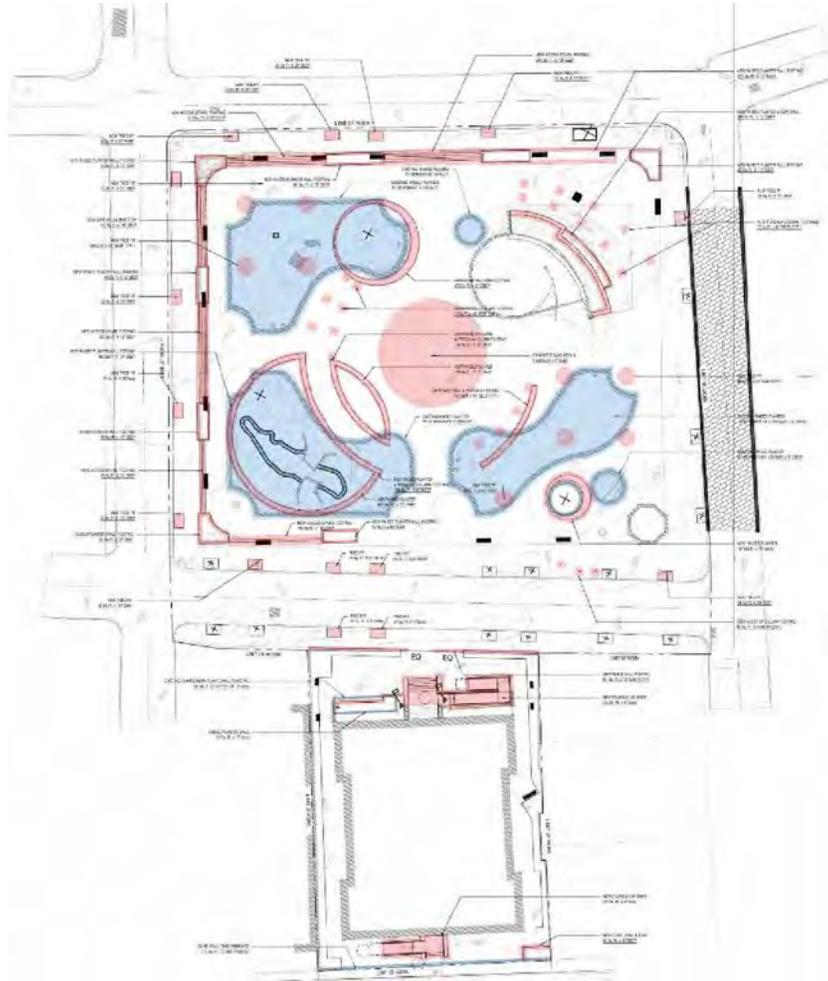
Figure 02, below, illustrates the Preliminary Excavation Diagram. Areas highlighted in red indicate ground disturbance activities associated with the proposed design interventions mentioned above. Activities related to the removal and/or demolition of existing elements are shown in blue.

Figure 02. Preliminary Excavation Diagram

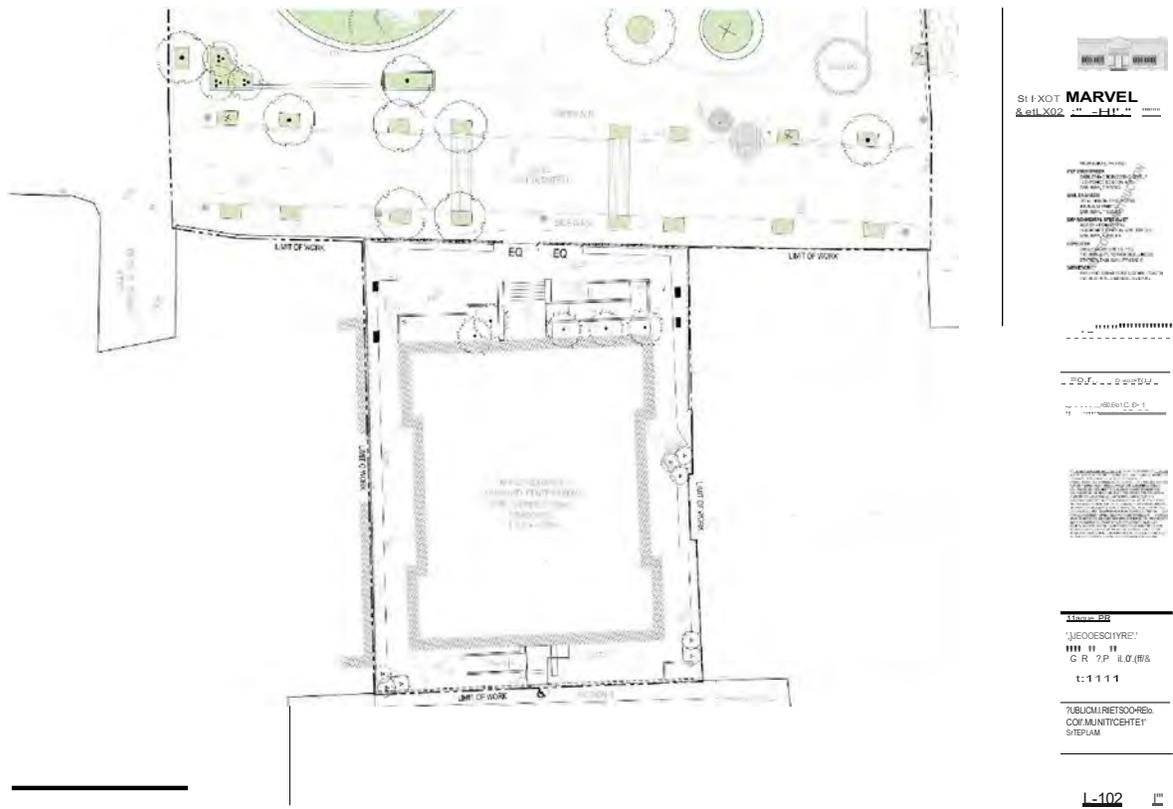
Figure 03. Market Square for Social and Community Transformation  
Proposed Overall Site Plan

The proposed intervention (See Fig. 03) will follow the Secretary of Interior's Standards for Rehabilitation and seeks to recover those character defining features that the property has. Therefore, on the building exterior, areas with spalled concrete will be repaired, and cracked or missing cornices, moldings, and window sills will be restored. The exterior walls will be altered only to recover original vent openings at the base of the building, which have been covered over time and contribute to the historic character of the structure.
