## **Environmental Review for Activity/Project that is Categorically Excluded Subject to Section 58.5**

**Project Name:** PR-CRP-000807: Mejoras a la Plaza Pública de Vieques & PR-CRP-001111: Centro Agrícola de Transformación Social y Comunitario

**Responsible Entity:** Puerto Rico Department of Housing (PRDOH)

**Preparer:** Angel Garcia PE, Sr. Environmental Engineer at AG Environmental PSC

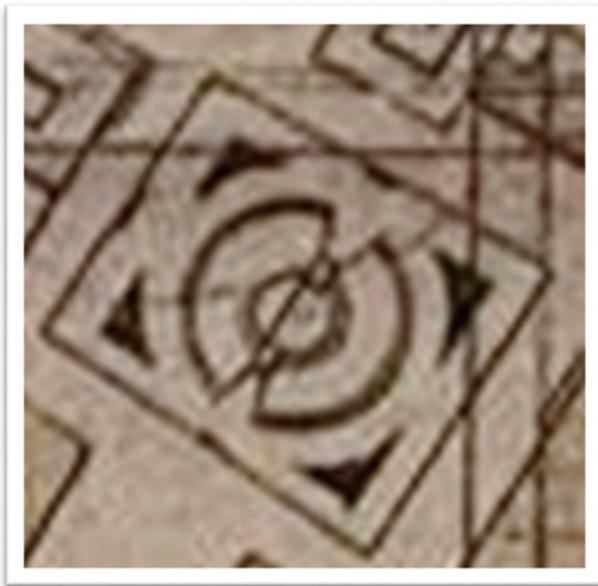
Figure 06: Detail of the design for the Public Plaza in 1893.

The 1887 plan by Jose Lagunas (Figure 03), points to the existence of the well structure in the central space of the Plaza. This structure is displaced from the center of space to the west of the Plaza esplanade. In the plans of Isabel II of 1893 and 1898, the details of the pattern of the original design of the Plaza Publica de Vieques are clearly observed (Figure 04, 05 and 06). Below, a 1900 blueprint made by the American government using information of an 1845 map, showing the plaza and the well already built (Figure 07), can be viewed.<sup>11</sup>

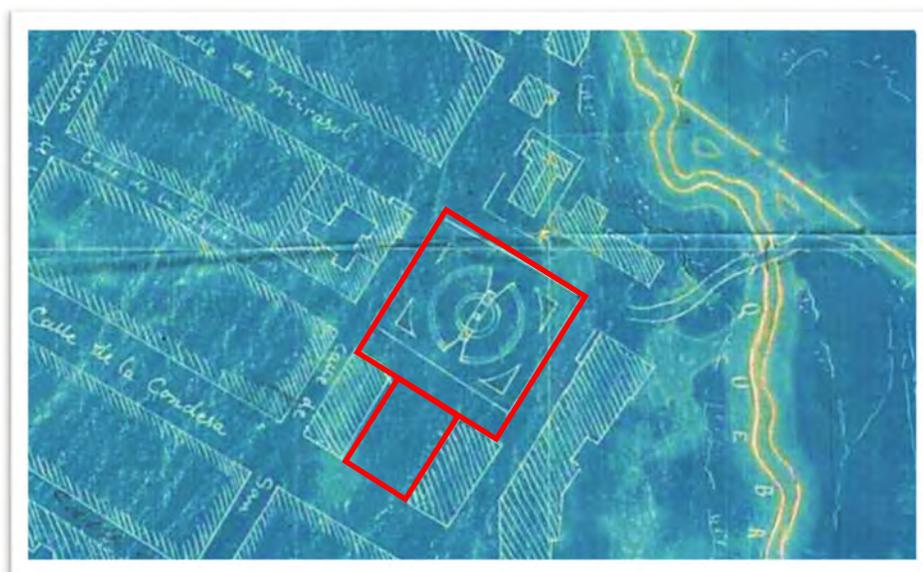
Figure 07: Fragment of a 1900 blueprint of Vieques island based on a Spanish map of 1845. Please observe the town square is delimited and the well and associated structures were built.<sup>12</sup>

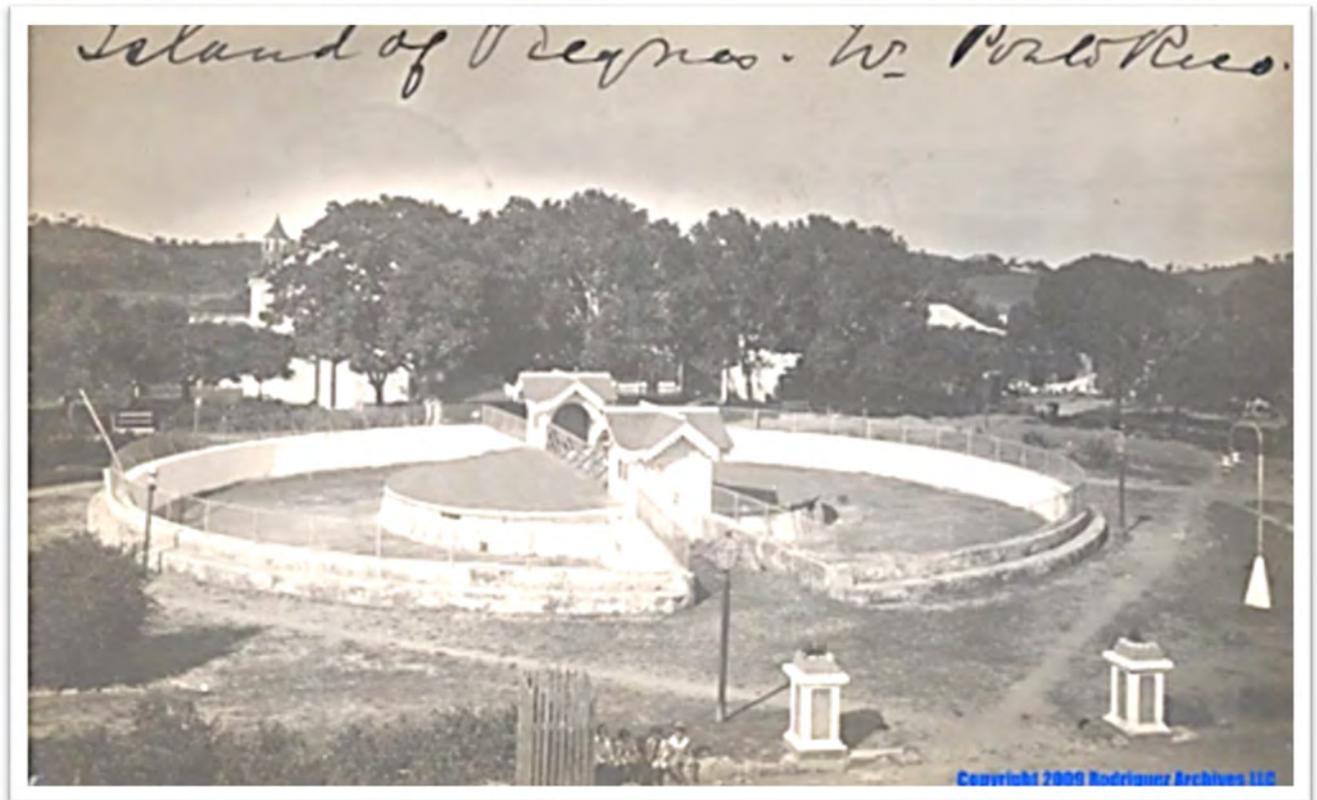
Figure 09: This 1909 photograph shows the details of the design and structure of the well of the Plaza de Isabel Segunda in Vieques. The Plaza continued as an embankment until the 1920s.<sup>14</sup> In the aerial photograph of 1936 the Plaza de Isabel Segunda is already paved.

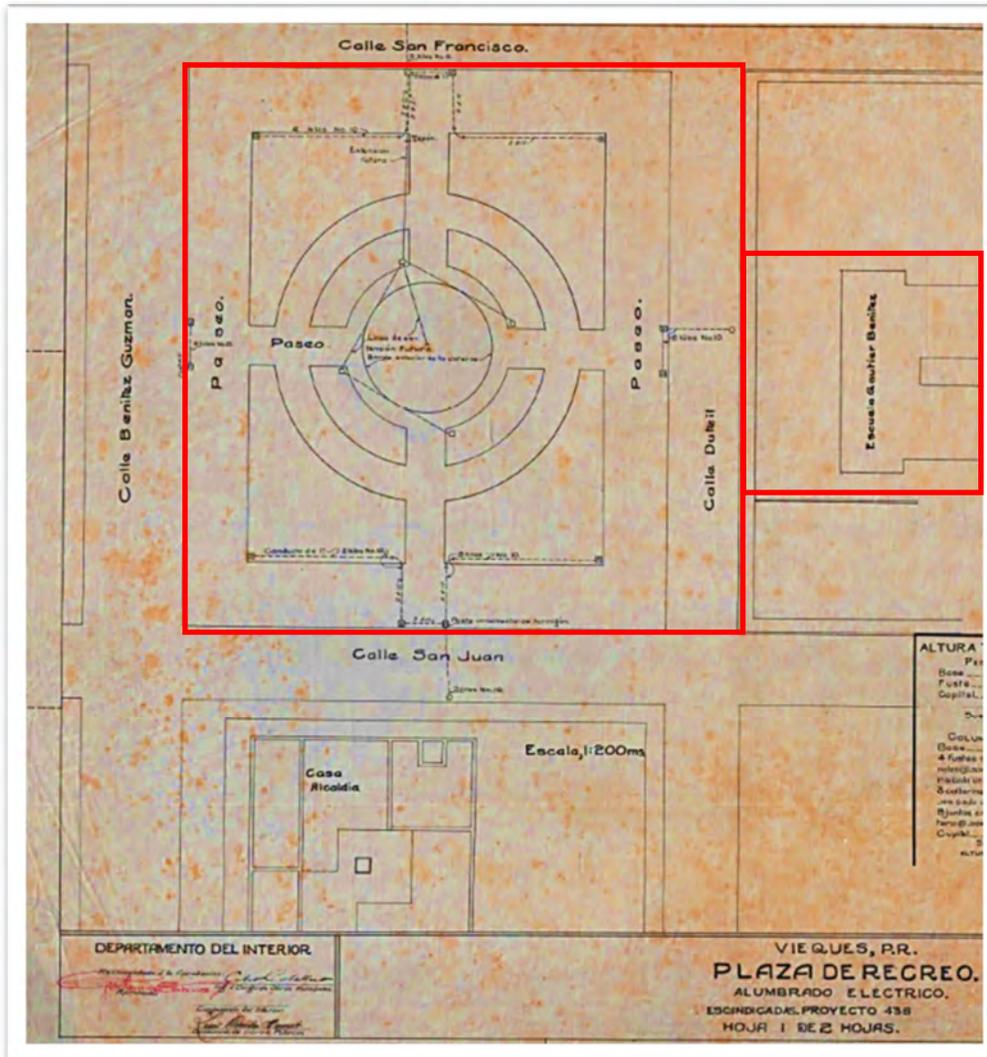
Figure 10: A 1919 Department of the Interior project for "Plaza de Recreo Electric Lighting", AGPR. The aerial photograph of 1936, shows the new design of the Plaza de Recreo.

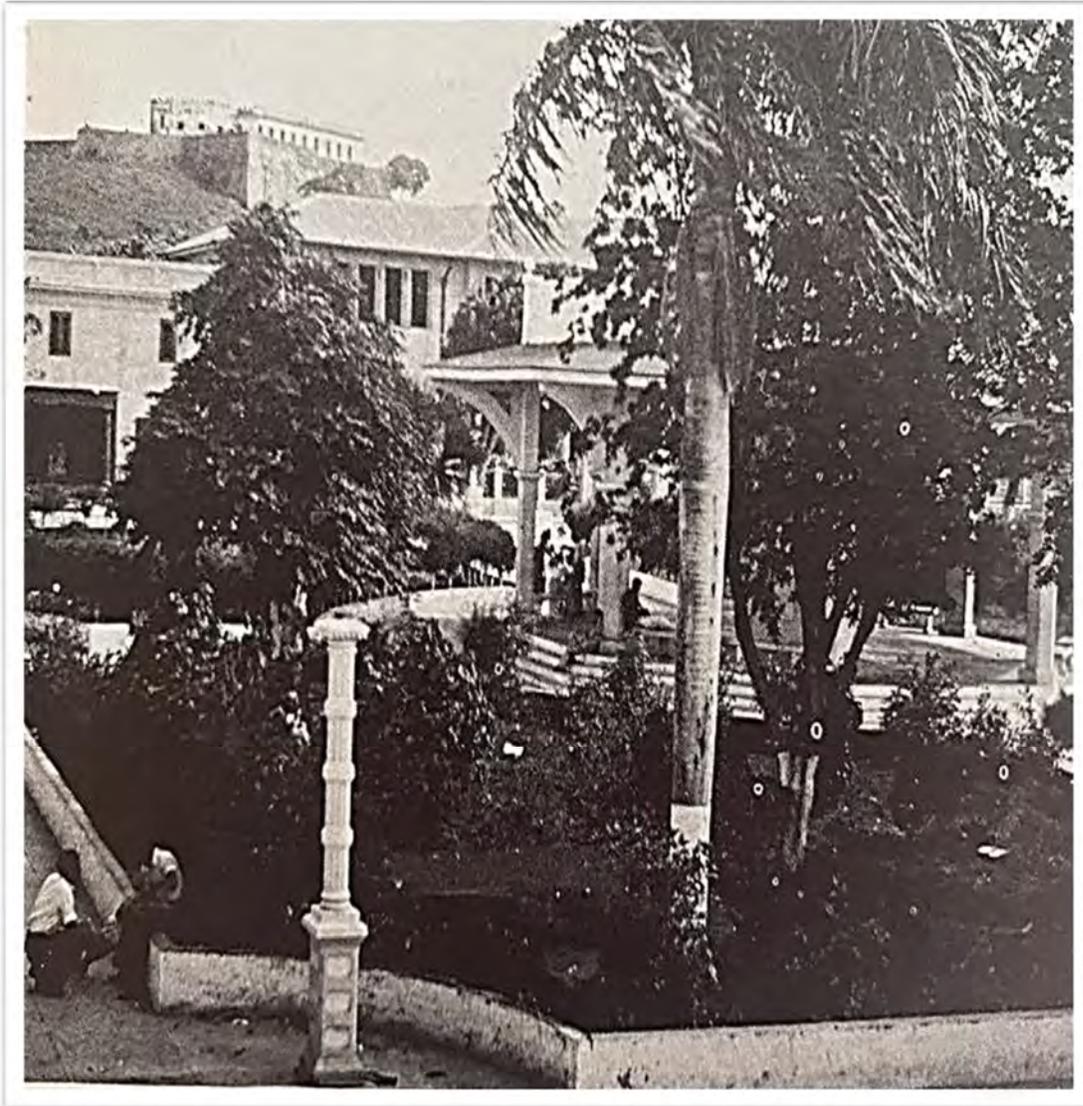
Figure 11: Photograph of the Vieques Public Plaza in c.1940.<sup>15</sup> A concrete structure was later constructed at the center of the plaza as a gathering space.

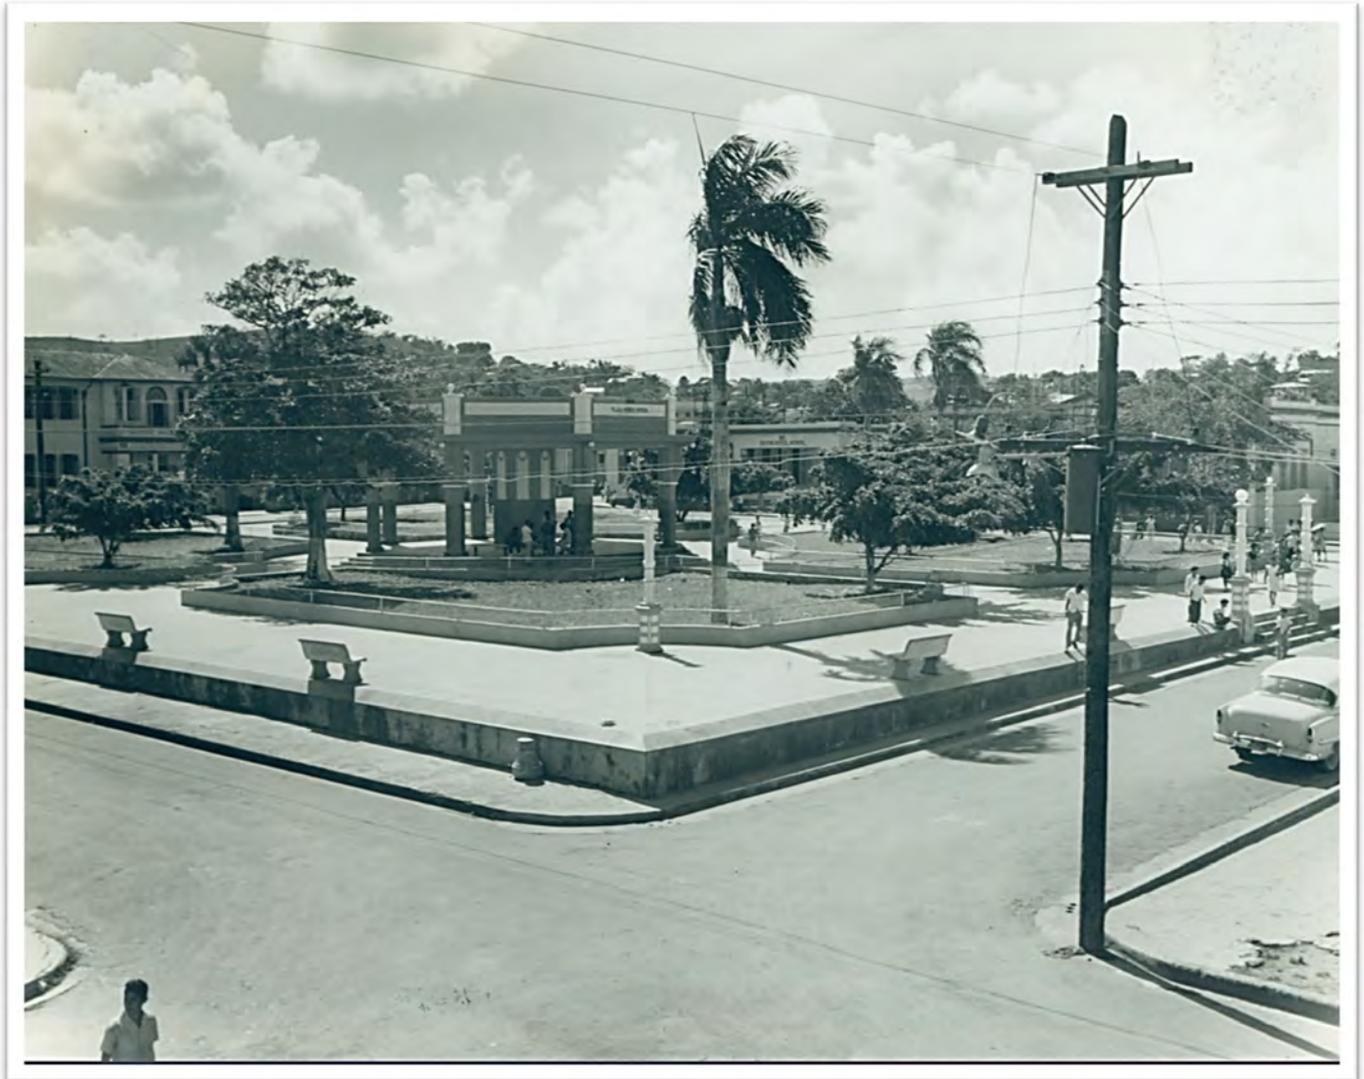
Figure 12: Photograph of the Vieques Public Plaza in 1957. Photography in Archive, Historical Archive of Puerto Rico, ICP. Photo Archive. This central structure suffered changes over time until its demolition in the early 2000's when a new design was implemented.

The topographic quadrangles of 1943, 1951 and 1982 (Figures 16-18) show the area of the Main Square of Isabel Segunda as an empty space with a “gazebo” element in the center of the public square. However, the record of the aerial photographs (Figures 19-23) of the Main square parcel shows evidence of at least four different arrangements in the Plaza occurring between 1936 and 2023. As evidenced by the photograph of the Plaza de Isabel Segunda in Vieques in 1957, a single decorative “gazebo” is present for the most part of the twentieth century (Figure 12).

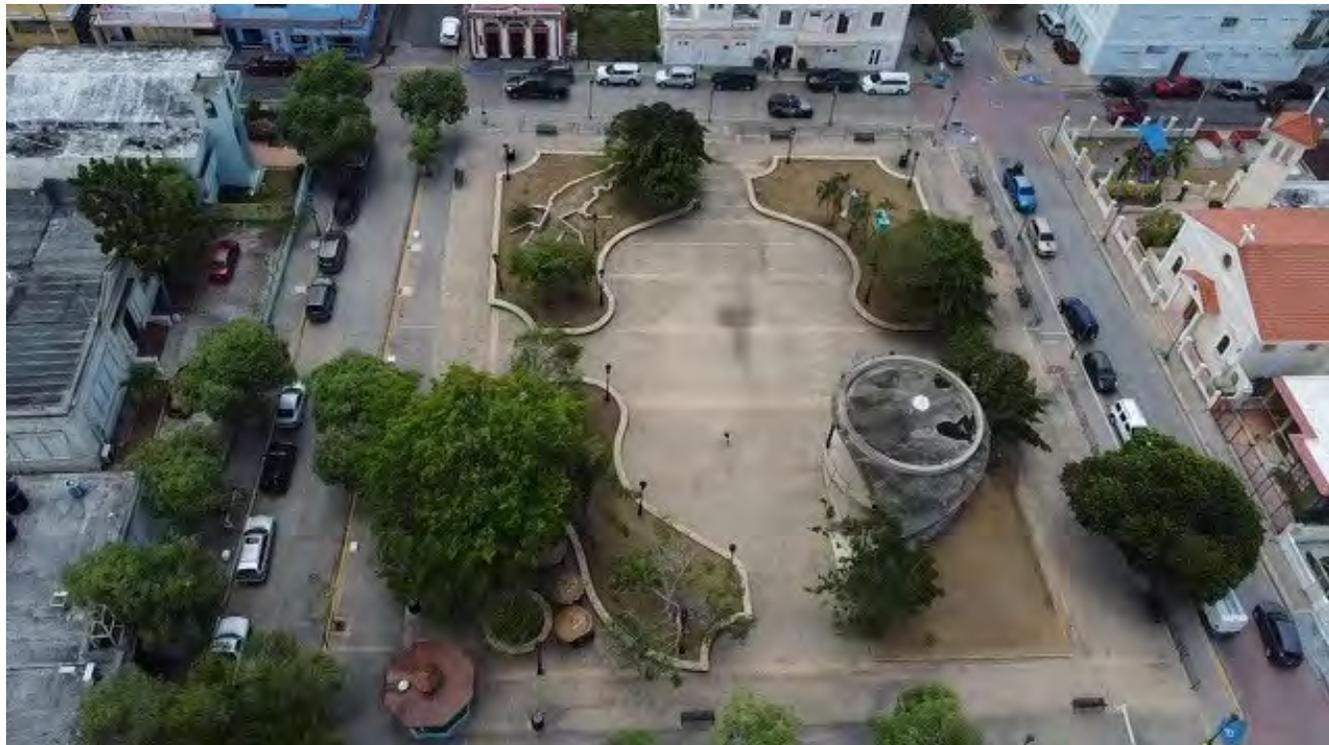
Figure 13: Vieques Public Plaza, 2023. The intervention in early 2000’s changed Vieques Plaza’s configuration. Refer to the architecture description below for additional information regarding this intervention.

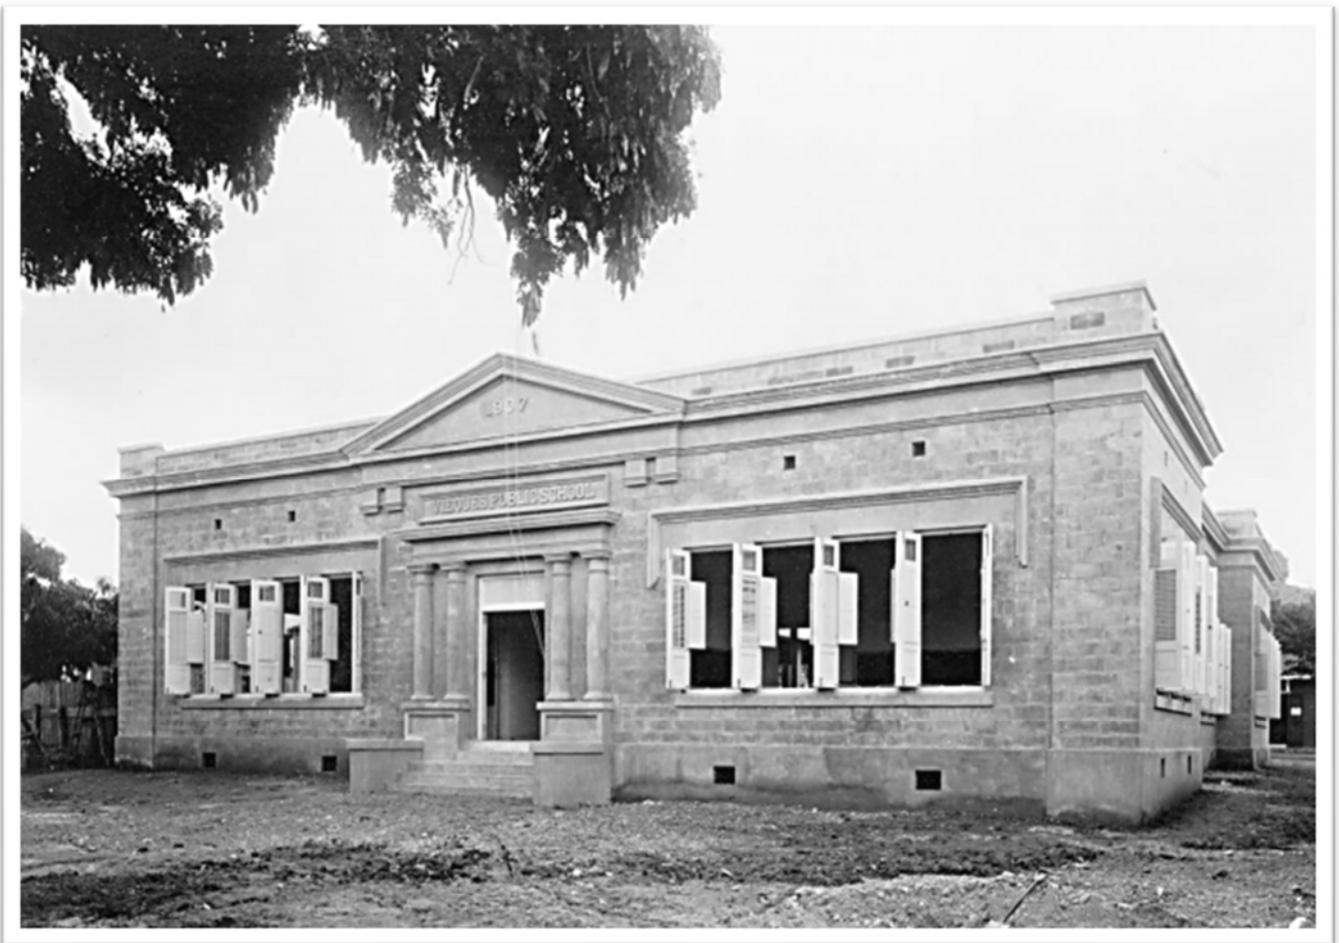
Figure 14: Vieques Public School, P.R., Antonin Nechodoma, architect. F.B. Hatch, builder / A. Moscioni photo, ca.1907. Photograph. <https://www.loc.gov/item/90710366>

Vieques Public School corresponds to the period of Early American Colonial period of the XX Century. The school was designed by Antonin Nechodoma. The school was built in 1907 and was repaired in 1919 by architect Adrian C. Finlayson (Figures 13 and 14).

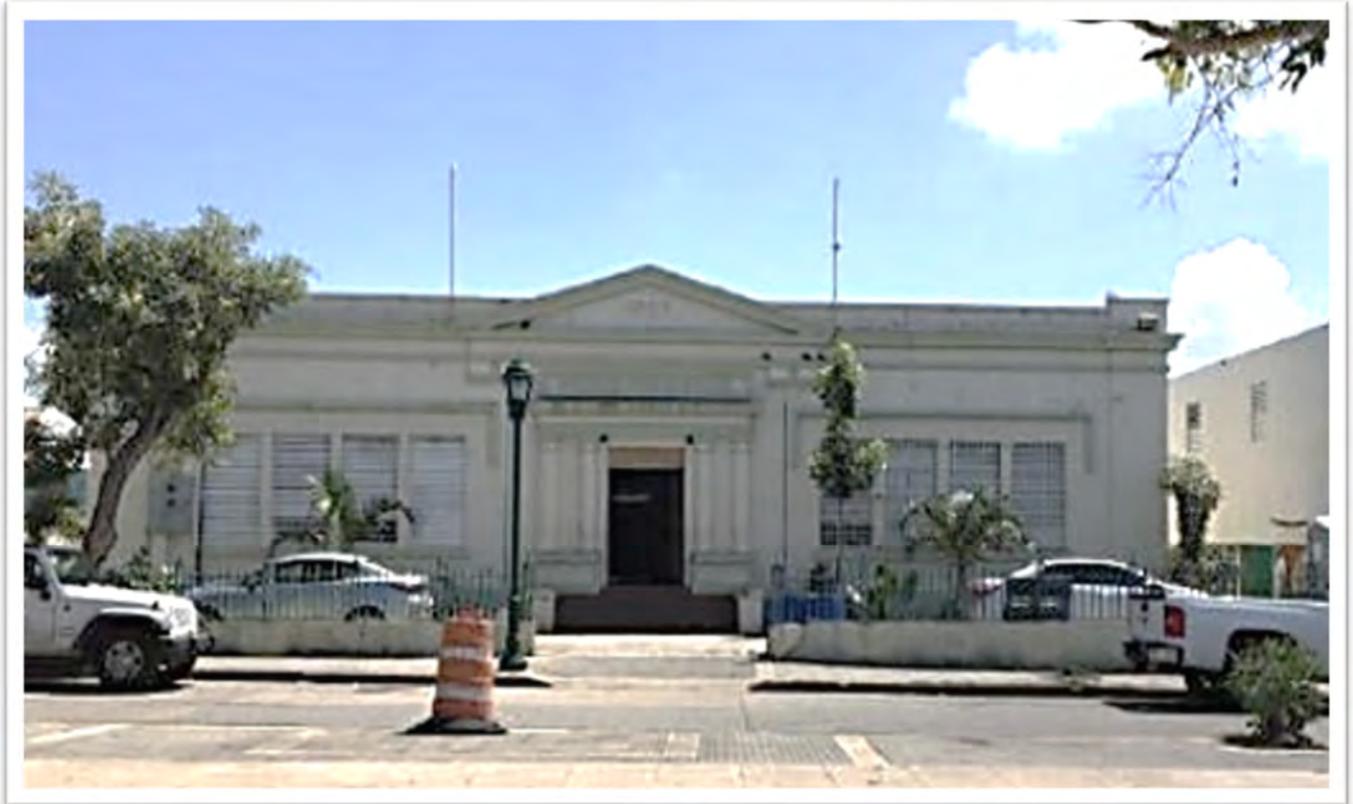
Figure 15: José Gautier Benitez School, Vieques, Puerto Rico, main façade.<sup>18</sup>

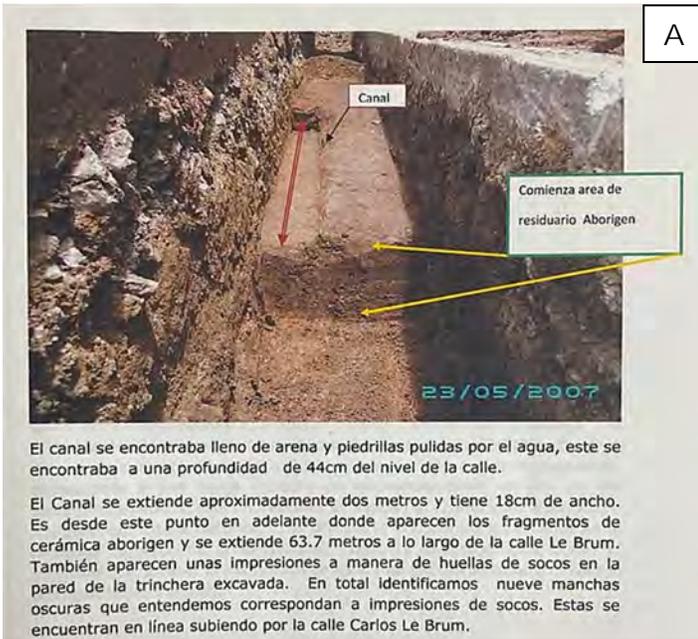
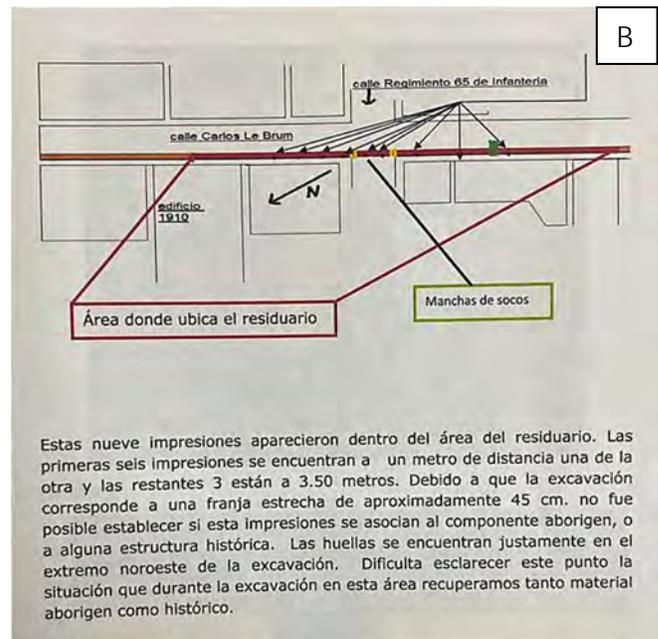
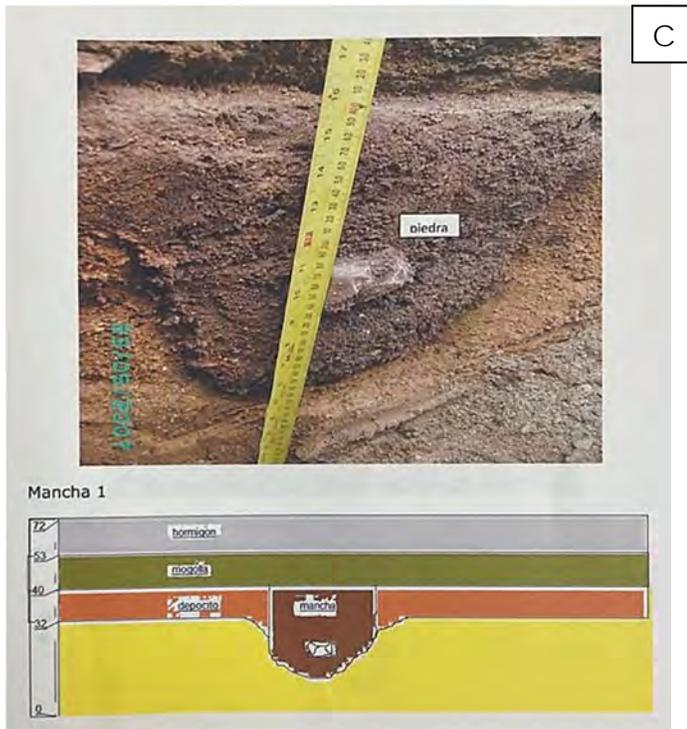
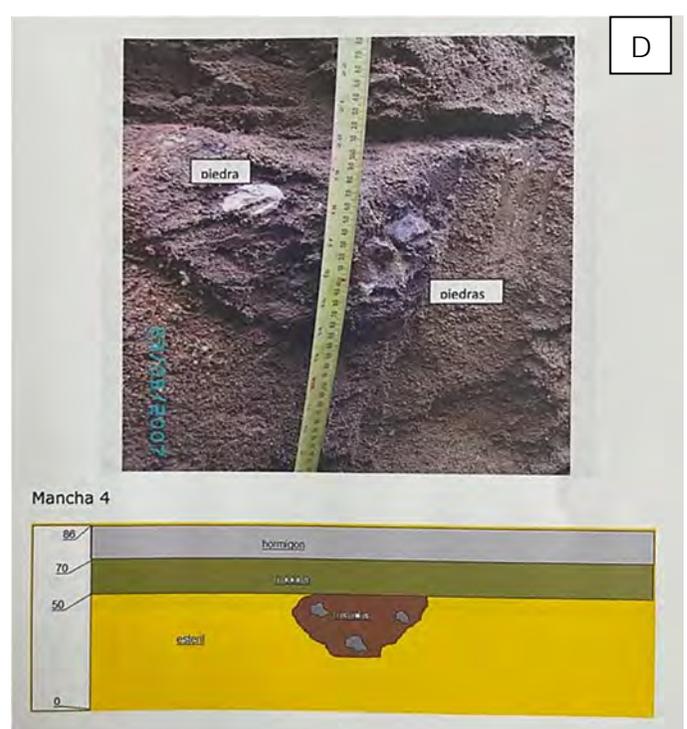
Figure 24 (A, B, C, and D): Evidence of traces of pre-Columbian Socos detected in Brum Street, 2007.

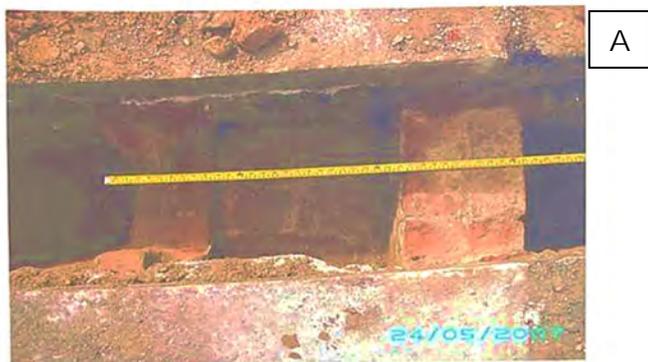
A

Figure 25 (A, B, C, and D): Evidence of the colonial canal system detected in Brum Street, 2007.

El Canal #2, lo ubicamos al lado norte del cruce. Este está construido en ladrillo y argamasa. El canal ocupa un área de 93cm por 46. Fue impactado con anterioridad durante la construcción de las aceras del pueblo hace muchos años atrás. El mismo se encuentra hoy debajo de un estrato de relleno de mogolla.

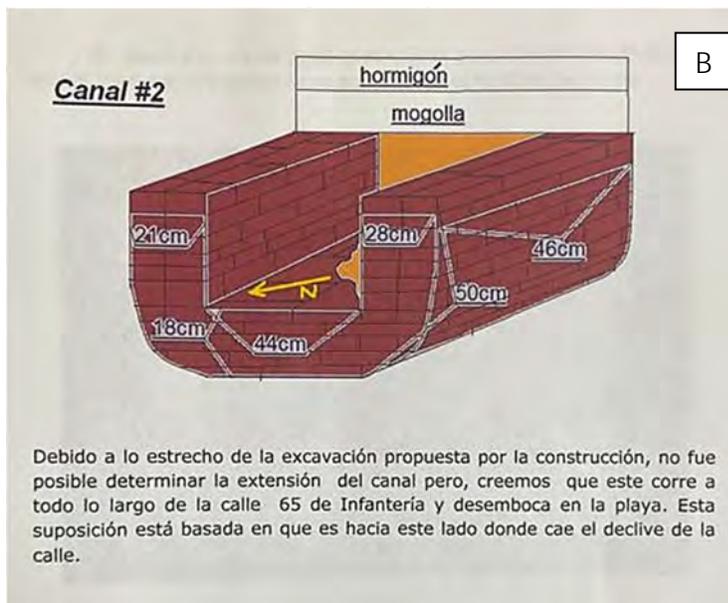
B

Debido a lo estrecho de la excavación propuesta por la construcción, no fue posible determinar la extensión del canal pero, creemos que este corre a todo lo largo de la calle 65 de Infantería y desemboca en la playa. Esta suposición está basada en que es hacia este lado donde cae el declive de la calle.

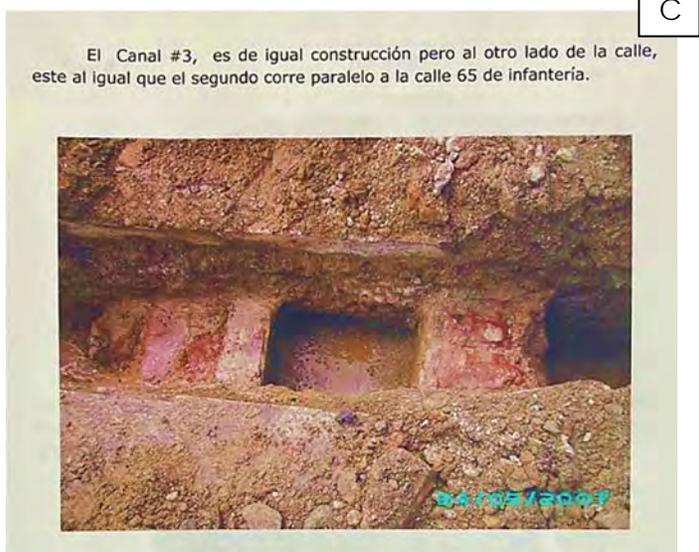
C

El Canal #3, es de igual construcción pero al otro lado de la calle, este al igual que el segundo corre paralelo a la calle 65 de infantería.

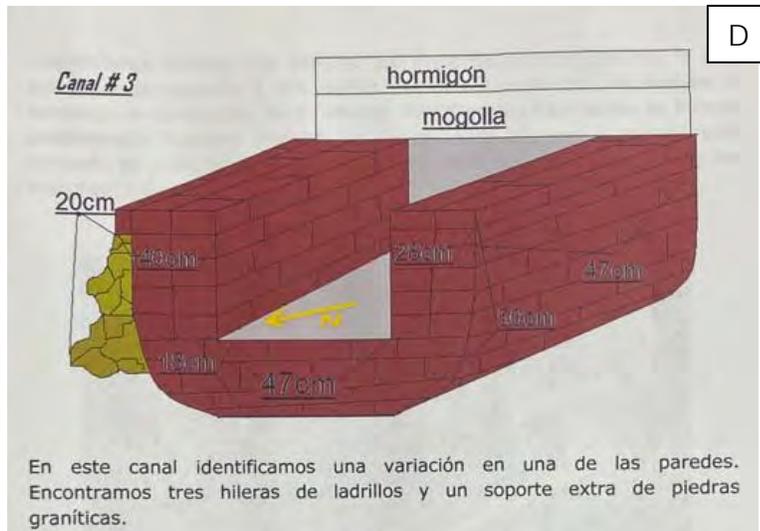
D

En este canal identificamos una variación en una de las paredes. Encontramos tres hileras de ladrillos y un soporte extra de piedras graníticas.

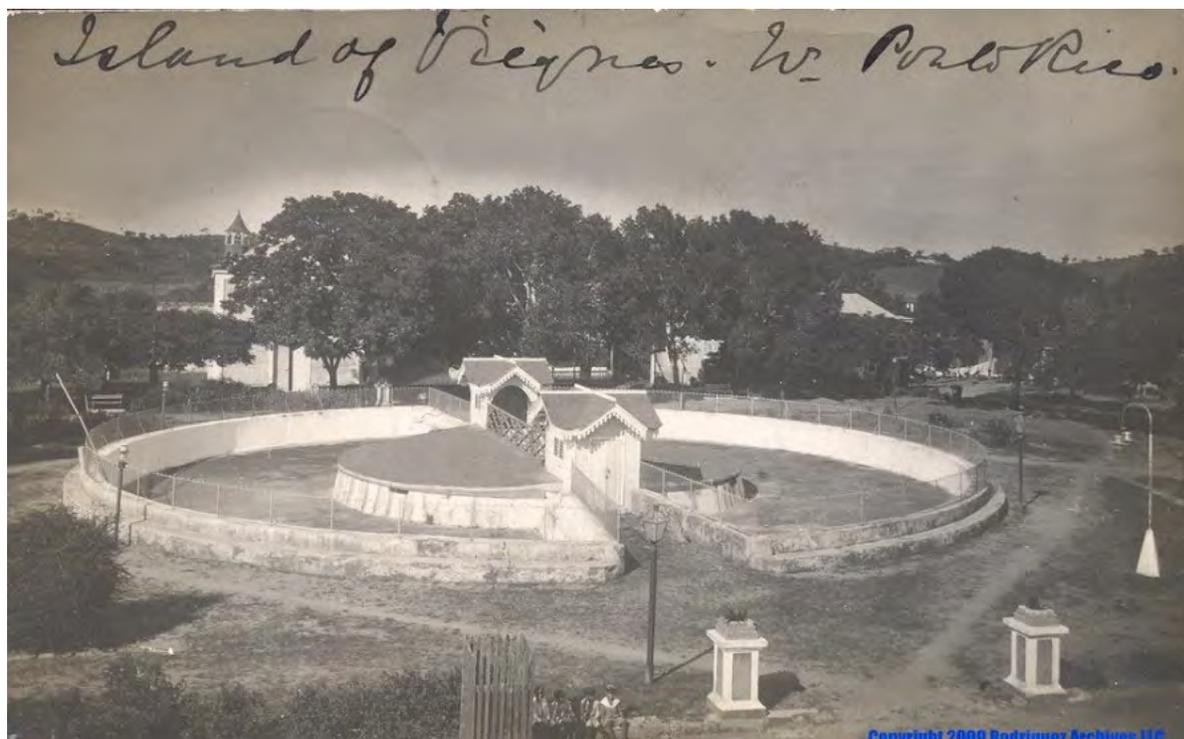
Figure 33: This 1909 photograph shows the details of the design and structure of the well of the Plaza de Isabel Segunda in Vieques. Archivo Histórico y Fotográfico de Puerto Rico, November 17, 1909.

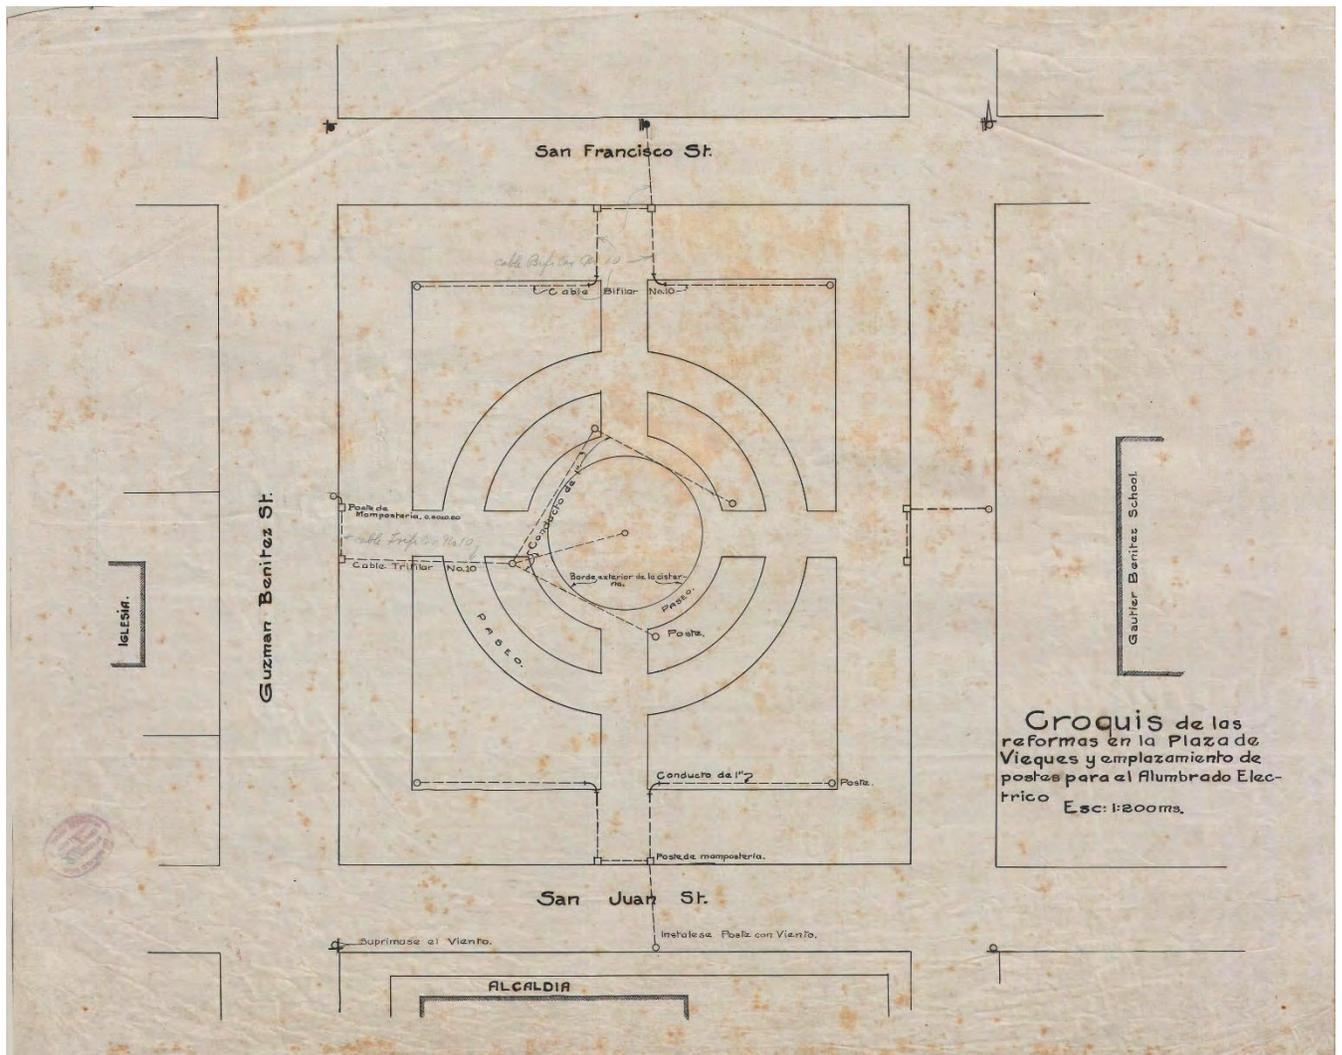
Figure 35: Vieques Public Square improvement plan, including electrical utilities. (c.1919) Archivo Digital Nacional.

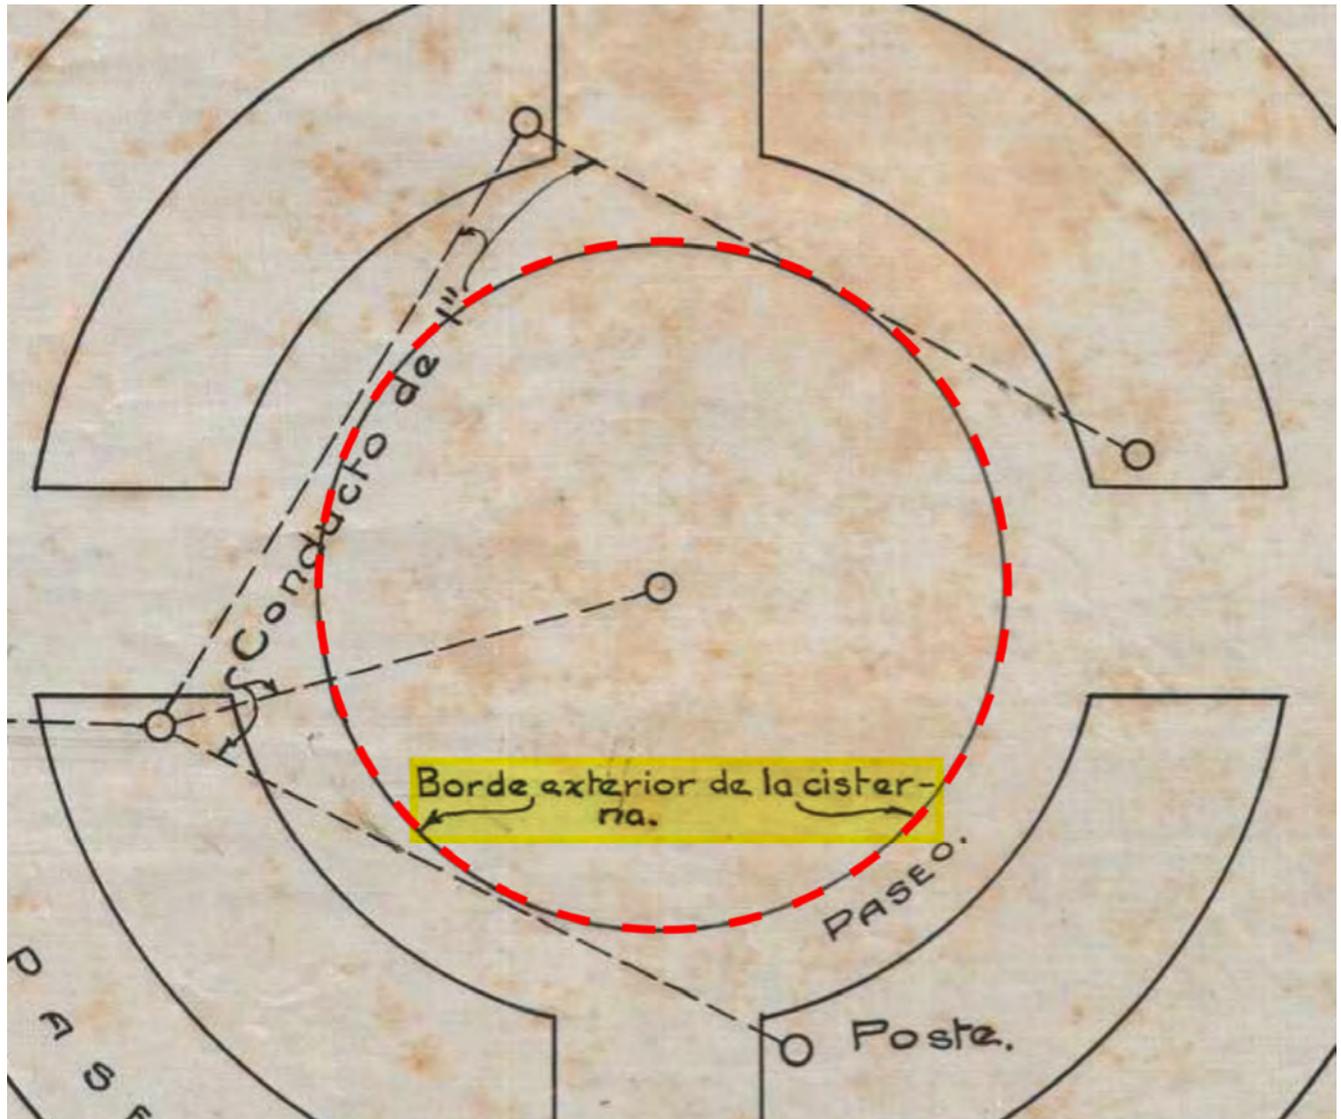
Figure 36: Zoom to Figure 35 outlining the border of the cistern, as noted in the plans.

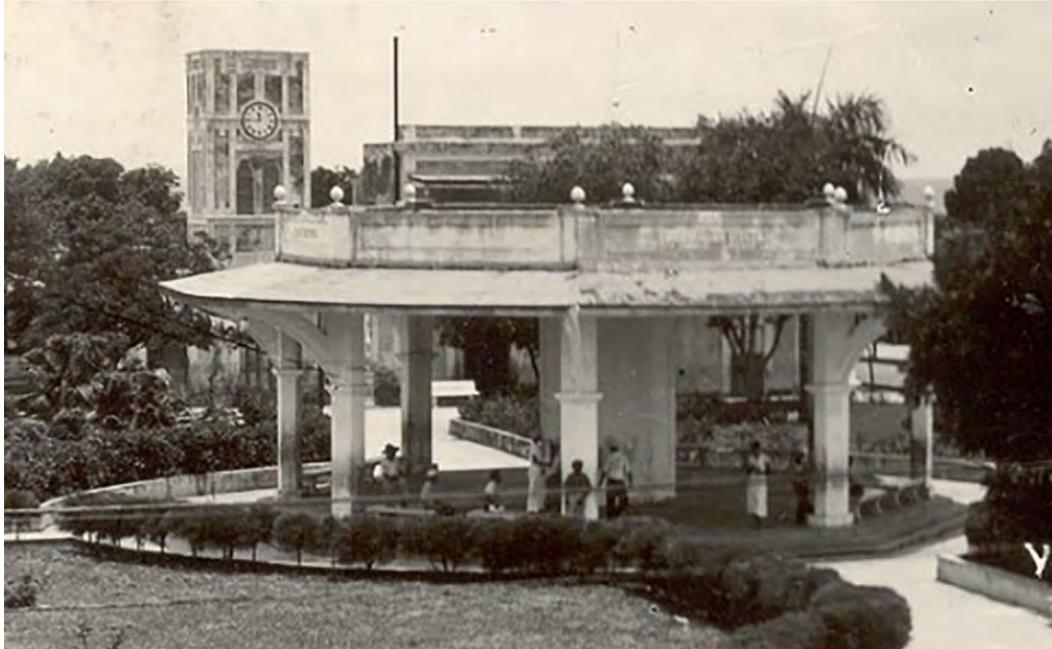
Figure 37: Plaza's gazebo original design. Archivo Histórico y Fotográfico de Puerto Rico, March 6, 1949.

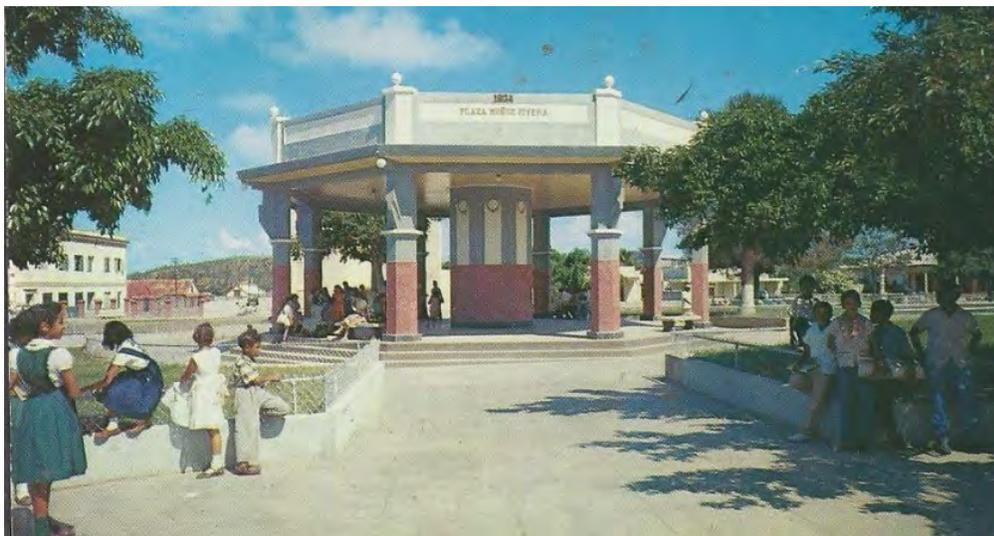
Figure 38: Gazebo overhang and brackets were modified. Children playing in Vieques Public Square, some with their school uniform.<sup>34</sup> Archivo Histórico y Fotográfico de Puerto Rico, 1957.

The organization around the plaza is found to be exceptional; not only the town hall and church are adjacent to it, as they typically do in a traditional urban center; but also, four (4) schools are also adjacent: Gautier Benítez (1907), Vieques High School (c. 1910), Víctor Duteil (1911), and Eugenio M. de Hostos (c. 1940). The number of schools around the Plaza transformed it to a playground, somehow, the liveliness and number of students activated the place, and surely it became a reference point in their development (Figures 38).

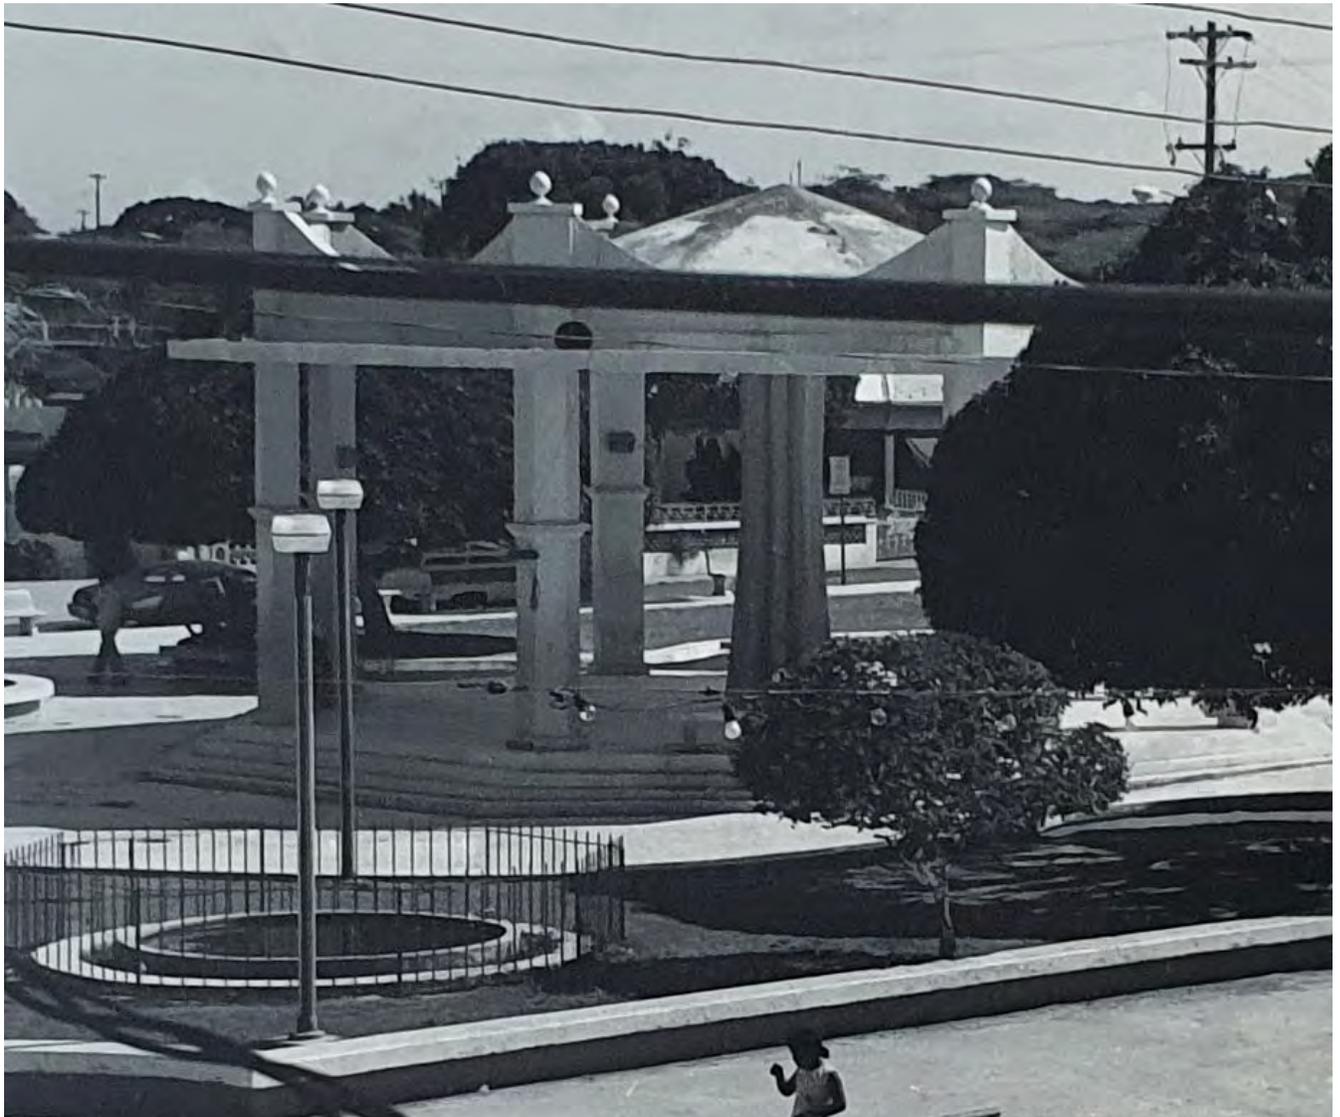
Figure 39: 1978, ICP photographic archive. It can be observed that the brackets were demolished, and the roof is made out of concrete with a new central column.

also repaved with terrazzo and the green areas were reconstructed (Figure 39-40).<sup>33</sup> The latest remodeling of the Plaza was in 2004-2007, led by Eng. José A. Marcano. The plaza was repaved with terrazzo and provided with a new pattern, the design of the existing planters was altered and covered in coral stone (Figure 41). The existing gazebo located at the center of the plaza was demolished (Figure 40) and another was constructed at the northeast corner of the plaza, designed by architect Jorge Rigau. (Figure 42). Also, a new fountain was constructed (Figure 43), designed and ornamented by architect and artist Jaime Suarez, located in the same place of the fountain that can be observed in Figure 39, inside a planter, with the shape of Vieques Island. Years later, the fountain was filled with earth.

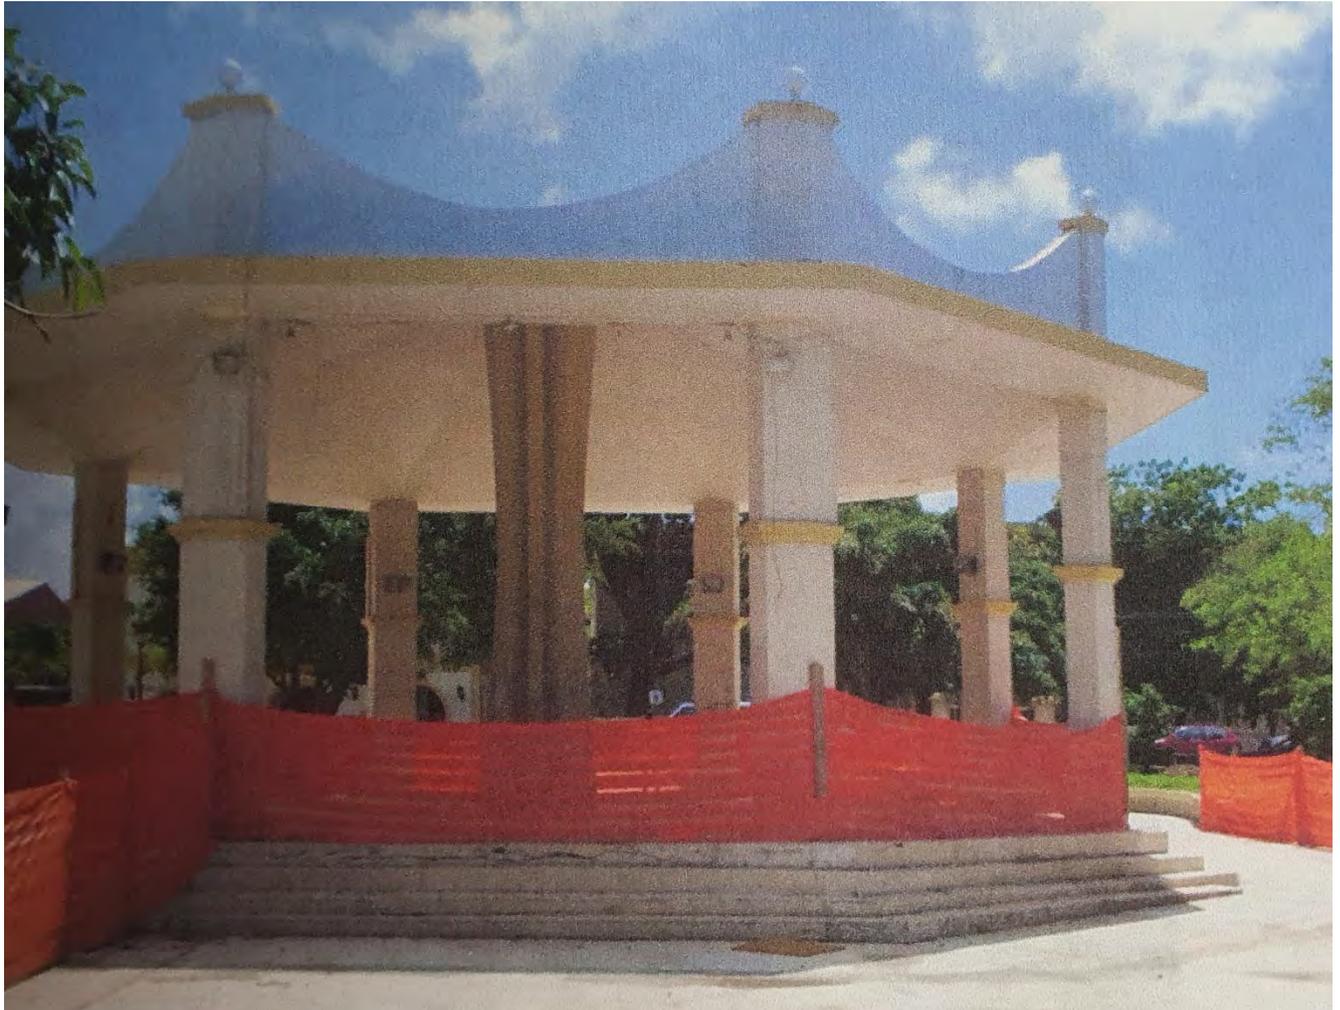
Figure 40: Until 2005 it maintains the same design. The demolition of the central gazebo was approved by the Institute of Puerto Rican Culture on November 22, 2005. ICP Archives.
