## **Environmental Review for Activity/Project that is Categorically Excluded Subject to Section 58.5**

**Project Name:** PR-CRP-000807: Mejoras a la Plaza Pública de Vieques & PR-CRP-001111: Centro Agrícola de Transformación Social y Comunitario

**Responsible Entity:** Puerto Rico Department of Housing (PRDOH)

**Preparer:** Angel Garcia PE, Sr. Environmental Engineer at AG Environmental PSC

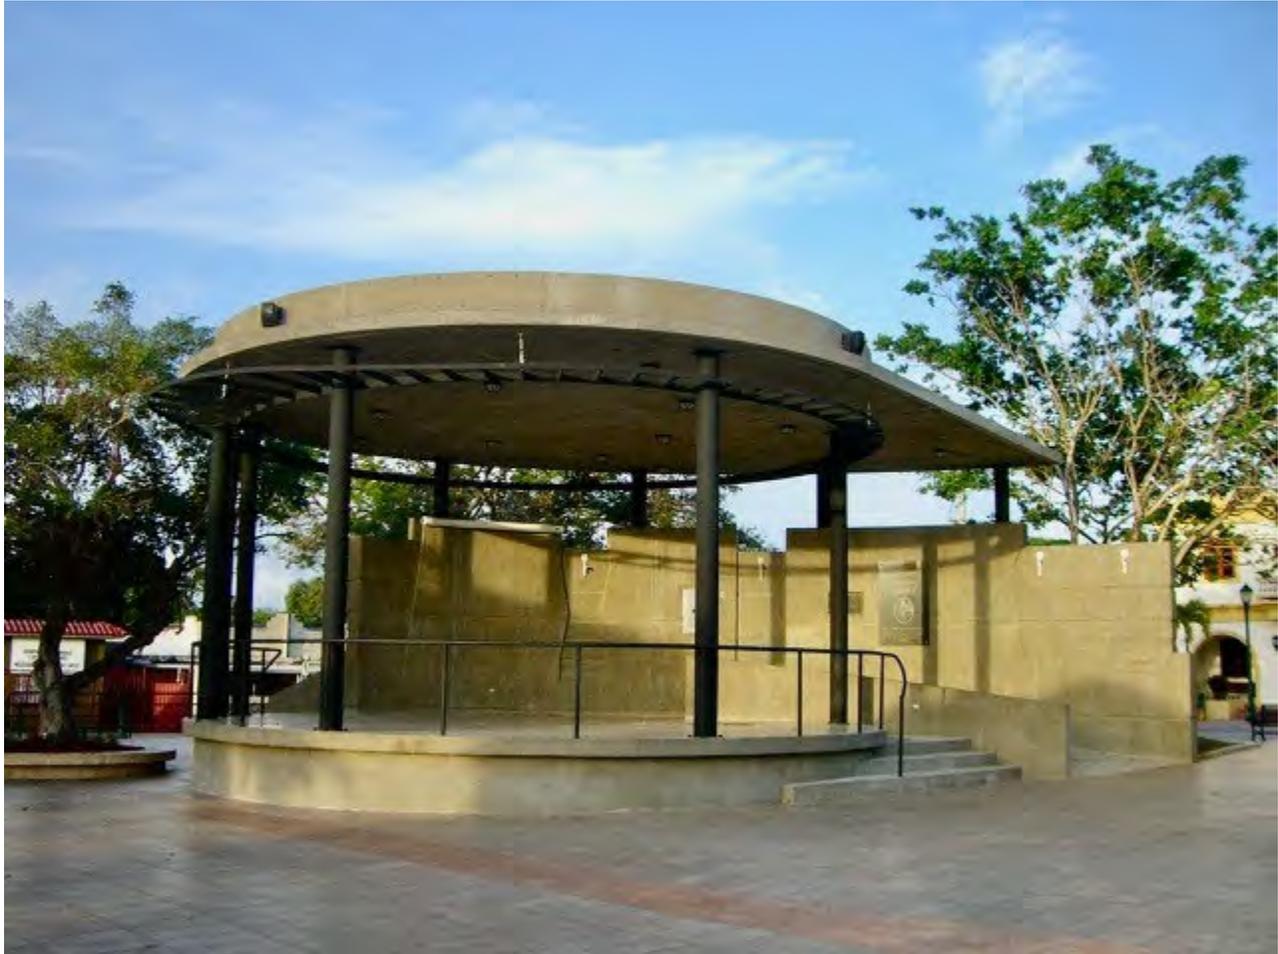
Figure 42: New gazebo constructed in c.2007.

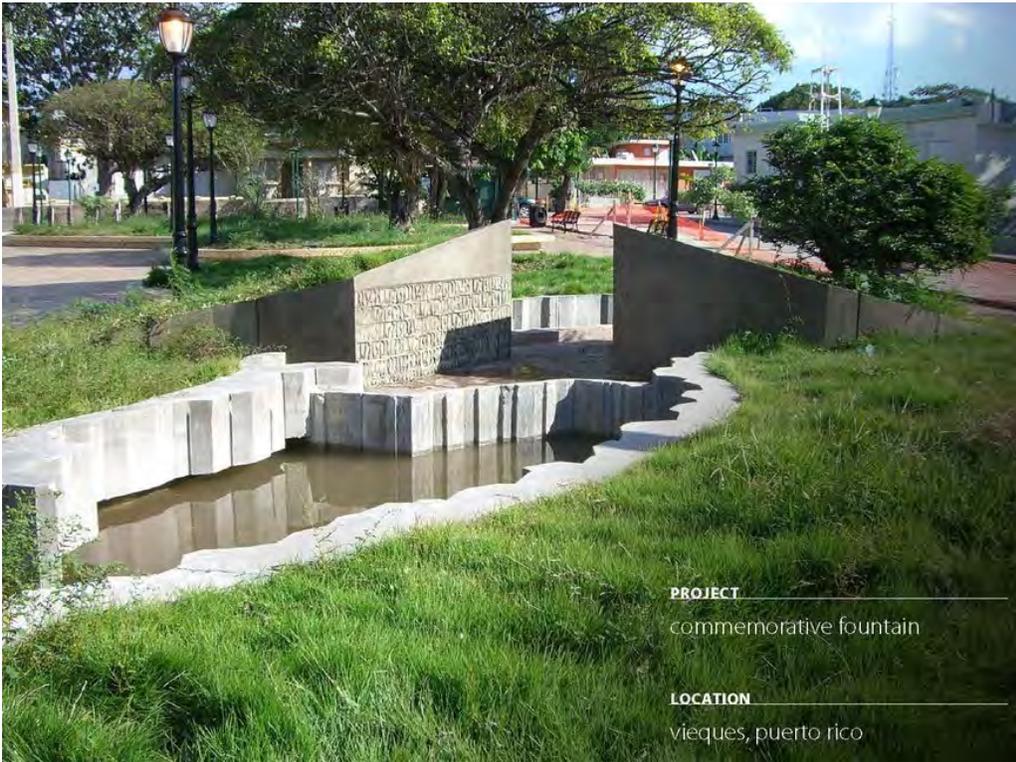
Figure 43: New fountain constructed in c.2007.

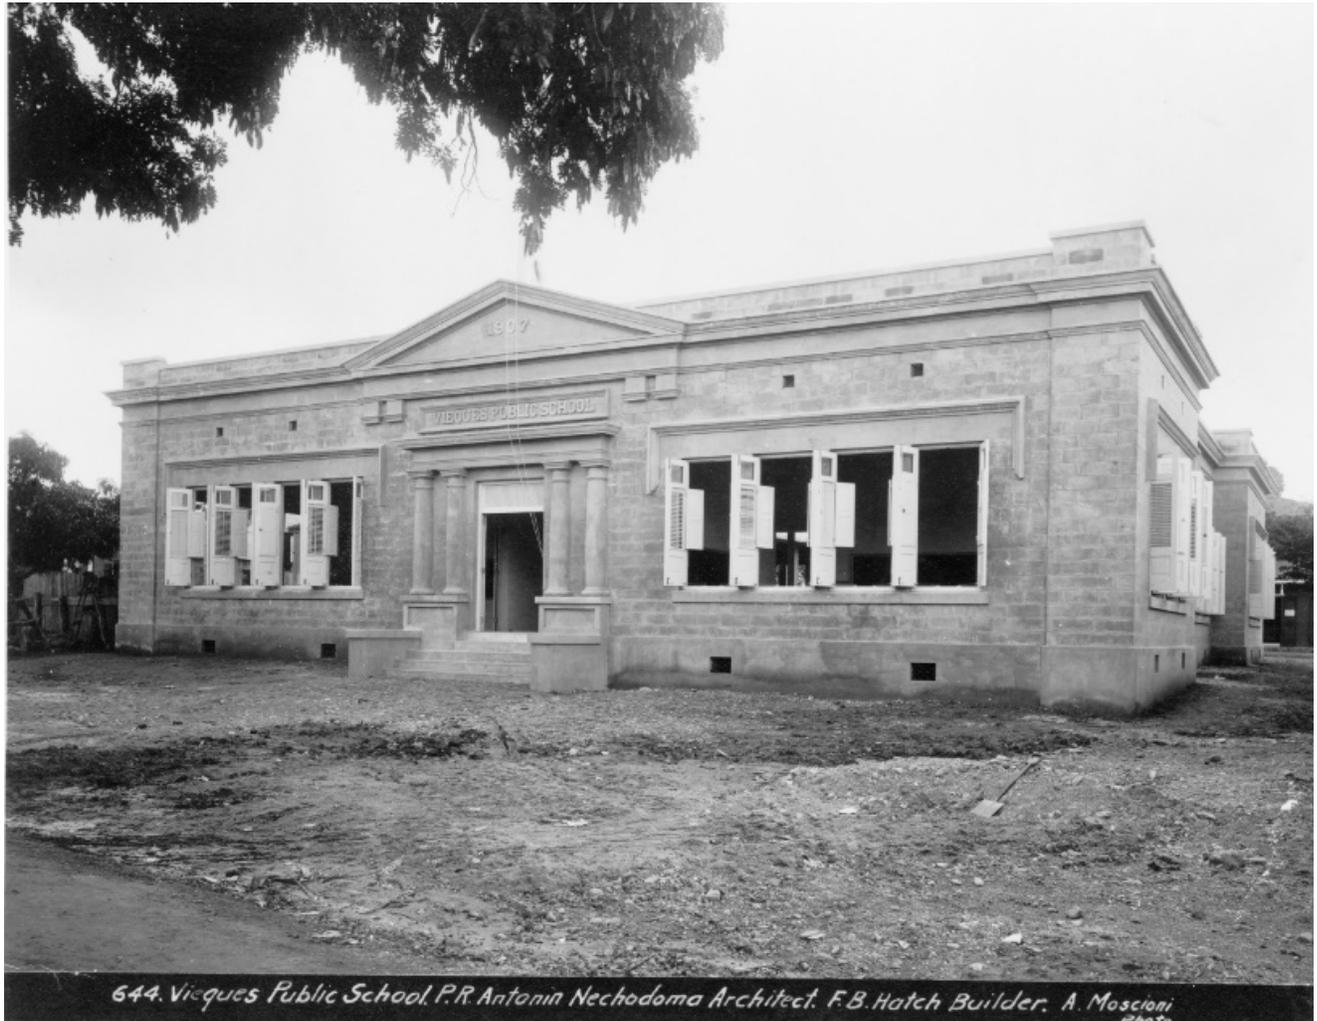
Figure 44: Vieques Public School main façade. A. Moscioni (c.1907)<sup>39</sup>

The construction of **Vieques Public School**<sup>35</sup>, also known as J. Gautier Benítez School, was part of the governmental educational development efforts, as described in the Multiple Property Listing Nomination *Early Twentieth Century Schools in Puerto Rico*<sup>36</sup>, important to the building’s significance. The *Vieques Public School* was constructed in 1907 by the Department of Education, Division of School Buildings.<sup>37</sup> The construction of this school was part of a broader mission of the United States education policy in Puerto Rico since the 1900’s and the implementation of the Foraker Act.<sup>38</sup> Architect Antonin Nechodoma designed the building and Frank B. Hatch, the contractor, built it. This information is taken from a photo (c.1907) made by Attilio Moscioni (1876-1950) in the recent times of its construction. (Figure 44).

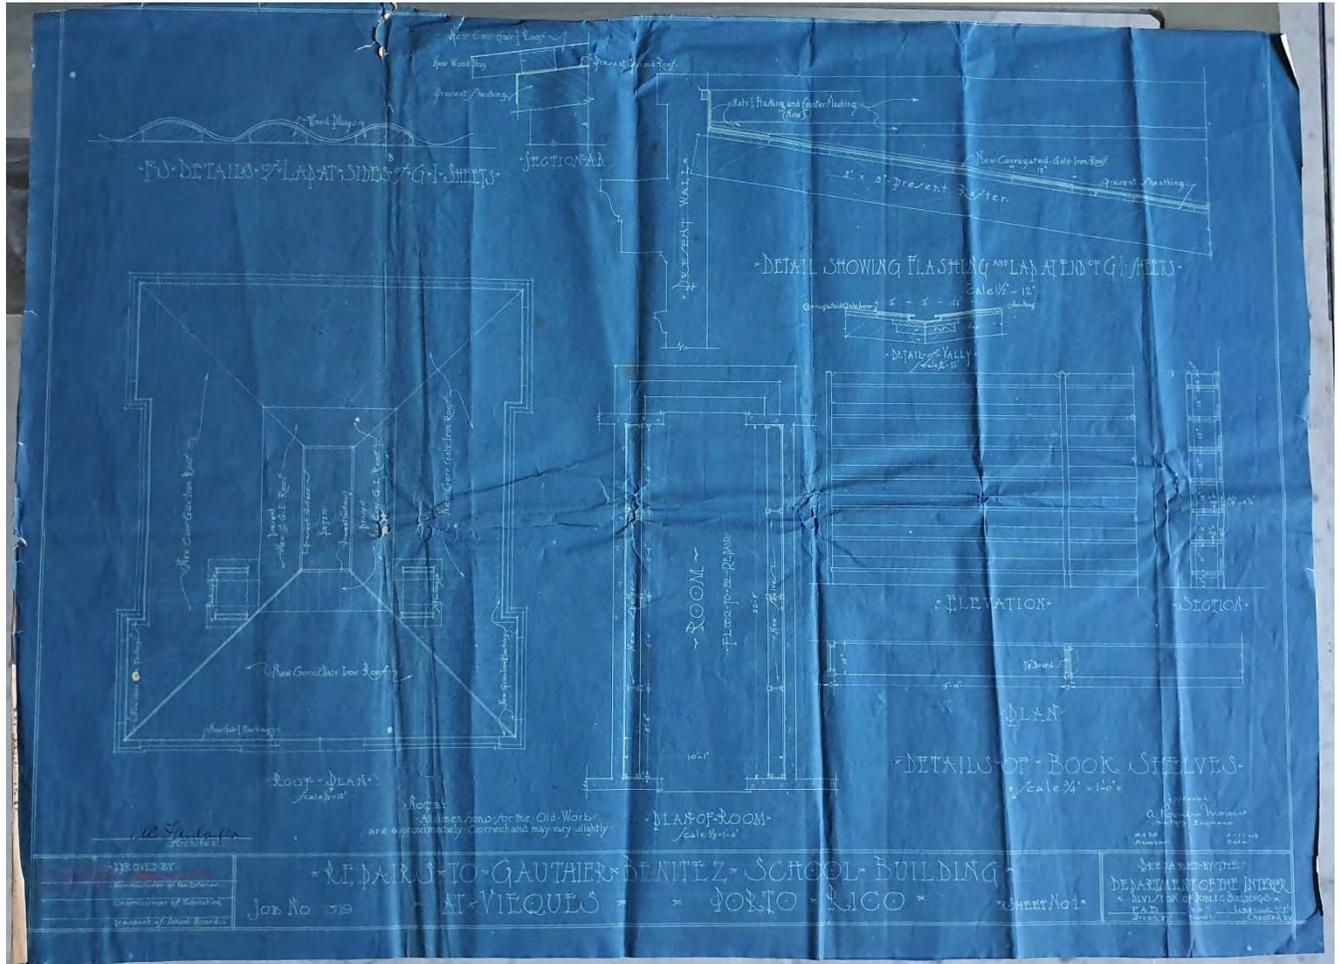
Figure 45: Gautier Benítez School repairs plan by Adrian C. Finlayson.<sup>46</sup>

The oldest construction documents found of Gautier Benítez School are located in the AGPR.<sup>44</sup> These documents illustrate the design for the roof repairs of the school, dated June 17, 1919 by architect Adrian Clark Finlayson. (Figure 45-49) He was another prominent architect in the Island, architect Jorge Rigau describes him as:

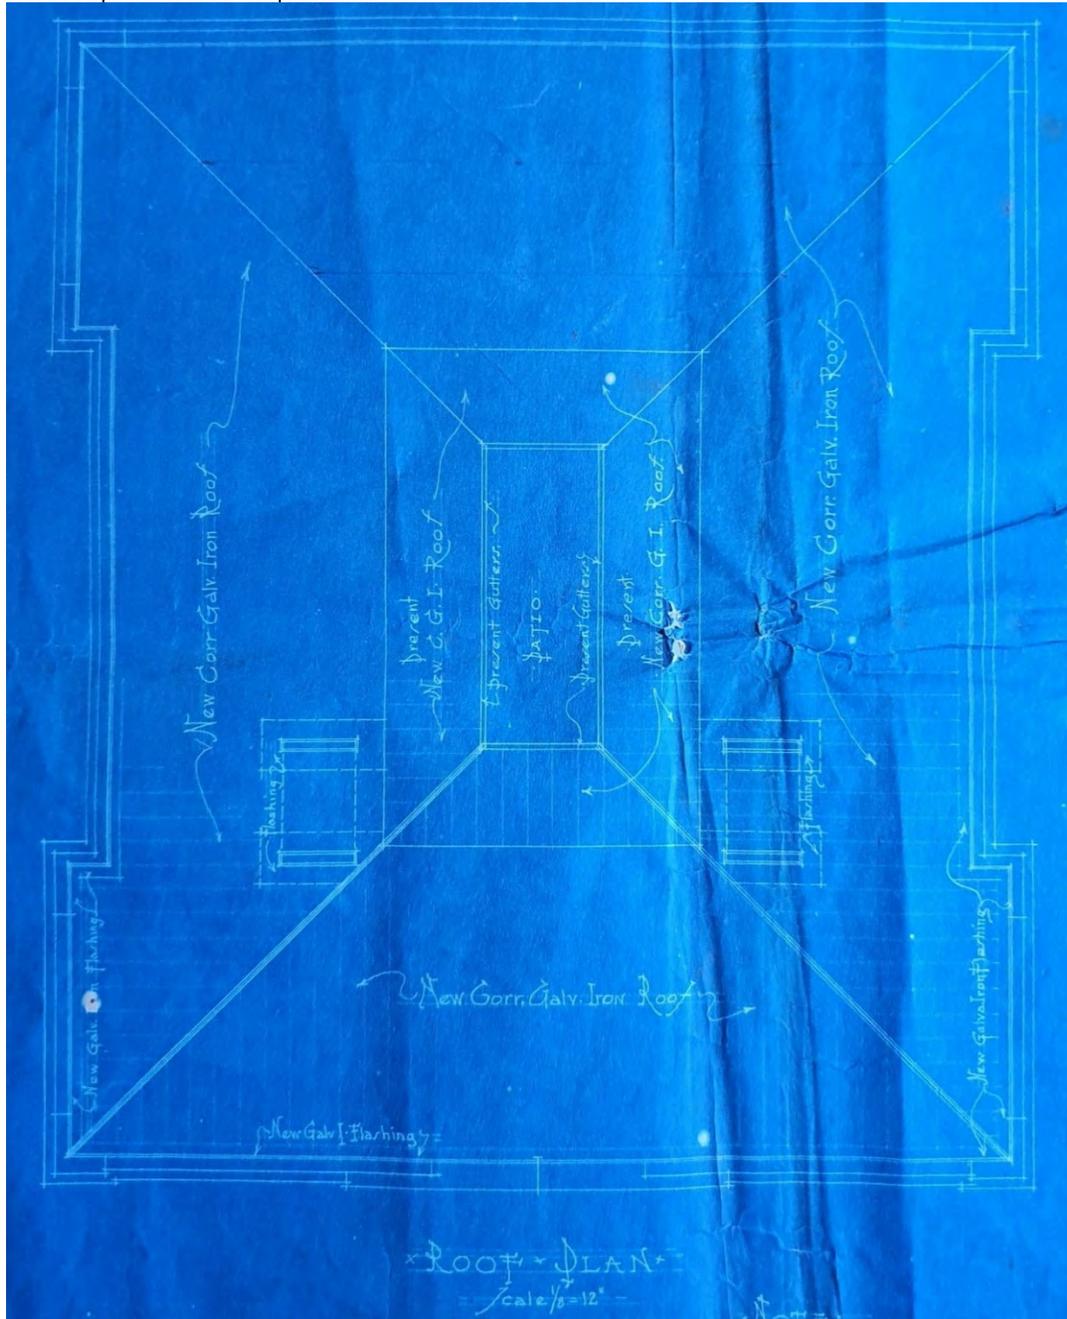
Figure 46: Repairs Roof Plan. It can be observed that the original roof was a hipped roof and the interior patio can be perceived.<sup>47</sup>

From this plan, some of the original components of the roof, marked as “present” features in the drawings, can be observed. These repairs consisted in the incorporation of a new corrugated galvanized iron roof, the installation of new flashing and counter flashing and other elements needed for this installation, like wood plugs. Also, some bookshelves were designed to be incorporated into the school entrance corridor. As noted, the roof wood structure existed with a negative slope, diverting water towards the interior patio to the existing gutters (Figure 47); it is also detailed that they maintain the existing sheathing with the installed paroid roofing system<sup>48</sup> (Figure 48). Also, from the “Plan of Room” (Figure 49) we can perceive that door openings towards this area did not exist, as we have it today.

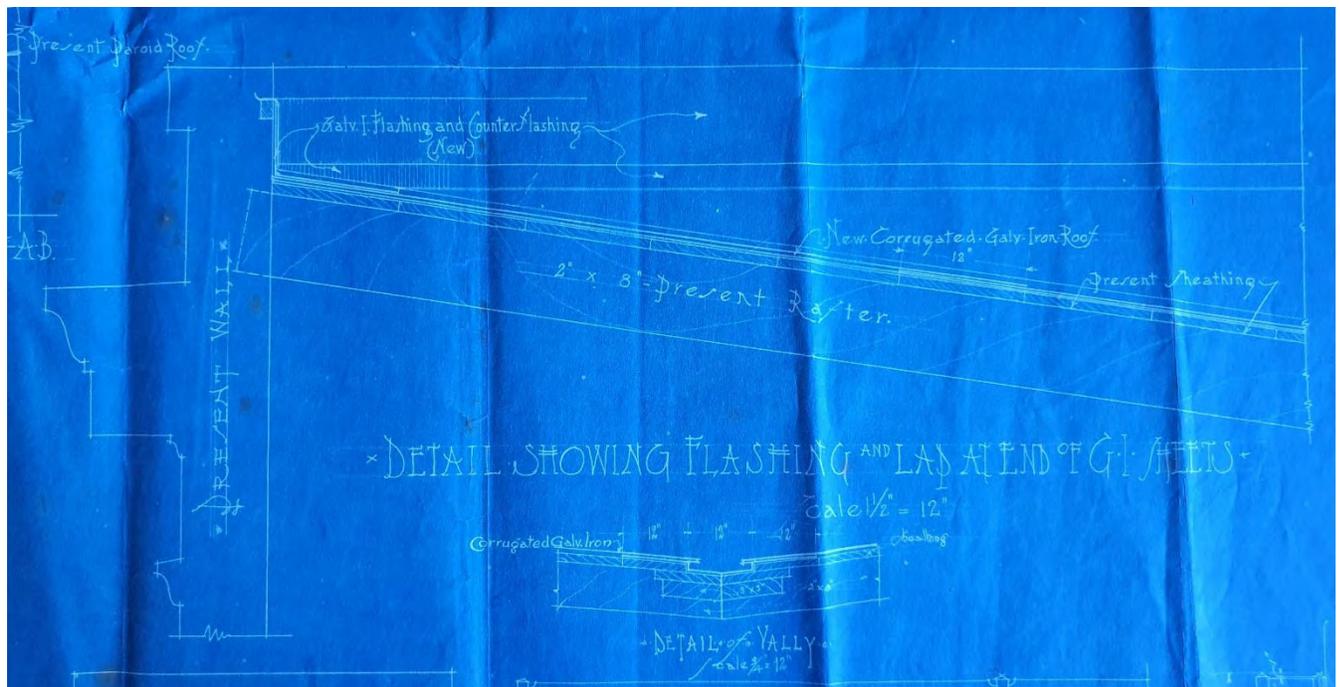
Figure 47: Section showing the negative slope of the roof towards the direction of the interior patio. Also existing elements can be observed identified as “present”<sup>49</sup>.

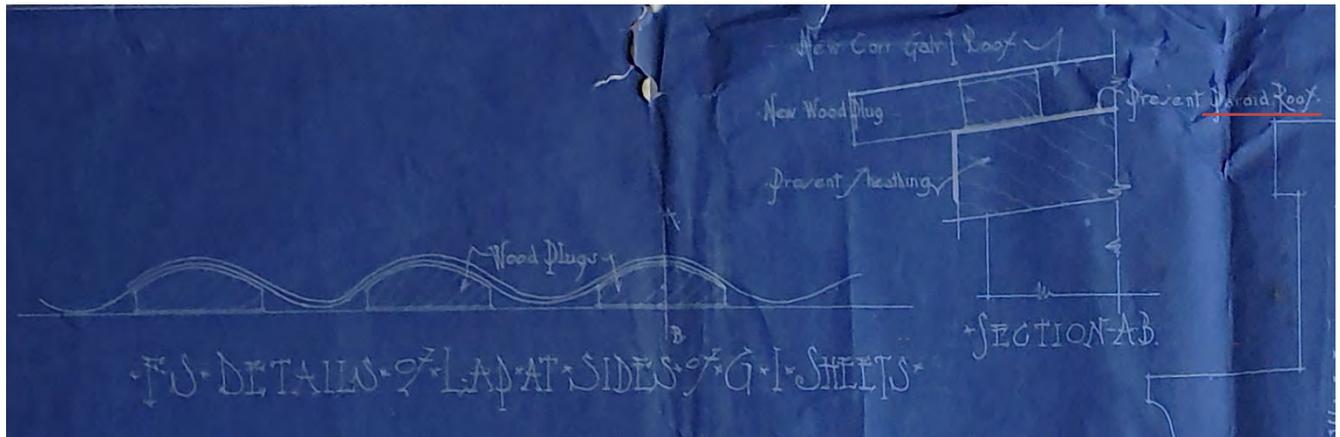
Figure 48: Project details, existing paroid roof installation is noted.<sup>50</sup>

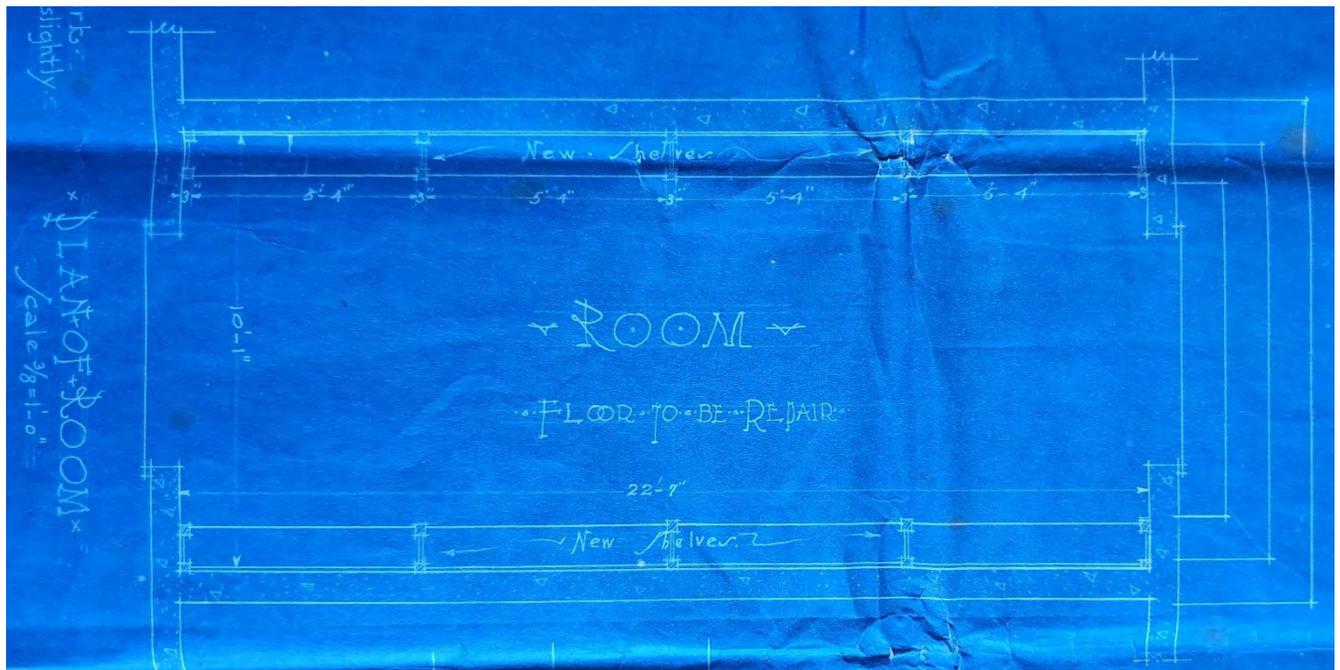
Figure 49: This plan of the room, located at one of the building entrances, we can observe that no doors opened to this area.<sup>51</sup>

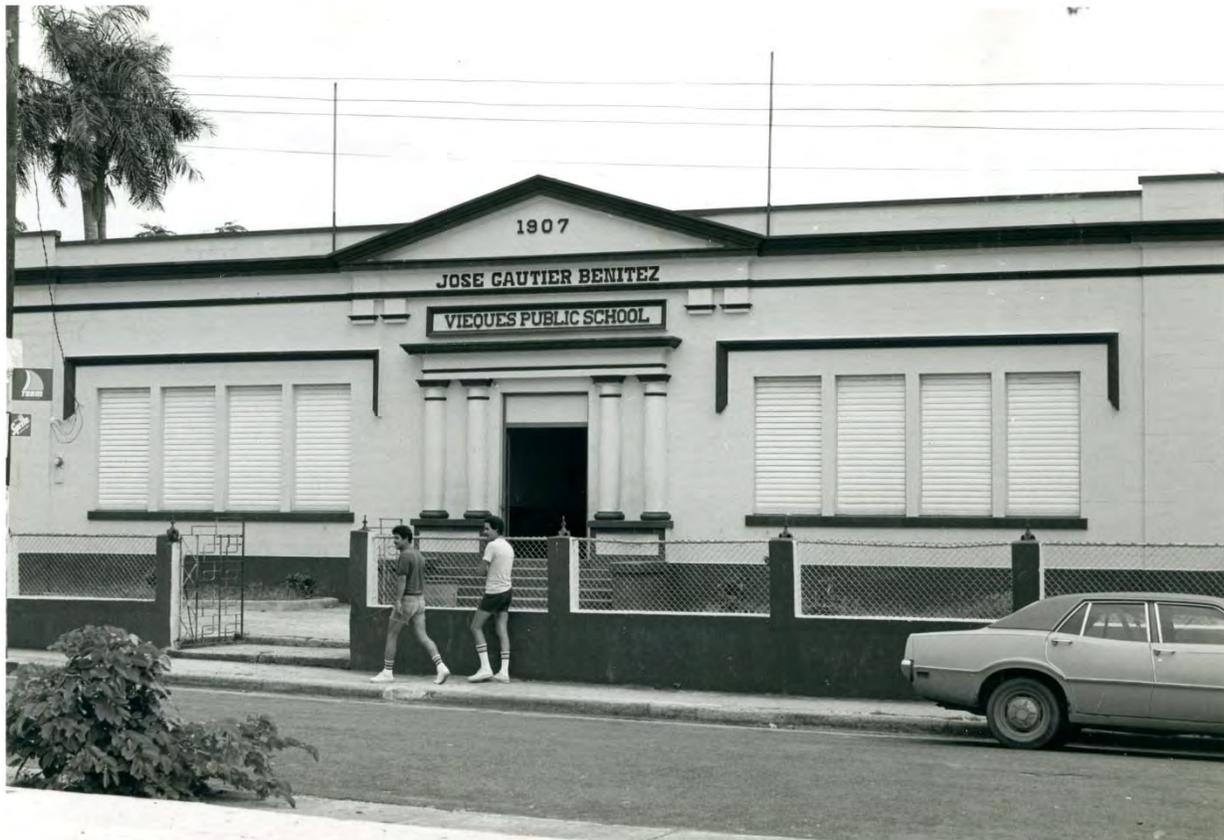
Figure 50: Photo taken by architect T.S. Marvel, c.1970's. AACUPR. Change of main façade door and windows can be observed, fence has also changed.

No other information was found from the years preceding these repairs. One of the main interventions was the reconstruction of the roof in reinforced concrete (no date), that also incorporated concrete columns inside the building. To our knowledge the building was used as a school, and later the Municipality of Vieques reused the building for offices and community services. In the photos at the end of this document (I. APE Inventory – Image No.28) we can observe how some features, like doors, windows, covered patio and roof, have changed over time (Figure 50).

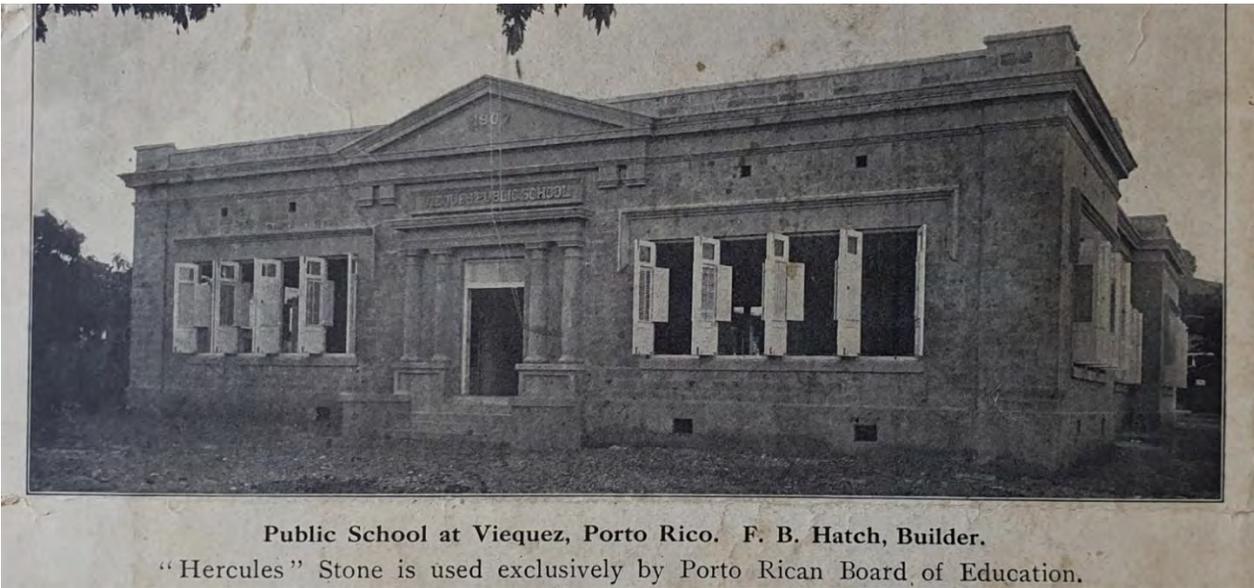
Figure 51: Vieques Public School used for concrete block advertisement.

The main building system used for the construction is the hollow-core cement or concrete block, a number of almost 12,000 concrete blocks were used in this building, 11,994 to be exact.<sup>52</sup> The use of this material is very significant, since it was one of the first material used by

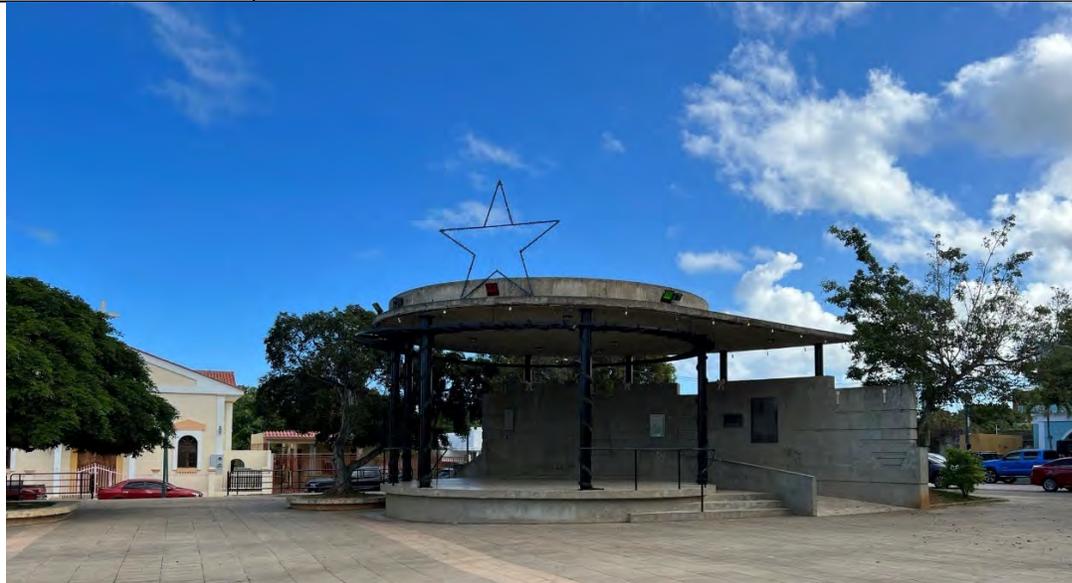
**Photo #:** F

**Description (include direction):** View from the center of Vieques Public Plaza towards the existing gazebo. Camera looking northeast.

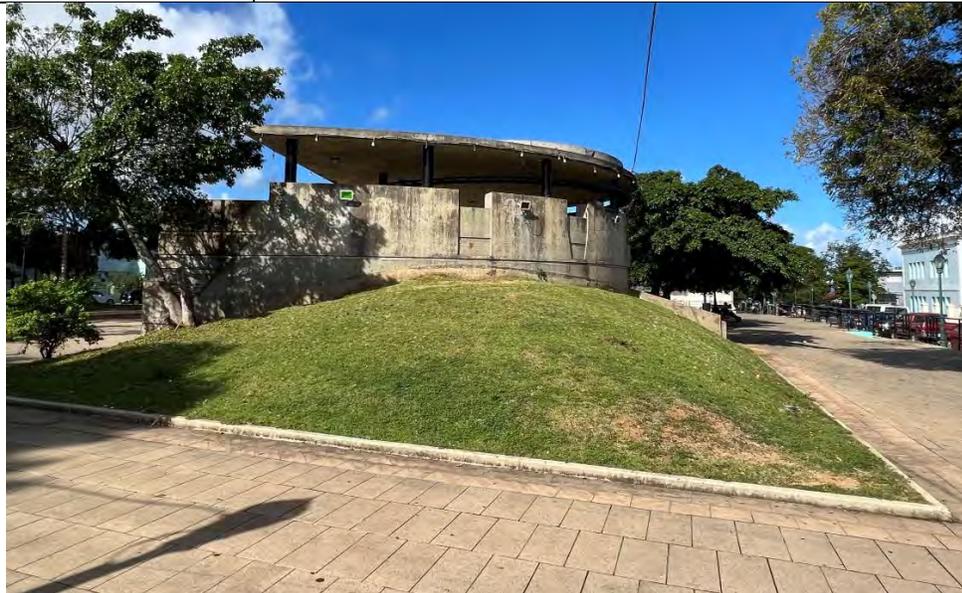
**Photo #:** H

**Description (include direction):** View of the rear façade of the Plaza gazebo. Camera looking southwest.

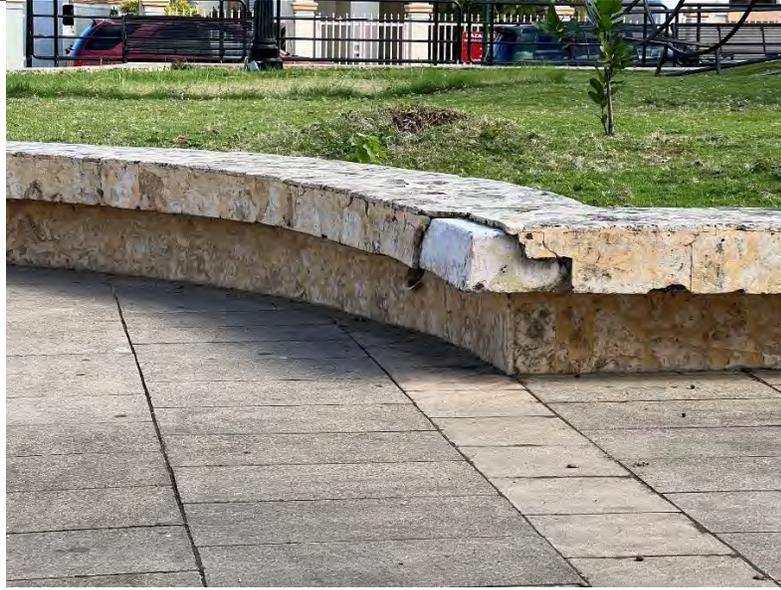
**Photo #:** I

**Description (include direction):** Detail of Plaza’s bench deterioration. Camera looking north.

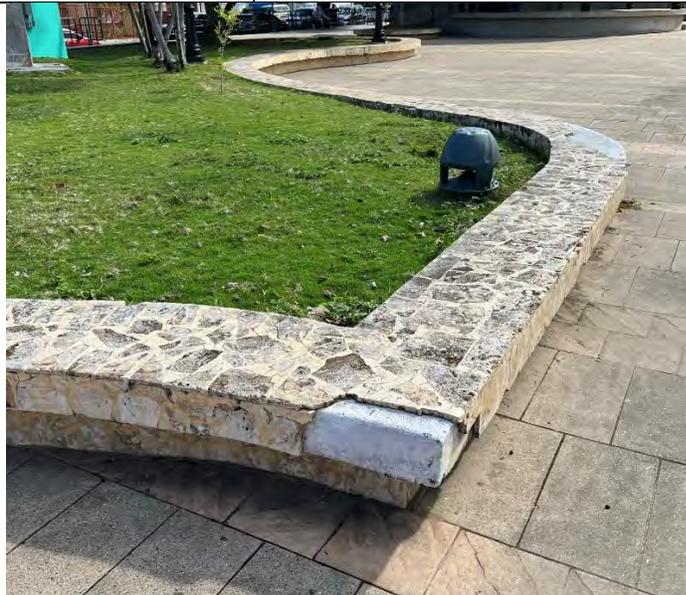
**Photo #:** J

**Description (include direction):** Detail of Plaza’s bench deterioration. Camera looking east.

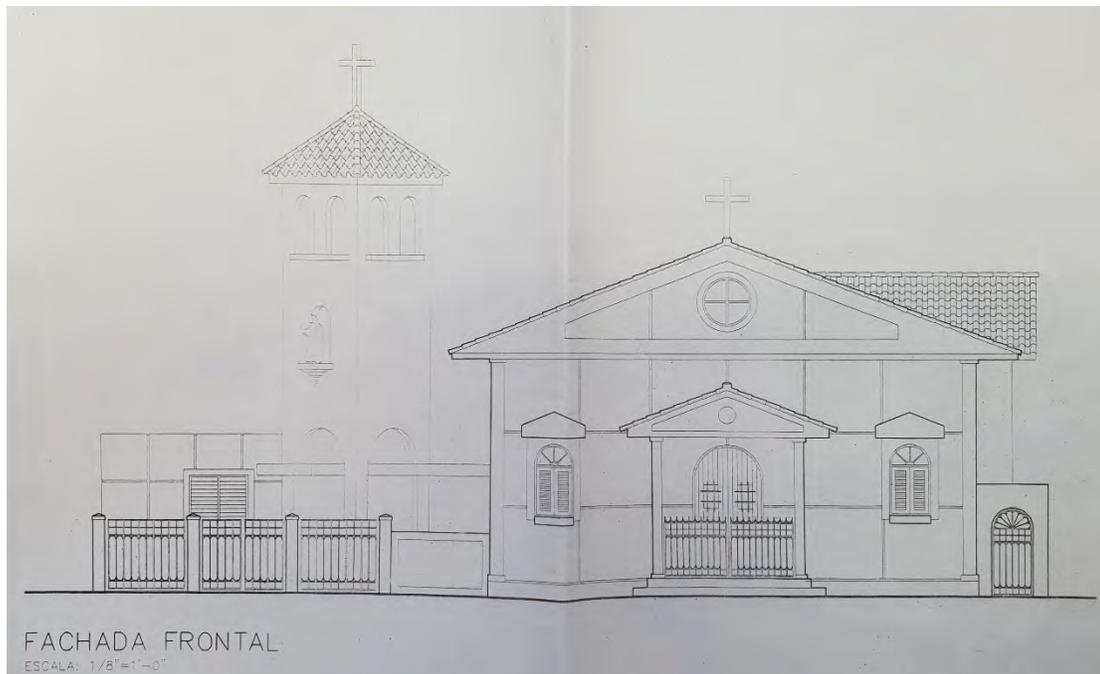
ICP Archives, Architectural Plans, Arch. Efrén Badía, May 13, 1998.

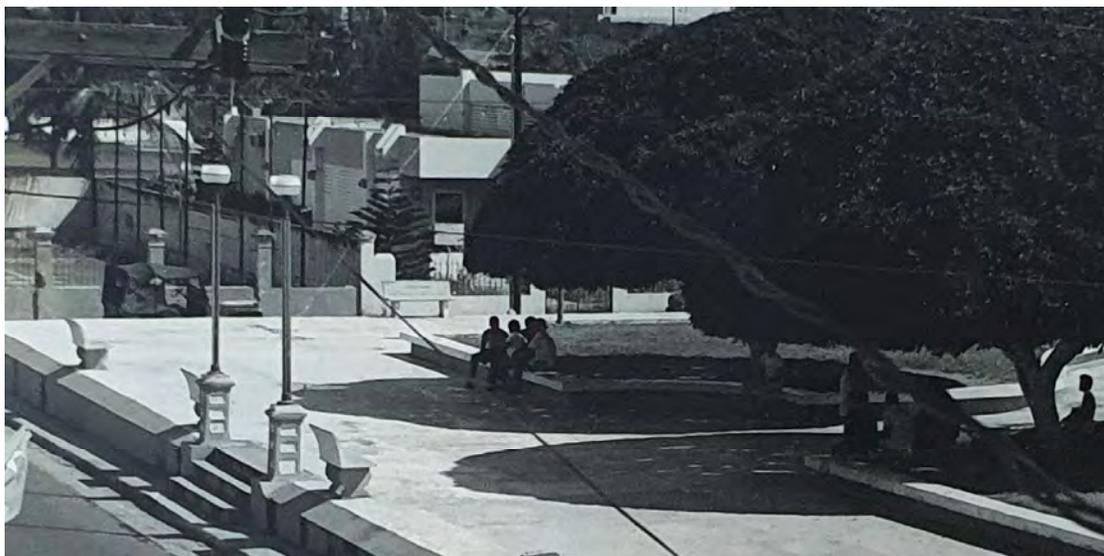
ICP Photographic Archives: 1978, the photo shows a 1 level concrete building in the site.

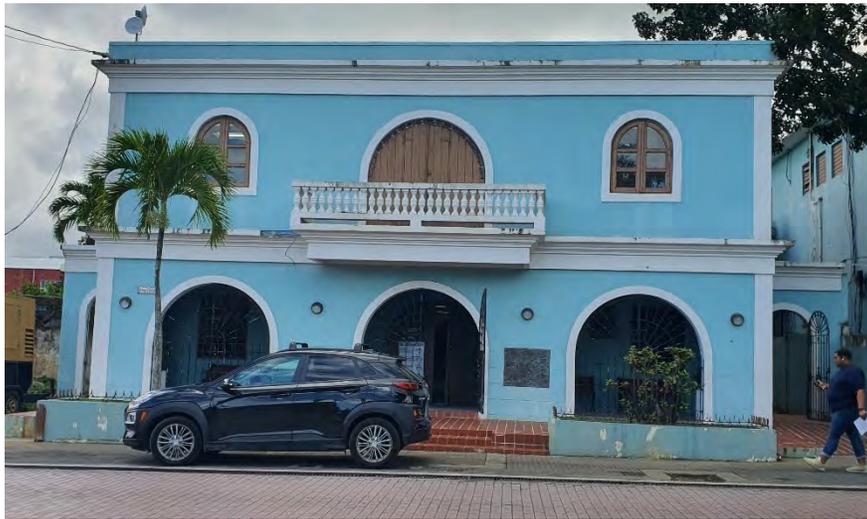
**Image No. 11**

<b>Parcel/Lot #: Cadaster Number</b>	457-043-021-06
<b>Address:</b>	Antonio Mellado St. (San Francisco St.); Isabel Segunda, Vieques, P.R.
<b>Name / Historic name:</b>	Centro de Usos Múltiples de Vieques.
<b>Approx. Constr. Date/Style:</b>	No date available / Neoclassical.
<b>NRHP Status or Eligibility/Other:</b>	Non-Contributing Property.

**Description** (include direction of image and other important information):  
 West façade, looking east (main façade). Marked at ICP Inventory (No date - after 2001) as: Eligible. The façade of the building was reconstructed, original façade can be perceived in the historic photos attached. Further investigation on other building components (Ex. interior distribution and materials) should be investigated to determine building eligibility.

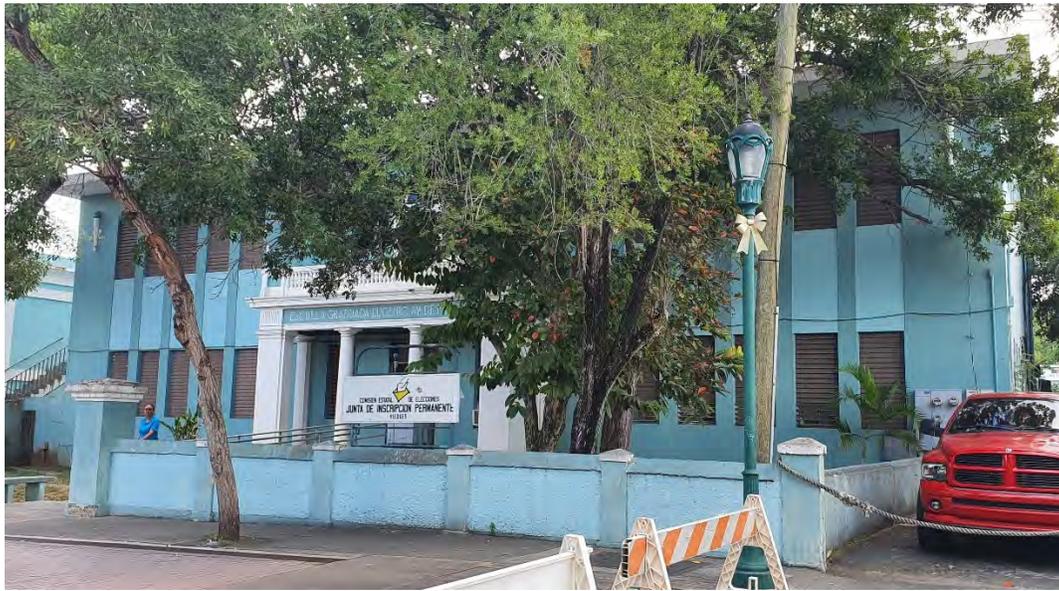
**Image No. 12**

<b>Parcel/Lot #: Cadaster Number</b>	457-053-021-07
<b>Address:</b>	Antonio Mellado St. (San Francisco St.); Isabel Segunda, Vieques, P.R.
<b>Name / Historic name:</b>	Escuela Graduada Eugenio María de Hostos
<b>Approx. Constr. Date/Style:</b>	c.1930
<b>NRHP Status or Eligibility/Other:</b>	Eligible under Criterion A and C. The building maintains its original location, design, feeling, association, and setting. This building is also eligible for being part of the educational development in P.R. in the 20 <sup>th</sup> century.

**Description** (include direction of image and other important information):  
 West façade, looking northeast (main façade). Identified in the "Inventario de estructuras históricas en el pueblo de Isabel Segunda, Vieques, Puerto Rico" by Robert Rabin, 1991; ICP Archives. Marked at ICP Inventory (No date - after 2001) as: Eligible.

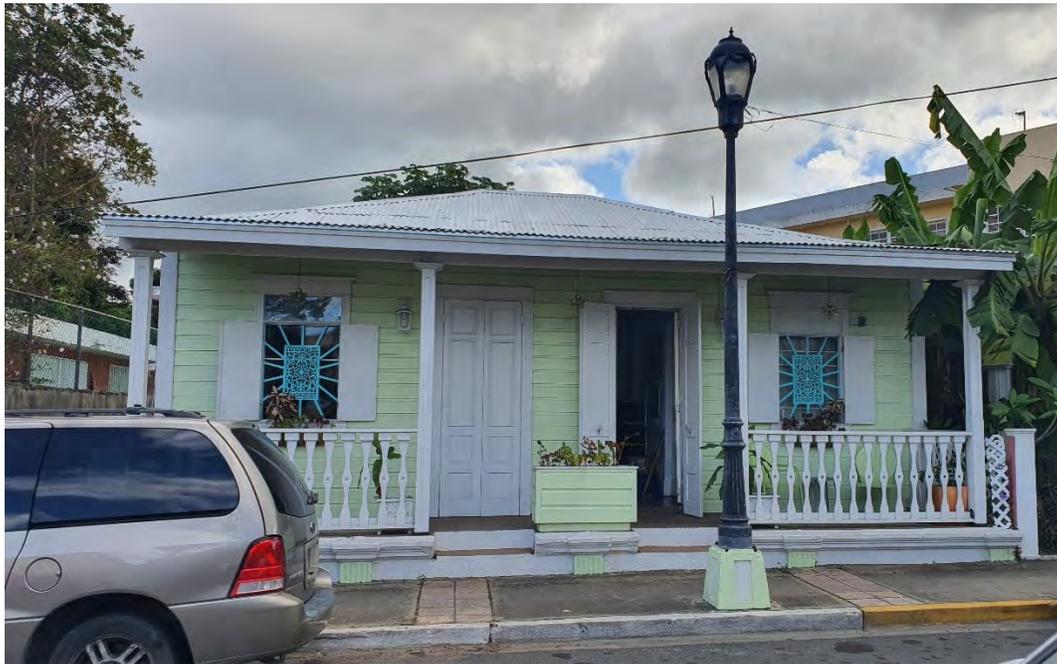
**Image No. 14**

<b>Parcel/Lot #: Cadaster Number</b>	457-053-021-09
<b>Address:</b>	370 Antonio Mellado St. (San Francisco St.); Isabel Segunda, Vieques, P.R.
<b>Name / Historic name:</b>	Residence / Historic Name: Gertrudis Guadalupe residence
<b>Approx. Constr. Date/Style:</b>	c.1900
<b>NRHP Status or Eligibility/Other:</b>	Eligible under Criterion C. The building maintains its original location, design, feeling, association, setting, material and workmanship.
<b>Description</b> (include direction of image and other important information): East façade (main), photo looking west. Identified in the "Inventario de estructuras históricas en el pueblo de Isabel Segunda, Vieques, Puerto Rico" by Robert Rabin, 1991; ICP Archives. Marked at ICP Inventory (No date - after 2001) as: Eligible.

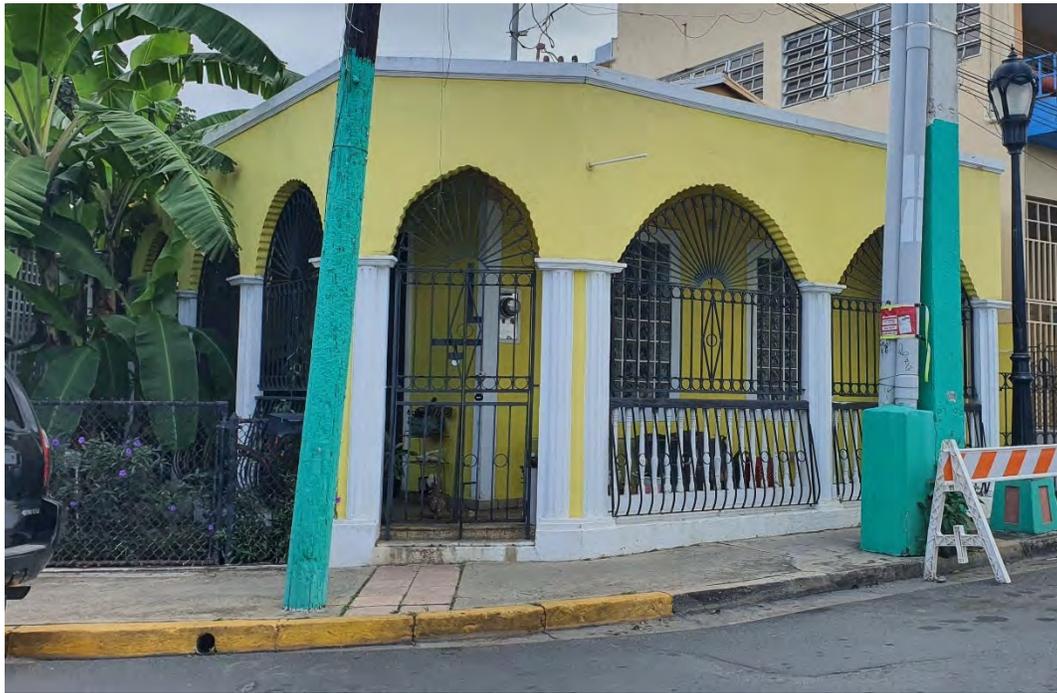
**Image No. 15**

<b>Parcel/Lot #: Cadaster Number</b>	457-053-021-10
<b>Address:</b>	368 Antonio Mellado St. (San Francisco St.); Isabel Segunda, Vieques, P.R.
<b>Name / Historic name:</b>	Residence / Historic Name: Adrian Emeric residence.
<b>Approx. Constr. Date/Style:</b>	N/A
<b>NRHP Status or Eligibility/Other:</b>	Non-Contributing Property.
<b>Description</b> (include direction of image and other important information): East façade (main), photo looking west. Identified as a wood residence (S.XIX) in the "Inventario de estructuras históricas en el pueblo de Isabel Segunda, Vieques, Puerto Rico" by Robert Rabin, 1991; ICP Archives. Building has been intervened; concrete gallery/balcony and a wooden roof can be observed.	
<b>Historic photo:</b> (N/A)

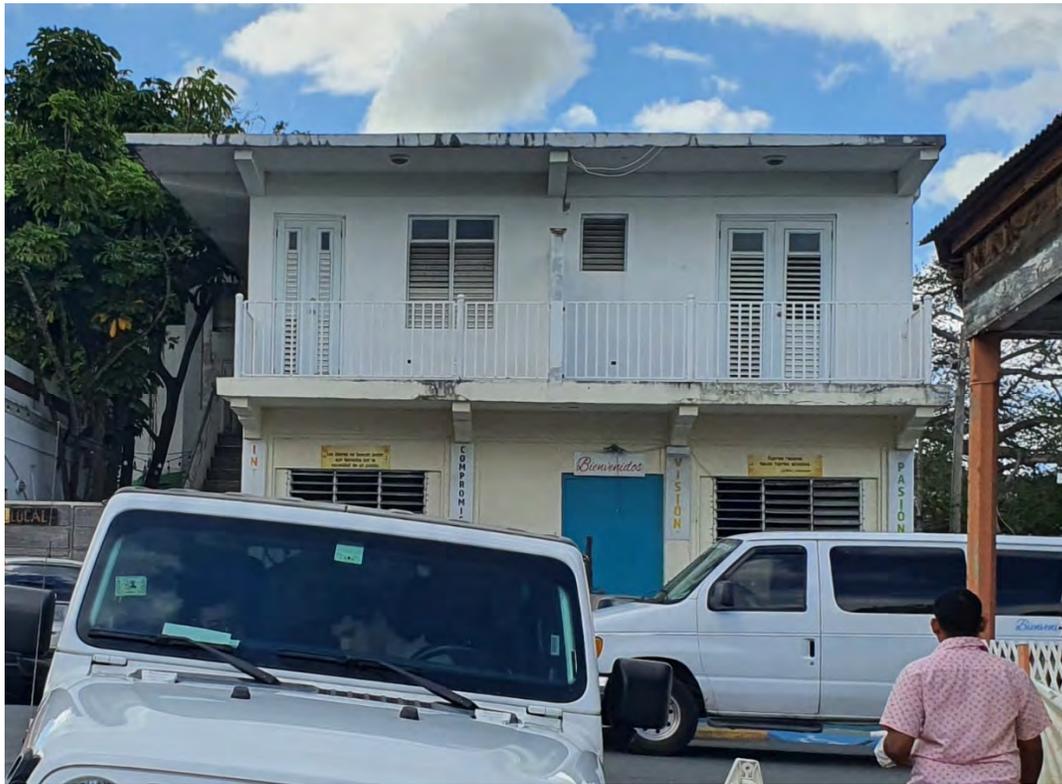
**Image No. 16**

<b>Parcel/Lot #: Cadastral Number</b>	457-052-026-01
<b>Address:</b>	Muñoz Rivera St.; Isabel Segunda, Vieques, P.R.
<b>Name / Historic name:</b>	Mixed use building.
<b>Approx. Constr. Date/Style:</b>	N/A
<b>NRHP Status or Eligibility/Other:</b>	Non-Contributing Property.
<b>Description</b> (include direction of image and other important information): North façade (main), photo looking south. Alterations to building caused an adverse effect to the existing/historic structure. Upper-level structure was originally a wood residence. Balcony beams seems to maintains building's original design.

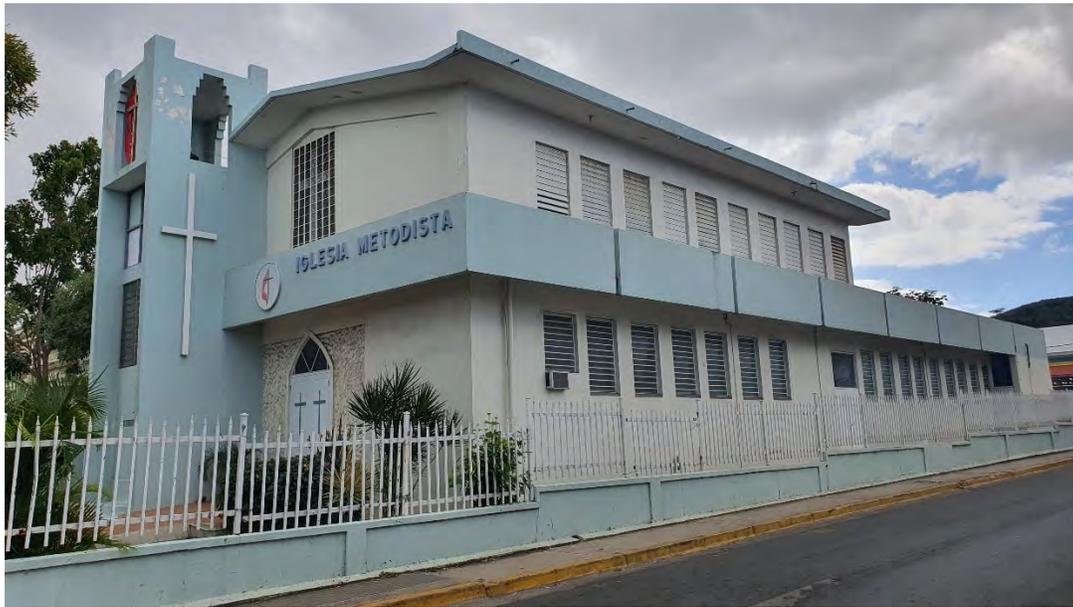
Image No. 24

<b>Parcel/Lot #: Cadastral Number</b>	A. 457-042-020-03 B. 457-042-020-02 C. 457-042-020-01
<b>Address:</b>	Víctor Duteil St.; Carlos Le Brun St.; Isabel Segunda, Vieques, P.R.
<b>Name / Historic name:</b>	The Methodist Church
<b>Approx. Constr. Date/Style:</b>	N/A
<b>NRHP Status or Eligibility/Other:</b>	Non-Contributing Property.

**Description** (include direction of image and other important information):  
 Corner view, photo looking east. Alterations to building caused an adverse effect to the existing/historic structure. Original architecture is highly impacted by later interventions. Marked at ICP Inventory (No date - after 2001) as: Not Eligible.

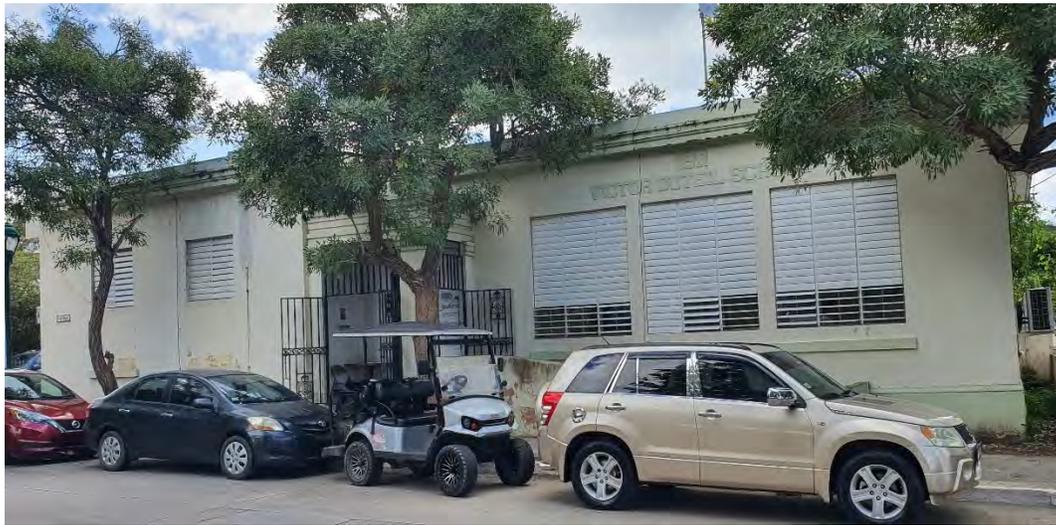
**Image No. 25**

<b>Parcel/Lot #: Cadaster Number</b>	457-052-020-05
<b>Address:</b>	Victor Duteil St.; Isabel Segunda, Vieques, P.R.
<b>Name / Historic name:</b>	Victor Duteil School / Historic Name: Vieques two (2) room school building, and Victor Duteil.
<b>Approx. Constr. Date/Style:</b>	1911.
<b>NRHP Status or Eligibility/Other:</b>	Previously Surveyed (Early XXth Century Schools in Puerto Rico, NRHP - Multiple Property Documentation, 2012.) / Eligible under Criterion A and C.

**Description** (include direction of image and other important information):  
 North façade view (main), photo taken looking south. Identified in the "Inventario de estructuras históricas en el pueblo de Isabel Segunda, Vieques, Puerto Rico" by Robert Rabin, 1991; ICP Archives. Marked at ICP Inventory (No date - after 2001) as: Eligible.

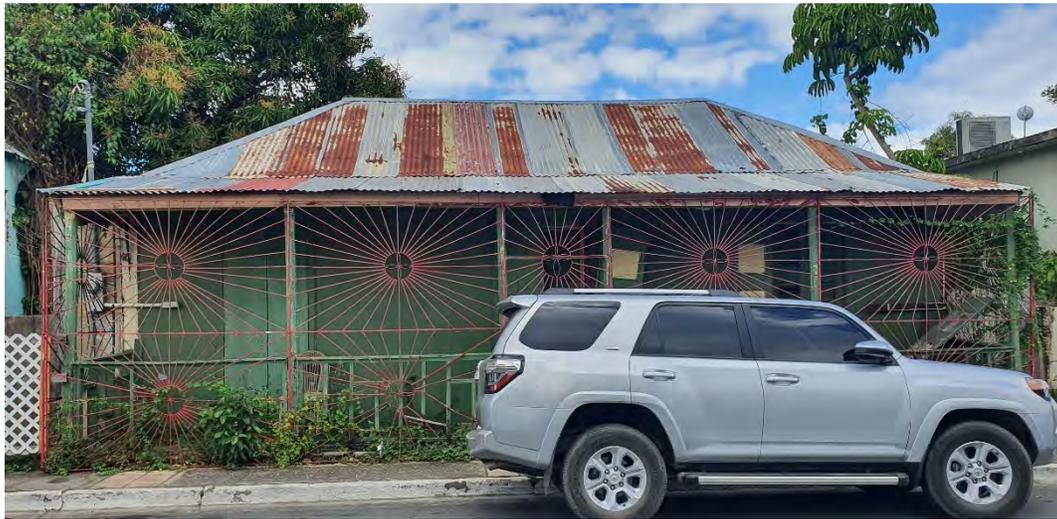
**Image No. 26**

<b>Parcel/Lot #: Cadaster Number</b>	457-052-020-06
<b>Address:</b>	355 Antonio Mellado St.; Isabel Segunda, Vieques, P.R.
<b>Name / Historic name:</b>	Casa Delerme-Anduze No. 2, Casa de Don Rosendo Delerme
<b>Approx. Constr. Date/Style:</b>	c.1872
<b>NRHP Status or Eligibility/Other:</b>	Individually Listed (Casa Delerme-Anduze No. 2, NRHP, 1993.) / Eligible with locally significance under Criteria C. / ICP: Historic Site; 2000-(RE)-18-JP-SH; May 16, 2001.

**Description** (include direction of image and other important information): East façade (main), photo taken looking west. Identified in the "Inventario de estructuras históricas en el pueblo de Isabel Segunda, Vieques, Puerto Rico" by Robert Rabin, 1991; ICP Archives. Marked at ICP Inventory (No date - after 2001) as: Historic Site.

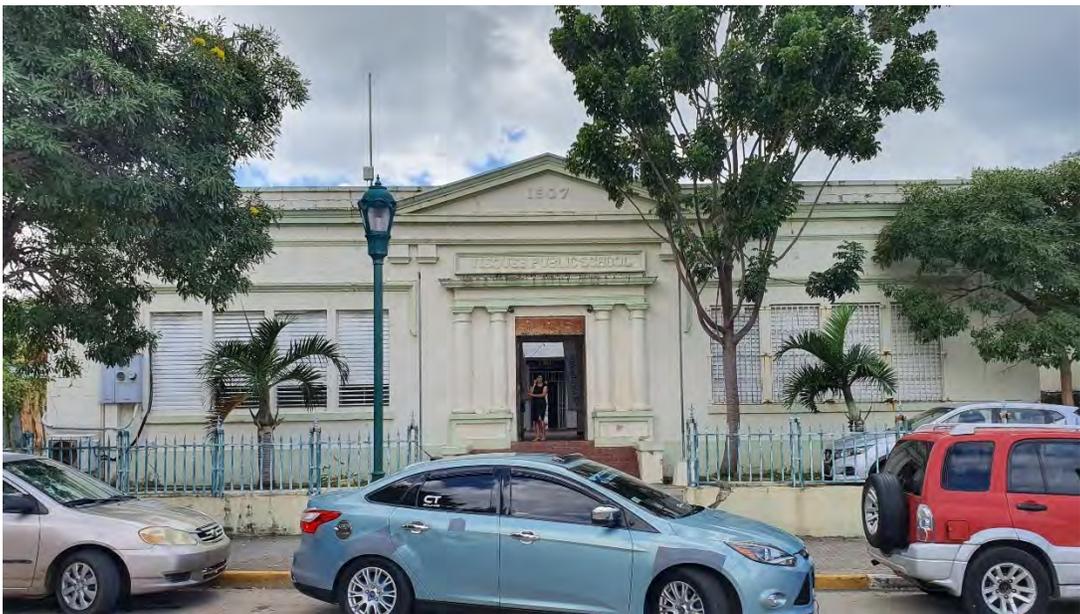
Image No. 28	Date photo taken: 01/25/2023

<b>Parcel/Lot #: Cadaster Number</b>	457-052-020-04
<b>Address:</b>	Victor Duteil St.; Isabel Segunda, Vieques, P.R.
<b>Name / Historic name:</b>	Gautier Benítez School / Historic Name: Vieques Graded School Building.
<b>Approx. Constr. Date/Style:</b>	1907
<b>NRHP Status or Eligibility/Other:</b>	Previously Surveyed (Early XXth Century Schools in Puerto Rico, NRHP - Multiple Property Documentation, 2012.) / Eligible under Criterion A & C.
<b>Description</b> (include direction of image and other important information): North façade (main), photo looking south. Identified in the “Inventario de estructuras históricas en el pueblo de Isabel Segunda, Vieques, Puerto Rico” by Robert Rabin, 1991; ICP-PPHE Archives. Marked at ICP Inventory (No date - after 2001) as: Eligible.
