## **Environmental Review for Activity/Project that is Categorically Excluded Subject to Section 58.5**

**Project Name:** PR-CRP-000807: Mejoras a la Plaza Pública de Vieques & PR-CRP-001111: Centro Agrícola de Transformación Social y Comunitario

**Responsible Entity:** Puerto Rico Department of Housing (PRDOH)

**Preparer:** Angel Garcia PE, Sr. Environmental Engineer at AG Environmental PSC

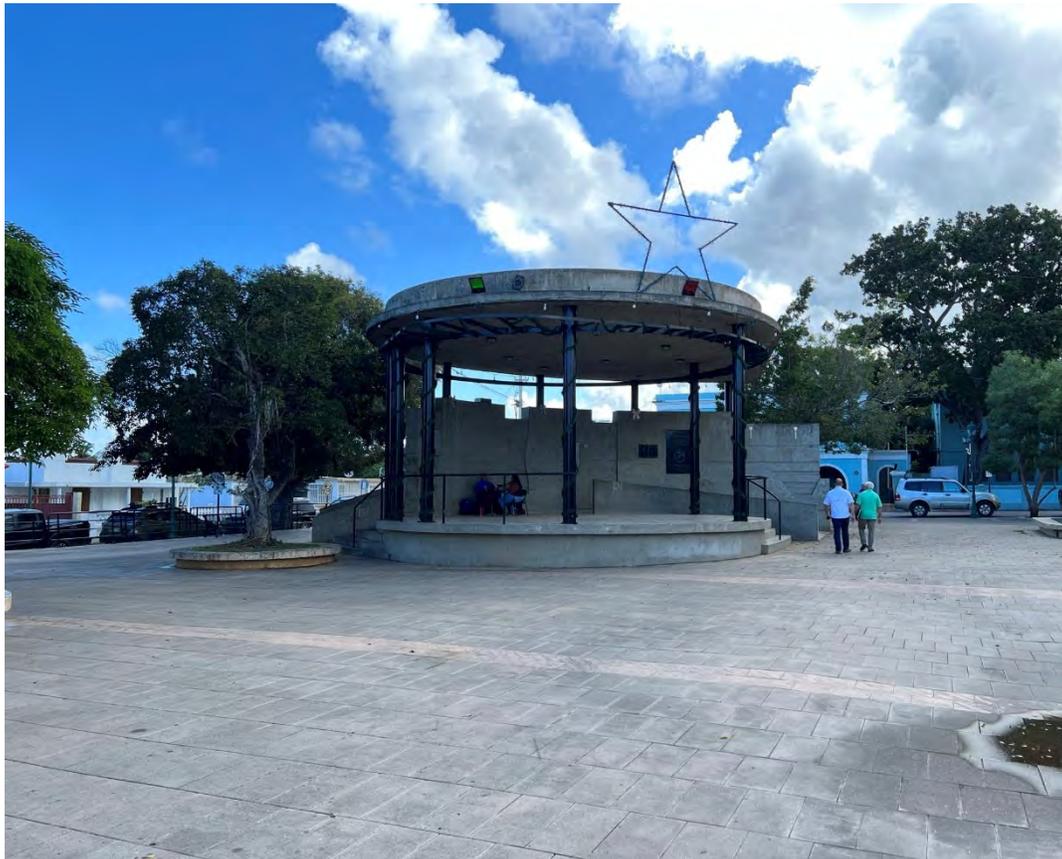
**Image No.** 029

Photo looking east. Even though its design has changed throughout the years, it is documented to have 1900's cistern walls under the Plaza. Also, its importance of being the foundational center of the City of Vieques makes it eligible. Marked at ICP Inventory (No date - after 2001) as: Historic Site.

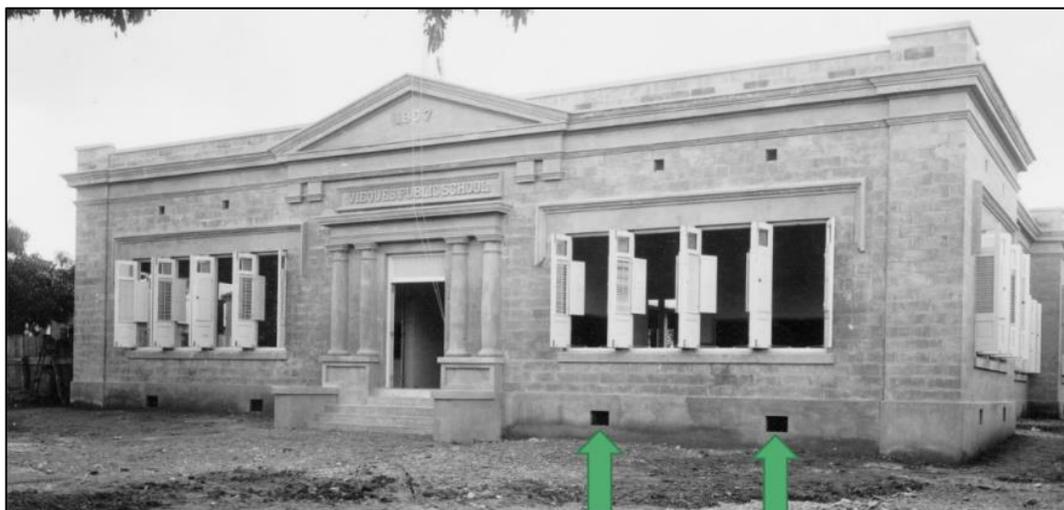
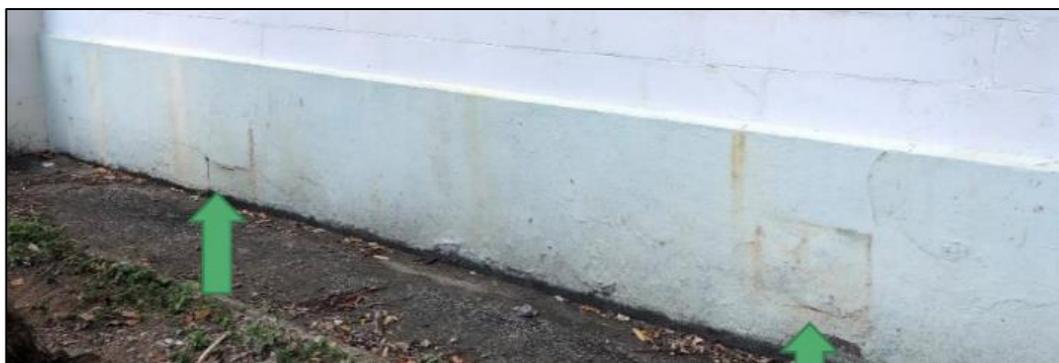
Figura 2: Respiraderos 1907 & condición existente (Maurás 2024:5).

En la escuela se realizaron excavaciones de un 1x1x1m en dos localidades, a modo de exploratorias, para conocer la condición de la zapata de la estructura (Anejo 2: Vieques JG Benítez School-Exploratory Locations). También se removió en las paredes exteriores material cementoso, utilizado para tapar unos huecos en la base del edificio, para poder conocer la condición existente bajo la losa del piso del edificio (Figura 2).

La Monitoria se realiza durante la excavación de tres unidades de 1x1x1m, una en la Plaza adyacente a la jardinera sur oeste [ U1-Plaza ], y en dos localidades próximo a las paredes externas de la Escuela Gautier Benitez, a modo de exploratorias [ U2-Esc GB & U3-Esc GB ], para conocer la condición de la zapata de la estructura (y Anejo 2 y 3: Exploratory Locations). También se removió material cementoso, utilizado para tapar unos huecos en la base del edificio, para poder conocer la condición existente bajo la losa del piso del edificio (Figura 2 ).

En la fachada lateral izquierdo del edificio de la Escuela Gautier Benitez, en su parte inferior se ubican dos respiraderos. Se abrió el respiradero derecho, el más cercano a las escaleras de entrada del edificio, utilizando un martillo eléctrico manual, [Figura 9]. El respiradero mide 42cm de ancho x 30cm de alto. En el proceso de su apertura observamos una matriz de arena con restos de construcción, [Figura 10]. Una vez limpio podemos observar que el grosor de la pared es de 33cm, [Figura 11].

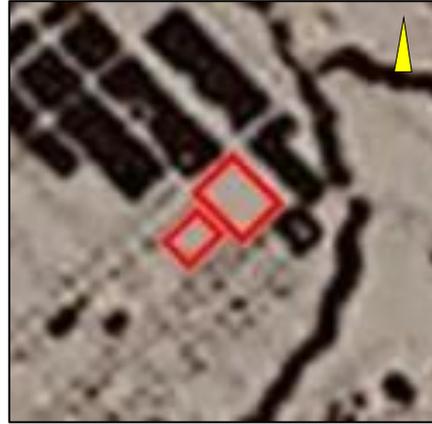
Figura 4: Plano Isabel Segunda - 1887  
(Sepúlveda 2004: T3:444).

La primera intervención en la Plaza se realiza entre 1869-1871 cuando se construye una cisterna pública de forma circular, según el croquis de 1887 (Figura 4). El plano de 1898 evidencia el diseño de la Plaza, y el contorno del "pozo" circular. El plano también destaca el espacio donde ubicaría la Escuela Gautier Benites (Figura 5 y 7).

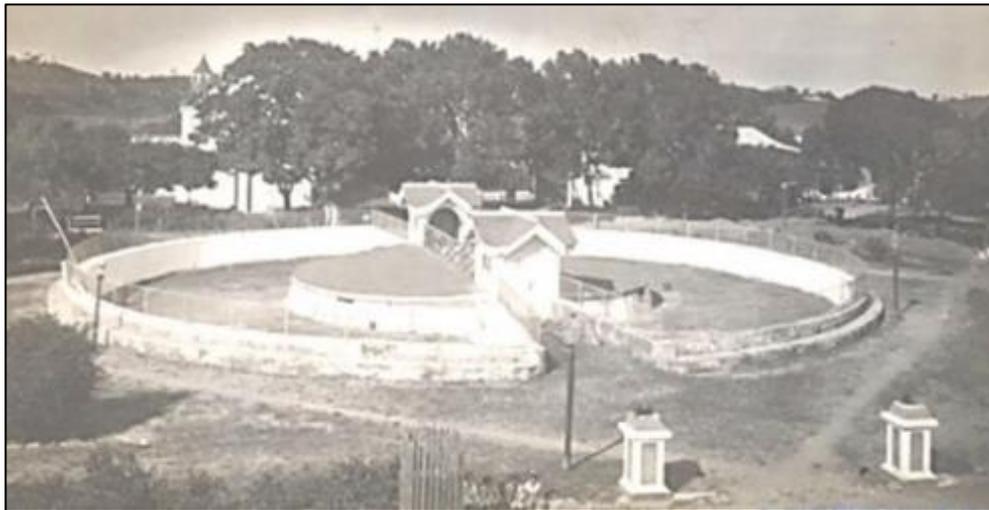
Figura 6: Estructura delimitando el aljibe 1909 (Maurás 2024:8).

La Plaza continuó como terraplén hasta la década de 1920. En la intervención de 1916-1920, parte de la cisterna fue demolida, y otra parte sigue bajo tierra. Entre 1920-1940 se demuele la estructura redonda protegiendo el aljibe, se sella el pozo y se niveló toda el área (Figura 6). La fotografía aérea de 1936 muestra la nueva Plaza de Recreo pavimentada con jardineras (Figura 7).

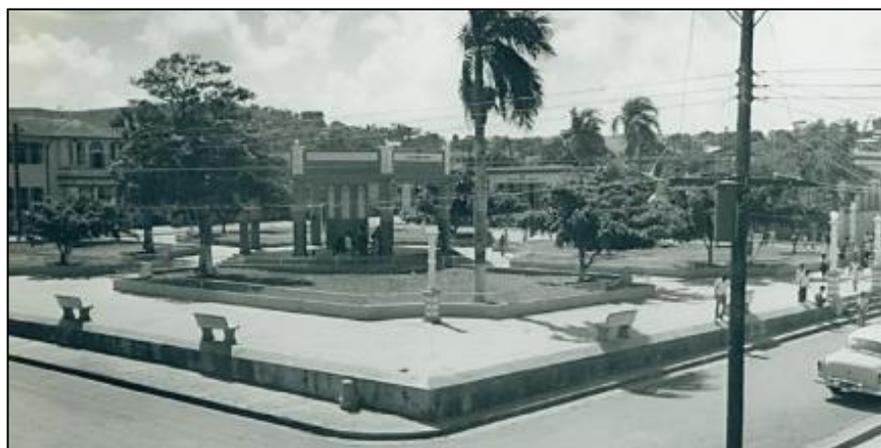
Figura 8: Plaza de Recreo de Isabel Segunda 1957 (Maurás 2024:10).

En 1947-1953 se reconstruyó el techo de la glorieta en hormigón armado, la plaza se repavimentó con terrazo y se reconstruyeron las áreas verdes (Figura 8).

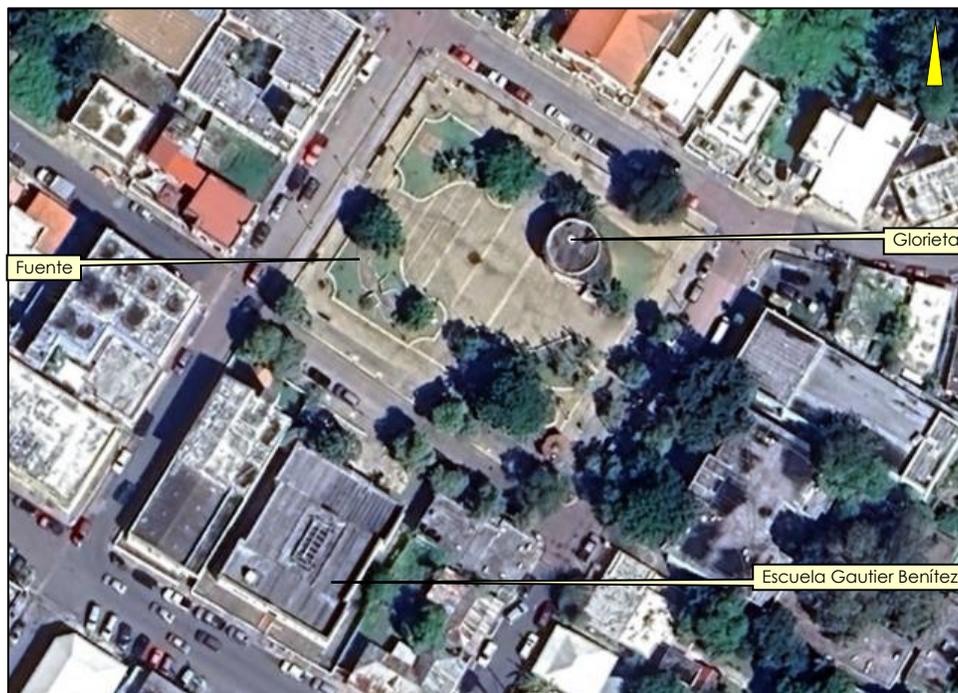
Figura 9: Plaza de Recreo de Isabel Segunda - Aérea 2023 (Google Earth 2024).

En la última remodelación entre 2004-2007, la plaza se repavimentada con terrazo, se alteró el diseño de las jardineras, la glorieta en el centro de la plaza fue demolida, se construye una nueva fuente y se construyó otra en la esquina noreste de la plaza (Figura 9).

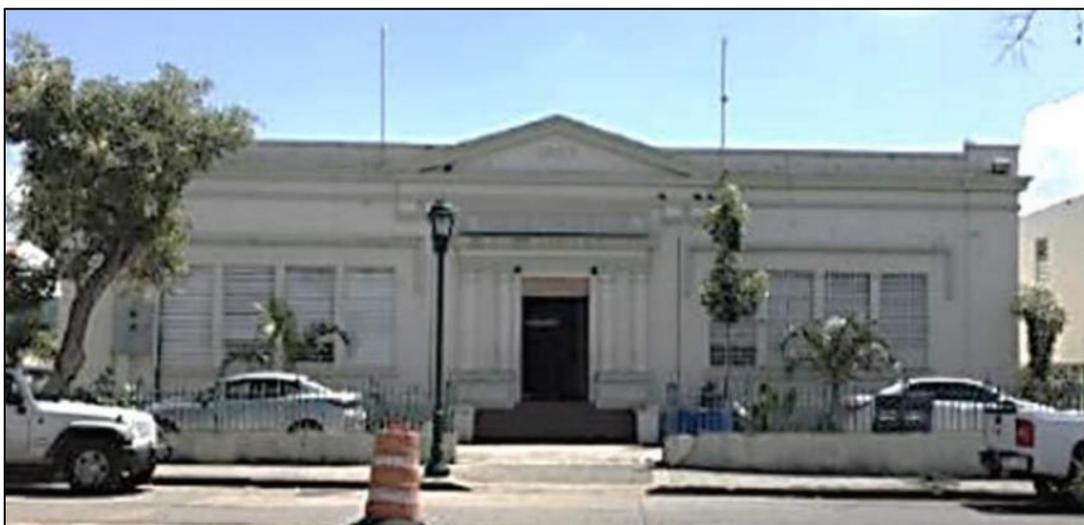
Figura 10: Fachada – Esc. Gautier Benítez 2023 (Maurás 2024:12).

La Escuela J. Gautier Benítez, también conocida como la Escuela Pública de Vieques, fue diseñada por el arquitecto Antonin Nechodoma. El inmueble fue construido en 1907 por la División de Edificios Escolares del Departamento de Educación, Frank B. Hatch contratista. La construcción la escuela fue parte de una misión más amplia de la política educativa de los Estados Unidos desde la década de 1900, resultado de la americanización educación en Puerto Rico. El inmueble corresponde en diseño al período Colonial Americano Temprano neoclásico, típico de este período histórico en Puerto Rico (Figura 10).

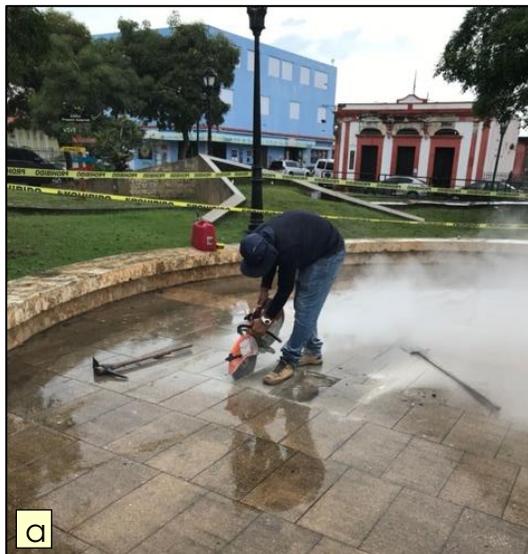
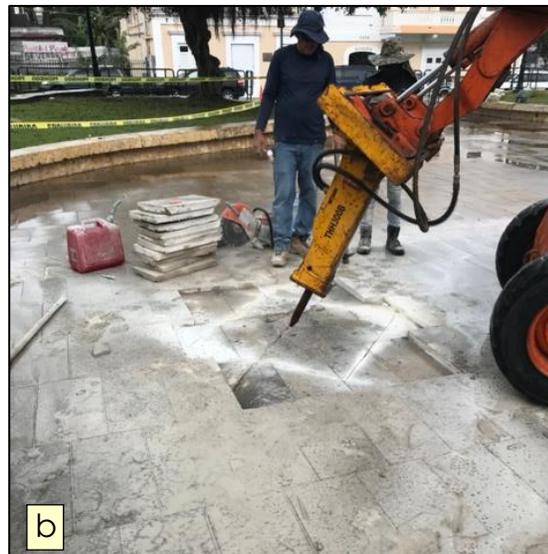
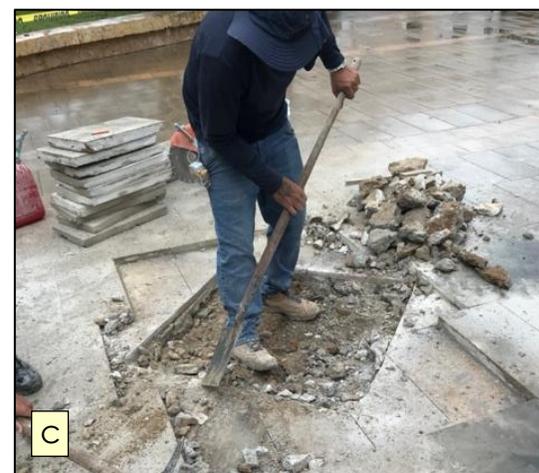
Figura 13: Exploratoria 1 – comienzo de excavación.

Foto a - corte de losetas con sierra; b y c - demolición de losa de cemento base de las losetas en superficie.

La remoción empleó una cierra de gasolina con hoja de diamante para separar cada una de las losetas sin que sufrieran rupturas para poder reubicarlas. Se removió un área más amplia de loseta para poder acomodar la exploratoria de 1 x 1m. Bajo las losetas se identifica una losa en cemento de unos 10cm promedio, base sobre la cual se ubican las losetas que cubren toda el área peatonal de la plaza. Bajo la losa, demolida utilizando un martillo hidráulico montado en un Bobcat (Figura 13), la excavación continuó con el digger y luego a mano (Figura 14). Luego de la losa se identifica una camada de caliche de unos 8cm. En el perfil este el tercio norte de este nivel estratigráfico lo ocupa cemento histórico confeccionado con chinos de río (Figura 18). Seguido, se identifica un relleno de arcilla arenosa húmeda, a causa de la lluvia, 10YR 6/6, con detrito de construcción histórico, cuyo grosor se encuentra en dependencia a la presencia del Elemento 1, compuesto por peñones de granodiorita. El detrito consiste en fragmentos planos de piso, otros fragmentos de cemento con un tinte rojizo, confeccionados con chinos de río, posiblemente relacionados con las primeras intervenciones del siglo XX (Figura 14e). La Figura 16 evidencia los materiales y artefactos encontrados: los peñones del Elemento 1, fragmentos de cemento histórico, una herradura y un clavo en hierro identificados en el relleno histórico, Estrado D.

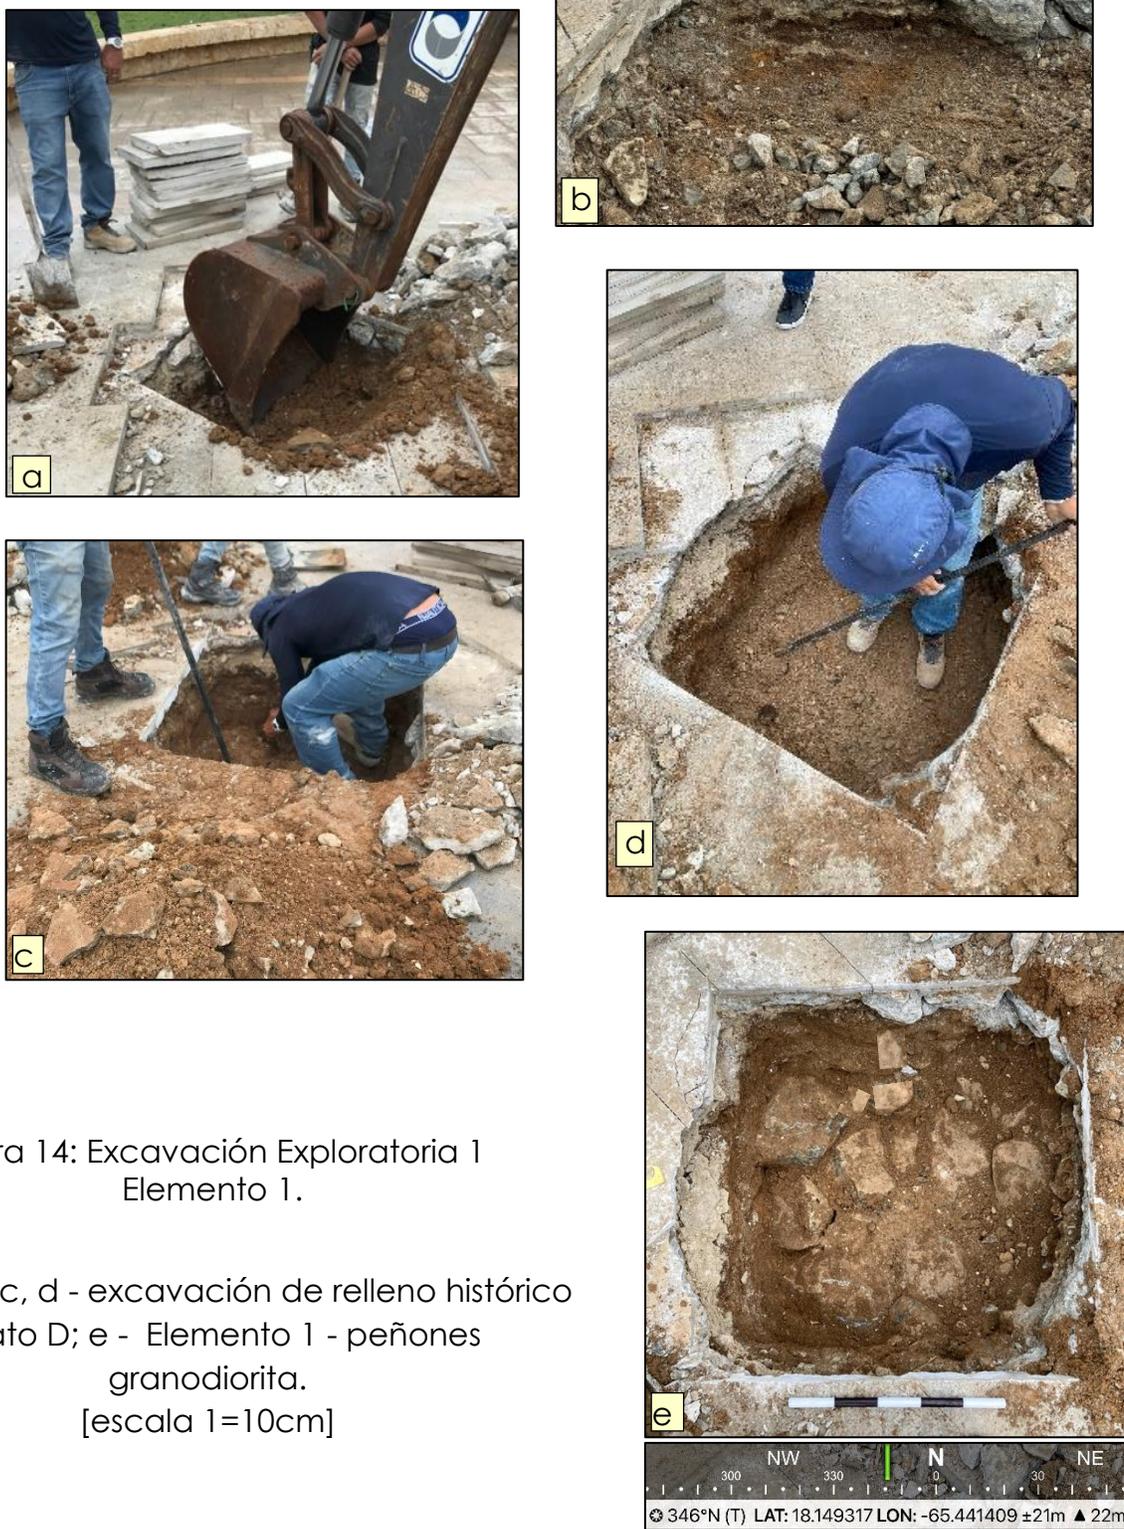
Figura 14: Excavación Exploratoria 1  
Elemento 1.

Foto a, b, c, d - excavación de relleno histórico  
Estrato D; e - Elemento 1 - peñones  
granodiorita.  
[escala 1=10cm]

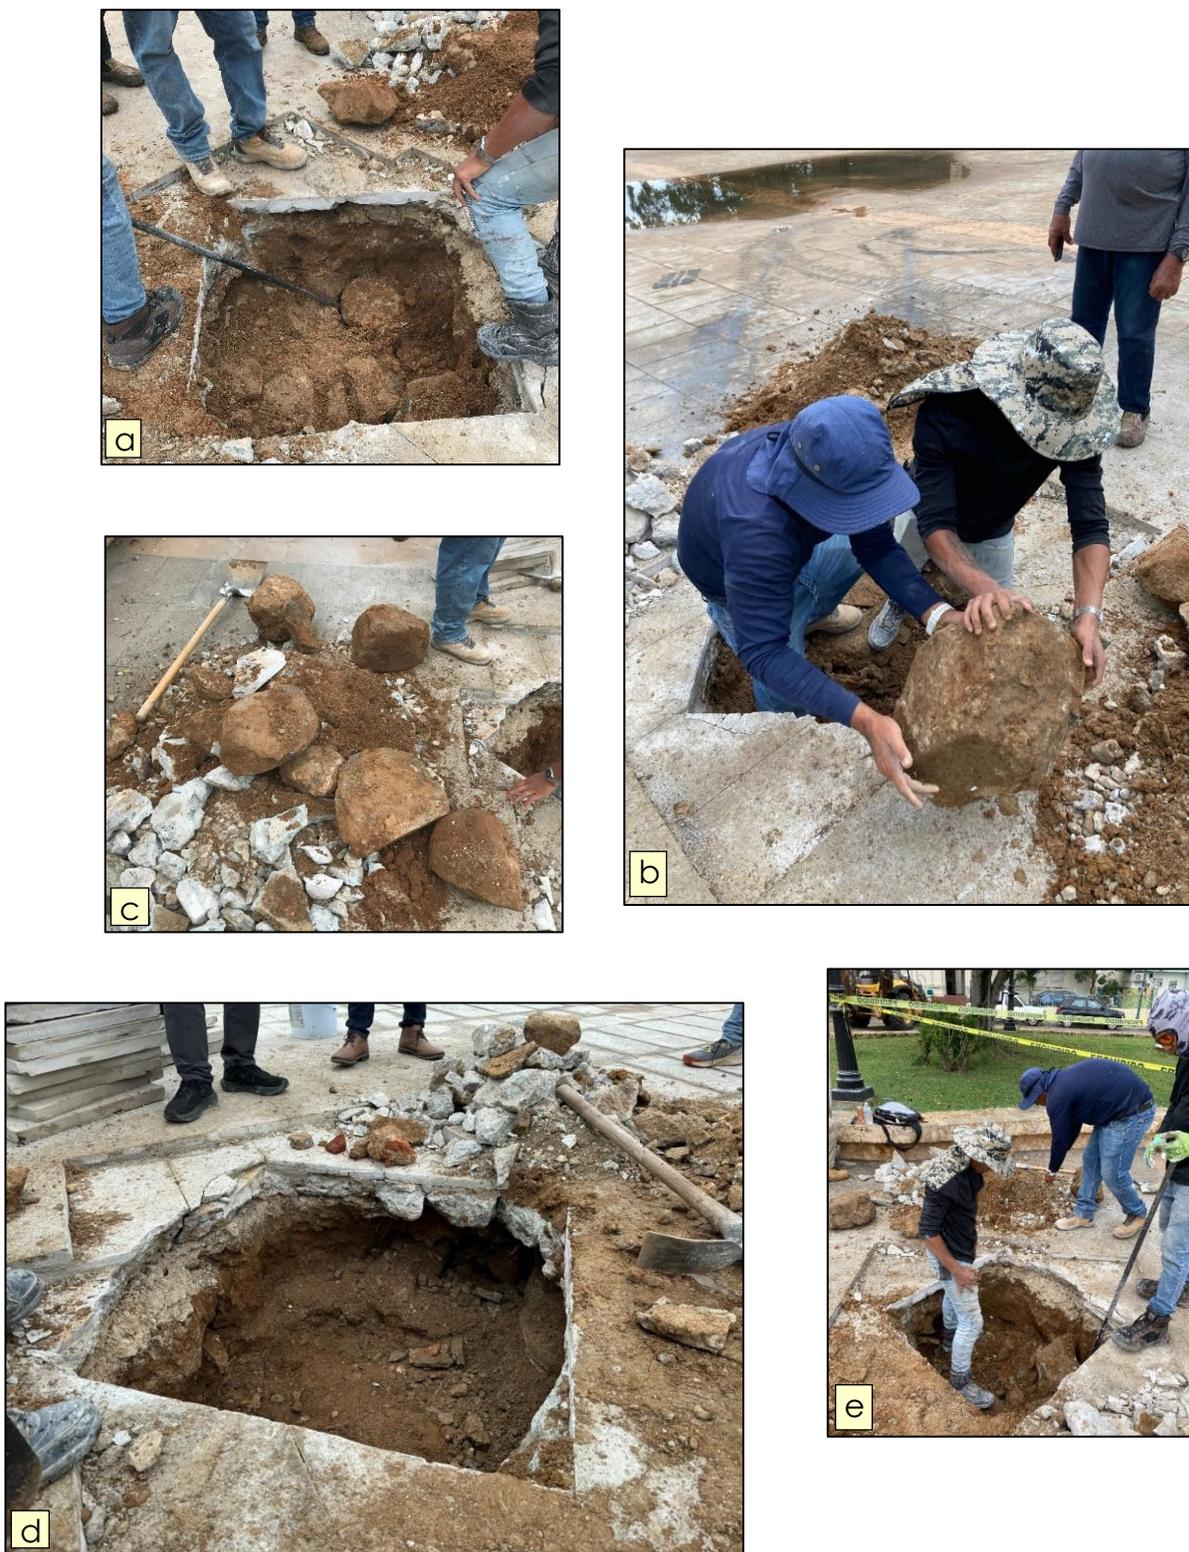
Figura 15: Extracción - Elemento 1.

Foto a – e: Elemento 1 - extracción manual de peñones de granodiorita.  
[escala 1=10cm]

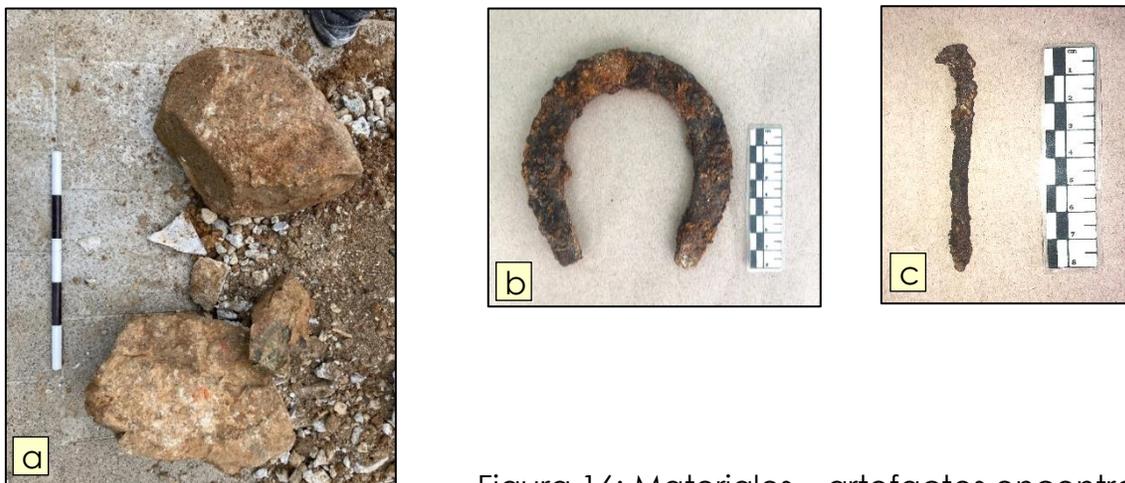
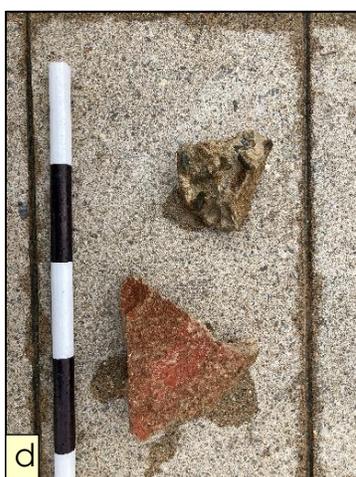
Figura 16: Materiales – artefactos encontrados.

Foto a - Peñones de granodiorita ubicados planos con su parte longitudinal de forma horizontal, según aparecen puestos en el Elemento 1; b – herradura; c – clavo en hierro; d - fragmentos de cemento con agregado de chinos de río y tinte rojo encontrados en el Estrato D - relleno histórico, sobre el elemento de granodioritas.

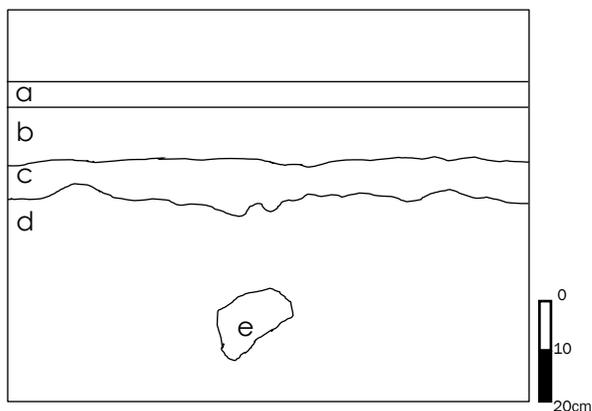
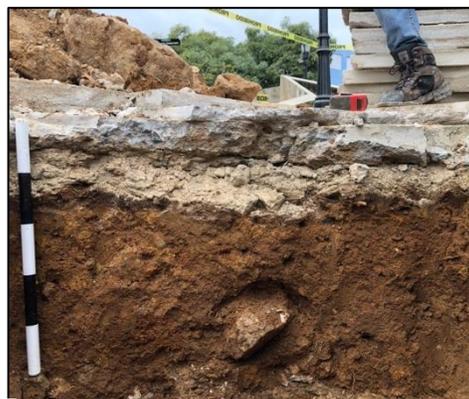
Figura 17: Perfil Sur.

- a - Losetas en la superficie
- b - Losa en cemento base de losetas
- c - Camada de caliche
- d - Relleno histórico húmedo - 10YR 6/6
- e - Piedra

El Elemento 1 (Figura 19), se caracteriza como una posible calzada por su nivelación y elemento de contención por su incremento en grosor y volumen hacia el centro de la plaza donde ubica la cisterna. En la Figura 17, perfil sur de la exploratoria, los peñones del Elemento 1 no se extienden hasta el perfil sur, sino que estos llegan justo hasta su base. En la Figura 18, perfil este de la exploratoria, se evidencia la losa moderna base de las losetas y la camada de caliche. Sin embargo, a diferencia del perfil sur donde el caliche se observa uniforme ocupando el Estrato C, en este perfil aparece cemento histórico ocupando el tercio norte del mismo espacio estratigráfico. Bajo estos, el relleno histórico ocupa la mitad sur del perfil, los peños de granodiorita del

Elemento 1 ocupan la mitad norte. El Elemento 1 aparece a unos 42cm en el perfil norte y a unos 53cm de profundidad en el perfil sur, donde termina el depósito de peñones junto donde se excava la pared sur de la Exploratoria. Estos evidencian haber sido acomodados con su parte plana y menos ancha de forma horizontal una sobre otra y sobre el terreno en un intento de crear algún tipo de nivelación superficial, a diferencia a ser depositadas *ad hoc*, sin una sistemática en pie. La calzada / elemento de contención aparecen al pie del perfil sur y se adentran magnificando su volumen y grosor por el aumento en la cantidad de peñones hacia el norte, noroeste, en dirección al centro de la plaza donde yacen los remanentes de la cisterna histórica de la plaza.

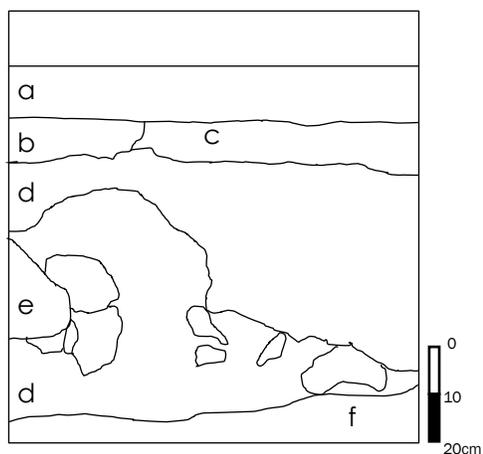
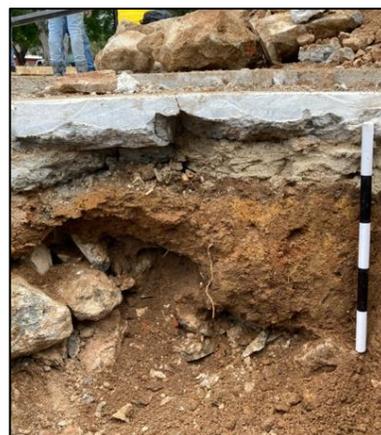
Figura 18: Perfil Este.

- a - Losa para base de losetas
- b - Losa en cemento histórico
- c - Camada de caliche
- d - Relleno histórico húmedo - 10YR 6/6
- e - Piedra Granodiorita
- f - Fondo de la excavación

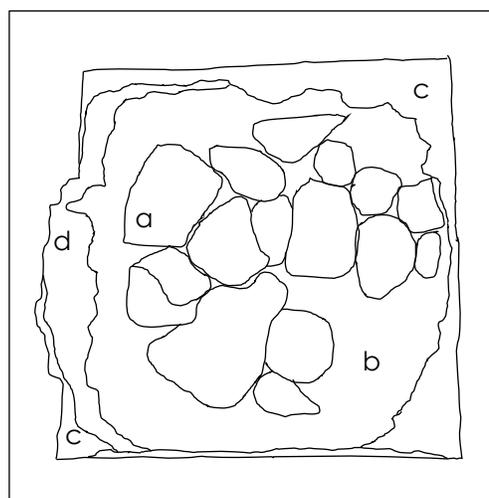
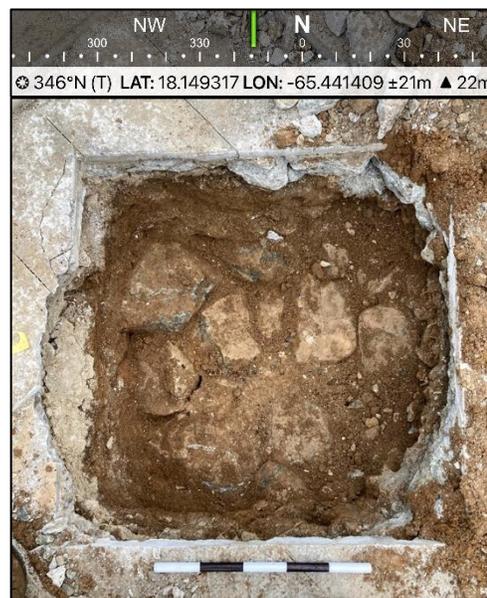
Figura 19: Elemento 1 – planta.

- a - Elemento 1 – peñones de granodiorita
- b - Relleno histórico húmedo - 10YR 5/6
- c - Losa base de losetas
- d - Camada de caliche

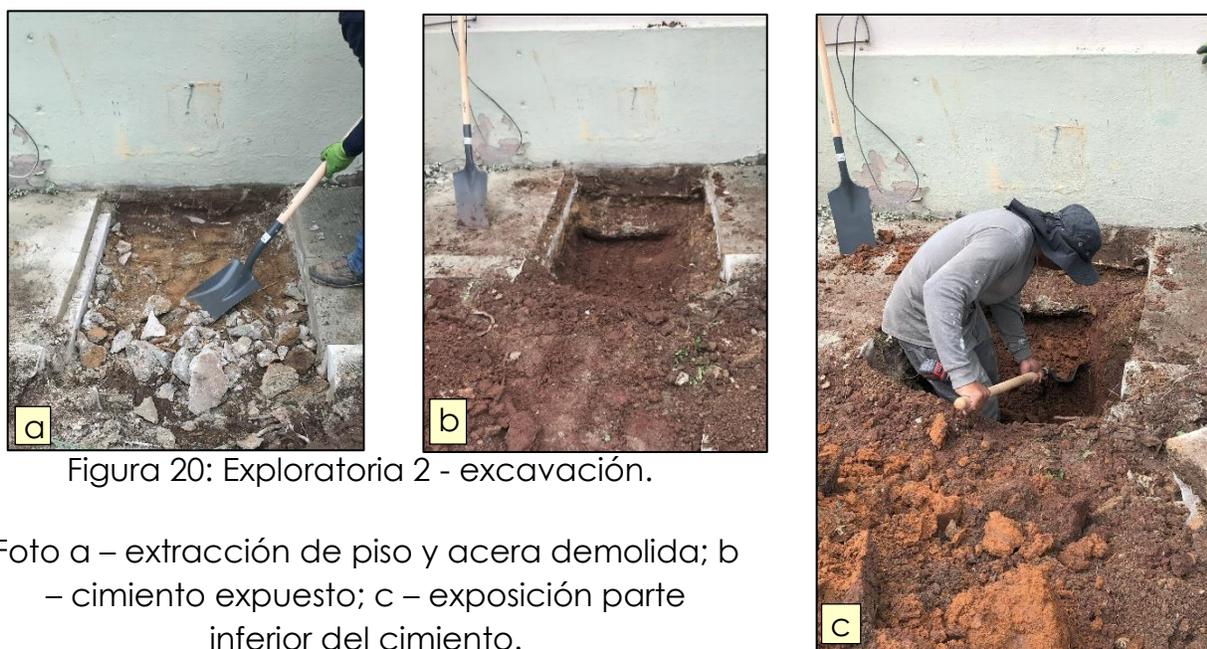
Figura 20: Exploratoria 2 - excavación.

Foto a – extracción de piso y acera demolida; b – cimiento expuesto; c – exposición parte inferior del cimiento.

La Exploratoria 2 se excava en el costado izquierdo de la fachada del edificio de la Escuela Gautier Benitez, pegado a la pared. Esta, de 1m x 1m, requiere la remoción de una acera que corre segada a la pared, parte de la jardinera que ocupa esta área, En la superficie encontramos una acera, de unos 7cm de ancho, demolida, con una cierra de gasolina y un martillo hidráulico. Bajo de esta se identificó un piso en cemento, de unos 8cm de ancho, demolido con cierra y martillo hidráulico. Este se correlaciona al primer tiro de cemento cubriendo el perímetro de la escuela. Bajo este se identifica la camada de arena 10YR 4/4 y una arcilla con piedra 10YR 3/2 entrelazada conformando la camada sobre el cual se depositó el cemento que rodea la escuela. A 23cm de profundidad se identifica a arcilla húmeda 10YR 3/6, Estrato D. Excavando el estrato aparece a 31cm promedio de profundidad, la parte superior del cimiento del edificio (Figura 20). Esta parte consiste en el derrame de exceso de material fuera de la trinchera cortada en la matriz natural del terreno, empleada como molde para el cimiento (Figura 21). Continuando la excavación, a unos 54cm promedio de profundidad se identifica una arcilla maleable 7.5YR 6/8. Una vez expuesto el cimiento posee un grosor promedio de 30cm, en dependencia al volumen de derrame de material. A 90cm promedio, una vez el personal de Marvel Designs concluye su inspección, termina la excavación.

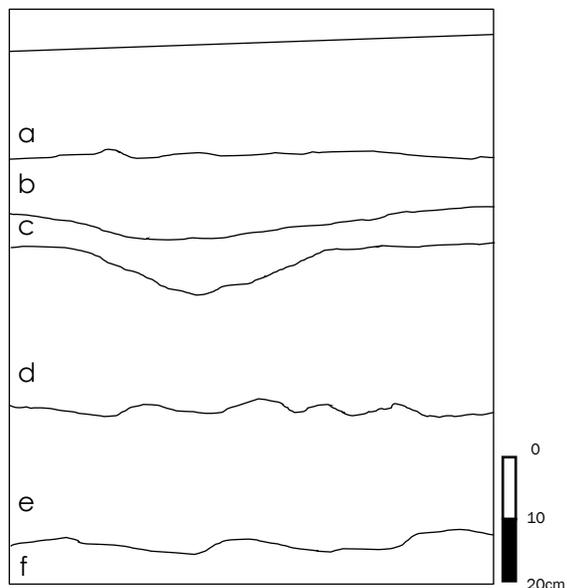
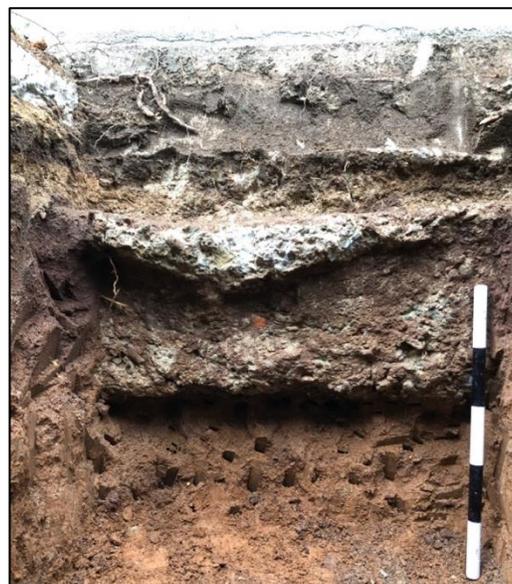
Figura 21: Exploratoria 2 - Perfil pared exterior frontal del edificio - cimiento.

- a - Pare edificio empañetada bajo la superficie
- b - Pare edificio sin empañetar bajo la superficie
- c - Derrame tiro de cimiento
- d - Cimiento en cemento y chinós de río
- e - Subsuelo - 7.5YR 6/8
- f - Fondo de la excavación

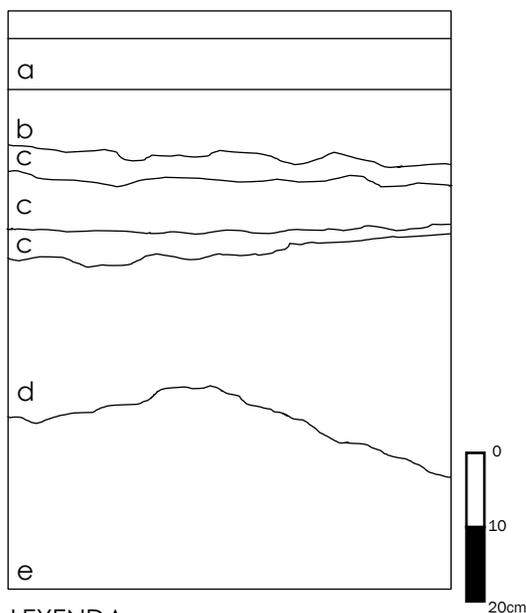
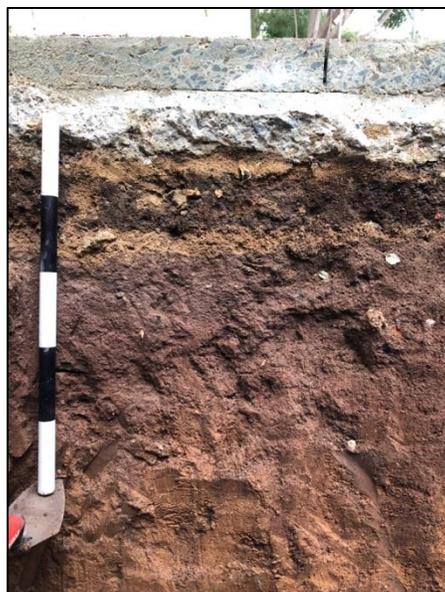
Figura 22: Exploratoria 2 - Perfil pared Oeste.

- a - Acera de superficie
- b - Losa de cemento
- c - Capada arena 10YR 4/4 y arcilla 10YR 3/2
- d - Arcilla humada - 10YR 3/6
- e - Subsuelo - 7.5YR 6/8

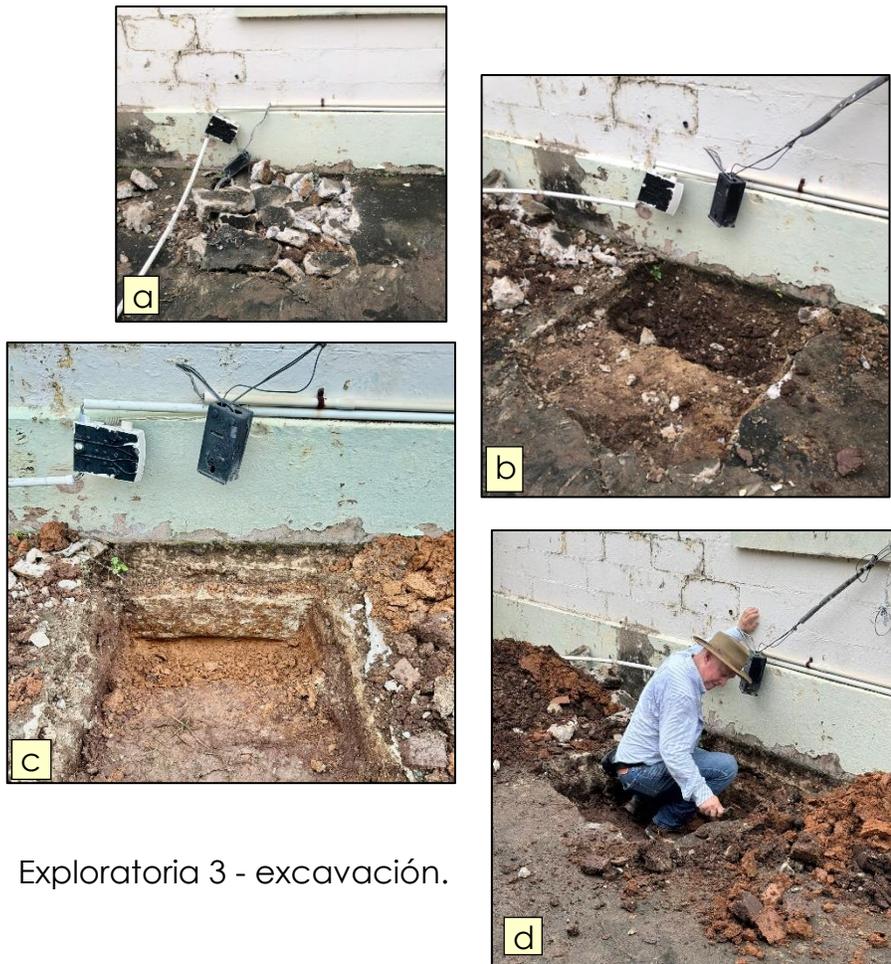
Figura 23: Exploratoria 3 - excavación.

Foto a – demolición de cemento perímetro de escuela; b y c – exposición de cimiento; d – documentación de perfiles.

La Exploratoria 3 se excava al pie de la pared de la fachada lateral izquierdo del edificio de la Escuela Gautier Benitez. Esta, de 1m x 1m, requiere la remoción del piso en cemento, de unos 6cm de ancho, que cubre el perímetro de la escuela. Bajo este se identifica en el perfil sur oeste (Figura 24), una arcilla arenosa 10YR 4/4 mezclada con caliche, esta fluctúa en grosor y posee bolsillos de caliche, mientras que el perfil noreste de la exploratoria evidencia un estrato de arcilla plástica húmeda 10YR 3/2 bajo el cemento a 6cm de profundidad. Excavando el Estrato D, a 24cm de profundidad se identifica la parte superior del cimiento del edificio (Figura 24). A 41cm se identifica el subsuelo una arcilla plástica 7.5YR 6/8. A 63cm promedio, una vez el personal de Marvel Designs concluye su inspección, termina la excavación (Figura 25).

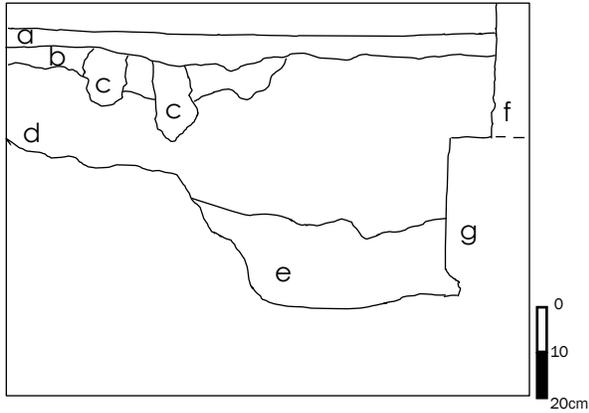
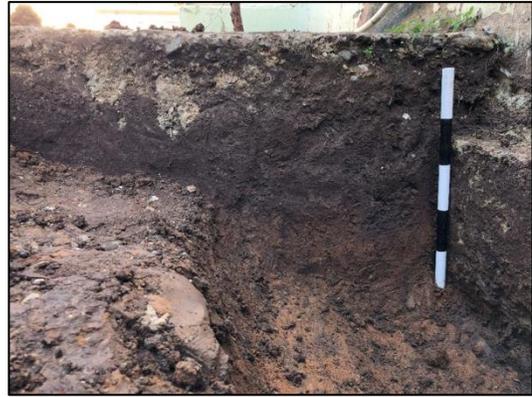
Figura 24: Exploratoria 3 - perfil sur oeste.

- a - Tiro de cemento perímetro de la escuela
- b - Relleno arcilloso húmeda 10YR 3/2 y caliche
- c - Bolsillos de caliche
- d - Arcilla húmeda plástica - 10YR 3/2
- e - Subsuelo húmedo - 7.5YR 6/8
- f - Pared del edificio
- g - Cimiento

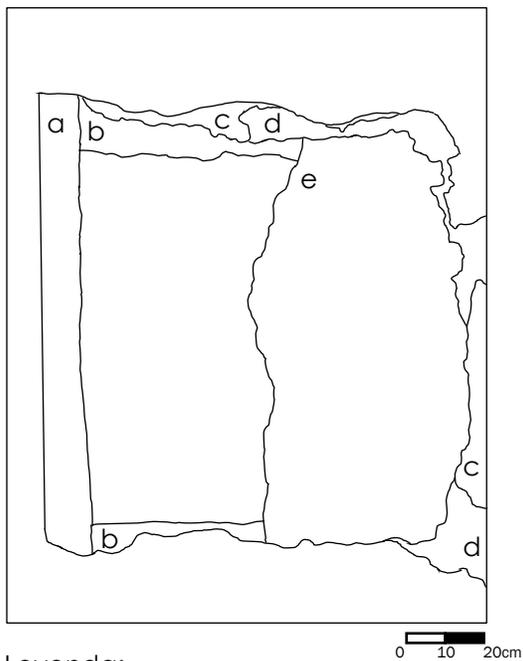
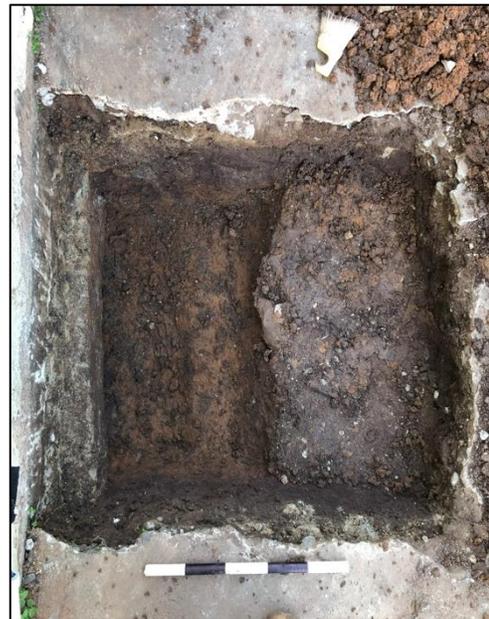
Figura 25: Exploratoria 3 – planta.

- a - Parte superior del cimiento
- b - Perfiles de la unidad
- c - Tiro de cemento perímetro de escuela
- d - Mezcla de caliche y relleno
- e - Escalón

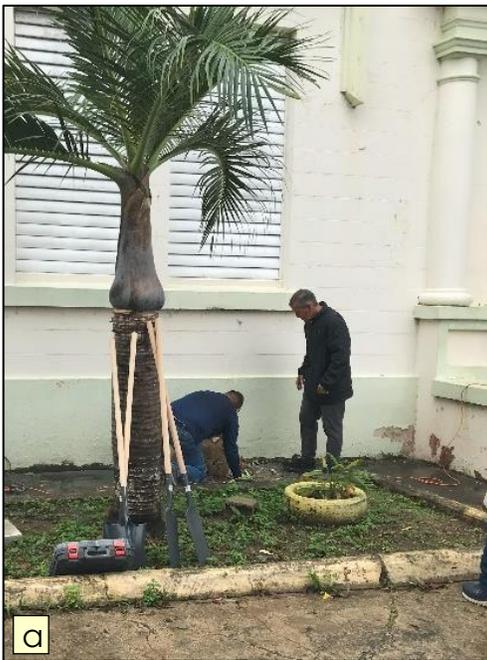
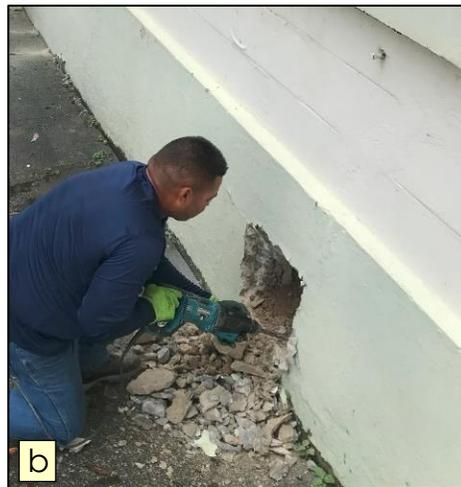
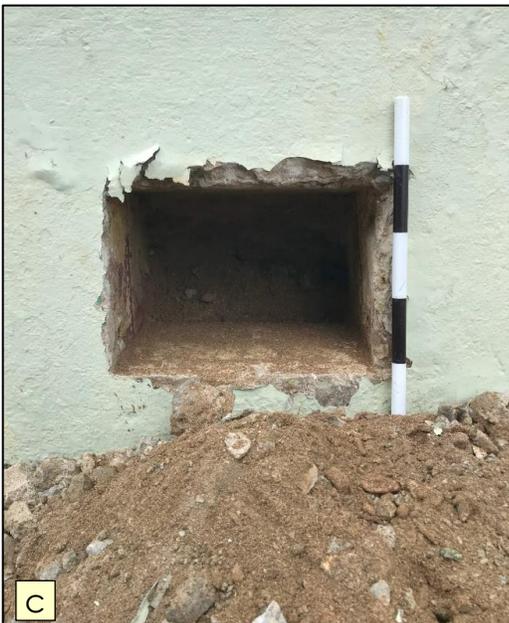
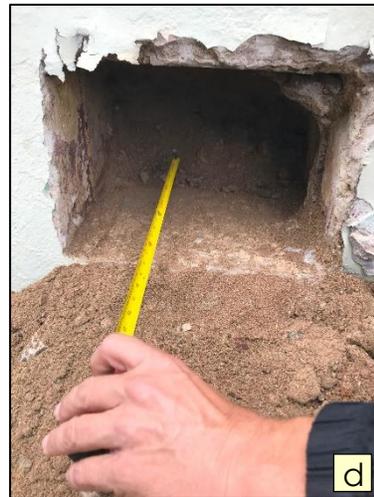
Figura 26: Respiradero – apertura.

Foto a y b – Proceso de apertura;  
c y d – documentación.  
[escala 1=10cm]
