## **Environmental Review for Activity/Project that is Categorically Excluded Subject to Section 58.5**

**Project Name:** PR-CRP-000807: Mejoras a la Plaza Pública de Vieques & PR-CRP-001111: Centro Agrícola de Transformación Social y Comunitario

**Responsible Entity:** Puerto Rico Department of Housing (PRDOH)

**Preparer:** Angel Garcia PE, Sr. Environmental Engineer at AG Environmental PSC

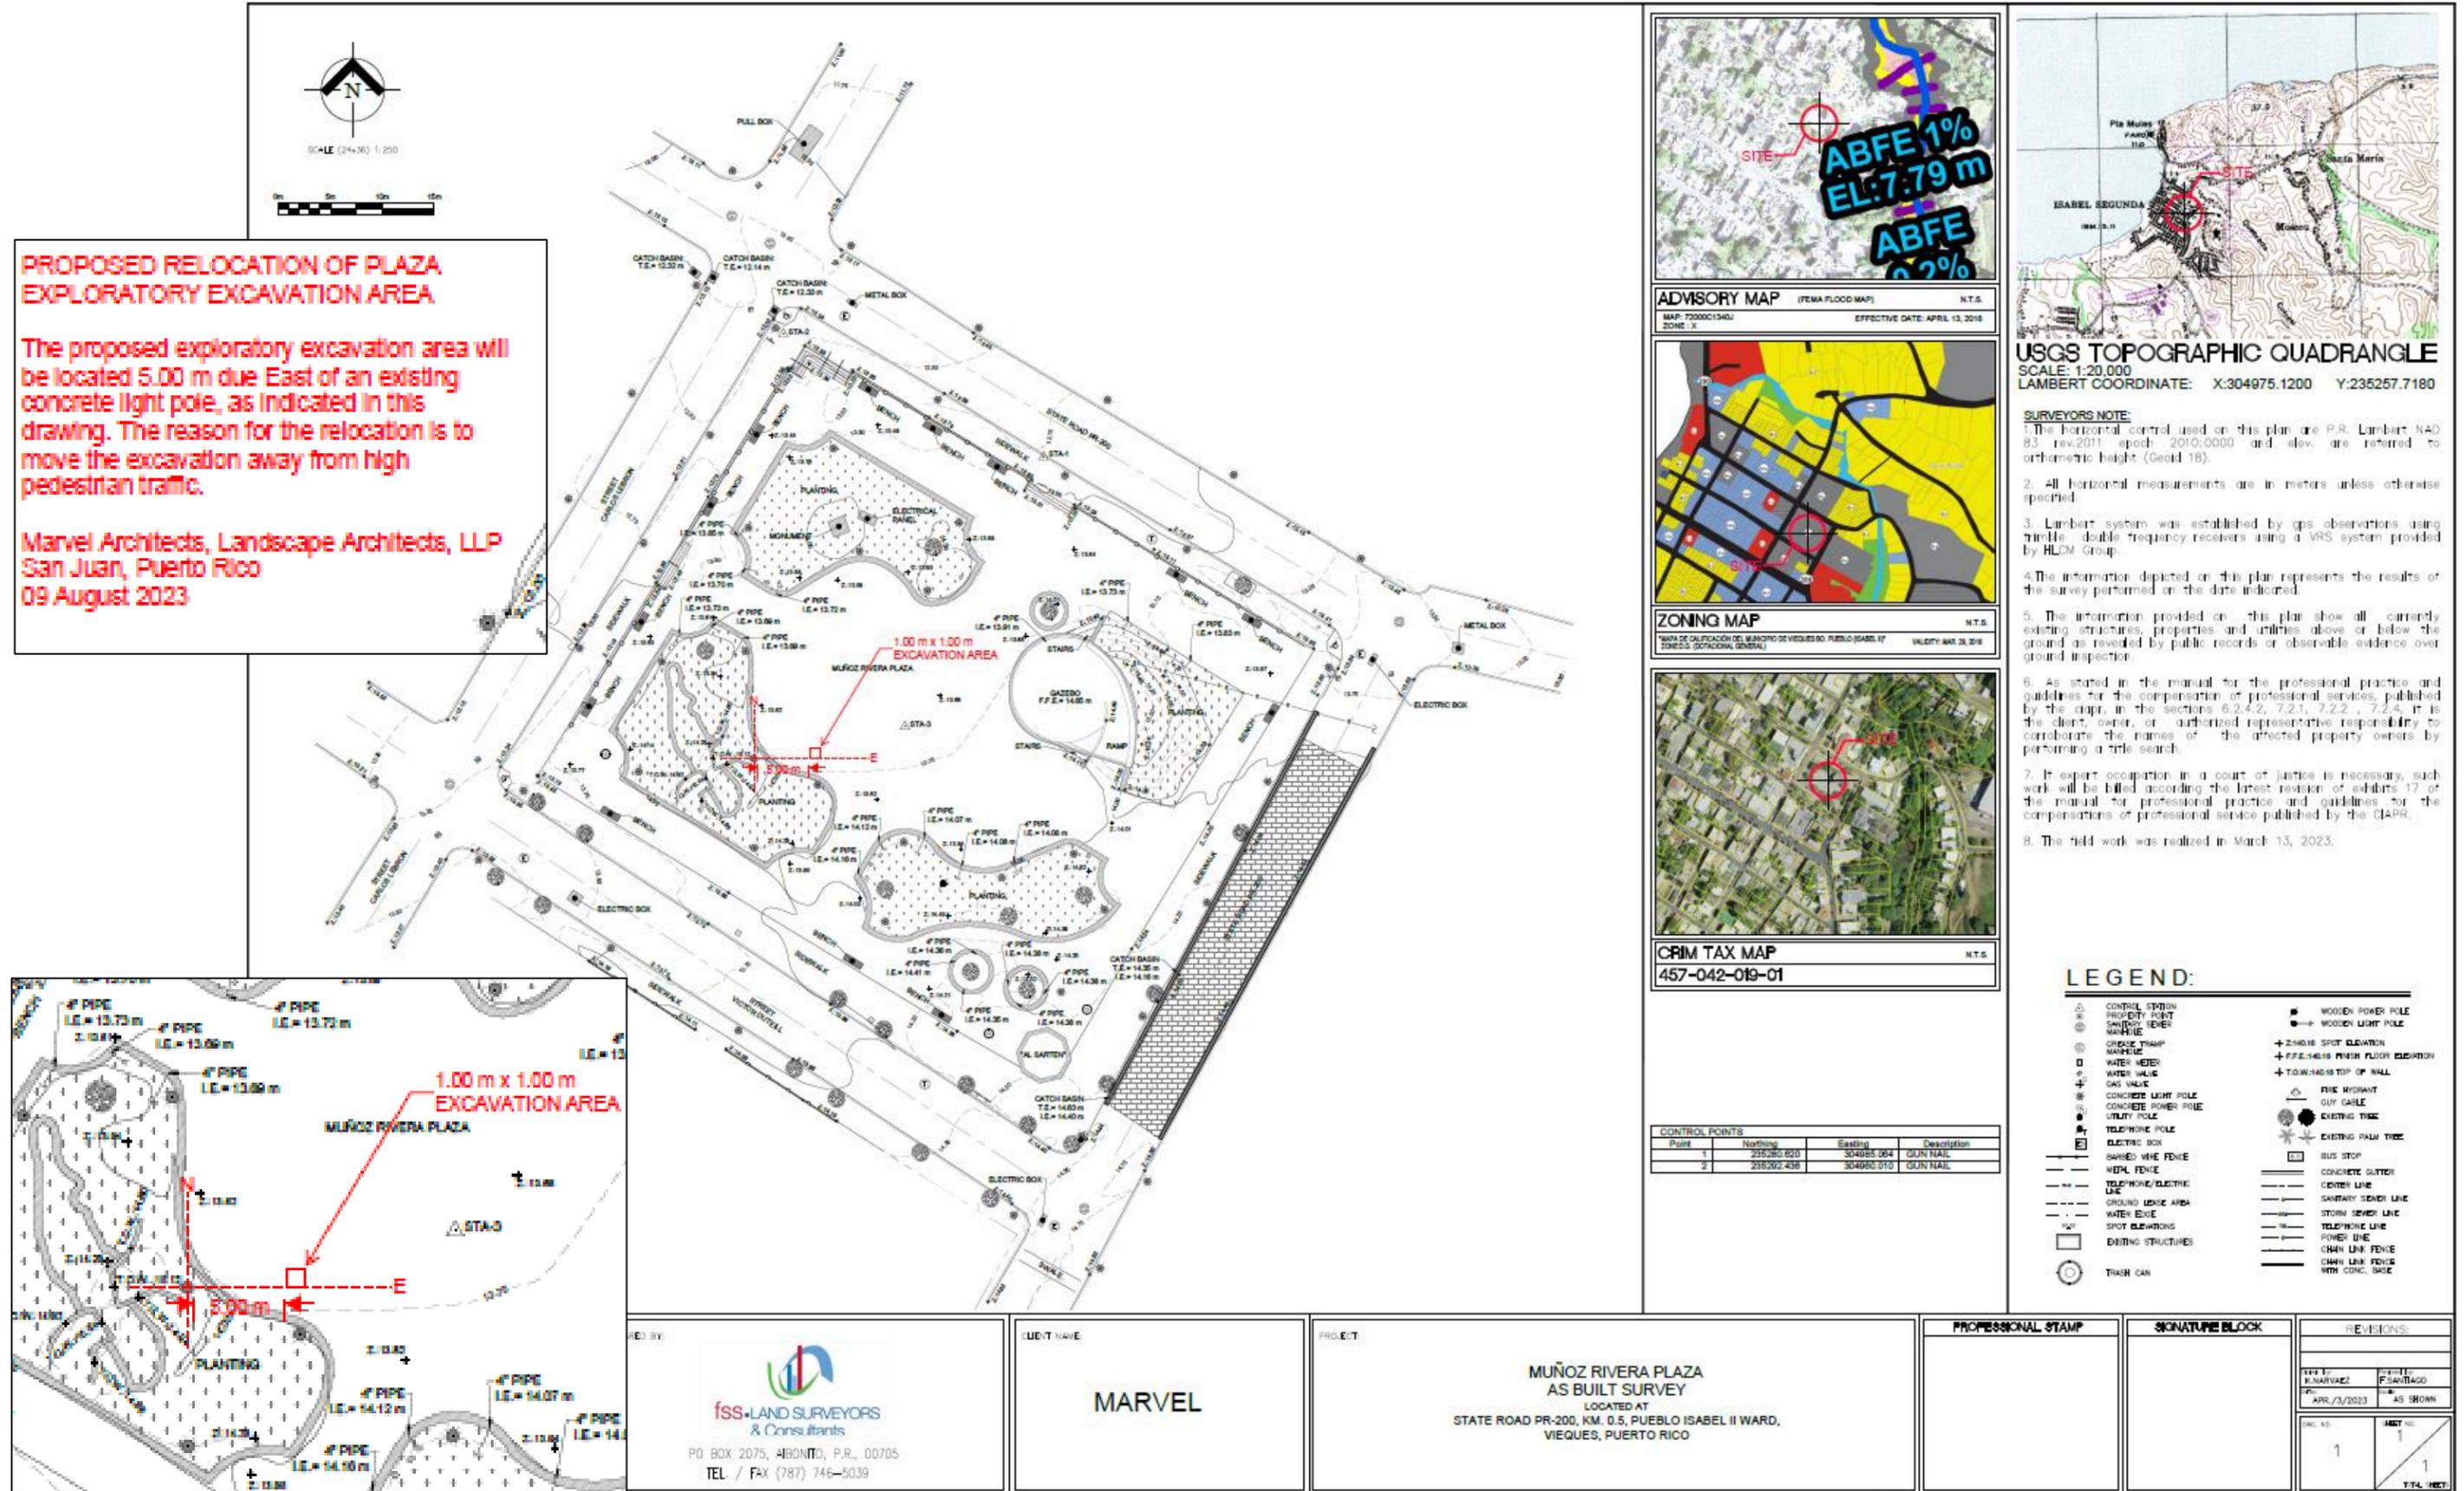
**PROPOSED RELOCATION OF PLAZA EXPLORATORY EXCAVATION AREA**

The proposed exploratory excavation area will be located 5.00 m due East of an existing concrete light pole, as indicated in this drawing. The reason for the relocation is to move the excavation away from high pedestrian traffic.

This Technical Assistance application is specifically focused on the need for studies to understand the structural condition of the School, as well as the Plaza. At the School, studies will be carried out with electronic equipment to scan structural elements such as beams, walls and columns. Also, it will be necessary to carry out some exploratory excavations to find out the condition of the footing. As part of these exploratory studies, it will also be necessary to remove cementitious material from the exterior walls that was used to cover some holes/vents, corresponding to its original design, at the base of the building, this in order to know the existing condition under the floor slab of the building. (Please refer to the attached images) Only one exploration will be carried out in the Plaza, it will be an excavation one (1) meter long, one (1) meter wide, and one (1) meter deep. This excavation will be carried out, adjacent to the south-west planter, inside the plaza.

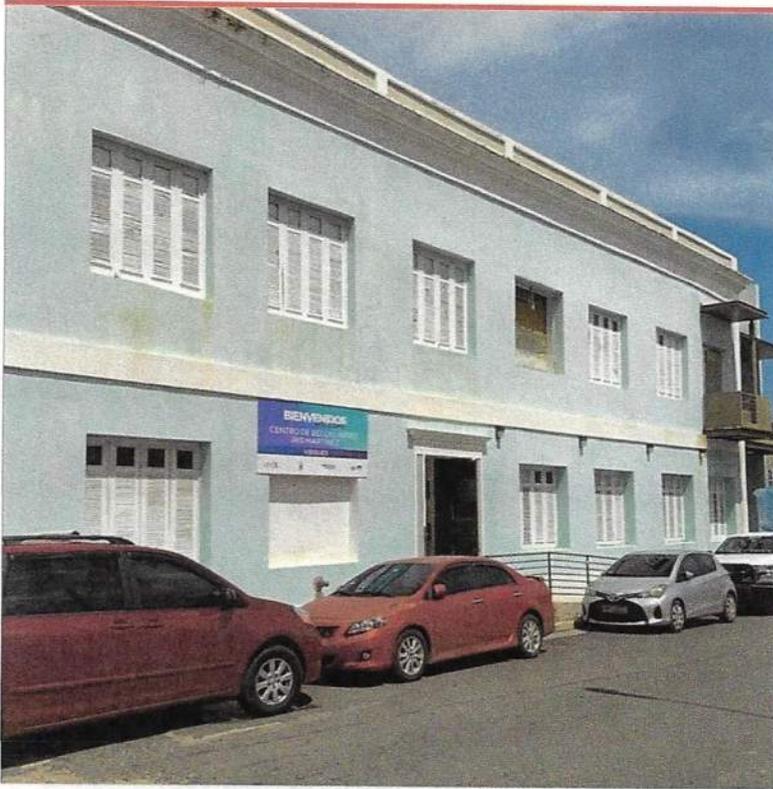
ISSUE 1 FRONT ELEVATION

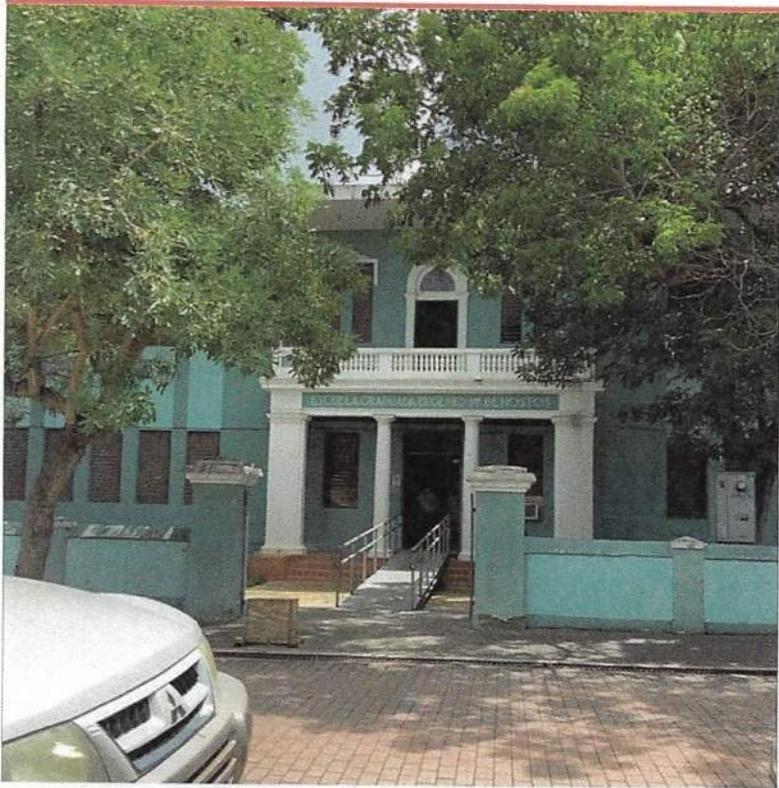
**ISSUE 1 FRONT ELEVATION**

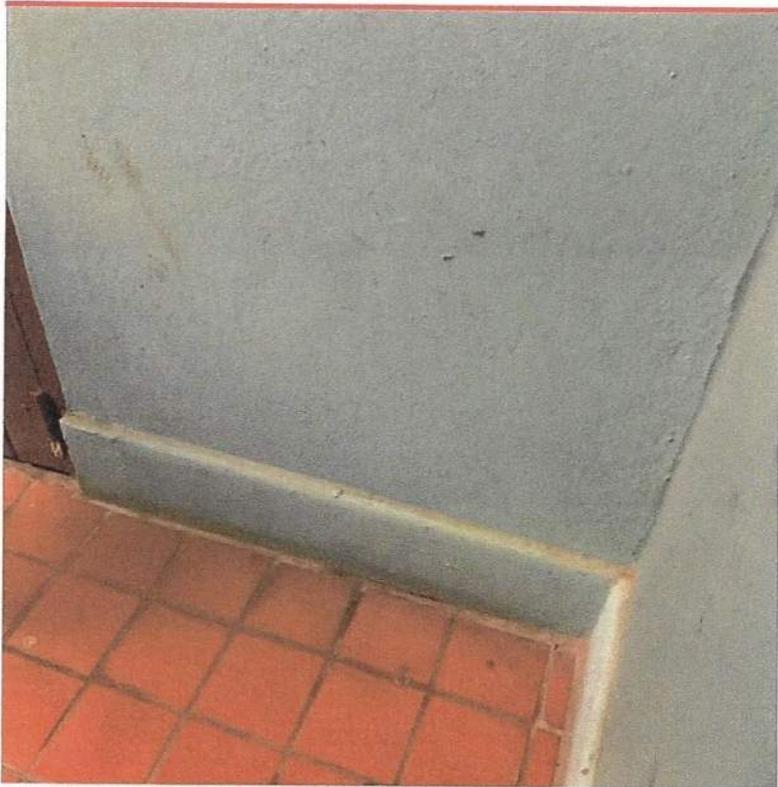
**ISSUE 3. POSITIVE FOR LEAD  
BASE PAINT BASEBOARDS**

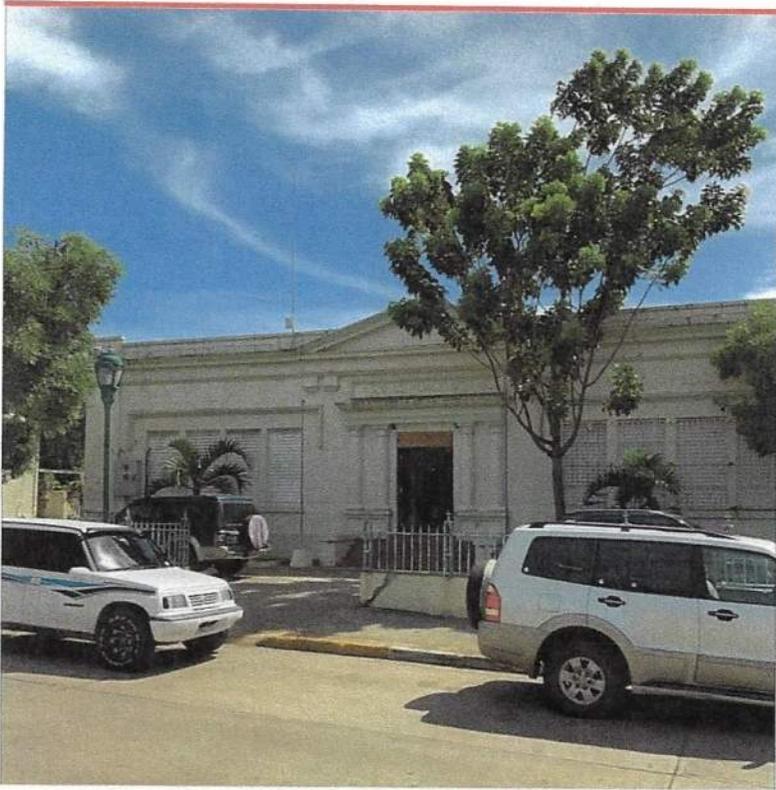
ISSUE 1 FRONT ELEVATION

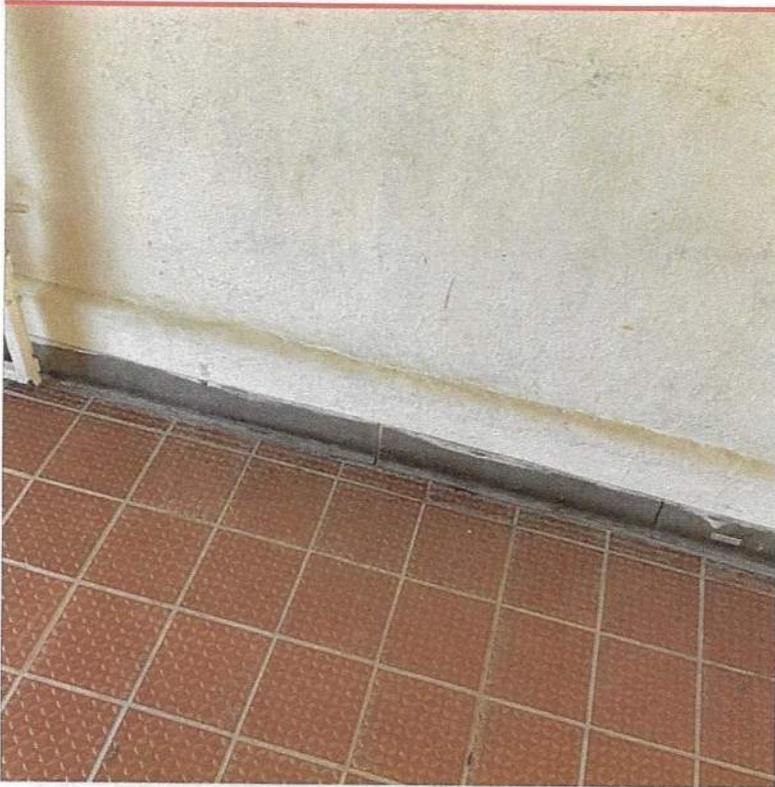
**ISSUE 3. POSITIVE FOR LEAD  
BASE PAINT BASEBOARDS**

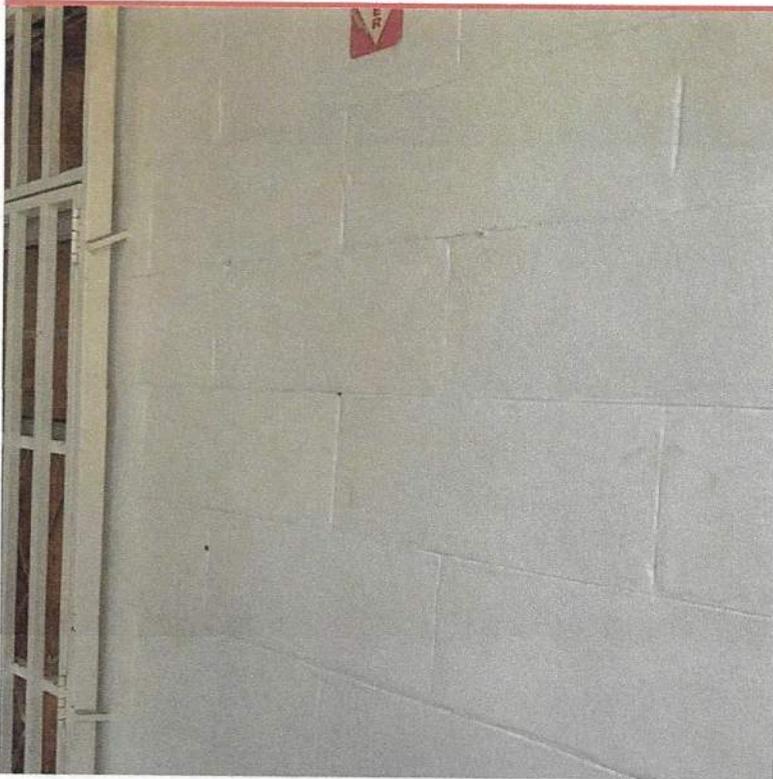
**ISSUE 4. CONCRETE WALL  
WITH LEAD BASE PAINT**

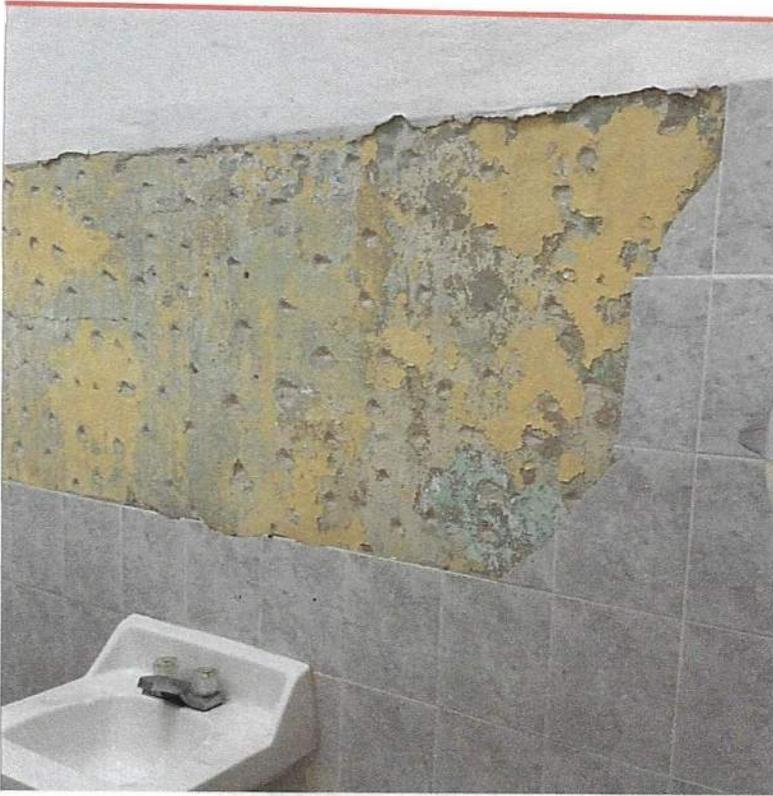
**ISSUE 5. CERAMIC WALL TILES  
WITH LEAD, AND PAINT ON  
WALLS**

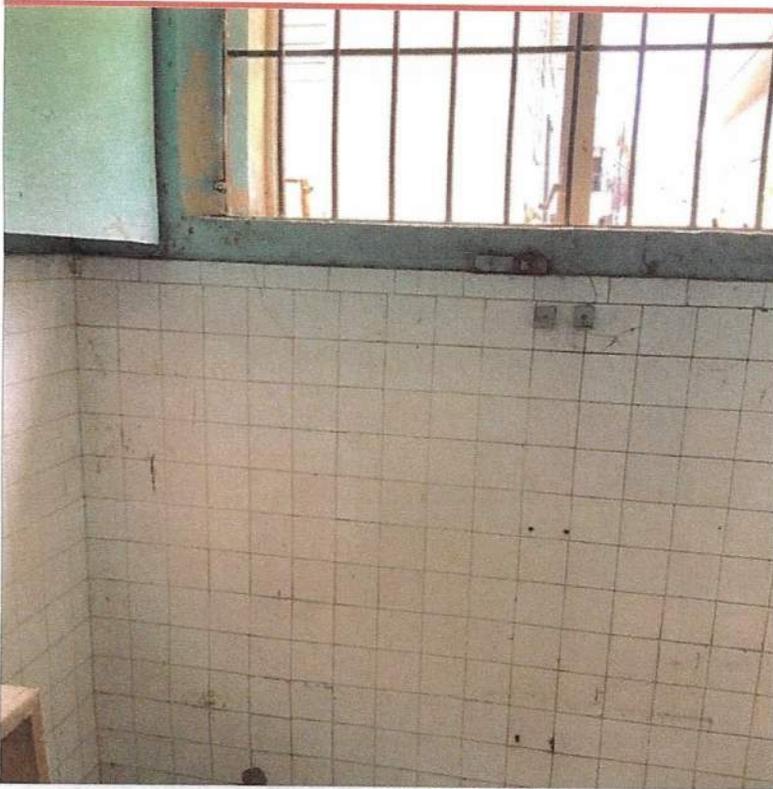
**ISSUE 3. CERAMIC WALL TILES  
POSITIVE FOR LEAD**

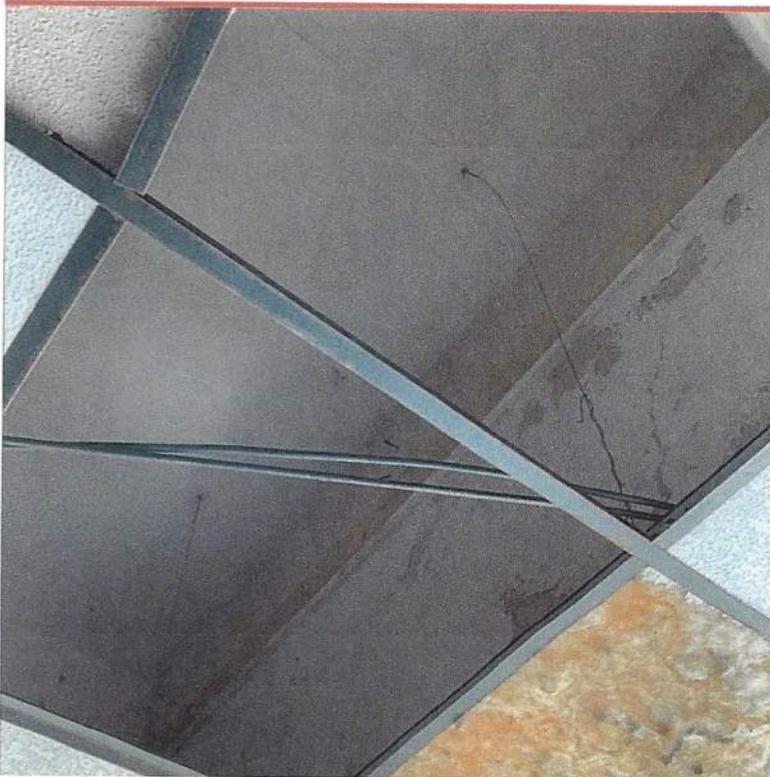
**ISSUE 4. ENTIRE CEILING 2ND  
FLOOR POSITIVE FOR LEAD  
BASE PAINT**

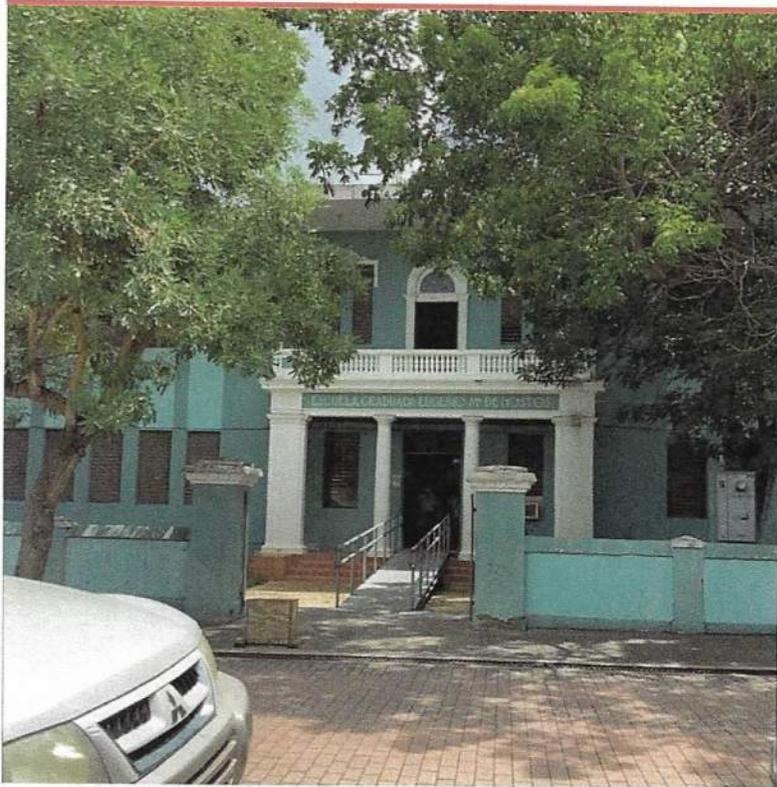
**ISSUE 1 FRONT ELEVATION**

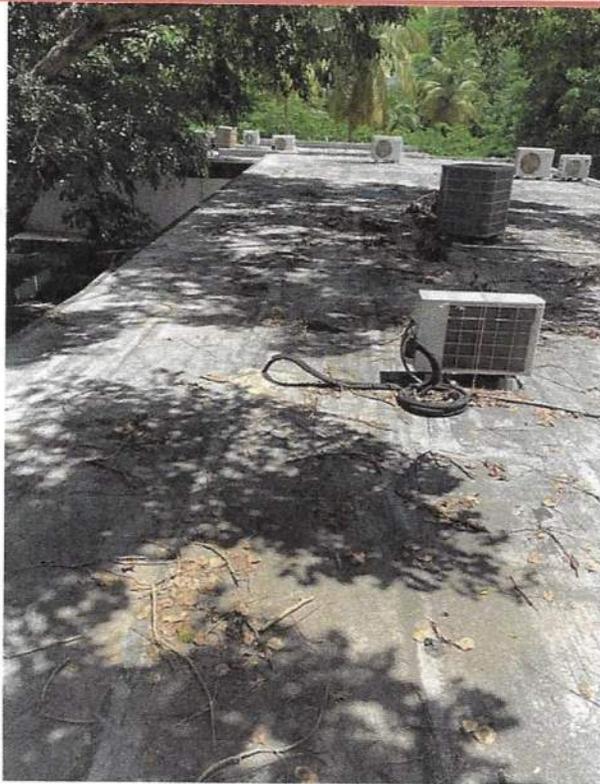
**ISSUE 3. BUILT-UP ROOF  
TREATMENT**

1. **City Hall, no sample was collected from the Built-up Roof because it will damage the integrity of the system. According to the owner the roof was remodeled with Danosa brand, but no evidence was submitted at the time of the inspection. Assumed positive to asbestos content.**
