Environmental Assessment

Determinations and Compliance Findings for HUD-assisted Projects

Project Name: Remodel of Parque Gándara (PR-CRP-000927)

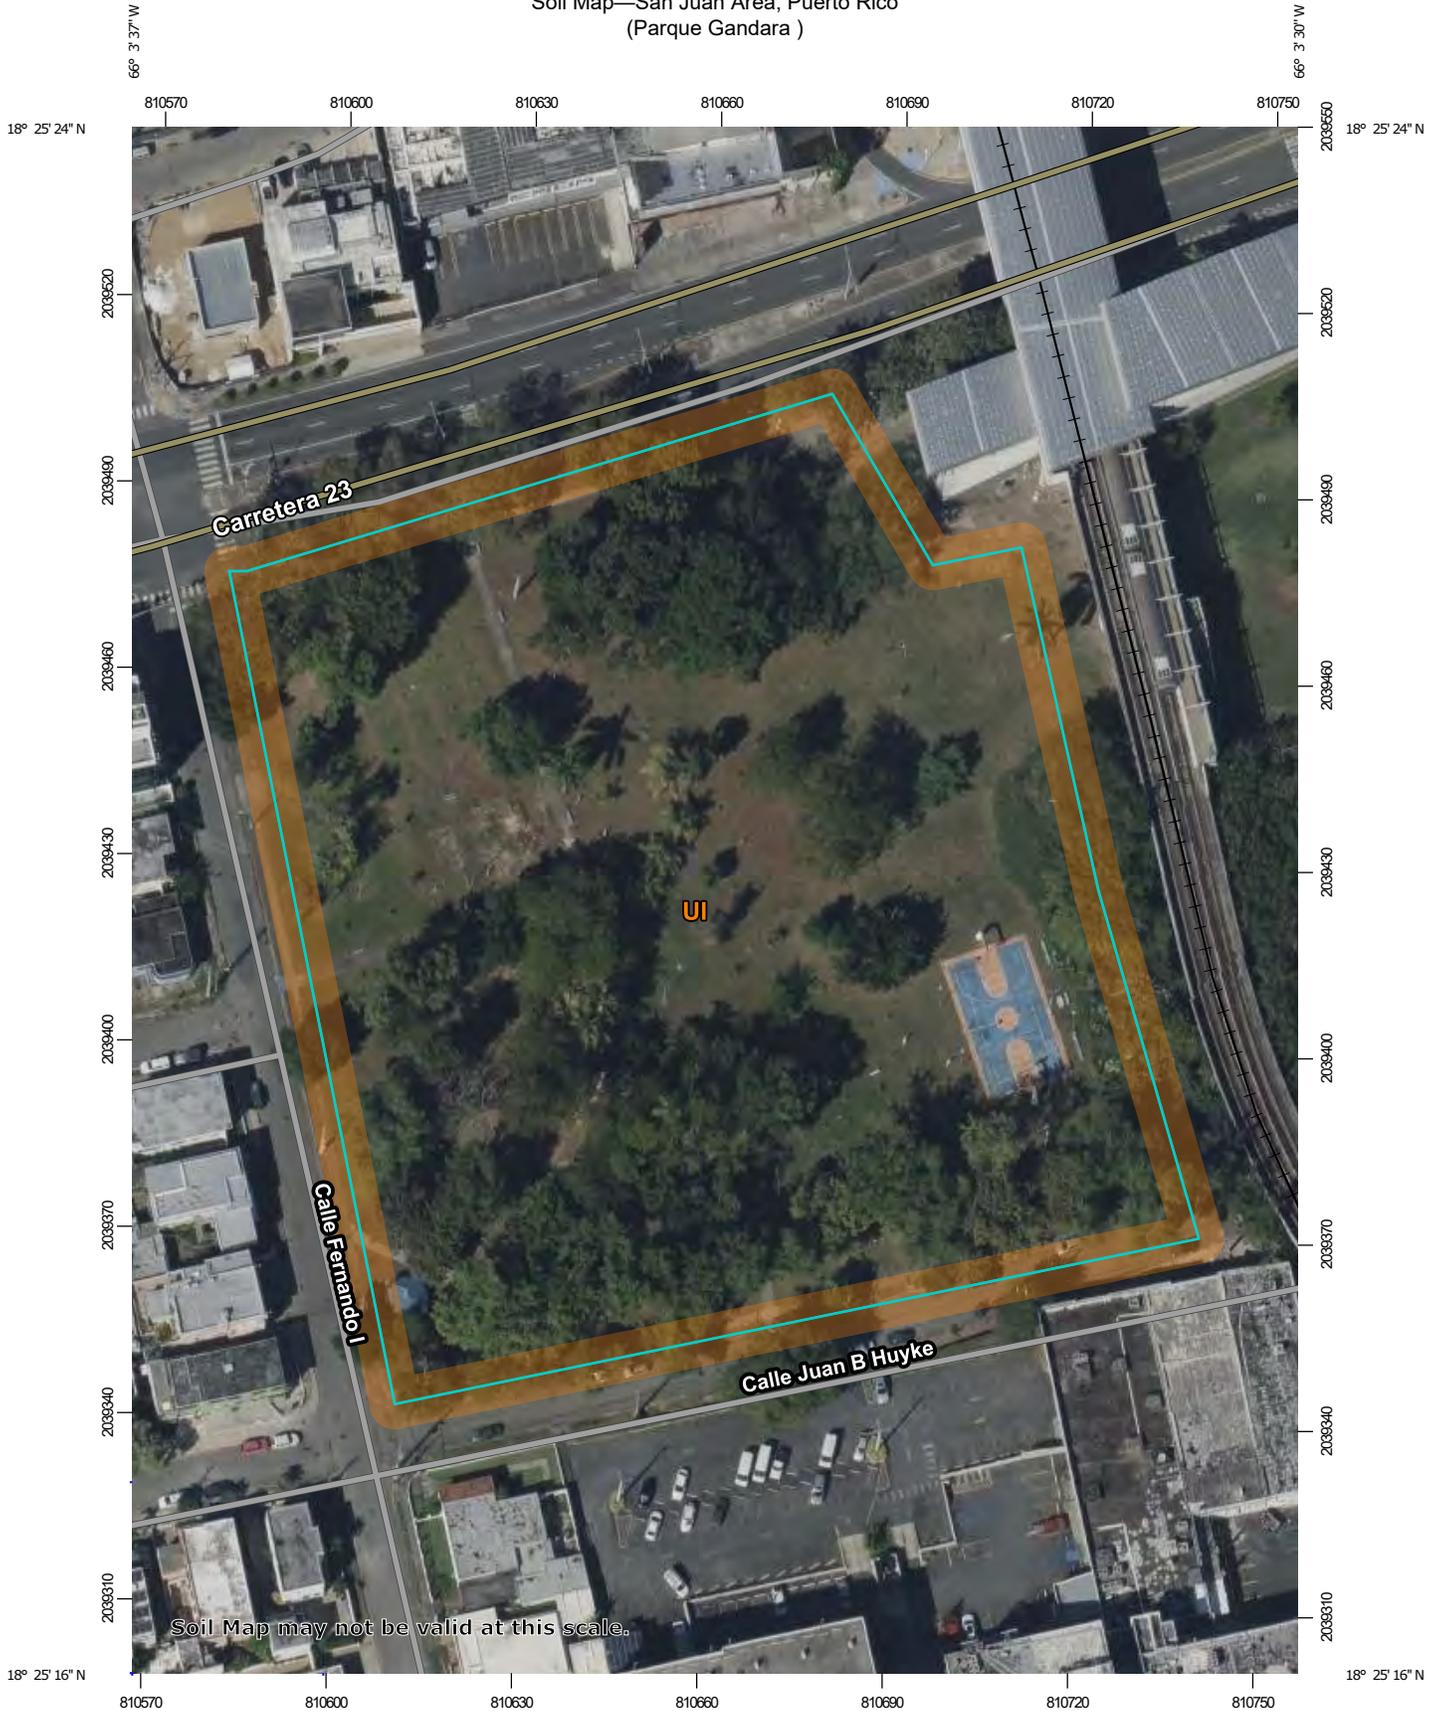
Soil Map—San Juan Area, Puerto Rico
(Parque Gandara)

Map Unit Symbol	Map Unit Name	Acres in AOI	Percent of AOI
UI	Urban land	4.3	100.0%
Totals for Area of Interest		4.3	100.0%

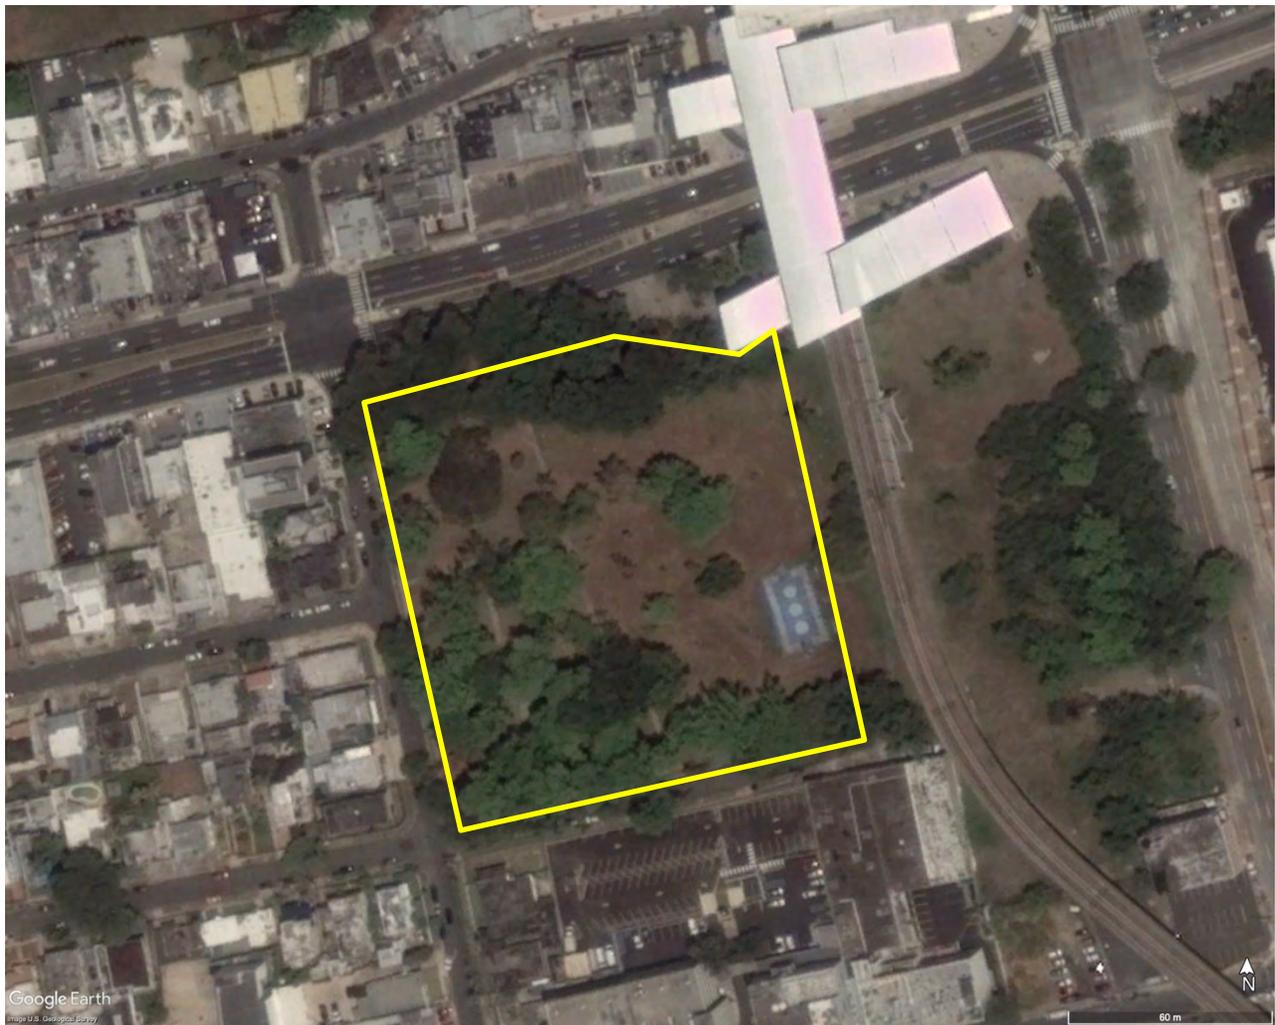
Figure 16. August 2015 satellite image of Parque Gándara in Hato Rey, San Juan. Project APE is highlighted in yellow. (Source: Google Earth Pro, <https://www.google.com/intl/es-419/earth/versions/#earth-pro>).

The overall configuration of Gándara Park has remained the same since, with minor changes such as a slightly denser vegetation cover on the southwest corner of the park and a design change on the basketball court, as seen on satellite images from 2014 and 2015 (Figures 15 and 16). The vegetation appears overgrown in a satellite image from August 2017 (Figure 17), one month prior to the passing of hurricanes Irma and María, which devastation is evidenced in a subsequent satellite image taken approximately two months later (Figure 18). Gándara Park was completely abandoned in the following years.

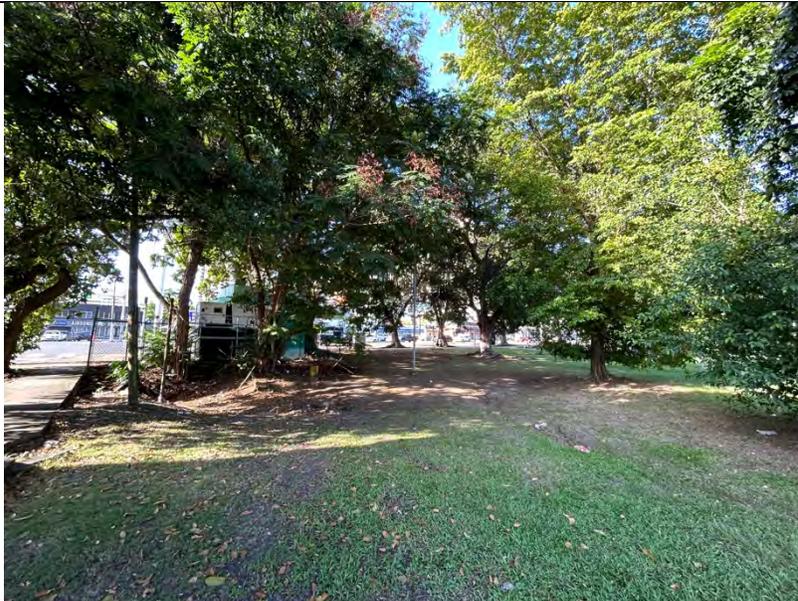
Photo #: 1

Description: Rear of pump station, northwest limit of the park.

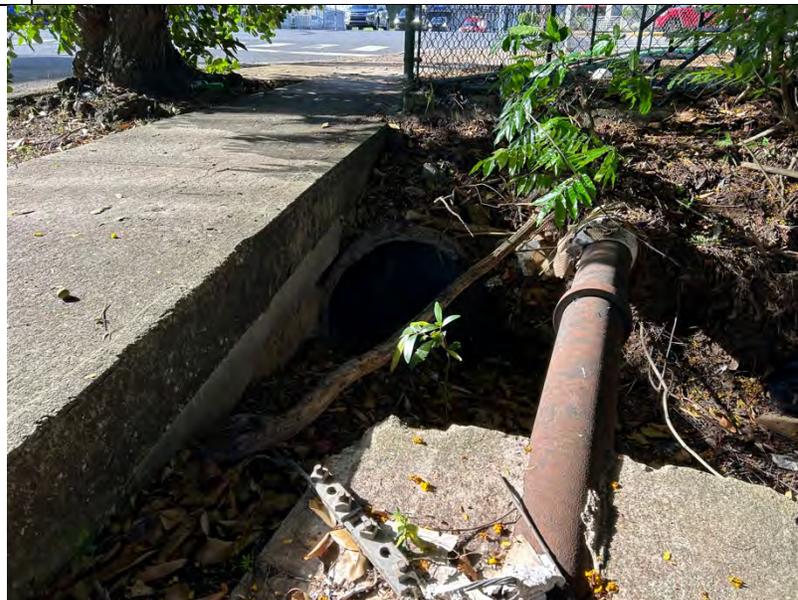
Photo #: 2

Description: Drainage system beside sidewalk, northwest limit.

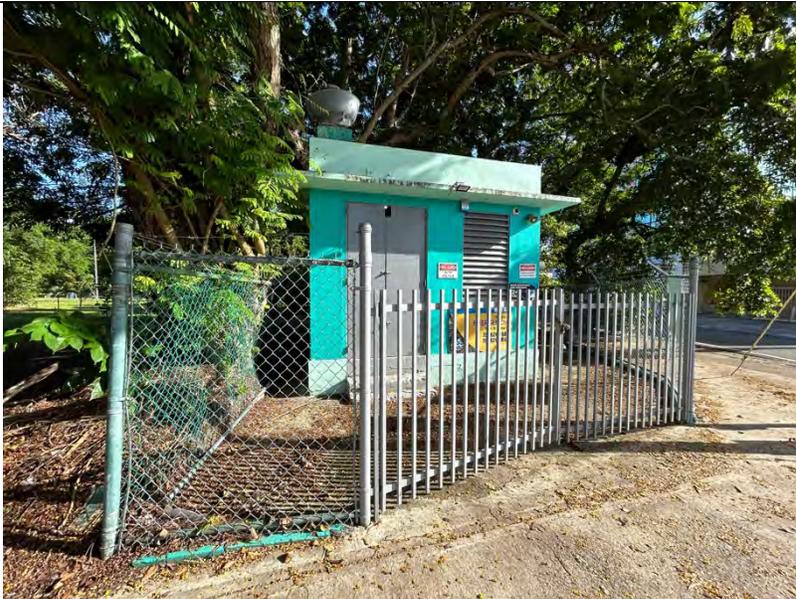
Photo #: 3

Description: Pump station, northwest limit of the park.

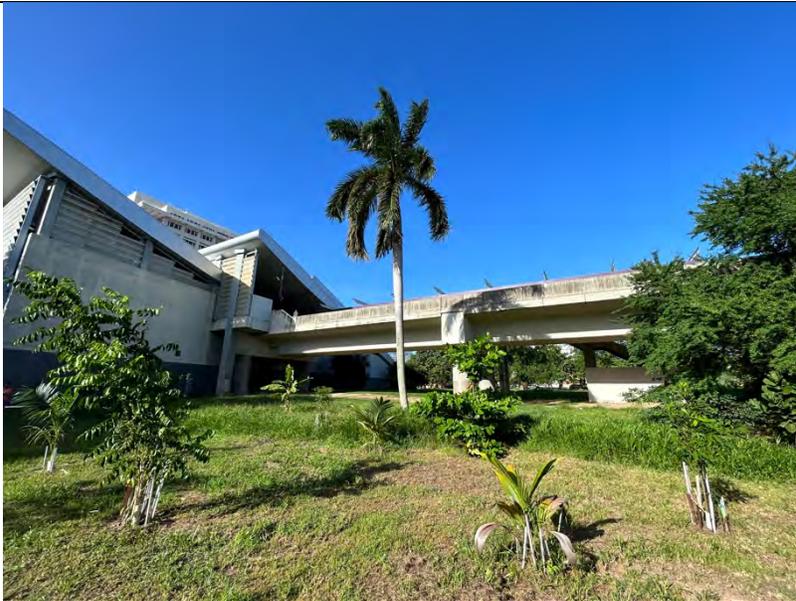
Photo #: 7

Description: Aerial train tracks, northeast limit of the park.

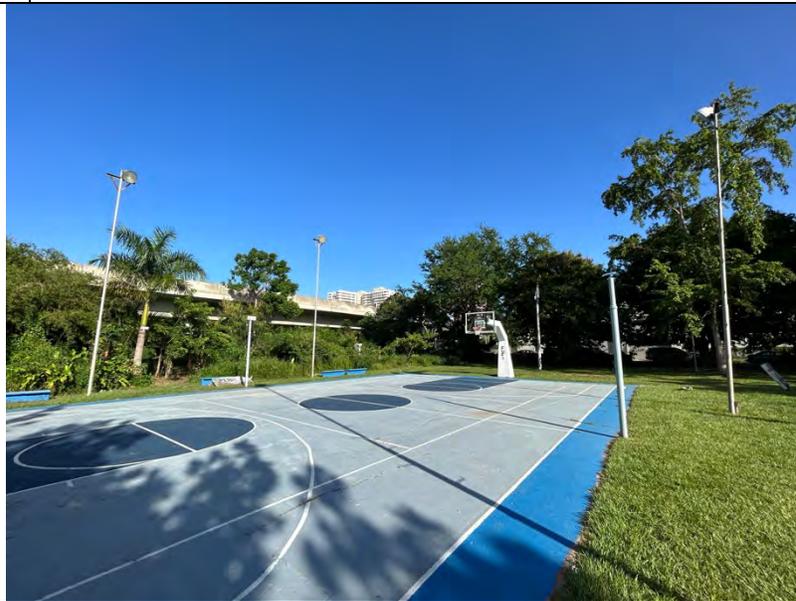
Photo #: 8

Description: Basketball court, southeast side of the park.

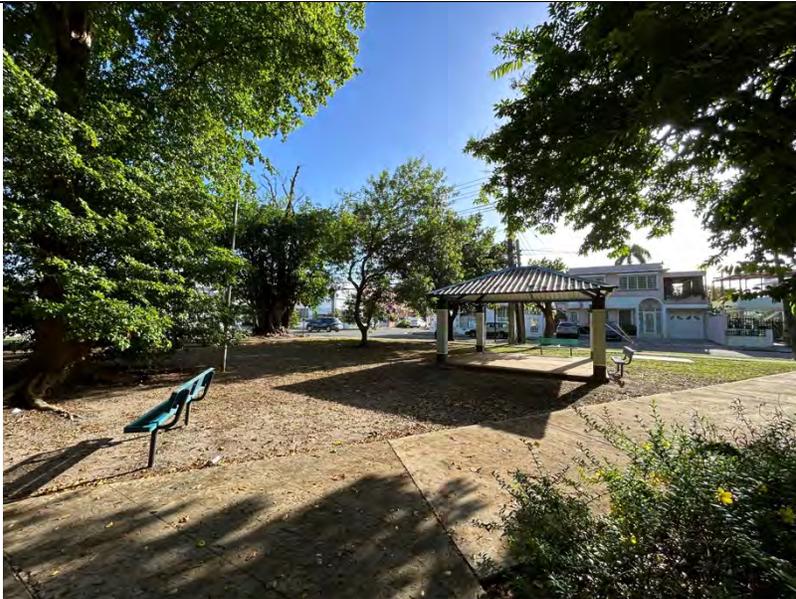
Photo #: 17

Description: Gazebo on southwest limit, bordering Fernando I Street.

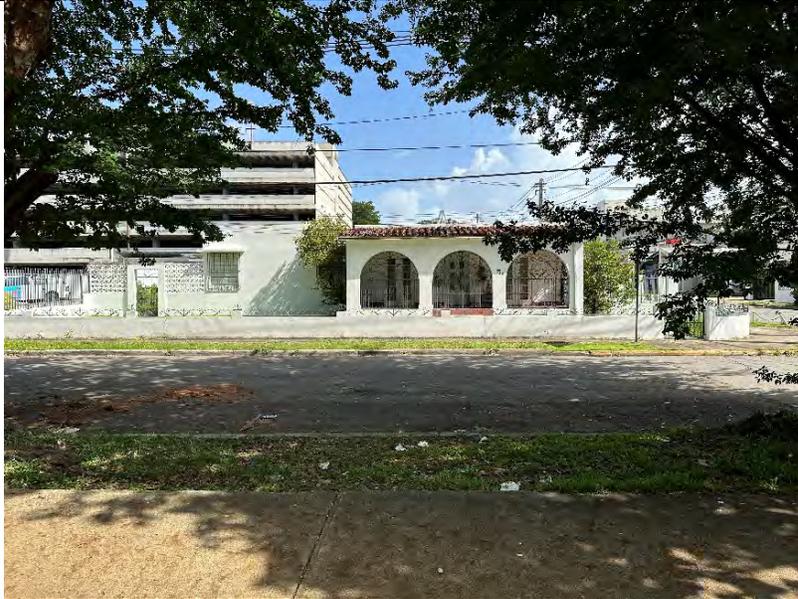
Photo #: 1

Description: Mid-20th century concrete one-level residential structure. Corner of Juan B Huyke & Fernando Primero Streets (063-041-136-14). Looking at S, from undertaking. Hato Rey Centro Ward, San Juan, PR 00918

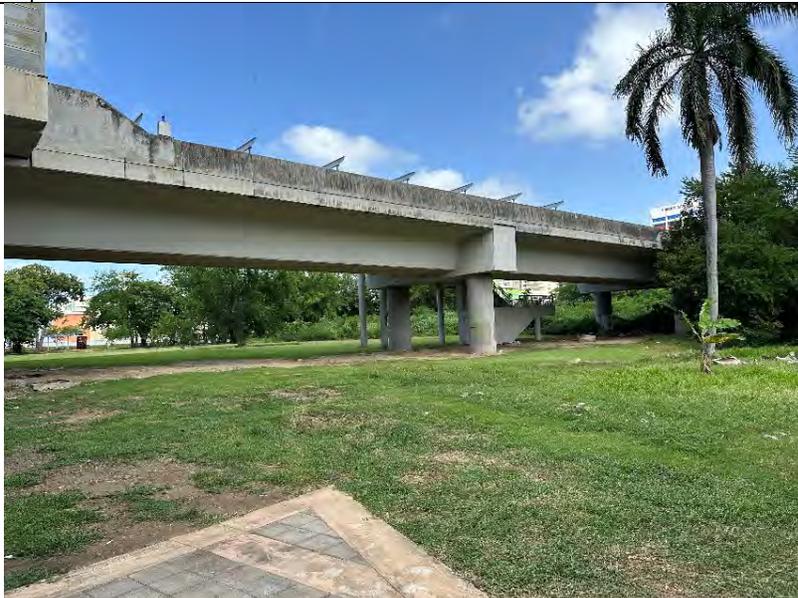
Photo #: 8

Description: Late 20th century concrete *Tren Urbano* mass transit system, raised track & easement. Looking E, from undertaking. Hato Rey Centro Ward, San Juan, PR 00918

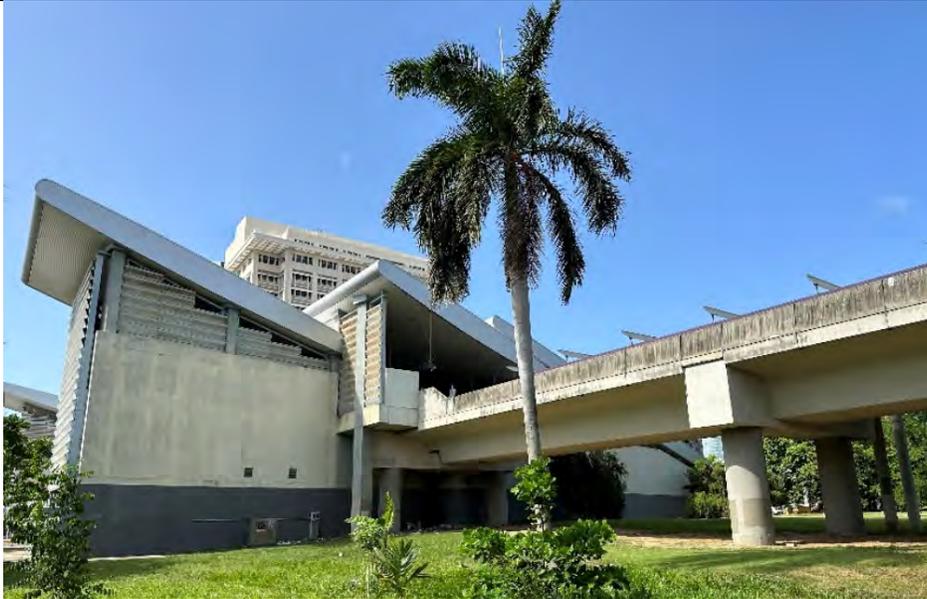
Photo #: 9

Description: Late 20th century concrete Tren Urbano Roosevelt Avenue Station, South Section (063-041-136-22). Looking NE, from undertaking. Hato Rey Centro Ward, San Juan, PR 00918

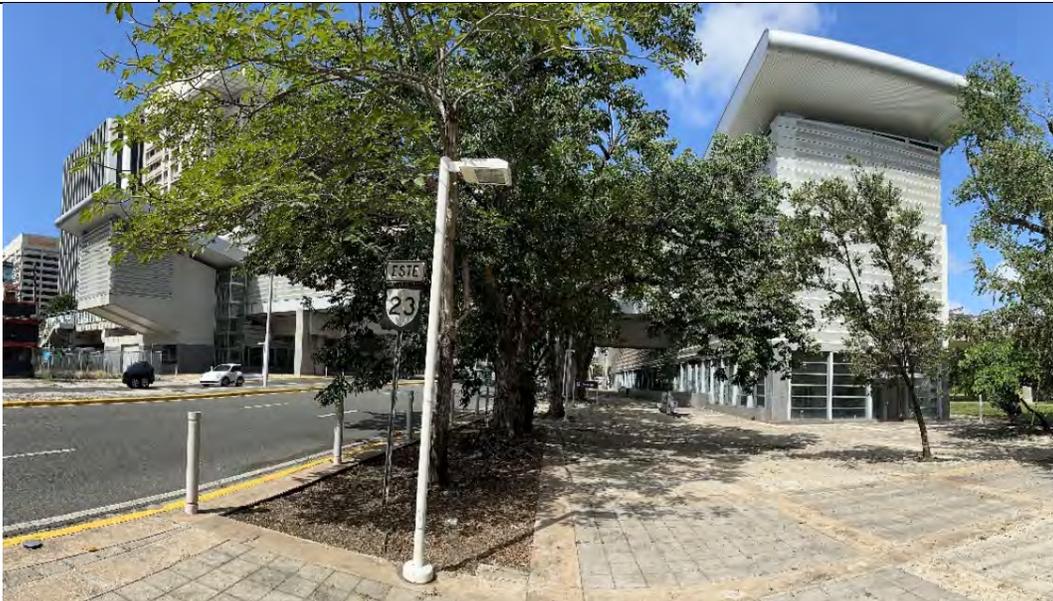
Photo #: 10

Description: Late 20th century concrete Tren Urbano Roosevelt Avenue Station, North & South Sections (06-041-103-08 & 063-041-136-22). Looking ENE, from undertaking. Hato Rey Centro Ward, San Juan, PR 00918

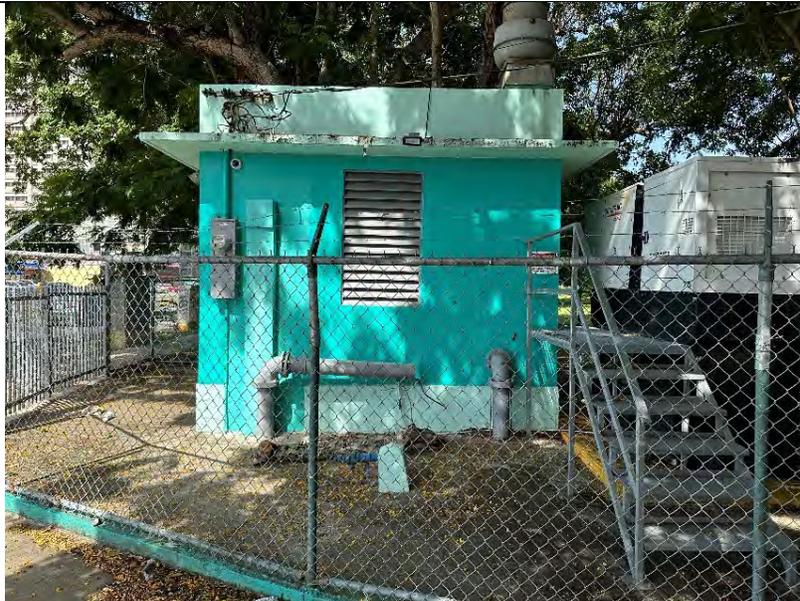
Photo #: 35

Description: Mid-20th century concrete one-level sewer pump station. Located at the undertaking's northwest corner. Looking E, from undertaking & Fernando Primero Street. Hato Rey Centro Ward, San Juan, PR 00918

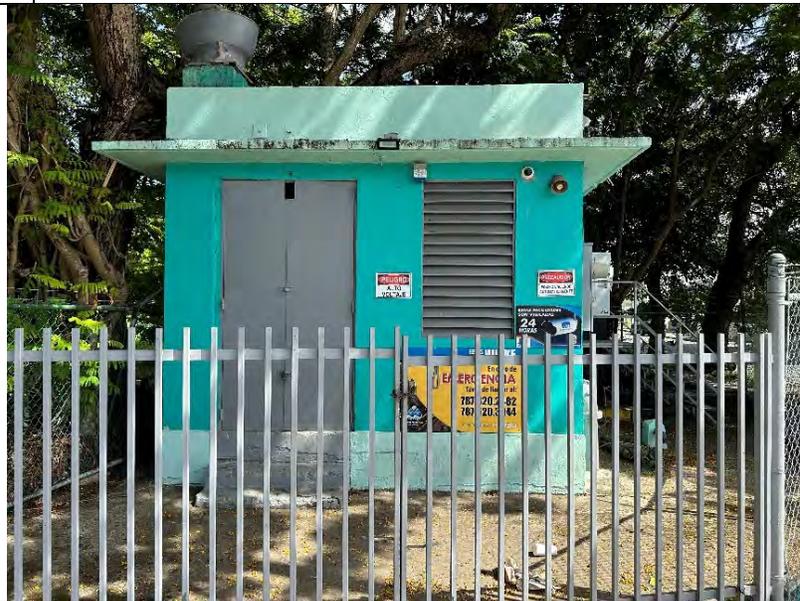
Photo #: 36

Description: Mid-20th century concrete one-level sewer pump station. Located at the undertaking's northwest corner. Looking N, from State Road PR-12 (Franklin Delano Roosevelt Avenue) & Fernando Primero Street. Hato Rey Centro Ward, San Juan, PR 00918

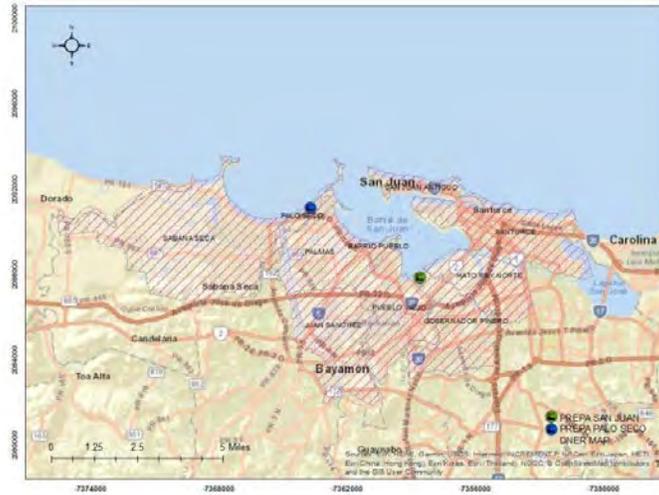
Figure 1: The striped area includes the non-attainment municipalities and wards. The map also presents the site location for PREPA San Juan and PREPA Palo Seco Power Plants

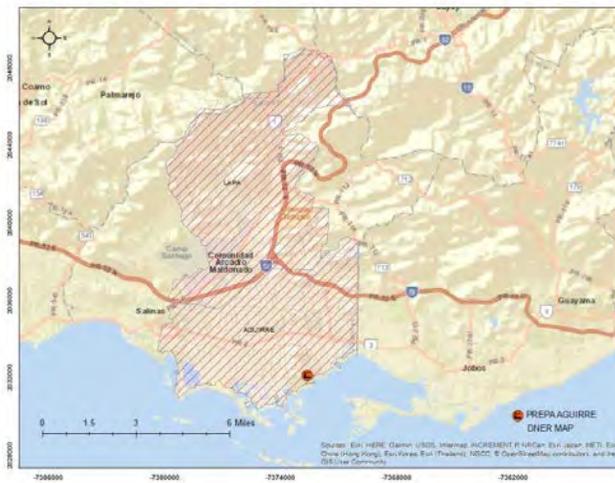
Figure 2: The striped area includes the non-attainment municipality and wards. The map also presents the site location for PREPA Aguirre Power Plant

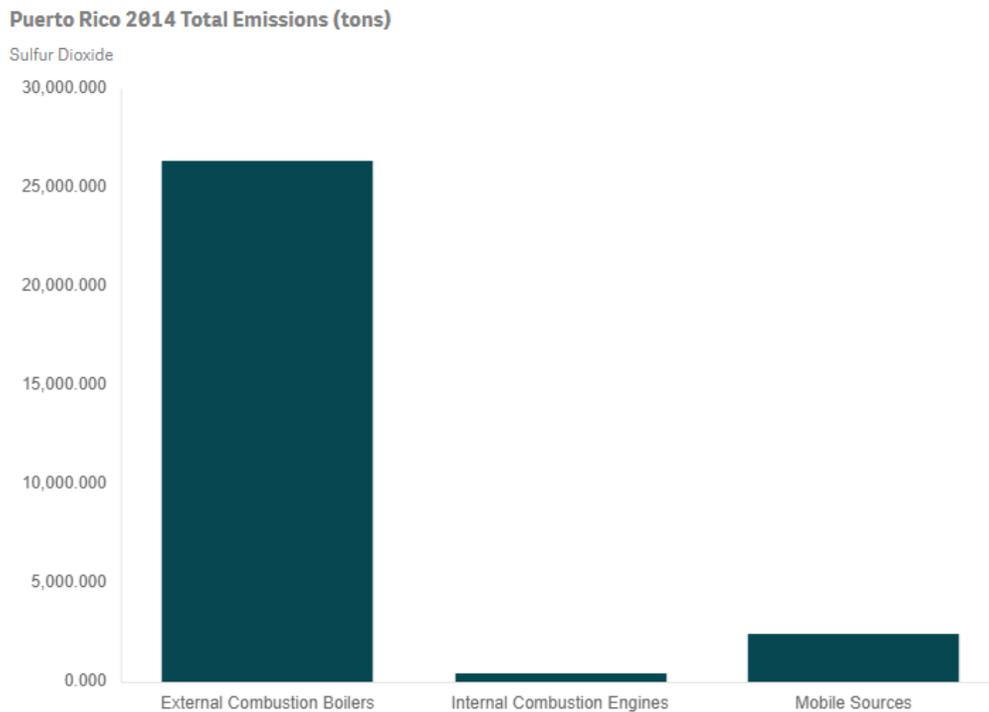
Figure #3: NEI 2014 SO₂ Emission based on process

Emissions inventory and source emission rate data serve as the foundation for modeling and other required analyses. Sulfur dioxide emissions come from anthropogenic sources such as fossil fuel combustion and biogenic sources such as volcanic activity. Anthropogenic emissions of SO₂ in Puerto Rico are mainly due to combustion of fossil fuels by external combustion boilers (~90 %), internal combustion engines (~1.6%) and transportation-related sources (~8.4%) based on 2014 EPA National Emission Inventory (USEPA, 2014), shown in Figure #3.

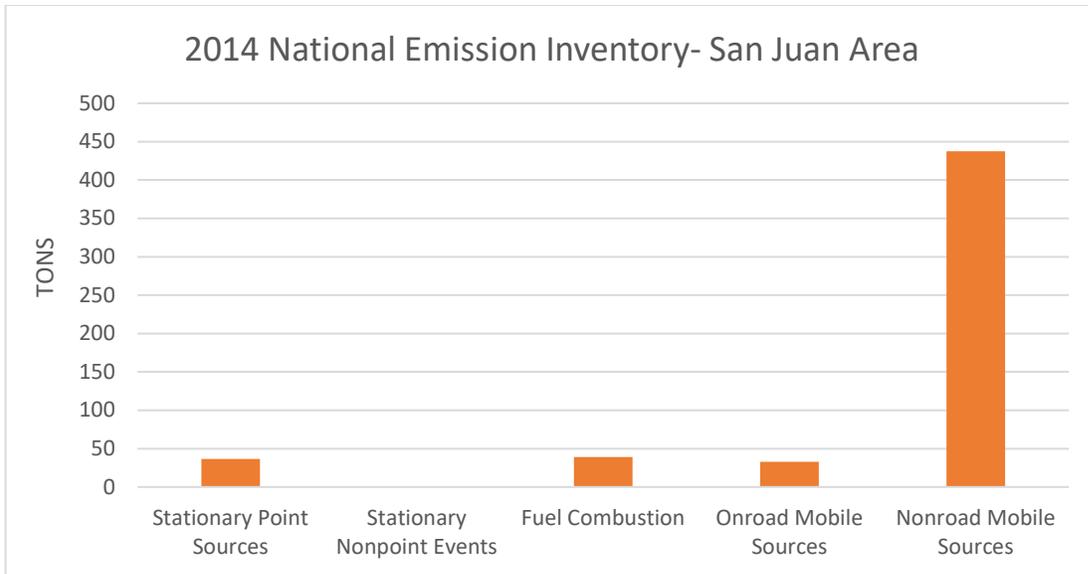
Figure #4: SO₂ Non Attainment Areas- San Juan

The 2014 National Emission Inventory for SO₂ Non Attainment Areas for San Juan Area and Guayama-Salinas Area are shown as follows:

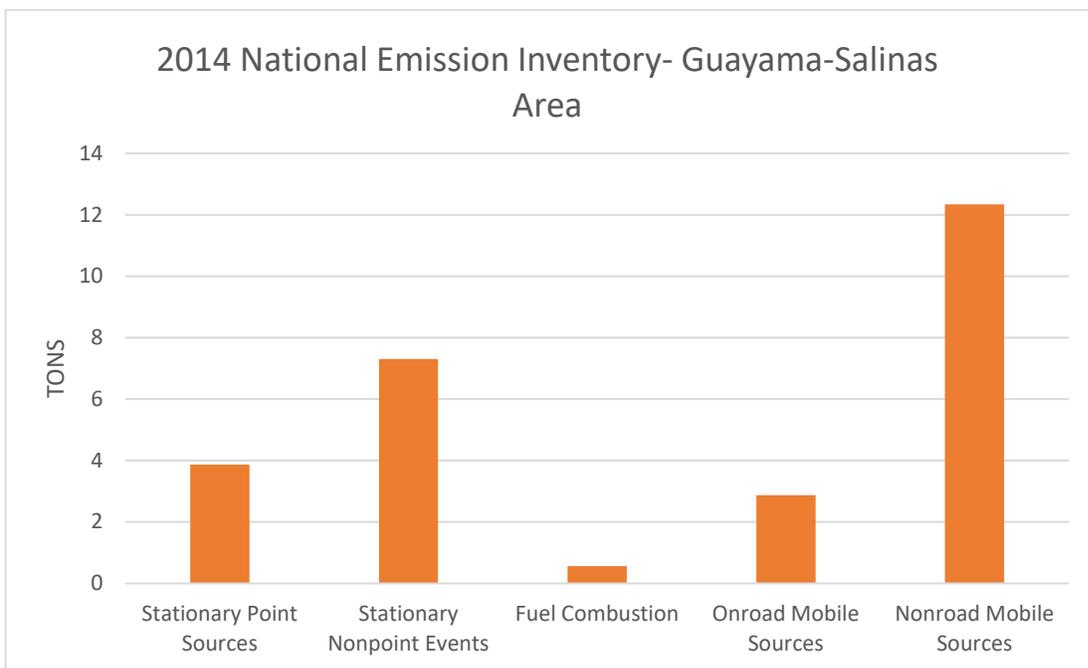
Figure #5: SO₂ Non Attainment Areas-Guayama

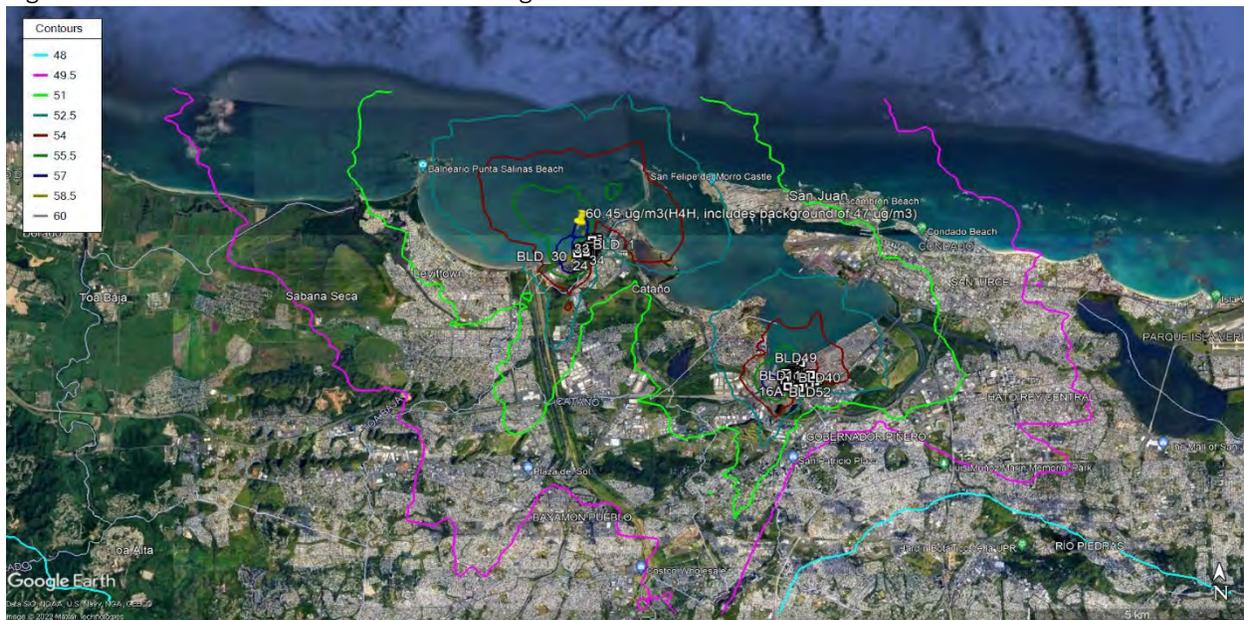
Figure 6: San Juan Metro Area LNG Modeling Results

The H4H in San Juan Metro area was 60.45 µg/m³ and was registered to the northwest of PREPA Palo Seco. PREPA Palo Seco had the major contribution to this concentration. Refer to Figure 1. The Palo Seco boilers were the emission units with more contribution to the H4H design concentration.

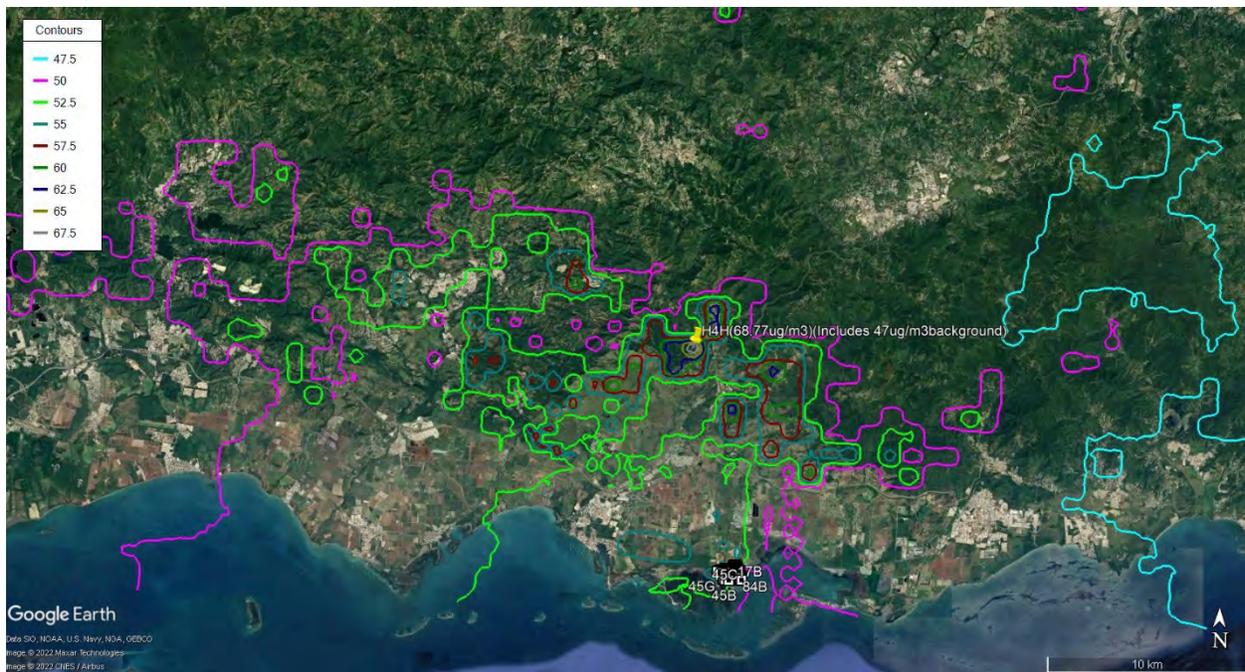
Figure 7: Guayama-Salinas Area LNG Modeling Results

In the Guayama-Salinas area the H4H was 68.77 µg/m³ and was registered north of PREPA Aguirre. Refer to Figure 2. The major contribution to this concentration was from the boilers and the combined cycles HRSG.

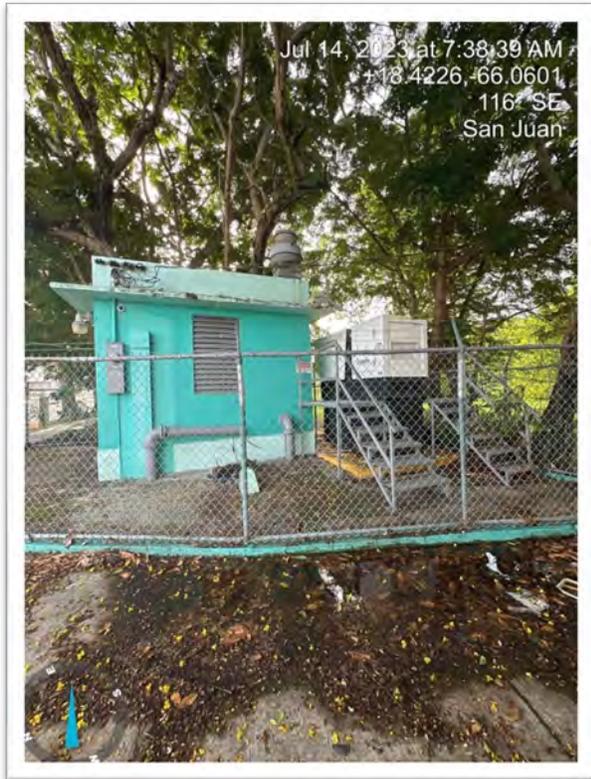
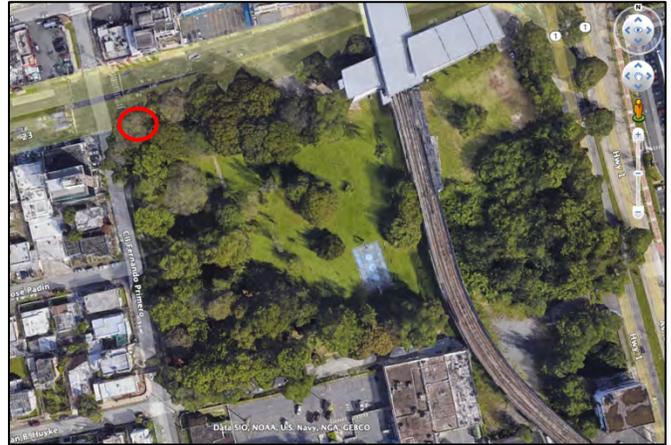
Photo 1:

Photo description:
Northwest corner of the park, there is a AAA station with an generator. The project will not impact that area, only the fence to cover the structure.

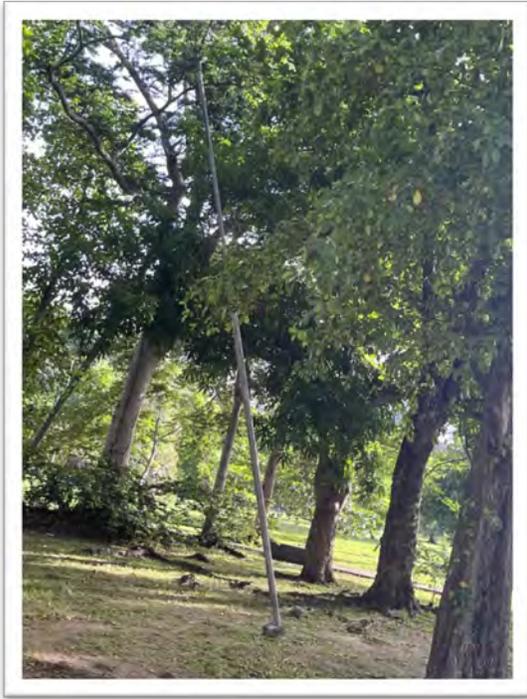
Photo 3:

Photo description: Damaged light pole.

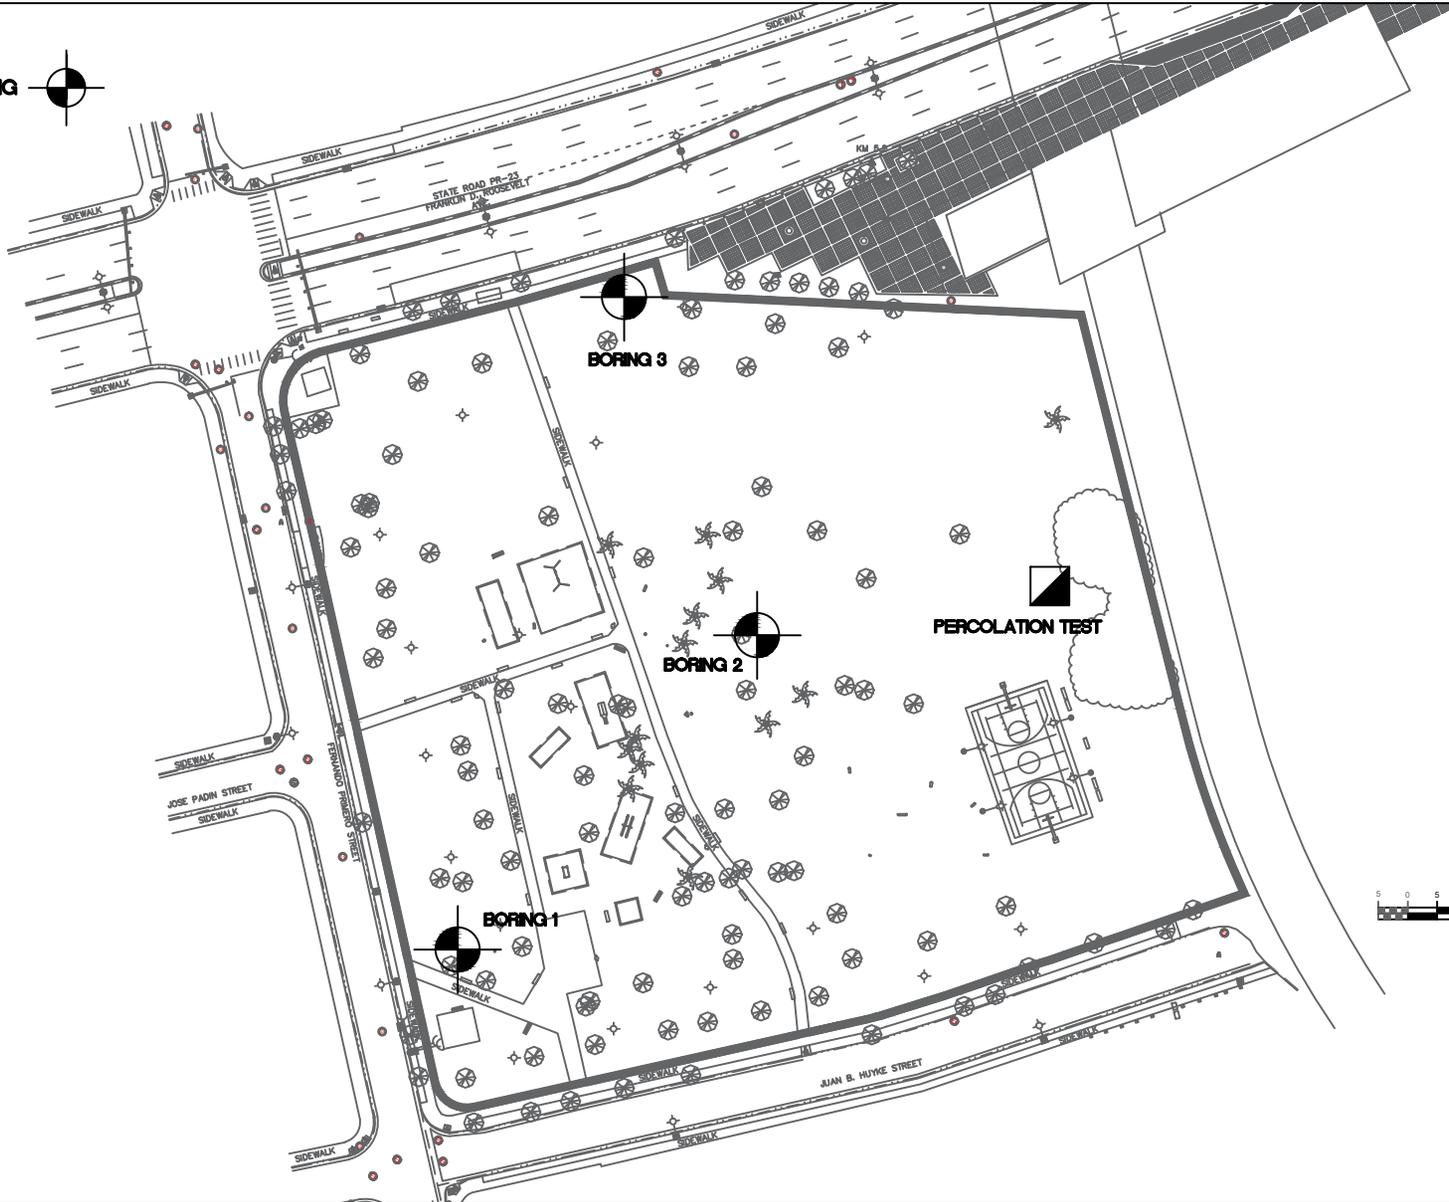
SITE PLAN
 GEOTECHNICAL SUBSURFACE EXPLORATORY SERVICES
 FOR THE PROPOSED IMPROVEMENTS TO GANDARA RECREATIONAL PARK
 AT JUAN B. HUYKE STREET, HATO REY CENTRAL WARD
 OF THE MUNICIPALITY OF SAN JUAN, PUERTO RICO.
 REFERENCE NO. DA23Y4249

LEGEND:

BORING

ITEM	DESCRIPTION
Site layout	Refer to the Site Location Map and Boring Location Plan (Figures 1 through 3 of Appendix A)

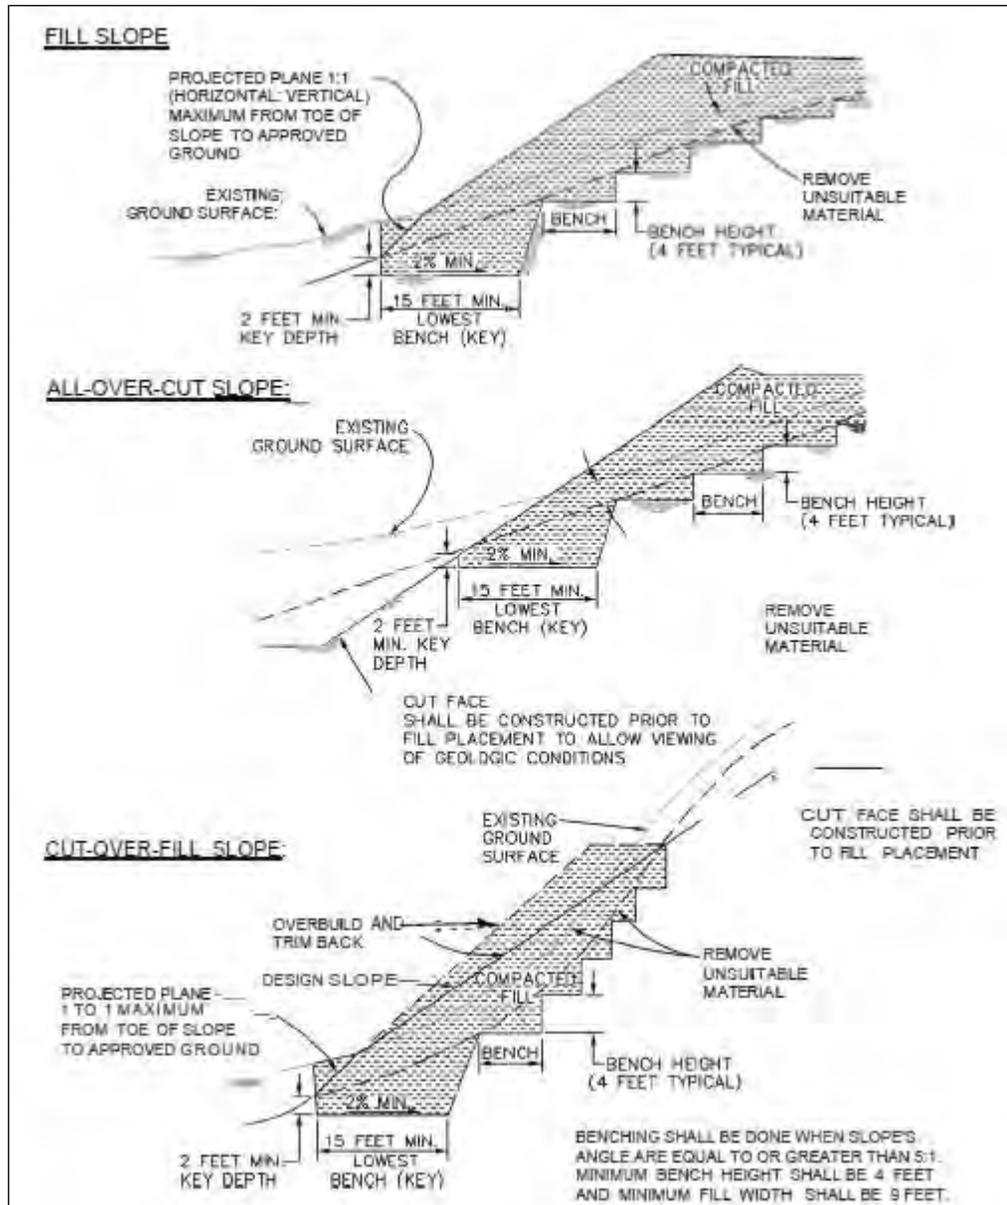
GENERAL EARTHWORK AND GRADING SPECIFICATIONS STANDARD DETAIL "A"

KEYING AND BENCHING

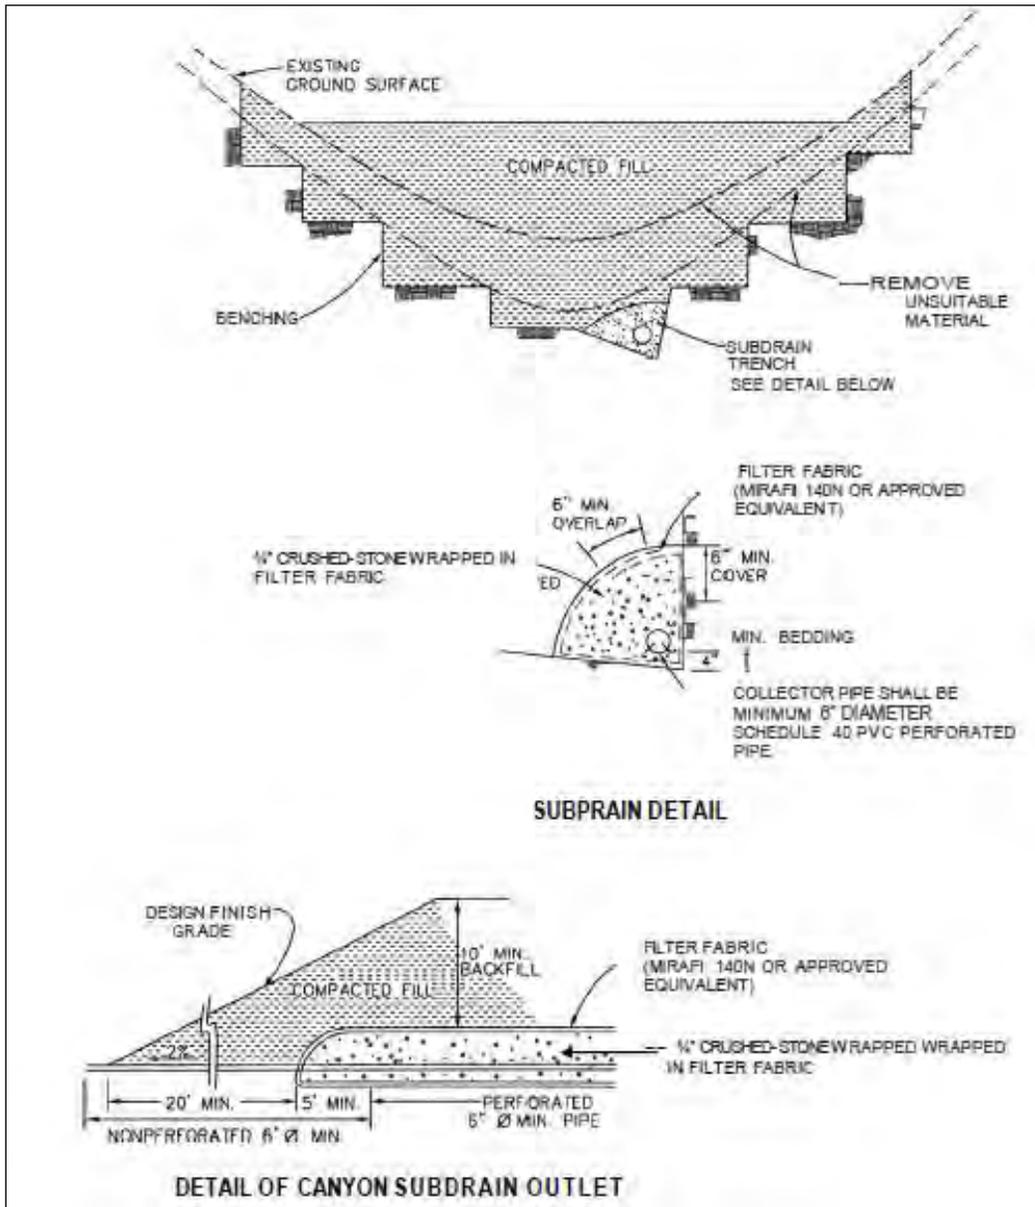
GENERAL EARTHWORK AND GRADING SPECIFICATIONS STANDARD DETAIL "B"

SUBDRAINS

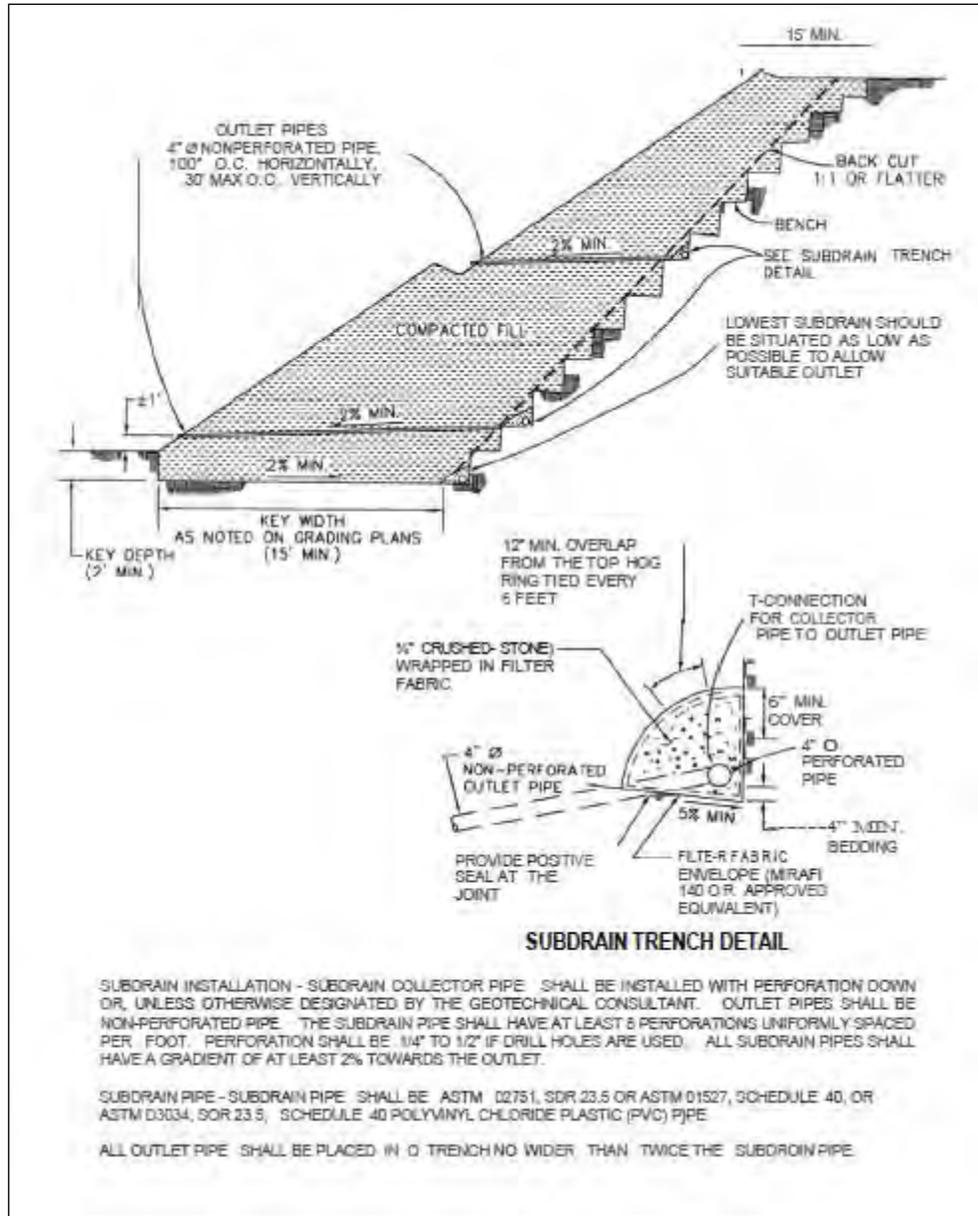
GENERAL EARTHWORK AND GRADING SPECIFICATIONS STANDARD DETAIL "C"

BUTTRESS OR REPLACEMENT FILL SUBDRAINS

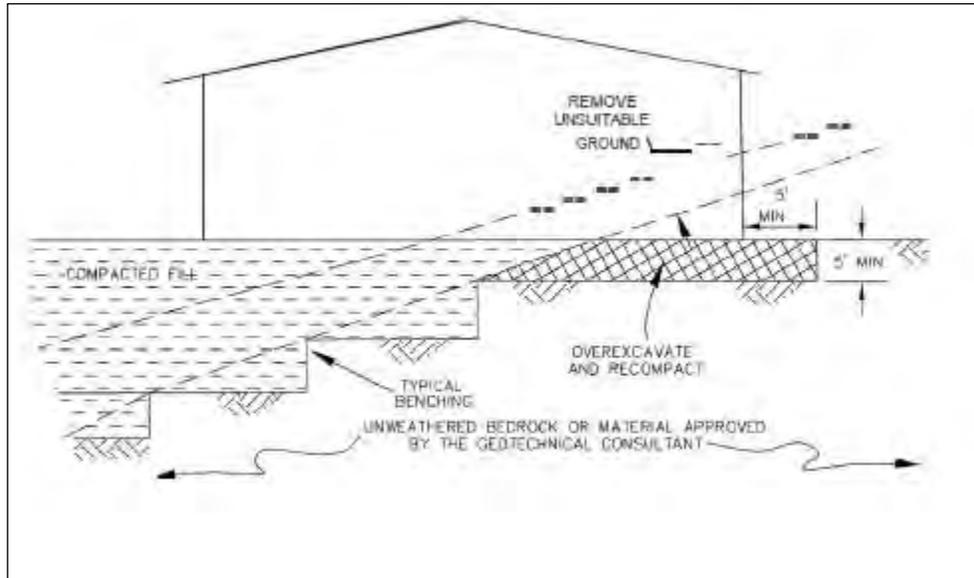
GENERAL EARTHWORK AND GRADING SPECIFICATIONS STANDARD DETAIL "D"

CUT-FILL TRANSITION FILL OVEREXCAVATION
