Environmental Assessment

Determinations and Compliance Findings for HUD-assisted Projects

Project Name: Remodel of Parque Gándara (PR-CRP-000927)

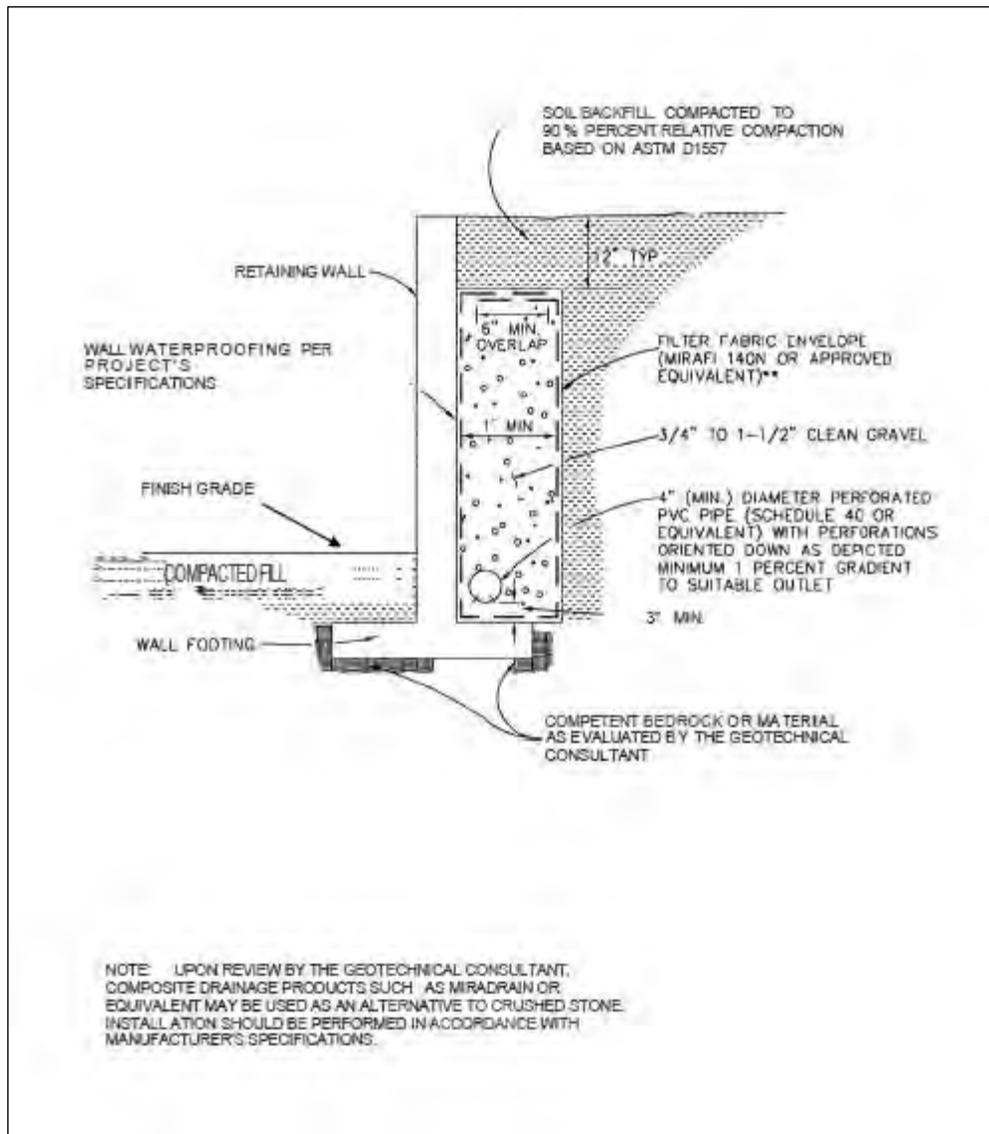
GENERAL EARTHWORK AND GRADING SPECIFICATIONS STANDARD DETAIL "E"

RETAINING WALL DRAINAGE

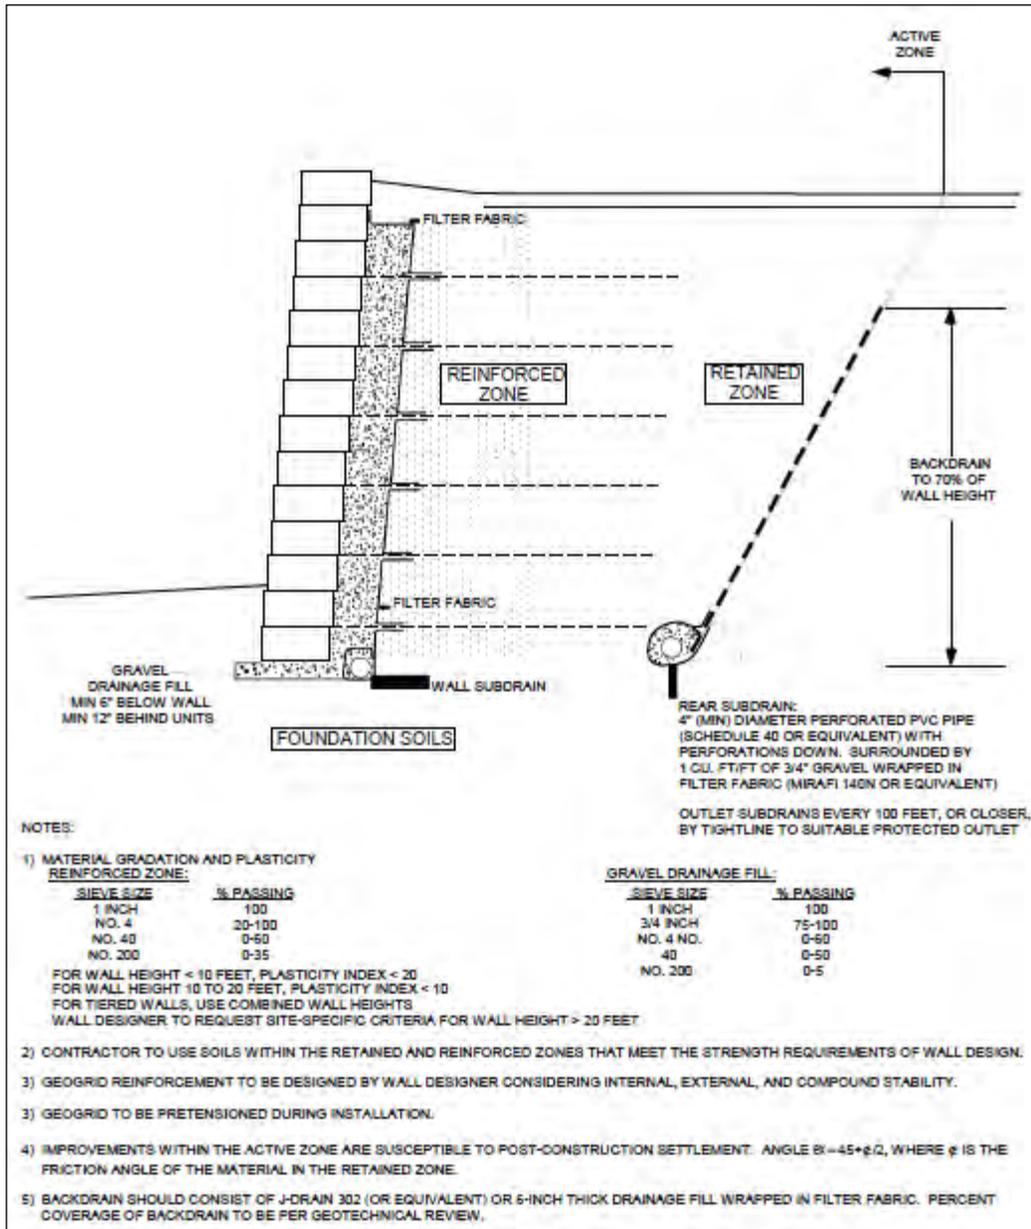
GENERAL EARTHWORK AND GRADING SPECIFICATIONS STANDARD DETAIL " F "

SEGMENTAL RETAINING WALL
