**Environmental Review for Activity/Project that is Categorically  
Excluded Subject to Section 58.5  
Pursuant to 24 CFR 58.35(a)**

**Project Name:** MEJORAS AL ESTACIONAMIENTO PÚBLICO DEL MUNICIPIO DE NAGUABO  
(PR-CRP-001011)

CONSTRUCTION  
PLANS 90%

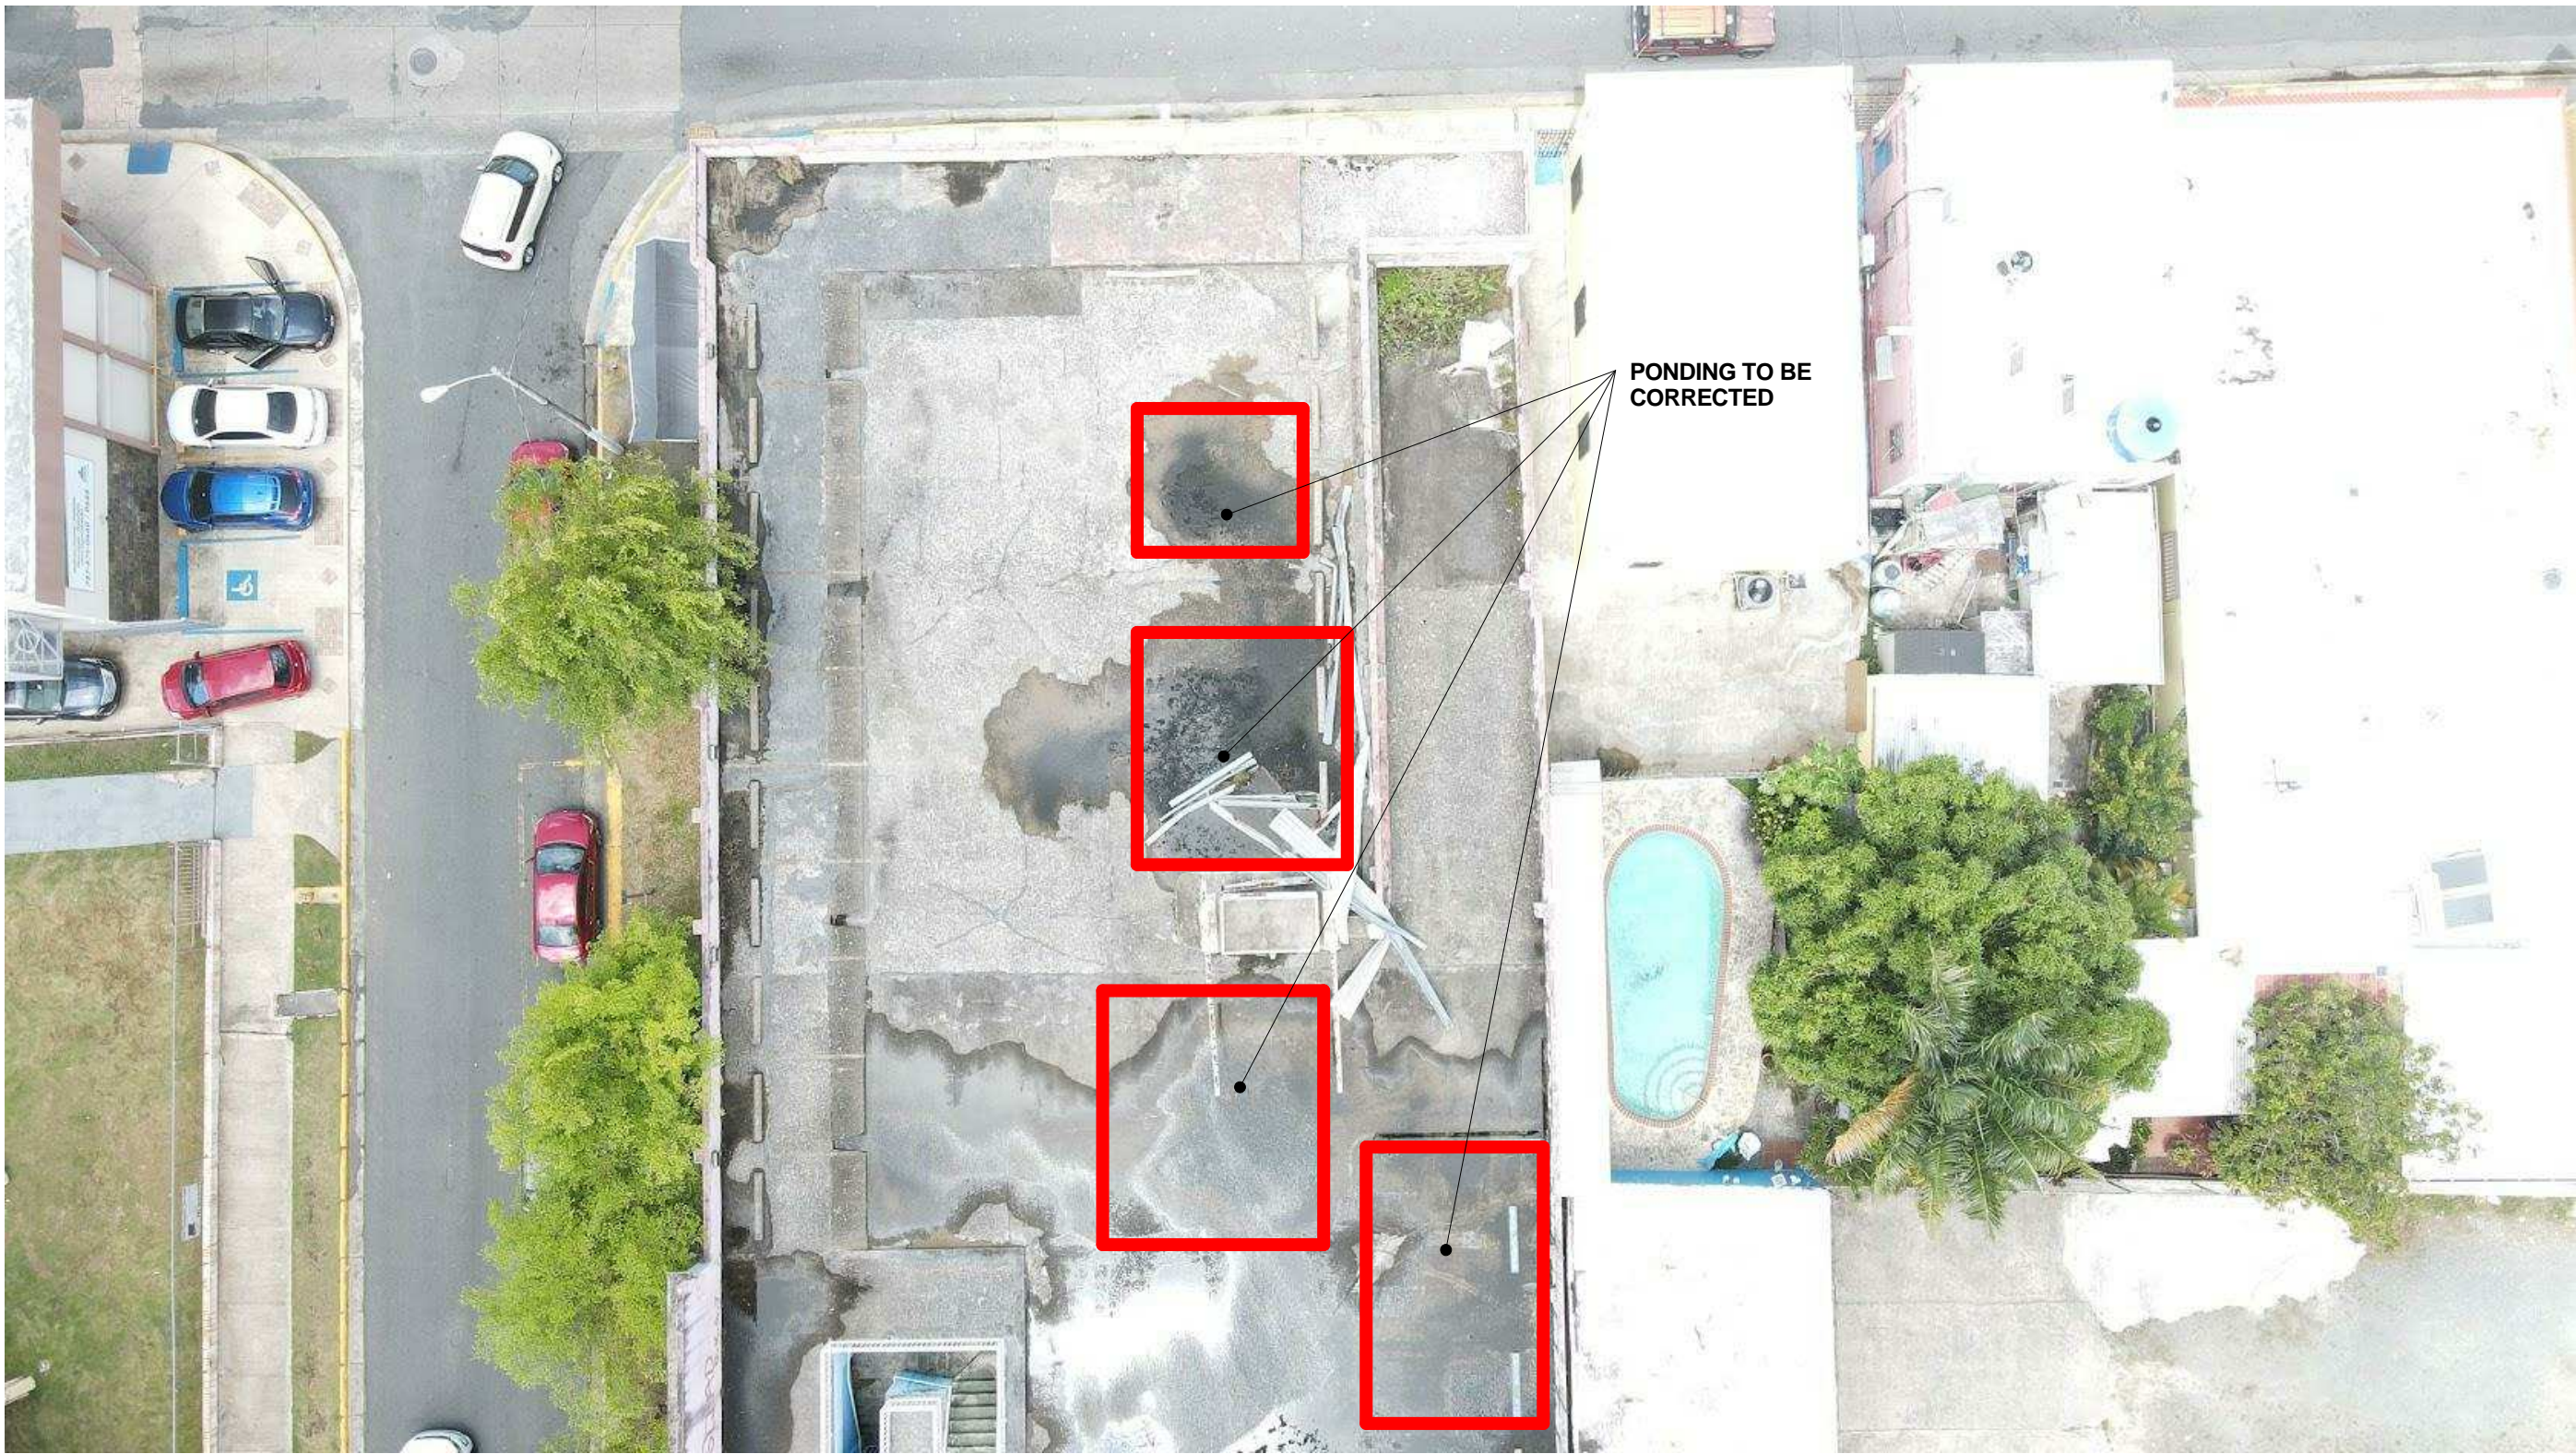
PHOTOS & CONCRETE REPAIR NOTES

1. THE ROOF DECK SHALL BE SHOT BLASTED
2. THE GENERAL CONTRACTOR SHALL CHECK ELVATIONS FOR BETTER WATER DRAINAGE. PONDING IN THE SECOND LEVEL CONCRETE DECK TO BE REPAIRED WITH TAMMSPATCH II REPAIR MORTAR. REFER TO PHOTOS

3. AFTER THE MECHANICAL PREPARATION OF THE SURFACE, THE GENERAL CONTRACTOR SHALL CHECK FOR CRACKS IN THE CONCRETE DECK. ALL CRACKS IN THE ROOF DECK TO BE REPAIRED WITH DURAL 452 LV, EQUAL OR SIMILAR (135 LINEAR FEET)

4. JOINTS SHALL BE SEALED WITH DYMONIC 100 BY TREMCO, EQUAL OR SIMIAR.
5. ALL FLOOR DRAINS SHALL BE UNCLOGGED AND VERIFIED TO BE IN WORKING CONDITIONS. ALL ROOF DRAIN COVERS TO BE REPLACED. THE GENERAL CONTRACTOR SHALL SUBMITT SHOP DRAWINGS FOR ALL DRAINS.

6. AFTER LOW AREAS OF THE DECK HAVE BEEN FILLED WITH THE TAMMSPATCH II AND CRACKS IN THE DECK HAVE BEEN COMPLETED, THE GENERAL CONTRACTOR SHALL INSTALL THE FLEXDECK - MEDIUM TRAFFIC SYSTEM

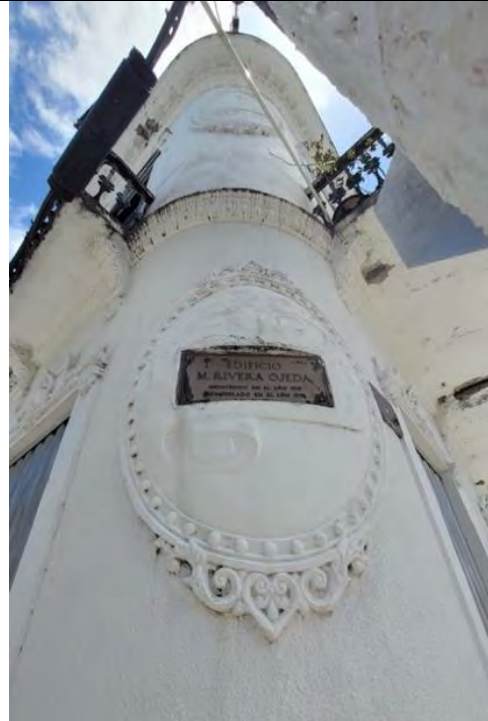
19.2 Corner ornament. Photo obtained from local Naguabo historian, Carlos Suarez.

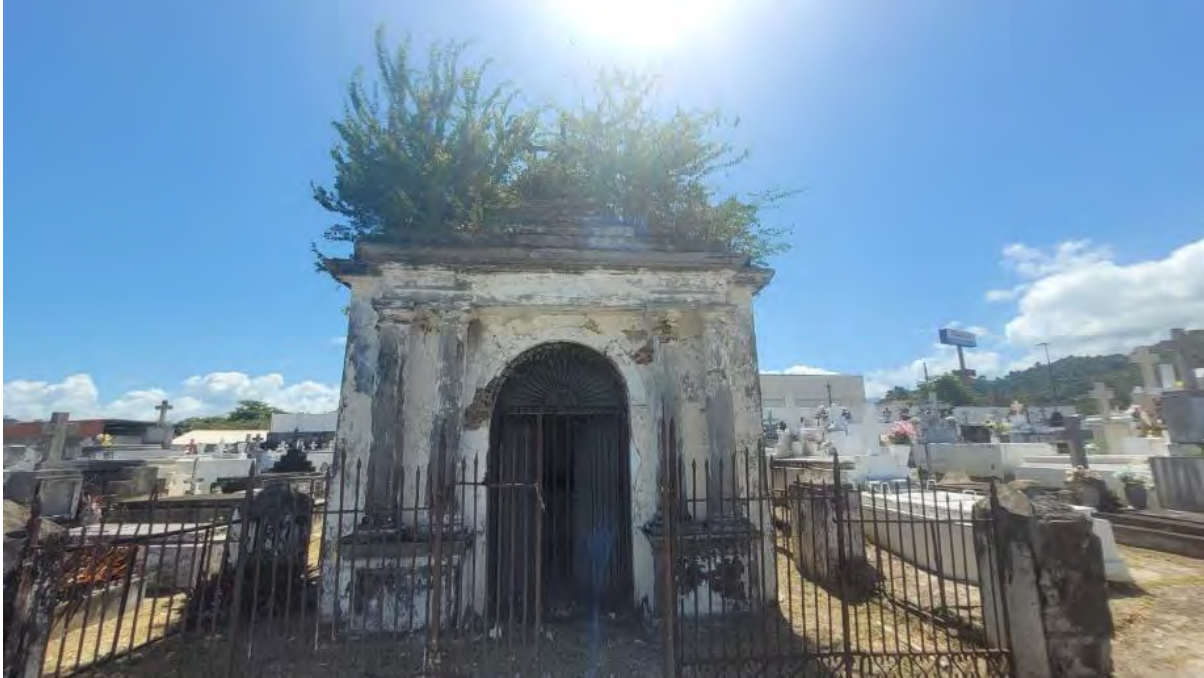
40.1 The mausoleum located in the center of the cemetery with engraved date of 1856.

In the center of the cemetery, you can find the oldest structure, which is the mausoleum built in brick masonry. Inside, there is a small altar, and the interior walls are covered with tiles. The floor appears to be the original one, with marble tiles. Sadly, it is in a deteriorated state, and bushes/trees are growing on the roof, with their roots penetrating the brick walls

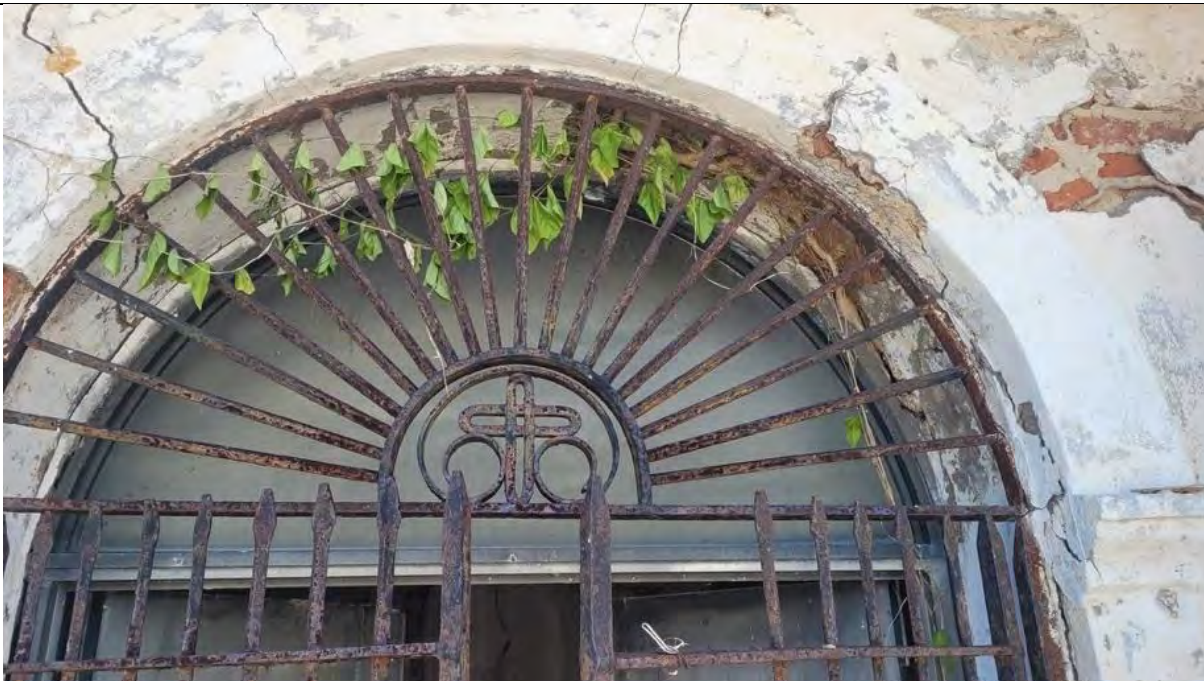
40.2 Entrance arch to the mausoleum. Bricks in walls are visible along with deteriorated metal gates.

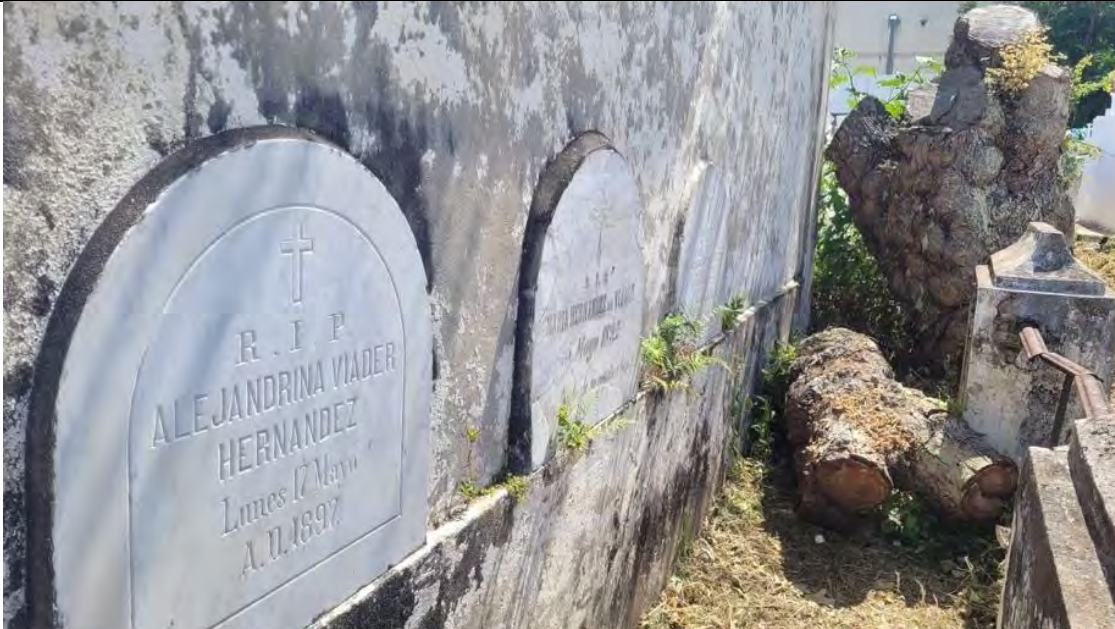
40.6 Tombstones in one of the mausoleum walls.

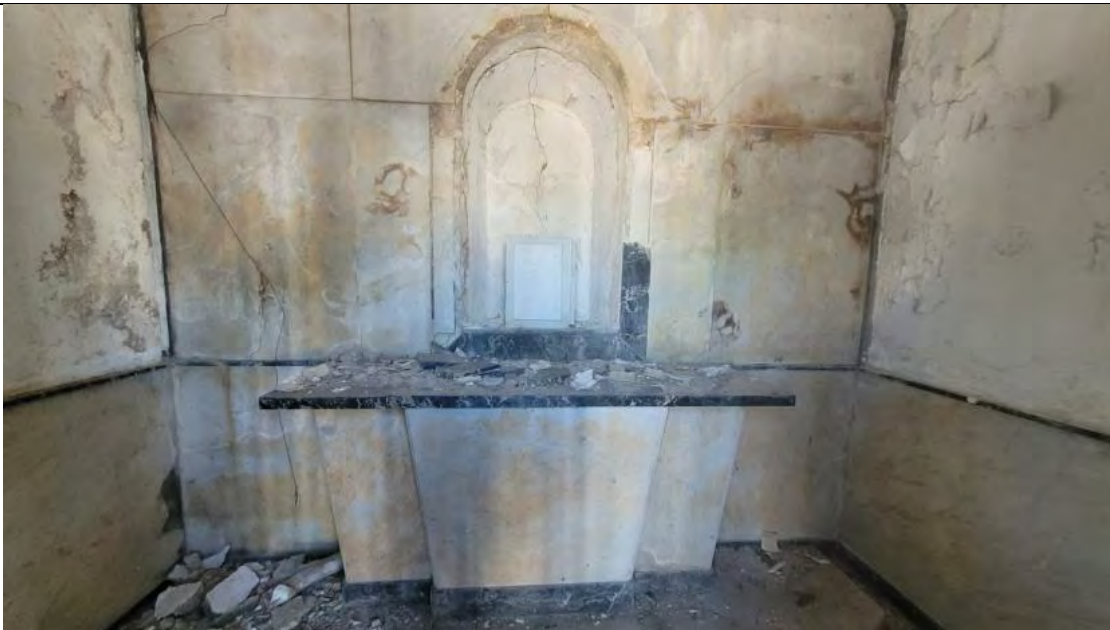
40.7 View of the interior of the mausoleum.

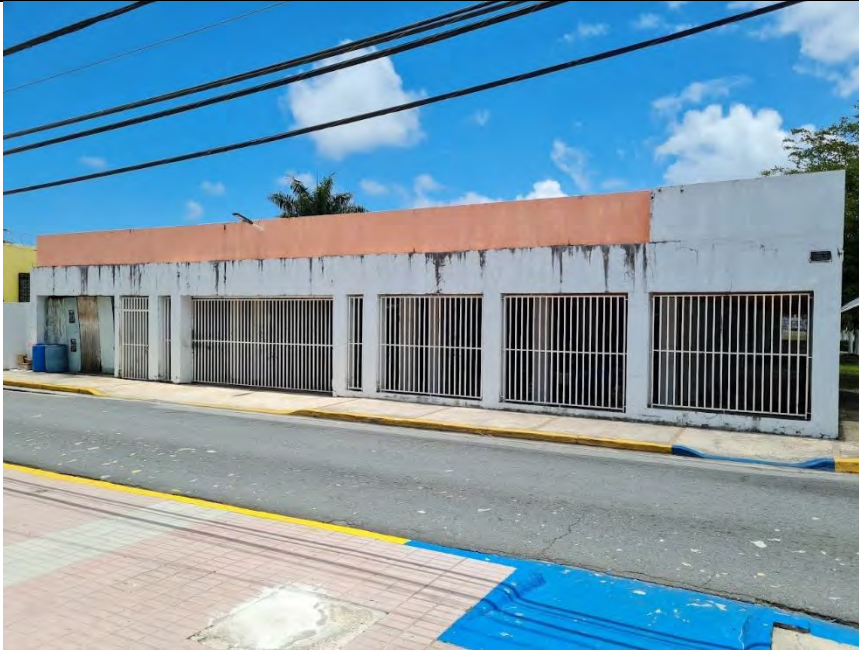
Photo #: 1

Description: Exterior view of the East façade taken from Garzot street in front of the Outdoor Theater

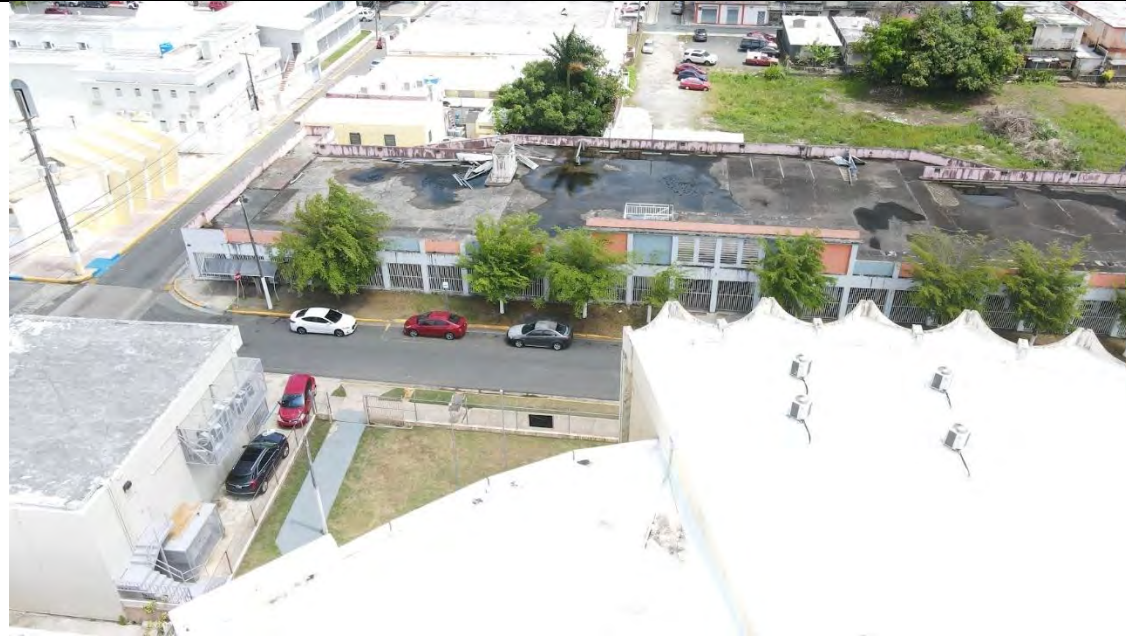
Photo #: 3

Description: Drone picture taken from the North side of the structure. Upper-level concrete slab damage visible

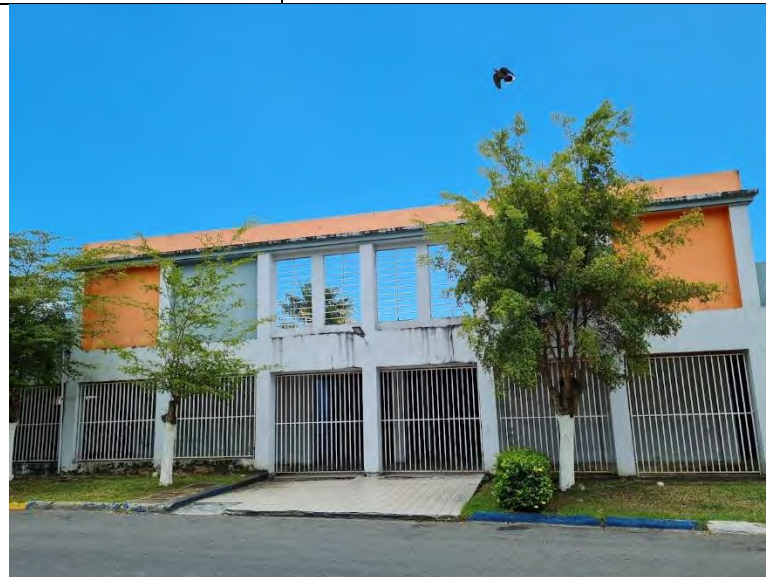
Photo #: 4

Description: Partial exterior view of the North side pedestrian entrance

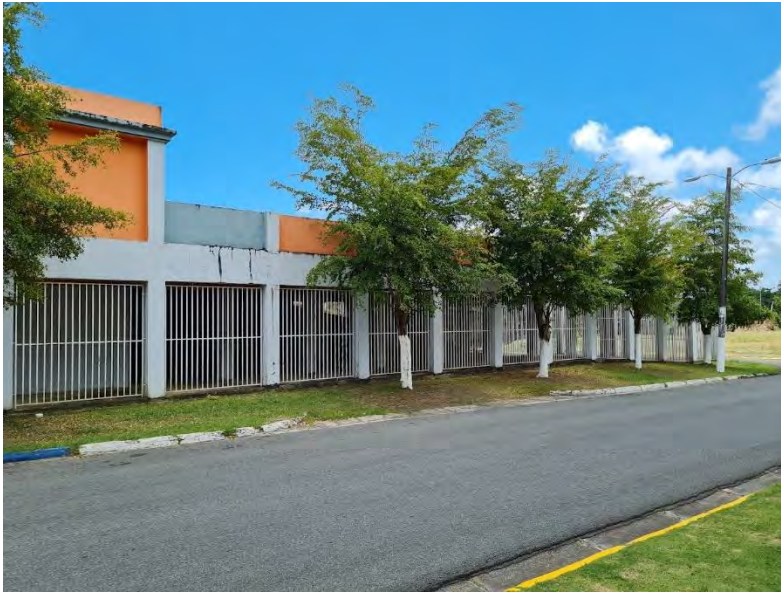
Photo #: 5

Description: Partial exterior view of the North side façade of the structure.

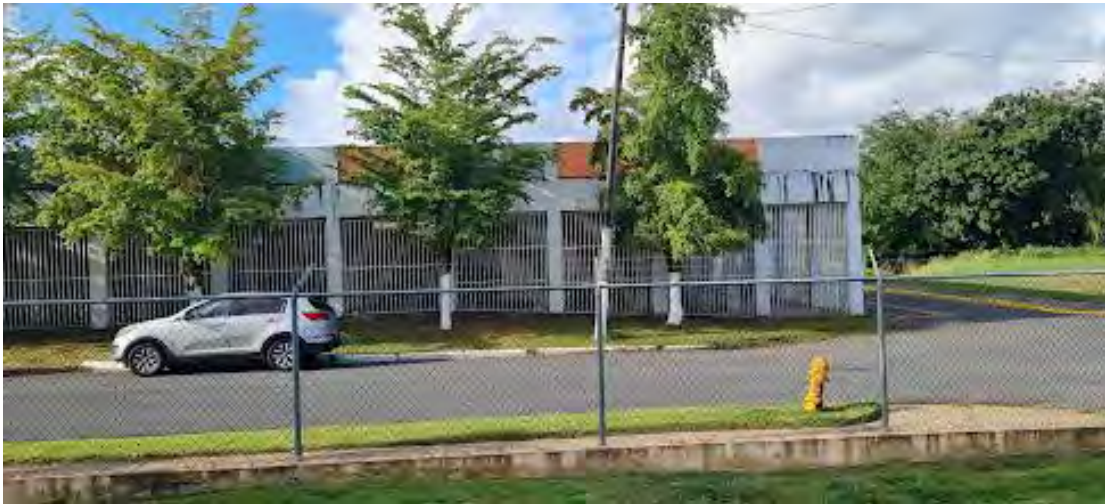
Photo #: 6

Description: Partial exterior view of the north side façade of the structure.

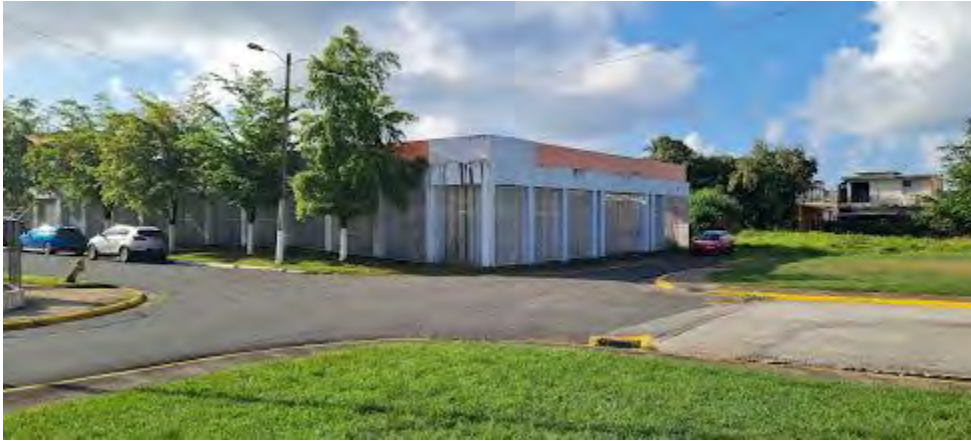
Photo #: 7

Description: Exterior view from empty lot located northwest of the structure

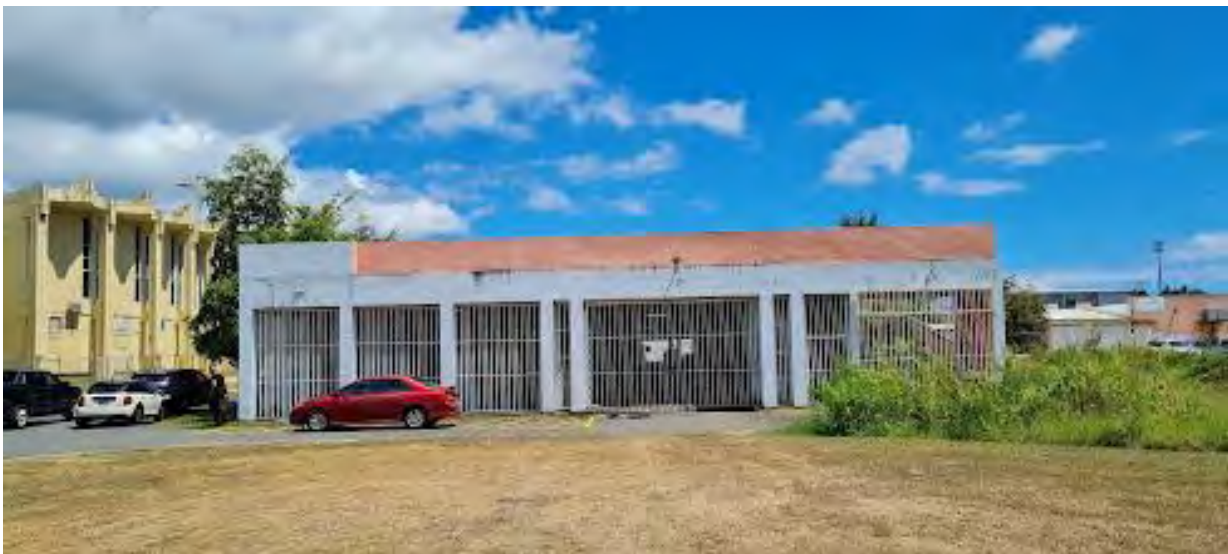
Photo #: 8

Description: Exterior view of the west side façade.

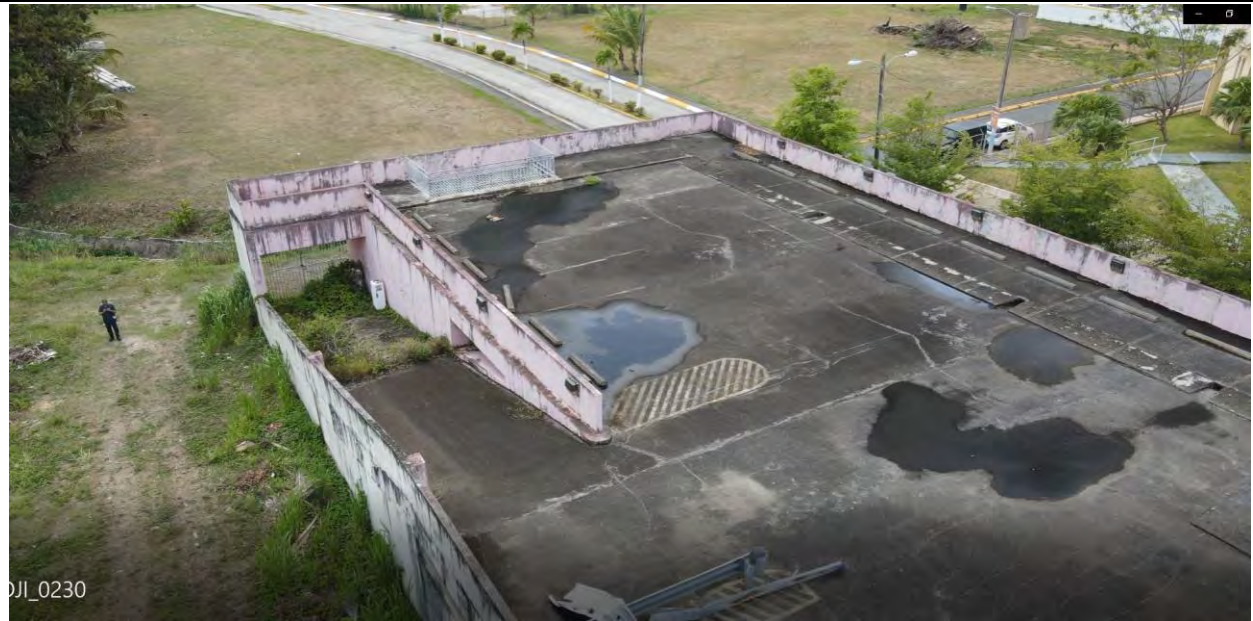
Photo #: 9

Description: Drone photo of the west side upper level.

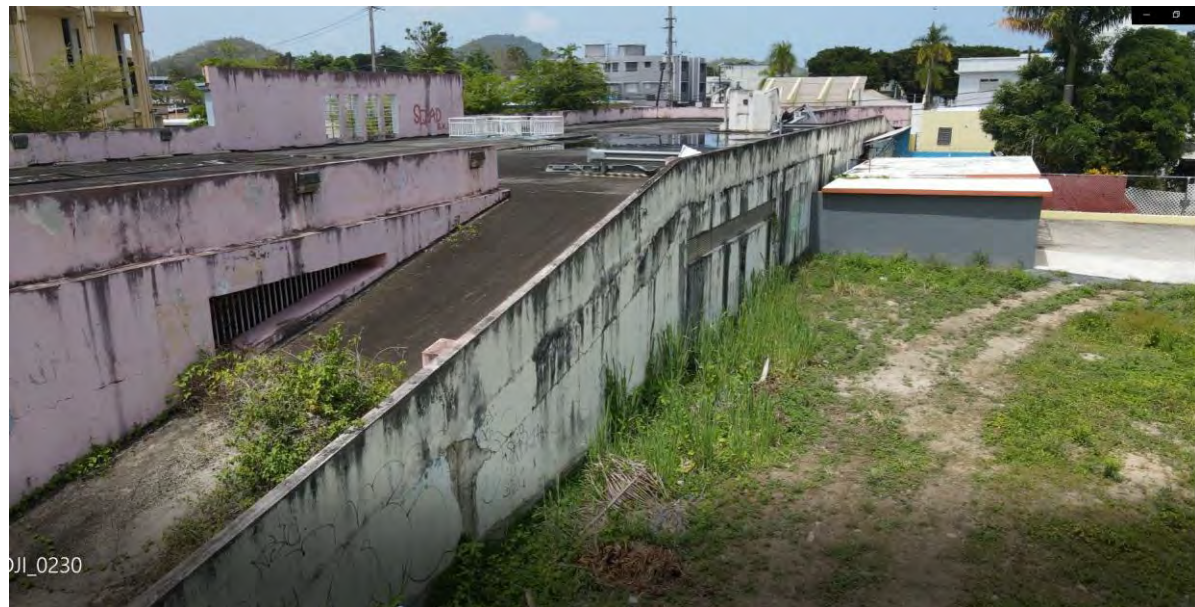
Photo #: 10

Description: Exterior view of the South side façade of the structure.

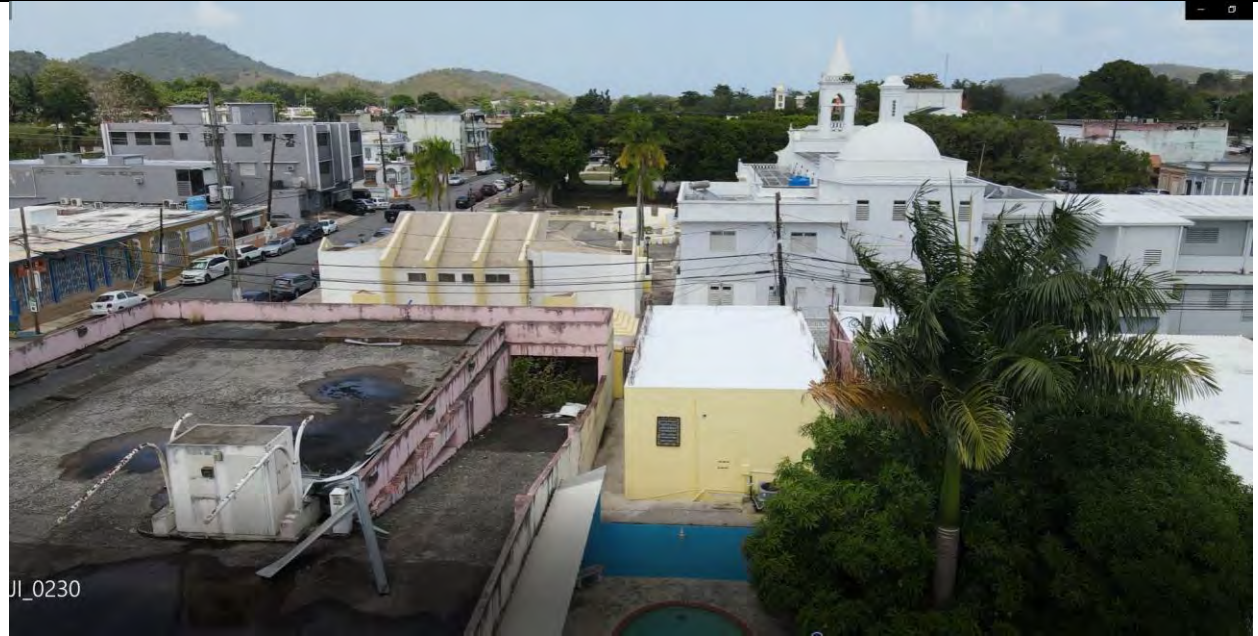
Photo #: 11

Description: Drone photo of the vehicular ramp on the Southeast side of the structure.

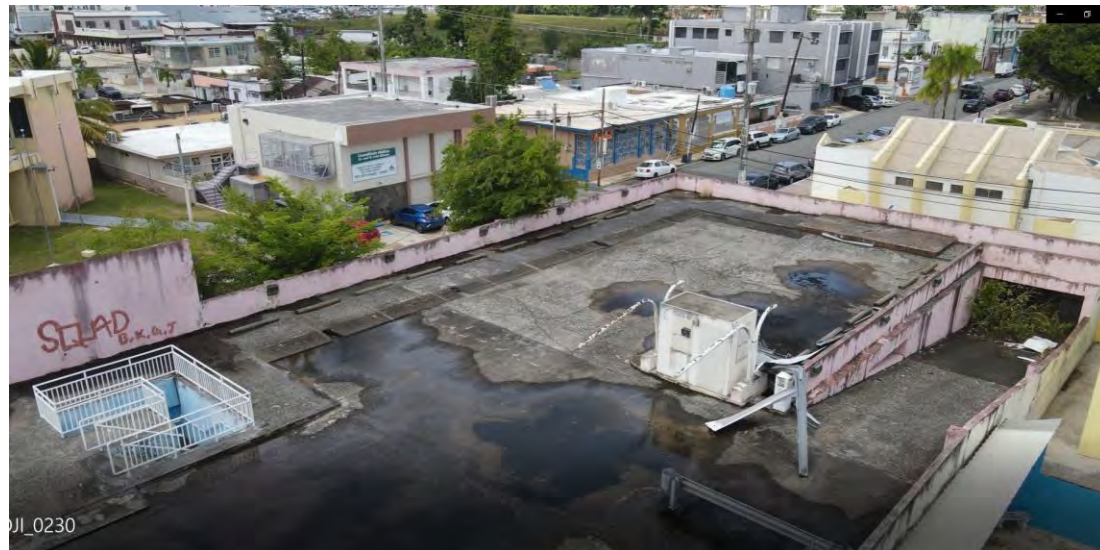
Photo #: 12

Description: Drone photo of the booth located on the upper level.

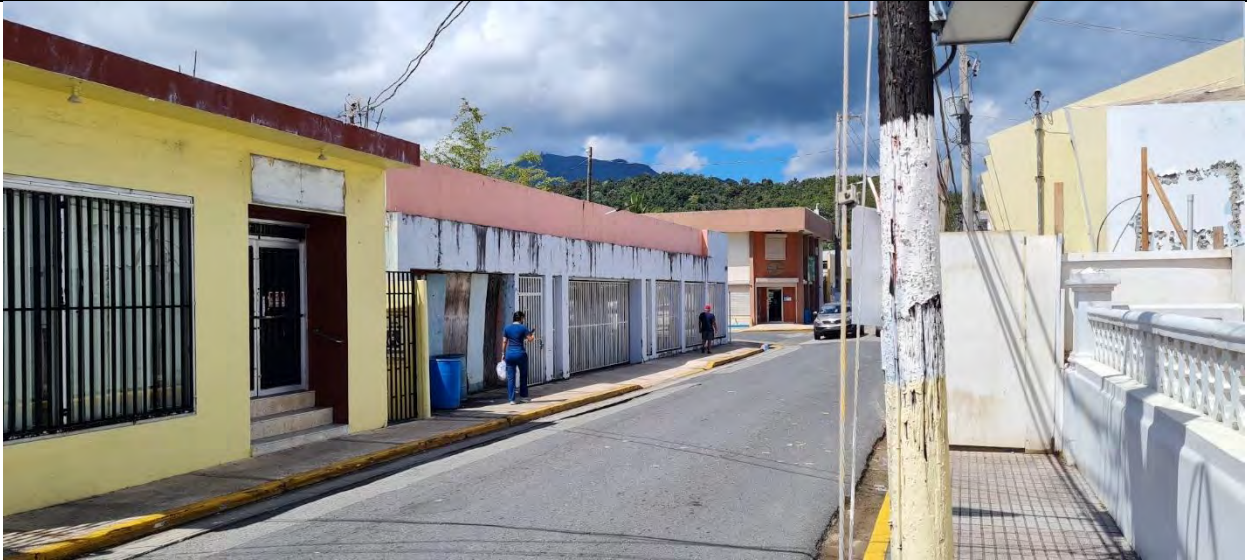
Photo #: 13

Description: Exterior view of the east side façade taken from the posterior side of the Nuestra Señora del Rosario Church.

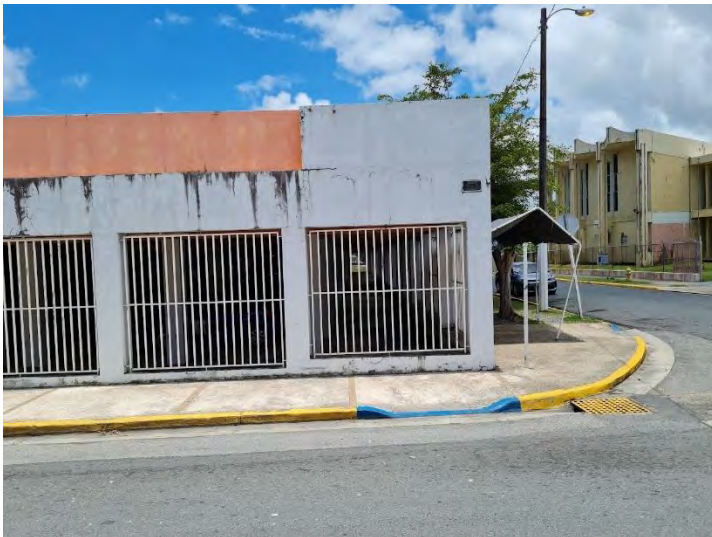
Photo #: 14

Description: Partial exterior view of the façade on the corner of Goyco and Garzot street.

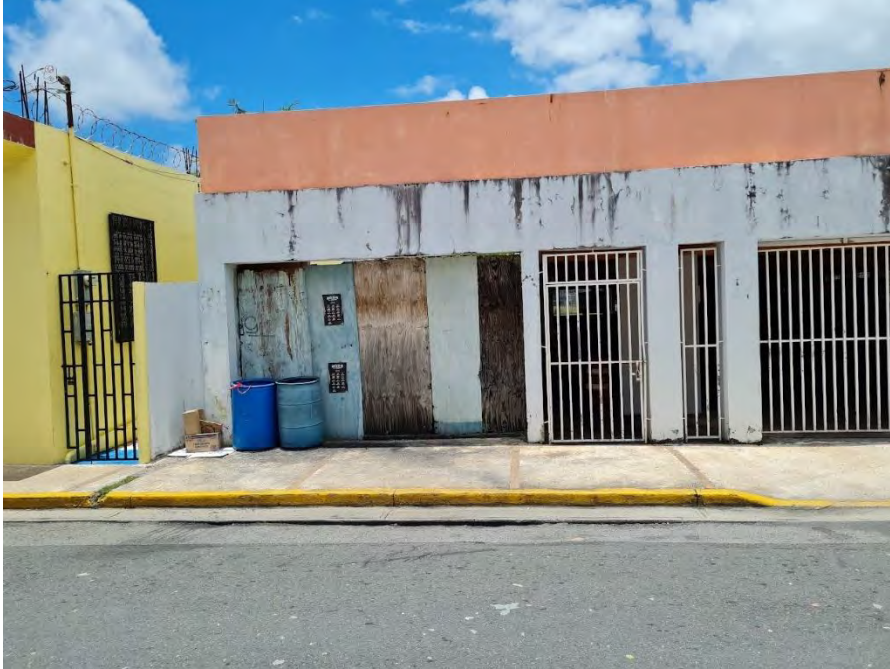
Photo #: 15

Description: View of the boarded up vehicular entrance to the second level on Garzot street.

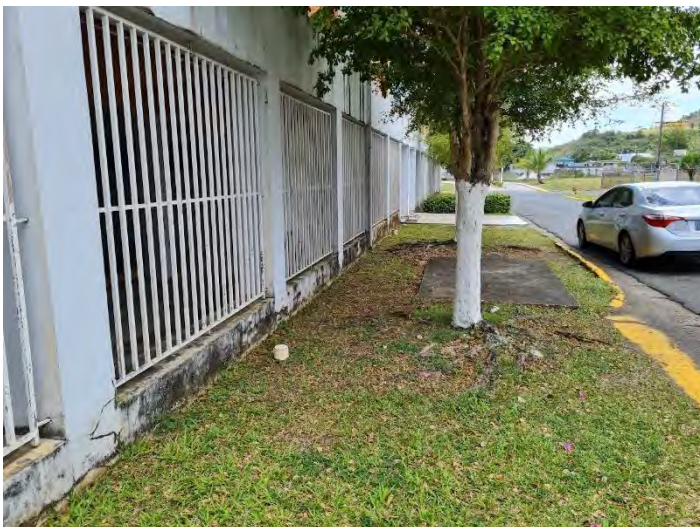
Photo #: 16

Description: Exterior view of the pedestrian entrance on the North façade.

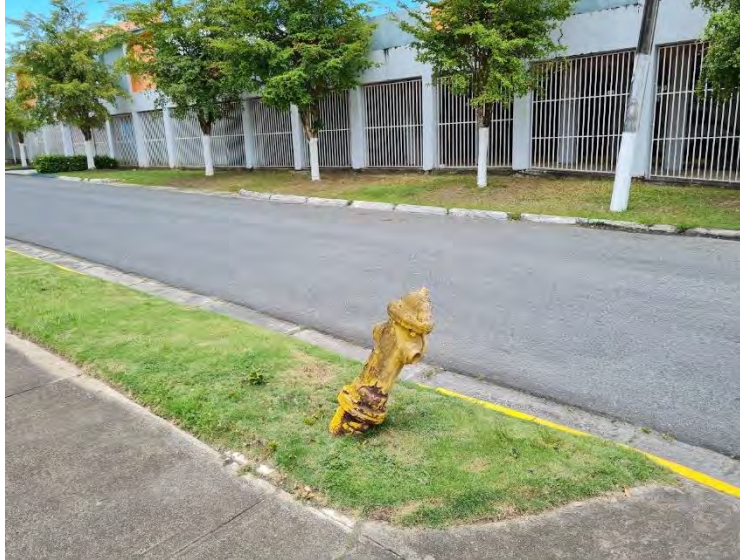
Photo #: 17

Description: Exterior view of the north side façade from the sidewalk on Goyco street.

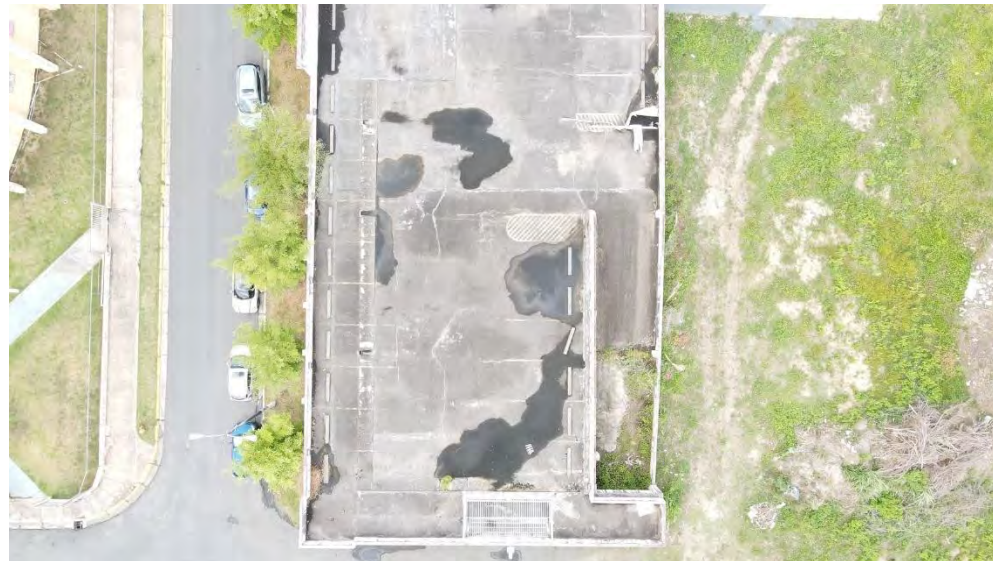
Photo #: 18

Description: Top view of the existing conditions of the upper-level parking area

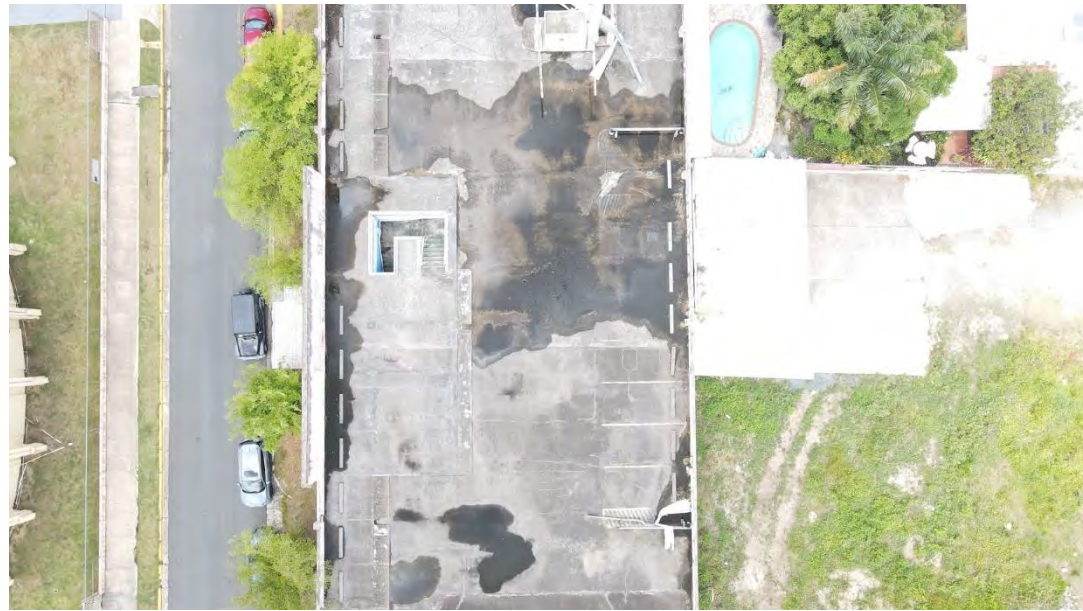
Photo #: 19

Description: Top view of the existing conditions of the upper-level parking area and stairs

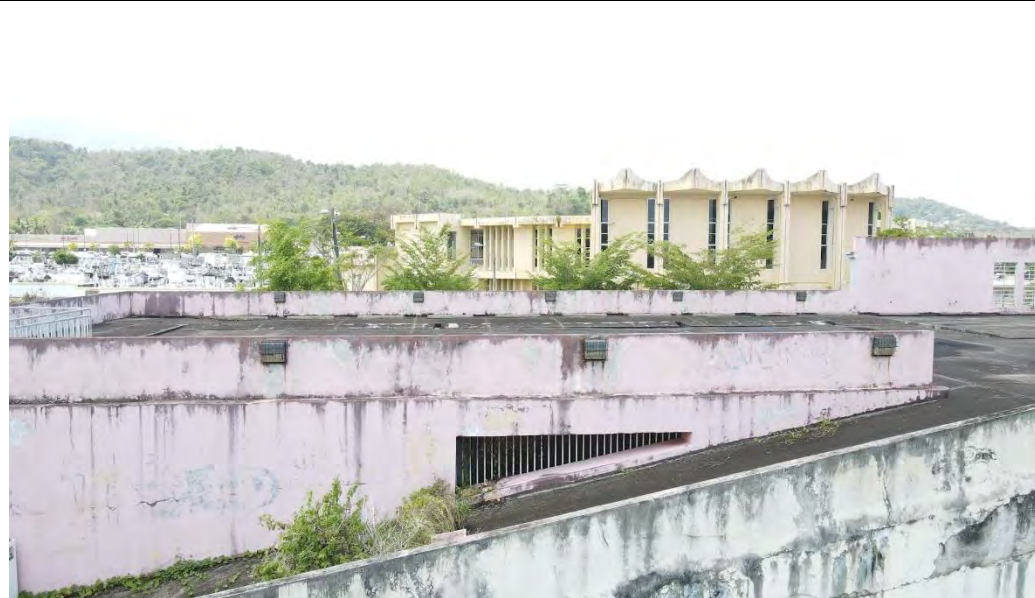
Photo #: 20

Description: Exterior view of the vehicular ramp located on the southwest side of the structure.

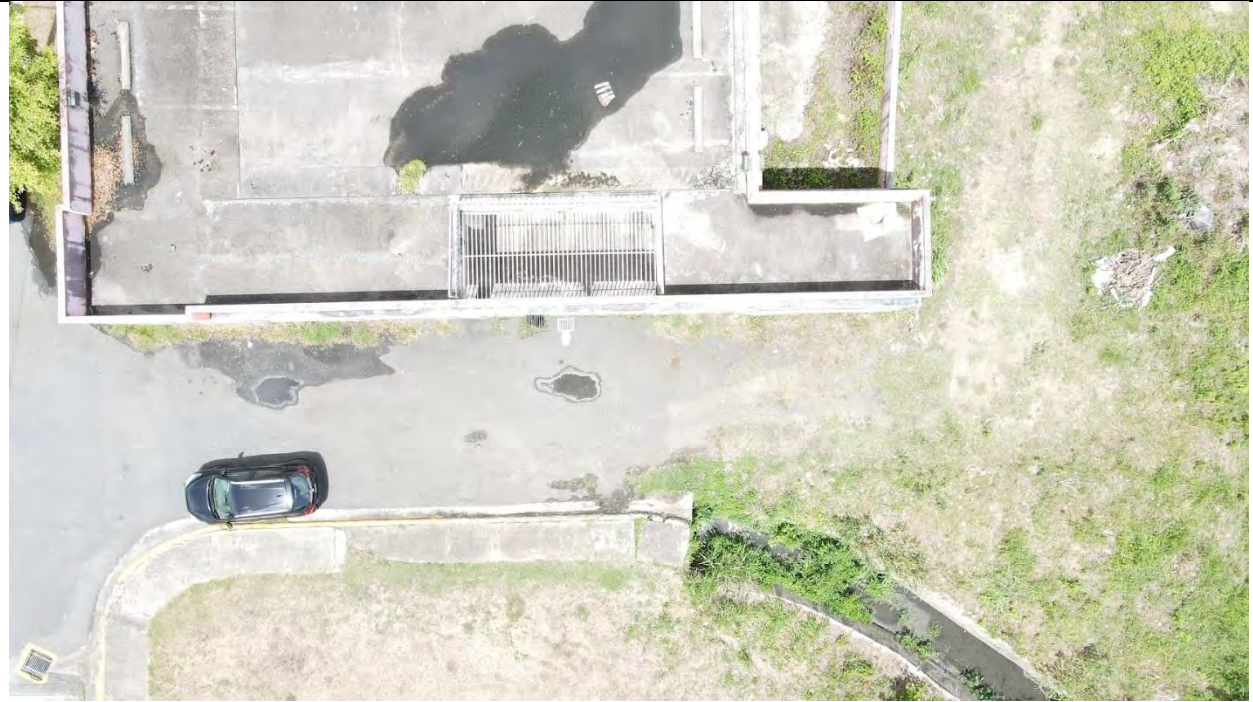
Photo #: 21

Description: Top view of the existing conditions of the upper level parking area

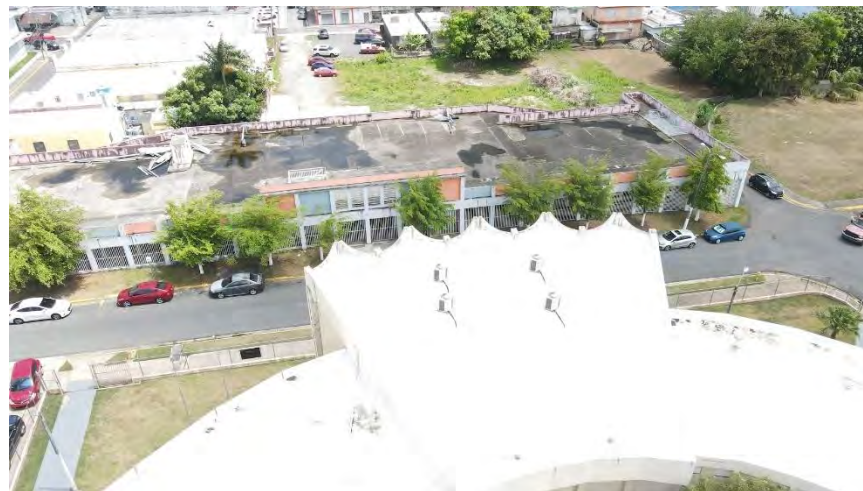
Photo #: 22

Description: Drone photo of the North Façade and upper level parking areas.

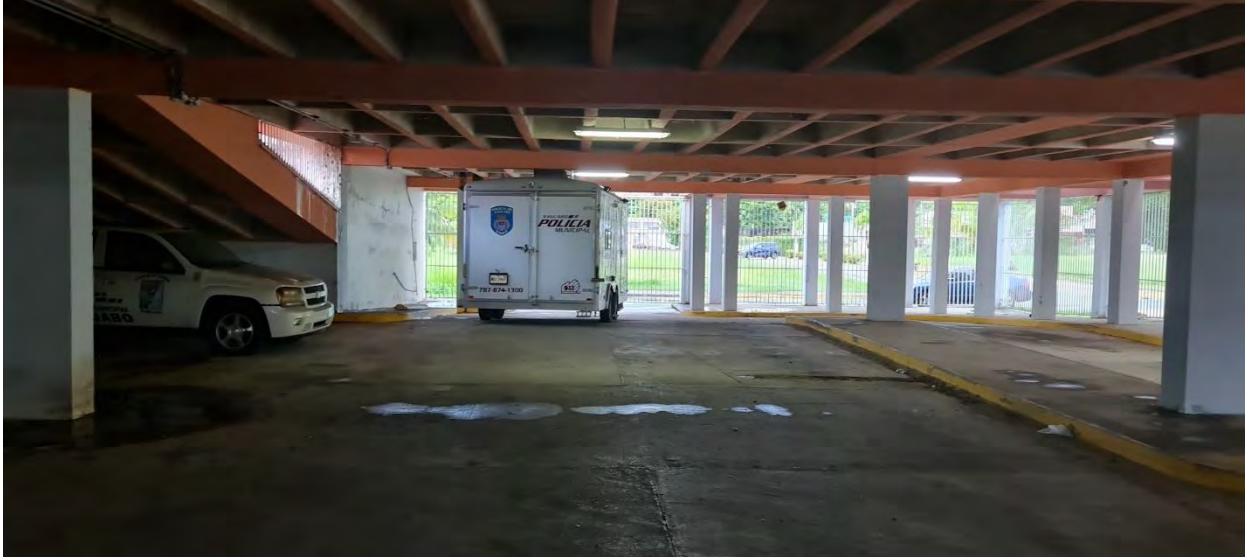
Photo #: 23

Description: Interior view of the vehicular entrance on the west side of the structure

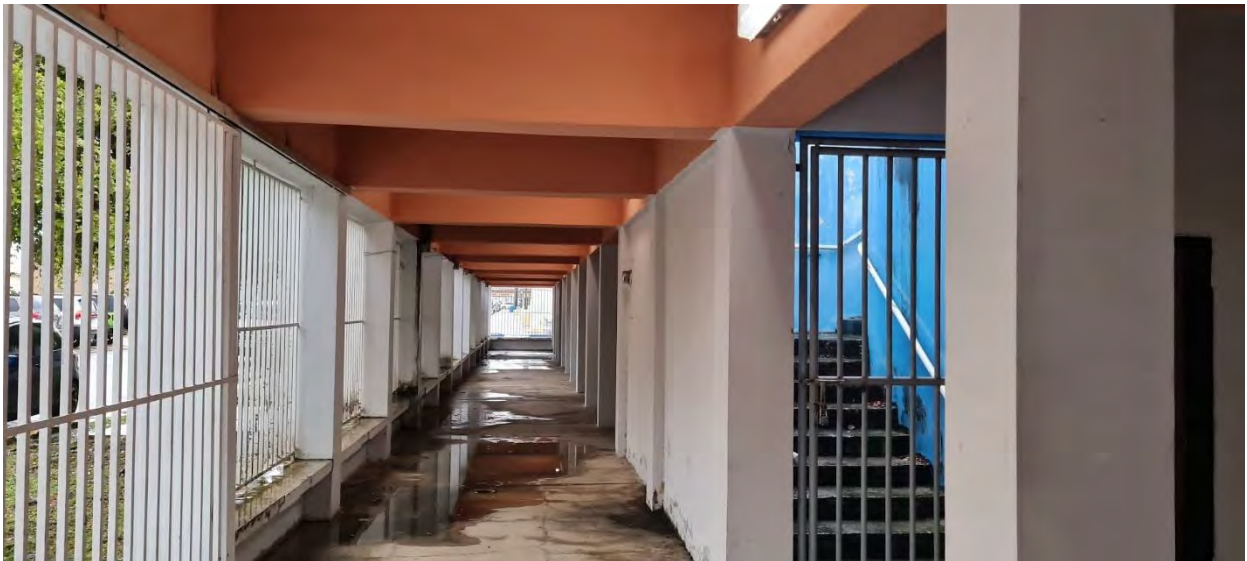
Photo #: 24

Description: Interior view of the stairs and corridor on the north side of the structure.

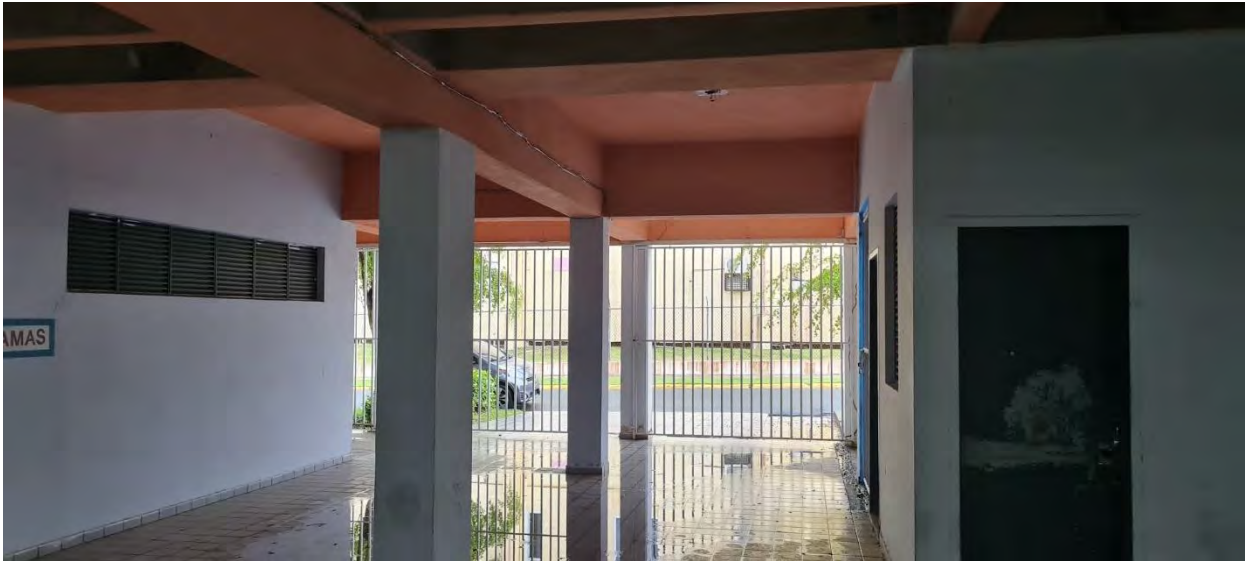
Photo #: 25

Description: Interior view of the pedestrian entrance located on Goyco Street

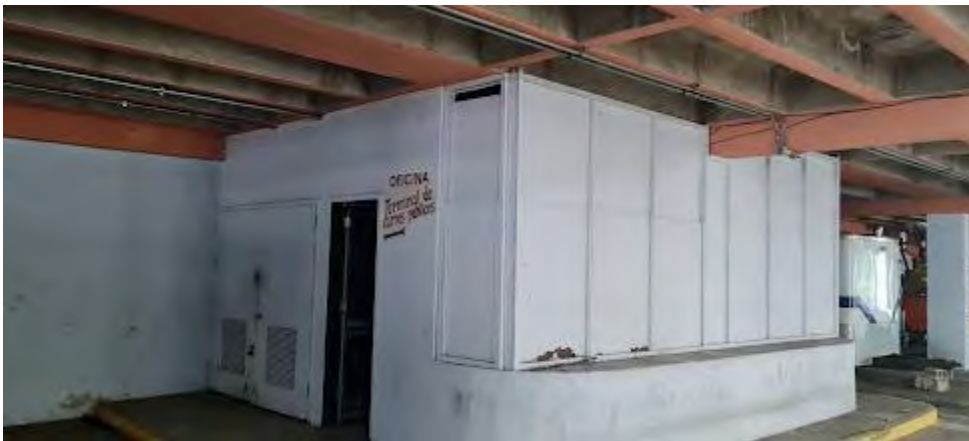
Photo #: 26

Description: Interior view of the existing administrative offices inside the parking garage structure.
