**Environmental Review for Activity/Project that is Categorically  
Excluded Subject to Section 58.5  
Pursuant to 24 CFR 58.35(a)**

**Project Name:** MEJORAS AL ESTACIONAMIENTO PÚBLICO DEL MUNICIPIO DE NAGUABO  
(PR-CRP-001011)

CONSTRUCTION  
PLANS 90%

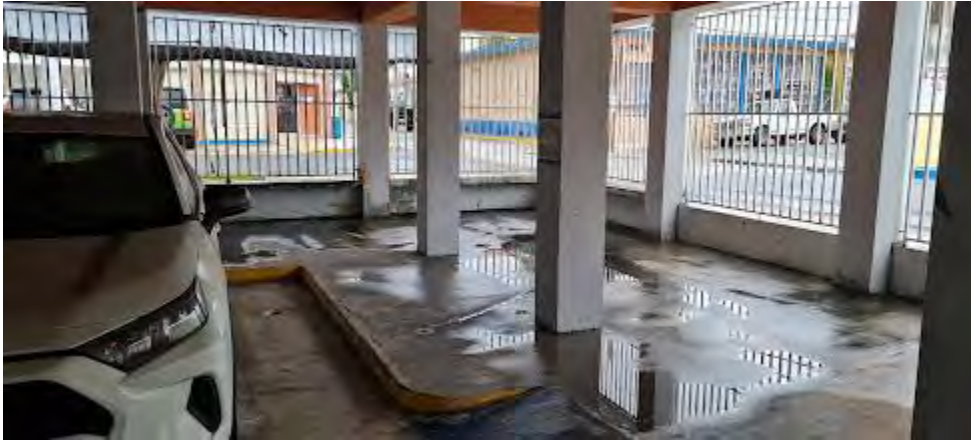
Photo #: 27

Description: View of the corner of Garzot & Goyco street from the interior.

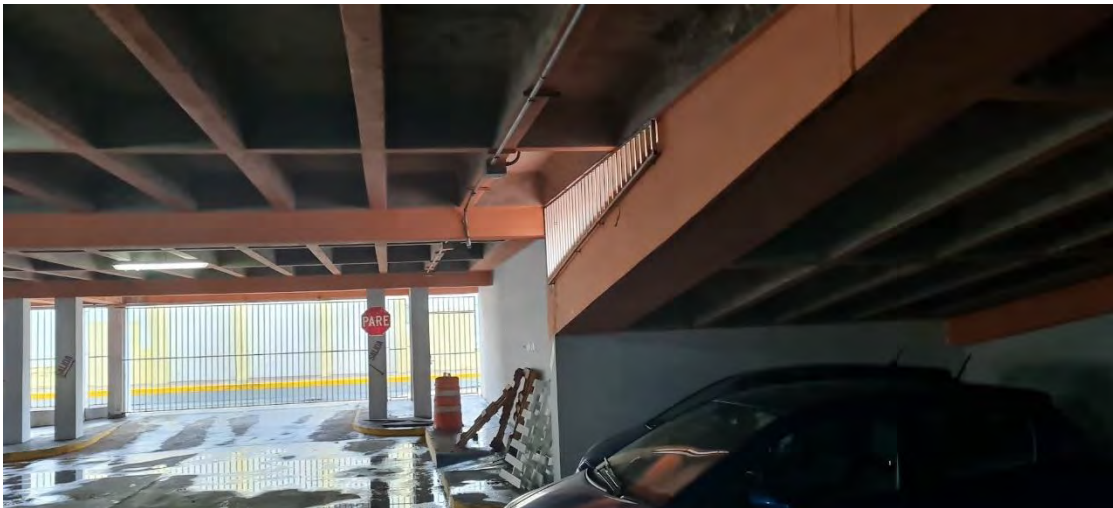
Photo #: 28

Description: View of the outdoor theater located on the corner of Garzot & Goyco street from the interior. Vehicular entrance on Garzot street.

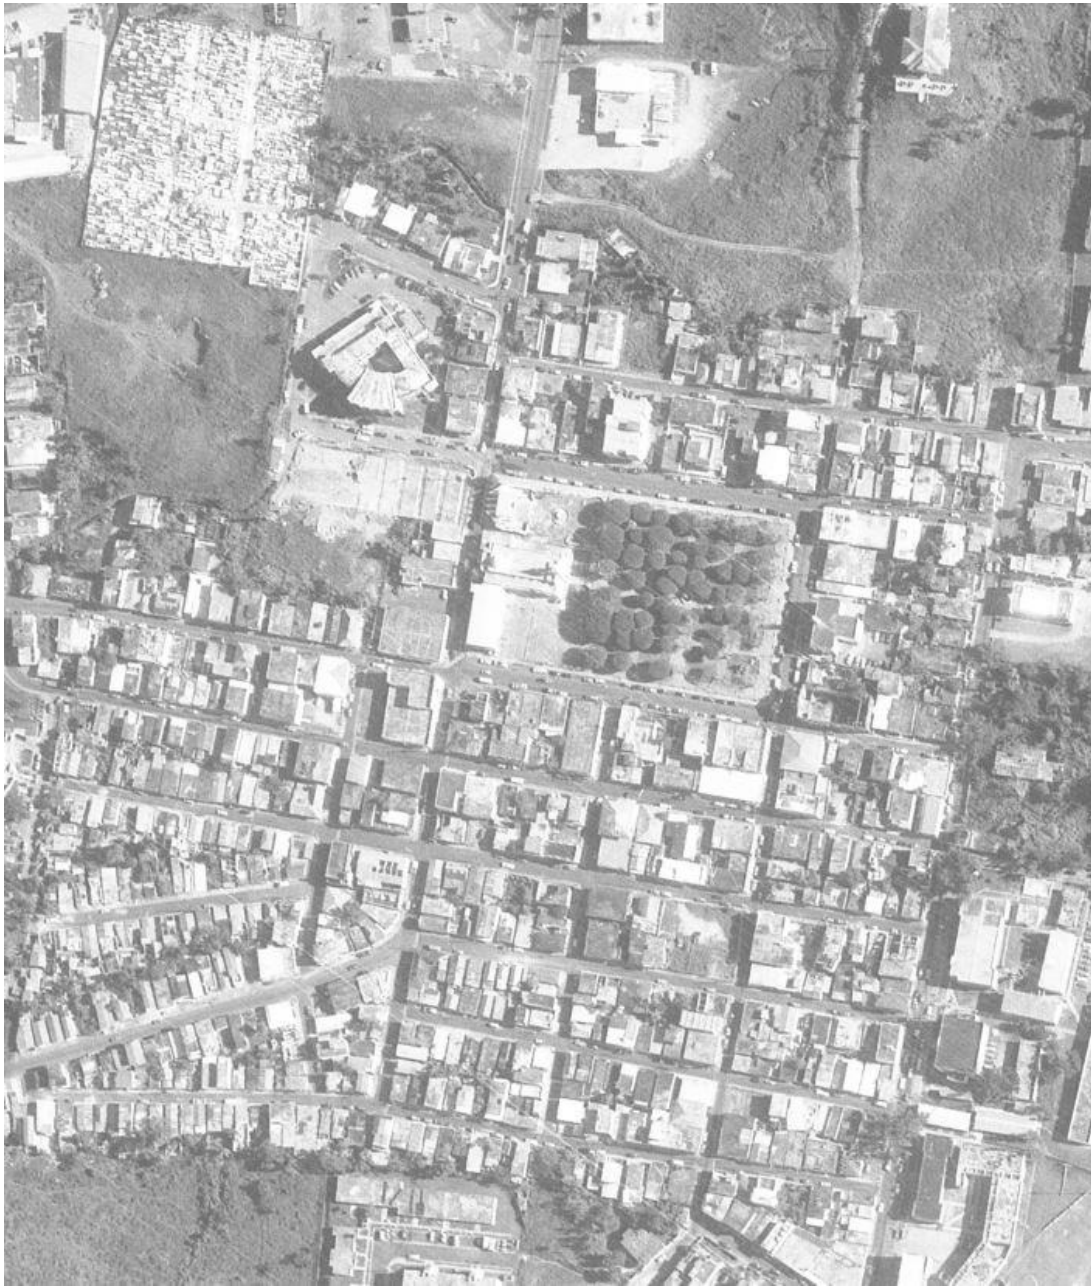
Figure 10. AERIAL VIEW OF THE STRUCTURE TAKEN IN 1990

PHOTO FROM THE ARCHIVES OF THE PHOTOGRAMETRY AUTORIDAD DE CARRETERAS

The municipal parking garage has a documented existence of less than 45 years. This is supported by photographic records from 1990-1991. These records are included in this document to substantiate the historical context. Refer to Figure 10 & 11. The parking structure does not meet standards for inclusion in the NRHP under any criterion.

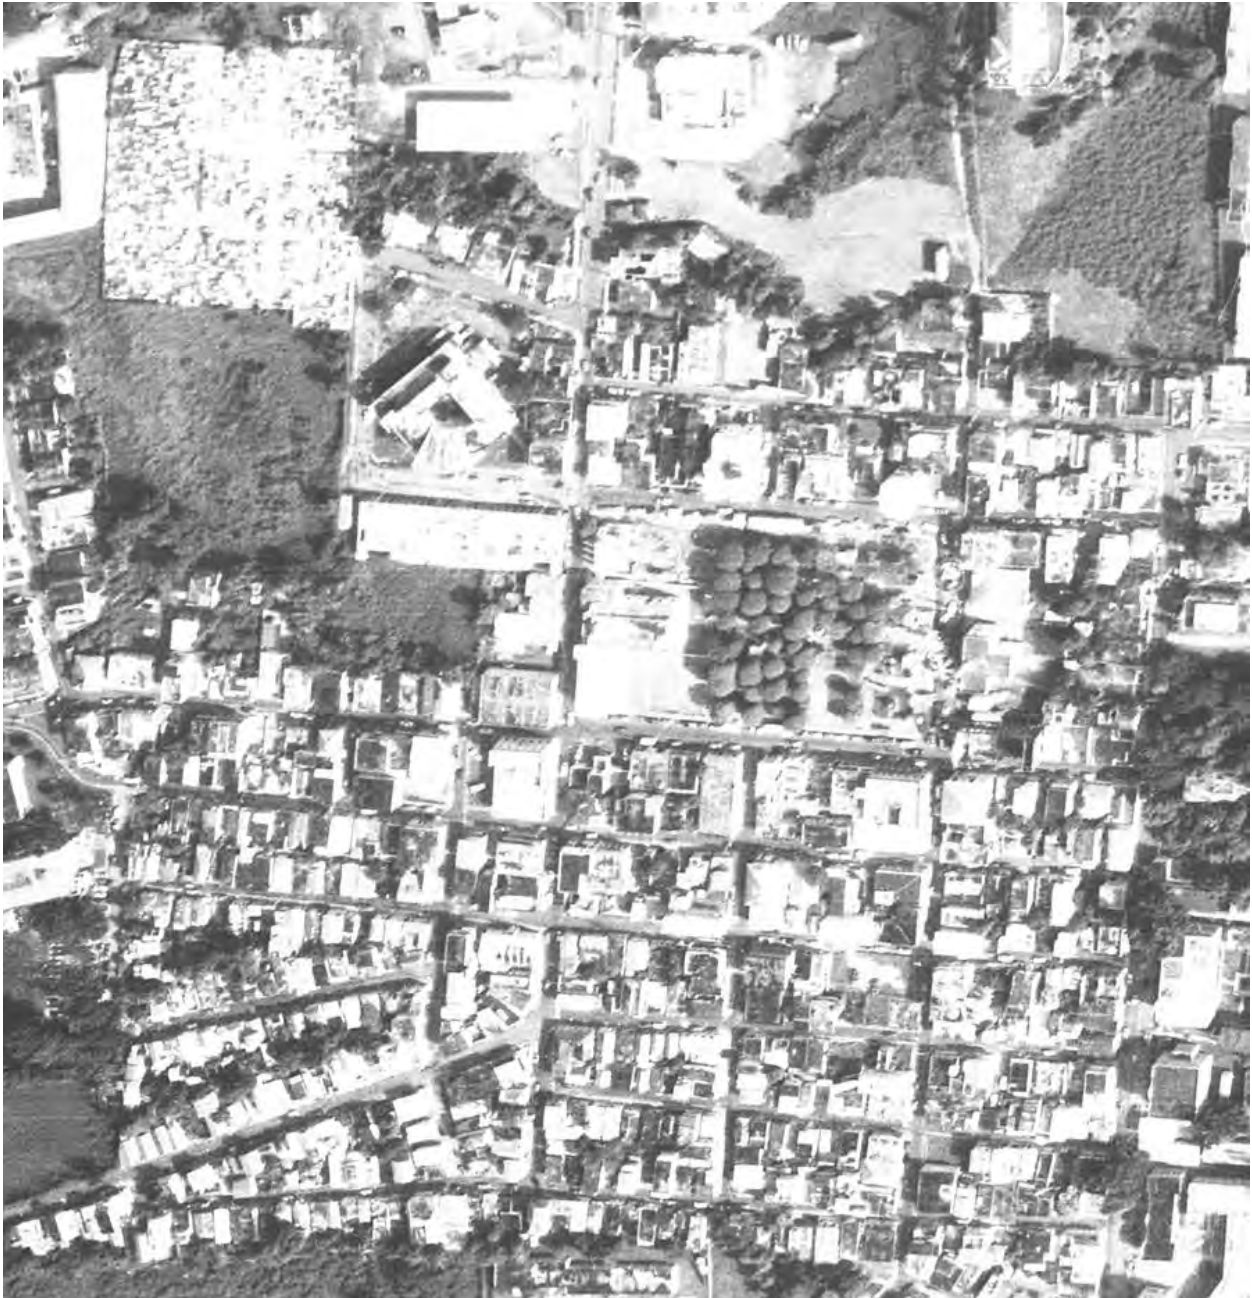
Figure 11. AERIAL VIEW OF THE STRUCTURE TAKEN IN 1991

PHOTO FROM THE ARCHIVES OF THE PHOTOGRAMETRY AUTORIDAD DE CARRETERAS
