**Environmental Review for Activity/Project that is Categorically
Excluded Subject to Section 58.5**

**MUSEO HISTORICO DE QUEBRADILLAS
QUEBRADILLAS, PR**
PR-CRP-000554
CDBG-DR

**Applicant: Municipality of Quebradillas
Prepared by: José D. Centeno Calero PE
Professional Engineer
License 20206
Date: October 23, 2023**

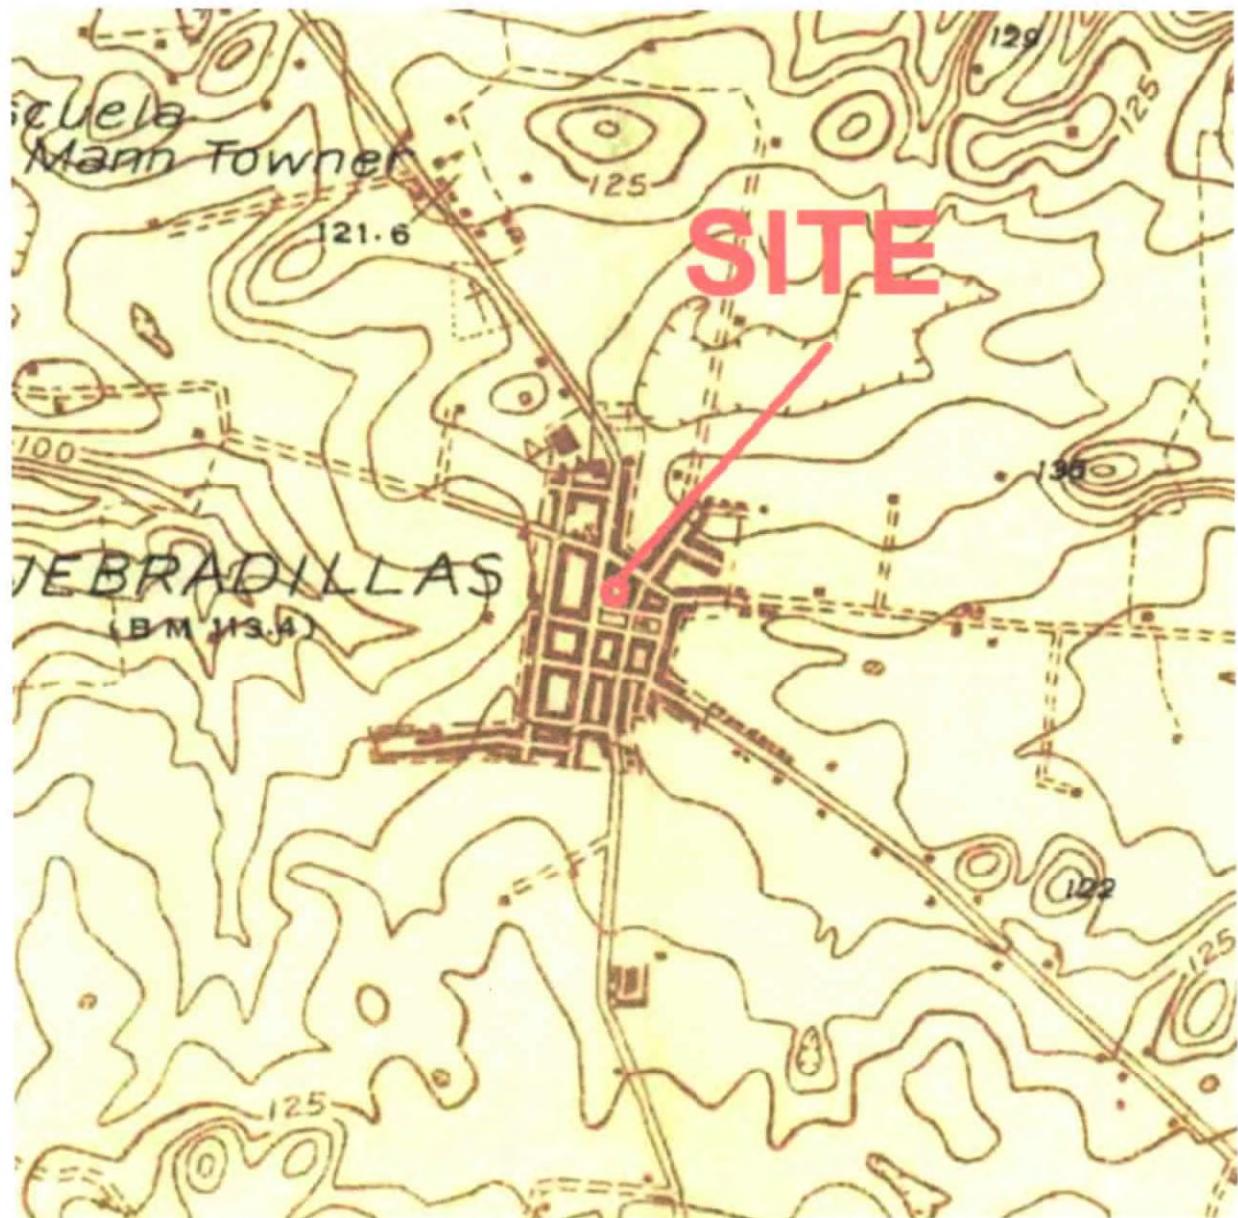
Figura #8 Cuadrángulo Topográfico 1937-38 (Surveyed 1922)

En el cuadrángulo del 1937-1938, se pudo observar las primeras cuadras construidas en el casco urbano de Quebradillas.

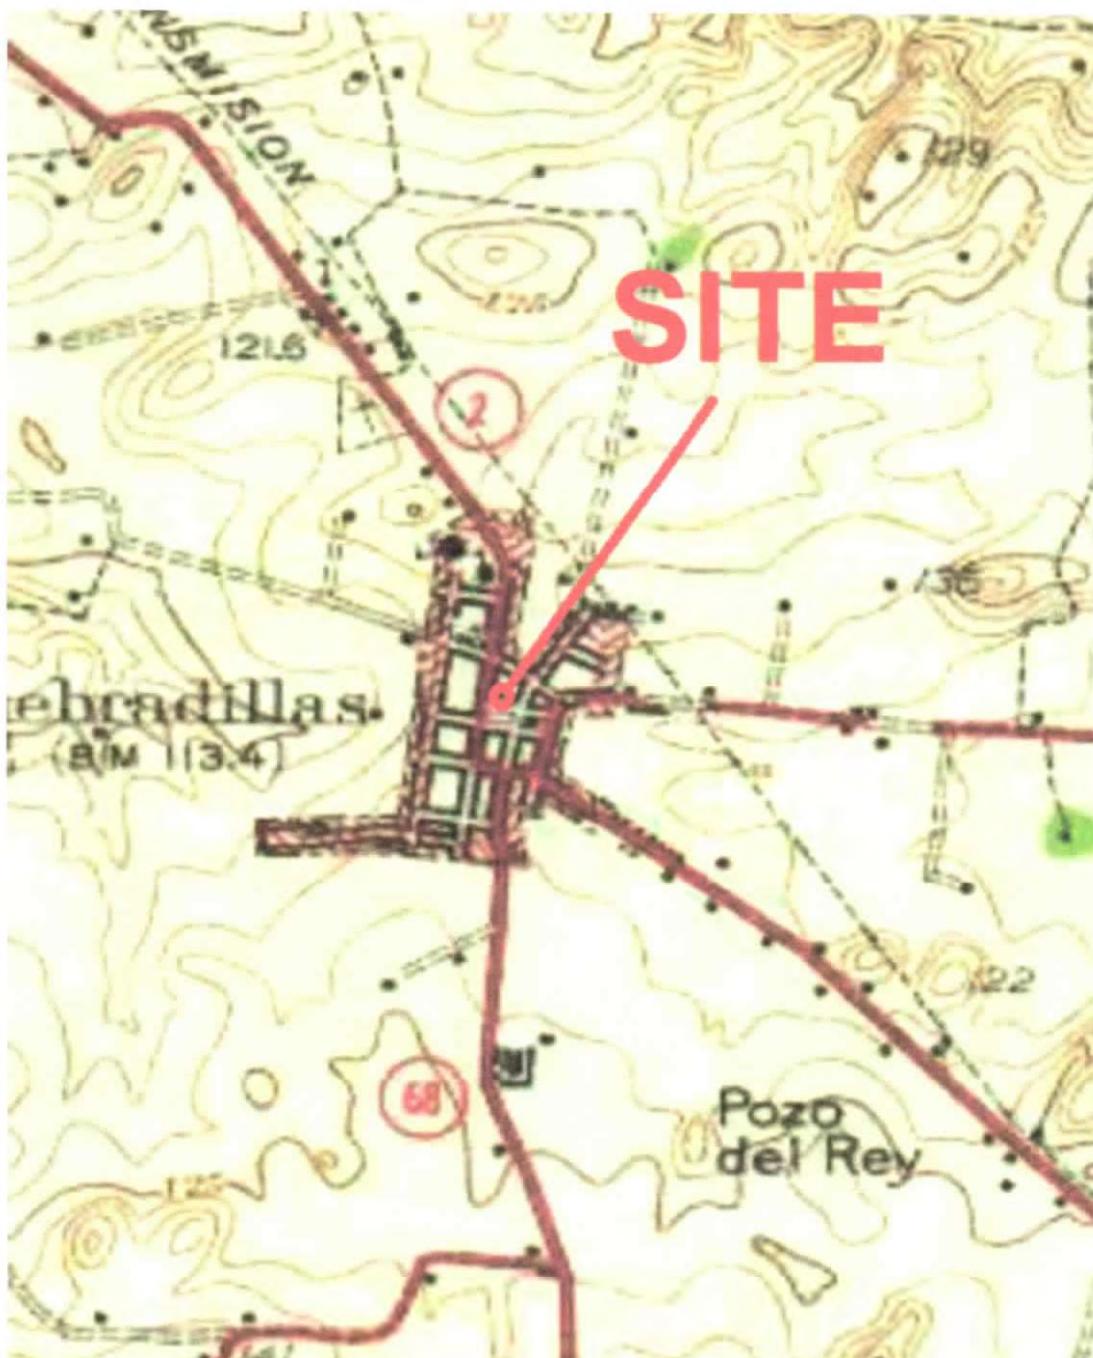
Figura #9 Cuadrángulo Topográfico 1942

Para el 1942, se observan otras cuadras desarrolladas con el pasar del tiempo.

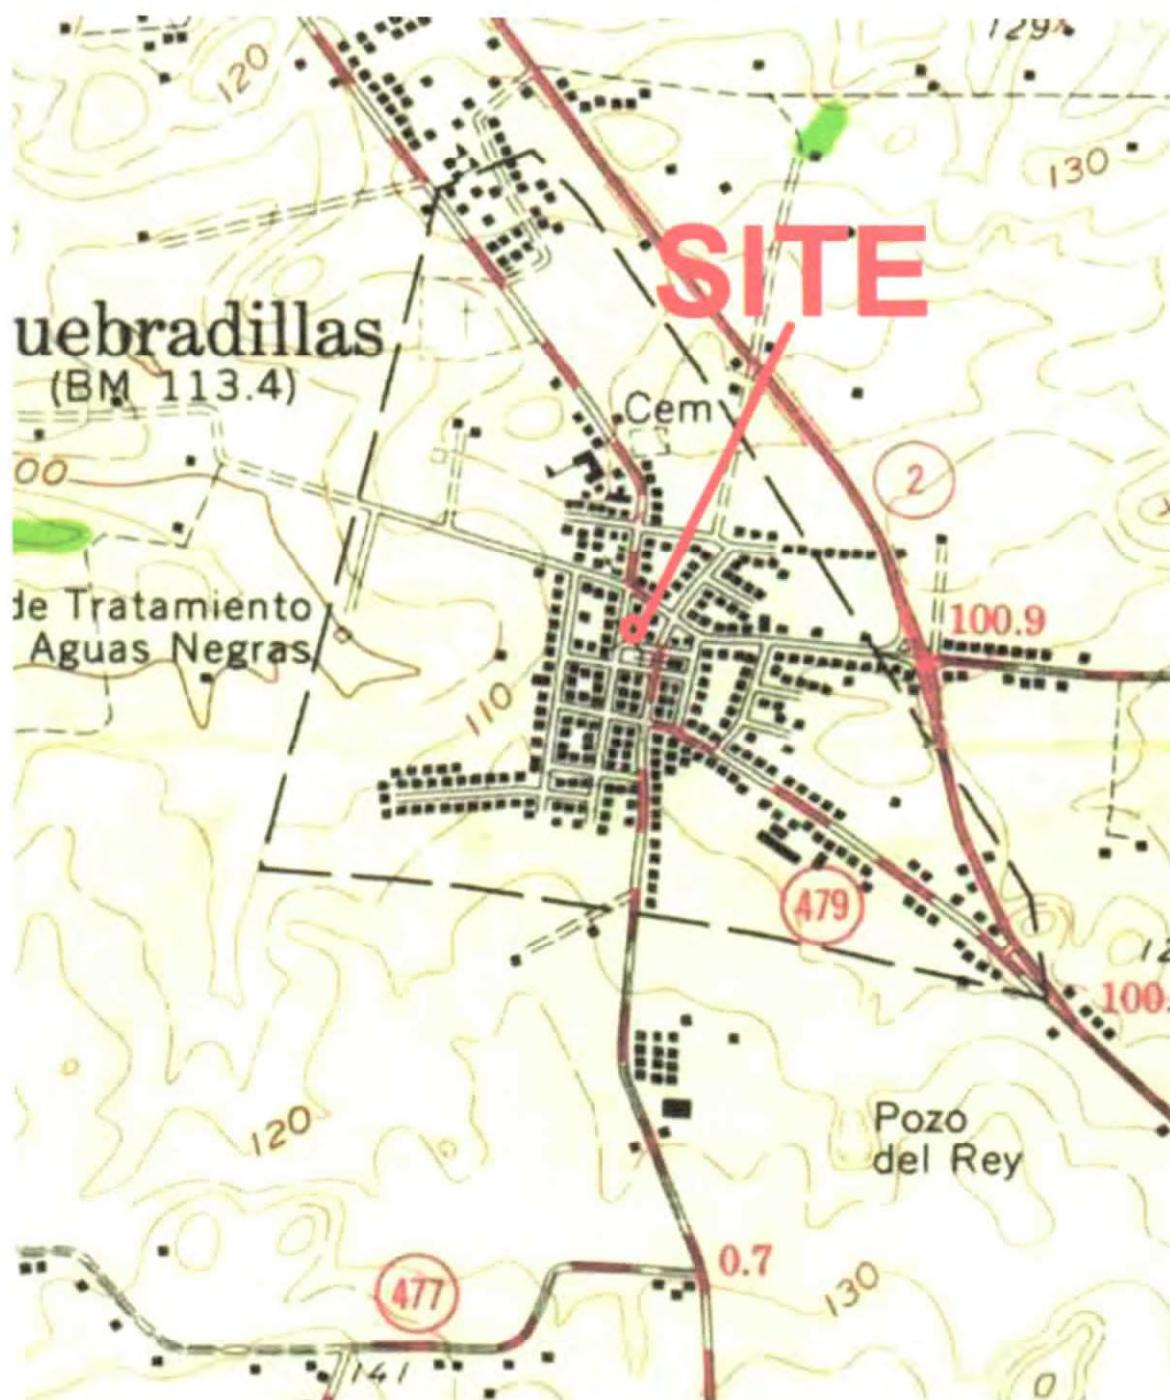
Figura #10 Cuadrángulo Topográfico 1957-1961

En la pasada imagen, se aprecia el desarrollo del casco urbano y la construcción de varias edificaciones construidas para la fecha.

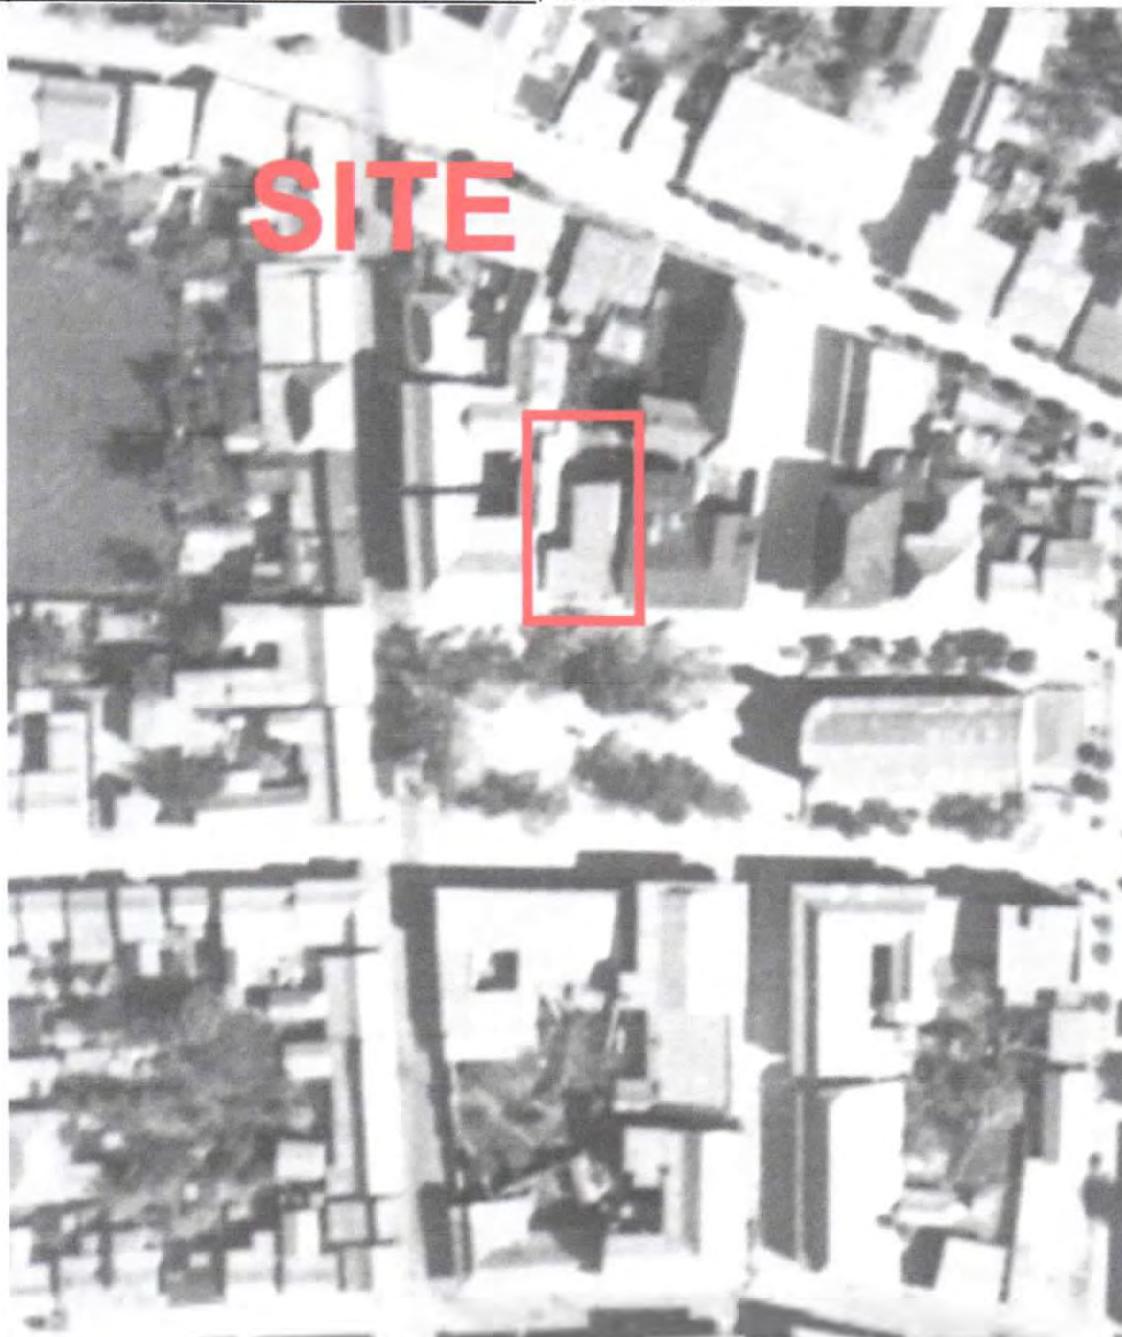
Figura #11 Quebradillas en 1931, DTOP

En el 1931, se observa la edificación en forma de martillo, observada en la actualidad. Otras edificaciones de gran tamaño son observables colindante con el área bajo estudio.

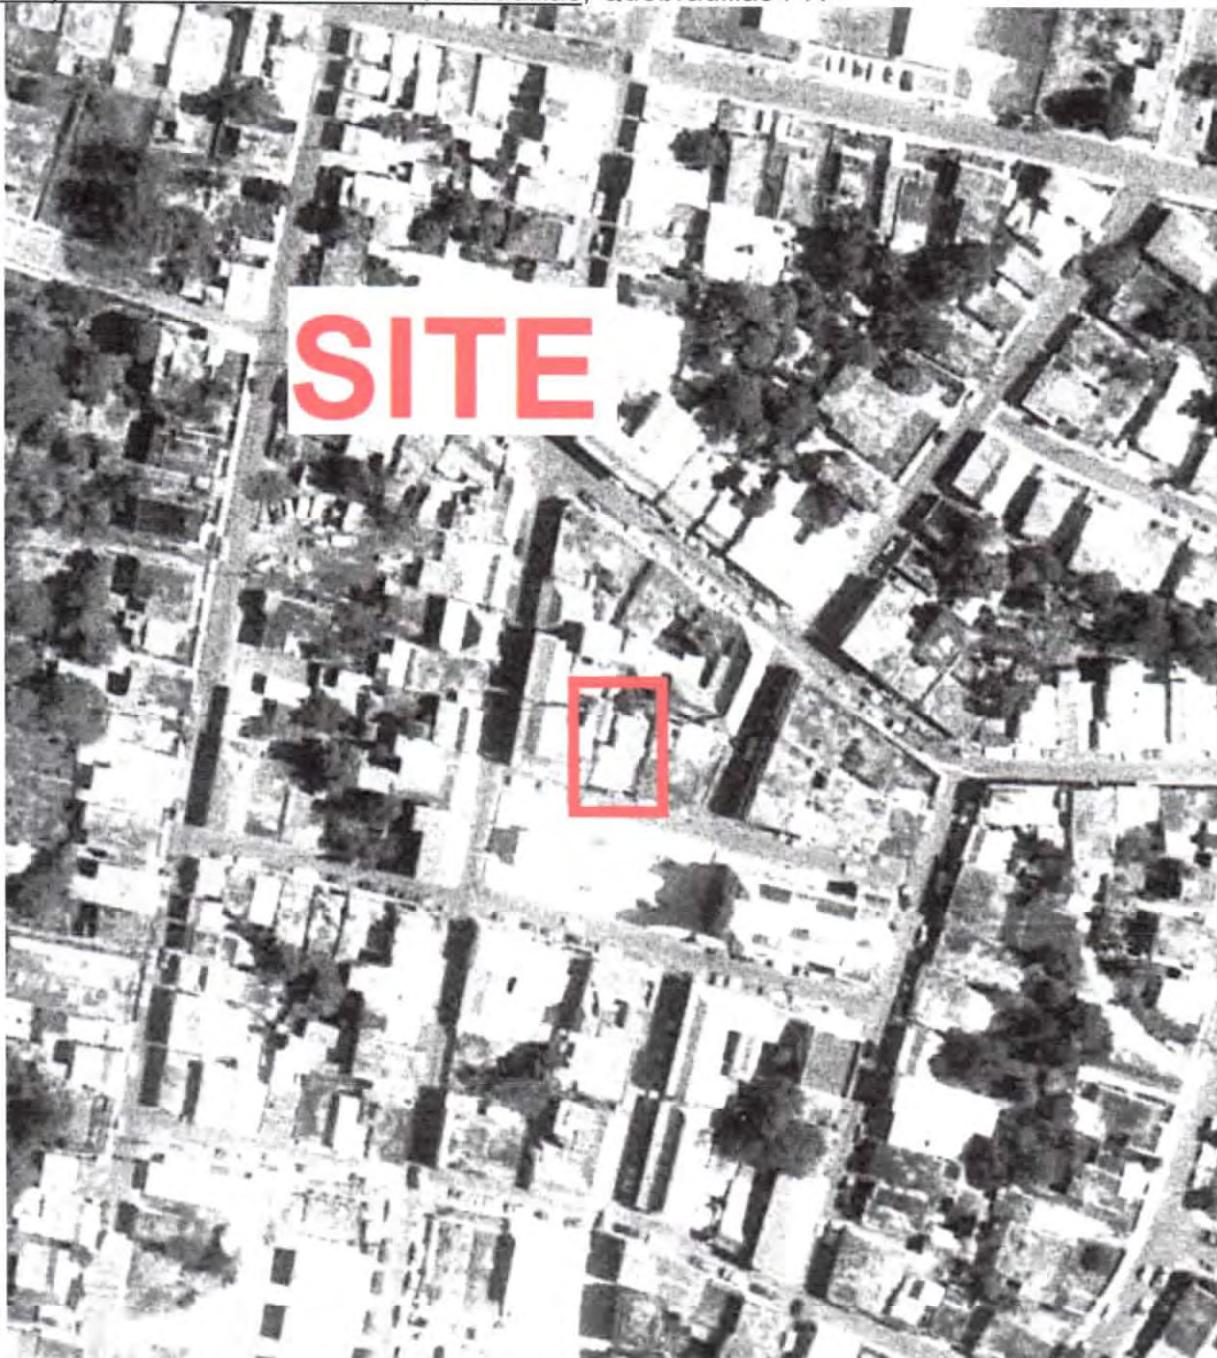
Figura #12 Quebradillas en 1976, DTOP

Para el 1972, se observa una pequeña ampliación hacia el costado oeste. En los alrededores del área bajo estudio, se encuentran nuevas construcciones en comparación con la imagen anterior del 1931.

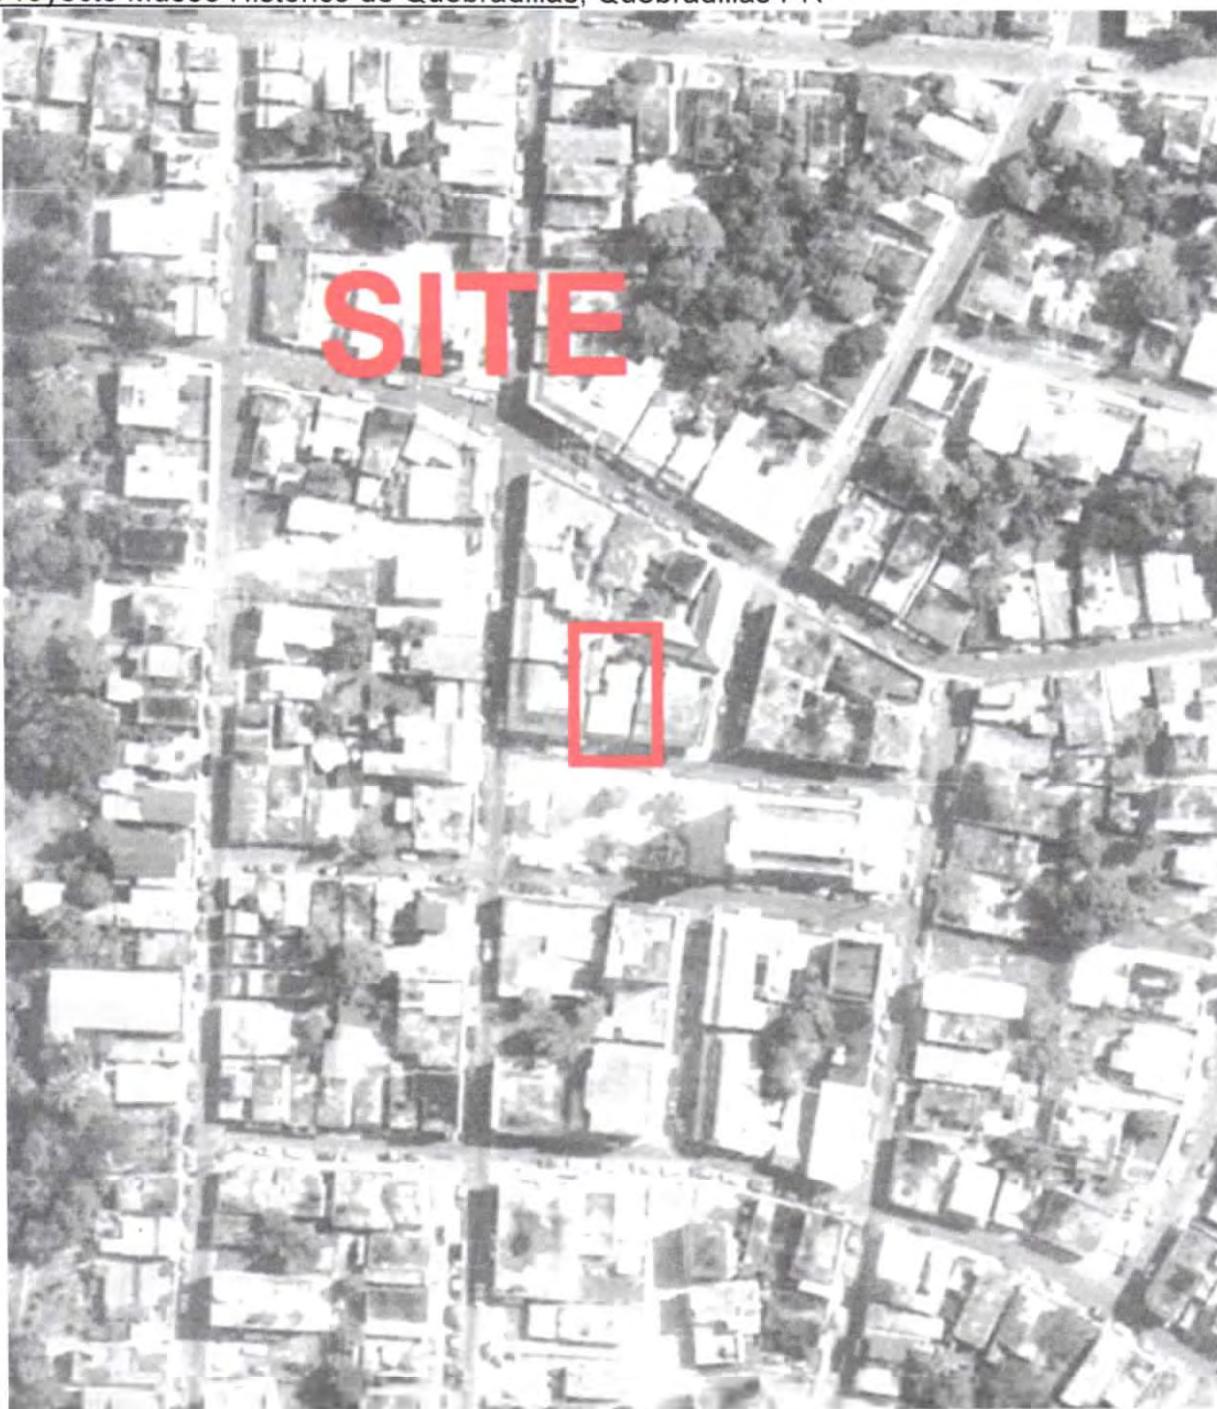
Figura #13 Quebradillas en 1985, DTOP

Para el 1985, no se observan cambios al área bajo estudio, con respecto a la foto del 1976.

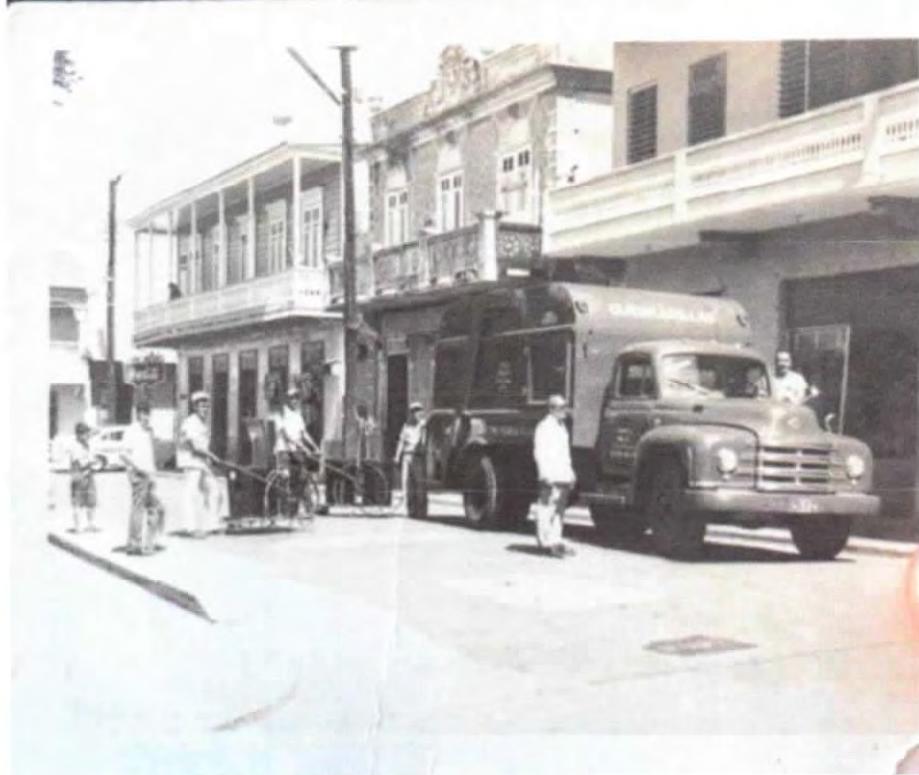
Foto #18 Vista antigua de la Calle Honorio Hernández. Se observa el área del proyecto (c. 1950)

Figure 14: Historical photograph of Honorio Hernández Street. The existing building in the project parcel is observed in good condition c. 1950.

The structure under evaluation is considered an architectural historical resource. The historical photograph of the building in the 1950s (Figure 14), gives us the information of its historical character and its original architectural style *Neoclassical-Colonial of the early twentieth century (1918)*. As part of the Phase I research for this project an architectural evaluation of the building was made by Conservationist Architect Carlos Ferrán. A technical report "**EVALUATIVE REPORT OF THE CULTURAL HERITAGE OF ARCHITECTURE... patrimonial resource in Quebradillas de Puerto Rico, July 2022**" was performed.

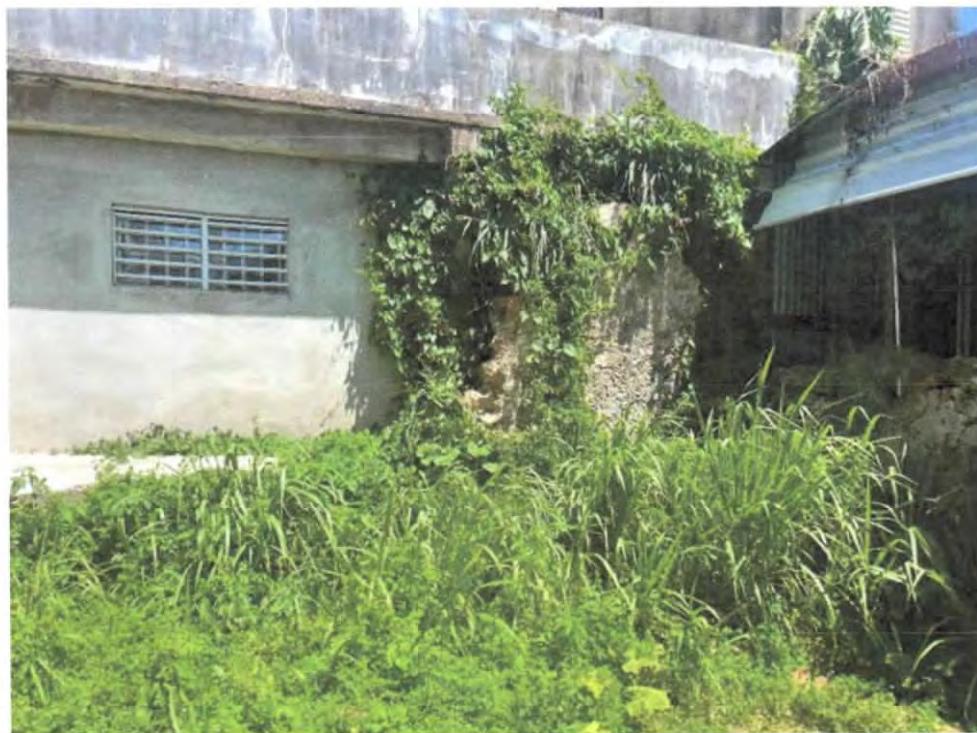
Foto #32 Vista de pared aledaña construida en piedra caliza

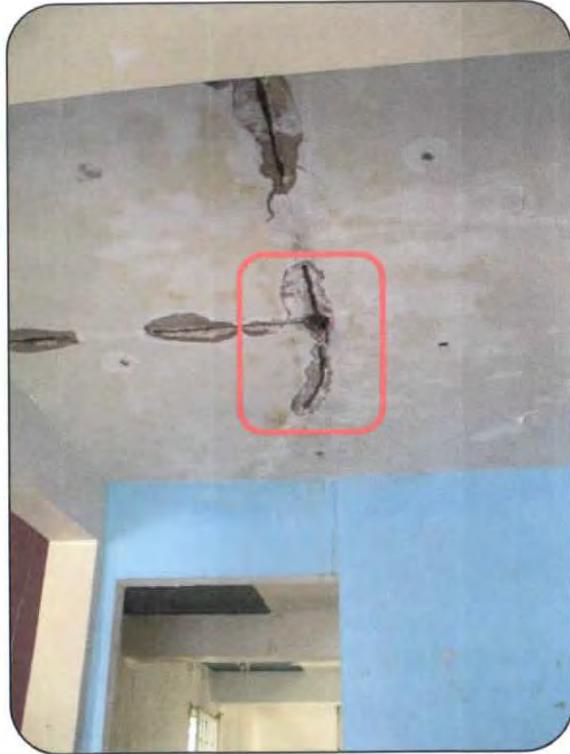
CRUJÍA SEGUNDA DEL NIVEL PRIMERO

1. CONDUCTOS METÁLICOS DE INFRAESTRUCTURA ELÉCTRICA CORROIDOS Y HAN PRODUCIDO LAMINADO DEL HORMIGÓN
2. INSTALACIONES DE CORRIDAS ELÉCTRICAS EXPUESTAS

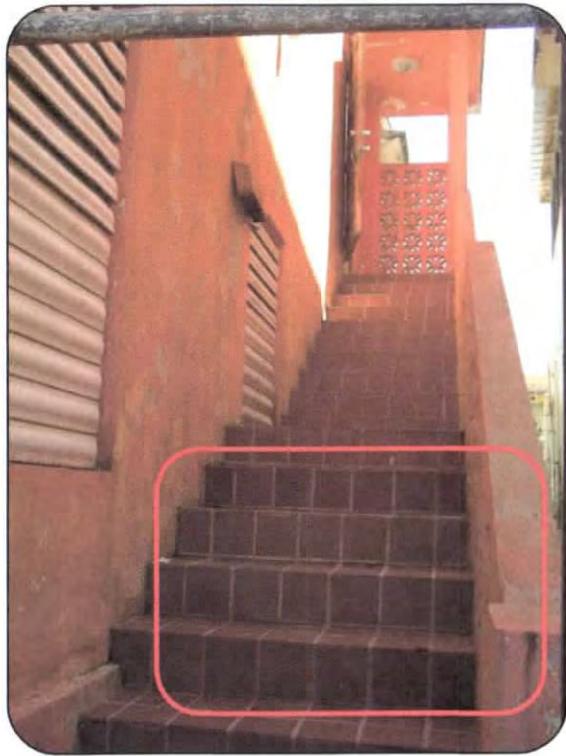
ESCALERA EXISTENTE EN EL PATIO LATERAL DERECHO

1. POSIBLEMENTE UBICACIÓN ORIGINAL Y ALTERADA.
2. TERMINACIÓN EN LOSA DE CANTERÍA, "QUARRY TILE"
3. BARANDA EN HORMIGÓN

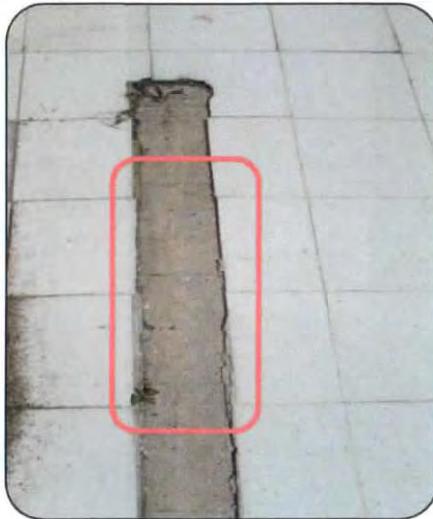
SEGUNDO NIVEL SIN TECHO Y CRUJIA PRIMERA

1. CONSTRUCCIÓN TOTALMENTE EN HORMIGÓN.
2. FENESTRACIONES CON VENTANAS DE CELOSÍAS DE METAL (NO ORIGINALES).
3. PISOS TERMINADOS EN LOSA DE CERÁMICA, INSTALADO SOBRE LOSA ORIGINAL (HIDRAULICA) MONOCROMÁTICA

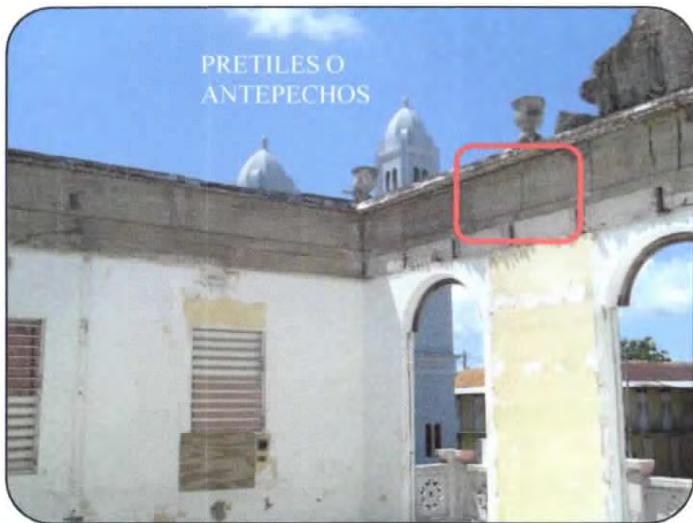
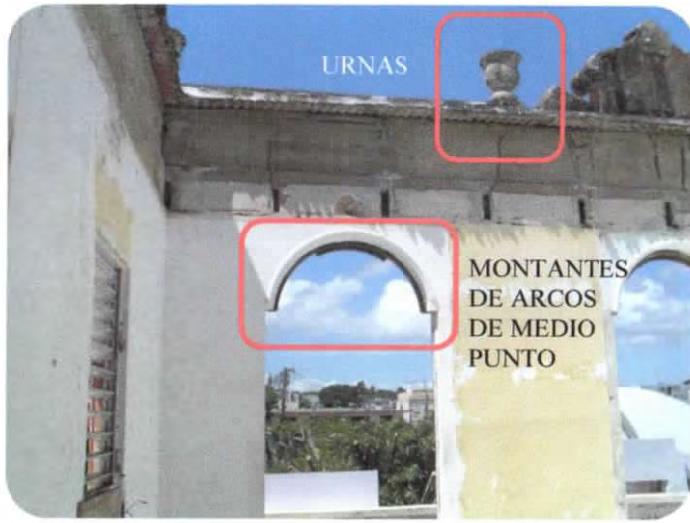
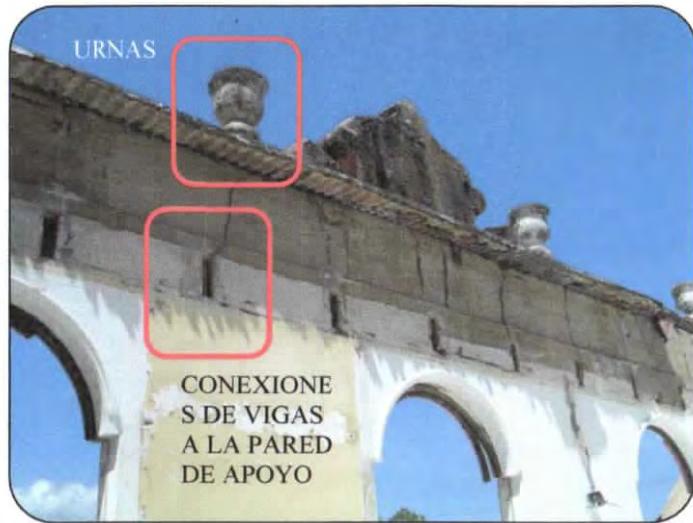
CRUJÍA PRIMERA DEL NIVEL SEGUNDO

1. LA AUSENCIA DEL TECHO ES EVIDENTE. ORIGINALMENTE ESTRUCTURA DE MADERA CUBIERTA CON PLANCAS ACANALADAS DE METAL (ZINC)
2. LOS PUNTARES DE LAS VIGAS DE MADERA QUE APOYABAN EL TECHO PENETRABAN LA PARED.
3. PRETIL O ANTEPECHO LEVANTADO CON URNAS DECORATIVAS SOBRE LA CORNISA Y ESCUDO AL CENTRO.
4. LAS FENETRACIONES DE LAS PUERTAS EN LA FACHADA PRINCIPAL CON **ARCOS DE MEDIO PUNTO** QUE INTEGRABAN MONTANTES TIPO SOL TRUNCO CON VITRALES (VER PÁG. 11)

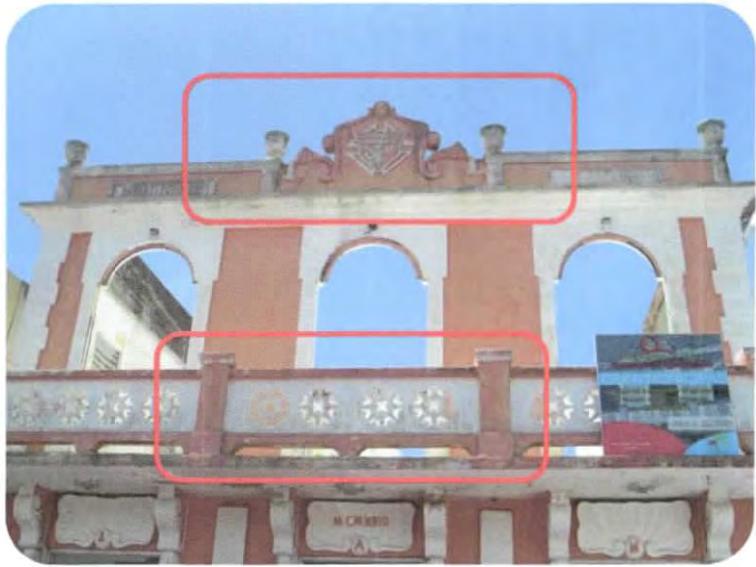
ALZADO PRINCIPAL PARCIAL DEL NIVEL SEGUNDO

1. BALCÓN VOLADO.
2. FENESTRACIONES DE PUERTAS CON MONTANTES DE MEDIO PUNTO Y FAJONES CON RESALTES.
3. ANTEPECHO O PETRIL ALTO SOBRE CORNISA, CON URNAS Y ESCUDO CENTRAL.
4. CUADROS RECTANGULARES DECORATIVOS EN EL ALMA DEL PETRIL Y REMATE CON CORNISA.

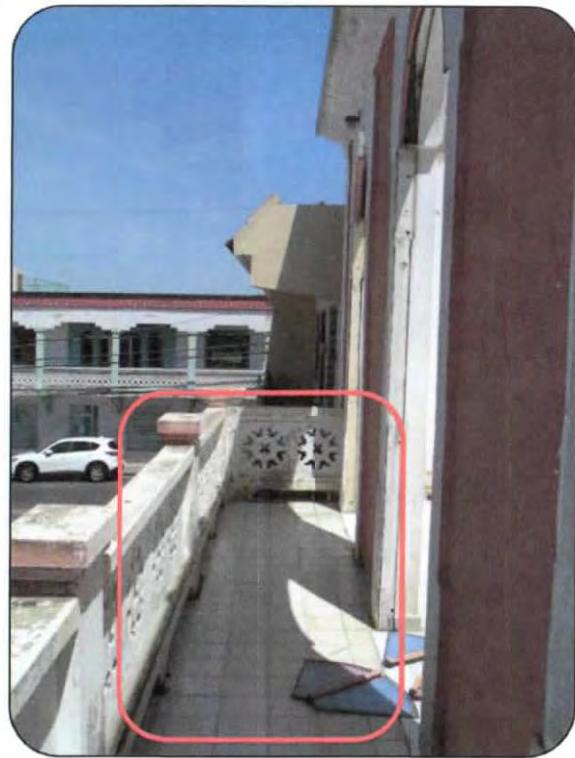
BALCÓN VOLADO EN EL NIVEL SEGUNDO

1. PASAMANO CON BLOQUES ORNAMENTALES MODULARES Y ORIGINAL
2. PISO TERMINADO EN LOSA DE CERÁMICA (NO ORIGINAL)

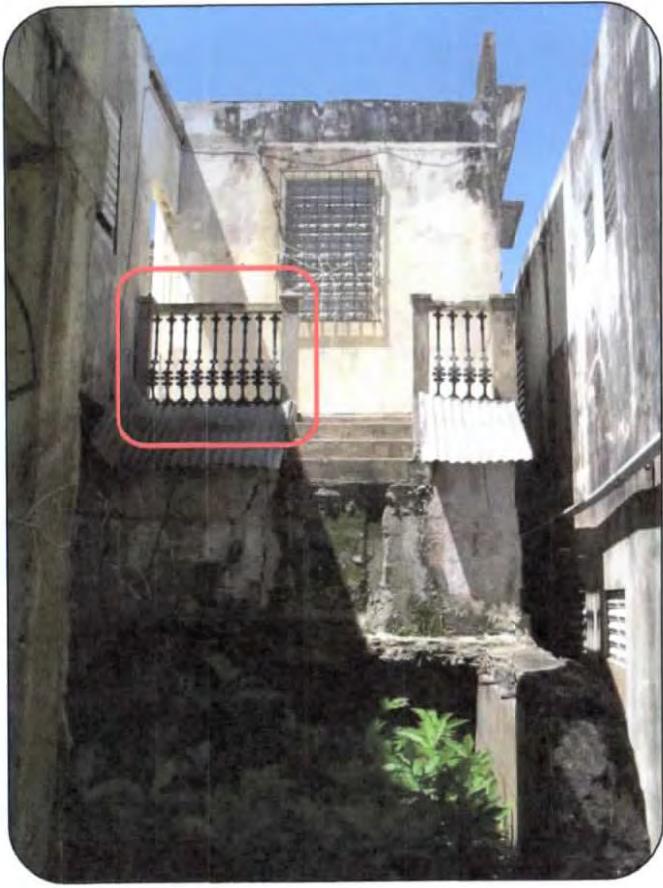
PATIO LATERAL

1. VISTA DE LA PRIMERA NAVE EN EL NIVEL SEGUNDO
2. PEQUEÑO BALCÓN ORIENTADO AL PATIO CON REMANENTES DE PASAMANOS DE BALAUSTRES DE HIERRO FORJADO Y PARTE DE UNA ESCALERA DEMOLIDA

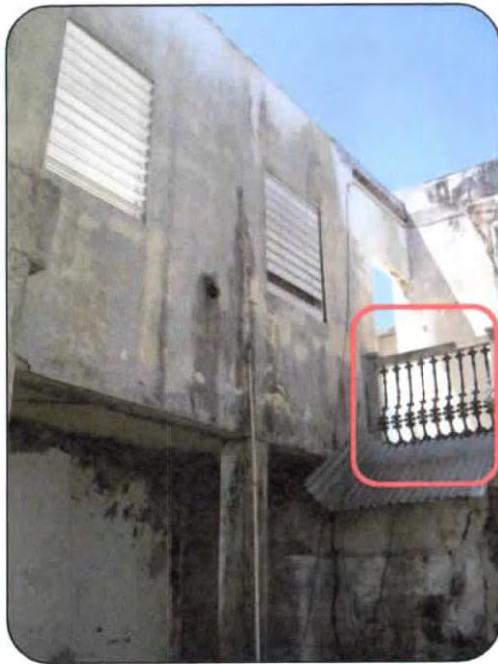
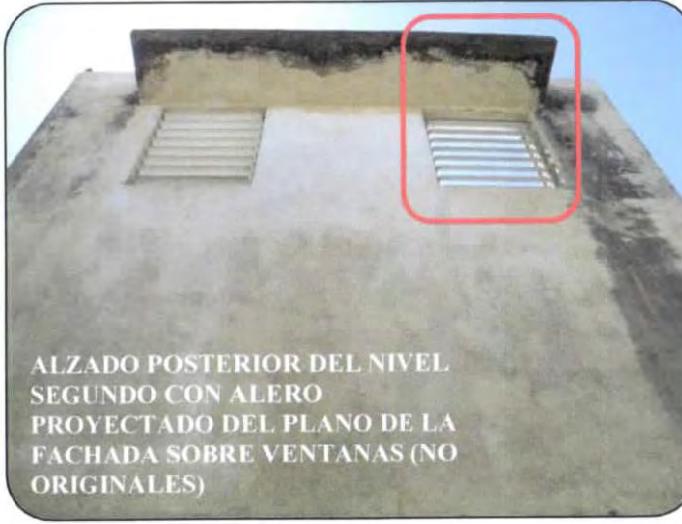
ALZADO POSTERIOR DEL NIVEL SEGUNDO CON ALERO PROYECTADO DEL PLANO DE LA FACHADA SOBRE VENTANAS (NO ORIGINALES)

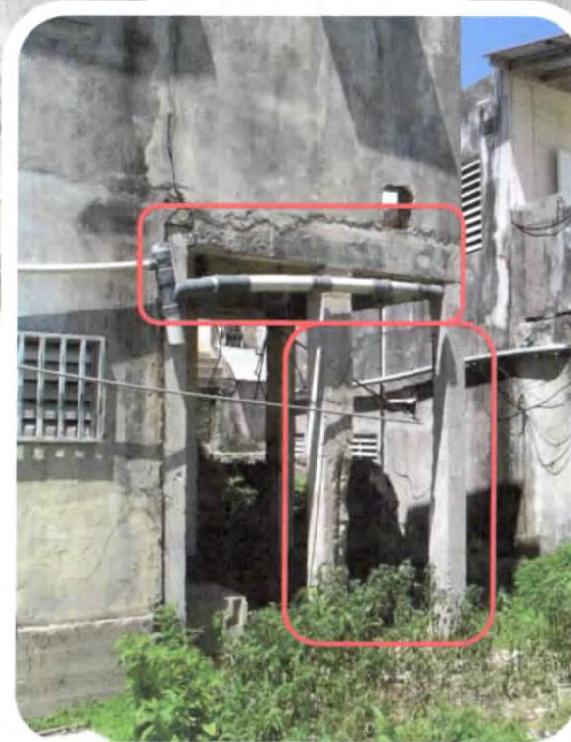
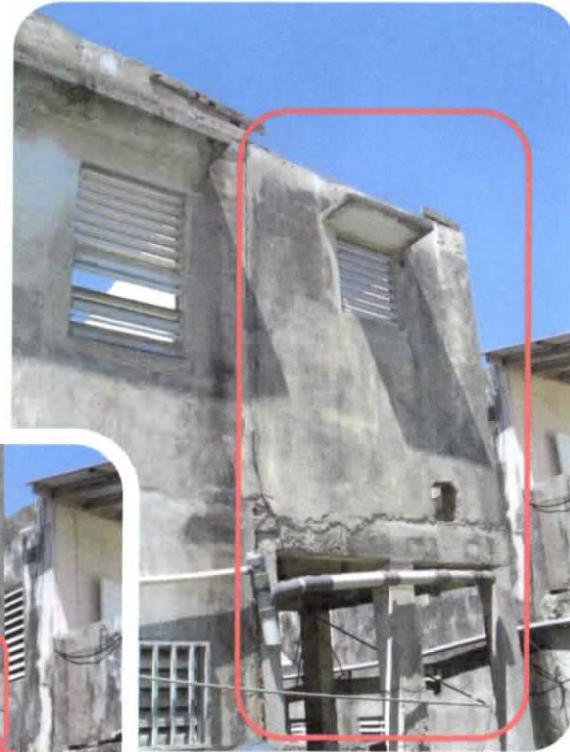
CONSTRUCCIÓN SOBRE NAVE
POSTERIOR DEL NIVEL
PRIMERO

1. NAVE EXTENDIDA HACIA EL PATIO LATERAL, APOYADO EN COLUMNAS DE HORMIGÓN.
2. ESTA SECCIÓN SE ENCUENTRA EN ESTADO ESTRUCTURAL MUY ADVERSAMENTE COMPROMETIDA.
3. INFRAESTRUCTURA SANITARIA EXPUESTA

Project contemplates demolishing a portion of the existing building. This portion corresponds to an addition to the building to provide an additional bathroom on the second level. This portion of the structure has structural deterioration that requires demolition (see photos #14 & 15). Columns and beams have exposed and corroded structural steel. The process for the demolition of this portion will be carried out with manual tools. This is because there is no access to the rear to allow the use of mechanical equipment, such as a small backhoe.

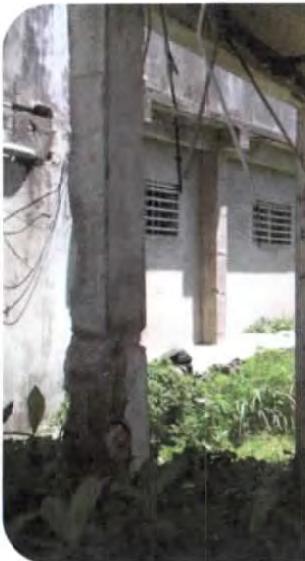
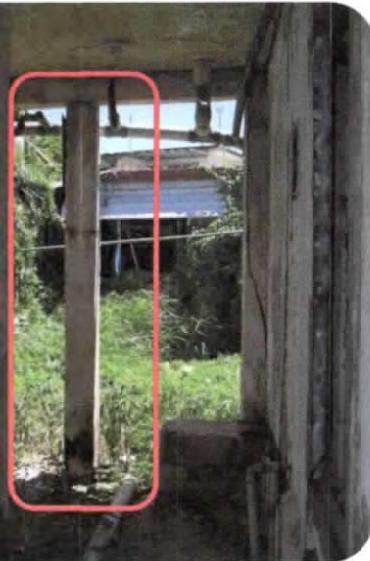
ESTRUCTURA CONSTRUÍDA HACIA EL PATIO LATERAL

- I. ESTRUCTURA EN COLUMNAS DE HORMIGÓN

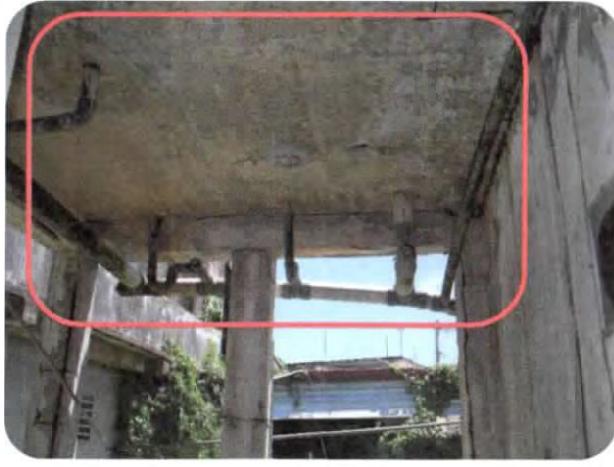
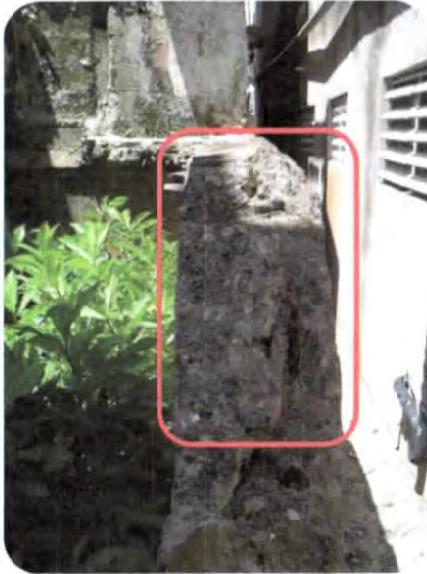
- Yes → Describe the findings, including any recognized environmental conditions (RECs), in Worksheet Summary below. Continue to Question 3.

3. Can adverse environmental impacts be mitigated?

RESTOS DE MURO

1. BRINDABA APOYO A UNA LOSA DE HORMIGÓN QUE SERVÍA DE DESCANSO A LA ESCALERA UBICADA HACIA EL PATIO POSTERIOR.
2. SE ENCUENTRA CONSTRUIDA CON AGREGADO DE PIEDRAS BLANCAS Y AMARILLAS, POSIBLEMENTE RETAZOS DE CUARZOS

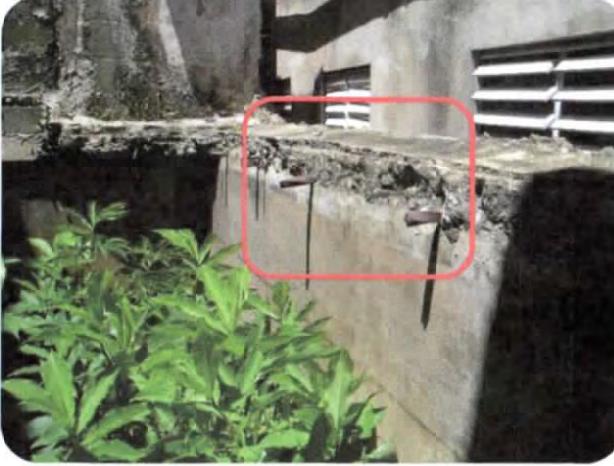
VARILAS DE ACERO

1. DEL TIPO CERPENTINA
2. LOSA EN HORMIGÓN DE DESCANSO DE LA ESCALERA (DEMOLIDA).

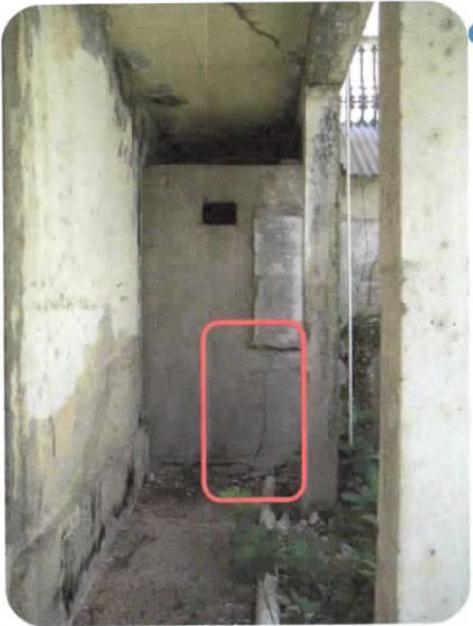
OBSERVACIONES:

1. CORREDOR EXTERIOR Y NAVE HACIA EL PATIO LATERAL EN NIVEL PRIMERO CON VARIAS INTERVENCIONES DE CERRAMIENTO.
2. CONDICIONES DETERIORADAS DE LA LOSA DE TECHO CON VARILLAS DE REFUERZO CORROIDAS Y LAMINADO DEL HORMIGÓN
3. INFECCIÓN DE INSECTOS (COMEJÉN)
4. FISURAS, GRIETAS Y HONGOS.

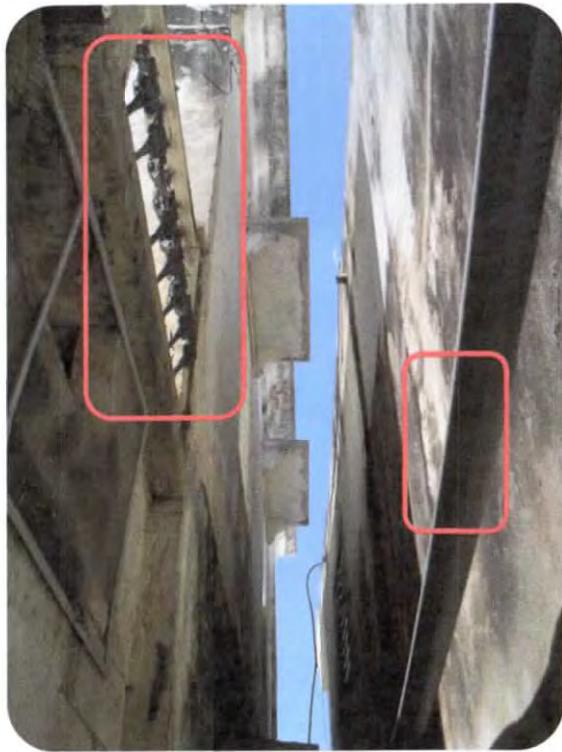
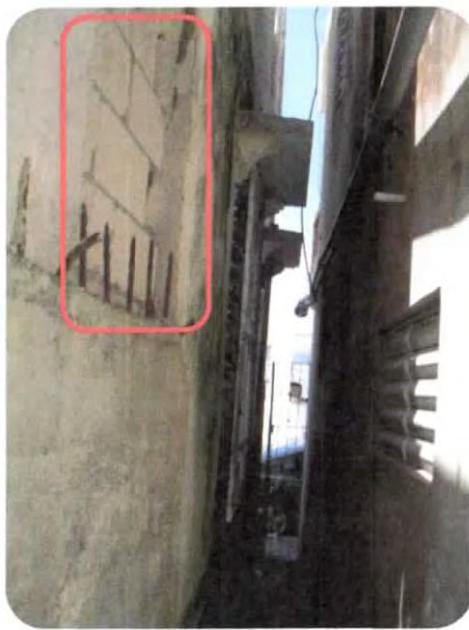
**ACCESO LATERAL
IZQUIERDO ENTRE
EDIFICIOS**

1. ALEROS PROYECTADOS
DEL PLANO DE LA
FACHADA, EN AMBOS
NIVELES.
2. INTERVENCIONES
POSTERIORES:
CERRAMIENTOS DE
FENESTRACIONES DE
LAS VENTANAS.
3. BARANDA EXISTENTE
DE BALAUSTRES DE
HIERRO FORJADO EN
FORMA DE PECHO DE
PALOMA
4. CONDUCTO DE
INFRAESTRUCTURA
ELÉCTRICA EXPUESTA
Y SOBRE LA FACHADA
LATERAL DEL EDIFICIO
CONTIGUO.

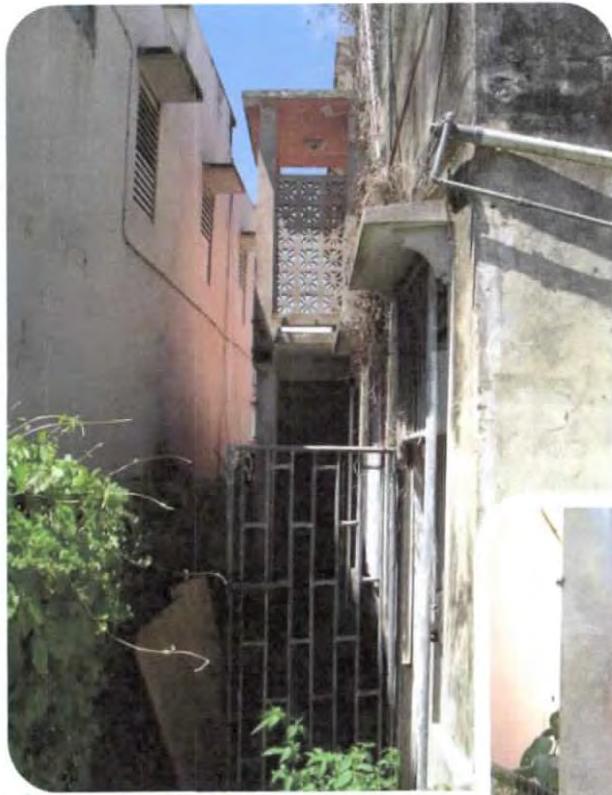
ÁREA DE PATIO
LATERAL, ENTRE
EDIFICIOS Y EN EL CUAL
SE UBICA LA ESCALERA

NOTA:
LUGAR EN DONDE SE ENCUENTRA
UNA ESCRITURA EN EL
EMPAÑETADO DE LA PARED. (VER
DETALLE EN PRÓXIMA PÁGINA)

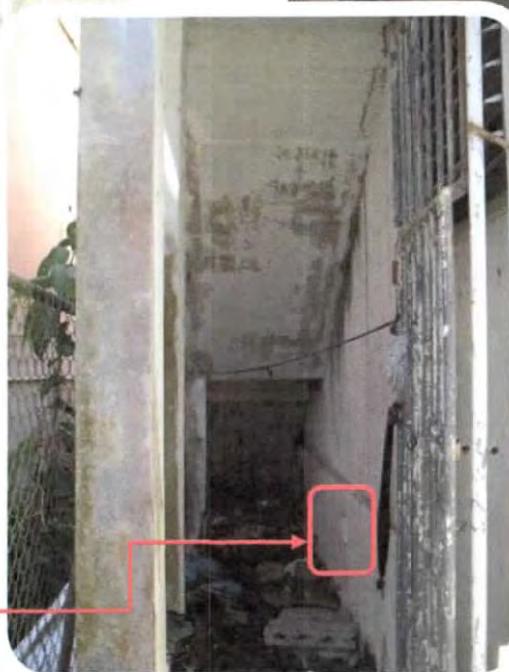
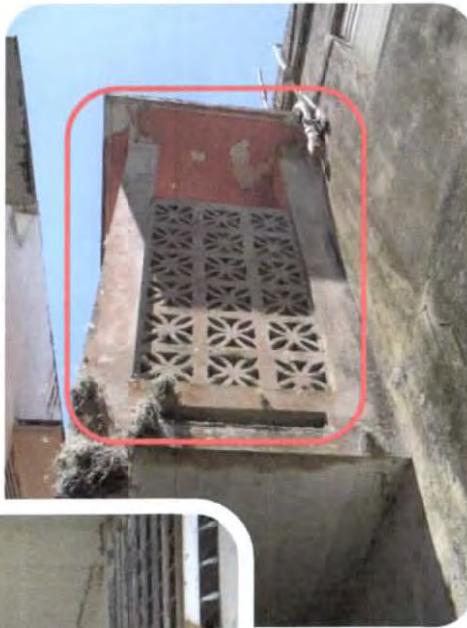
DESCANSO EN EL NIVEL SEGUNDO DE LA ESCALERA EXISTENTE

- I. CULMINA CON PARED DE BLOQUES ORNAMENTALES. LA ESCARELA ORIGINAL PUDO ESTAR UBICADO EN ESE LUGAR, PERO HA SIDO INTERVENIDA POSTERIORMENTE

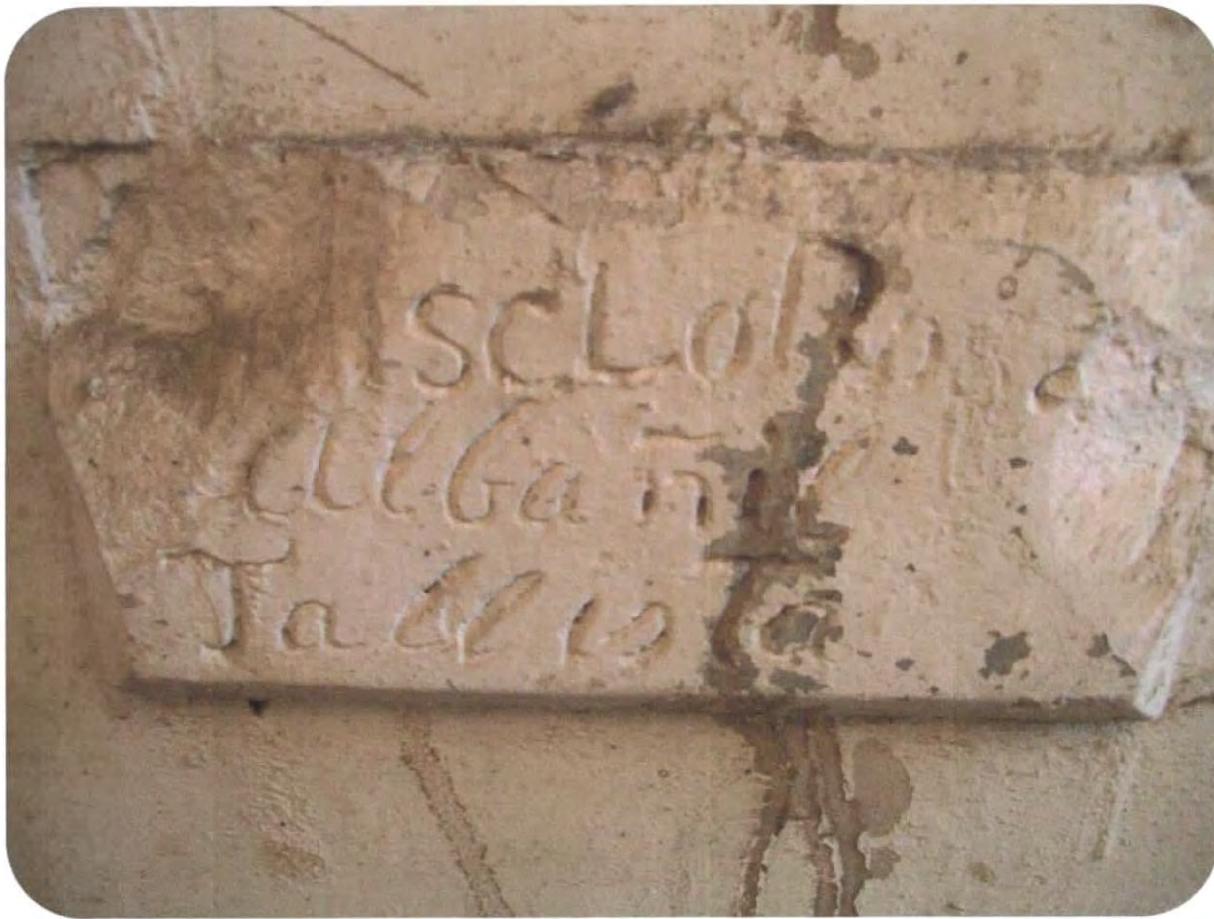
ESCRITURA EN RELIEVE SOBRE EL PLANO DE LA PARED

1. UBICADO BAJO LA ESCALERA EXTERIOR.
2. LAS PALABRAS QUE SE PUEDEN ENTENDER SON: "...SCLOROS, ALBAÑIL, TALLISTA".

POSSIBLEMENTE SE TRATA DE LA PERSONA QUE LABORÓ Y CONSTRUYÓ LOS DETALLES EXPRESADOS EN LA FACHADA PRINCIPAL
