**Environmental Review for Activity/Project that is Categorically
Excluded Subject to Section 58.5**

**MUSEO HISTORICO DE QUEBRADILLAS
QUEBRADILLAS, PR**
PR-CRP-000554
CDBG-DR

**Applicant: Municipality of Quebradillas
Prepared by: José D. Centeno Calero PE
Professional Engineer
License 20206
Date: October 23, 2023**

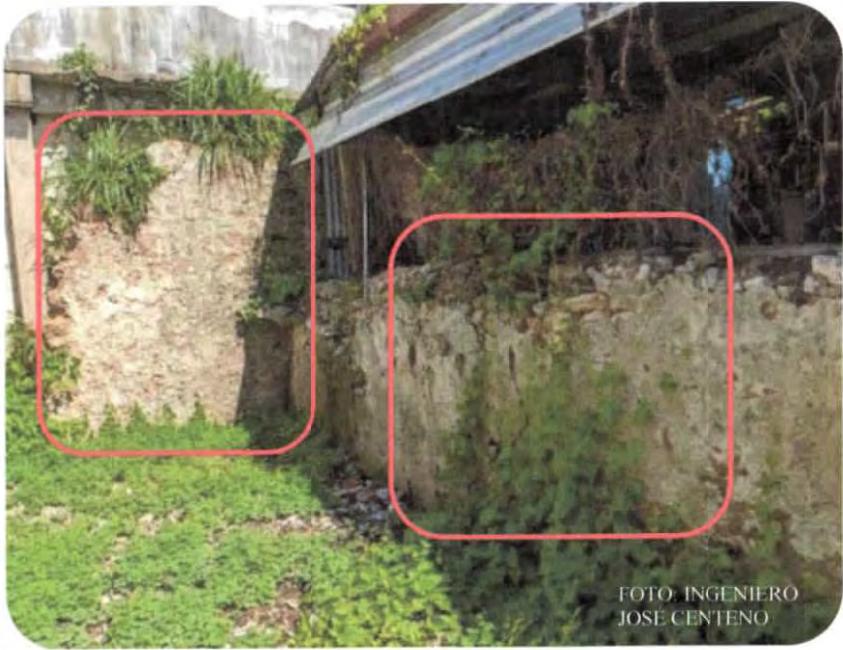
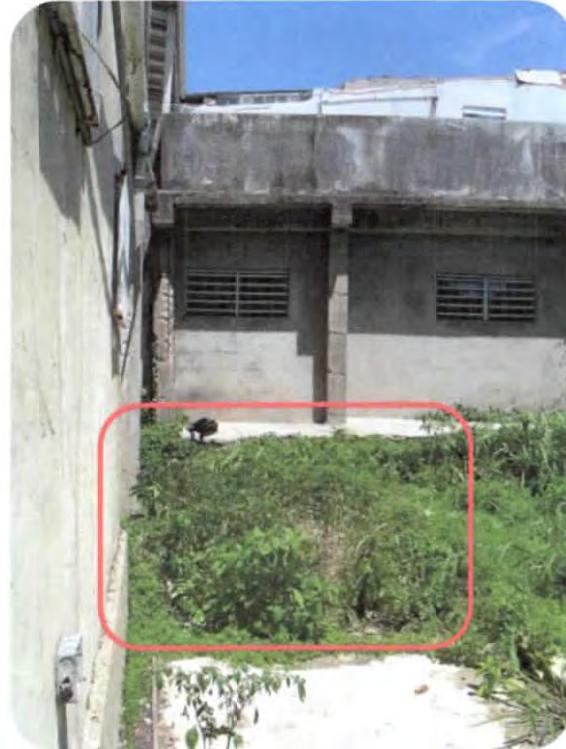
MURO COLINDANTE

- I. VISTA HACIA PATIO POSTERIOR EN LA QUE SE ENCUENTRA UN MURO COLINDANTE CONSTRUIDO EN MATERIALES TRADICIONALES (LADRILLO, ARGAMASA O MORTERO CON EMPAÑETADO DE RECUBRIMIENTO SOLAMENTE)

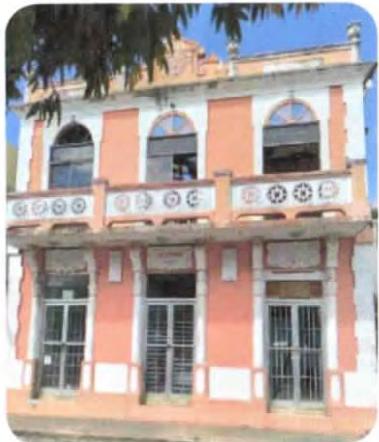
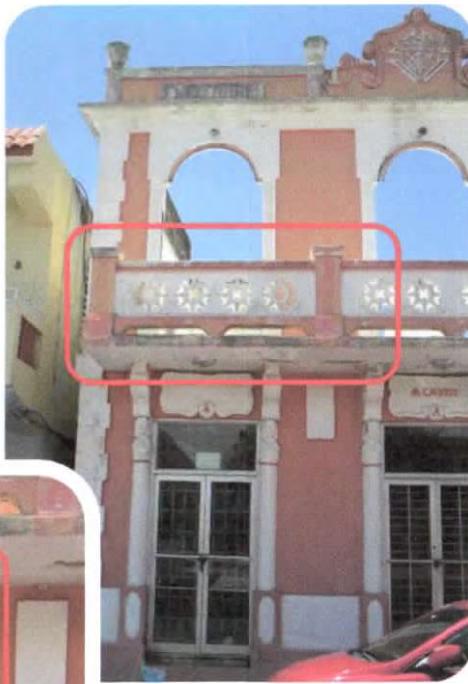
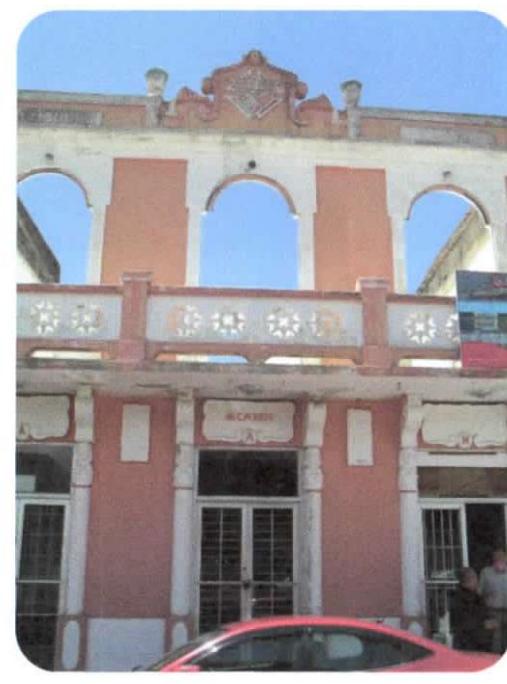
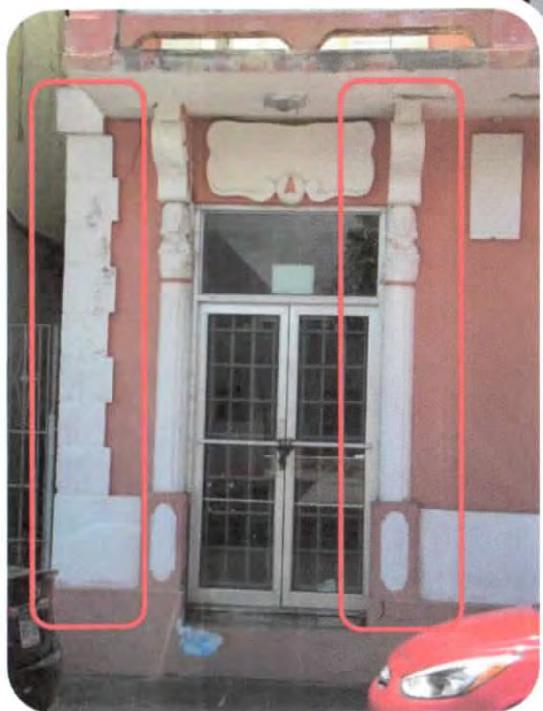
VISTAS DEL ALZADO PRINCIPAL Y DETALLES DE LOS COMPONENTES DE LA FACHADA

1. **NIVEL PRIMERO:** ALMOHADILLADOS O SILLARES DE ESQUINA EN LOS EXTREMOS, FAJONES DE LAS PUERTAS EN PILASTRAS CON BASE, ARISTAS Y CAPITÉLES CORINTIOS CON CANECILLO DE ROSTRO FEMENINO Y MÉNSULAS. EMBLEMAS DE CONCHA SOBRES LOS MONTANTES
2. **NIVEL SEGUNDO:** BALCÓN VOLADO CONTINUO, FENESTRACIONES DE LAS PUERTAS CON FAJONES Y MONTANTES DE ARCOS DE MEDIO PUNTO Y CORNISA PRINCIPAL CONTINUA
3. **PETRIL:** CORNISA MENOR Y RECUADROS DECORATIVOS EN LOS PAÑOS INTERIORES ARTICULADOS POR FAJONES. ESCUDO AL CENTRO CON URNAS EN AMBOS LADOS Y EN LAS ESQUINAS.

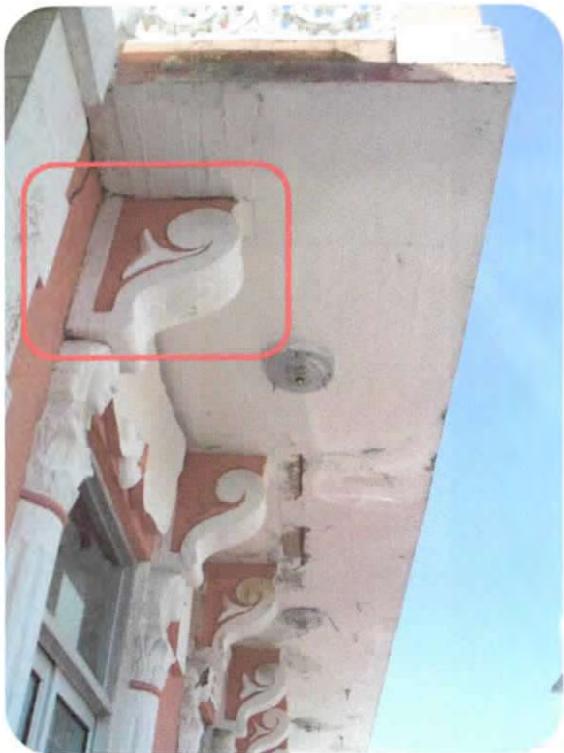
MÉNSULAS BAJO EL BALCÓN VOLADO

MÉNSULA: ELEMENTO QUE SOBRESALE DE UN PLANO VERTICAL Y SIRVE DE PARA SOSTENER ALGUNA COSA.

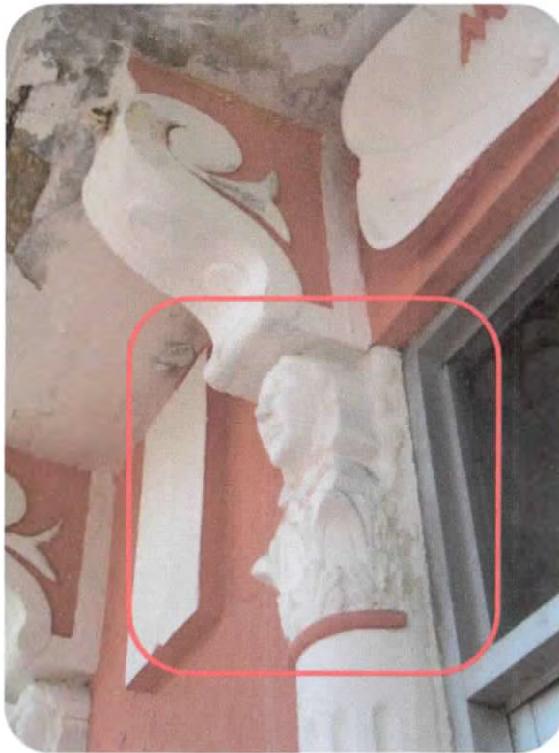
PILASTRAS

FUSTE: CUERPO DE UNA COLUMNA. LA PARTE COMPRENDIDA ENTRE LA BASE Y EL CAPITEL.

PILAstra: COLUMNA RECTANGULAR (EN ESTE CASO REDONDA) QUE SOBRESALE LIGERAMENTE DE UNA PARED Y QUE EN LOS ÓRDENES CLÁSICOS SIGUE LAS PROPORCIONES Y LINEAS CORRESPONDIENTES

1. **CAPITEL** ESTILO CORINTIO PARCIAL Y CANECILLO DE FIGURA DECORATIVA CON ROSTRO DE MUJER.
2. EL **FUSTE** O CUERPO DE LA PILASTRA CONTIENE ESTRÍAS EN SU SUPERFICIE
3. LAS **PILASTRAS** Y EL **CAPITEL** BRINDAN APOYO A LAS MÉNSULAS

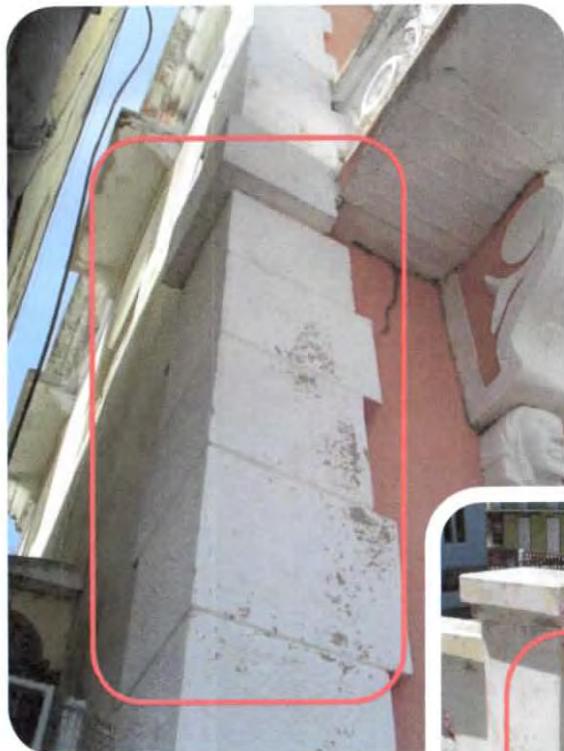
**ALMOHADILLAS O
SILLAR DE LAS
ESQUINAS**

ALMOHADILLAS:
PARTE SOBRESALIENTE DEL
PARAMENTO DE ALGUNOS SILLARES
QUE SE DISPONEN EN LAS ESQUINAS,
COMO ELEMENTOS PRINCIPALES DEL
APAREJO

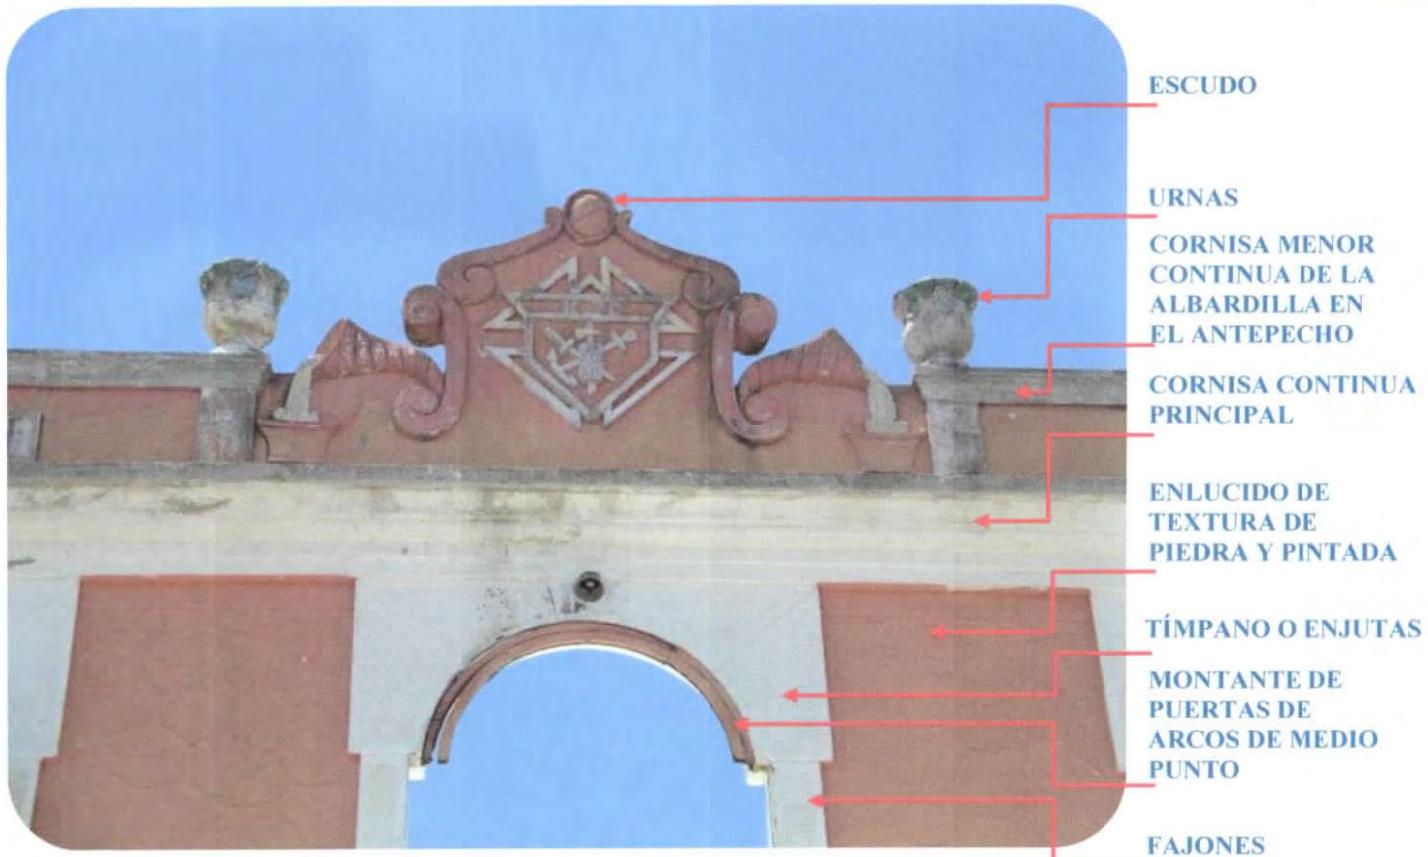
ESCUDO EN EL PRETIL DEL ALZADO PRINCIPAL

ESCUDO: ORNAMENTACIÓN ESCULPIDA O PINTADA EN FORMA DE ESCUDO DE ARMAS CON REPRESENTACIONES HERÁLDICAS, FIGURAS, CIFRAS O INSCRIPCIONES. SE APlica EN DECORACIÓN DE FRISOS

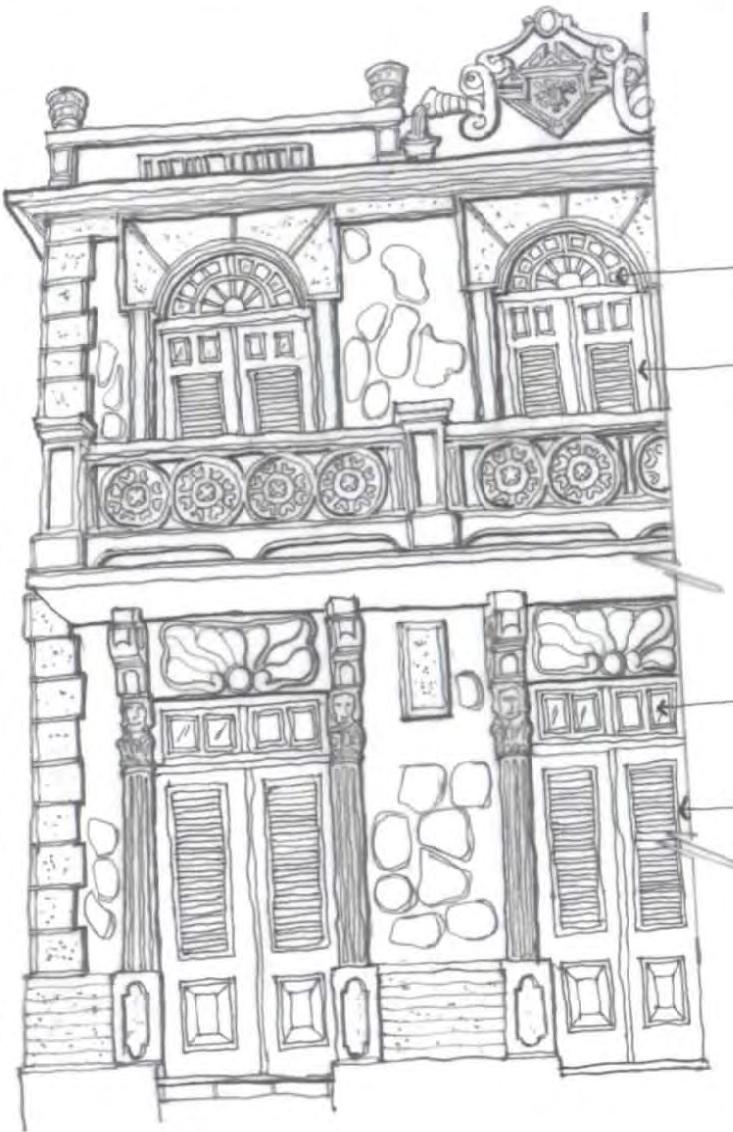
MONTANTE DE ARCO DE
MEDIO PUNTO CON
SOL TRUNCO & VITRALES
PUERTAS CON CRISTALES &
CELOSTÍAS MOVIBLES

MONTANTE CON
CRISTALES
PUERTAS CON
CELOSTÍAS MOVIBLES &
PANELES (QUARTERONES)

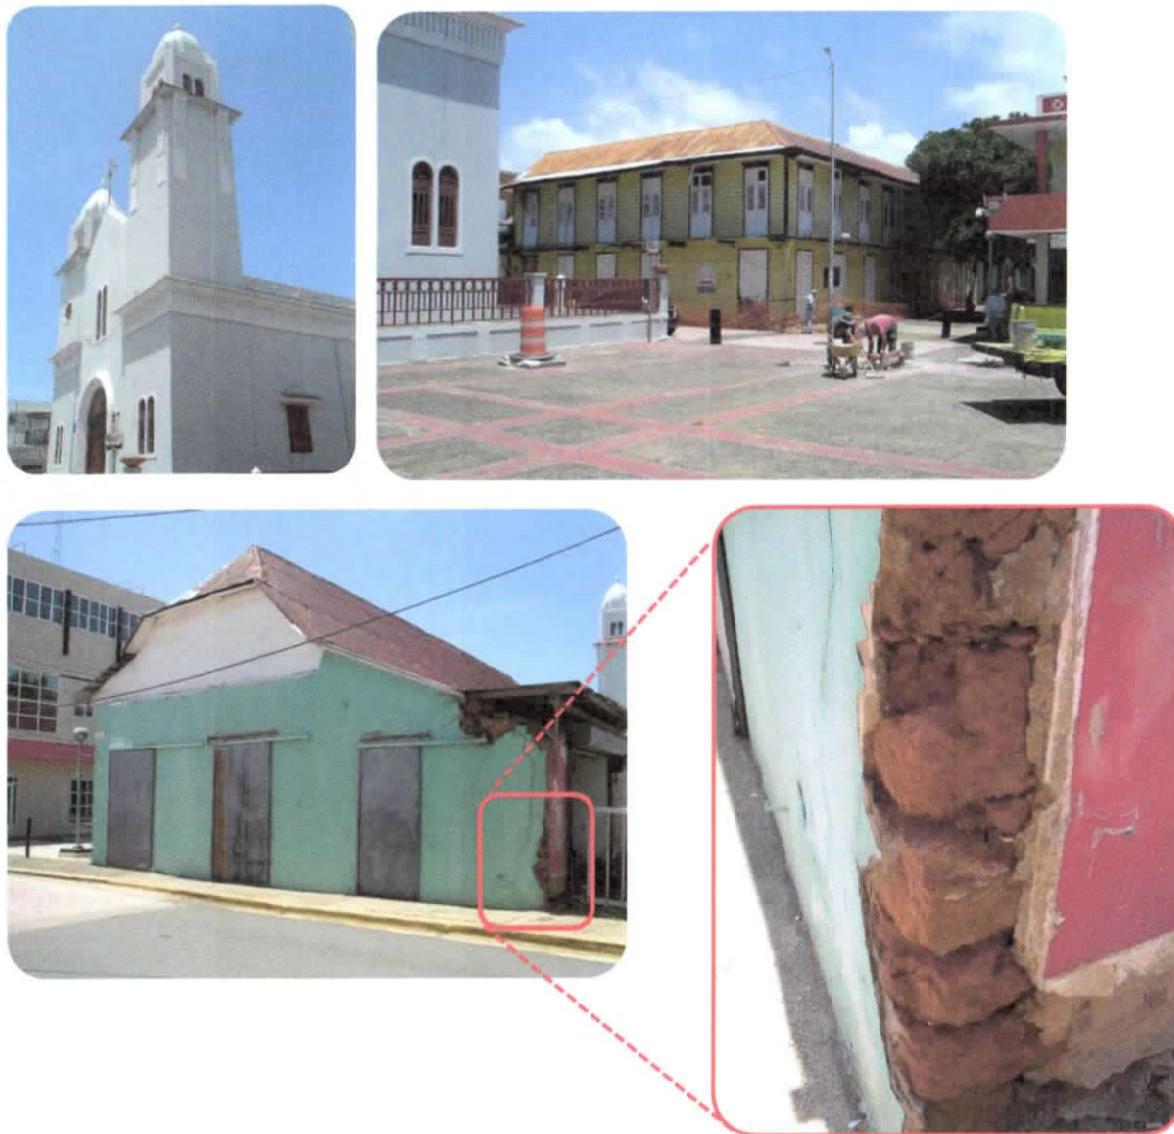
DETALLE DE ESQUINA EXPUESTA EN LA QUE SE APRECIA CONSTRUCCIÓN DE LADRILLO CON JUNTAS DE MORTERO A BASE DE CAL Y ARENA

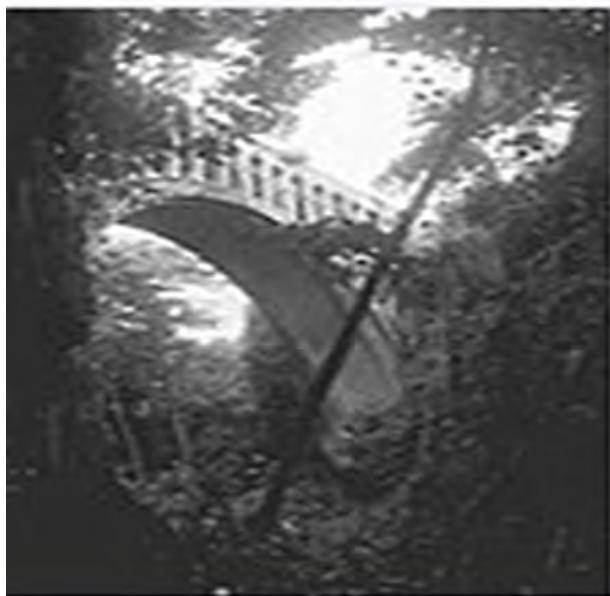
Photo 1: Puente Blanco

In the municipality of Quebradillas only has two historical records in the *National Register of Historical Sites*. The first was nominated in 1984. Registered as White Bridge, the Bridge built in 1922, and Encompassing the Quebrada Mala Canyon on Panoramic Street, in the Terranova neighborhood. The coordinates are 18°29'10" N 66°55' 34"W.

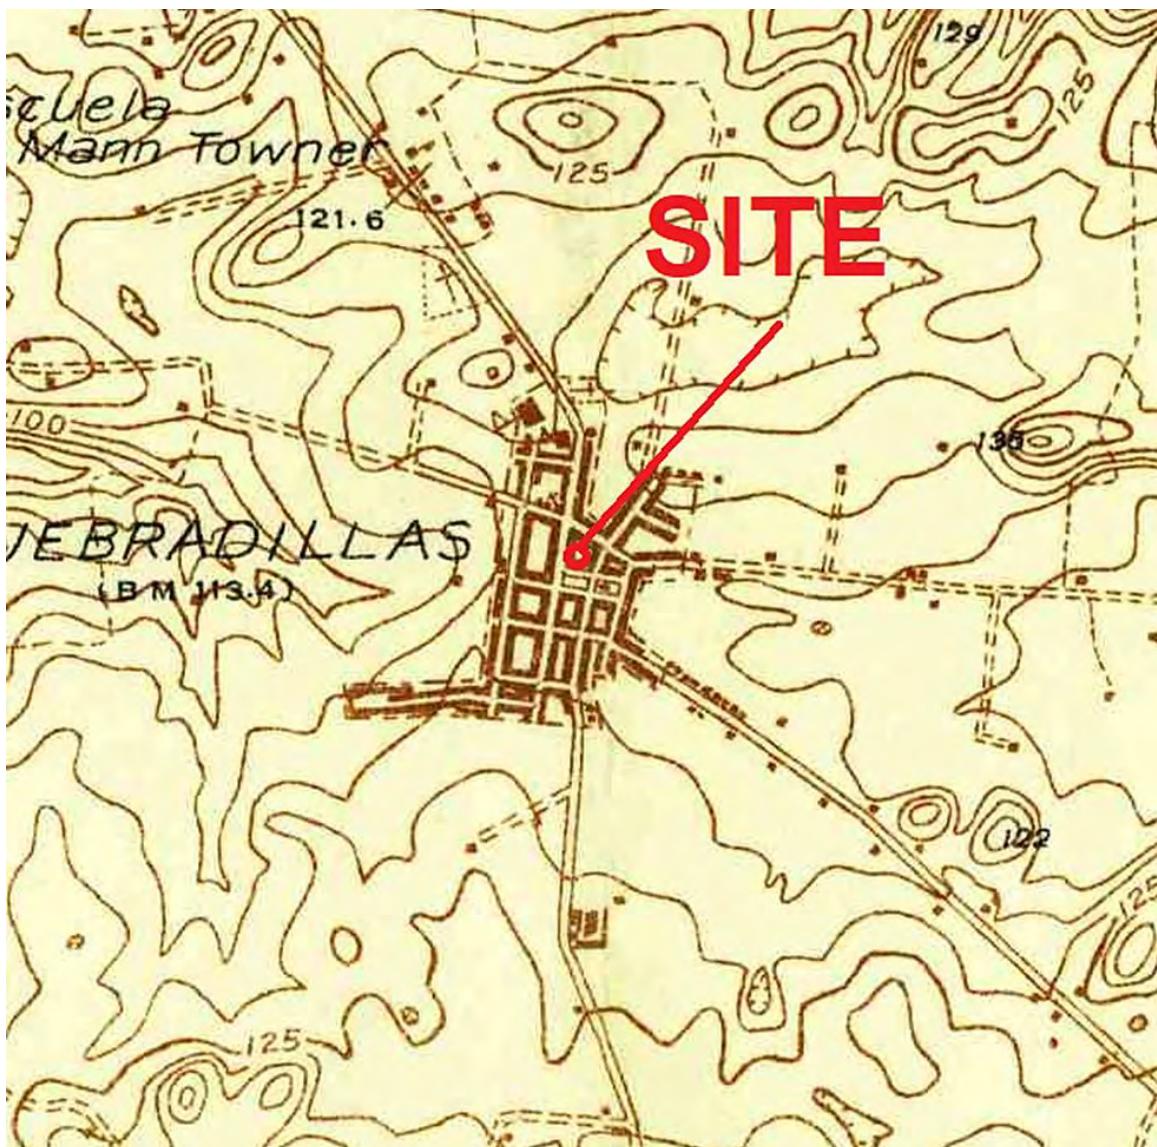
Figure 8: Topographic Quadrangle 1937-38 (Surveyed 1922)

In the quadrangle of 1937-1938, it can be observed the urban blocks built in the urban area of Quebradillas

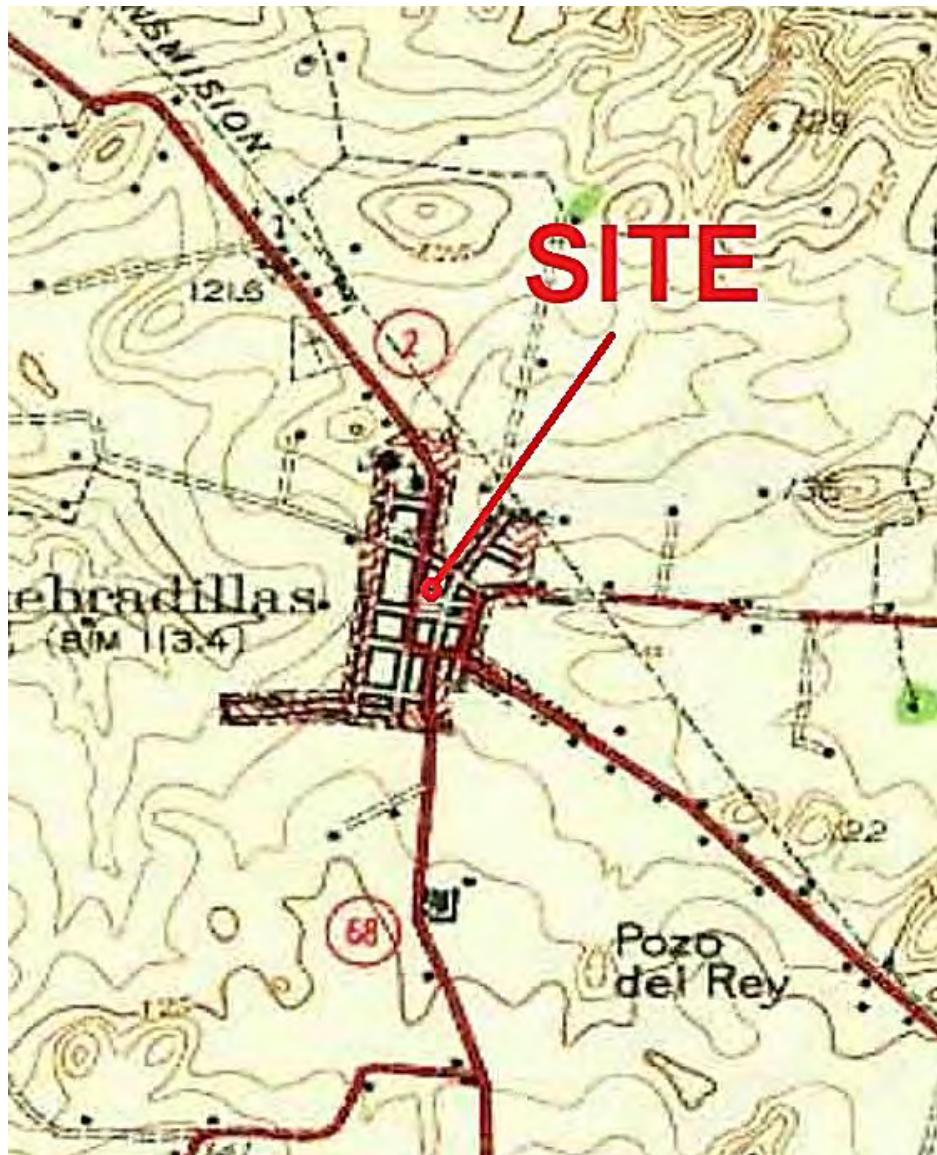
Figure 9: Topographic Quadrangle 1942

By 1942, Quebradillas urban grid remains almost the same as in 1938.

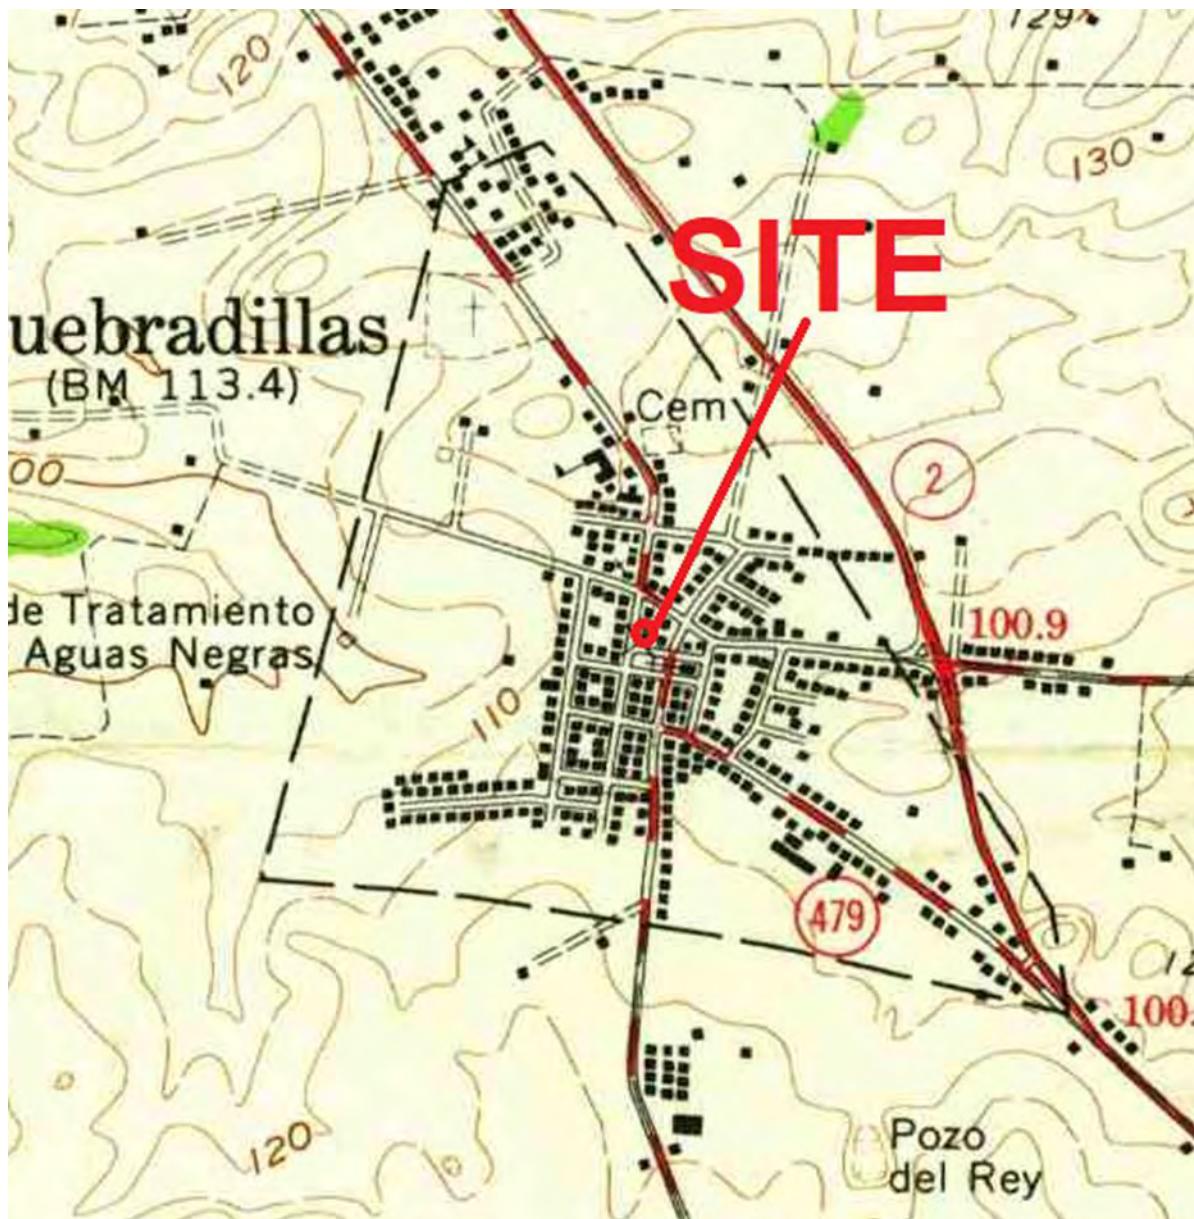
Figure 10: Topographic Quadrangle 1957-1961

Between 1942 and 1961 the urban grid of Quebradillas begins to extend to the east side of the town.

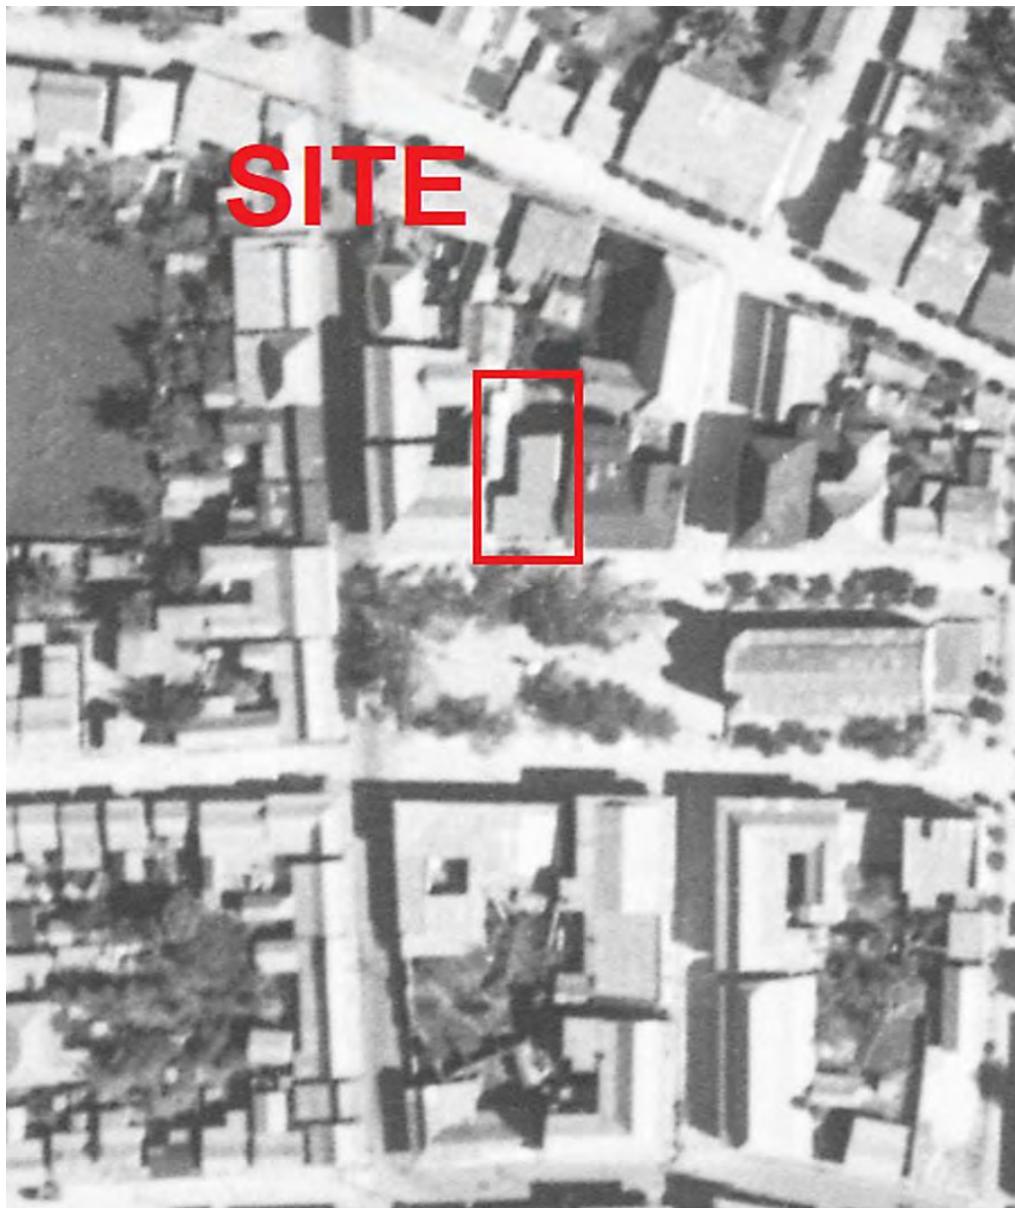
Figure 11: Quebradillas Urban Center Aerial photo in 1931, DTOP.

In 1931, the hammer-shaped building is observed in the parcel under evaluation.

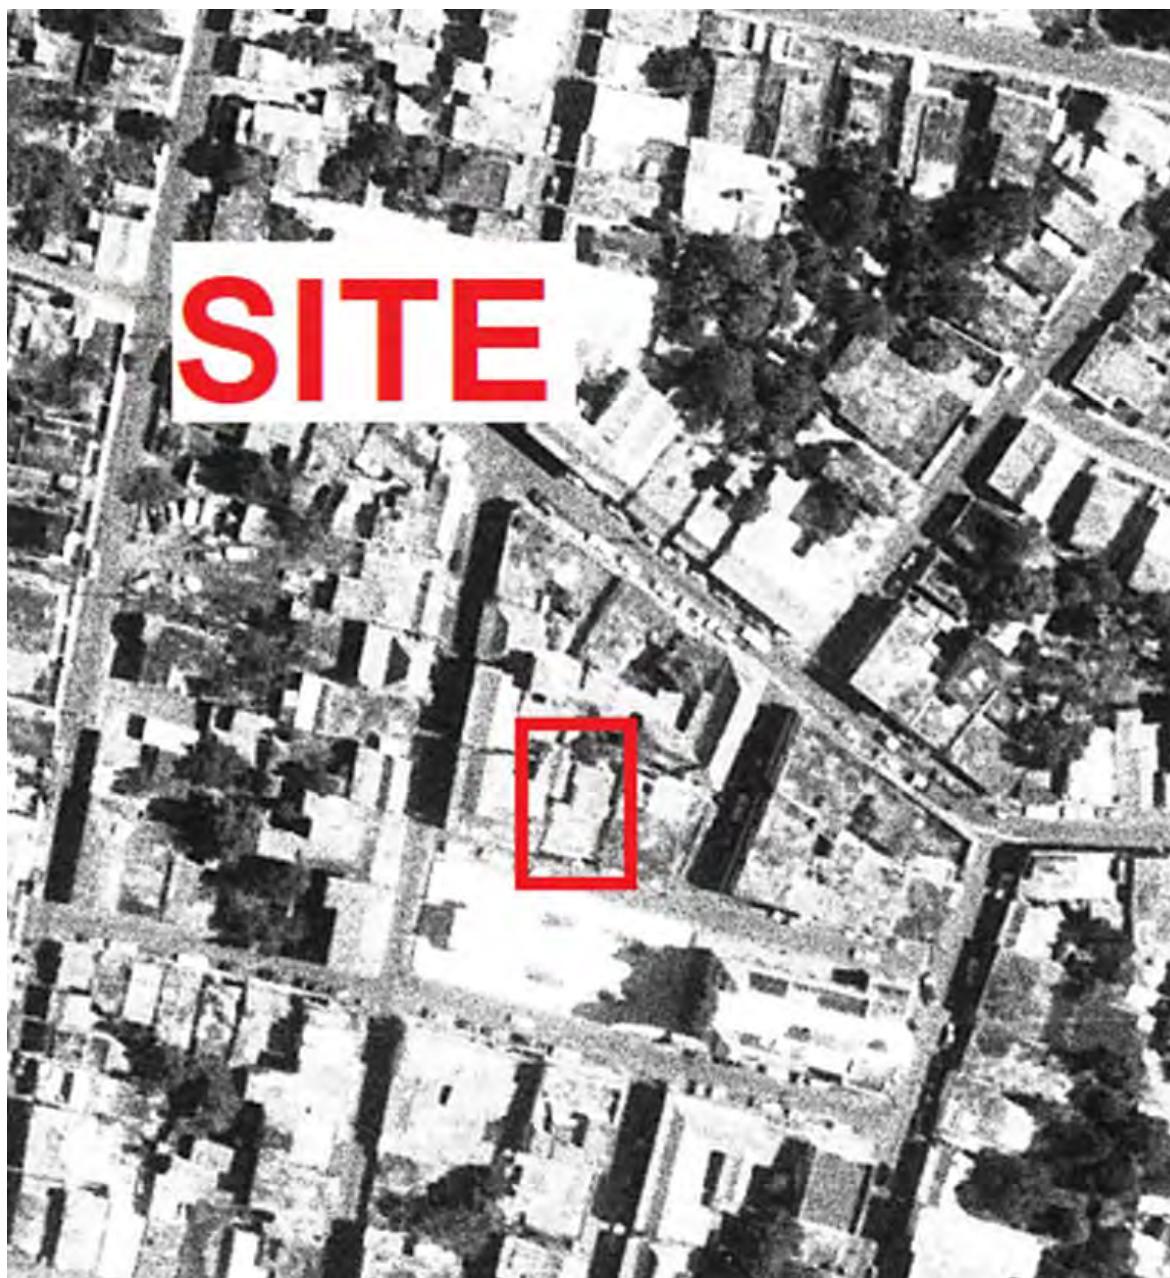
Figure 12: Quebradillas Urban Center Aerial Photo in 1985, DTOP. By 1985, no changes are observed in the area under study with respect to the 1976 photo.

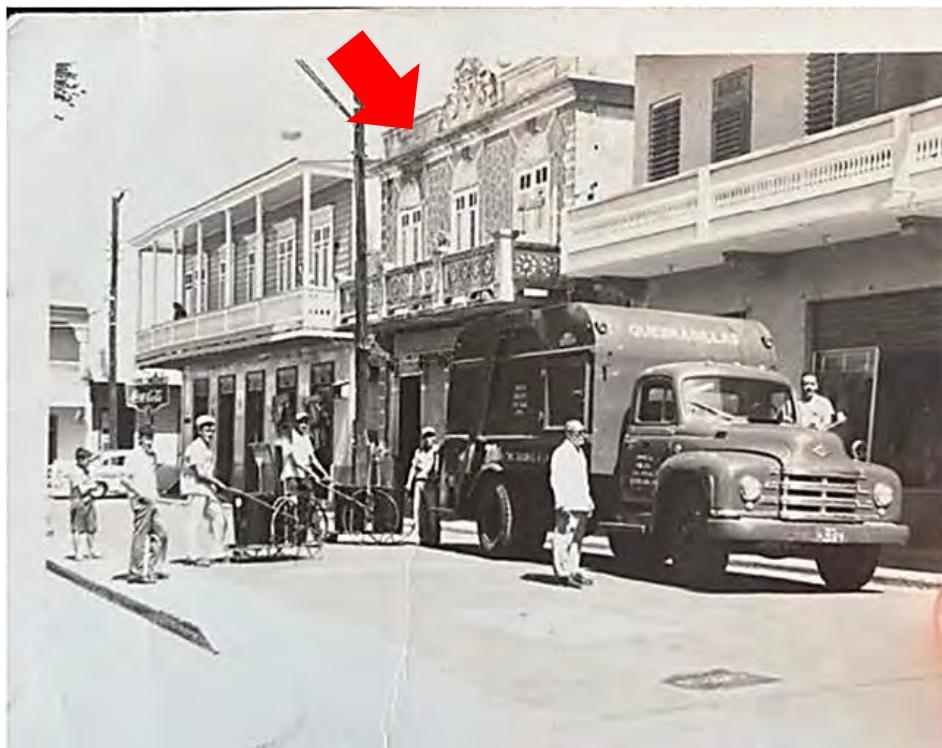
Figure 14: Historical photograph of Honorio Hernández Street. The existing building in the project parcel is observed in good condition c. 1950.

The structure under evaluation is considered an architectural historical resource. The historical photograph of the building in the 1950s (Figure 14), gives us the information of its historical character and its original architectural style *Neoclassical-Colonial of the early twentieth century (1918)*. As part of the Phase I research for this project an architectural evaluation of the building was made by Conservationist Architect Carlos Ferrán. A technical report "**EVALUATIVE REPORT OF THE CULTURAL HERITAGE OF ARCHITECTURE... patrimonial resource in Quebradillas de Puerto Rico, July 2022**" was performed.

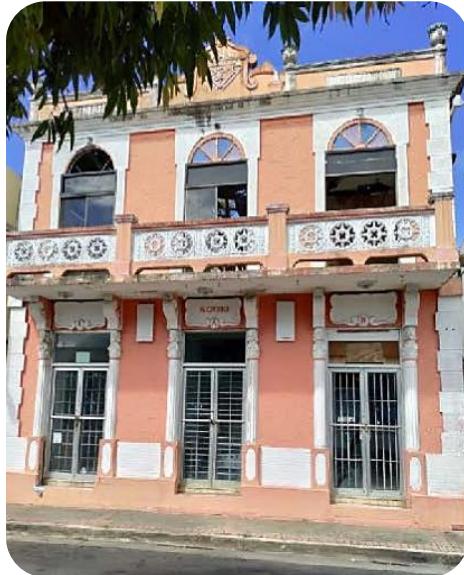
Photo: #01

Description: South view and main façade located at Honorario Hernández Street

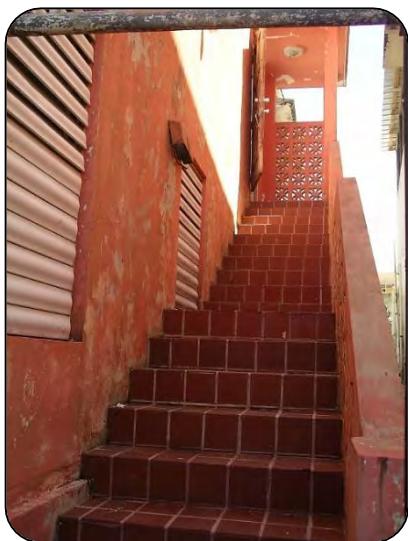
Photo: #02

Description: South-East view. Stairs on side courtyard to second floor.

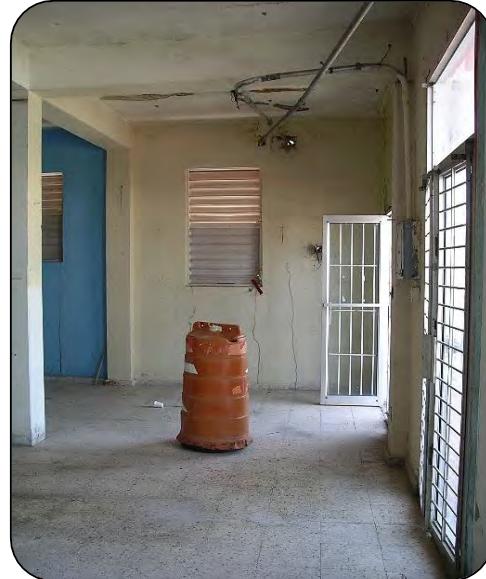
Photo: #03

Description: South, entrance from main façade, interior view of building. Concrete columns and beams.

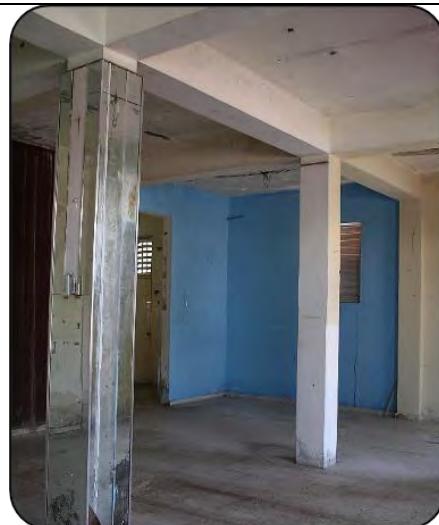
Photo: #04

Description: South, entrance from main façade, interior view of building. Concrete columns and beams.

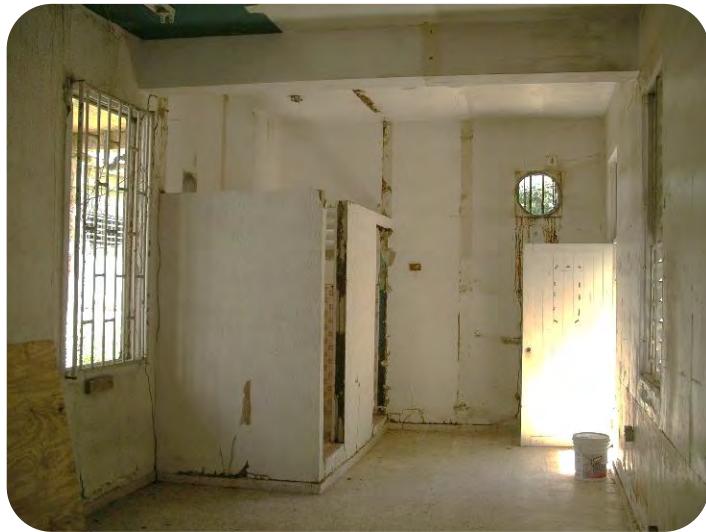
Photo: #05

Description: First floor level. South towards North side interior view of nave. Concrete roof walls and roof. Terrazzo tiles finished floor.

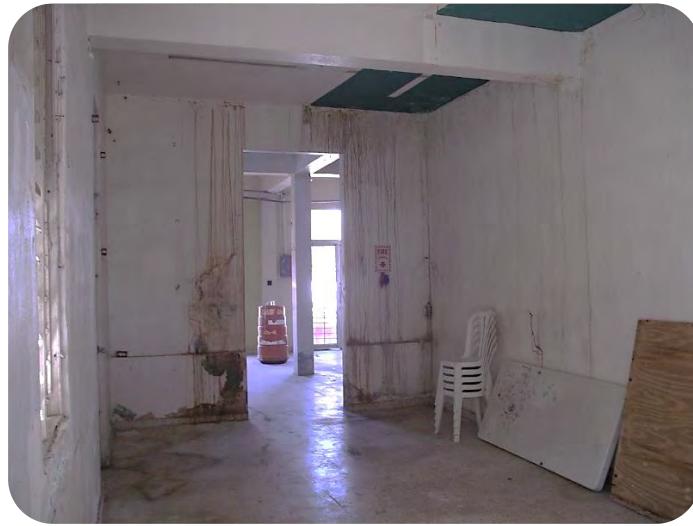
Photo: #06

Description: First floor level. North towards South, interior view of nave. Concrete roof, beams and walls. Terrazzo tiles finished floor.

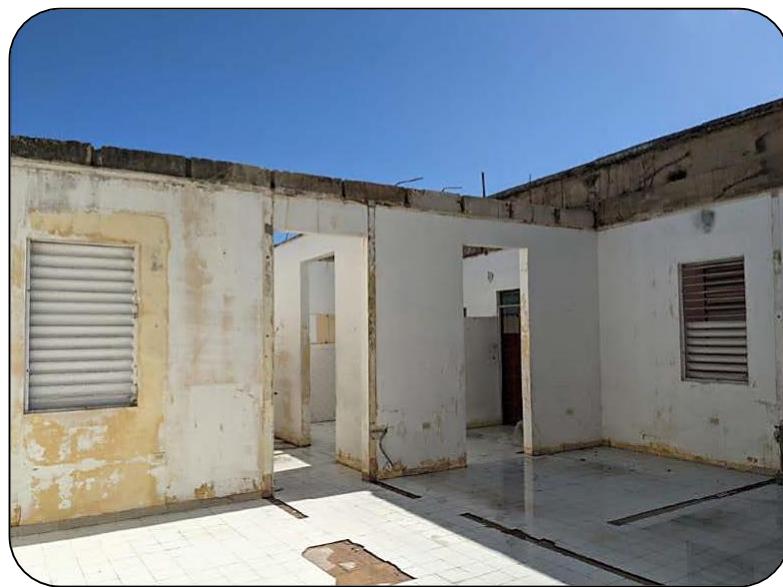
Photo: #07

Description: Second floor level interior. South view towards North. Concrete walls and floors with ceramic tiles over hydraulic concrete tiles finish. Roof is missing.

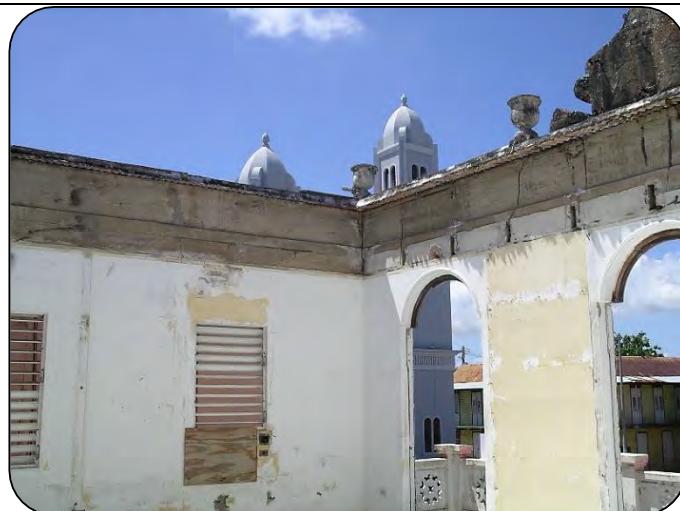
Photo: #08

Description: Second floor level interior. North view towards South and main façade balcony. Concrete walls and floors hydraulic. Roof is missing.

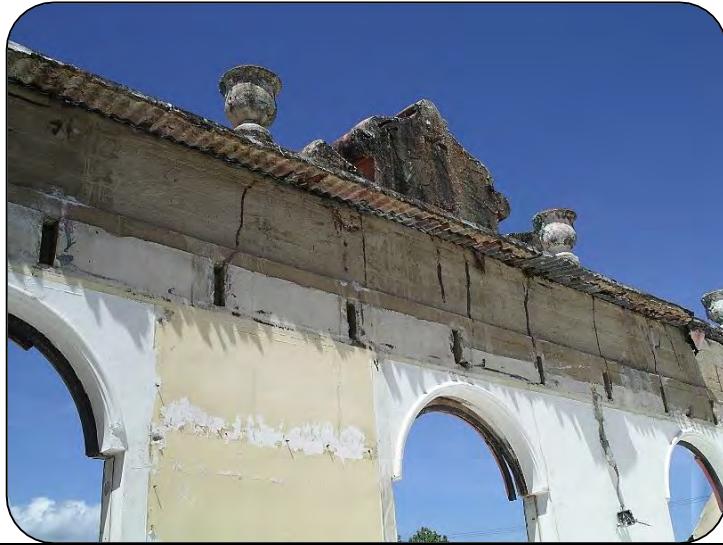
Photo: #09

Description: Second floor level interior. South view and main façade posterior concrete wall with arched doors fenestrations. Coat of arms at center of parapet with urns.

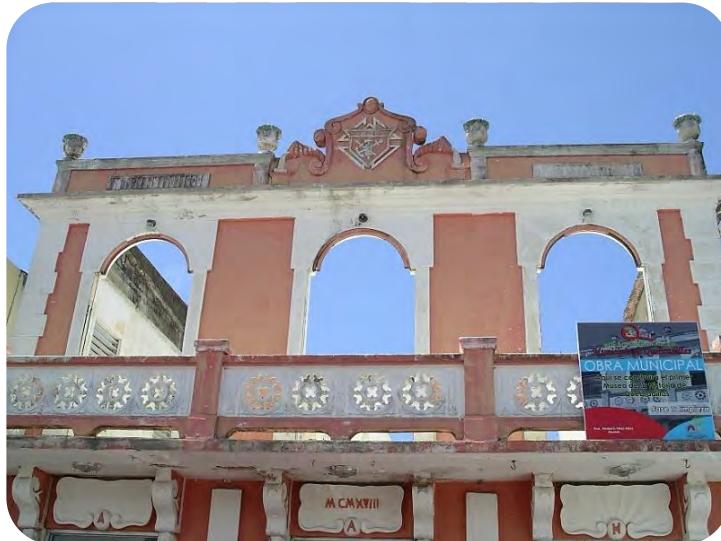
Photo: #10

Description: South view of second floor level main façade. Concrete wall with arched doors fenestrations and decorative elements on wall surface and balcony

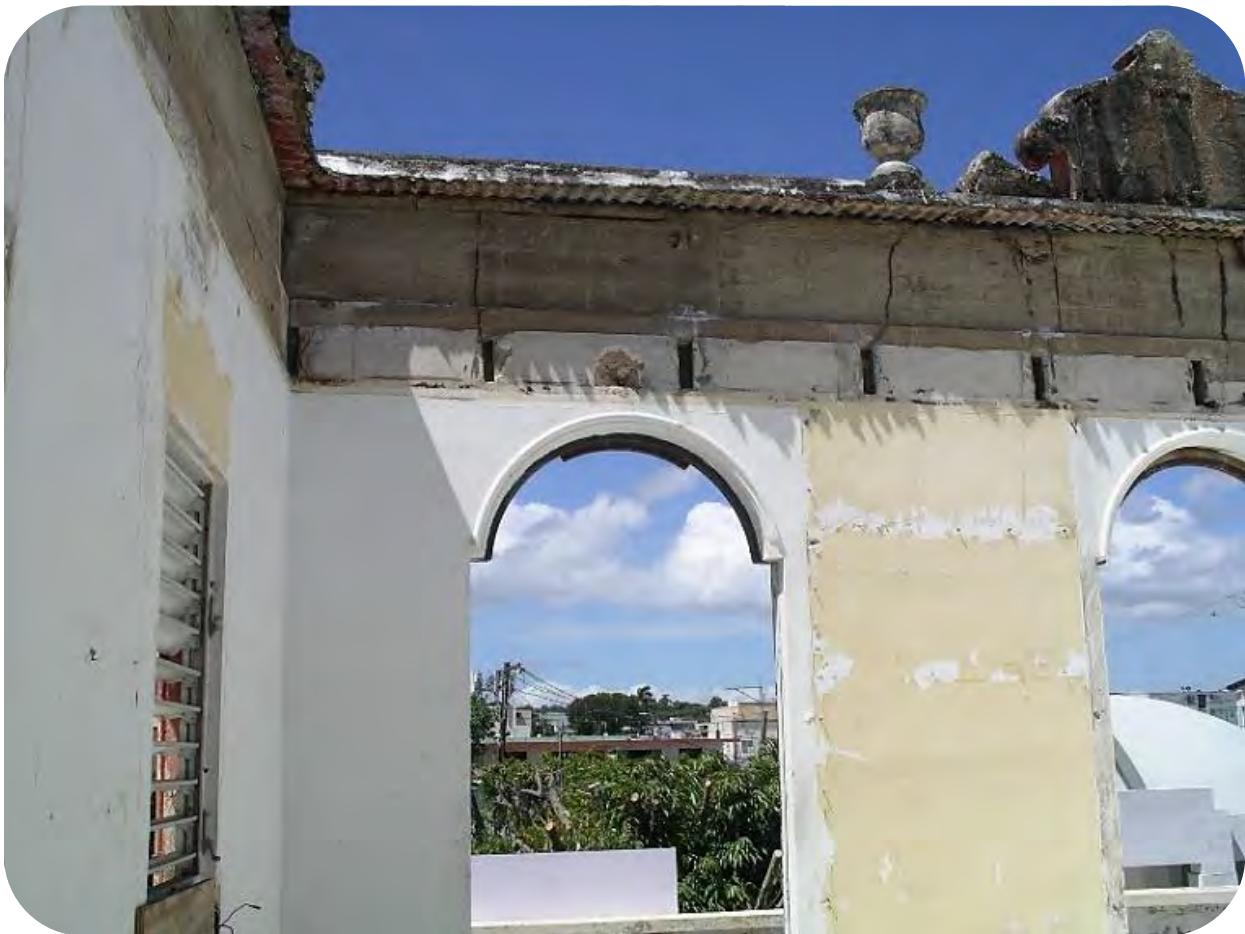
Photo: #11

Description: Second floor level interior. South view and main façade posterior concrete wall with arched doors fenestrations. Roof's wood beams wall connection shown.

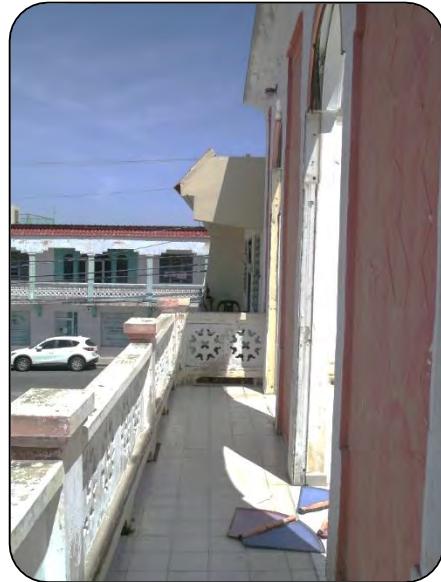
Photo: #12

Description: West view on second level's balcony area.

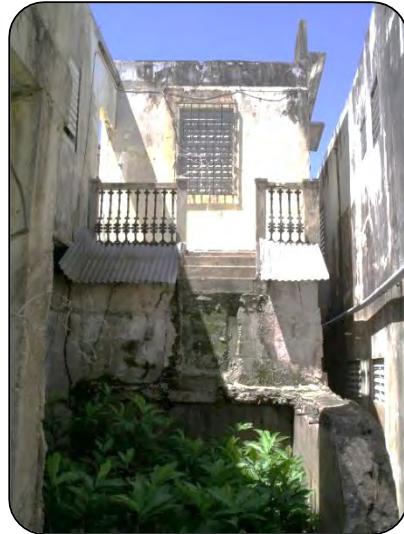
Photo: #13

Description: North towards south. Interior courtyard with existing concrete railings and partial stairs remains (recent construction)

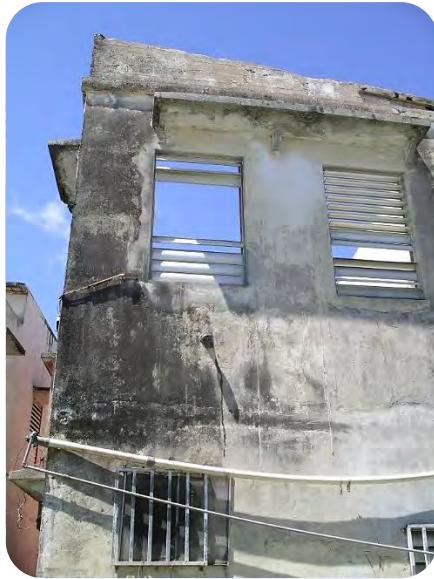
Photo: #14

Description: East view of second floor level façade, oriented towards interior courtyard.

Project contemplates demolishing a portion of the existing building. This portion corresponds to an addition to the building to provide an additional bathroom on the second level. This portion of the structure has structural deterioration that requires demolition (see photos #14 & 15). Columns and beams have exposed and corroded structural steel. The process for the demolition of this portion will be carried out with manual tools. This is because there is no access to the rear to allow the use of mechanical equipment, such as a small backhoe.

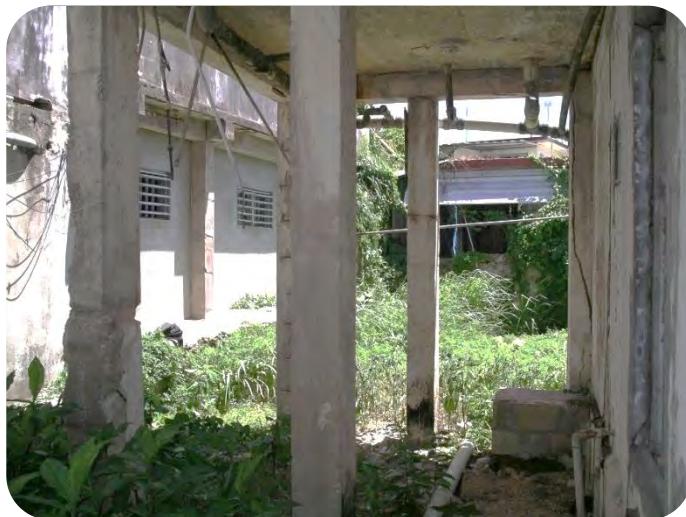
Photo: #15

Description: North view. Interior courtyard. First floor level corridor. Existing concrete columns (recent construction)

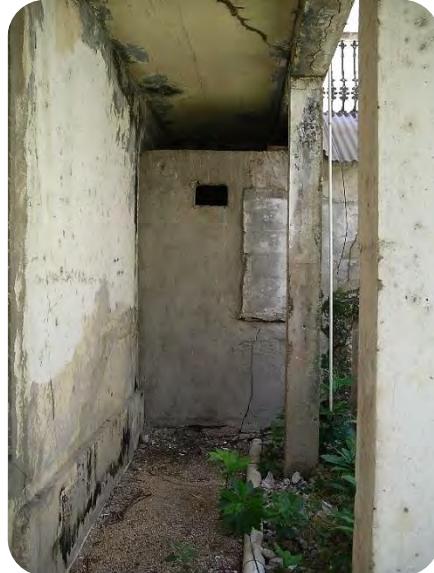
Photo: #16

Description: South view, interior courtyard corridor.

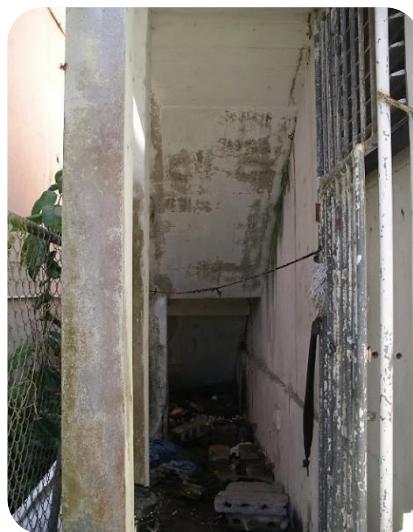
Photo: #17

Description: South view. Area under main stairs and first level access from backyard.

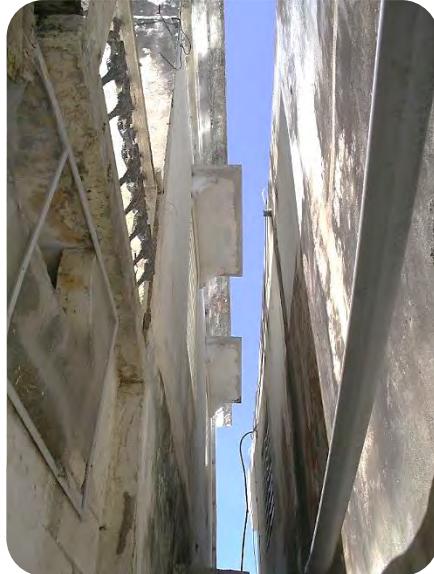
Photo: #18

Description: South view of West property line area and façade.

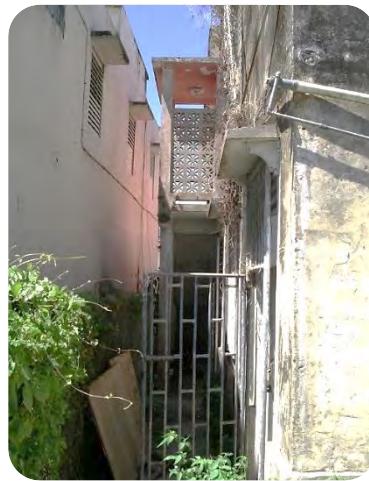
Photo: #19

Description: South view from posterior courtyard. East side property line.
