**Environmental Review for Activity/Project that is Categorically
Excluded Subject to Section 58.5**

**MUSEO HISTORICO DE QUEBRADILLAS
QUEBRADILLAS, PR**
PR-CRP-000554
CDBG-DR

**Applicant: Municipality of Quebradillas
Prepared by: José D. Centeno Calero PE
Professional Engineer
License 20206
Date: October 23, 2023**

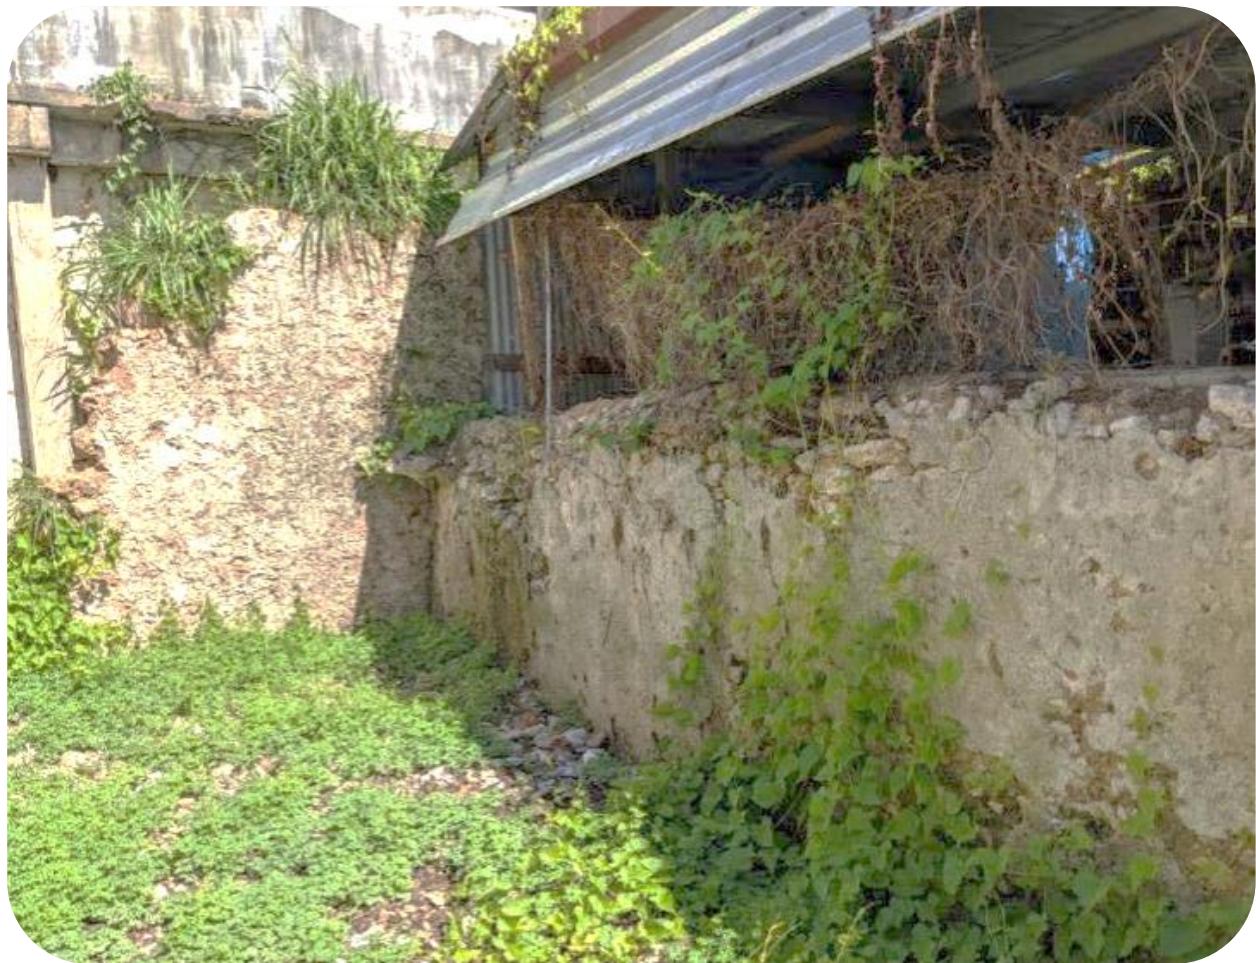
Photo: #20

Description: North and West property line at the posterior courtyard.

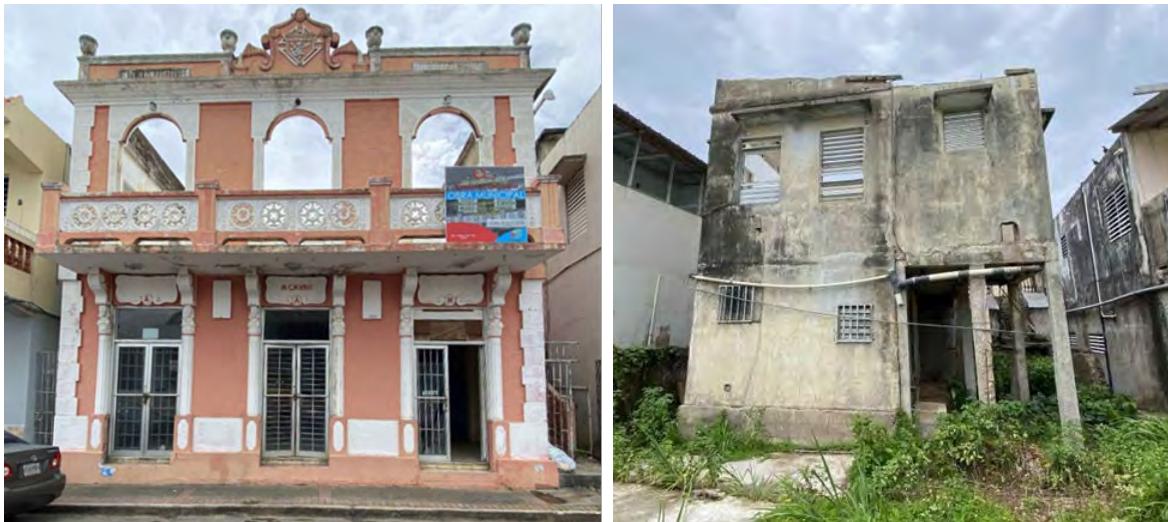
Figure 3: Frontal façade (left) and posterior façade (right) (Ingenieros del Oeste C.S.P 2022)

The building to be rehabilitated was built in 1918. It is a two-story Spanish Colonial Revival style building, which had a mixed use; commercial on the first level and residential on the second level (Figure 3). The building is "L" shaped, with stairs located on the exterior of the east side. The structure is currently vacant, having suffered significant damage during Hurricanes Irma and Maria, the most significant being the loss of the roof of the second floor. In contrast, the walls are structurally well preserved and in good condition. There is some existing recent construction in the lateral inner courtyard that is considered a negative intervention to the original floor plan.

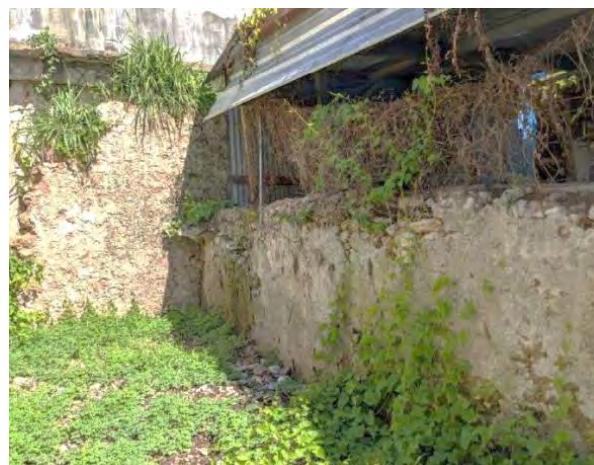
Figure 4: Bricks and mortar masonry wall at the posterior courtyard (from Alvarado and Ferrán 2023)

According to architect Carlos Ferrán Martínez, who completed the Section 106 NHPA Effect Determination Form for this case, the building is distinguished by the presence of a shield or "Cartuch" with a clear Masonic influence in the center of the front façade. It has a continuous balcony with railing on the second level. Above the doors there are walls or ornamentations in the form of very stylized shells. The central shell bears the year of construction of the building in Roman numerals. The presence of a cyclopean wall of brick and mortar in the north and west boundary of the 0.0553-acres lot is noteworthy (Figure 4). The project plans also mention the existence of a septic tank in the backyard.

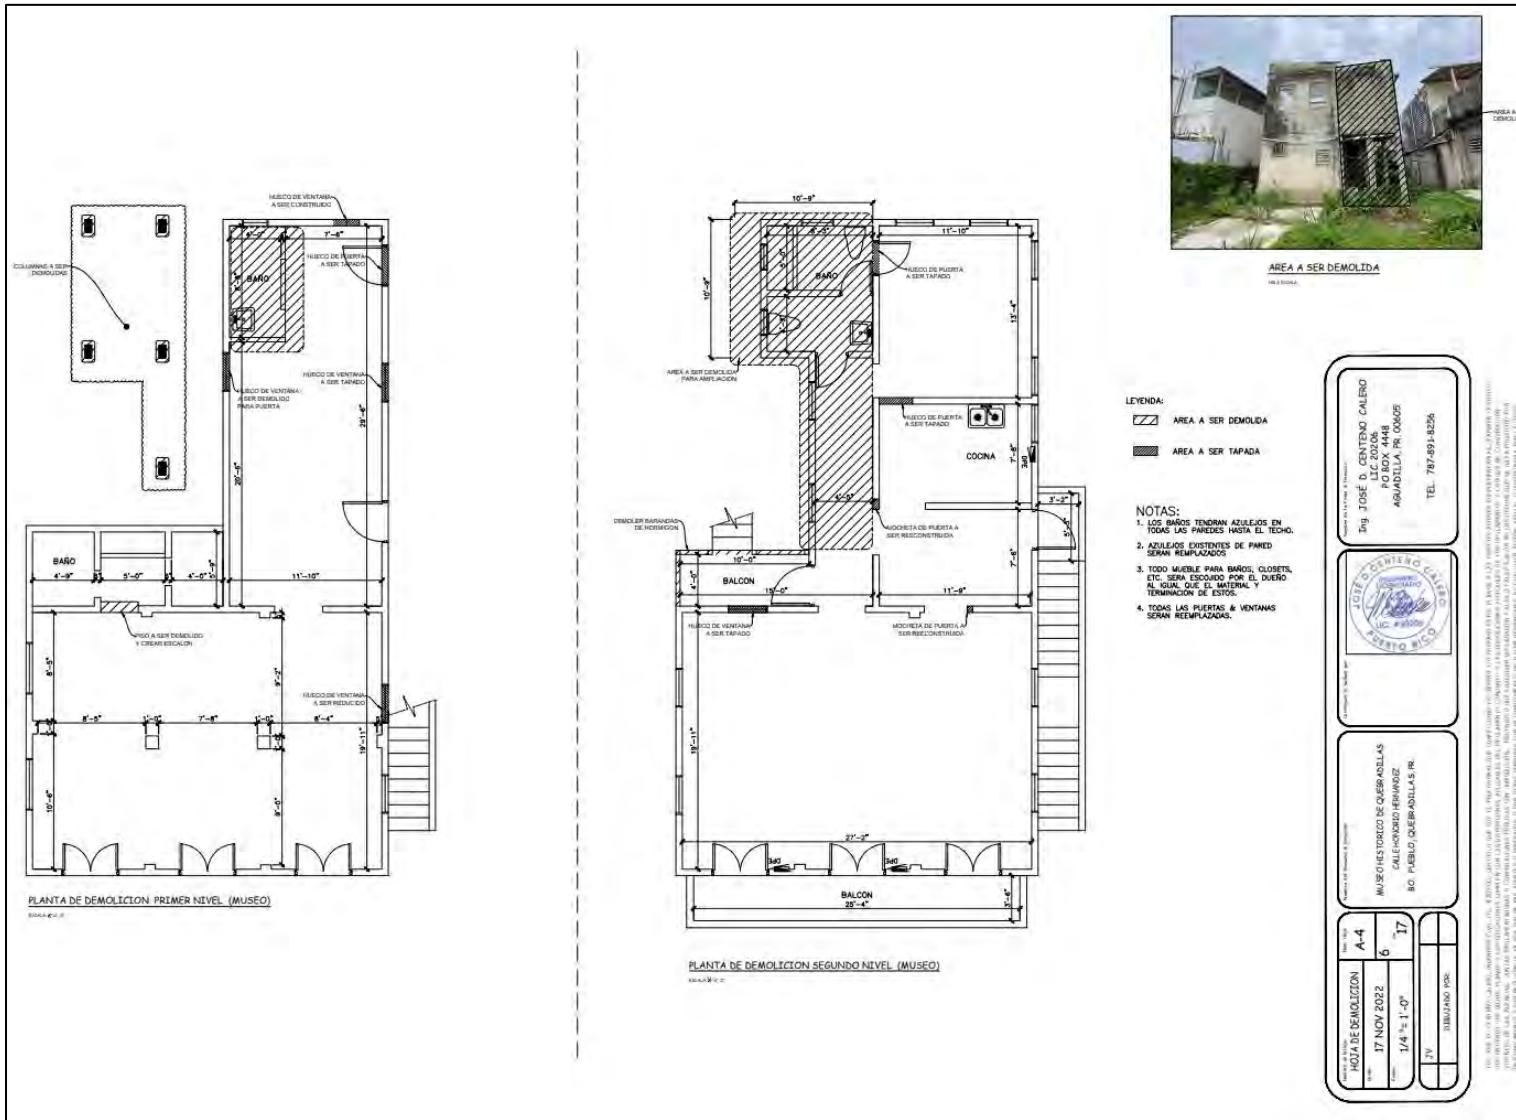
Figure 6: Demolition Plan (Ingenieros del Oeste C.S.P 2022)

The selective demolition works include the demolition of the bathroom located at the rear of the first floor and the bathroom located at the rear of the second floor. On the first level, the columns located at the rear (which are new additions), interior partitions and a segment of floor will be demolished to create a step. On the second level the concrete railings will also be demolished. All doors and windows will be replaced (Figures 6 and 7).

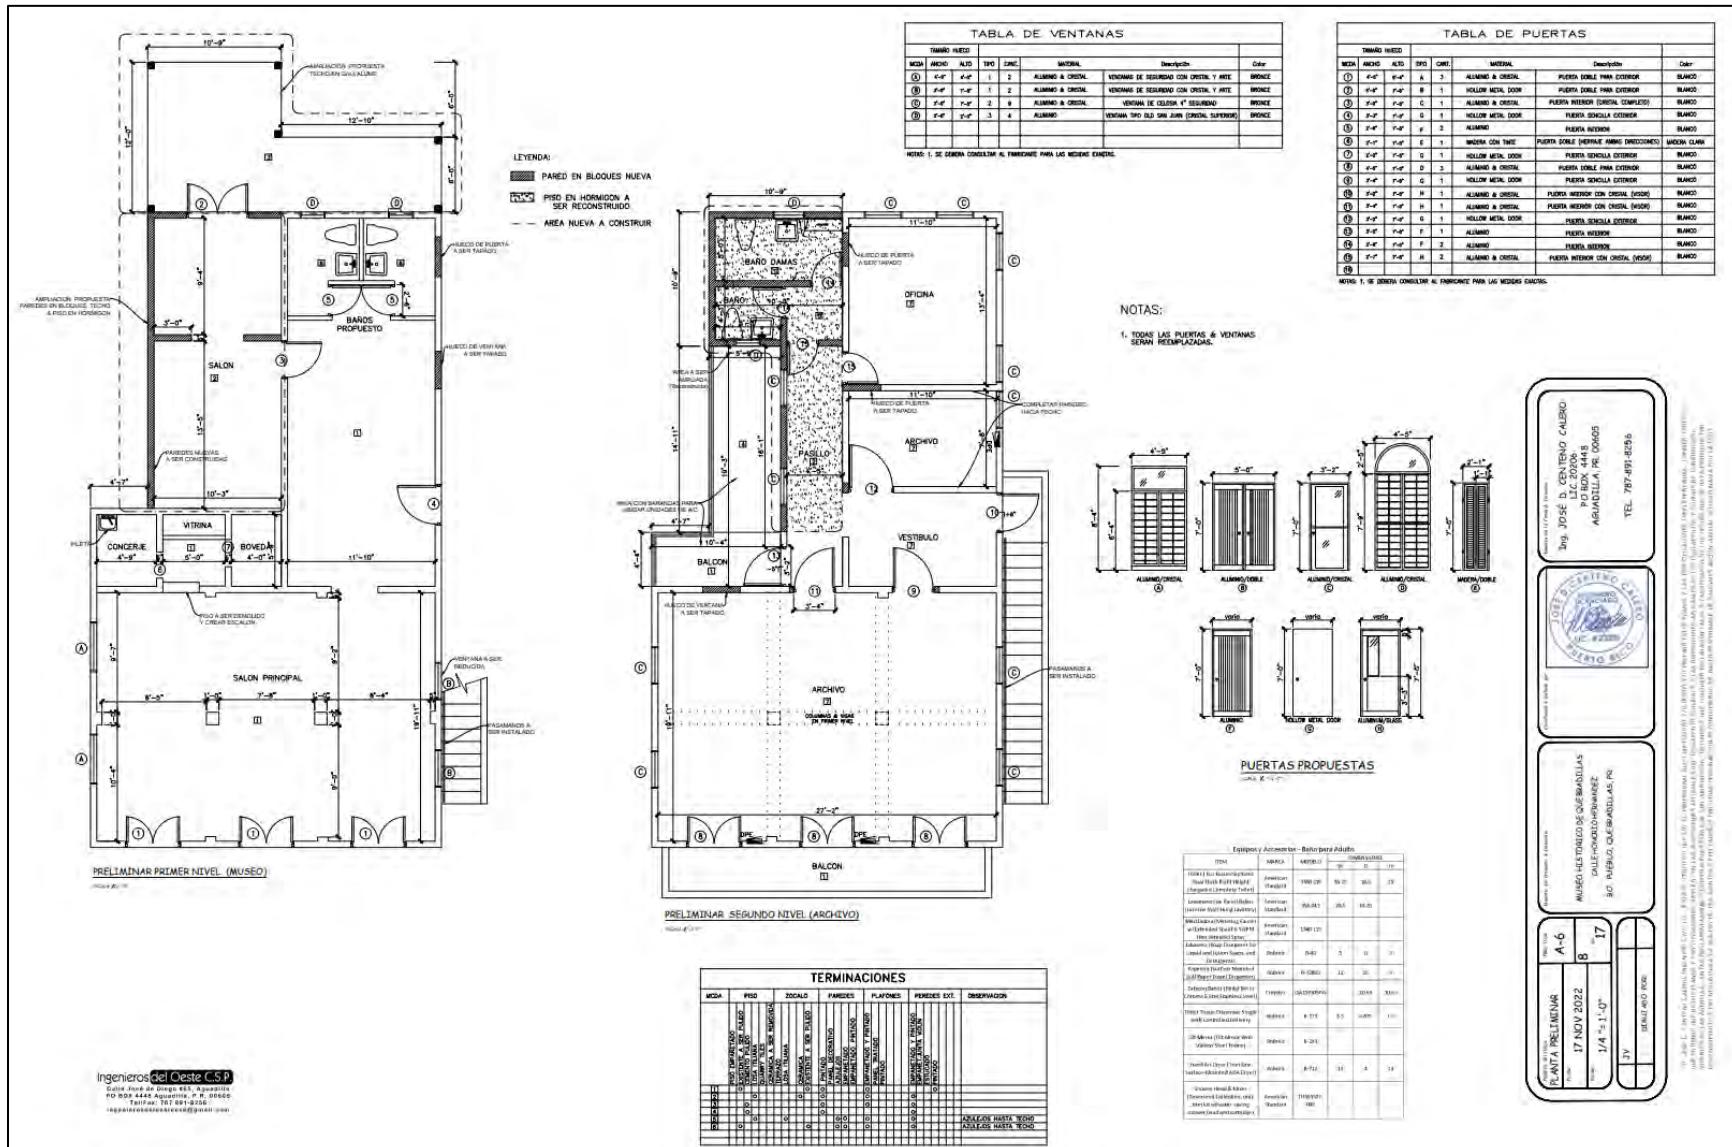
Figure 8: Preliminary Floor Plan (Ingenieros del Oeste C.S.P 2022)

The new construction in the first level entails an addition at the rear, which includes new concrete walls, roof and floor, and an addition for a patio terrace with a galvalume roof. The new construction requires excavation for footings 3'6" x 3'6" and 12" deep. In addition, door and window openings will be closed at the rear, window openings will be reduced, and a handrail will be installed on the stairway. On the second level, the new construction includes the construction of block walls and concrete floor of a new bathroom at the back, completing walls to the roof, and tapping doors and windows. A new roof will also be built. (Figures 8, 9 and 10)

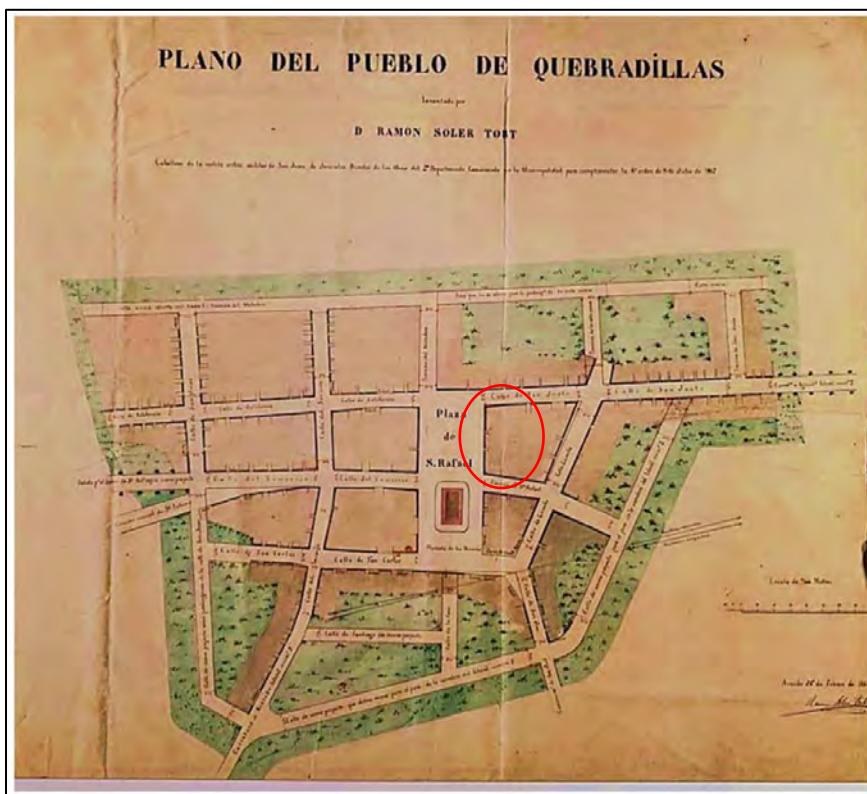
Figure 11: Map of the Town of Quebradillas, 1869 (Ramón Soler Tort in Sepúlveda 2004-2: 144)

A map of the town of Quebradillas from 1869 shows the urban blocks already formed around the plaza (Figure 11). The block in question has two "entrances" that suggest that there were at least two buildings.

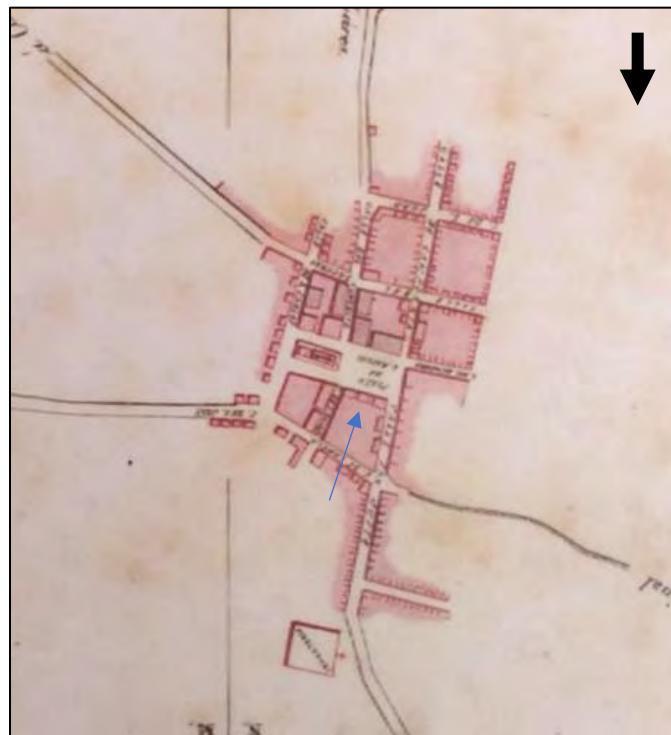
Figure 12: Map of Quebradillas, 1889 (Félix Ardanaz y Crespo, Corps of Military Engineers, Topographic Commission, in Sepúlveda 2004-3: 318) (Blue arrow shows the approximate location of the APE)

A later map, dated 1889, shows a structure within the APE. It was rectangular in shape and is shown at the front of the lot, next to the street (Figure 12). The way it is represented on the map suggests that it was already in "fabrica", in other words, a brick and stone masonry structure.

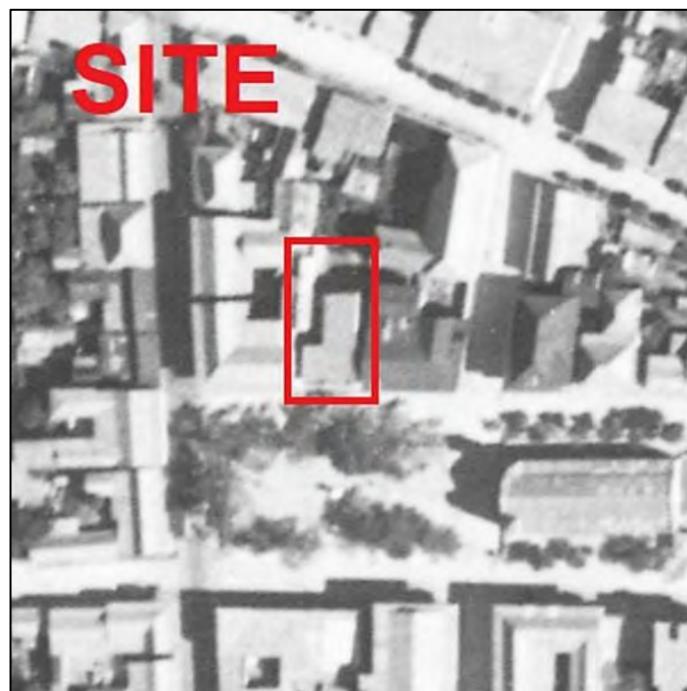
Figure 13: Quebradillas Urban Center Aerial photo, 1931
(DTOP, from Alvarado and Ferrán 2023: 21)

This building must have been demolished at some point in the early 20th century, being replaced by the existing one. The 1931 aerial photo already shows the building under study, with its characteristic "L" shape (Figure 13).

In 1931, the hammer-shaped building is observed in the parcel under evaluation.

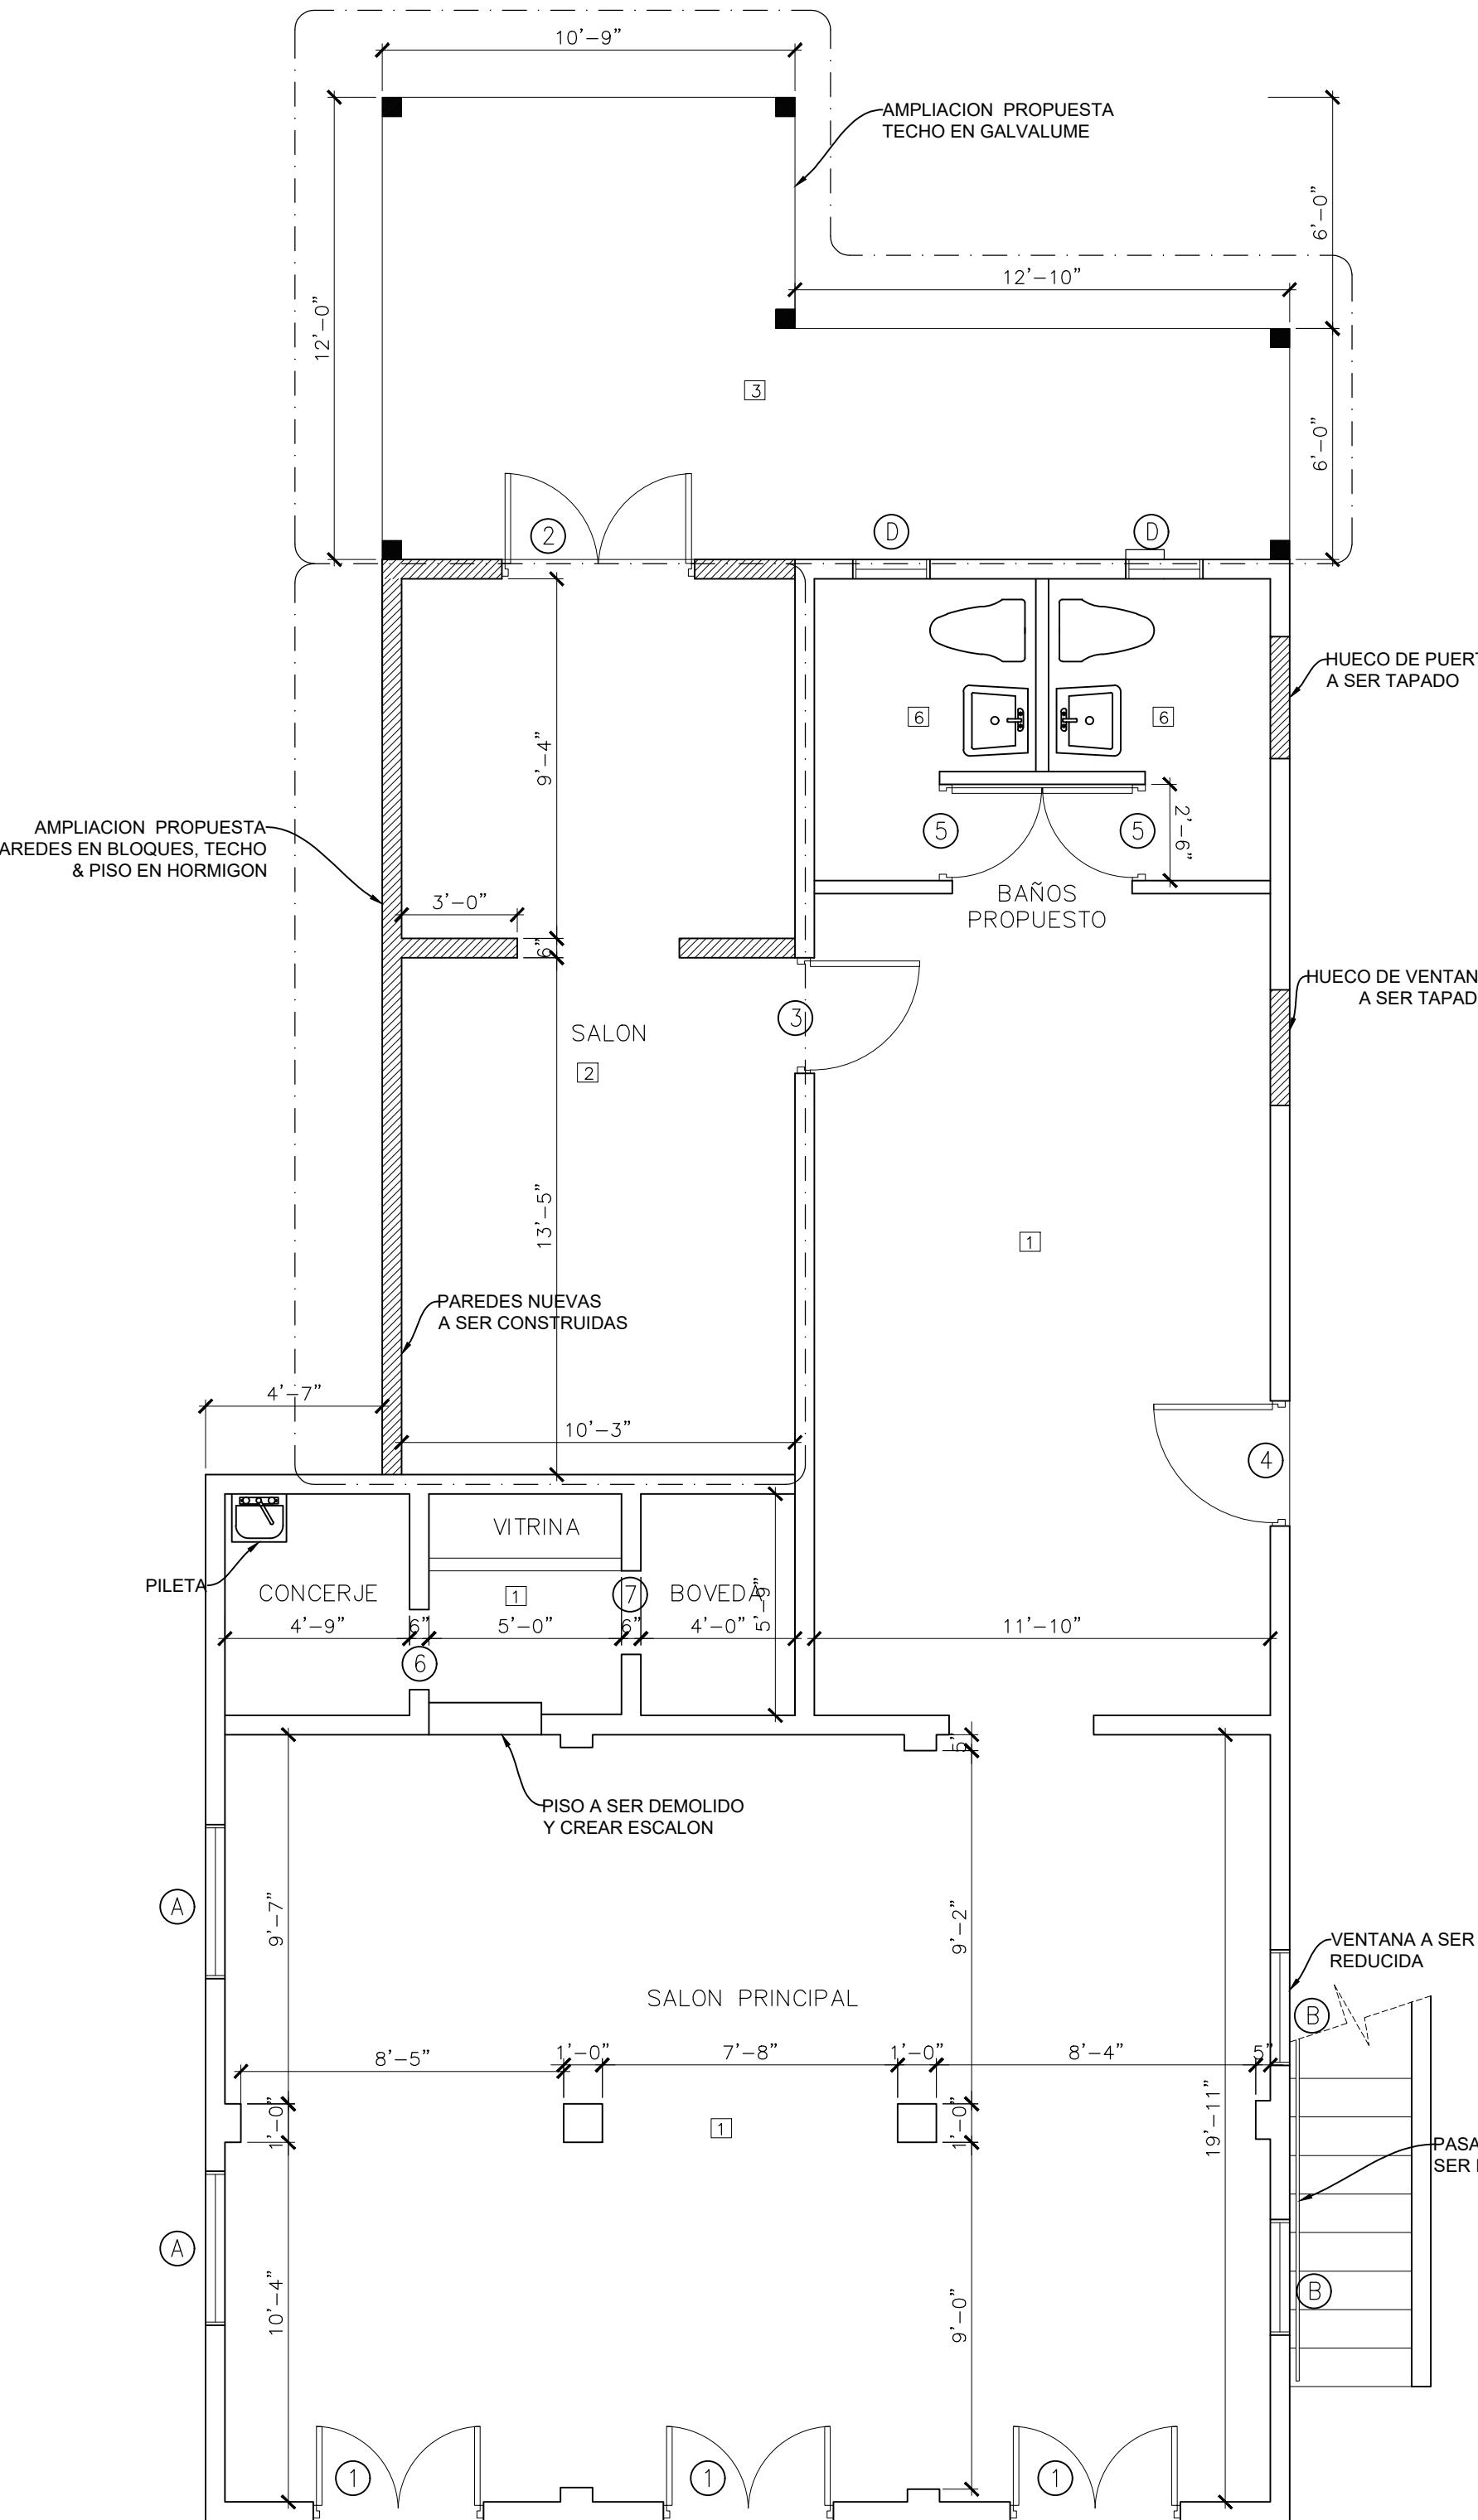
PRELIMINAR PRIMER NIVEL (MUSEO)

TABLA DE VENTANAS						
TAMAÑO HUECO		TIPO	CANT.	MATERIAL	Descripción	Color
M.C.D.A	Ancho Alto					
(A)	4'-0"	4'-0"	1	2	ALUMINIO & CRISTAL VENTANAS DE SEGURIDAD CON CRISTAL Y ARTE	BRONCE
(B)	3'-0"	7'-0"	1	2	ALUMINIO & CRISTAL VENTANAS DE SEGURIDAD CON CRISTAL Y ARTE	BRONCE
(C)	3'-0"	7'-0"	2	9	ALUMINIO & CRISTAL VENTANA DE CELOSIA 4" SEGURIDAD	BRONCE
(D)	2'-0"	2'-0"	3	4	ALUMINIO VENTANA TIPO OLD SAN JUAN (CRISTAL SUPERIOR)	BRONCE

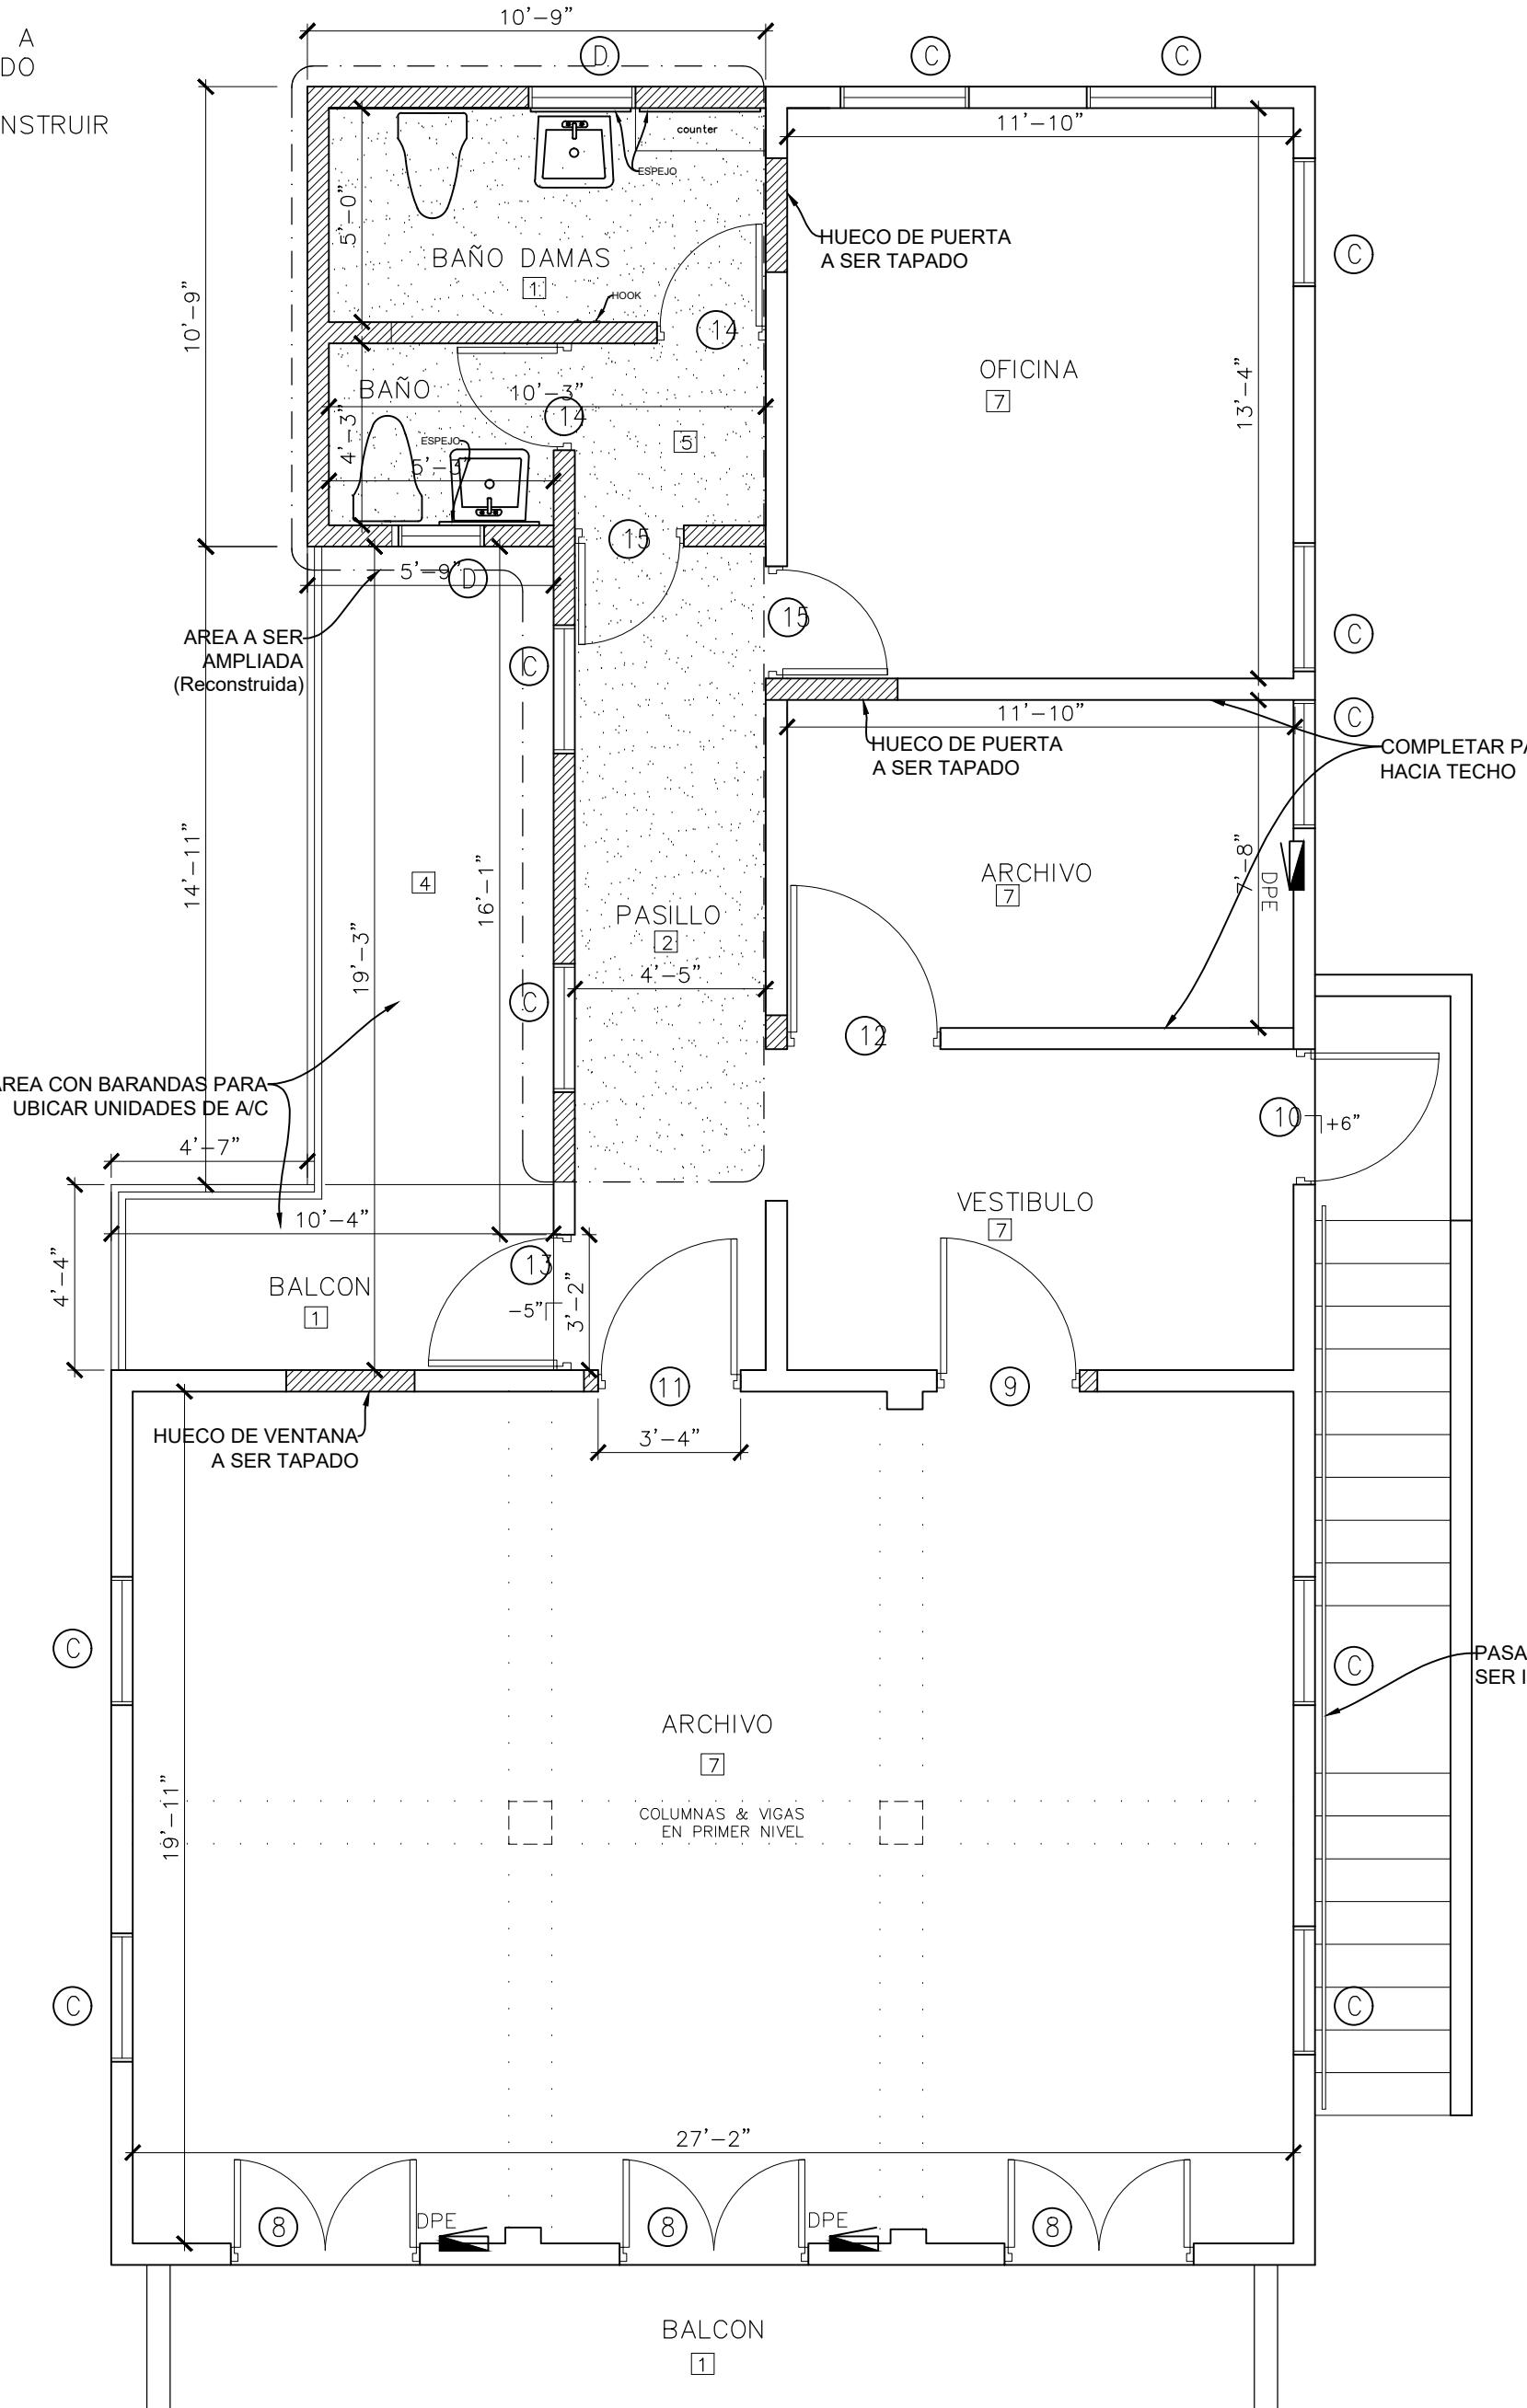
PRELIMINAR SEGUNDO NIVEL (ARCHIVO)

1. TODAS LAS PUERTAS & VENTANAS SERAN REEMPLAZADAS.

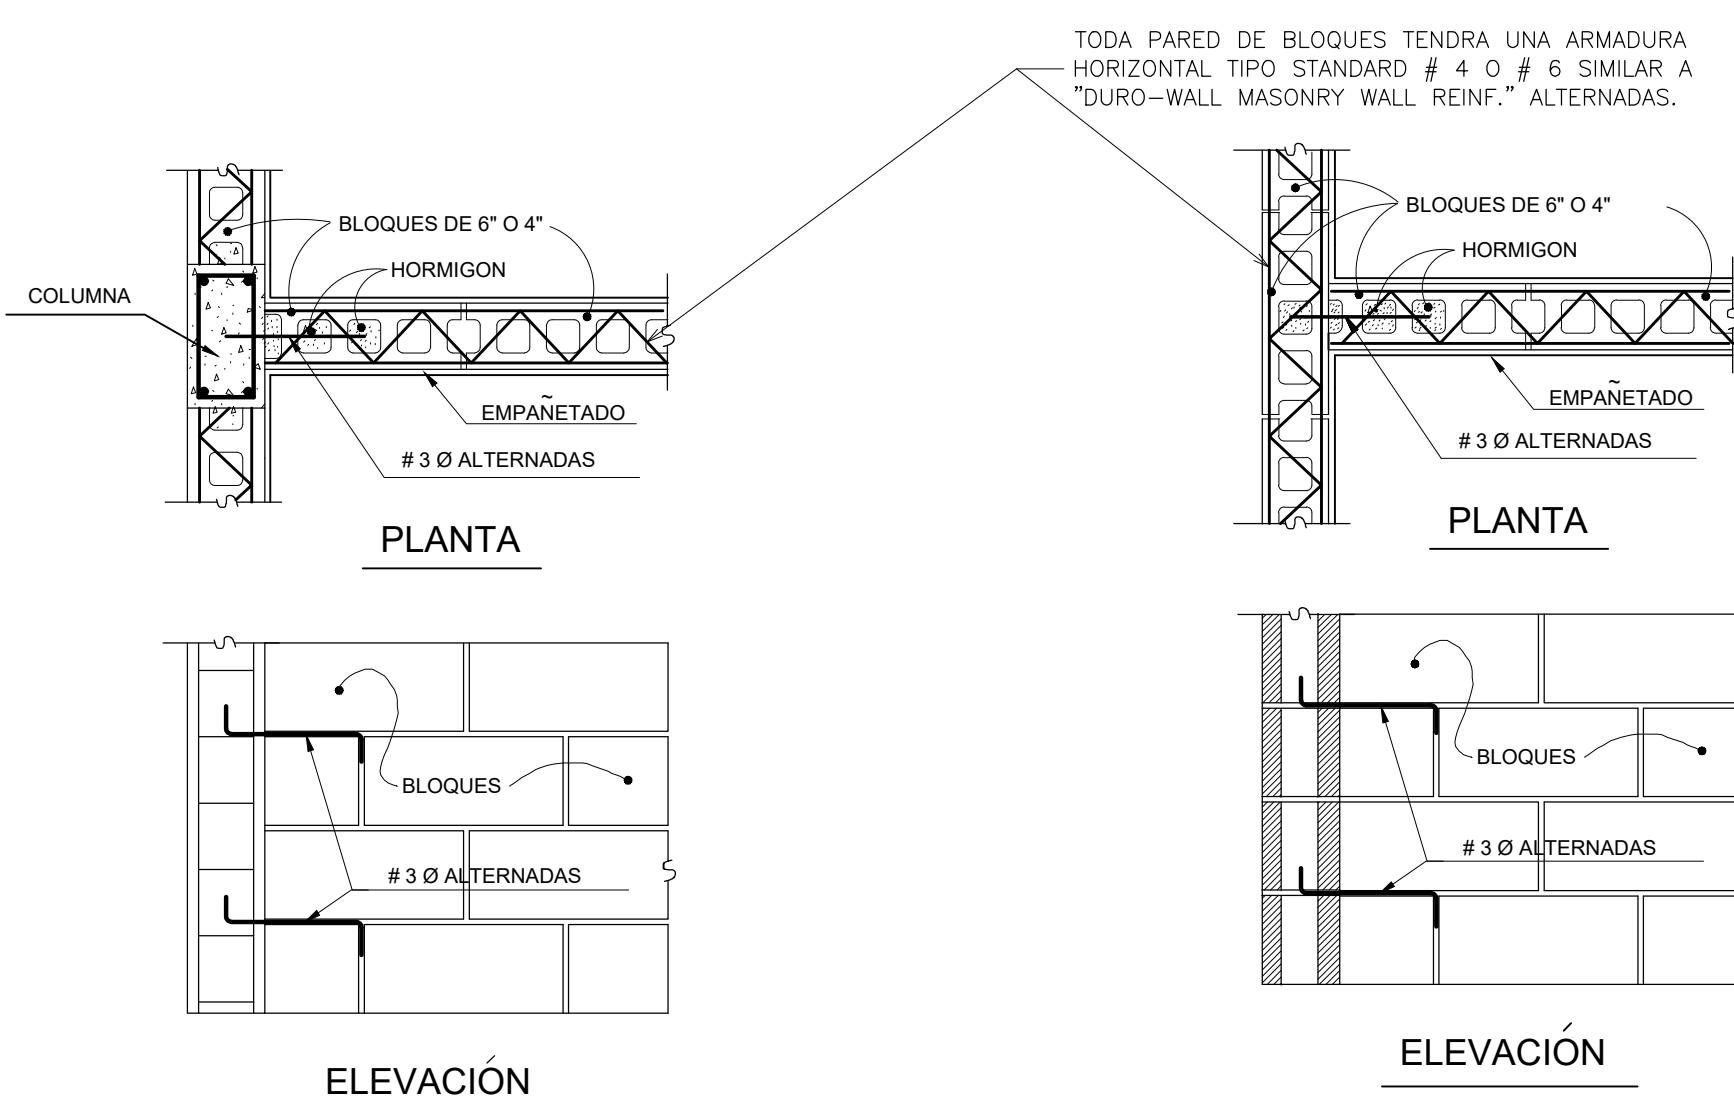
DET. INTERSECCIÓN ENTRE
COLUMNAS Y PAREDES DE BLOQUES

DET. INTERSECCIÓN ENTRE
PAREDES DE BLOQUES

22) PAREDES DE BLOQUES SERÁN ANCLADAS A LA ESTRUCTURA CON ARRIMOS VERTICALES Y HORIZONTALES #3 @ 16" C.C. EXTENDIENDOSE 1'-0" A CADA LADO. DISEÑOS ALTERNOS PODRÁN SER USADOS PREVIA AUTORIZACIÓN DEL DISEÑADOR. LINTELES SOBRE HUECOS EN PAREDES DE BLOQUES TENDRÁN EL MISMO ANCHO DE LA PARED Y ESTARÁN REFORZADOS CON 2 VAR. #5 ARRIBA Y ABAJO EXTENDIENDOSE 1'-0".

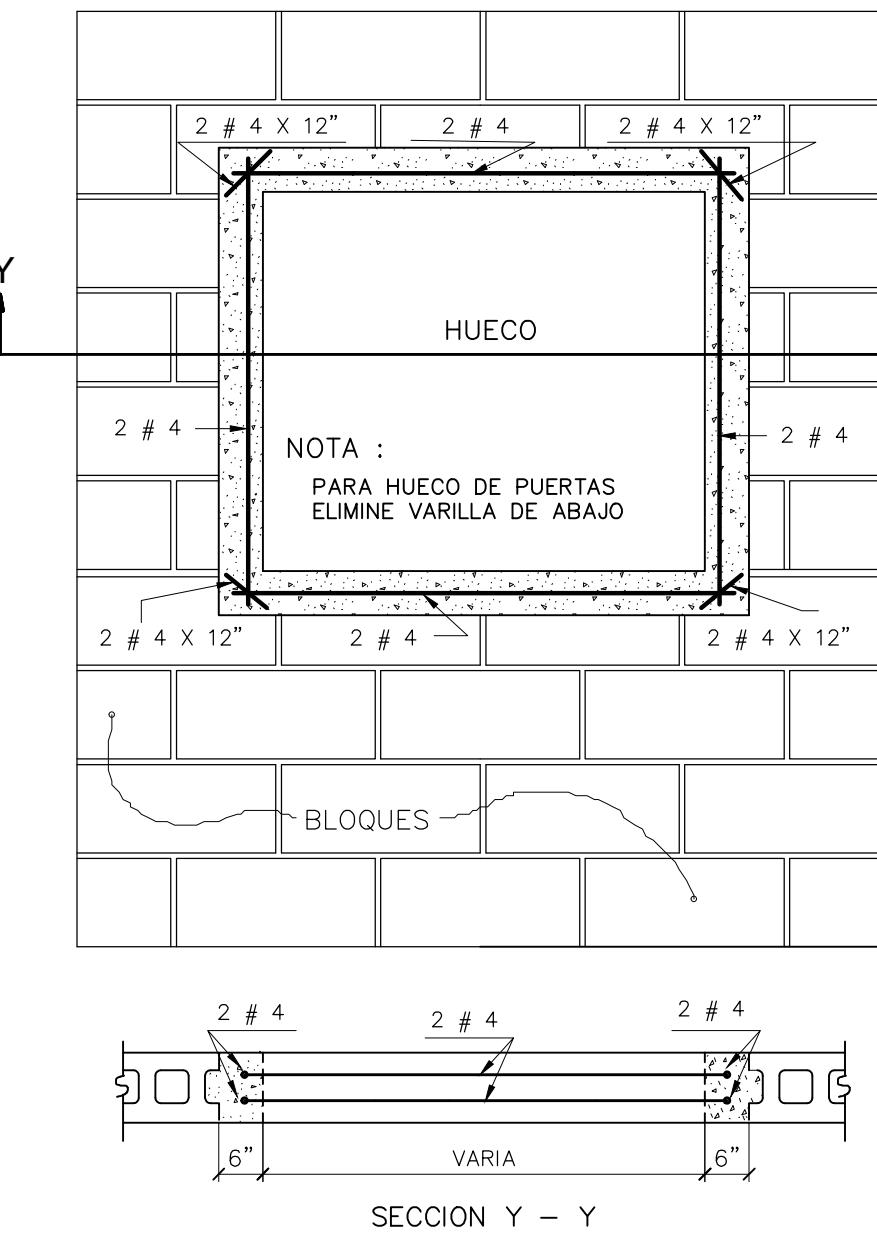
DET. REFUERZO EN HUECOS

DETALLE DE CONFINAMIENTO APLICABLE A COLUMNAS Y VIGAS

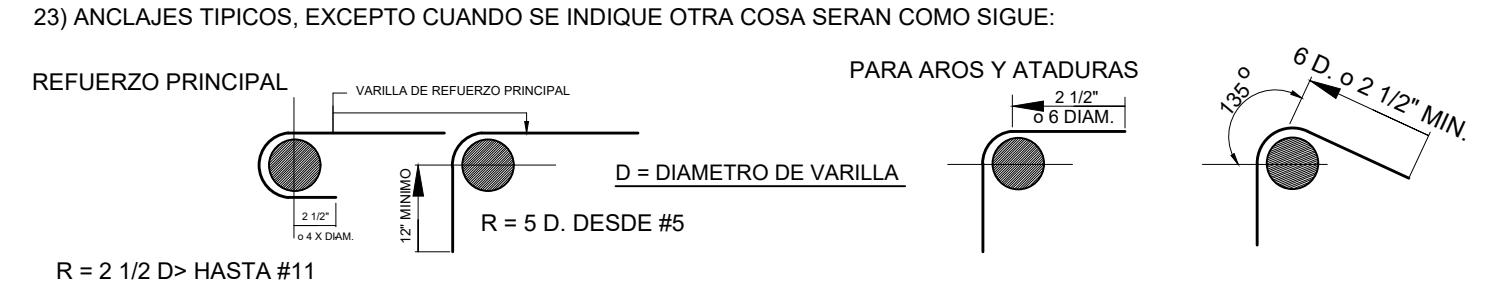
23) ANCLAJES TÍPICOS, EXCEPTO CUANDO SE INDIQUE OTRA COSA SERÁN COMO SIGUE:

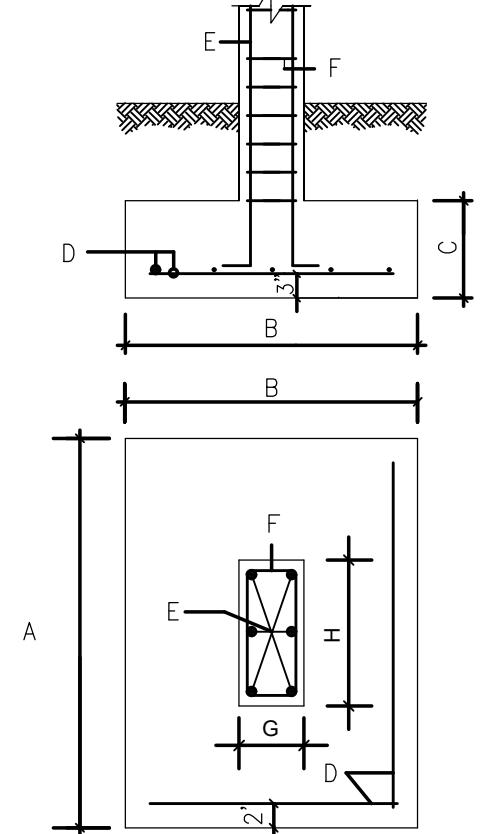
S-1

DETALLE DE COLUMNAS Y ZAPATAS
SIN ESCALA

COLUMNAS	DIMENSIONES ZAPATAS			ACERO DE REFUERZO	
	A	B	C	VARILLAS D	VARILLAS E
C-1	3'-6"	3'-6"	12"	#5 @ 9" C.C.	#5
					#3

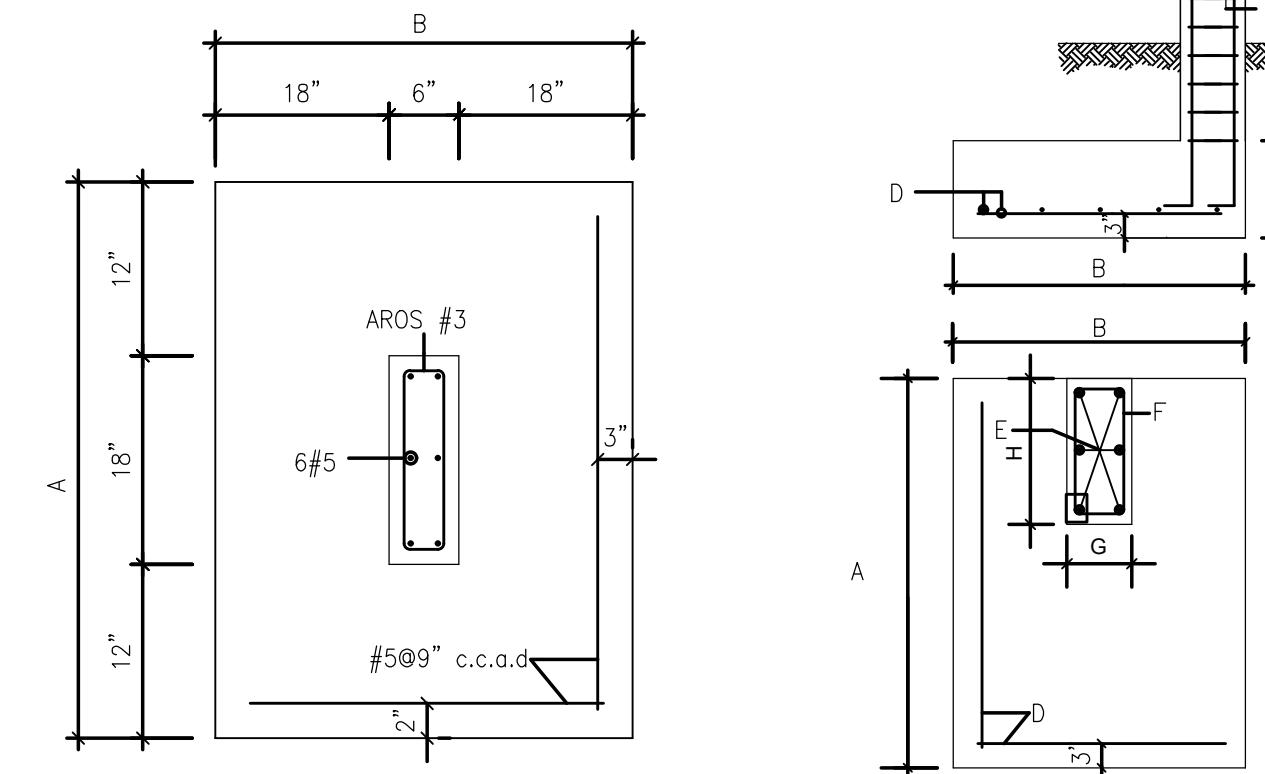
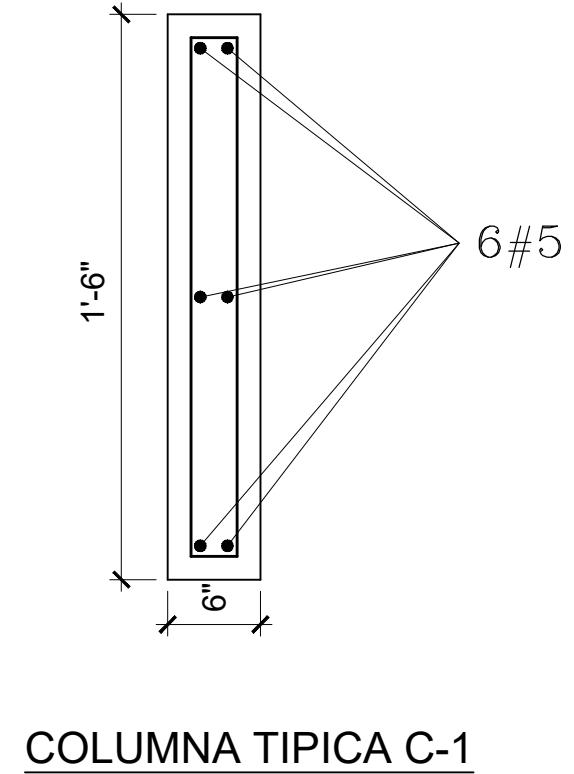
COLUMNA TIPICA C-1
SIN ESCALA

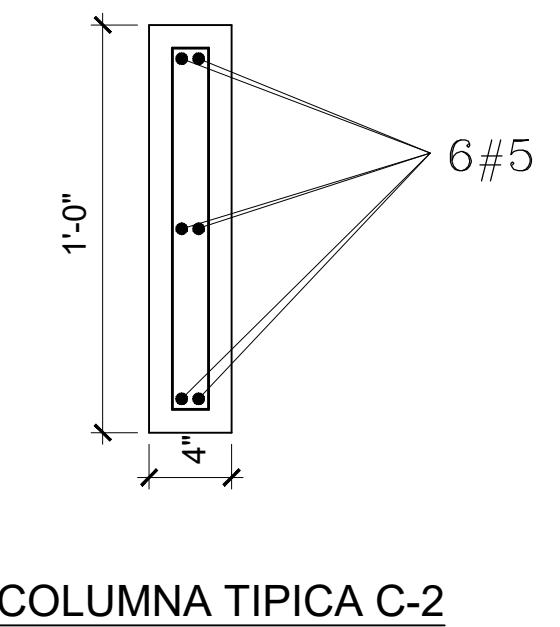
COLUMNA TIPICA C-2
SIN ESCALA

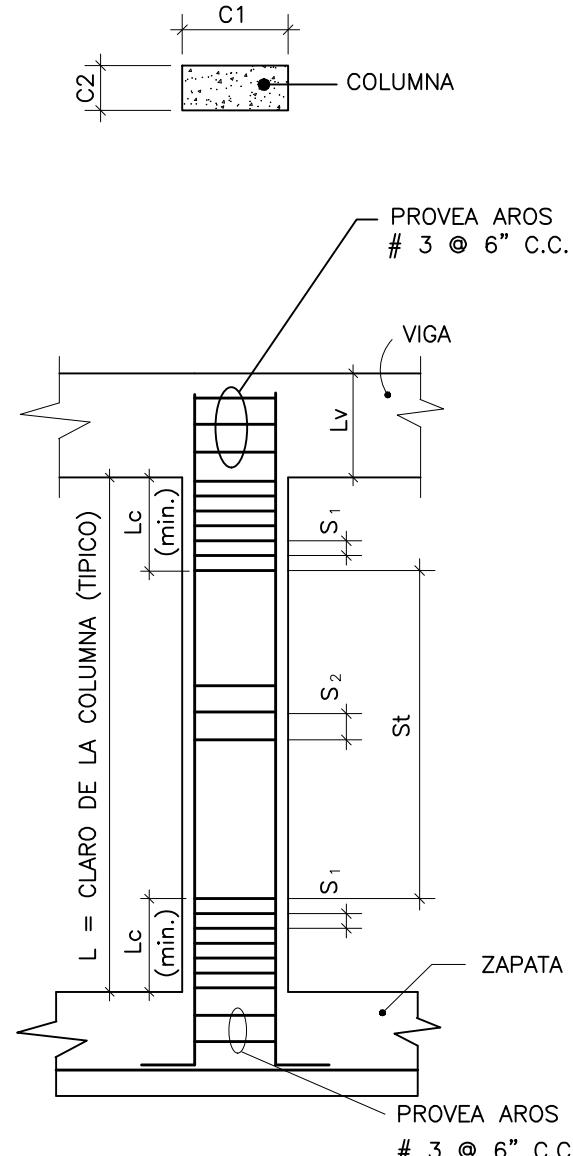
DETALLE TIPICO DE ESPACIMIENTO
DE AROS EN COLUMNAS
SIN ESCALA

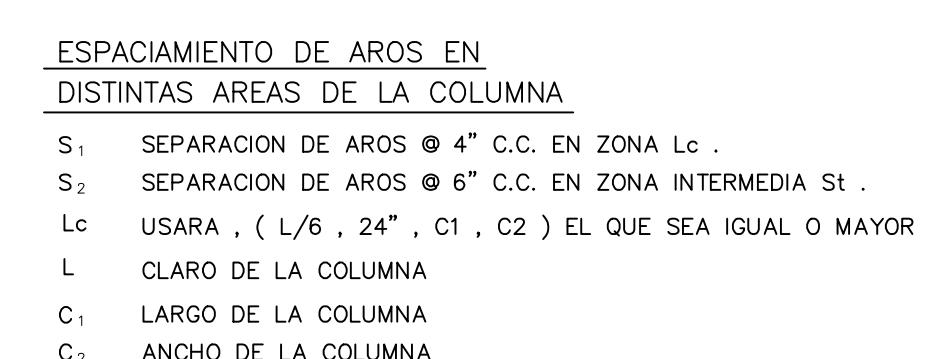
ESPACIMIENTO DE AROS EN
DISTINTAS AREAS DE LA COLUMNA
