**Environmental Review for Activity/Project that is Categorically
Excluded Subject to Section 58.5**

**MUSEO HISTORICO DE QUEBRADILLAS
QUEBRADILLAS, PR**
PR-CRP-000554
CDBG-DR

**Applicant: Municipality of Quebradillas
Prepared by: José D. Centeno Calero PE
Professional Engineer
License 20206
Date: October 23, 2023**

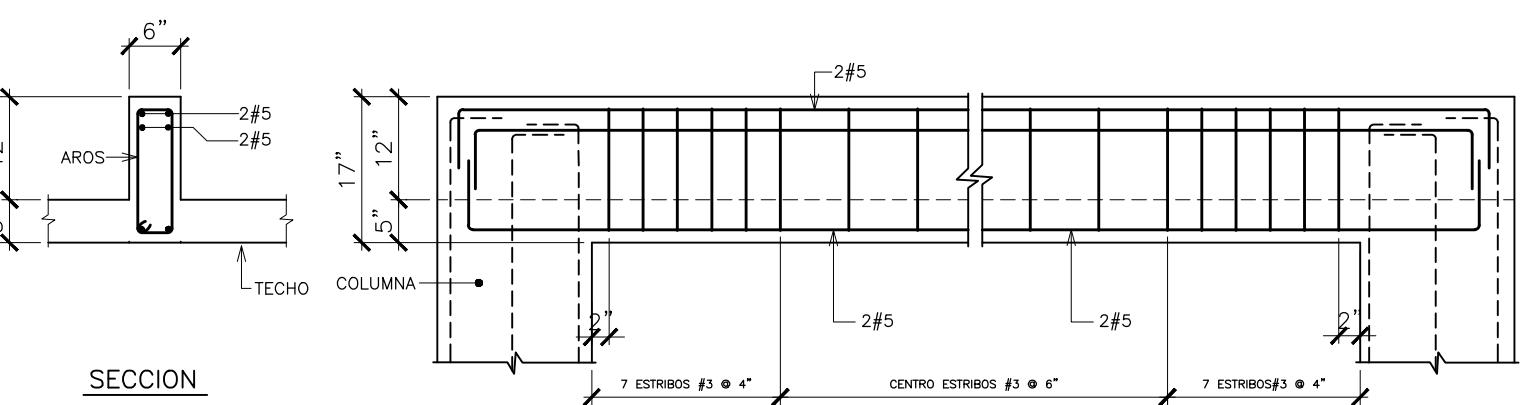
DETALLE DE VIGA VT-1

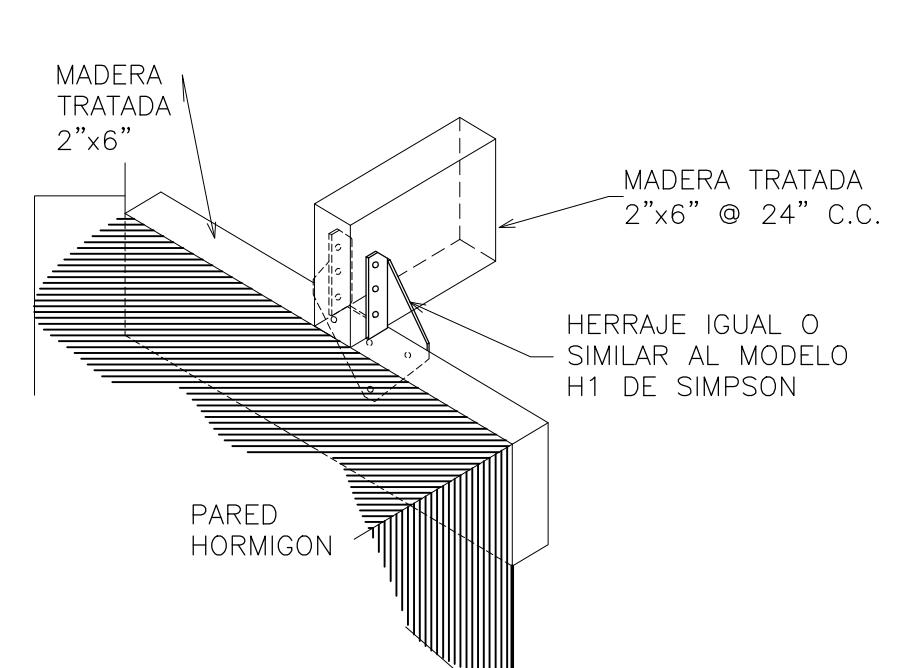
DETALLE DE VIGA VT-2-VIGA INVERTIDA

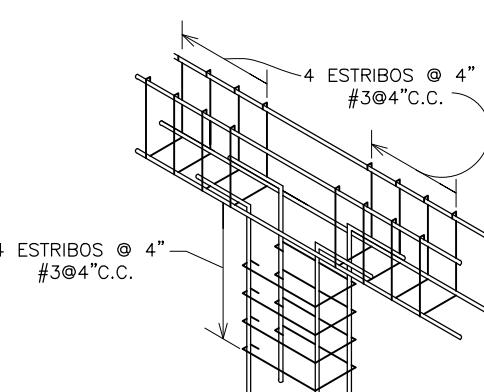
DETALLE AMARE PARA DISEÑO SISMICO ENTRE VIGAS Y COLUMNAS

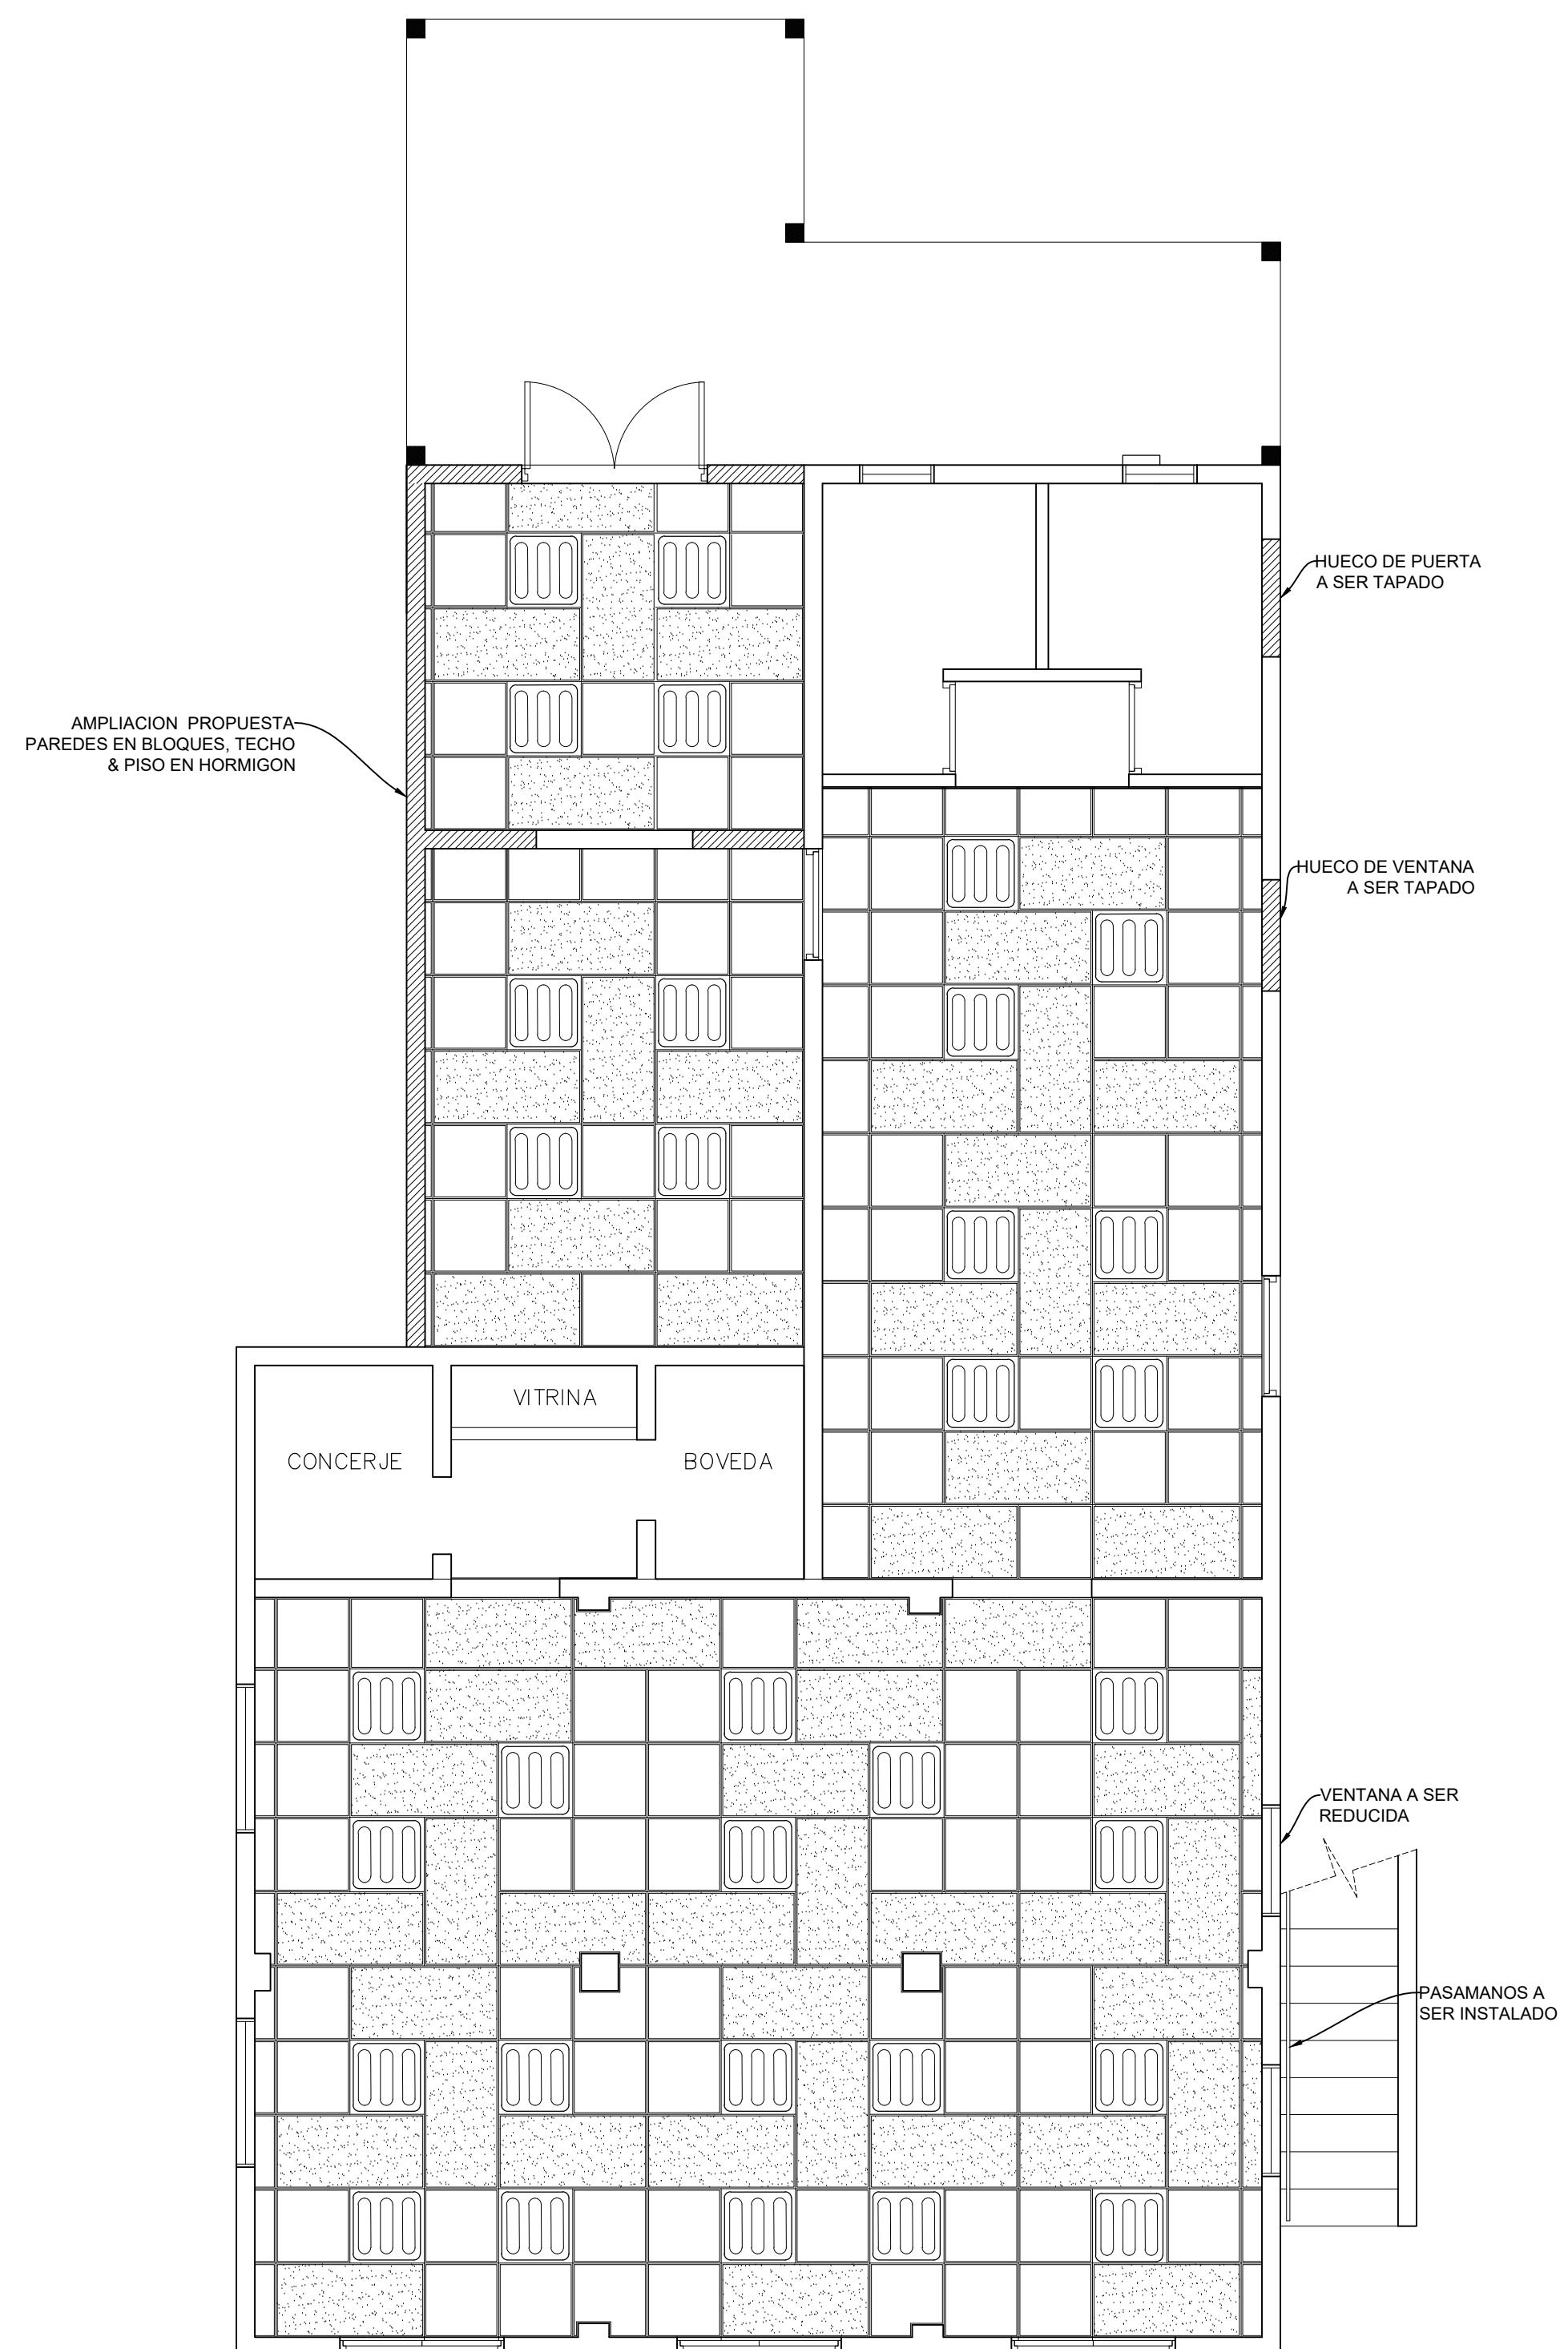
TECHO SUSPENDIDO PRIMER NIVEL (MUSEO)

The existing building plumbing and electrical system will be replaced and/or upgraded. To bring the proper distribution of interior lighting, it is necessary to install a suspended acoustic ceiling.

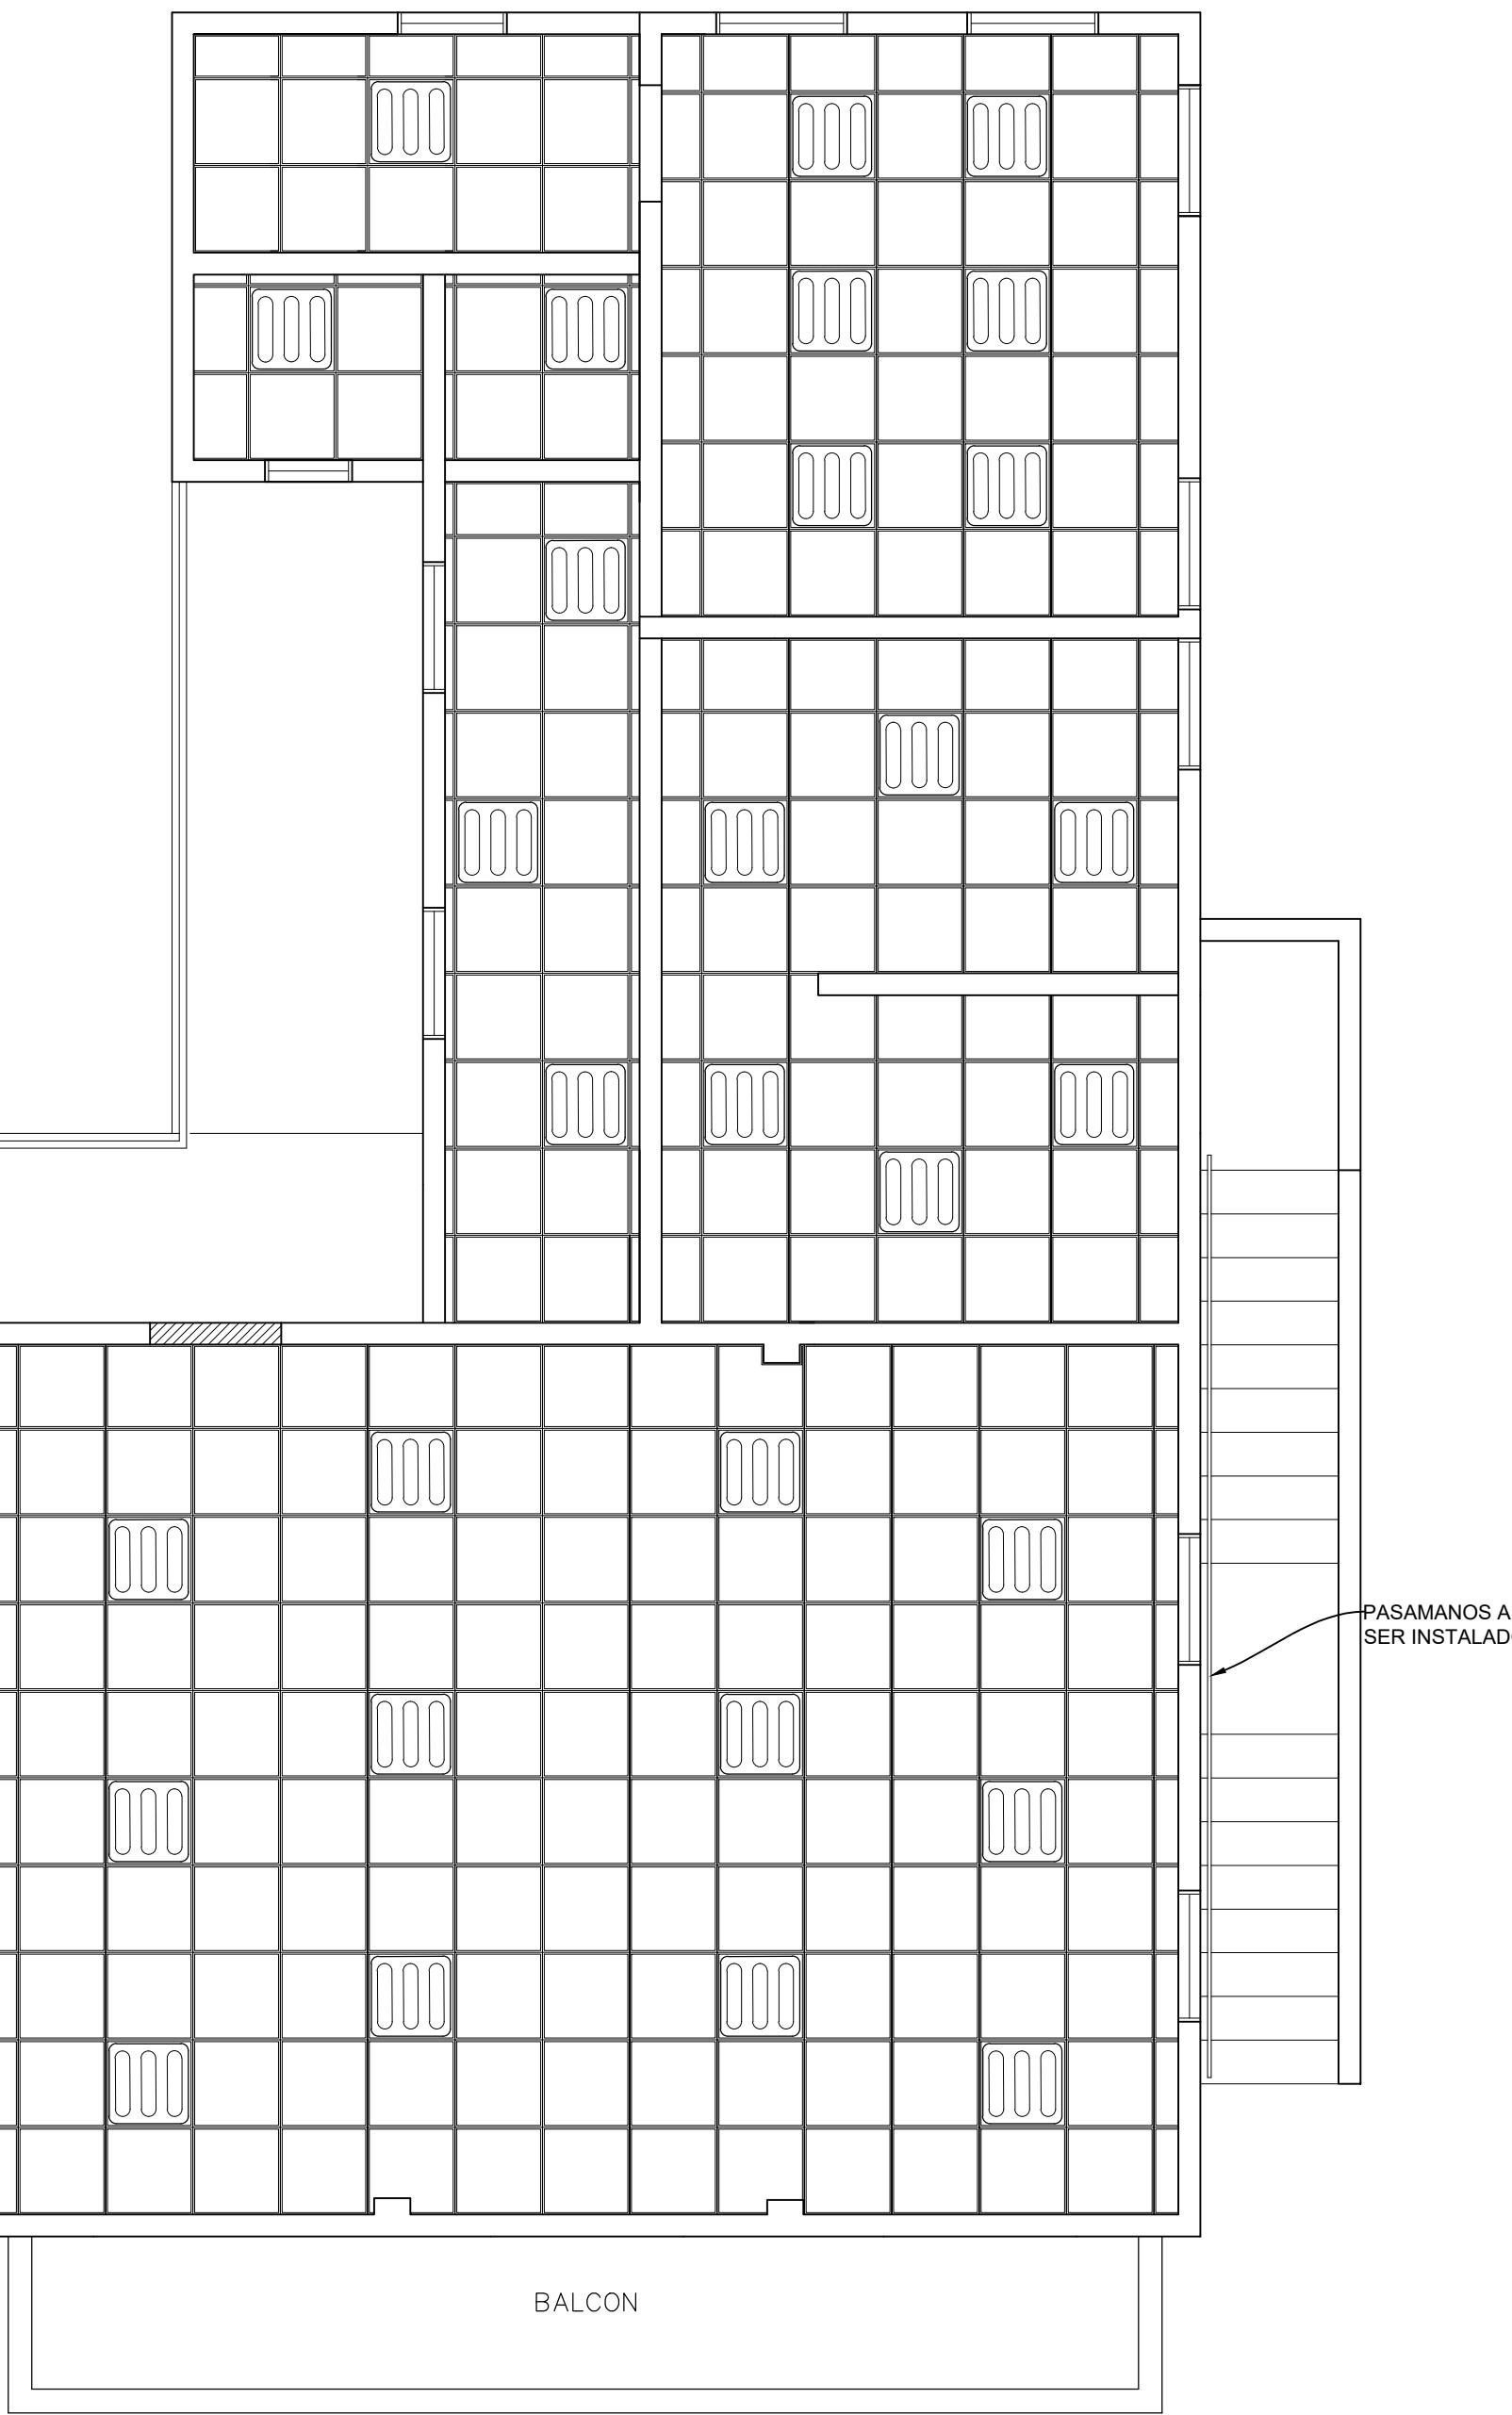
ECHO SUSPENSIÓN SEGUNDO NIVEL (ARCHIVO)

In the second level, it is proposed to repair the door openings using mortar. A new metal ceiling will be installed with a suspended ceiling inside.

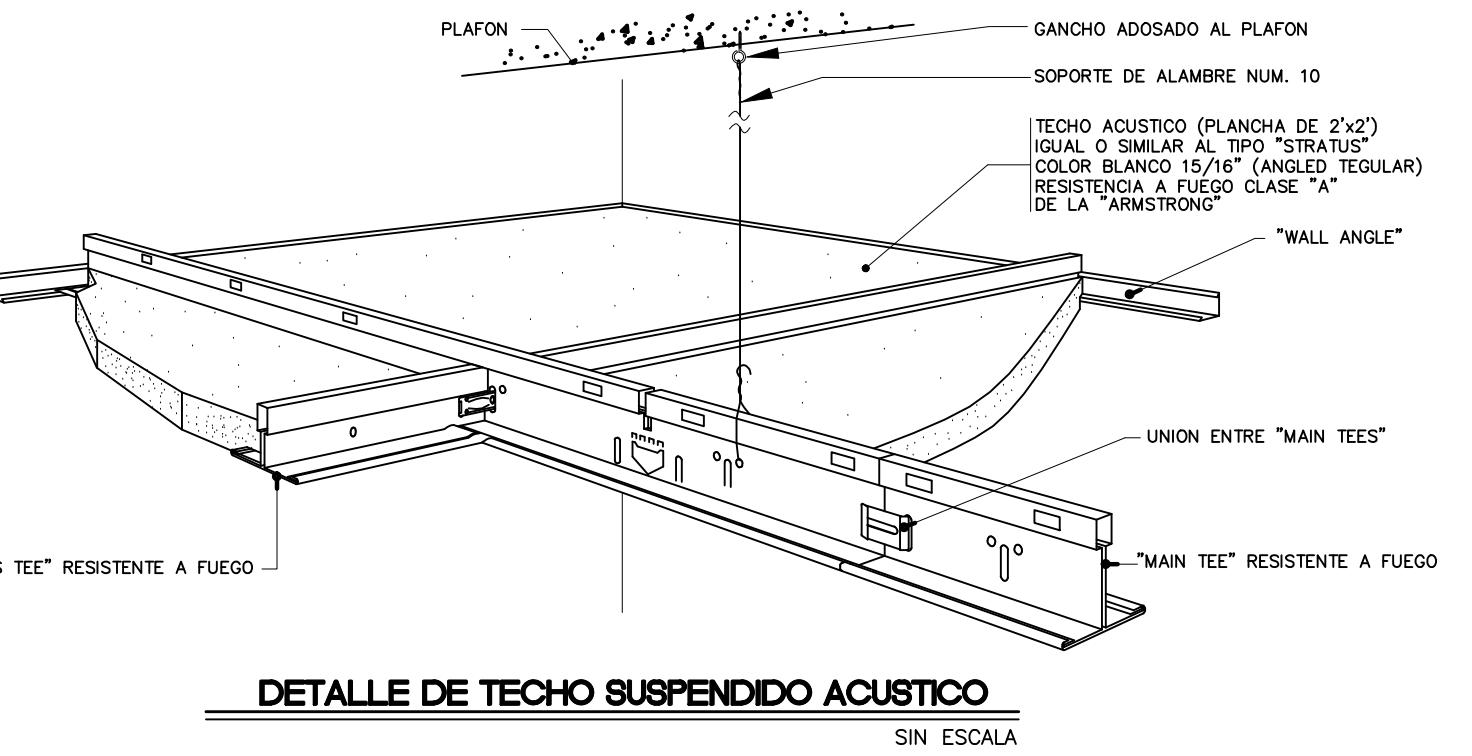
DETALLE DE TECHO SUSPENDIDO ACUSTICO

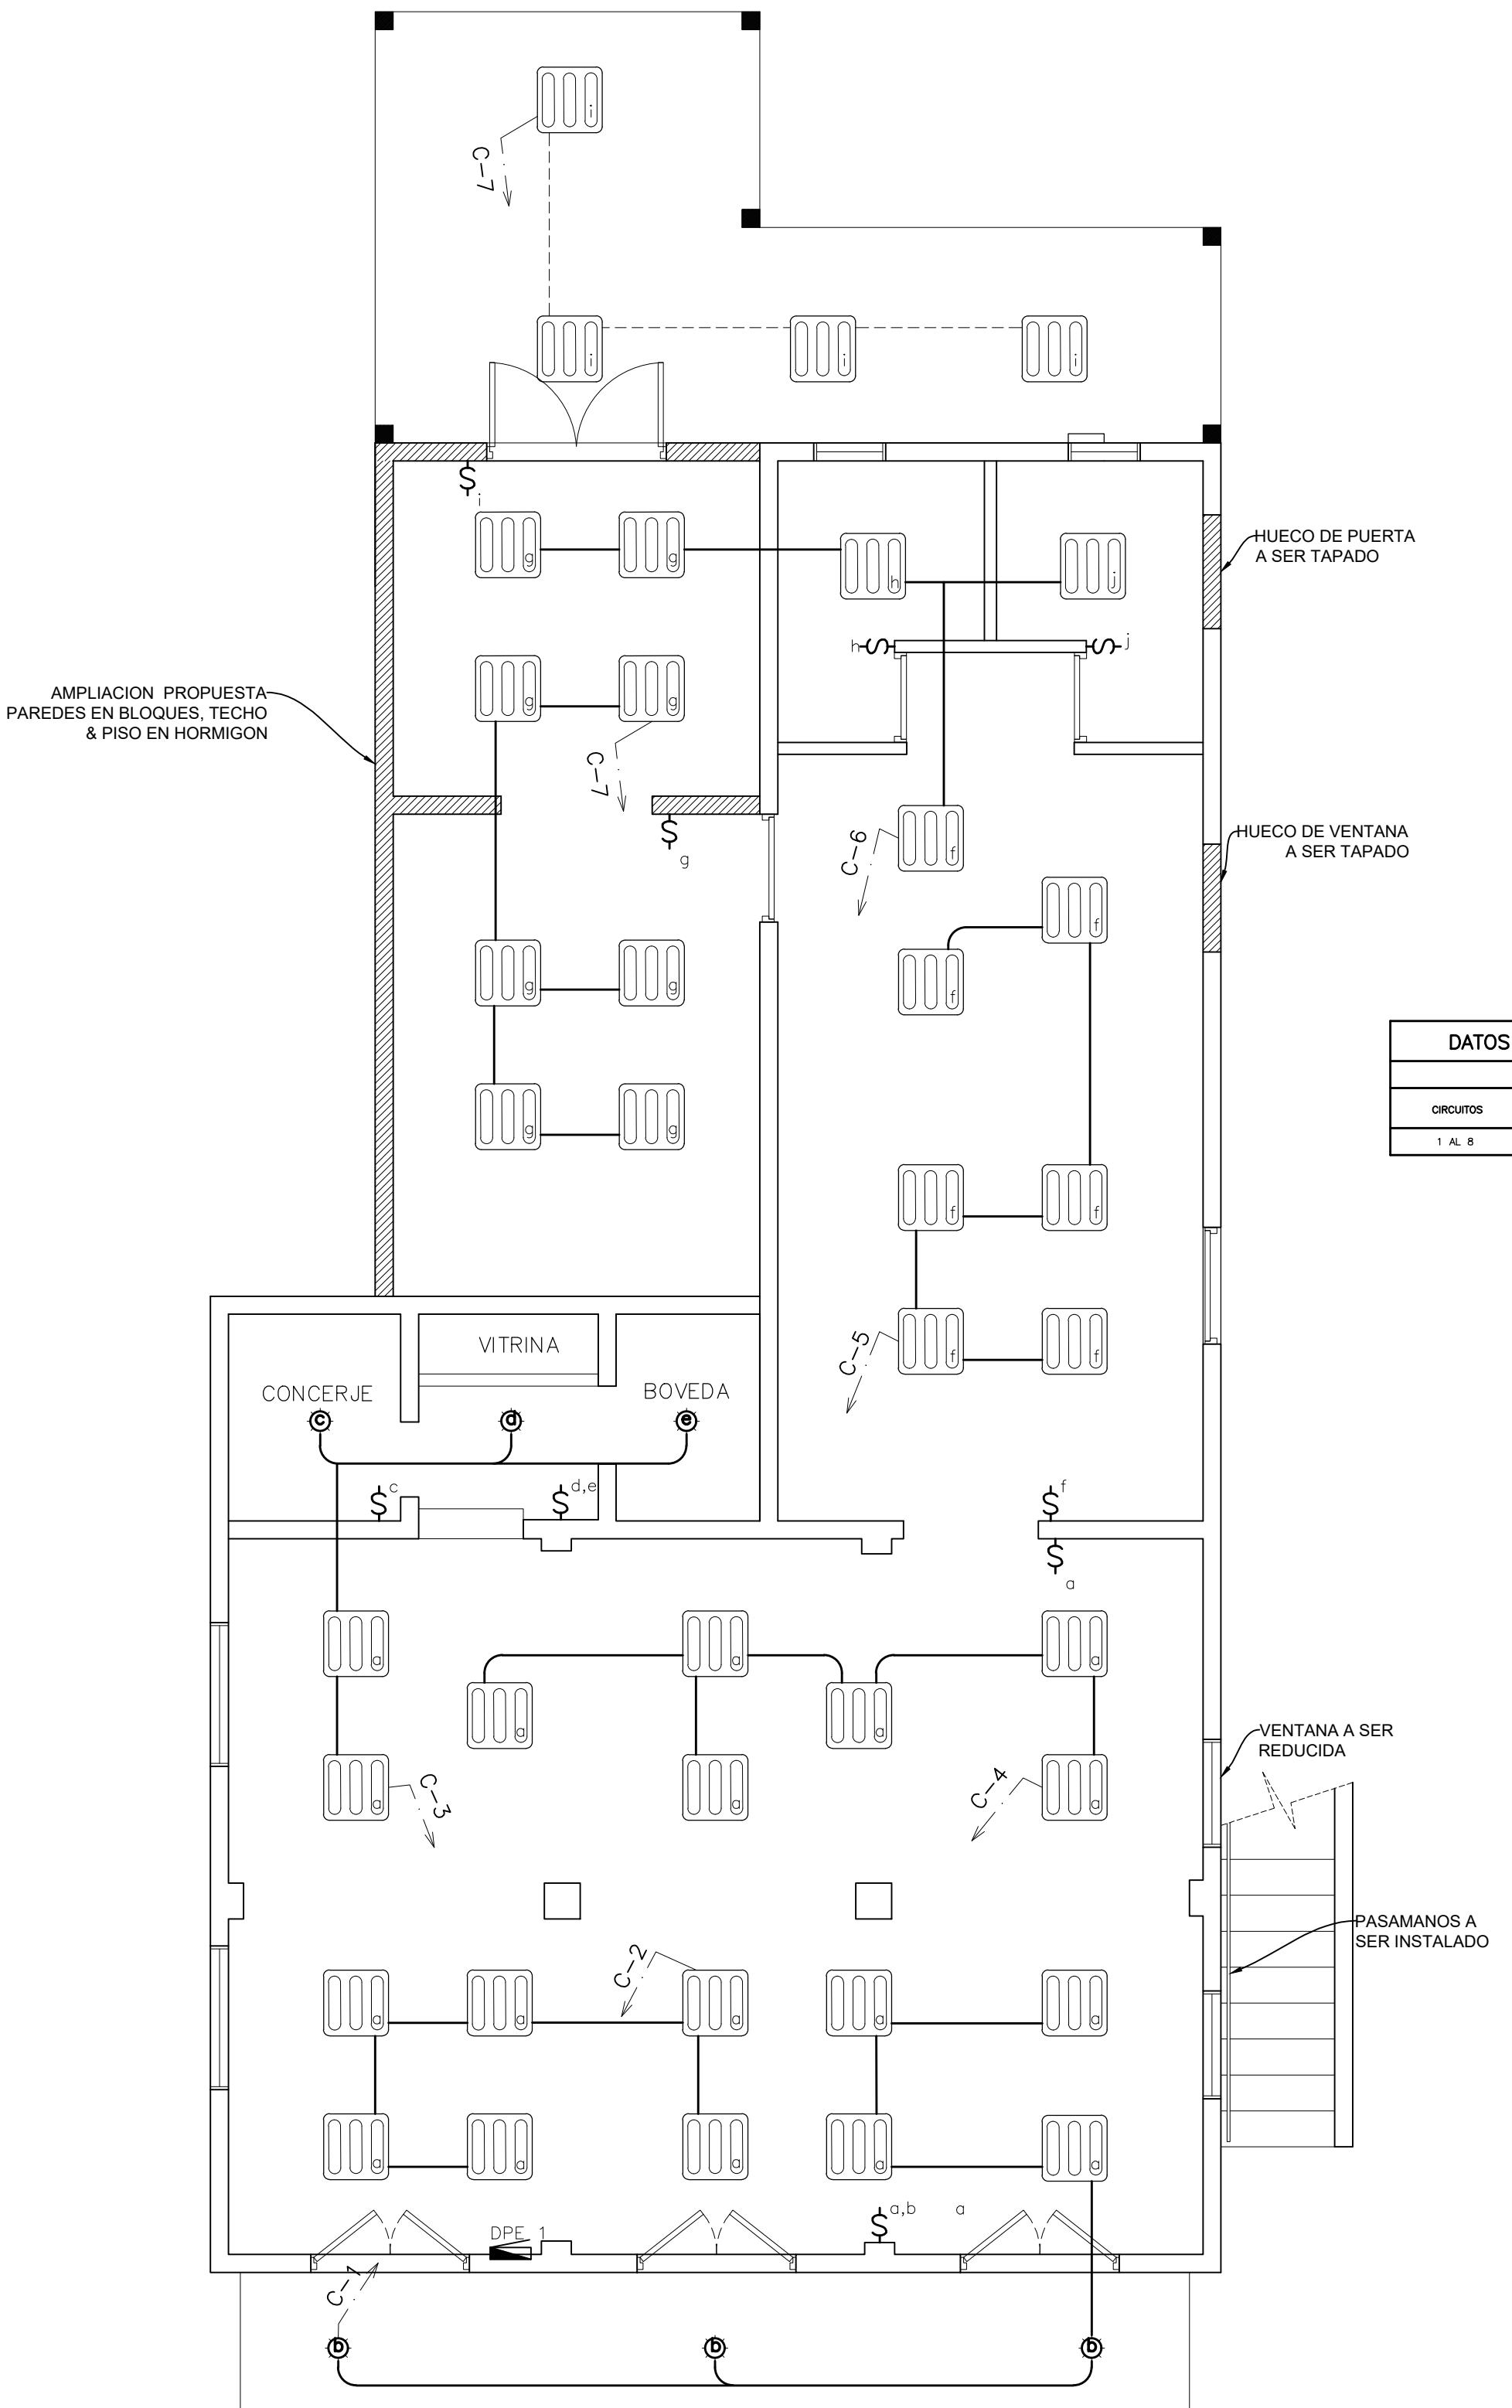
ELECTRICIDAD PRIMER NIVEL (LUMINARIAS)

DATOS DE CIRCUITOS PANEL DE DISTRIBUCION (DPE 1)						
PANEL 120/240 V. - 125 AMP. (MAIN PLUG ONLY)						
CIRCUITOS	USOS	ALAMBRES	PROTECTORES	VOLVOS	TUBO	
1 AL 8	LUZES	3	12	1	20	120 3/4"

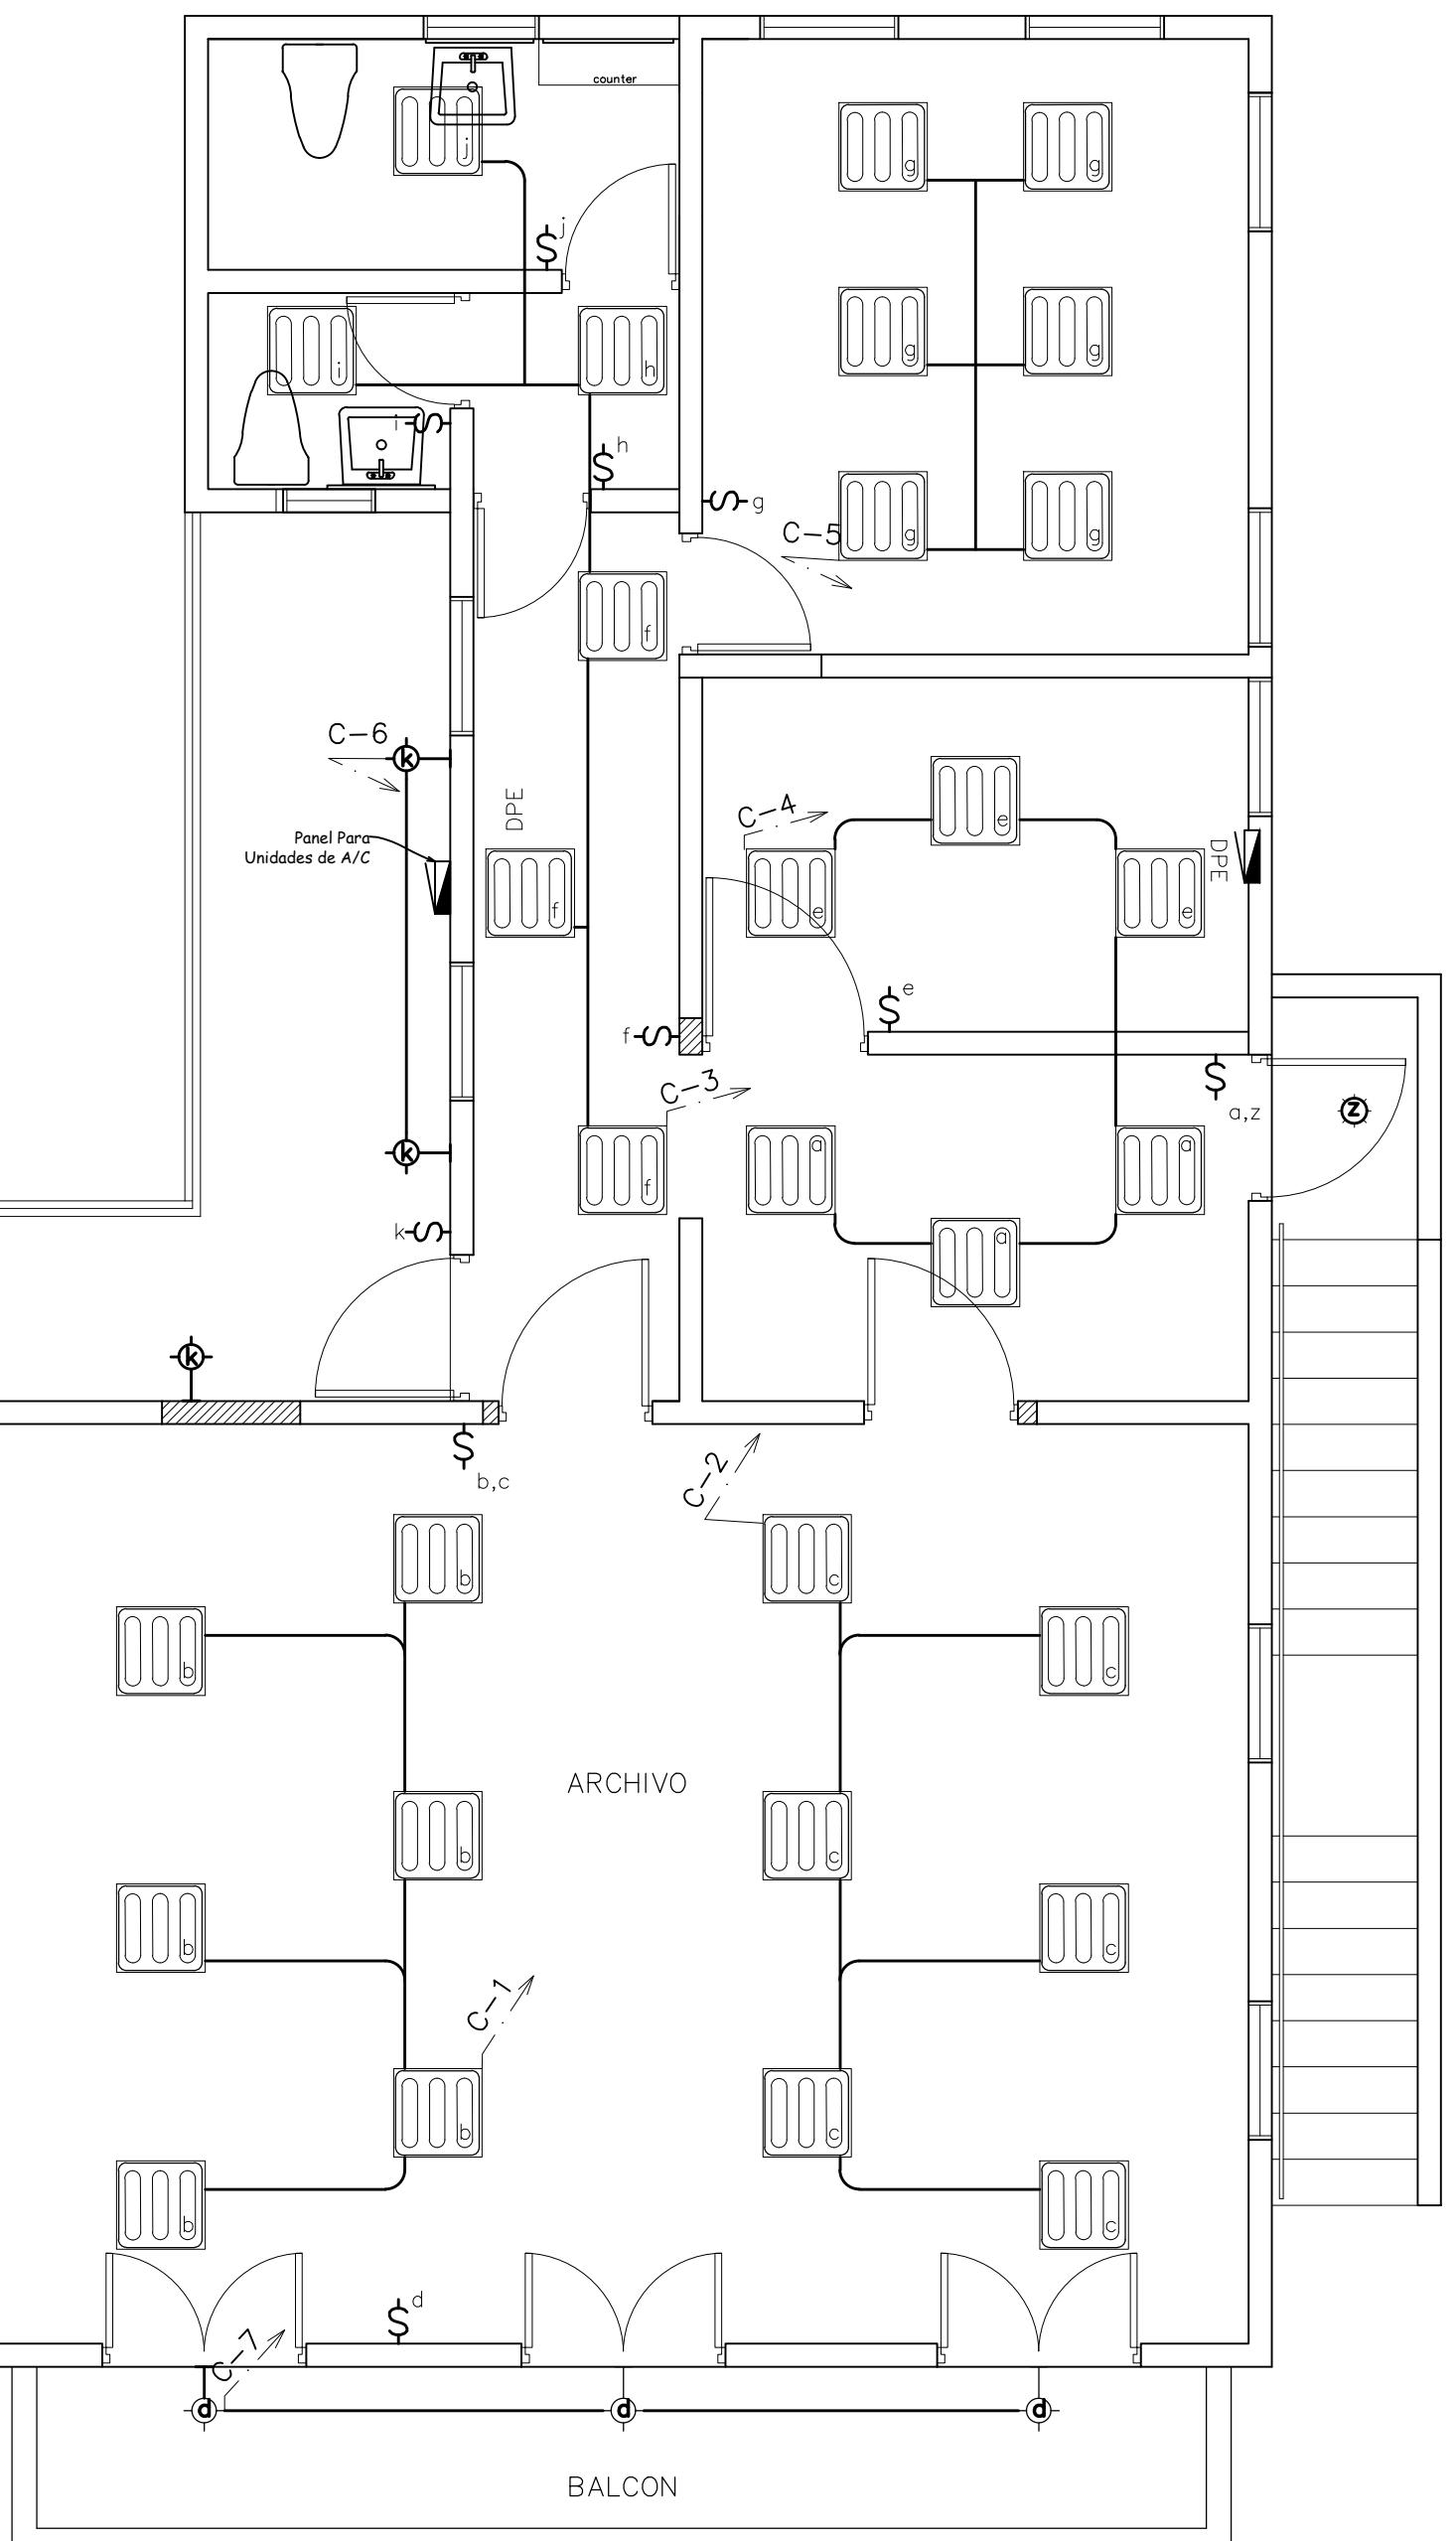
ELECTRICIDAD SEGUNDO NIVEL (LUMINARIAS)

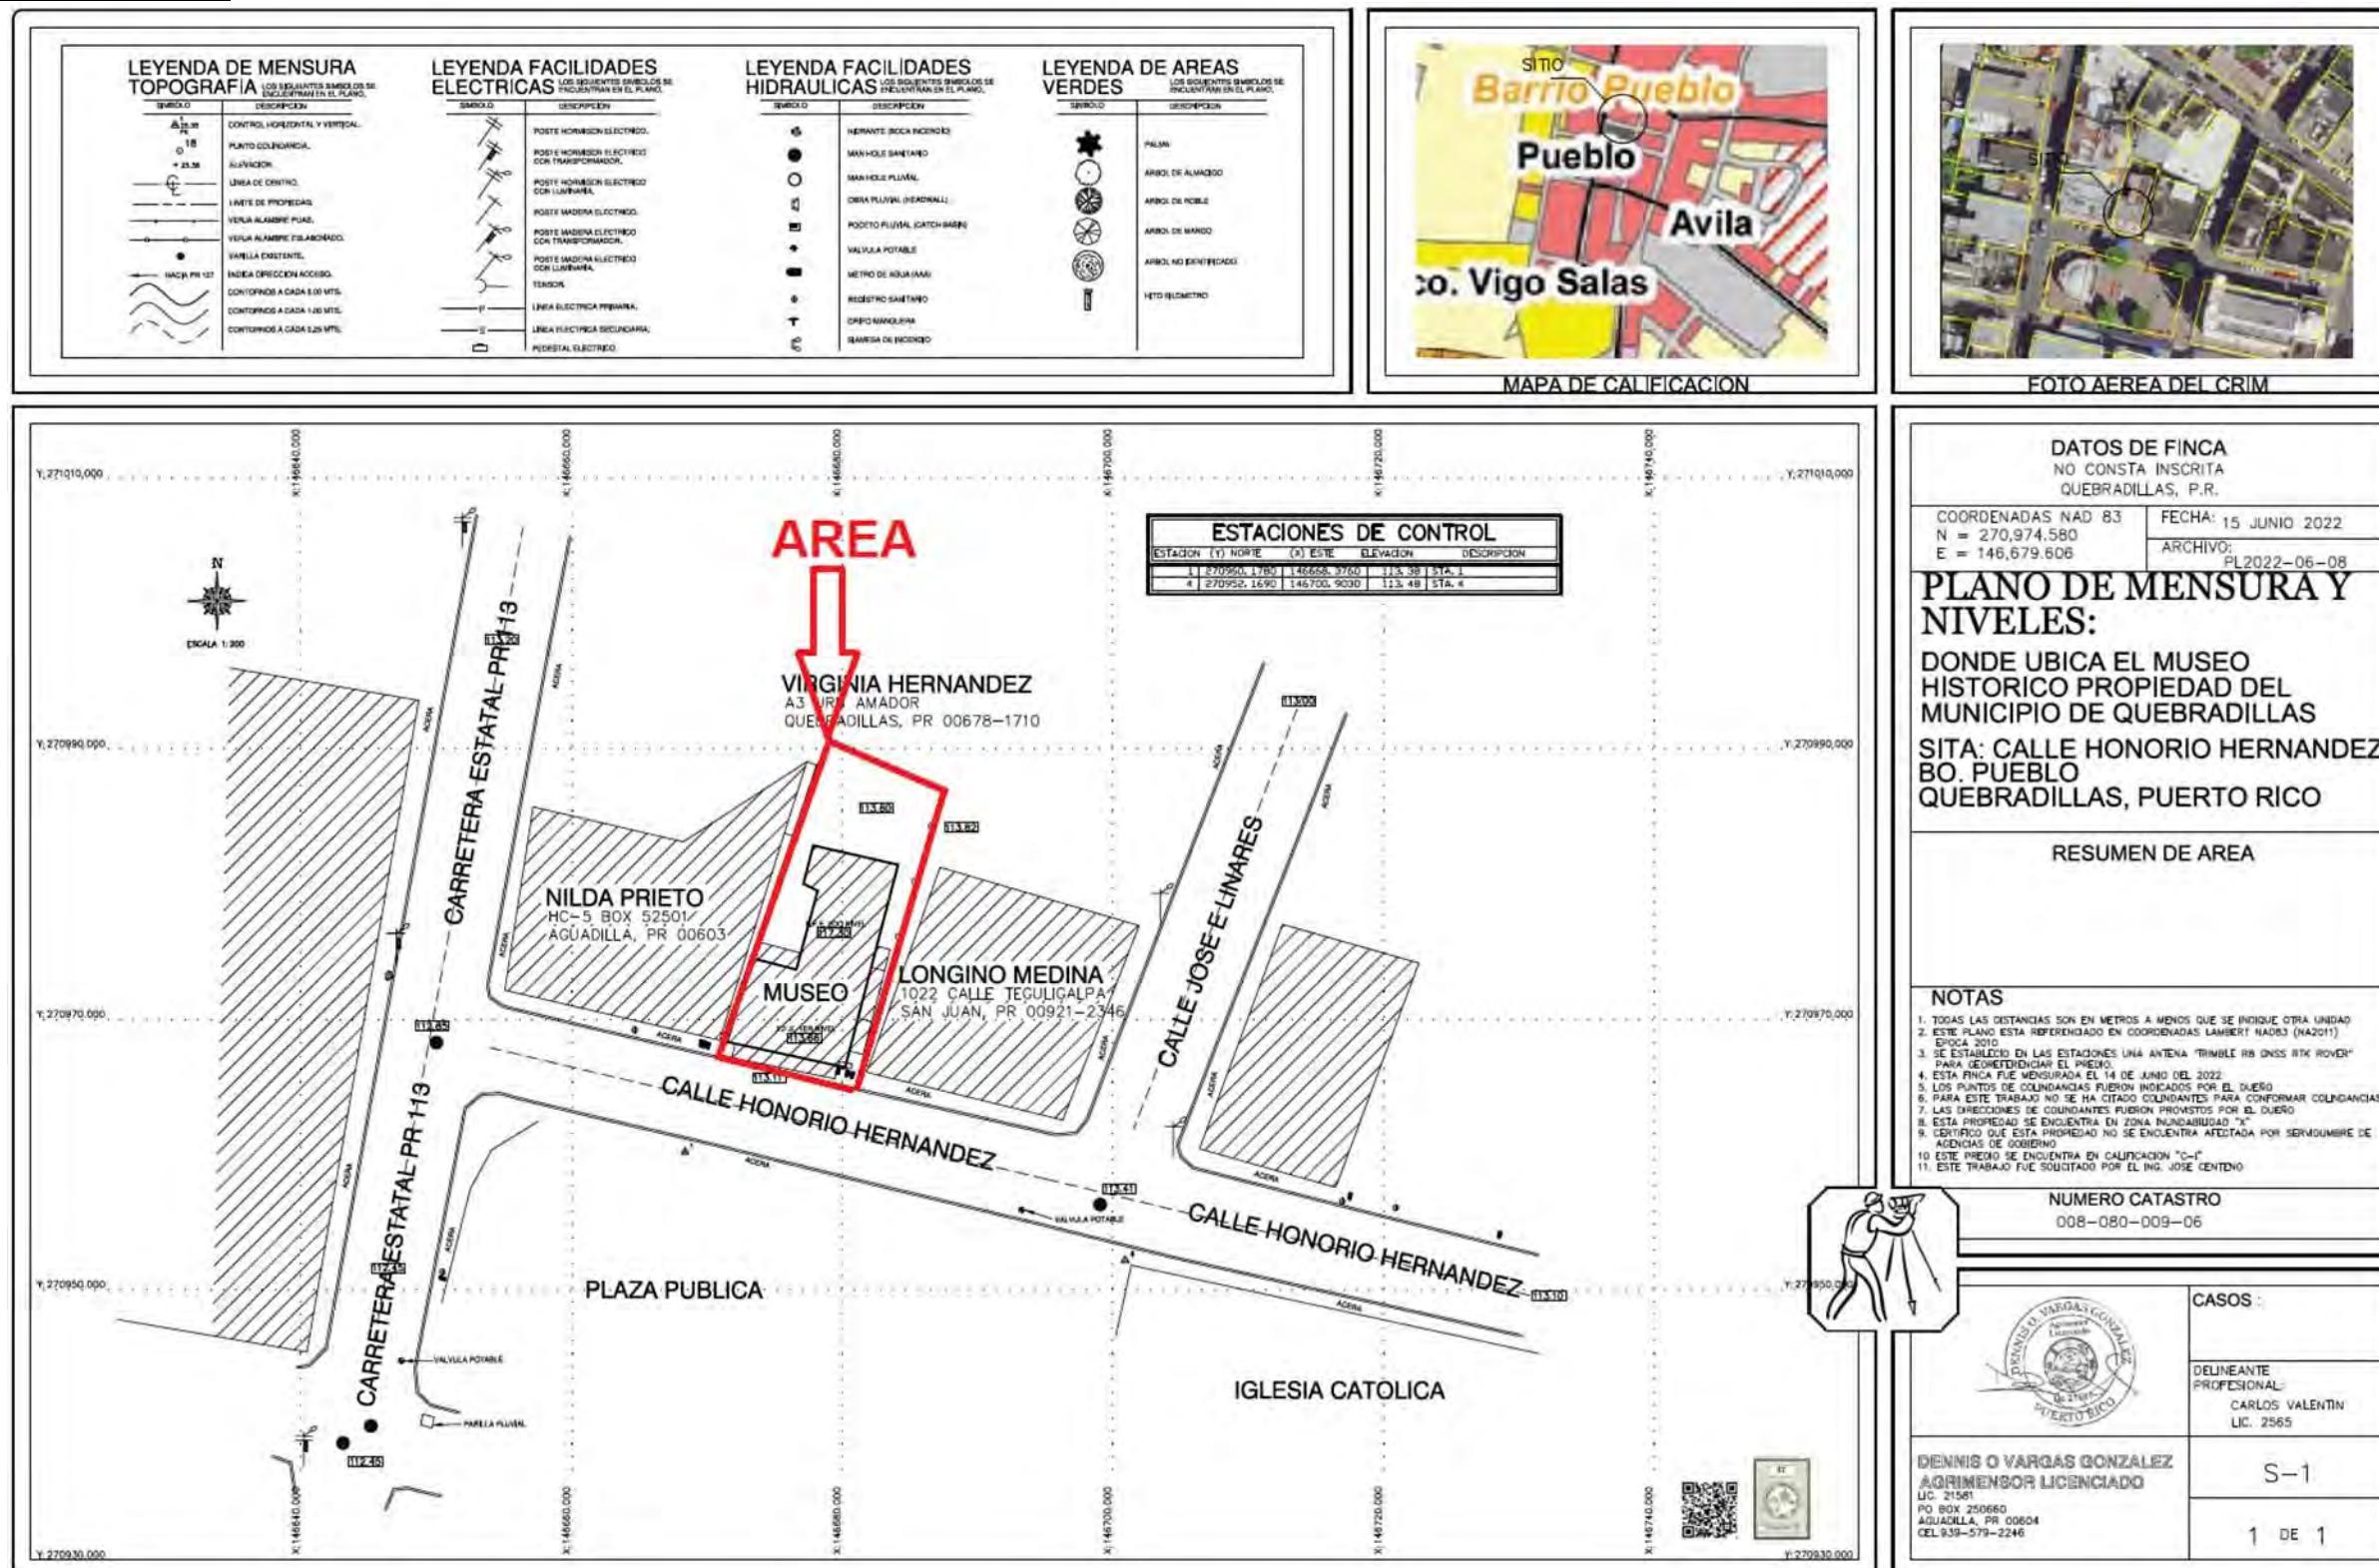
Figura #2 Plano del Proyecto.

La nueva construcción consta de un bloque de concreto de 23.25 pies (7.088 m) por 10.25 pies (3.125 m) y expansión del bloque para incluir una sala de exposición en el primer piso y proporcionar acceso al patio trasero. En el segundo piso hay dos baños y un pasillo. Además, se crearán dos nuevos baños en el primer nivel en la parte trasera del edificio. Ocuparán un área de 11'-10" por 8'-0" (94.667 pies cuadrados o 8.8 m²) y tendrán acceso solo desde adentro. El sistema eléctrico y de plomería del edificio existente será reemplazado y/o actualizado. Se sustituirán o modernizarán las instalaciones eléctricas y de fontanería del edificio y se instalará un techo acústico suspendido. En el segundo nivel se propone reparar los huecos de las puertas con mortero y un nuevo metal. En el patio se propone construir una terraza en forma de L que ocupa un espacio de 206 pies cuadrados (19.148 m²). El lote donde se ubica el proyecto tiene una superficie de 233 metros cuadrados. Los dos pisos de la estructura existente tiene un área de ocupación de 1,304 pies cuadrados (121,2076 metros cuadrados). El nuevo el área de ocupación será de 1,627 pies cuadrados (151,2307 metros cuadrados).

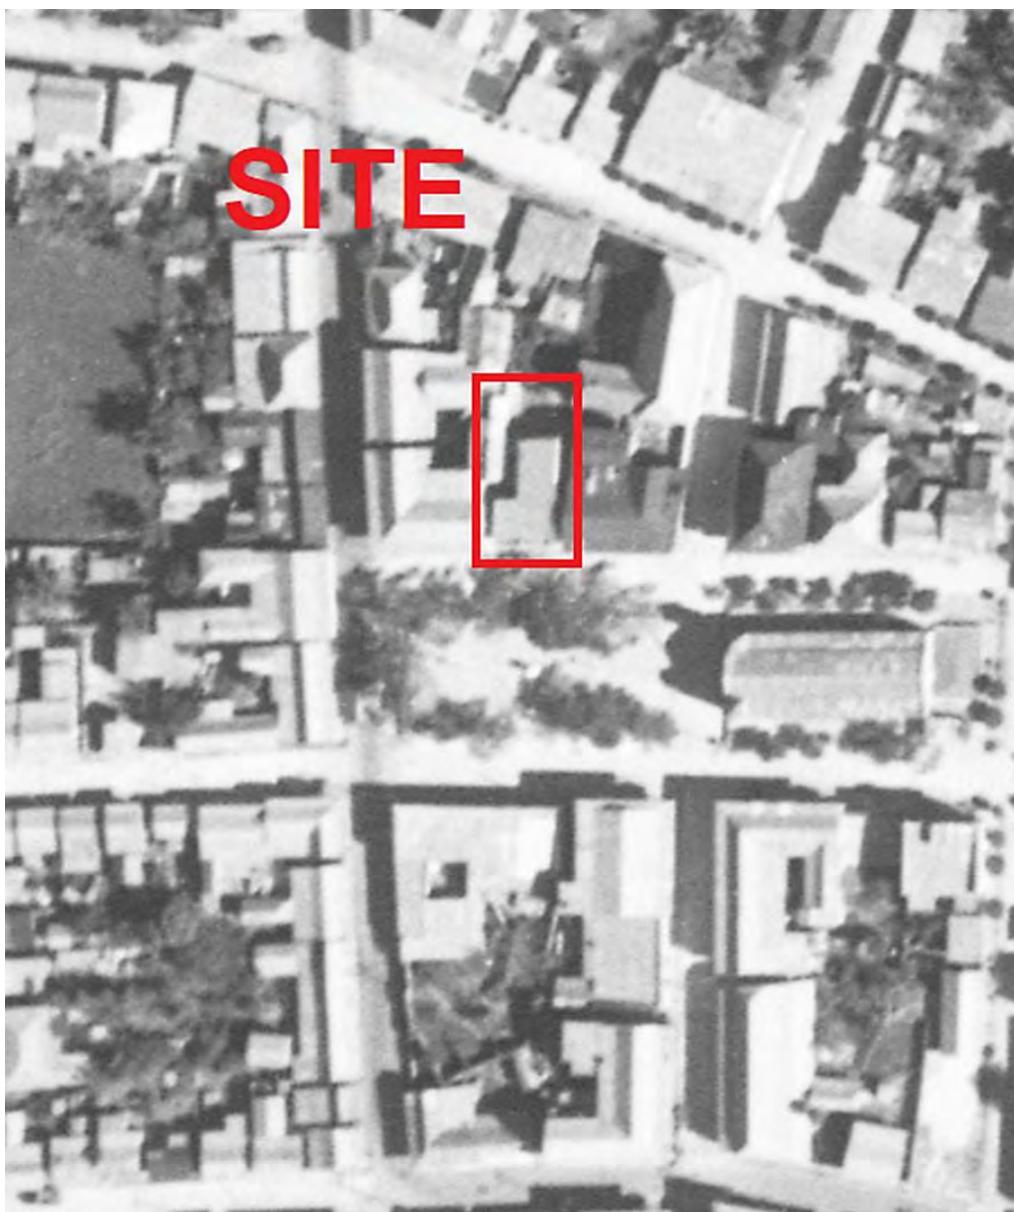
Figure 11: Quebradillas Urban Center Aerial photo in 1931, DTOP.

In 1931, the hammer-shaped building is observed in the parcel under evaluation.
