**Environmental Review for Activity/Project that is Categorically
Excluded Subject to Section 58.5**

**MUSEO HISTORICO DE QUEBRADILLAS
QUEBRADILLAS, PR**
PR-CRP-000554
CDBG-DR

**Applicant: Municipality of Quebradillas
Prepared by: José D. Centeno Calero PE
Professional Engineer
License 20206
Date: October 23, 2023**

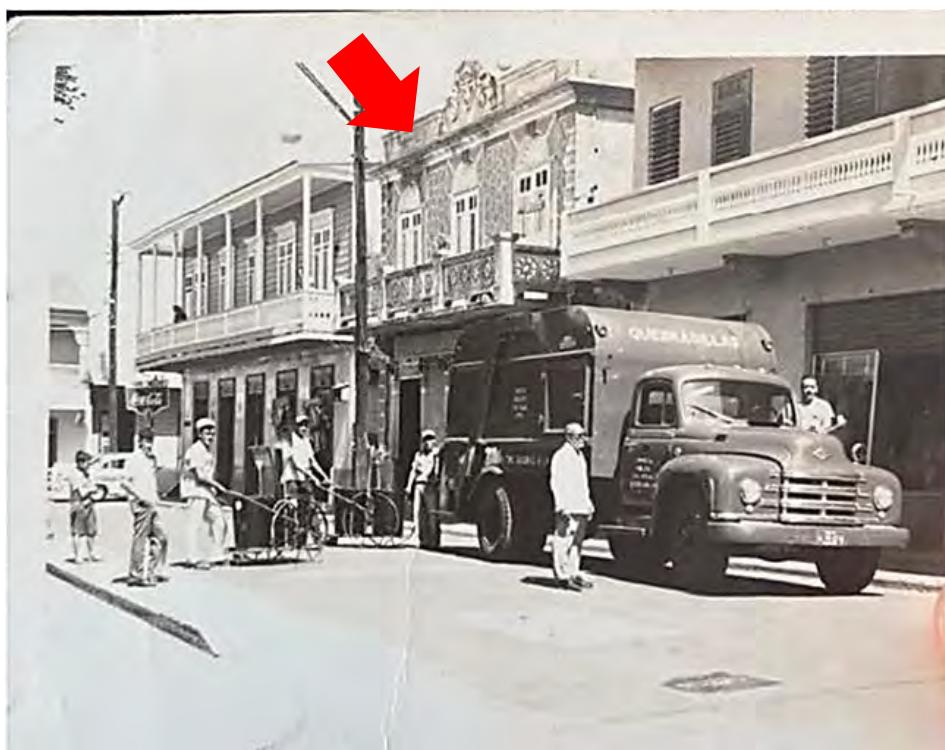
Figure 14: Historical photograph of Honorio Hernández Street. The existing building in the project parcel is observed in good condition c. 1950.

The structure under evaluation is considered an architectural historical resource. The historical photograph of the building in the 1950s (Figure 14), gives us the information of its historical character and its original architectural style *Neoclassical-Colonial of the early twentieth century (1918)*. As part of the Phase I research for this project an architectural evaluation of the building was made by Conservationist Architect Carlos Ferrán. A technical report "**EVALUATIVE REPORT OF THE CULTURAL HERITAGE OF ARCHITECTURE... patrimonial resource in Quebradillas de Puerto Rico, July 2022**" was performed.

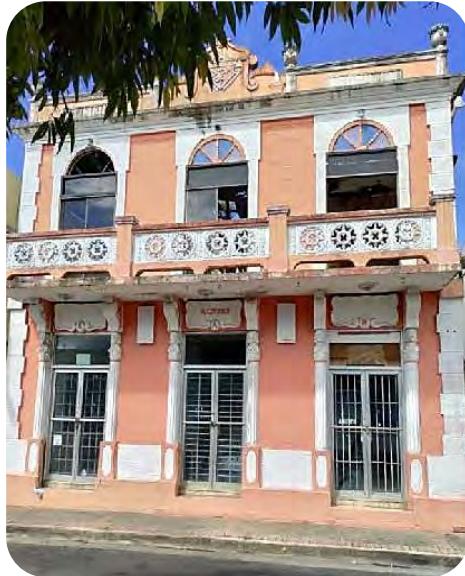
Photo: #01

Description: South view and main façade located at Honorario Hernández Street

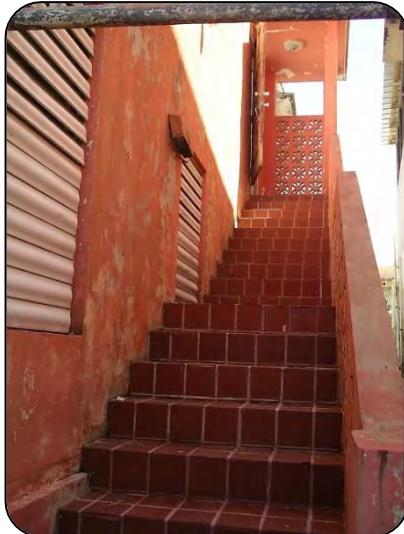
Photo: #02

Description: South-East view. Stairs on side courtyard to second floor.

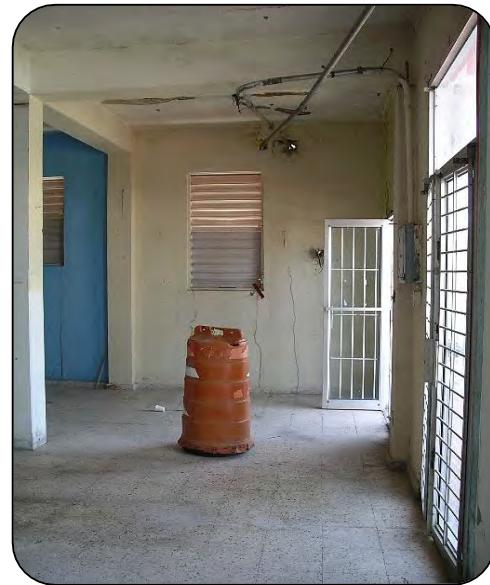
**Photo: #03****Description:** South, entrance from main façade, interior view of building. Concrete columns and beams.**Date: 07/22/22**

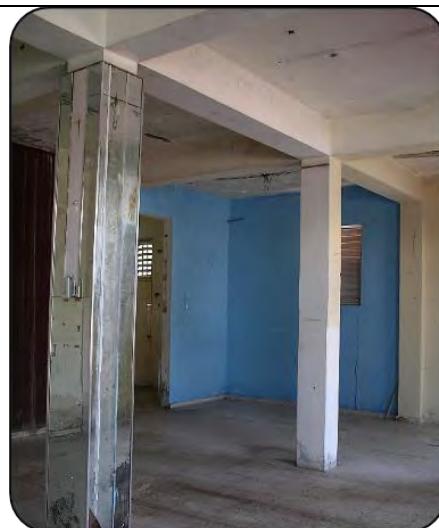
**Photo: #04****Description:** South, entrance from main façade, interior view of building. Concrete columns and beams.**Date: 07/22/22**

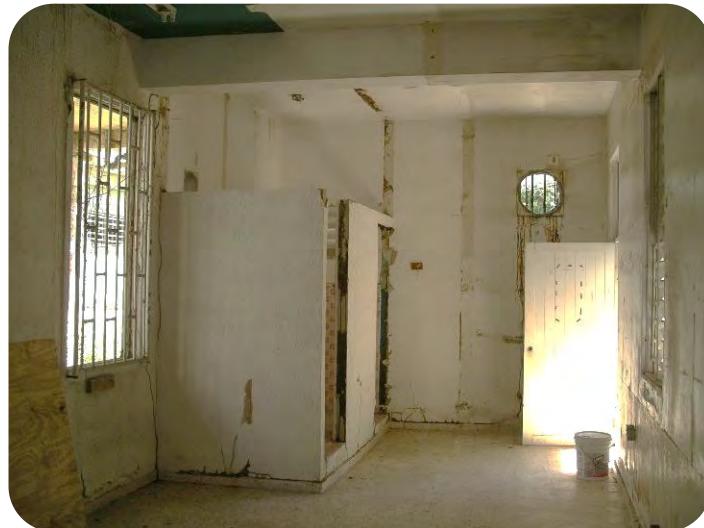
Photo: #05

Description: First floor level. South towards North side interior view of nave. Concrete roof walls and roof. Terrazzo tiles finished floor.

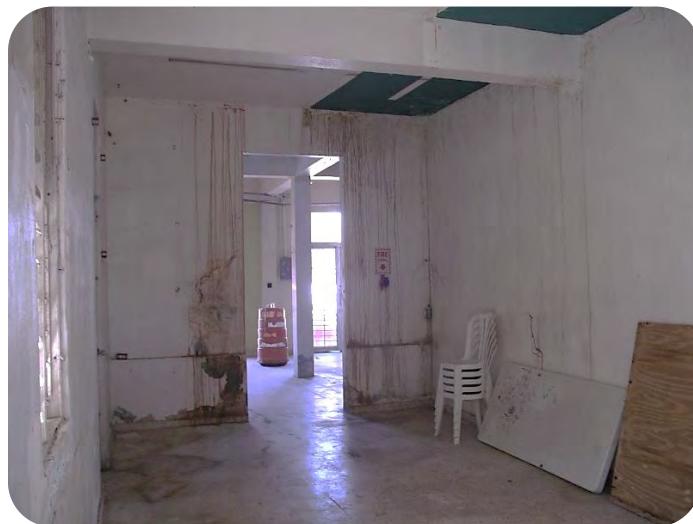
Photo: #06

Description: First floor level. North towards South, interior view of nave. Concrete roof, beams and walls. Terrazzo tiles finished floor.

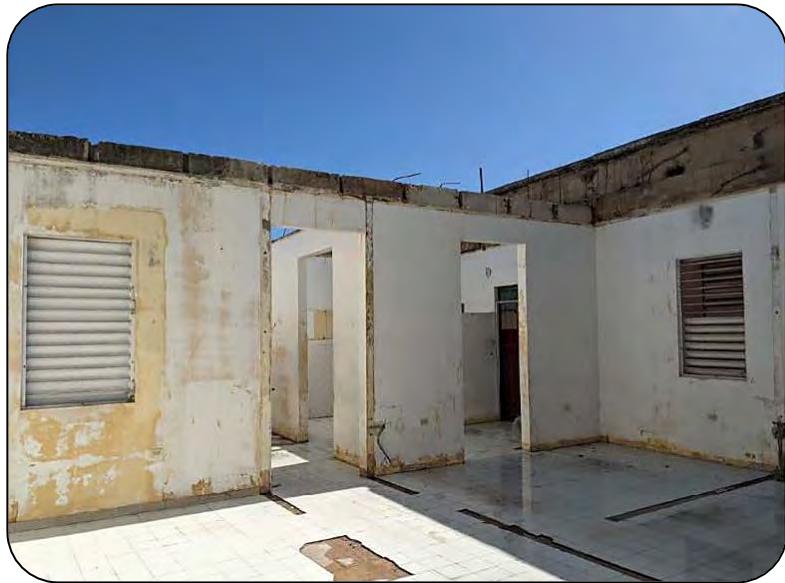
Photo: #07

Description: Second floor level interior. South view towards North. Concrete walls and floors with ceramic tiles over hydraulic concrete tiles finish. Roof is missing.

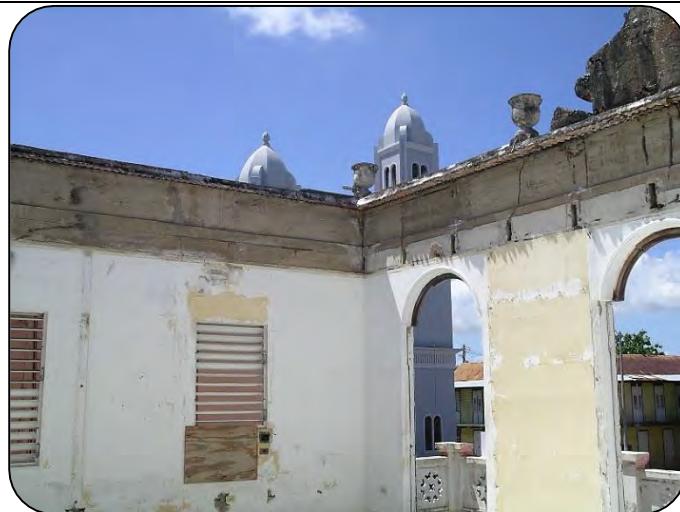
Photo: #08

Description: Second floor level interior. North view towards South and main façade balcony. Concrete walls and floors hydraulic. Roof is missing.

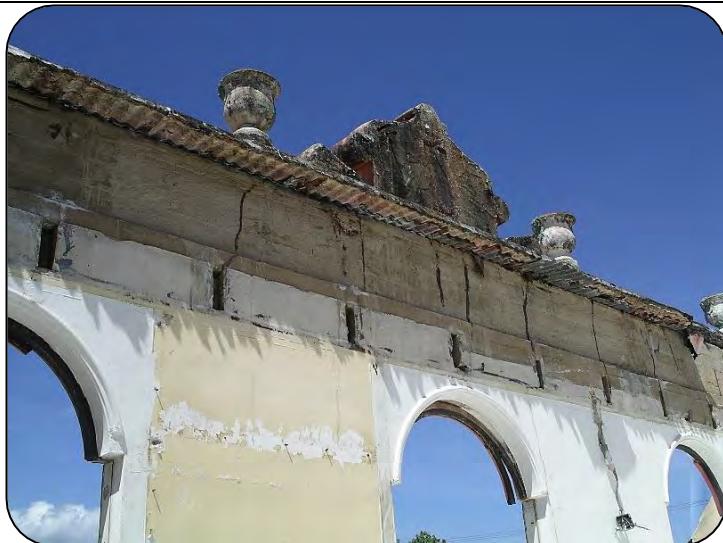
Photo: #09

Description: Second floor level interior. South view and main façade posterior concrete wall with arched doors fenestrations. Coat of arms at center of parapet with urns.

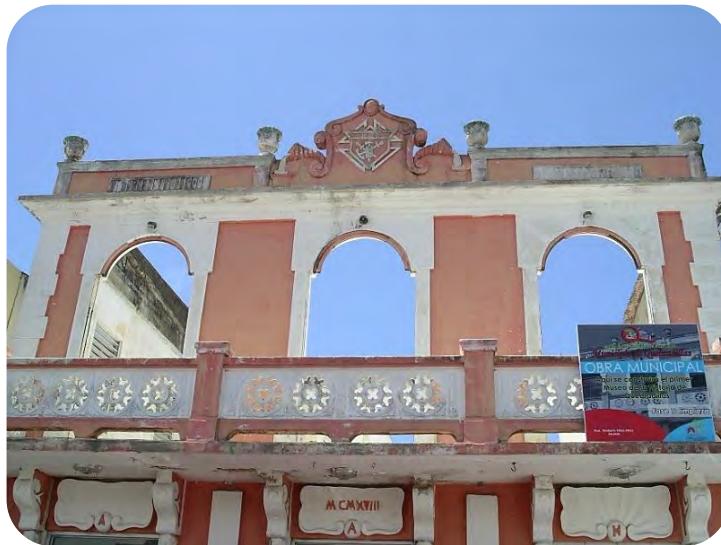
Photo: #10

Description: South view of second floor level main façade. Concrete wall with arched doors fenestrations and decorative elements on wall surface and balcony

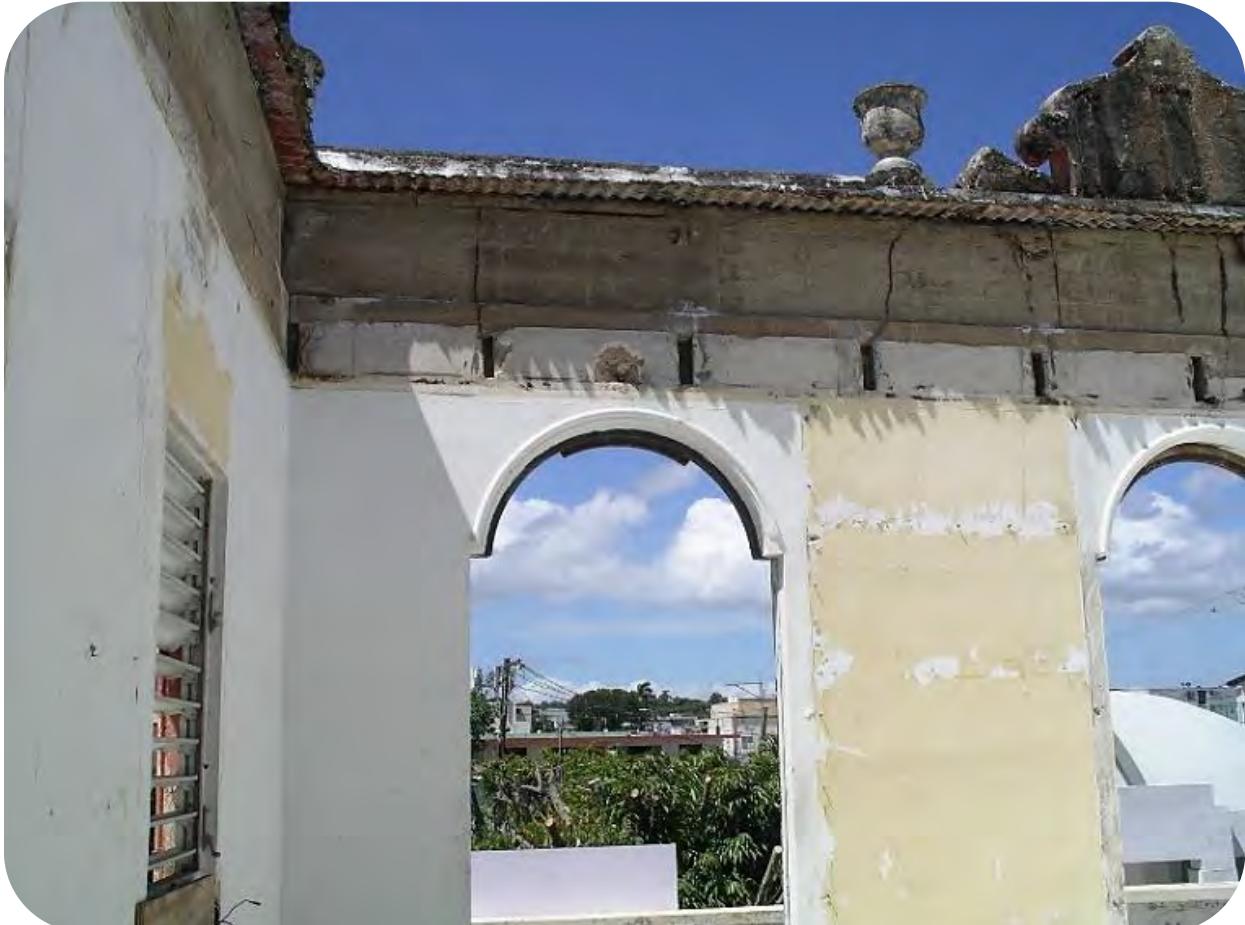
Photo: #11

Description: Second floor level interior. South view and main façade posterior concrete wall with arched doors fenestrations. Roof's wood beams wall connection shown.

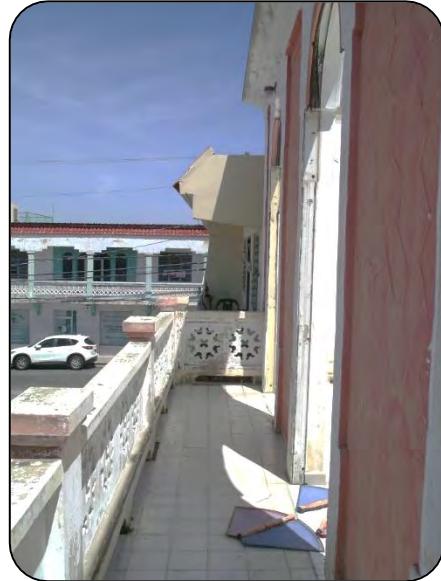
Photo: #12

Description: West view on second level's balcony area.

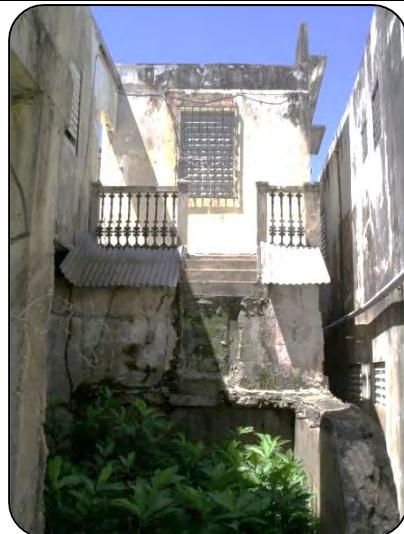
Photo: #13

Description: North towards south. Interior courtyard with existing concrete railings and partial stairs remains (recent construction)

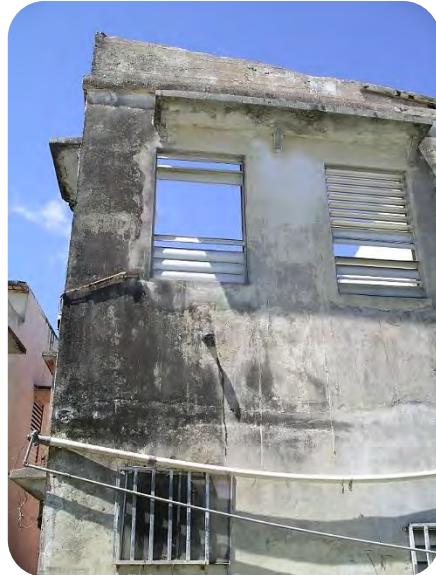
**Photo: #14****Description:** East view of second floor level façade, oriented towards interior courtyard.**Date: 07/22/22**

Project contemplates demolishing a portion of the existing building. This portion corresponds to an addition to the building to provide an additional bathroom on the second level. This portion of the structure has structural deterioration that requires demolition (see photos #14 & 15). Columns and beams have exposed and corroded structural steel. The process for the demolition of this portion will be carried out with manual tools. This is because there is no access to the rear to allow the use of mechanical equipment, such as a small backhoe.

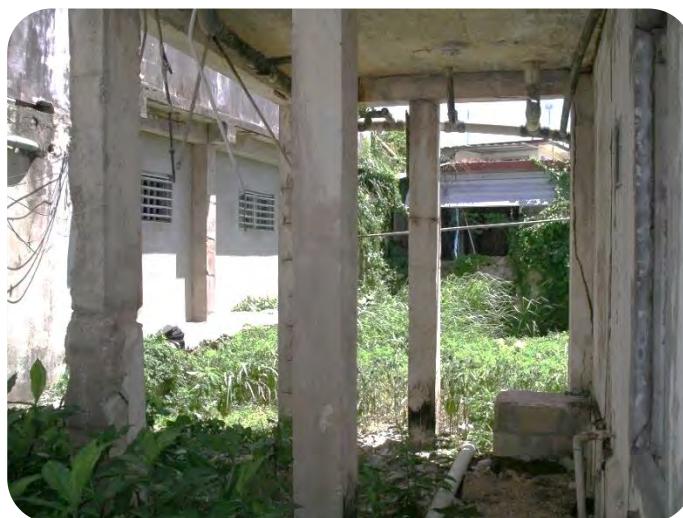
**Photo: #15****Description:** North view. Interior courtyard. First floor level corridor. Existing concrete columns (recent construction)**Date: 07/22/22**

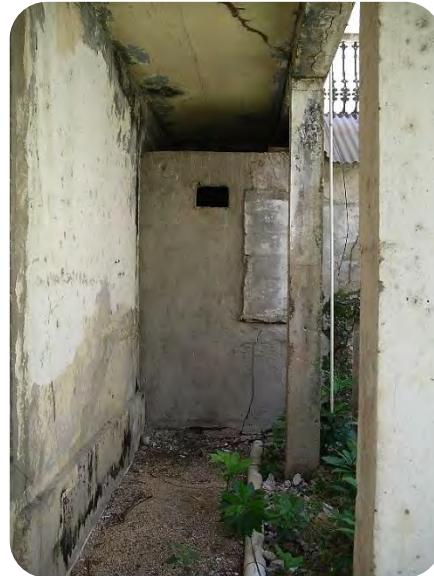
Photo: #16

Description: South view, interior courtyard corridor.

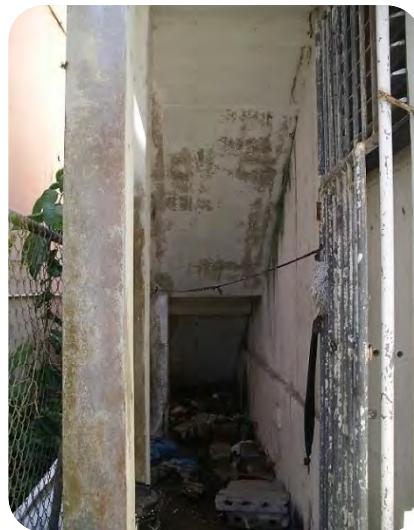
Photo: #17

Description: South view. Area under main stairs and first level access from backyard.

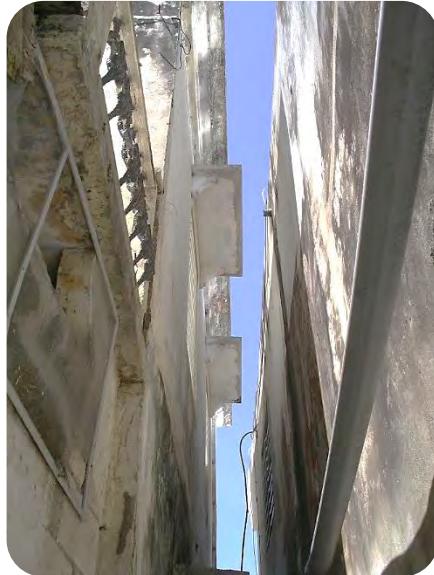
Photo: #18

Description: South view of West property line area and façade.

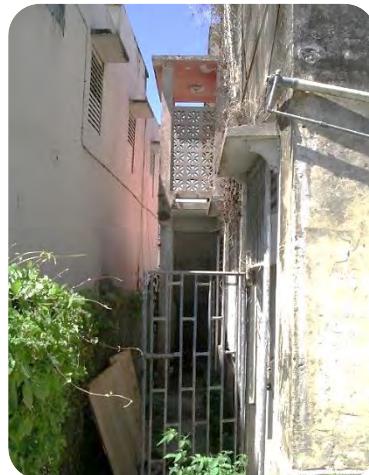
Photo: #19

Description: South view from posterior courtyard. East side property line.

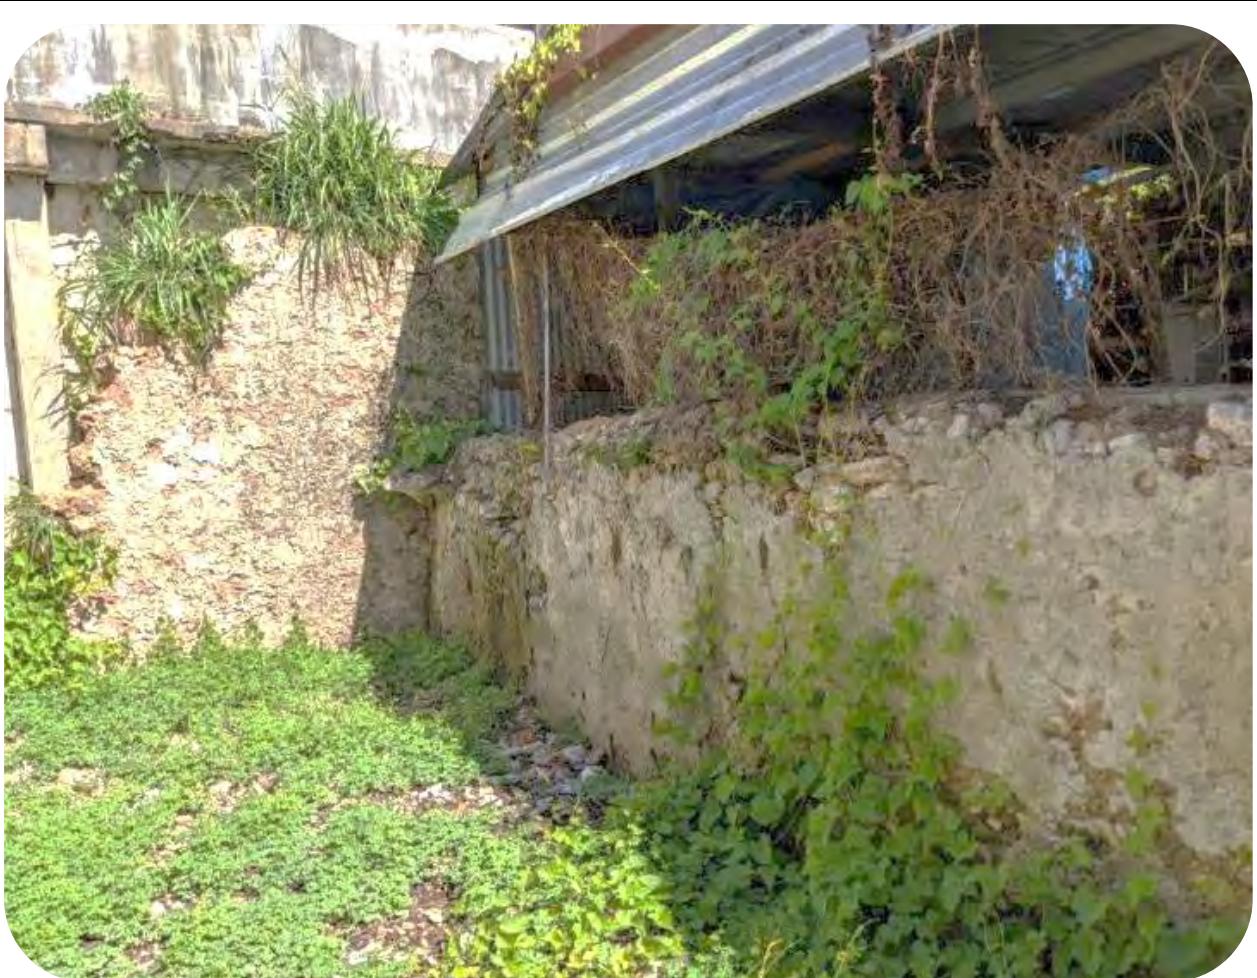
**Photo: #20****Description:** North and West property line at the posterior courtyard.

Cyclopean wall construction (bricks and mortar) with some rough plastered finished areas. Remnant of old fence

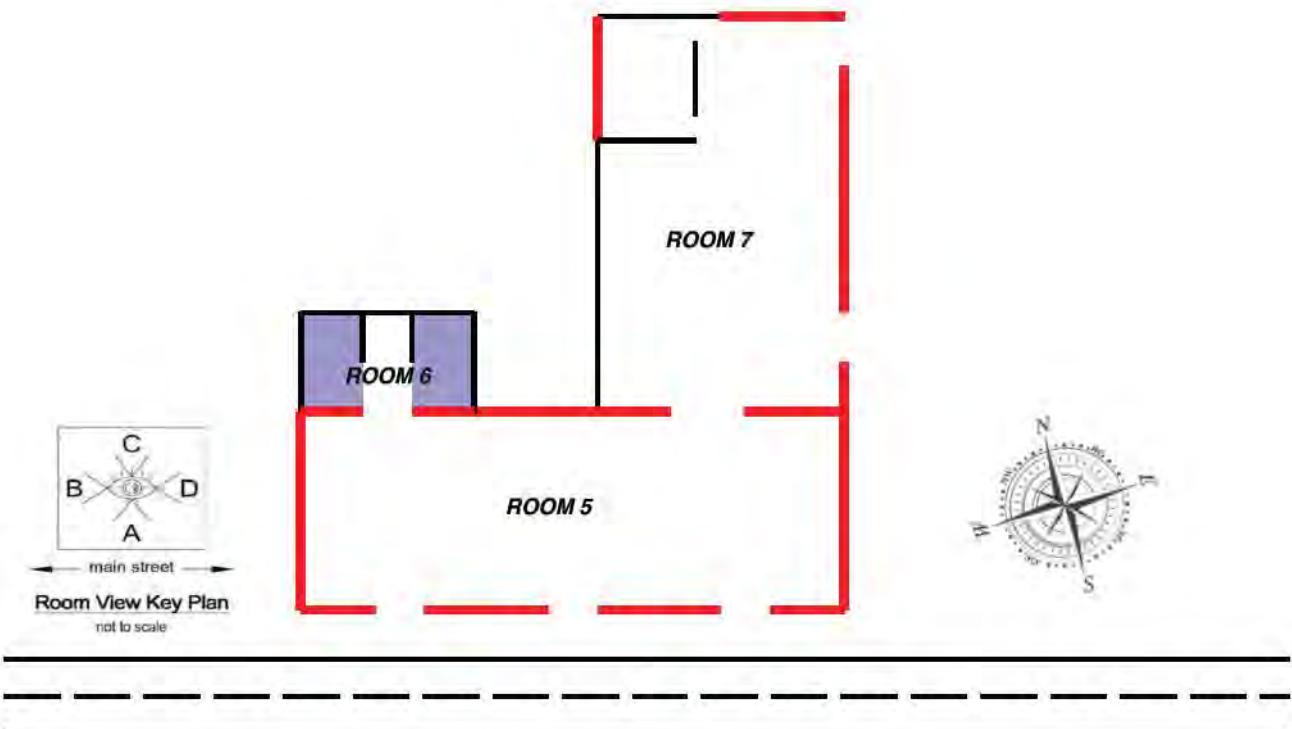
FIRST LEVEL

➔ **LBP POSITIVE, INTERIOR GRAY LEAD-GLAZED CERAMIC FLOOR TILE**

LBP was found at some of the project accessed components. Some interior concrete walls (approx. 2,450 Ft²) have LBP. Also, about 240 FT² of lead-glazed ceramic tiles (which are regulated in PR as LBP) were found on some walls or floors. Data from XRF analyzer testing is included in **Attachment 3 and 4** with positive readings marked in red or bold. **Attachment 5** includes the approximated location of identified LBP or lead-glazes at the subject structure. Representative Pictures\Photograph Log of identified LBP surfaces and/or lead-glazed ceramic components within the structure are provided in the **Attachment 6**.

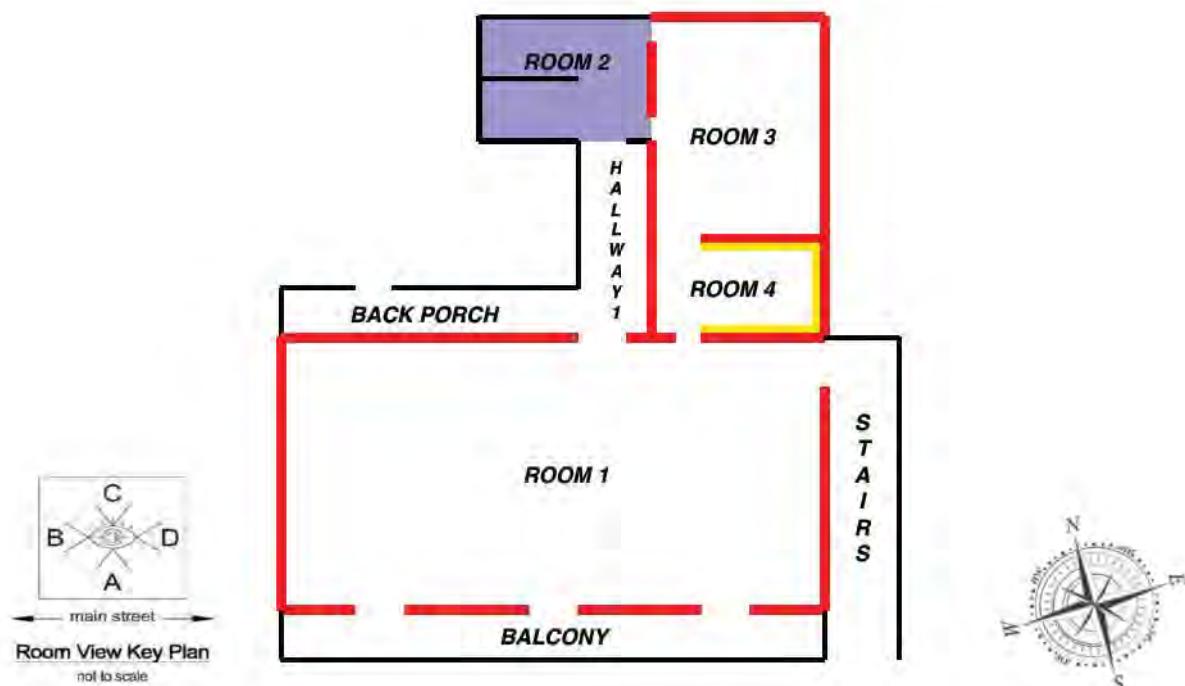
SECOND LEVEL

→ LBP POSITIVE, INTERIOR BLUE LEAD-GLAZED CERAMIC FLOOR TILE

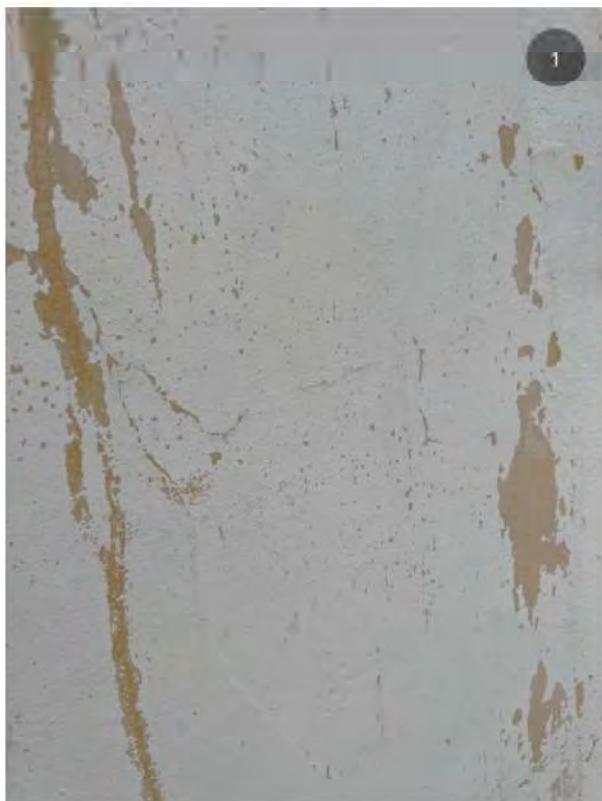
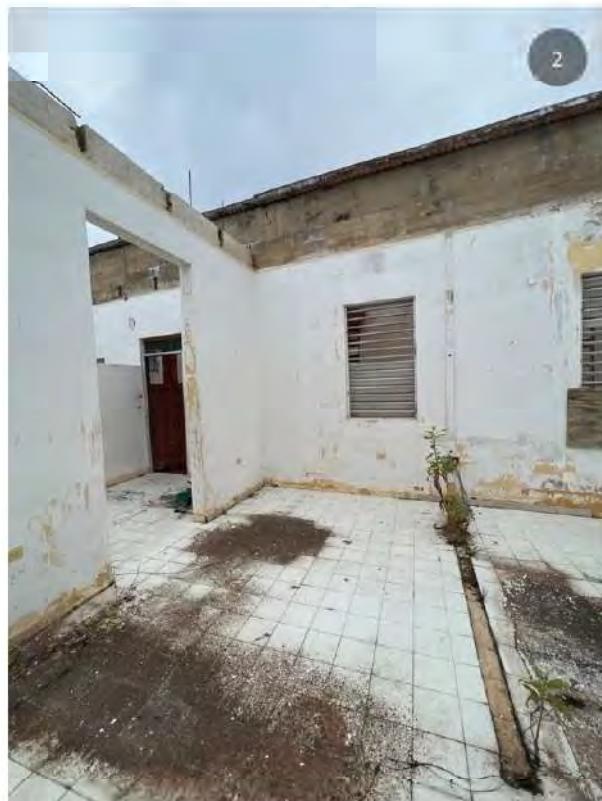
LBP DETECTED? ROOM 1 SECOND FLOOR

Interior, Reading #47, white concrete wall, side C, 6.4 mg/cm². (QTY. 180 S.F APPROX.)

Interior, Reading #48, white concrete wall, side D, 6.3 mg/cm². (QTY. 200 S.F APPROX.)

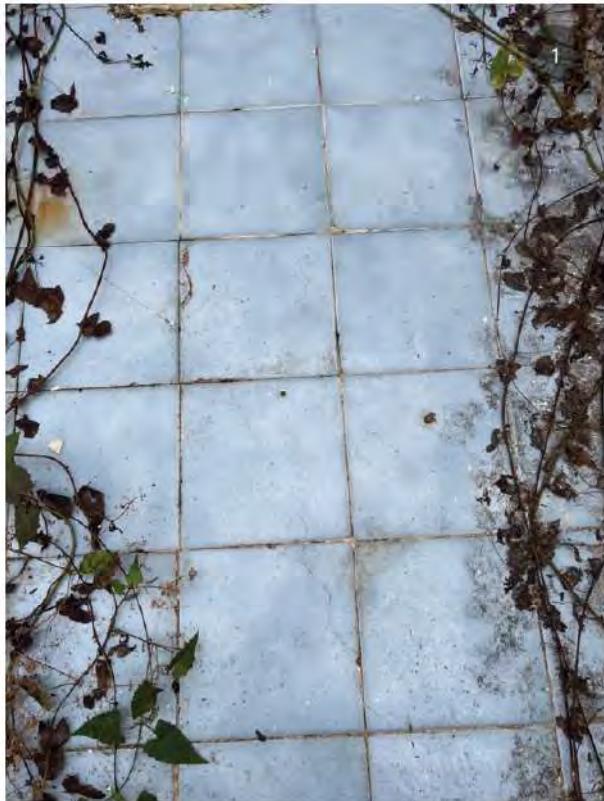
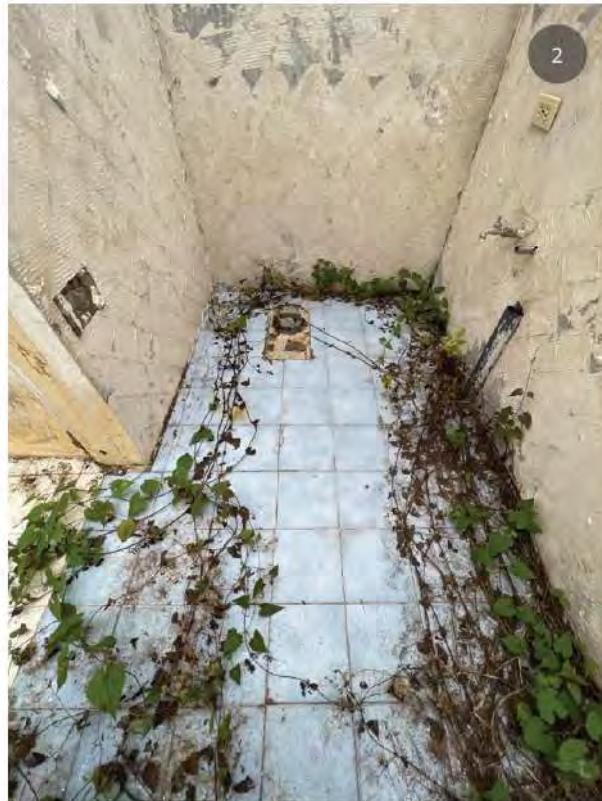
LBP DETECTED? ROOM 2 SECOND FLOOR

Interior, Reading #56, blue lead-glazed ceramic floor tile, 1.1 mg/cm². (QTY.
75 S.F APPROX.)

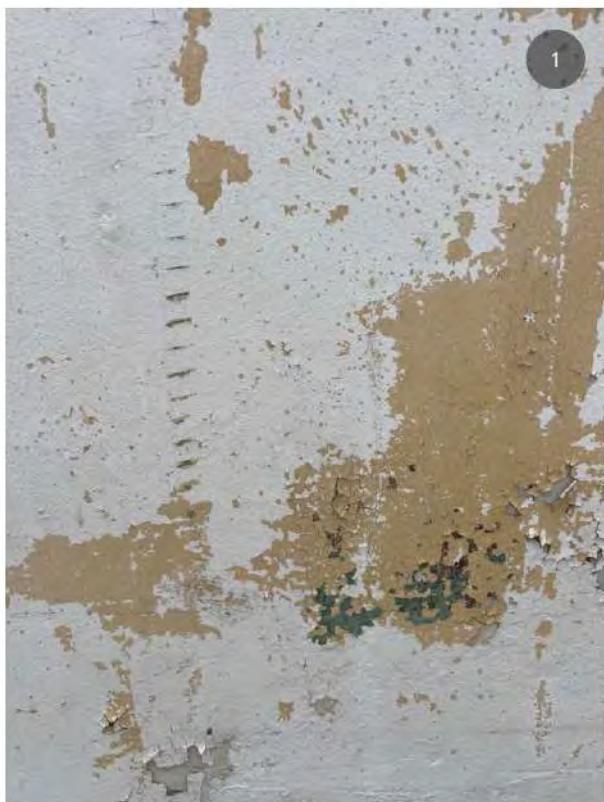
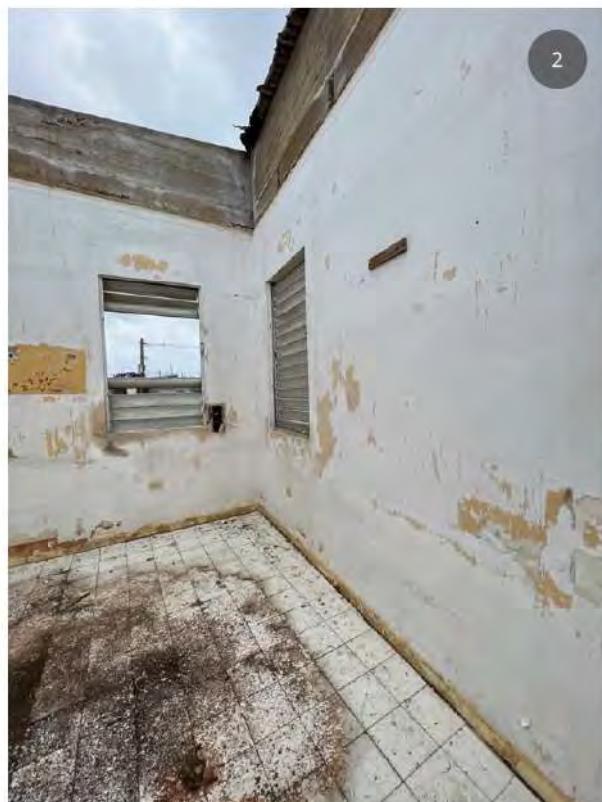
LBP DETECTED? ROOM 3 SECOND FLOOR

Interior, Reading #64, white concrete wall, side C, 5.5 mg/cm². (QTY. 110 S.F APPROX.)

Interior, Reading #65, white concrete wall, side D, 6.0 mg/cm². (QTY. 130 S.F APPROX.)

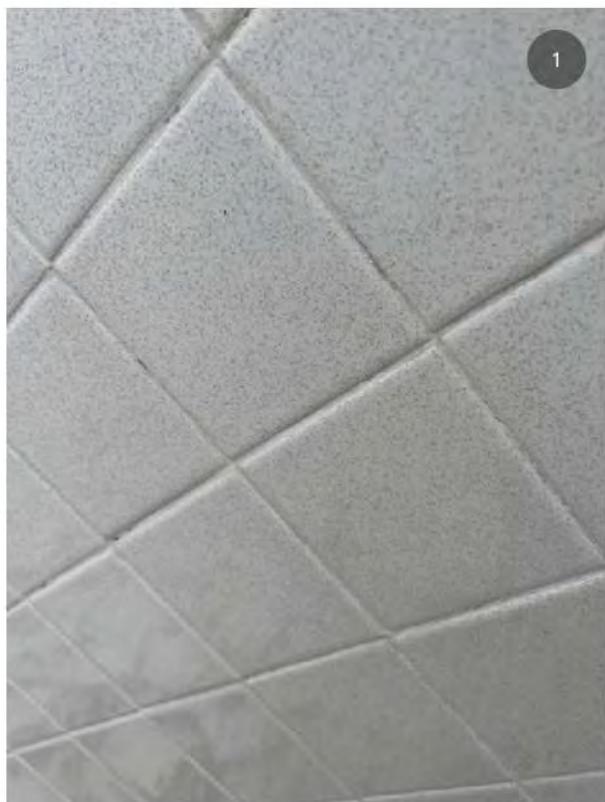
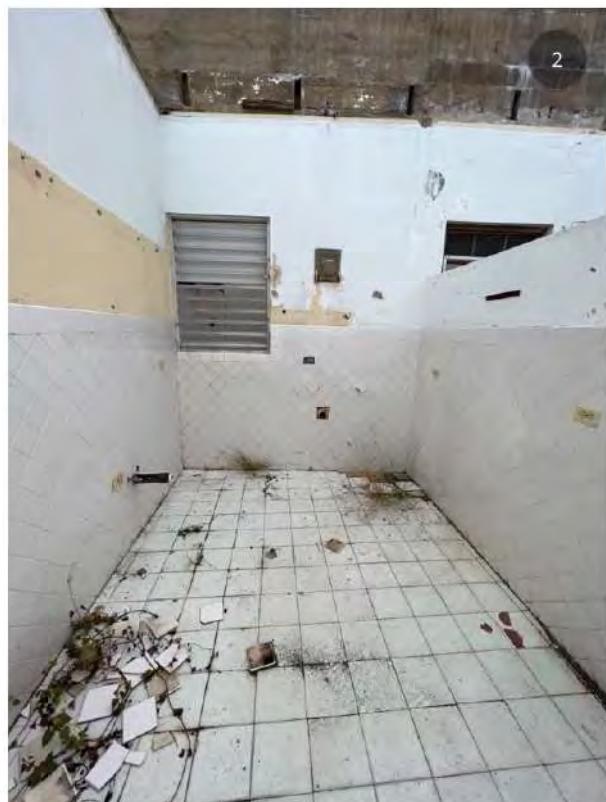
LBP DETECTED? ROOM 4 SECOND FLOOR

Interior, Reading #72, beige lead-glazed ceramic wall tile, side C, 3.1
mg/cm². (QTY. 40 S.F APPROX.)

Interior, Reading #73, beige lead-glazed ceramic wall tile, side D, 2.8
mg/cm². (QTY. 35 S.F APPROX.)

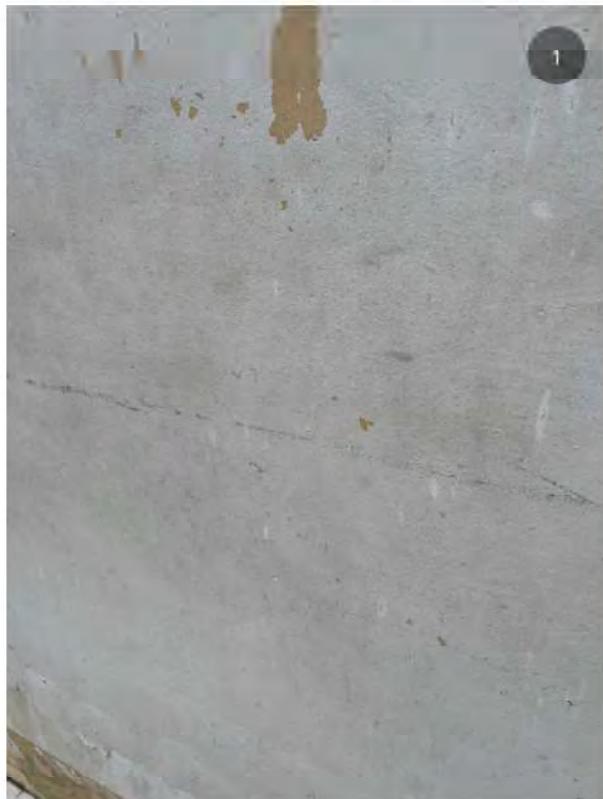
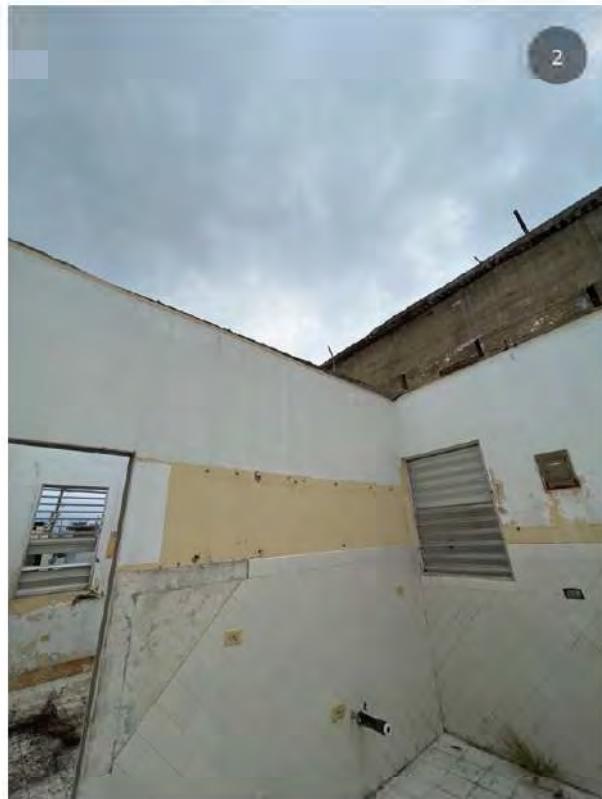
LBP DETECTED? ROOM 4 SECOND FLOOR

Interior, Reading #76, white concrete wall, side C, 5.7 mg/cm². (QTY. 55 S.F APPROX.)

Interior, Reading #77, white concrete wall, side D, 4.4 mg/cm². (QTY. 45 S.F APPROX.)

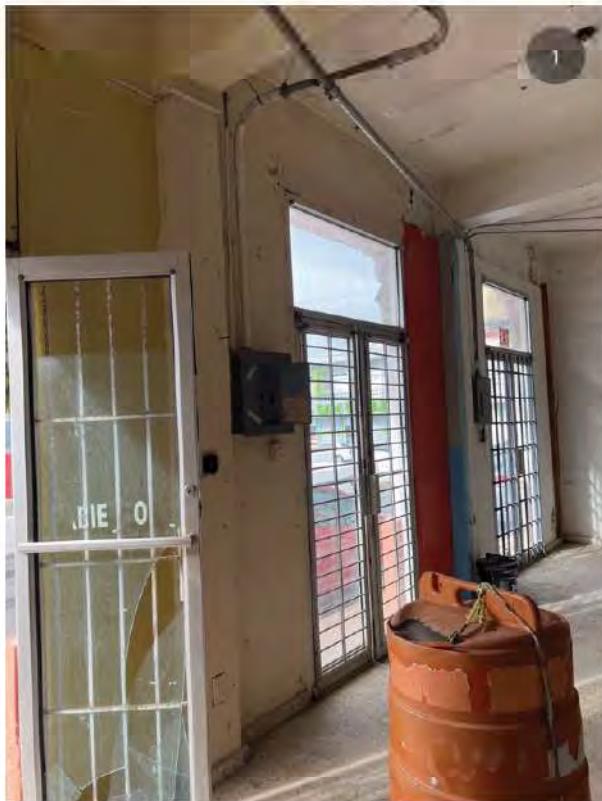
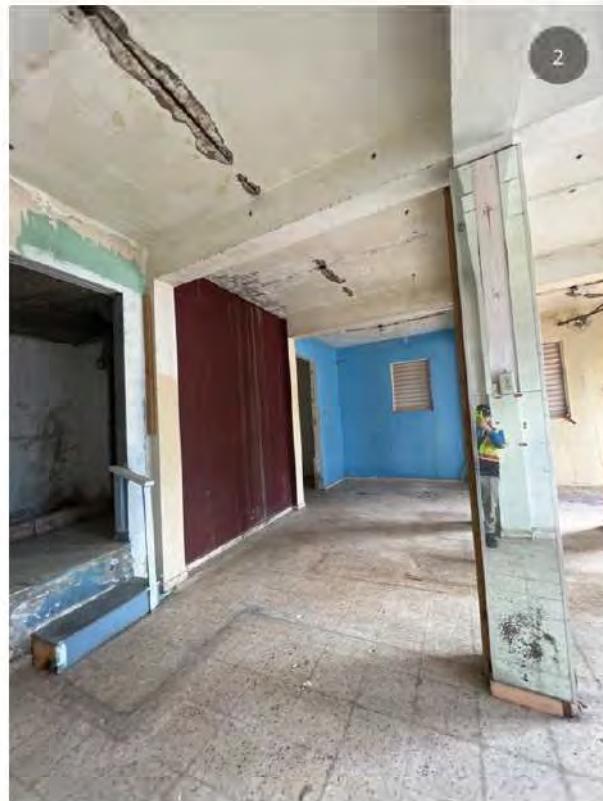
LBP DETECTED? ROOM 5 FIRST FLOOR

Interior, Reading #95, blue concrete wall, side D, 4.5 mg/cm². (QTY. 110 S.F APPROX.)

Interior, Reading #96, beige concrete wall, side D, 4.4 mg/cm². (QTY. 110 S.F APPROX.)

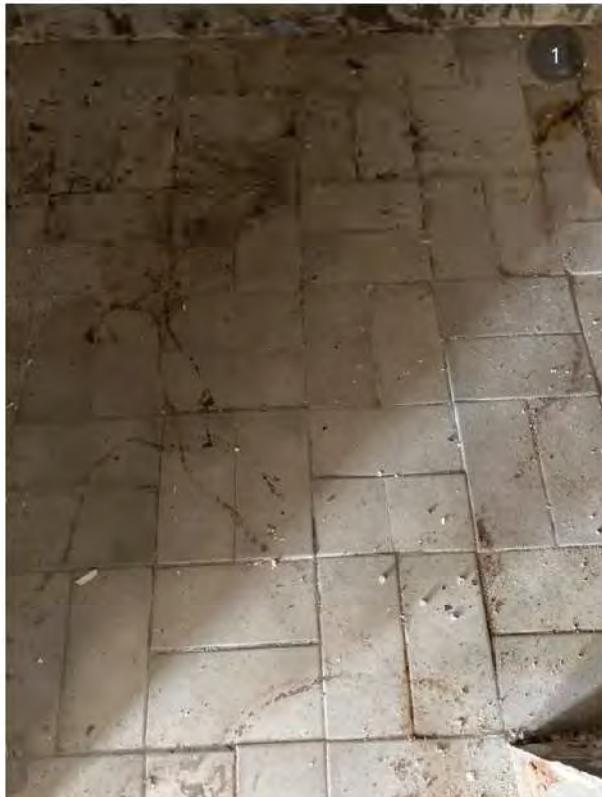
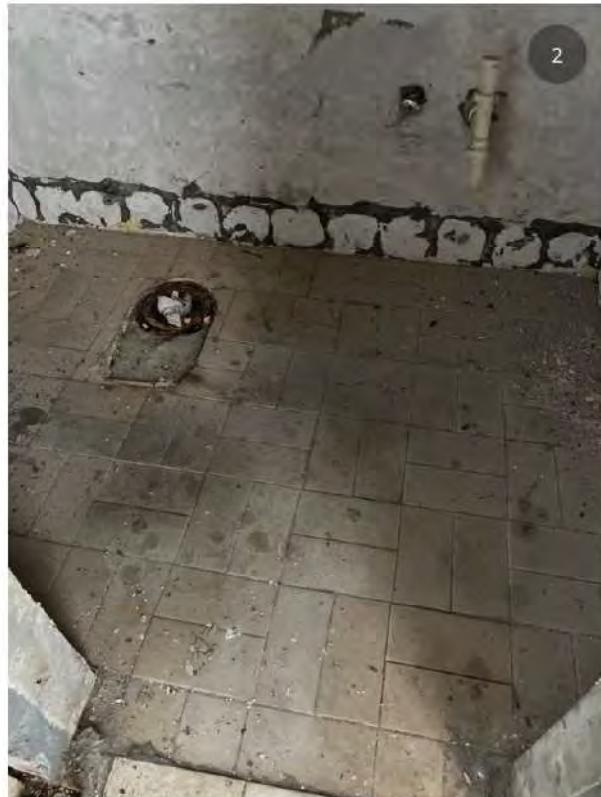
LBP DETECTED? ROOM 6 FIRST FLOOR

Interior, Reading #101, #102, gray lead-glazed ceramic floor tile, 3.7, 1.4 mg/cm². (QTY. 50 S.F APPROX.)

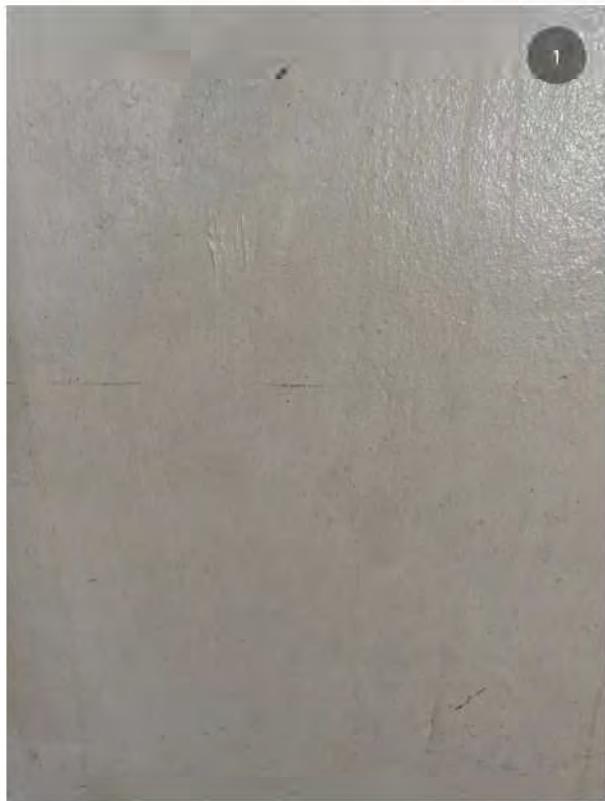
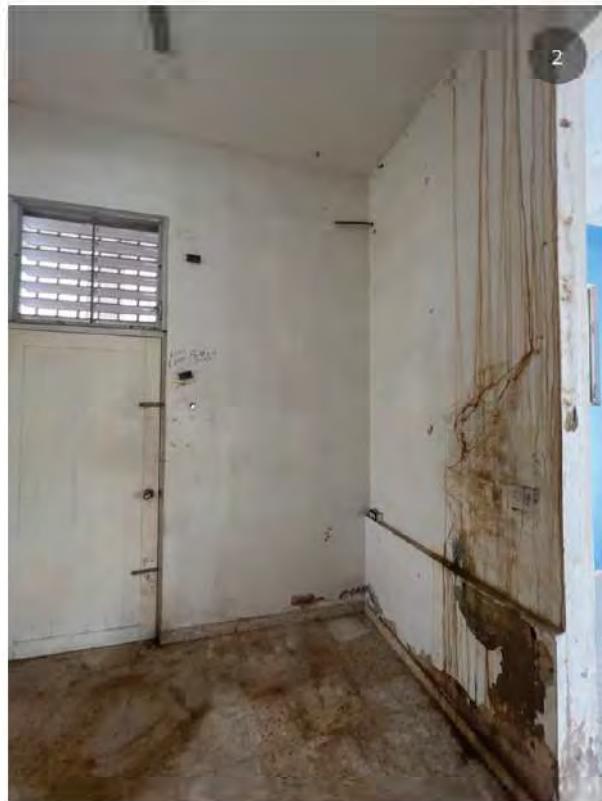
LBP DETECTED? ROOM 7 FIRST FLOOR

Interior, Reading #114, #115, white concrete wall, side C, 3.6, 4.1 mg/cm². (QTY. 60 S.F APPROX.)

Interior, Reading #116, #117, white concrete wall, side D, 1.4, 2.9 mg/cm². (QTY. 275 S.F APPROX.)

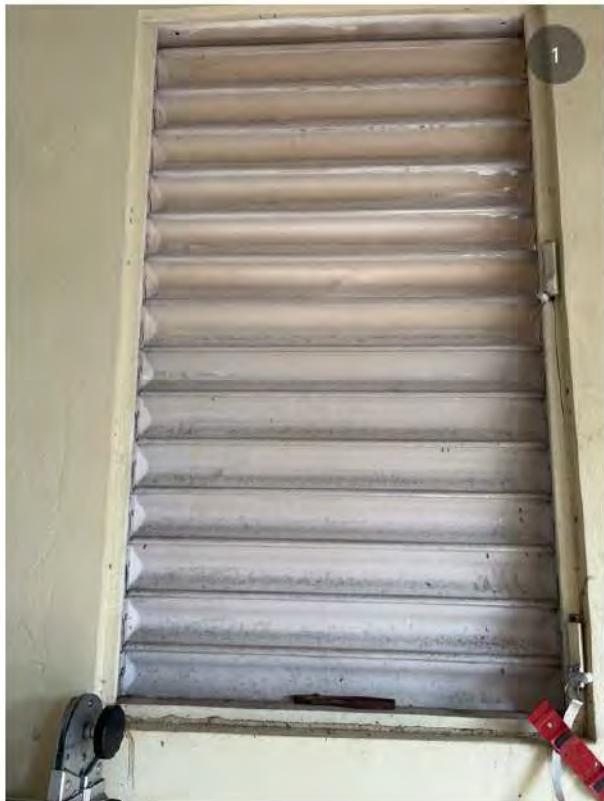
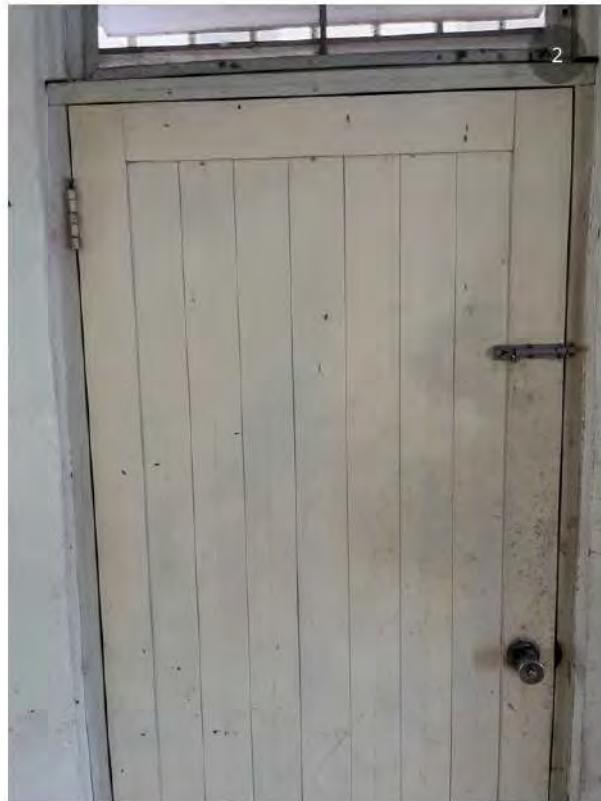
WINDOW/DOOR CAULKING:

None SACM caulking found visible at the moment of the inspection.

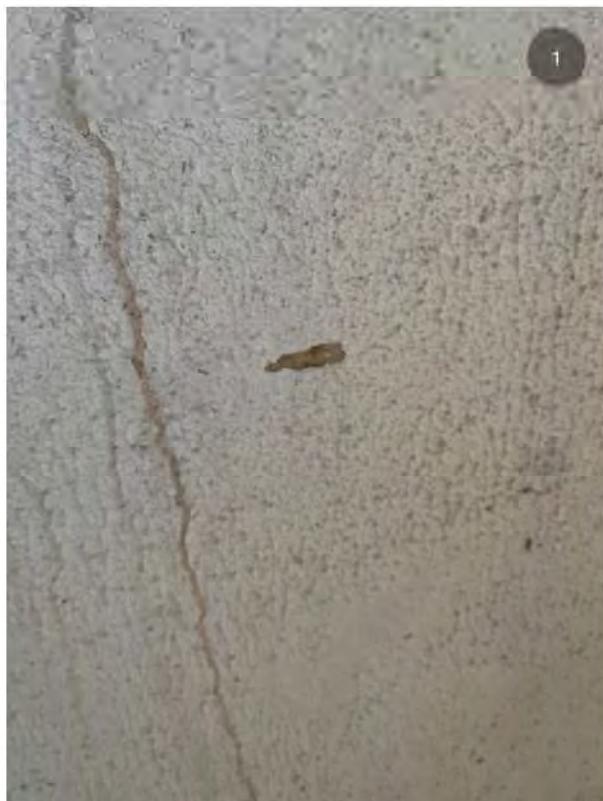
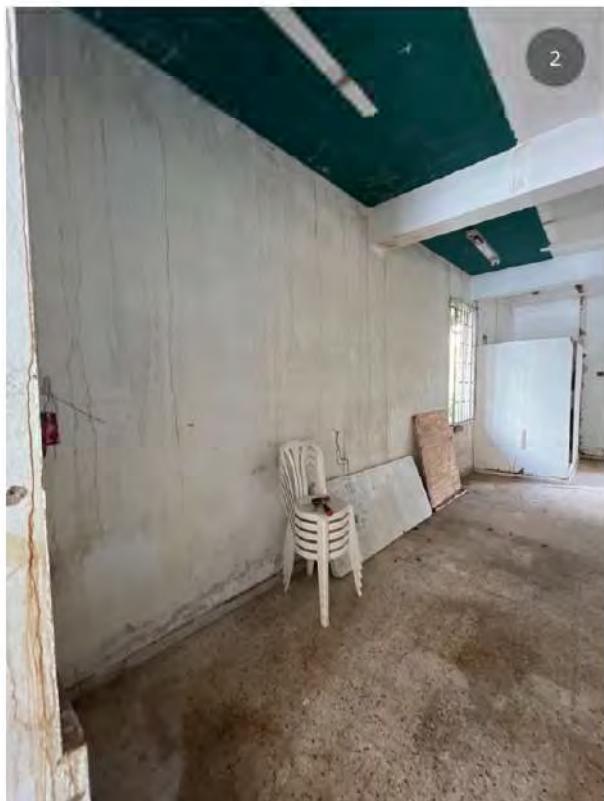
SACM VISIBLES? ROOM 7 - FIRST LEVEL

Condition: Damaged

MHQ-HA1-EC-01, 02 & 03.

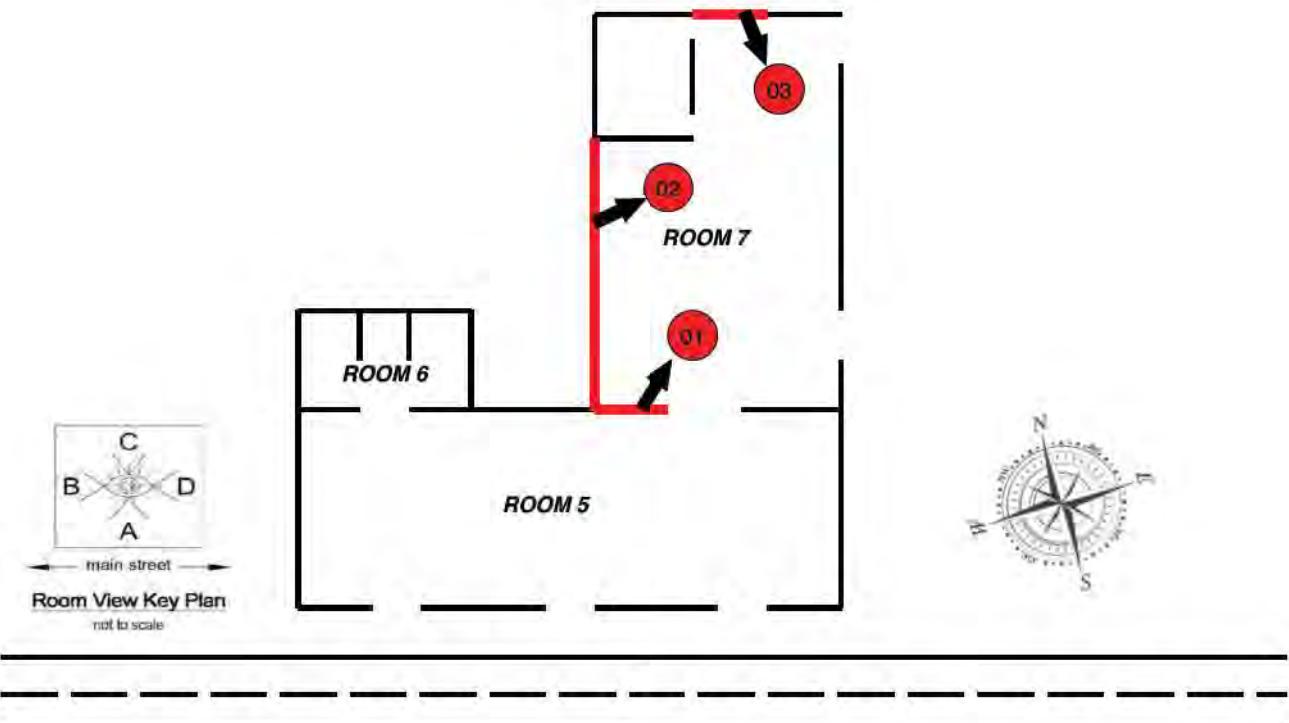
Attachment 6
Diagram
Bulk Sample's Approximated Location

█ ➔ HOMOGENEOUS AREA 1, WHITE WALL STUCCO

FIRST LEVEL
