**Environmental Review for Activity/Project that is Categorically
Excluded Subject to Section 58.5**

**MUSEO HISTORICO DE QUEBRADILLAS
QUEBRADILLAS, PR**
PR-CRP-000554
CDBG-DR

**Applicant: Municipality of Quebradillas
Prepared by: José D. Centeno Calero PE
Professional Engineer
License 20206
Date: October 23, 2023**

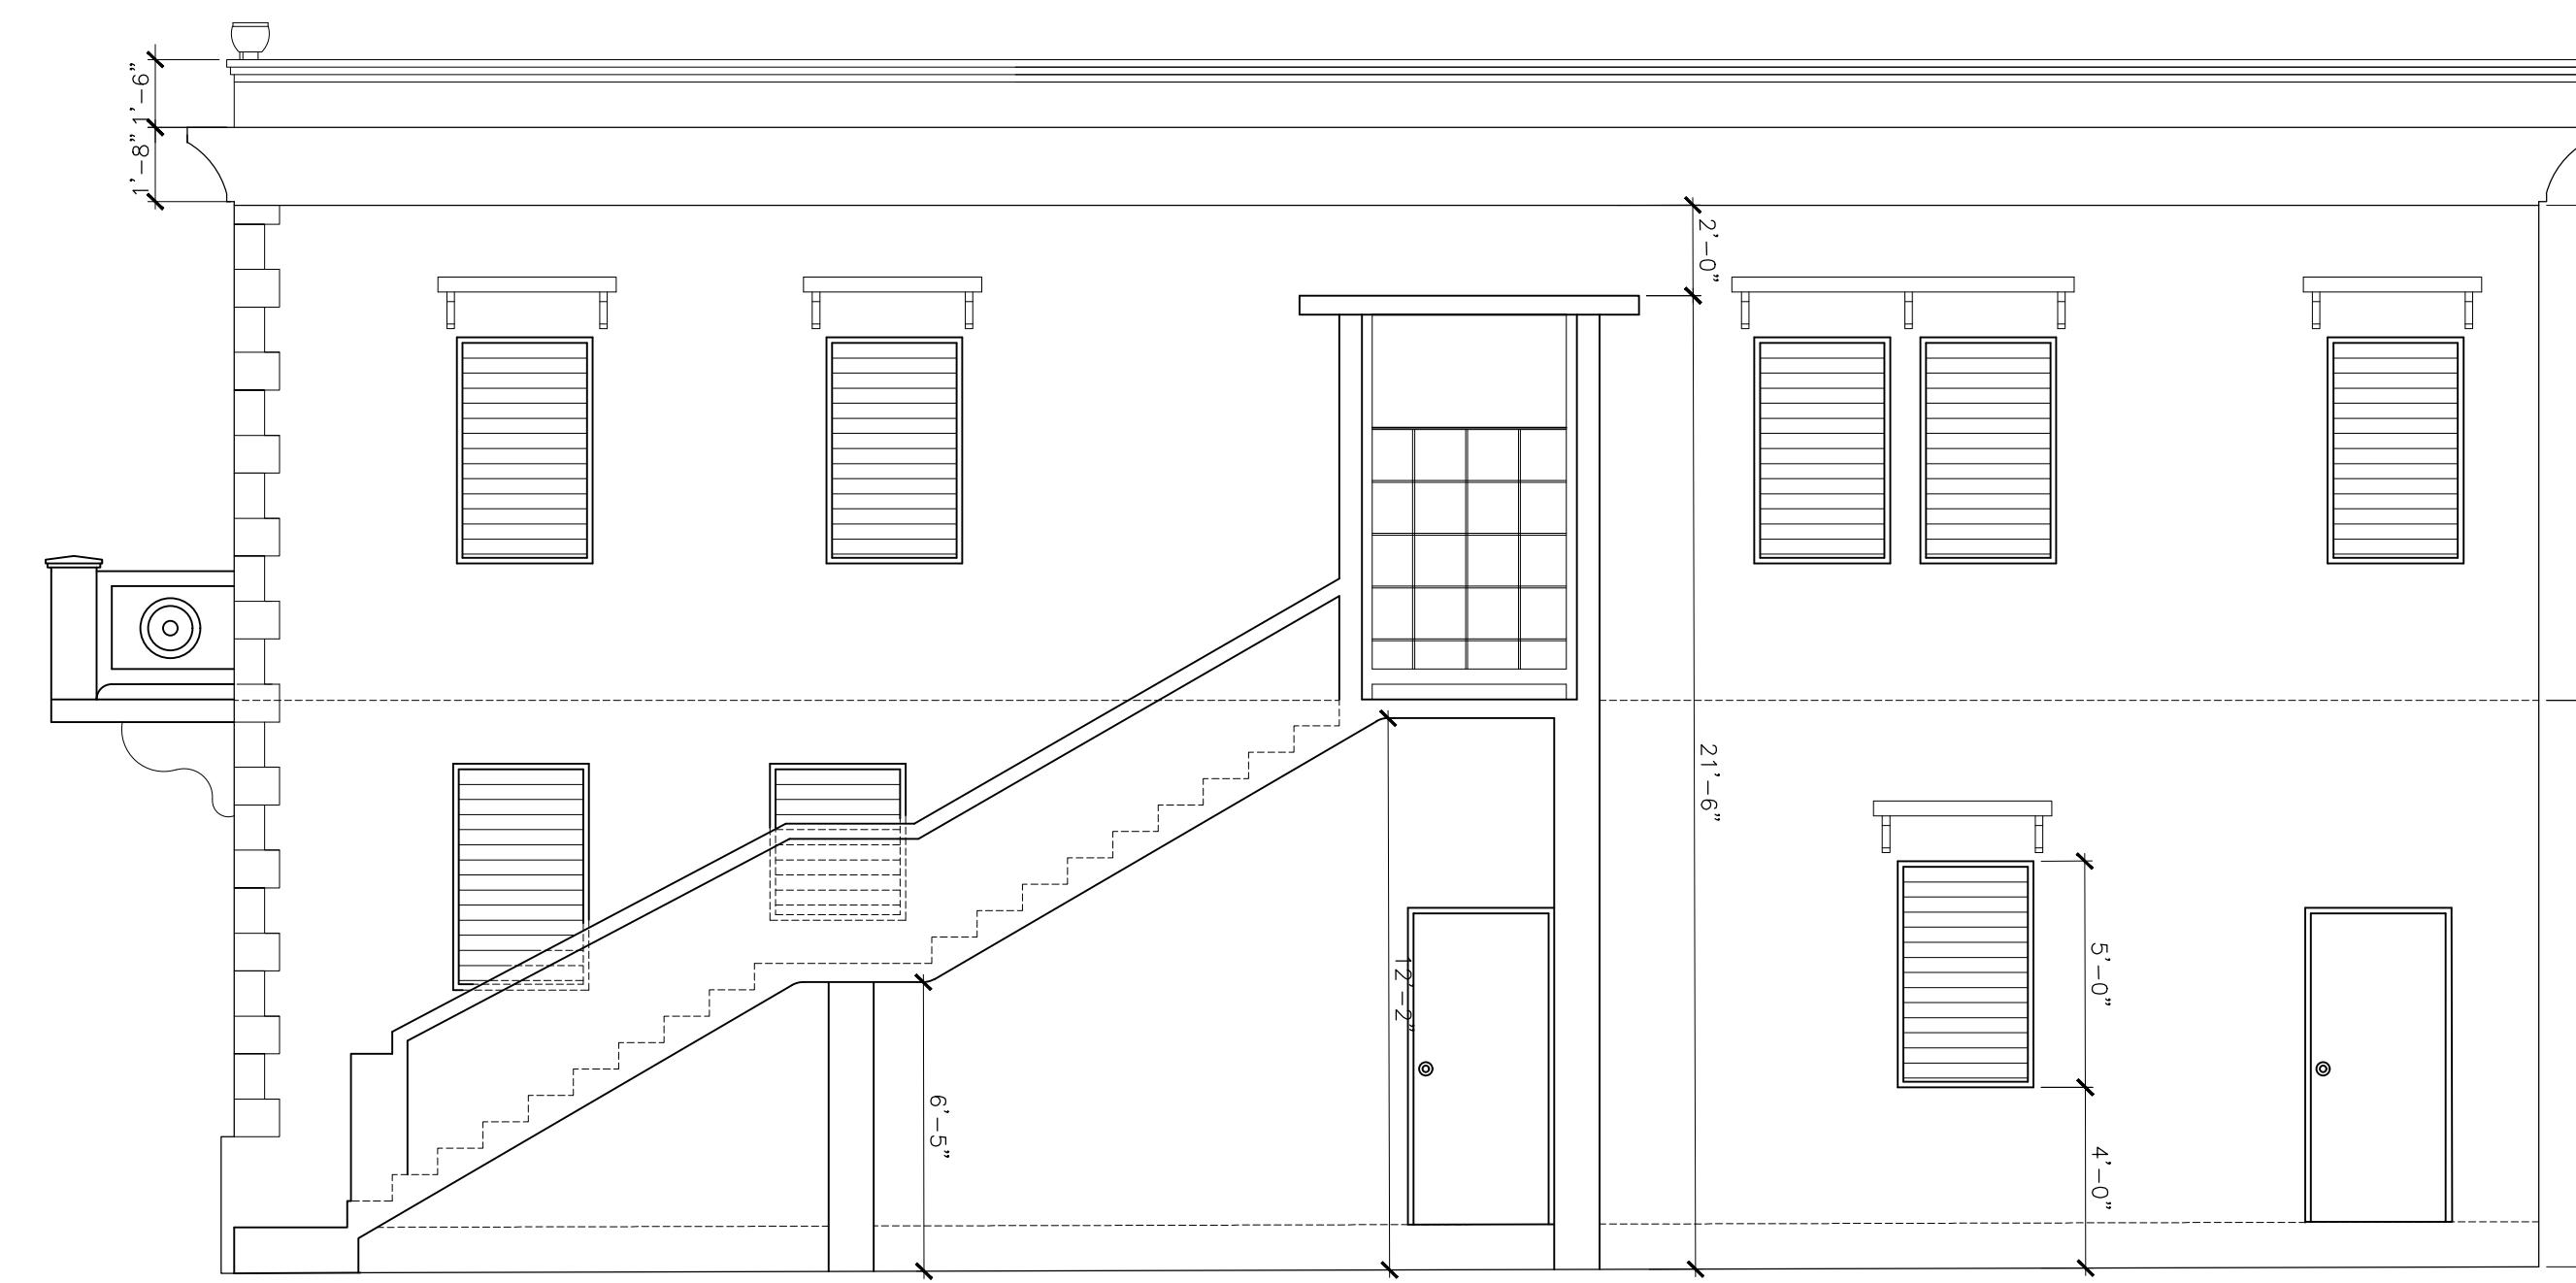
ELEVACION PRINCIPAL

ESCALA: 1/4"=1'-0"

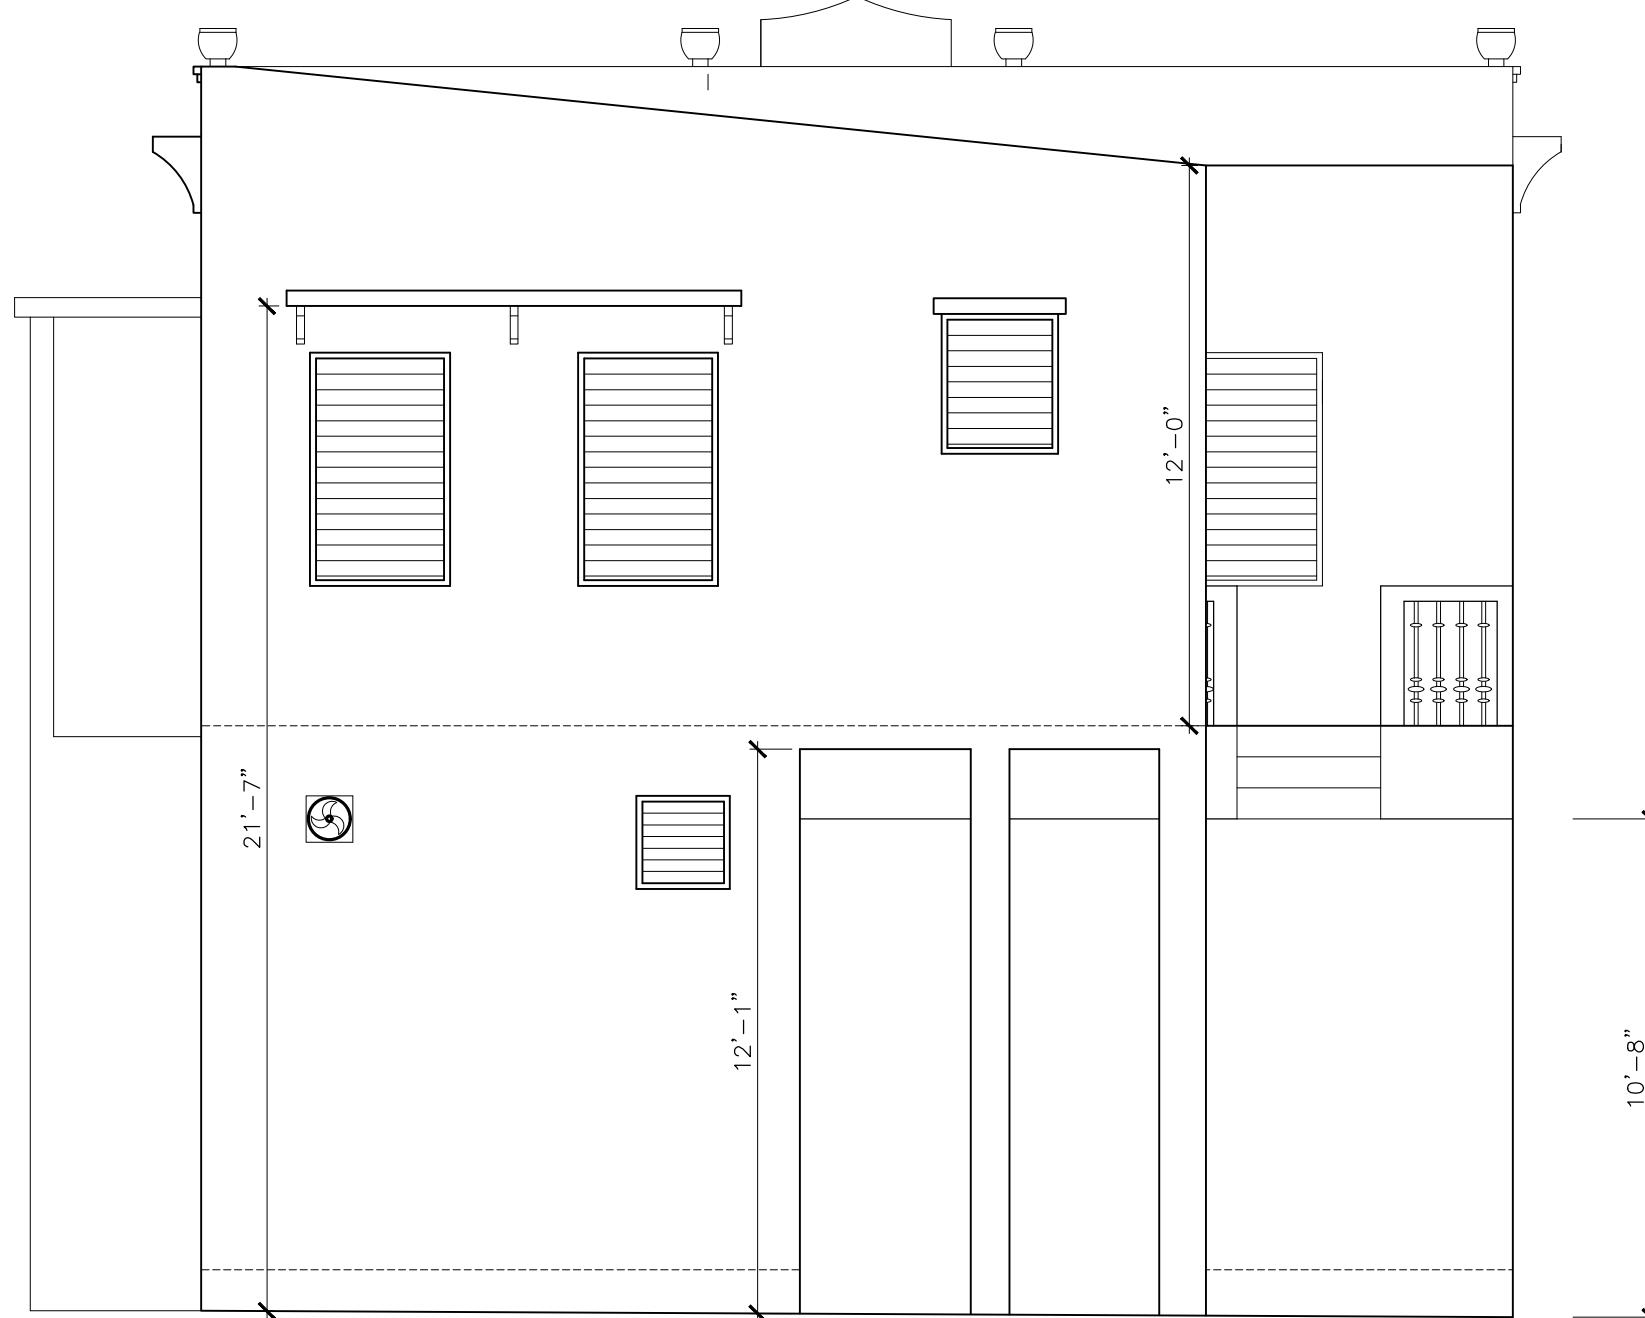
ELEVACION LATERAL DERECHA

ESCALA: 1/4"=1'-0"

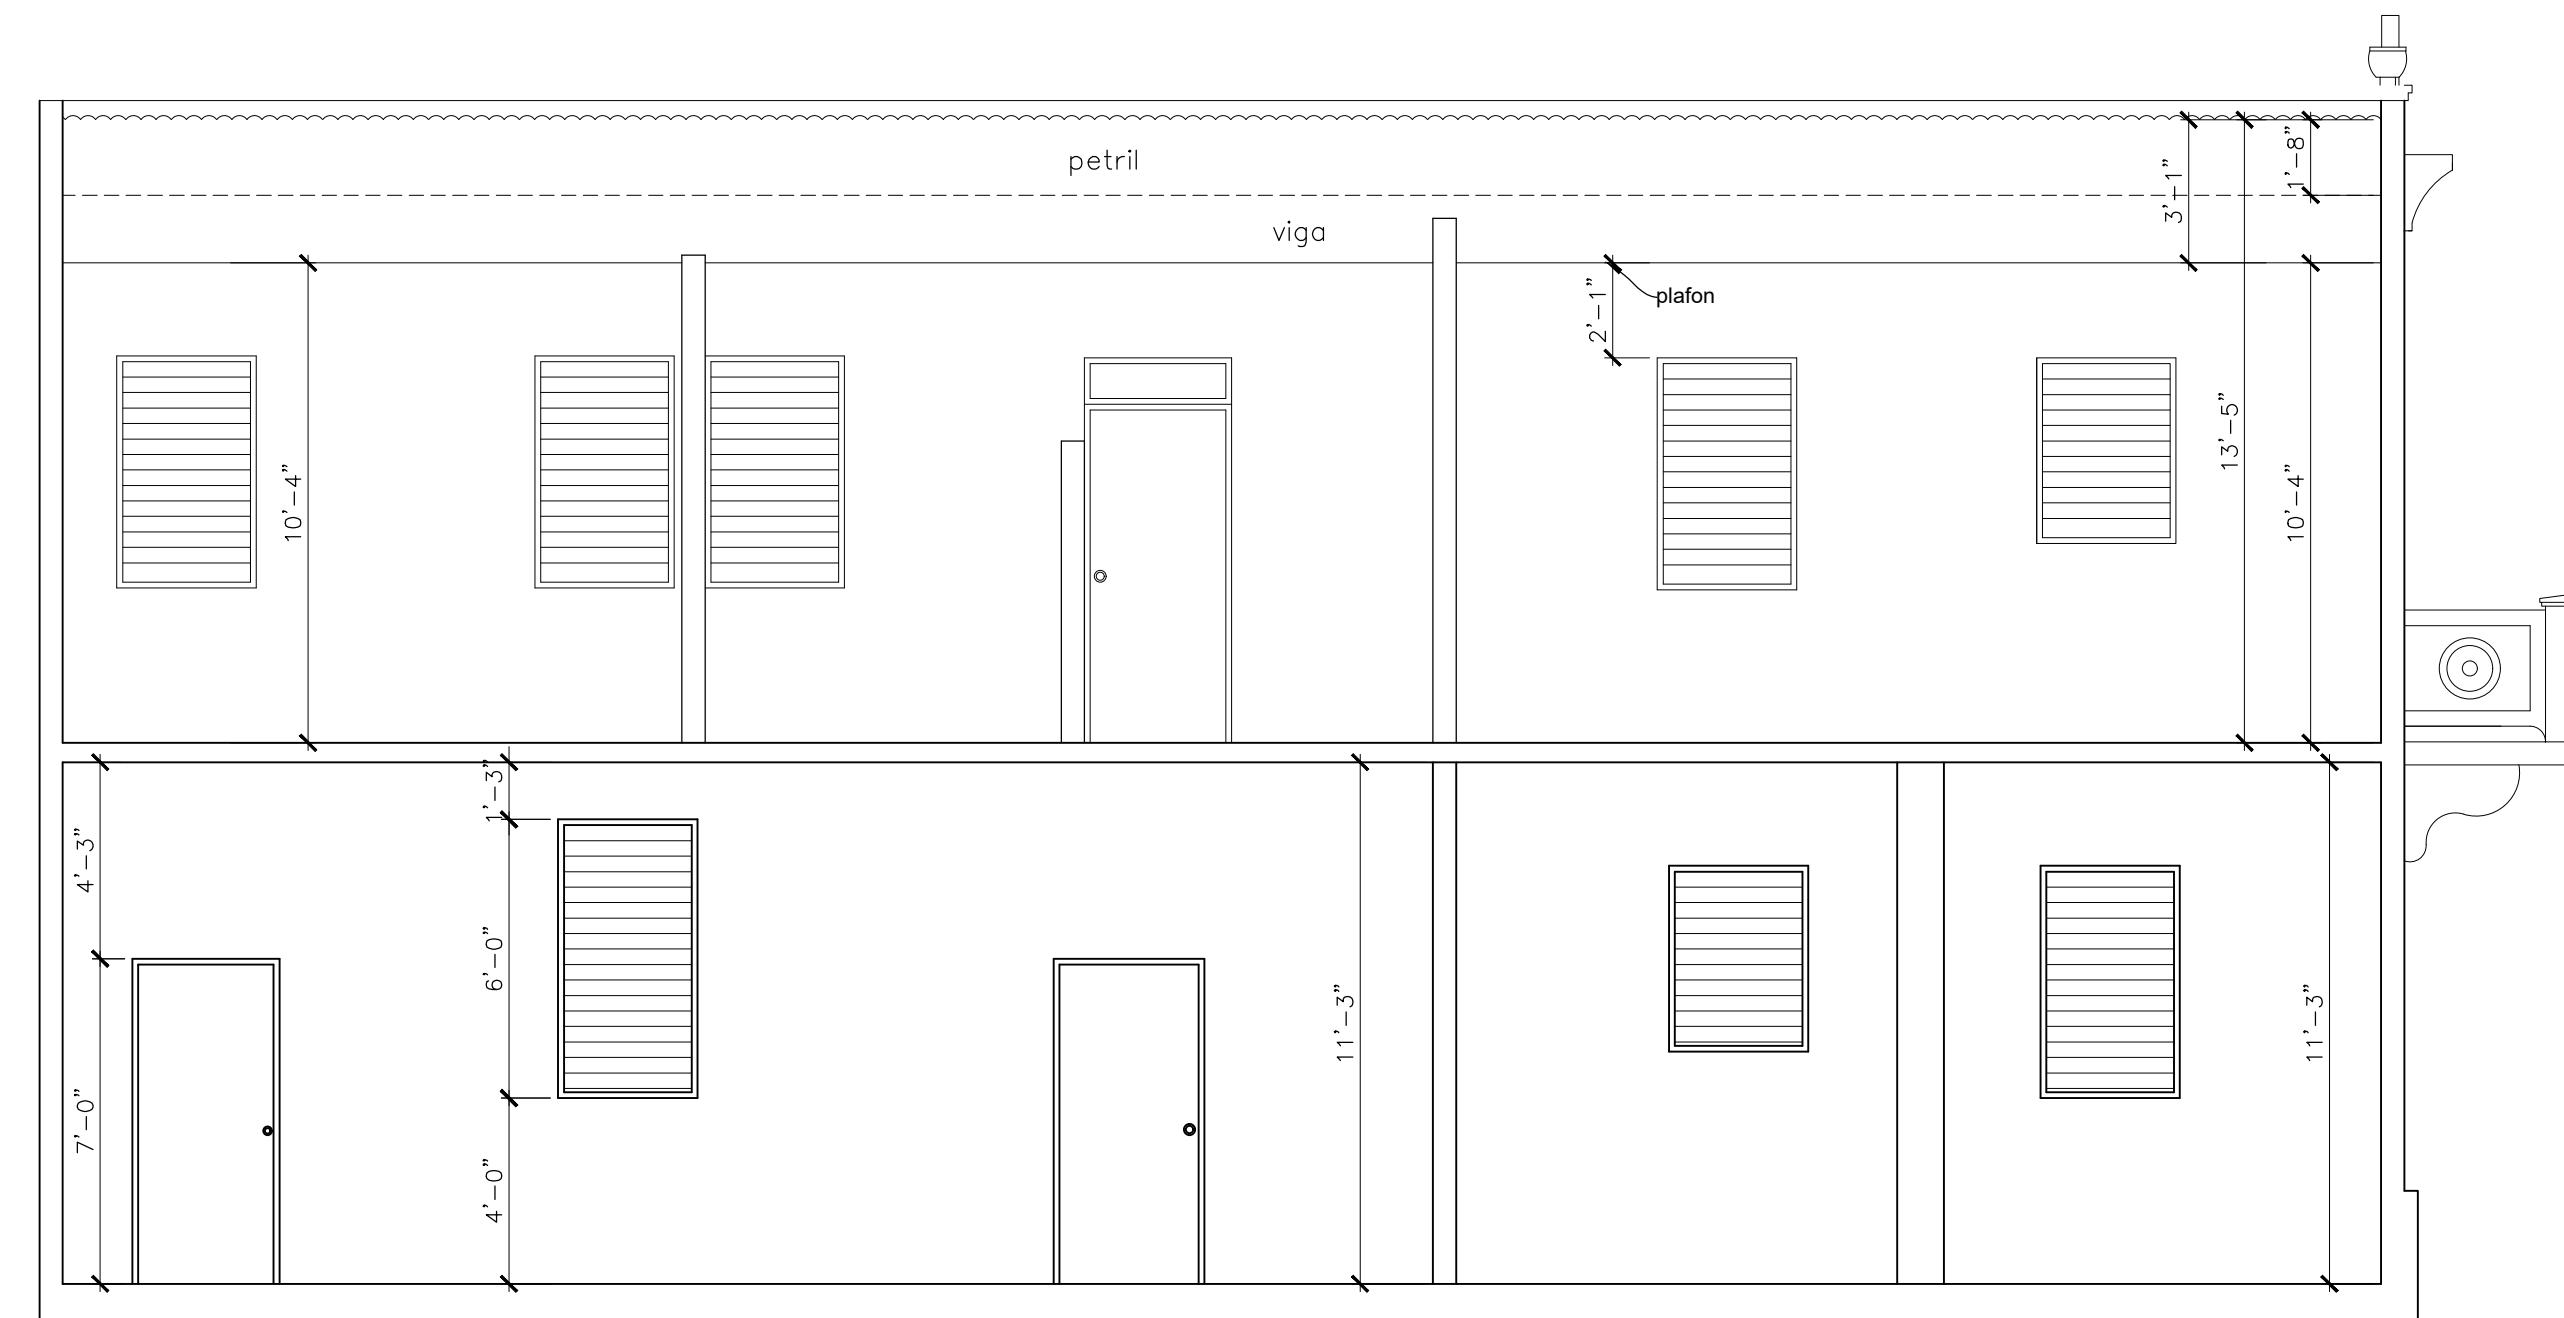
SECCION C-C

Nombre de la Hoja:	Nombre del Proyecto & Dirección:		
SECCIONES	MUSEO HISTÓRICO DE QUEBRADILLAS CALLE HONORIO HERNANDEZ BO. PUEBLO, QUEBRADILLAS, PR.		
Nombre Hoja: A-3	Certificado & Sello del Proy:	Ing. JOSE D. CENTENO CALERO LIC. #20206 PO BOX 4448 AGUADILLA, PR. 00605 TEL. 787-891-8256	
Folio: 5	Date: 17 NOV 2022	de 17

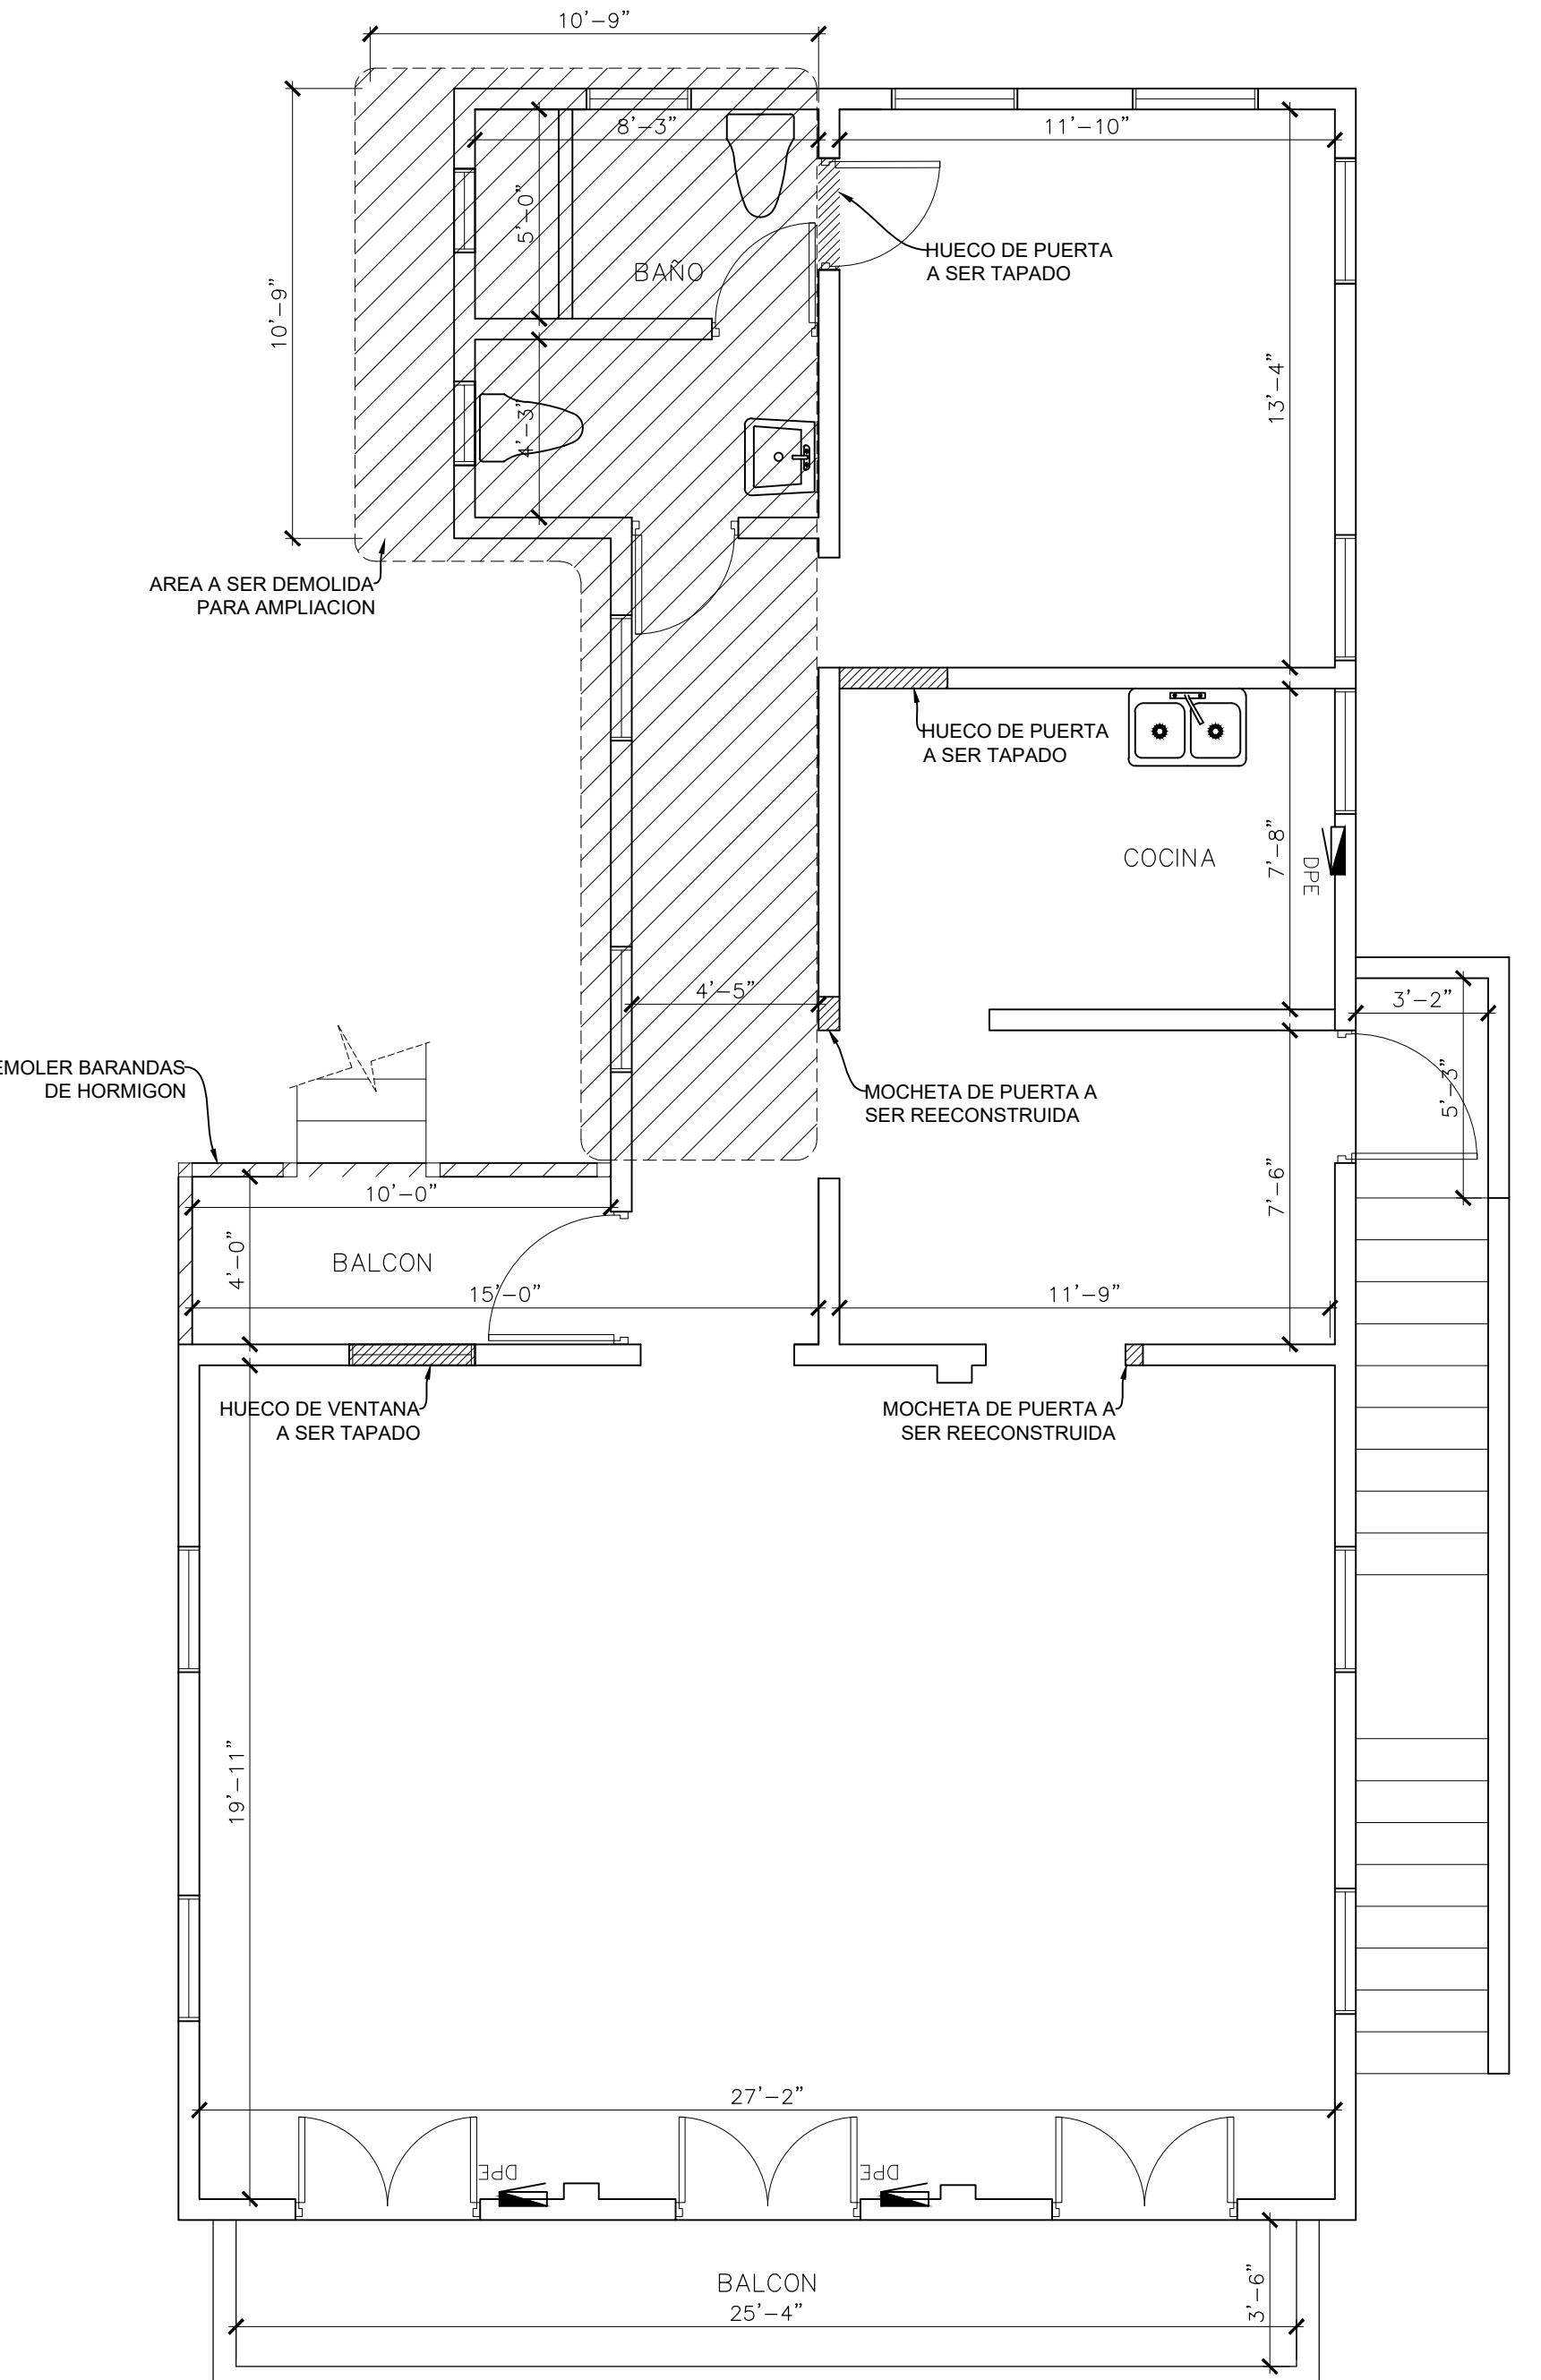
AREA A SER DEMOLIDA
NO A ESCALA

HONORIO HERNANDEZ INGENIERO LICENCIADO LIC. #20206
Nombre de la Agencia	
HOJA DE DEMOLICION	Nº. Hoja: A-4
Fecha:	17 NOV 2022
Escala:	1/4''= 1'-0"
DIBUJADO POR:	JV

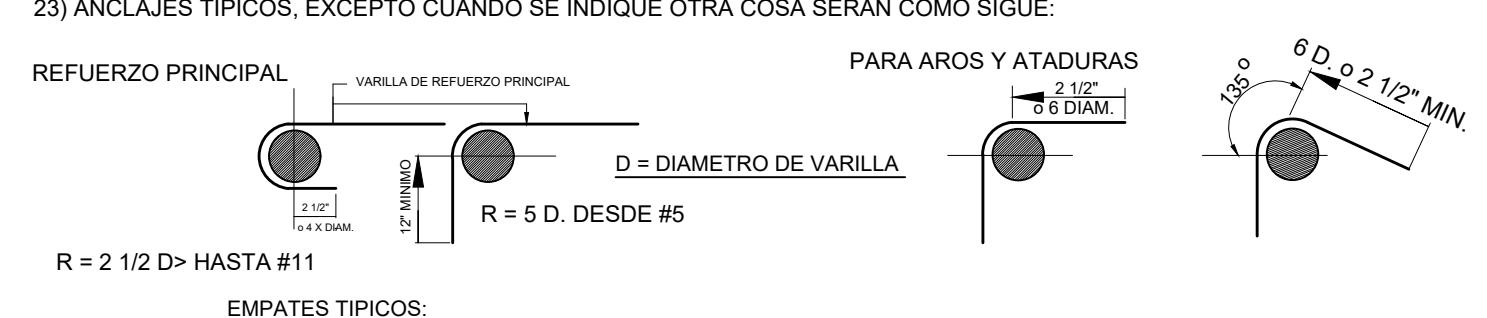
23) ANCLAJES TÍPICOS, EXCEPTO CUANDO SE INDIQUE OTRA COSA SERÁN COMO SIGUE:

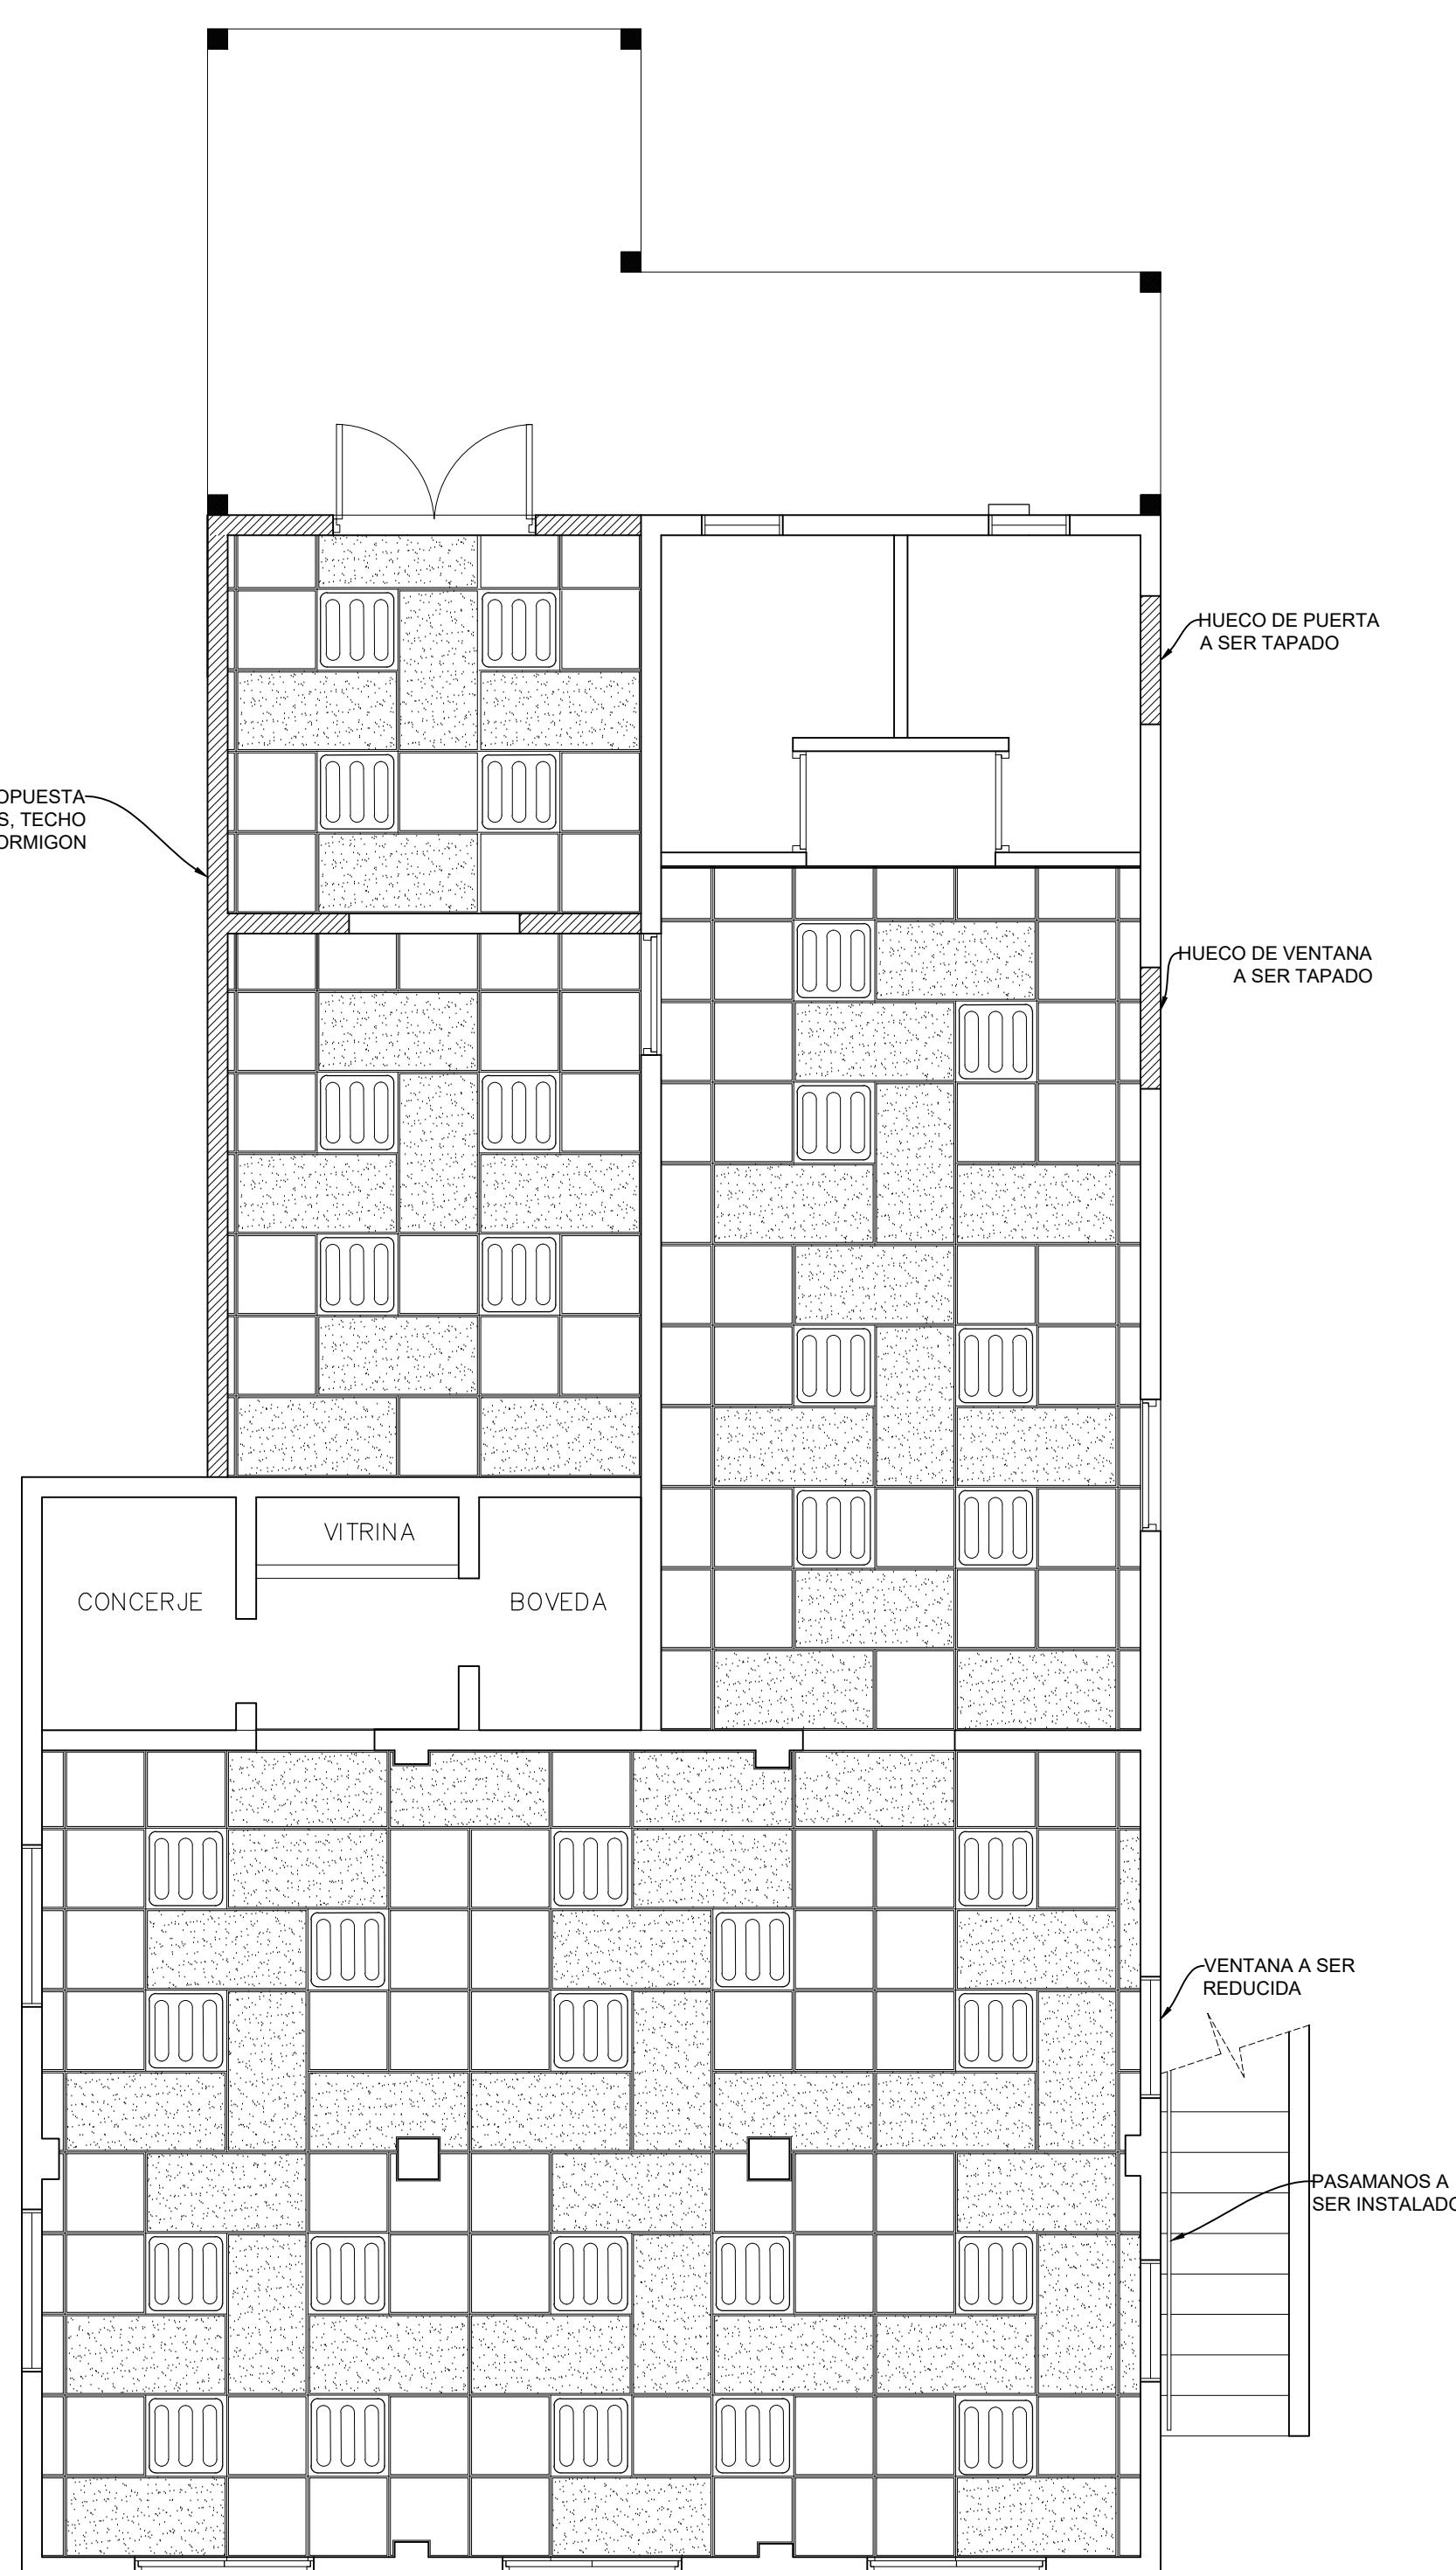
TECHO SUSPENDIDO PRIMER NIVEL (MUSEO)

- [Shaded square] PLAFON 24"X 48"
- [White square] PLAFON 24"X 24"
- [Grid icon] LAMPARA 24"X 24"

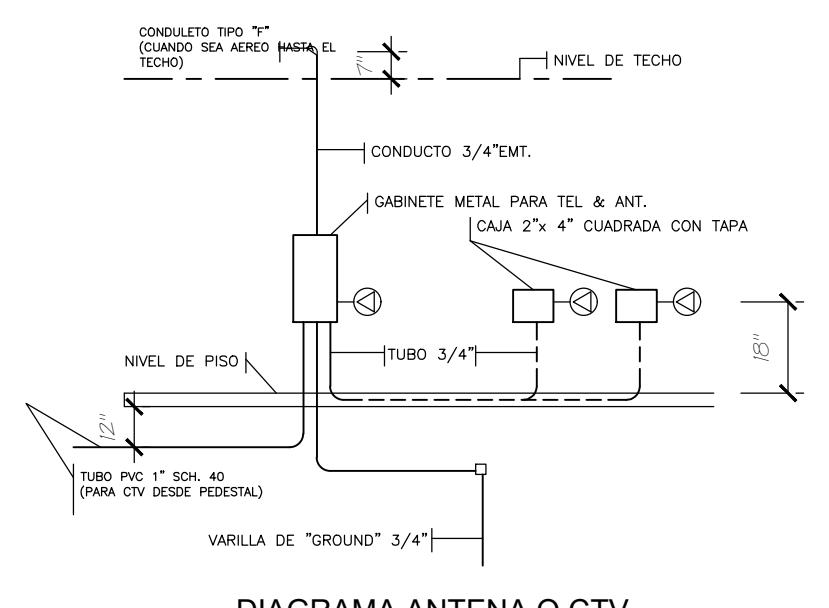
DIAGRAMA ANTENA O CTV.

- 16 - INTERCONECTESE TODA LAS SALIDAS PARA ANTENA DE TV. CON CONDUCTO PVC. DE 3/4" Y PROVEASE UN CONDUCTO PVC. 3/4" HACIA LA FAJA DE SEMBRADO PARA CABLE TV. INSTALARSE UN ALAMBRE PESCADOR NUMERO 14 AWG EN LOS CONDUCTOS.

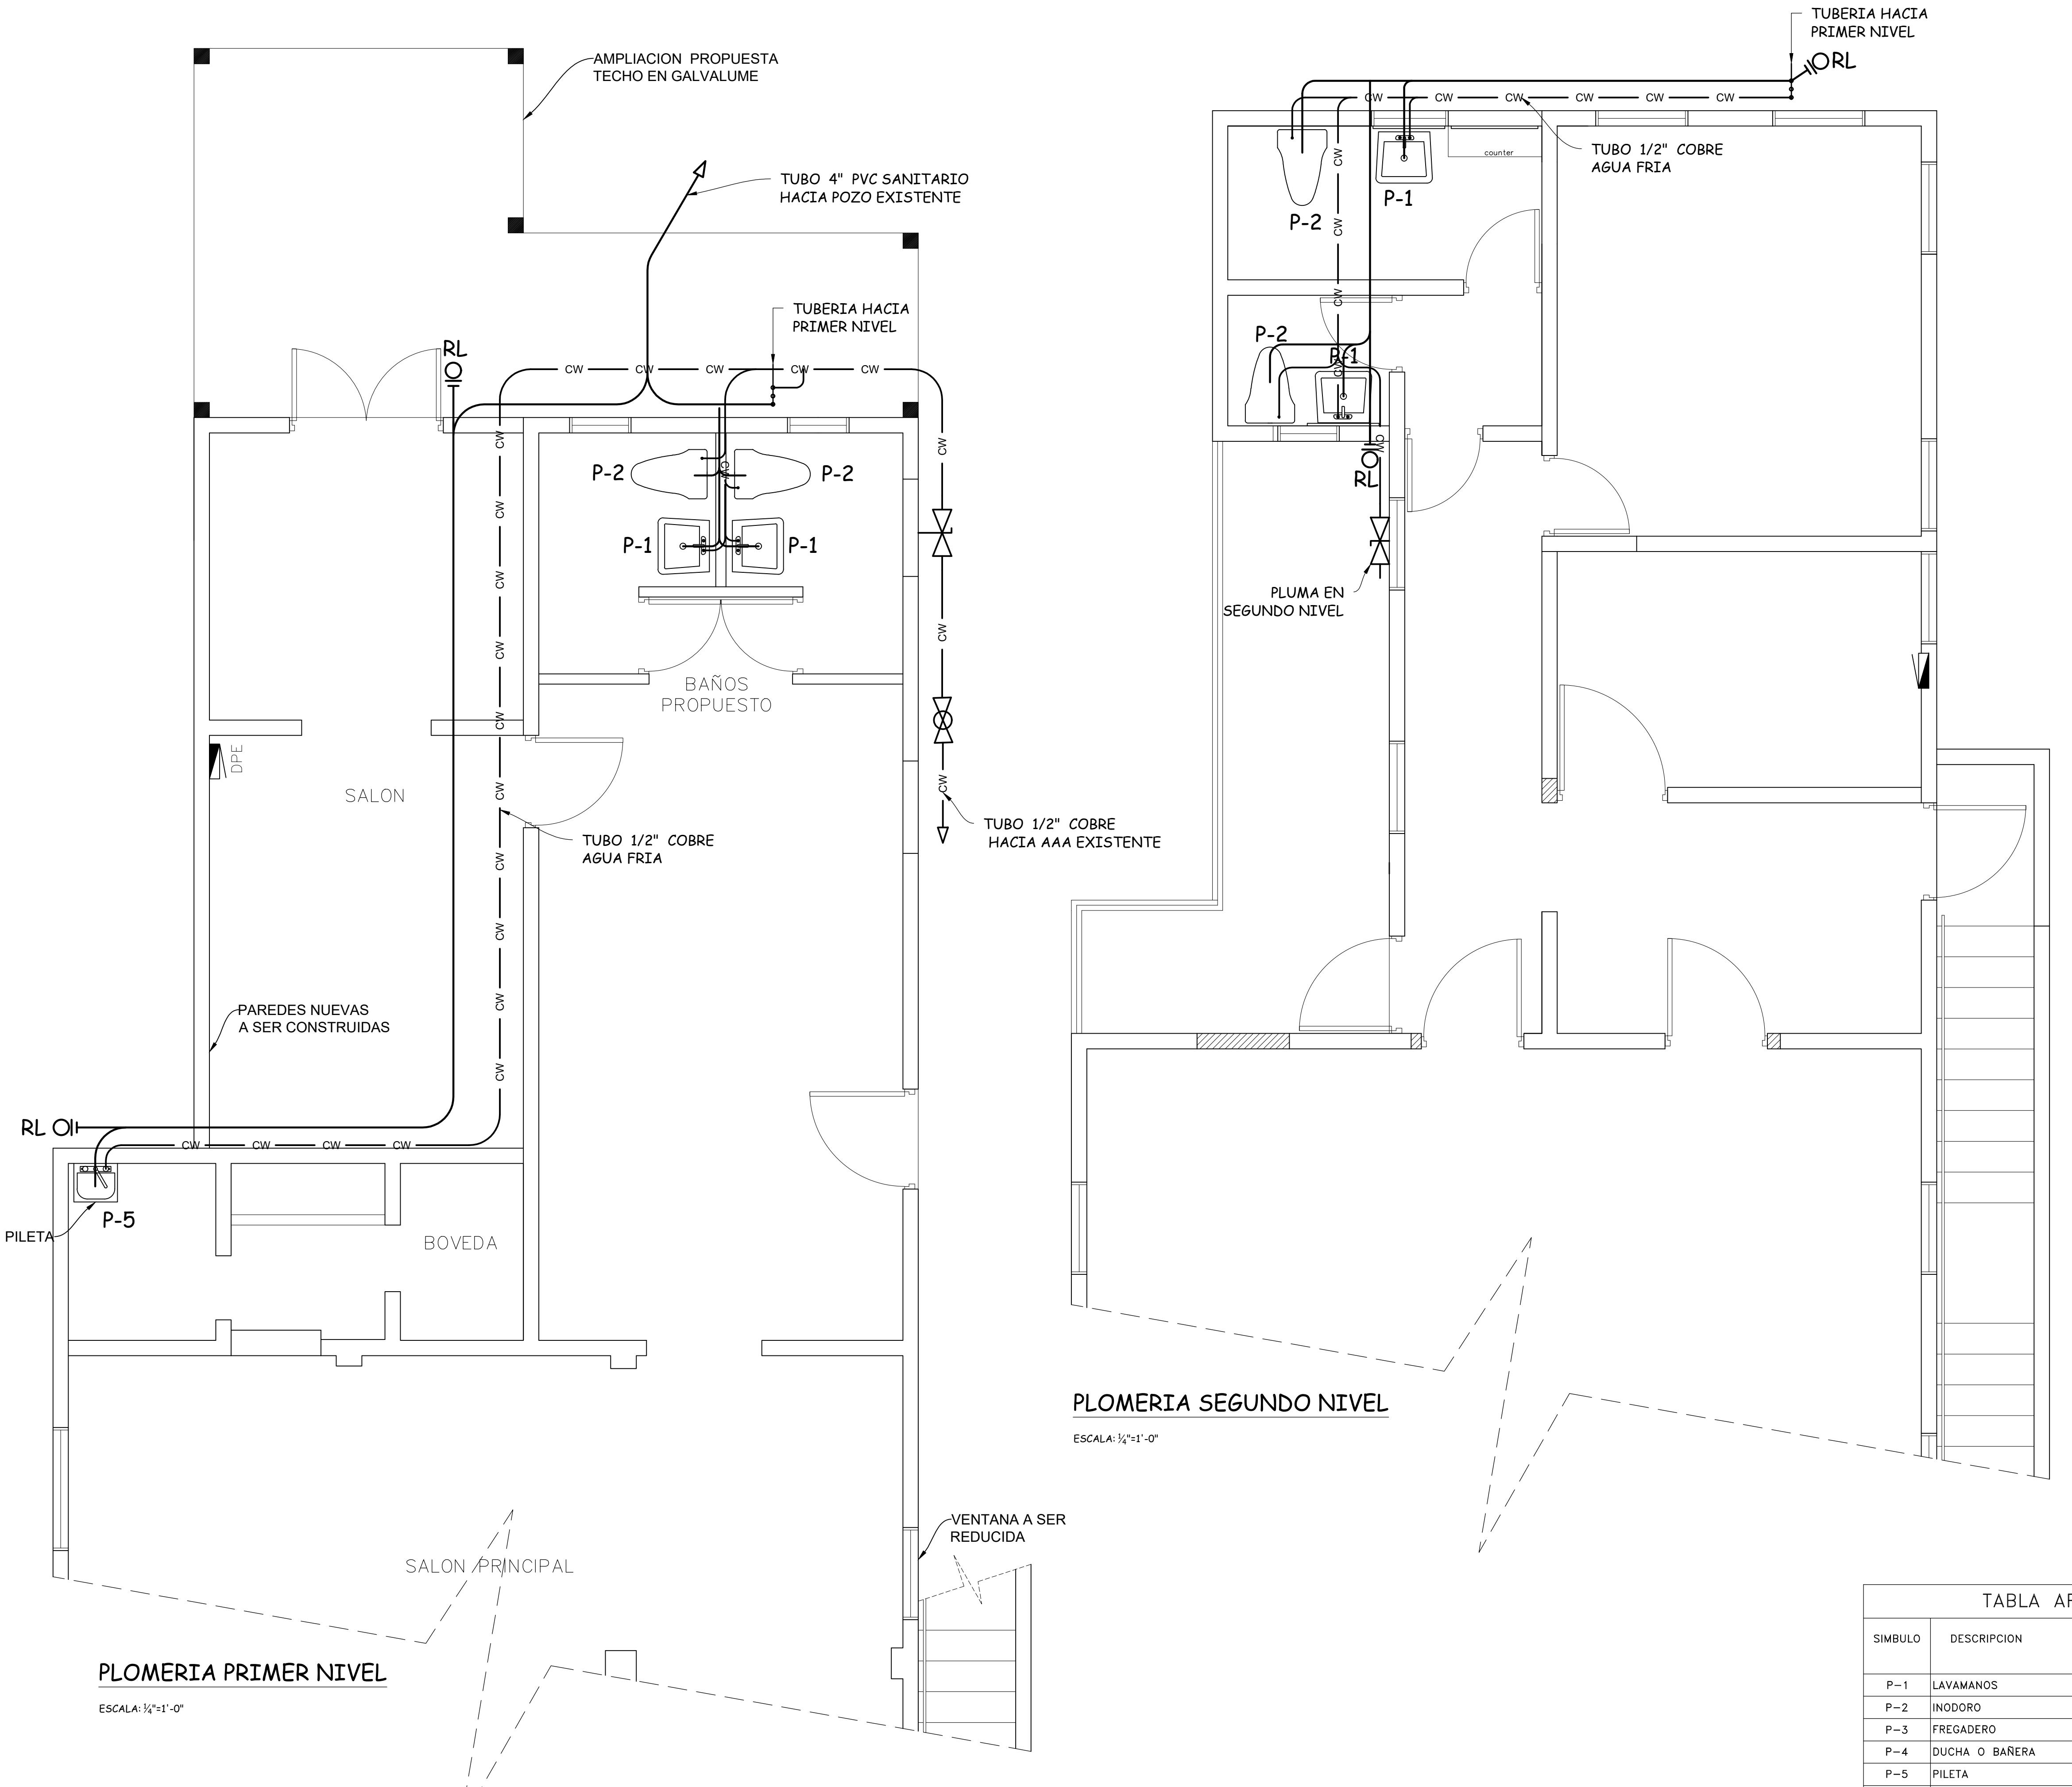
TABLA APARATOS SANITARIO					
SIMBULO	DESCRIPCION	AGUA CALIENTE	AGUA FRIA	TUBERIA SANITARIA	ALTURA LLAVES
P-1	LAVAMANOS	1/2"	1/2"	1 1/2"	24"
P-2	INODORO	-	1/2"	1 1/2"	8"
P-3	FREGADERO	1/2"	1/2"	1 1/2"	24"
P-4	DUCHA O BAÑERA	1/2"	1/2"	1 1/2"	30"
P-5	PILETA	1/2"	1/2"	1 1/2"	30"
P-6	LAVADORA	1/2"	1/2"	1 1/2"	30"

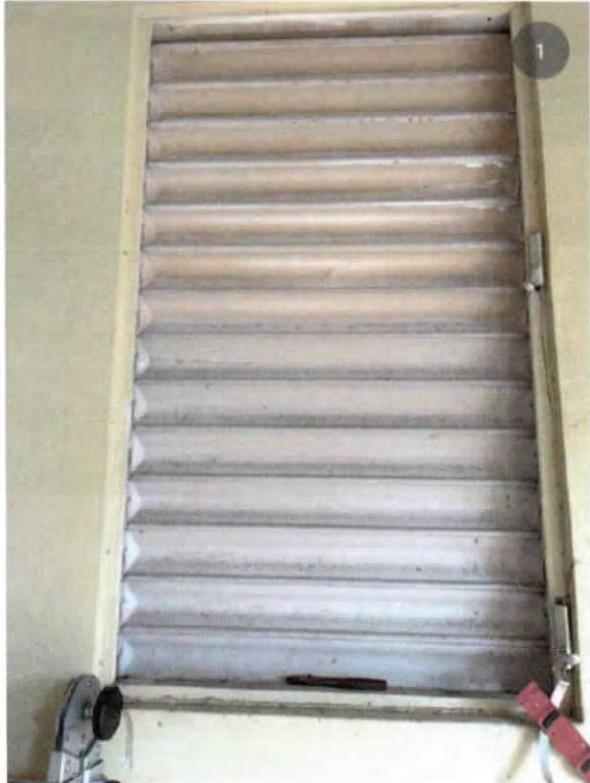
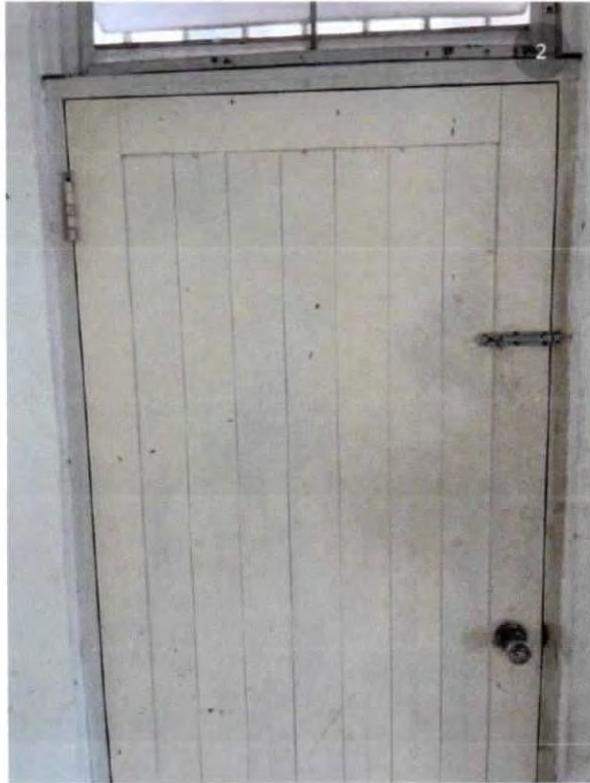
WINDOW/DOOR CAULKING:

None SACM caulking found visible at the moment of the inspection.

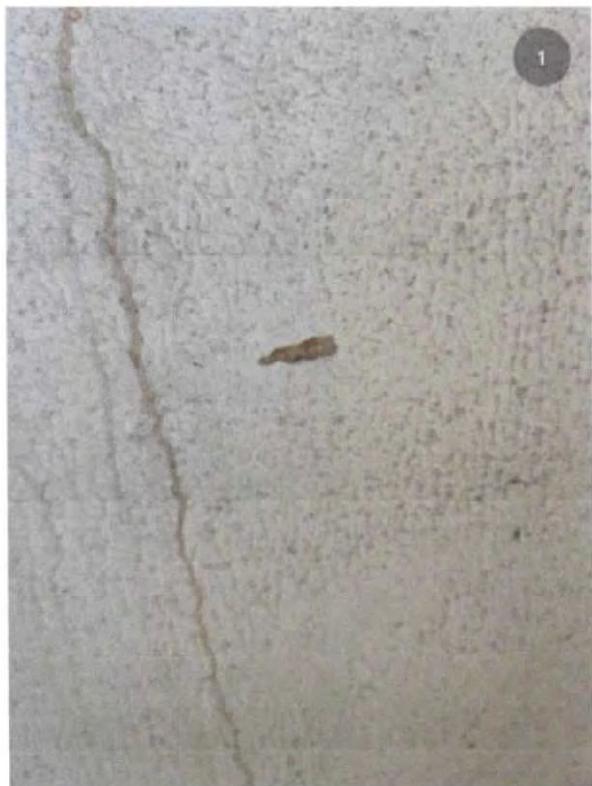
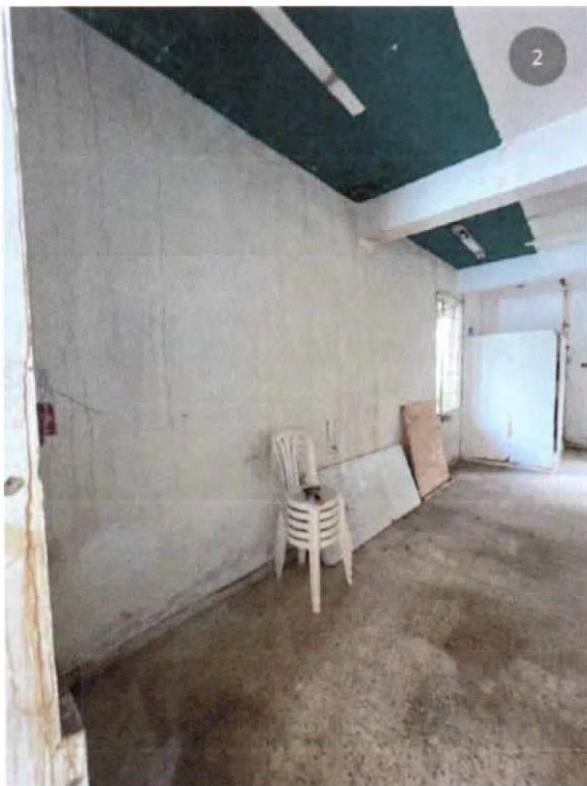
SACM VISIBLES? ROOM 7 - FIRST LEVEL

Condition: Damaged

MHQ-HA1-EC-01, 02 & 03.
