**Environmental Review for Activity/Project that is Categorically
Excluded Subject to Section 58.5**

**MUSEO HISTORICO DE QUEBRADILLAS
QUEBRADILLAS, PR**
PR-CRP-000554
CDBG-DR

**Applicant: Municipality of Quebradillas
Prepared by: José D. Centeno Calero PE
Professional Engineer
License 20206
Date: October 23, 2023**

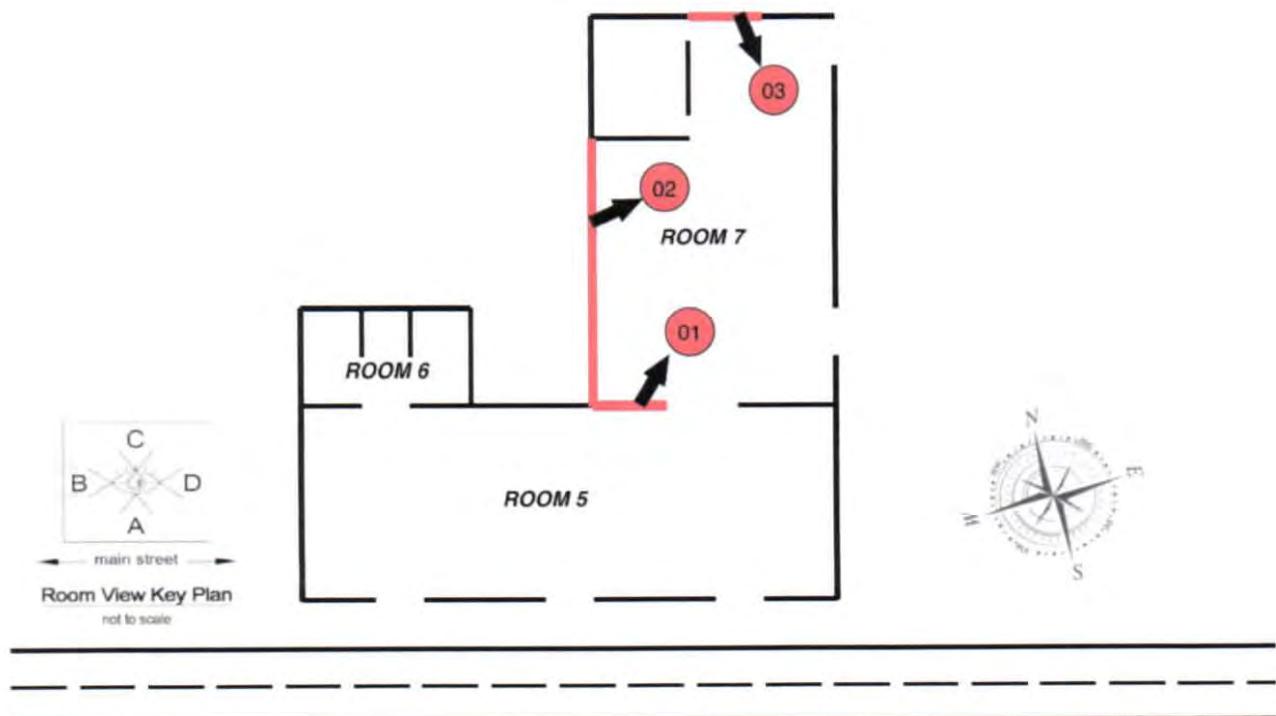
FIRST LEVEL

- ➔ AREA WHERE SAMPLES WERE TAKEN
- | ➔ HOMOGENEOUS AREA 1, WHITE WALL STUCCO

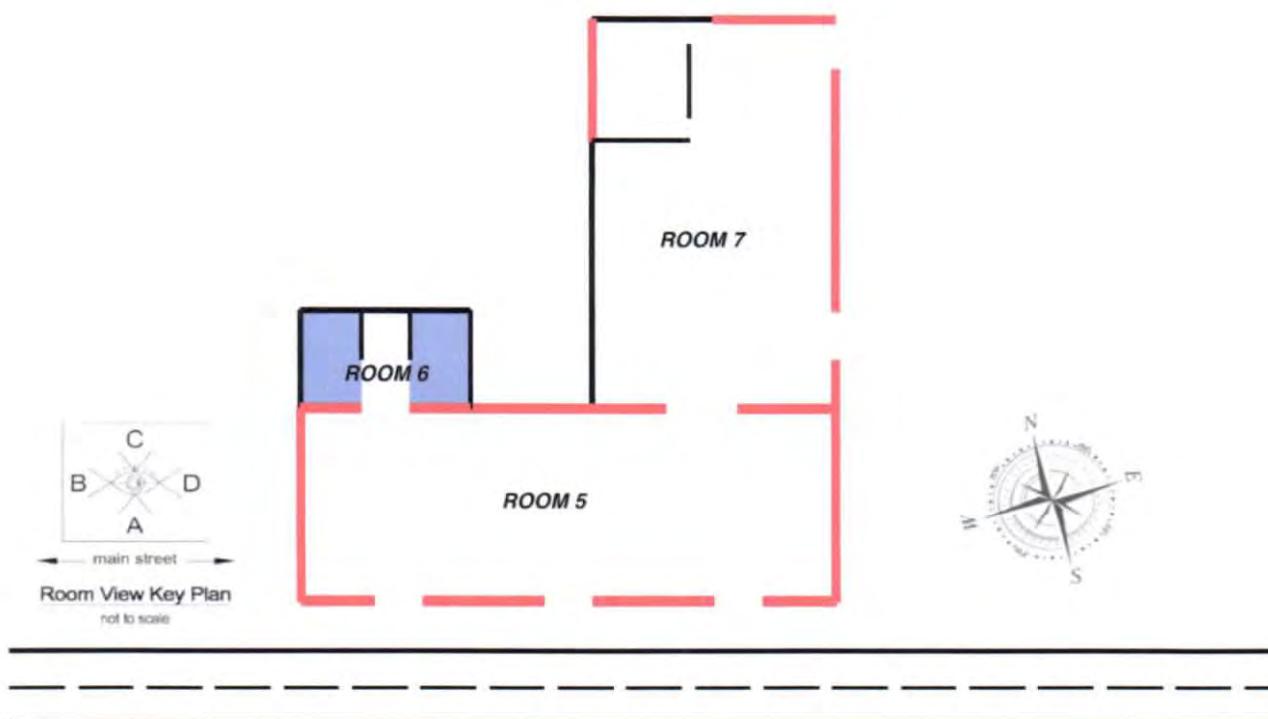
FIRST LEVEL

- | ➔ LBP POSITIVE, INTERIOR CONCRETE WALLS
- █ ➔ LBP POSITIVE, INTERIOR GRAY LEAD-GLAZED CERAMIC FLOOR TILE

LBP was found at some of the project accessed components. Some interior concrete walls (approx. 2,450 Ft²) have LBP. Also, about 240 FT² of lead-glazed ceramic tiles (which are regulated in PR as LBP) were found on some walls or floors. Data from XRF analyzer testing is included in **Attachment 3** and **4** with positive readings marked in red or bold. **Attachment 5** includes the approximated location of identified LBP or lead-glazes at the subject structure. Representative Pictures\Photograph Log of identified LBP surfaces and/or lead-glazed ceramic components within the structure are provided in the **Attachment 6**.

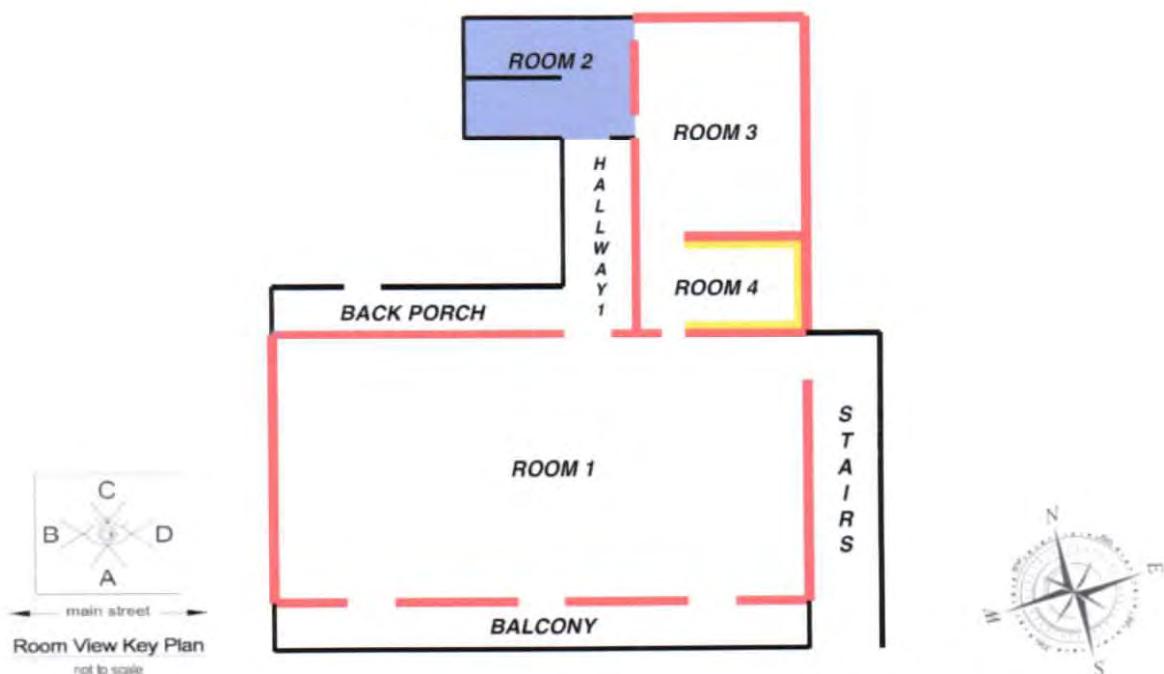
SECOND LEVEL

- ➔ LBP POSITIVE, INTERIOR WHITE CONCRETE WALLS
- ➔ LBP POSITIVE, INTERIOR BEIGE LEAD-GLAZED CERAMIC WALL TILE
- ➔ LBP POSITIVE, INTERIOR BLUE LEAD-GLAZED CERAMIC FLOOR TILE

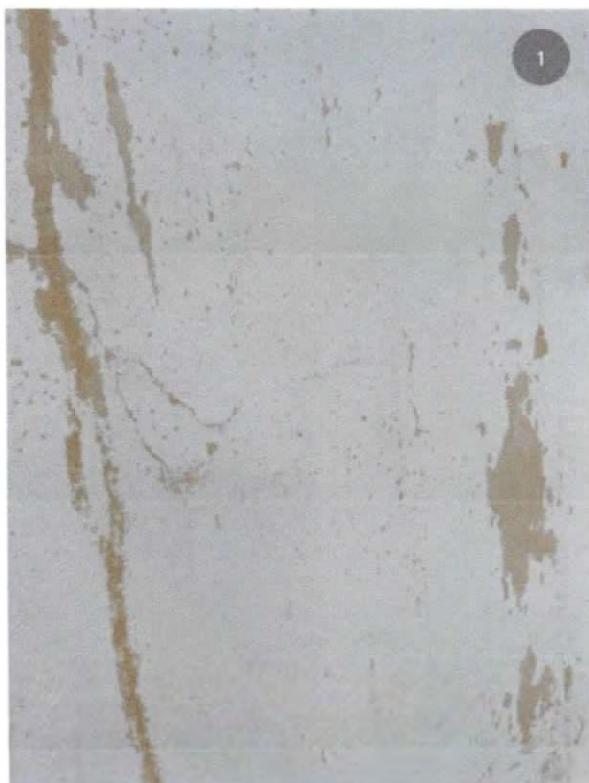
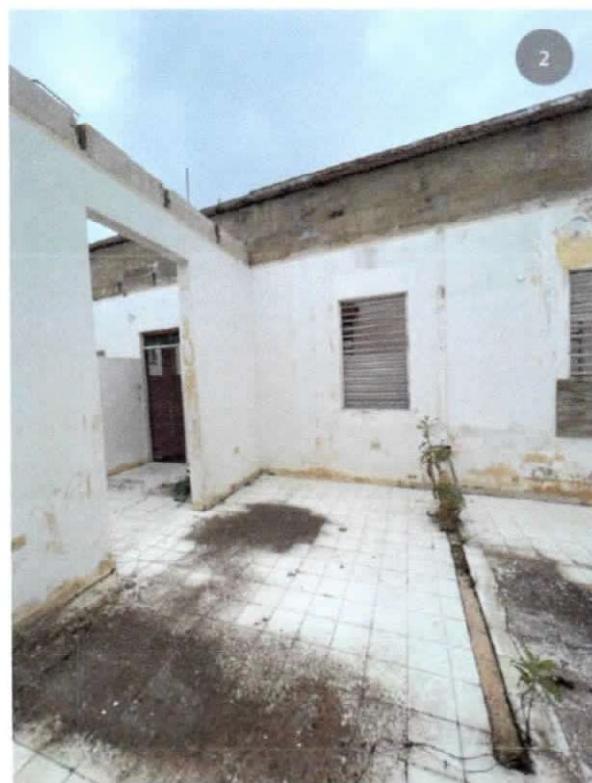
LBP DETECTED? ROOM 1 SECOND FLOOR

Interior, Reading #47, white concrete wall, side C, 6.4 mg/cm². (QTY. 180 S.F APPROX.)

Interior, Reading #48, white concrete wall, side D, 6.3 mg/cm². (QTY. 200 S.F APPROX.)

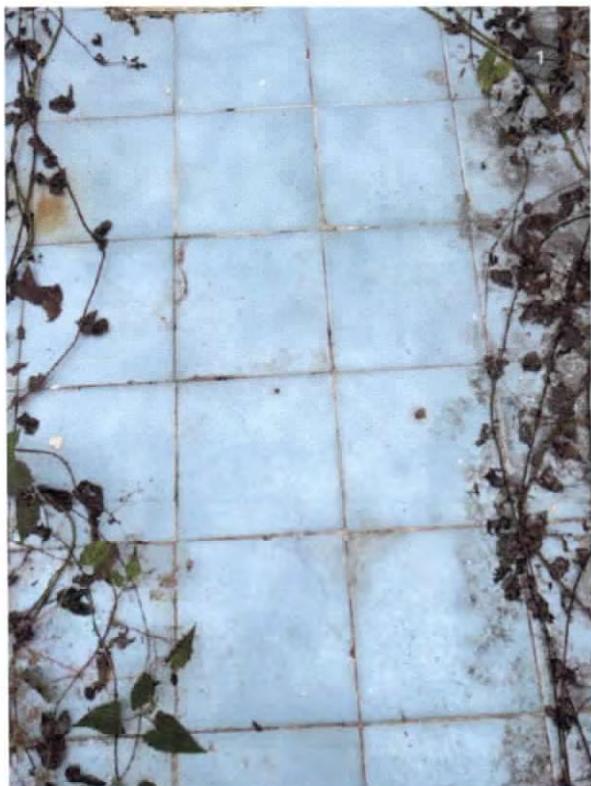
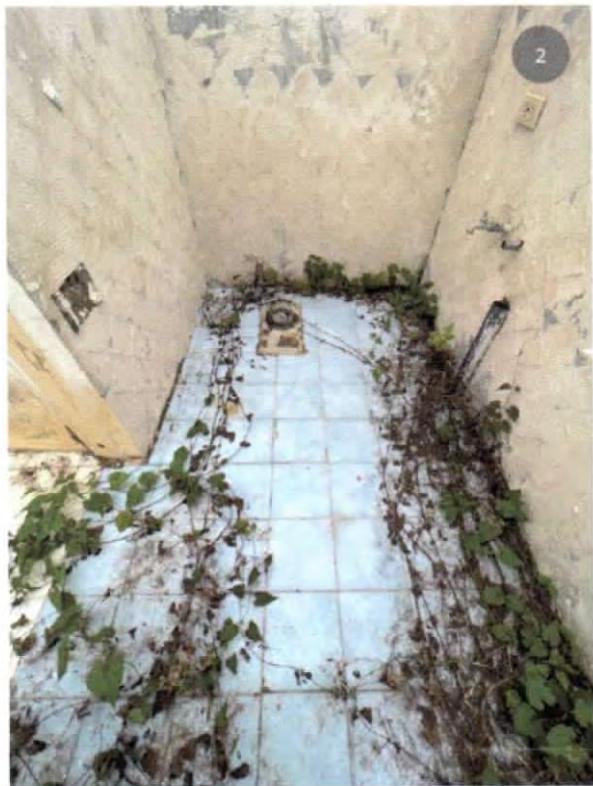
LBP DETECTED? ROOM 2 SECOND FLOOR

Interior, Reading #56, blue lead-glazed ceramic floor tile, 1.1 mg/cm². (QTY. 75 S.F APPROX.)

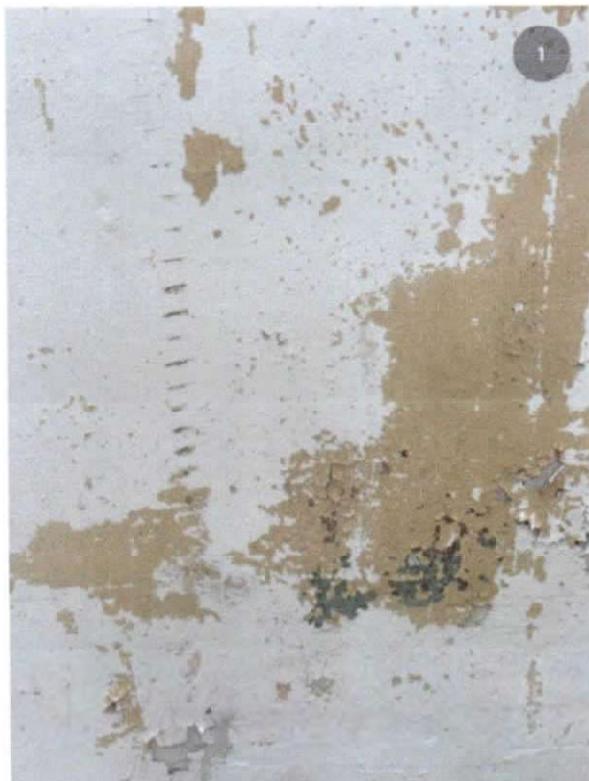
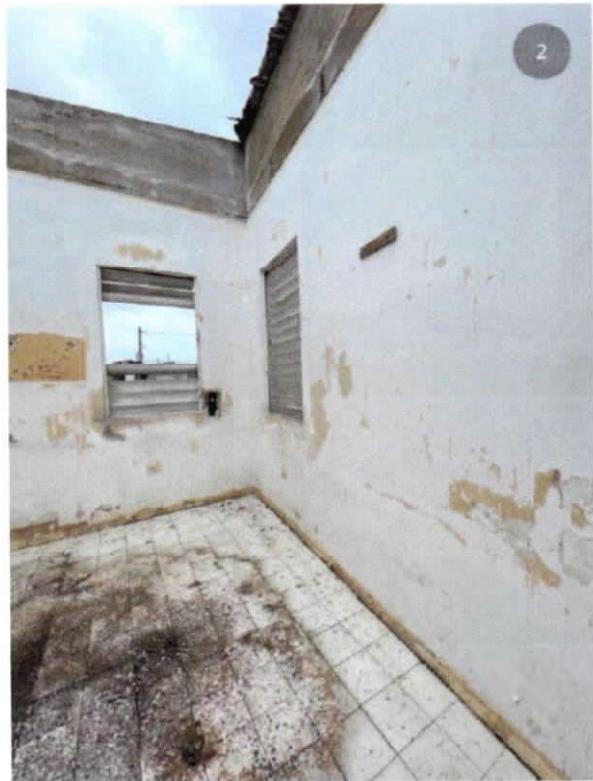
LBP DETECTED? ROOM 3 SECOND FLOOR

Interior, Reading #64, white concrete wall, side C, 5.5 mg/cm². (QTY. 110 S.F APPROX.)

Interior, Reading #65, white concrete wall, side D, 6.0 mg/cm². (QTY. 130 S.F APPROX.)

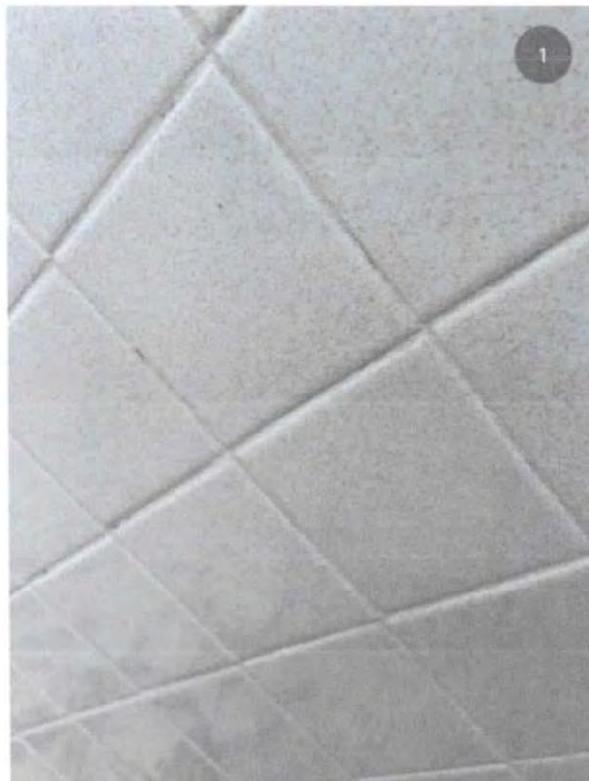
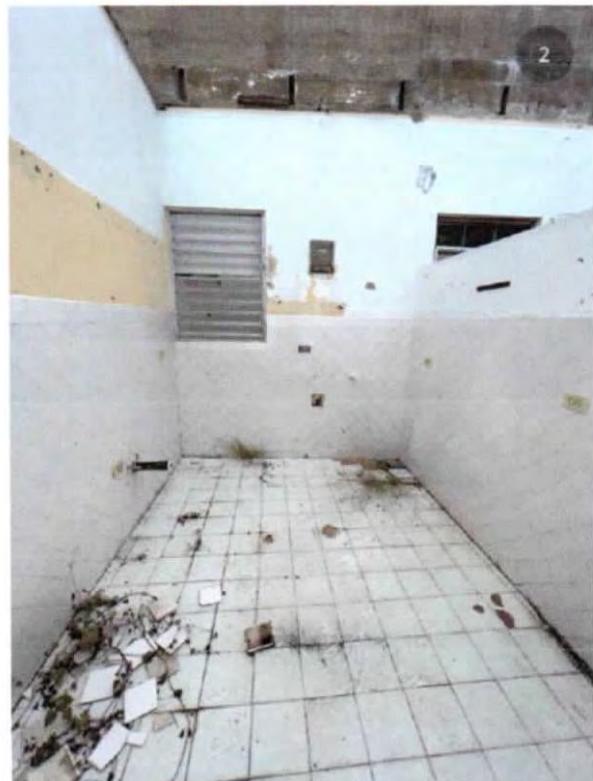
LBP DETECTED? ROOM 4 SECOND FLOOR

Interior, Reading #72, beige lead-glazed ceramic wall tile, side C, 3.1
mg/cm². (QTY. 40 S.F APPROX.)

Interior, Reading #73, beige lead-glazed ceramic wall tile, side D, 2.8
mg/cm². (QTY. 35 S.F APPROX.)

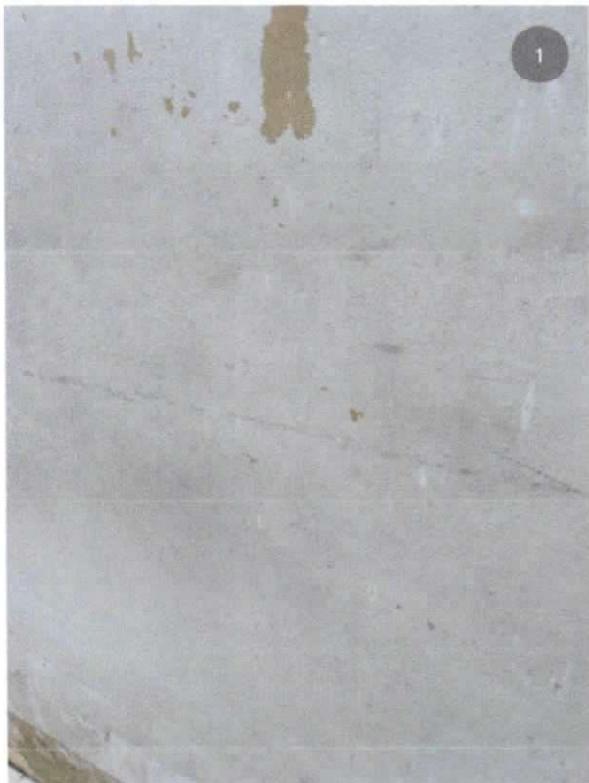
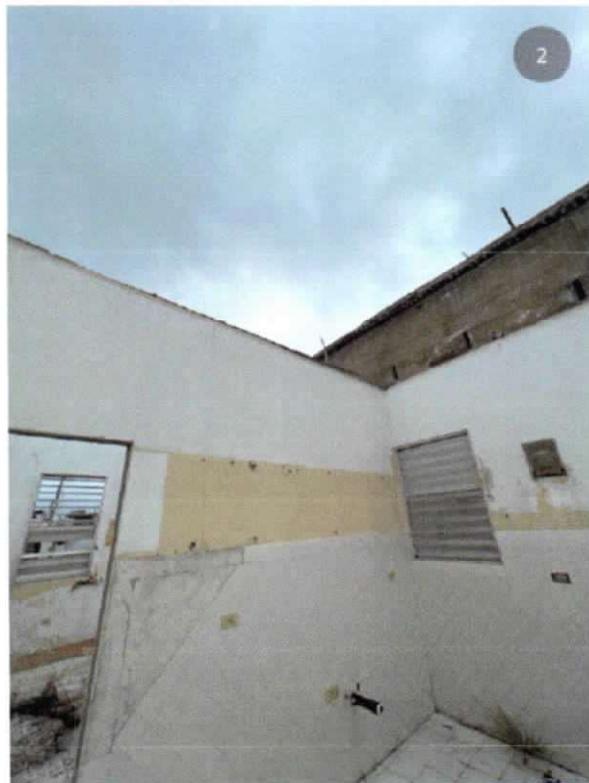
LBP DETECTED? ROOM 4 SECOND FLOOR

Interior, Reading #76, white concrete wall, side C, 5.7 mg/cm². (QTY. 55 S.F APPROX.)

Interior, Reading #77, white concrete wall, side D, 4.4 mg/cm². (QTY. 45 S.F APPROX.)

MUSEO HISTORICO QUEBRADILLAS	76	5.7	mg/cm ²	Positive	2	1/24/2023	10:39:44	R.RODRIGUEZ	526	Interior	Room 4	Wall	Concrete	C	White	Deteriorated	55 SF APPROX															
MUSEO HISTORICO QUEBRADILLAS	77	4.4	mg/cm ²	Positive	2	1/24/2023	10:39:58	R.RODRIGUEZ	526	Interior	Room 4	Wall	Concrete	D	White	Deteriorated	45 SF APPROX															
MUSEO HISTORICO QUEBRADILLAS	78	0	mg/cm ²	Negative	2	1/24/2023	10:40:39	R.RODRIGUEZ	526	Interior	Room 4	Gate	Metal	D	White	Deteriorated	-															
MUSEO HISTORICO QUEBRADILLAS	79	0.3	mg/cm ²	Negative	2	1/24/2023	10:40:55	R.RODRIGUEZ	526	Interior	Room 4	Floor	Ceramic	-	White	Deteriorated	-															
MUSEO HISTORICO QUEBRADILLAS	80	0.1	mg/cm ²	Negative	2	1/24/2023	10:41:35	R.RODRIGUEZ	526	Interior	Room 4	Door	Wood	D	Brown	Deteriorated	-															
MUSEO HISTORICO QUEBRADILLAS	81	0.1	mg/cm ²	Negative	2	1/24/2023	10:41:42	R.RODRIGUEZ	526	Interior	Room 4	Door Frame	Wood	D	Brown	Deteriorated	-

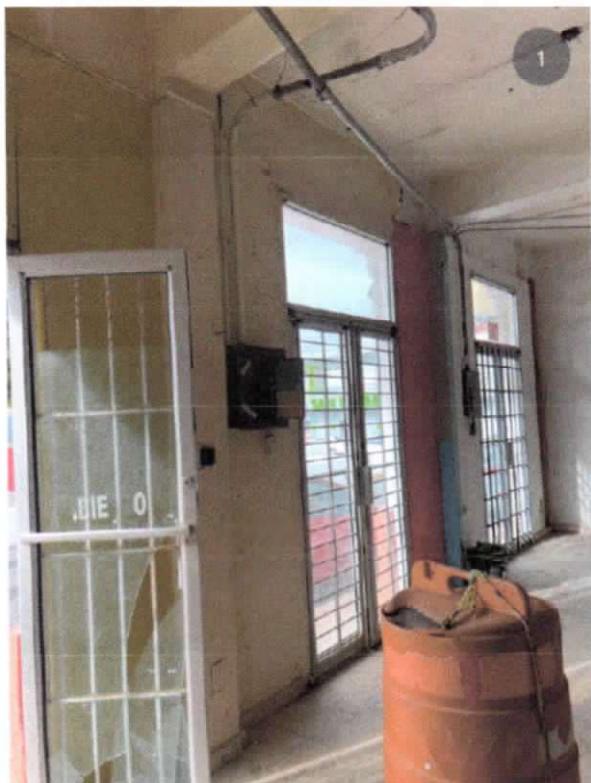
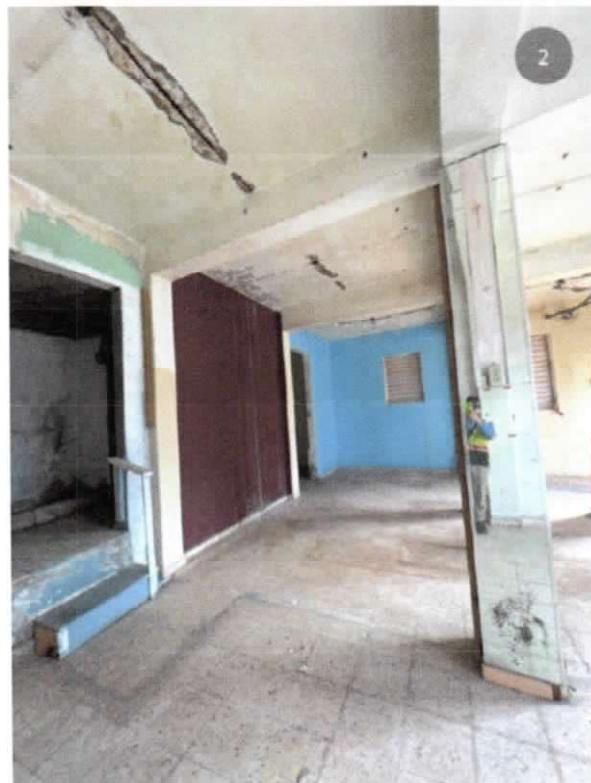
LBP DETECTED? ROOM 5 FIRST FLOOR

Interior, Reading #95, blue concrete wall, side D, 4.5 mg/cm². (QTY. 110 S.F APPROX.)

Interior, Reading #96, beige concrete wall, side D, 4.4 mg/cm². (QTY. 110 S.F APPROX.)

MUSEO HISTORICO QUEBRADILLAS	96	4.4	mg/cm ²	Positive	1	1/24/2023	10:51:31	R.RODRIGUEZ	526	Interior	Room 5	Wall	Concrete	D	Beige	Deteriorated	110 SF APPROX
MUSEO HISTORICO QUEBRADILLAS	97	0.1	mg/cm ²	Negative	1	1/24/2023	10:52:41	R.RODRIGUEZ	526	Interior	Room 5	Ceiling	Concrete	-	Beige	Deteriorated	-
MUSEO HISTORICO QUEBRADILLAS	98	0.1	mg/cm ²	Negative	1	1/24/2023	10:52:48	R.RODRIGUEZ	526	Interior	Room 5	Ceiling	Concrete	-	Beige	Deteriorated	-
MUSEO HISTORICO QUEBRADILLAS	99	0.2	mg/cm ²	Negative	1	1/24/2023	10:53:11	R.RODRIGUEZ	526	Interior	Room 5	Floor	Terrazo	-	Beige	Deteriorated	-
MUSEO HISTORICO QUEBRADILLAS	100	0.2	mg/cm ²	Negative	1	1/24/2023	10:53:46	R.RODRIGUEZ	526	Interior	Room 6	Floor	Ceramic	-	White	Deteriorated	-
MUSEO HISTORICO QUEBRADILLAS	101	3.7	mg/cm ²	Positive	1	1/24/2023	10:53:59	R.RODRIGUEZ	526	Interior	Room 6	Floor	Ceramic	-	Gray	Deteriorated	50 SF APPROX
MUSEO HISTORICO QUEBRADILLAS	102	1.4	mg/cm ²	Positive	1	1/24/2023	10:54:10	R.RODRIGUEZ	526	Interior	Room 6	Floor	Ceramic	-	Gray	Deteriorated

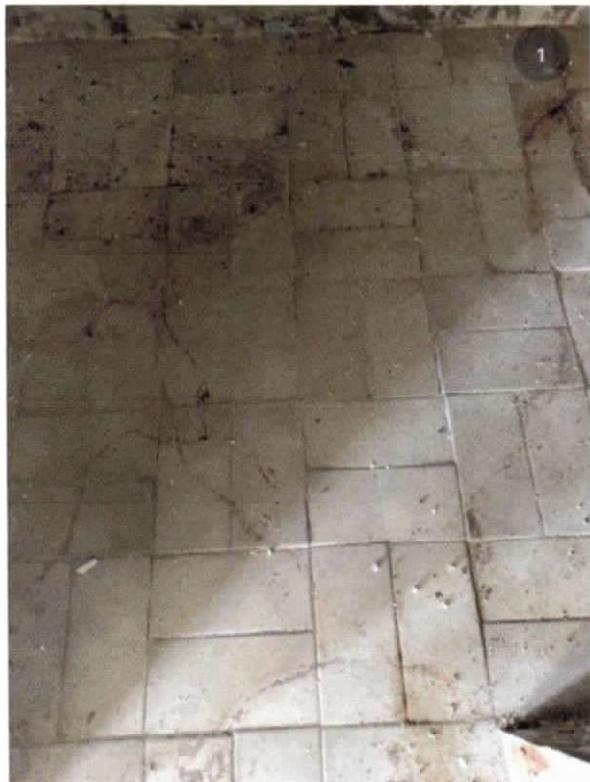
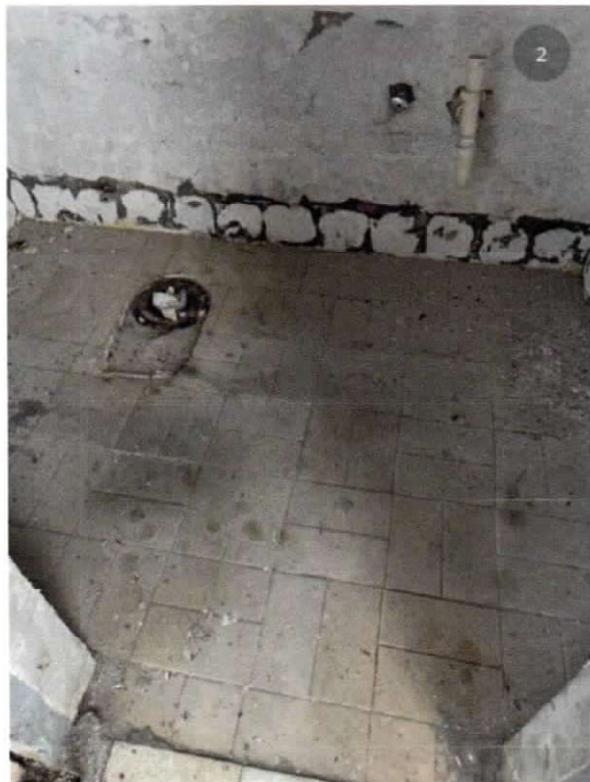
LBP DETECTED? ROOM 6 FIRST FLOOR

Interior, Reading #101, #102, gray lead-glazed ceramic floor tile, 3.7, 1.4 mg/cm². (QTY. 50 S.F APPROX.)

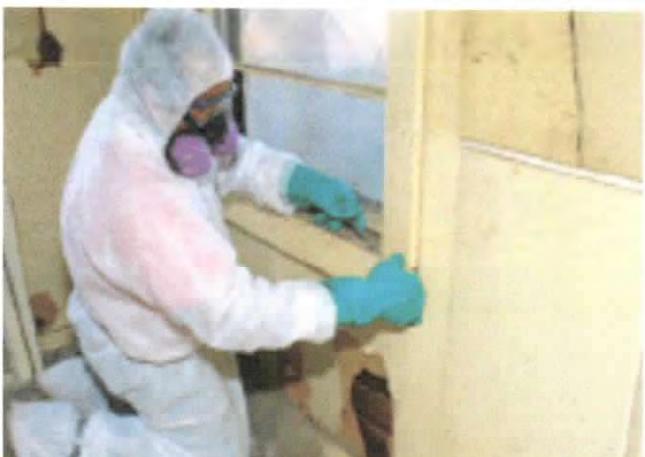
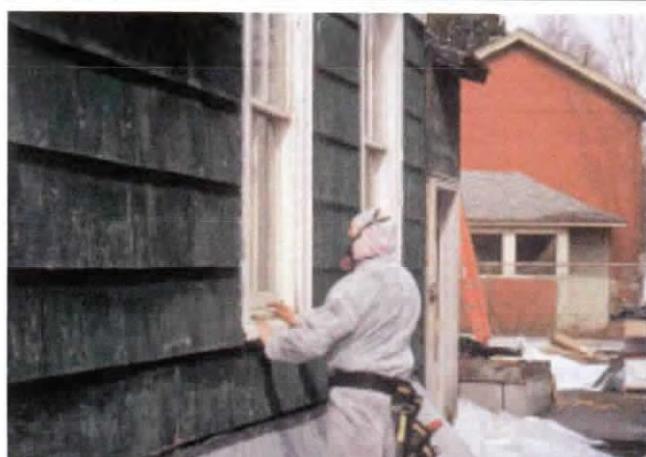
FIGURE 12.1 Removing and Replacing Trim: interior (left), exterior (right).

The term "other trim" applies to such components as window casings, interior sills (stools), aprons, door casings, baseboards (including caps and shoe moldings), chair rails, exterior fascia, soffits, shutters, and crown moldings (see Figure 12.1). Components with lead-based paint should be removed as described in the previous section.

New lead-free components should be installed in a professional manner using standard carpentry practices. In situations where trim is being applied to lead-based painted walls, ceilings and floors that were enclosed, or casings for windows or doors where the jambs have been enclosed, the trim should be back-caulked before installation as an added precaution. Back-caulking refers to the application of caulk to the perimeter of the backside of rigid building materials to seal them before installation, preventing lead-dust from entering the living space through cracks and crevices. Use a high quality caulk that is warranted for at least 20 years.

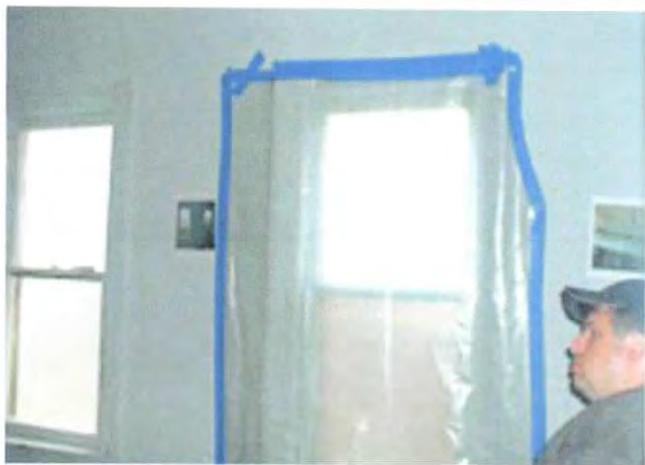
FIGURE 12.2 Protecting the interior of a unit for exterior window abatement.

Depending on the building construction, it may be possible to remove the entire window system. The new lead-free components should be installed in a professional manner using standard carpentry practices. Windows may be replaced from the interior or exterior of the property. If windows are replaced from the exterior and only exterior clearance is planned, the interior of the unit must be protected by polyethylene sheeting.

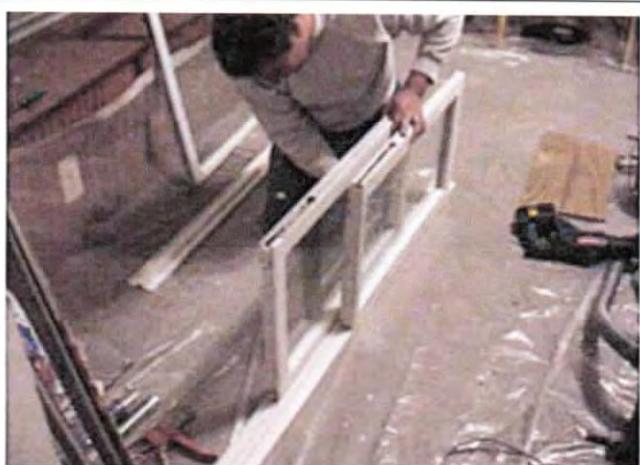
FIGURE 12.3 Replacement window system.

The term "window" applies to the sash, the stop and parting beads, window jambs, door frame and trim. Affected components should be removed as described in Section B. Window replacement can involve the removal of a wooden or metal unit and the installation of a wood, vinyl, or metal unit in its place (see Figure 12.2 and 12.3). If the jamb is not removed, it can often be enclosed by the new window frame system, which should be caulked and fastened. The remaining exterior portion of the jamb, if any, can be wrapped with coil stock (aluminum or vinyl or equivalent) after back-caulking. In situations where window units must be replaced in kind (e.g., historic preservation), the jambs should be removed and replaced also to make sure that no friction surfaces coated with lead-based paint remain. Generally, friction surfaces should not be painted.

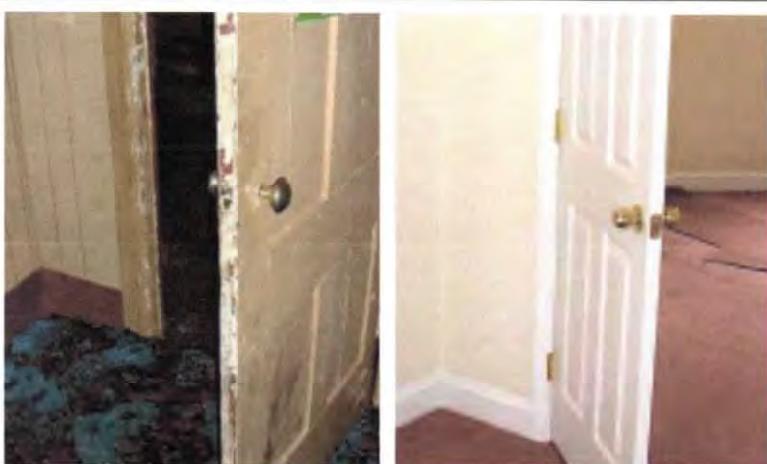
FIGURE 12.4 Pre-and post-abatement interior doors.

Interior and exterior doors include the doorstops, door jambs and door frame (see Figure 12.4). Affected components should be removed as described above. Typical door replacement usually involves the removal of a wooden unit and the installation of a pre-hung wooden unit in its place. In this type of door replacement, the jamb is rarely removed, but is usually saved and enclosed with the new doorjamb after back-caulking. Wooden jamb extensions or coil stock, properly back-caulked, can be used to enclose any remaining portion of the jamb. In situations where pre-hung door units are not permissible (e.g., code requirements, historic preservation regulations), the original jamb should also be removed and replaced, if possible, to make sure that no friction surfaces coated with lead-based paint remain. If the jamb cannot be replaced, the stop should be removed and replaced with new material after the old jamb is carefully stripped.

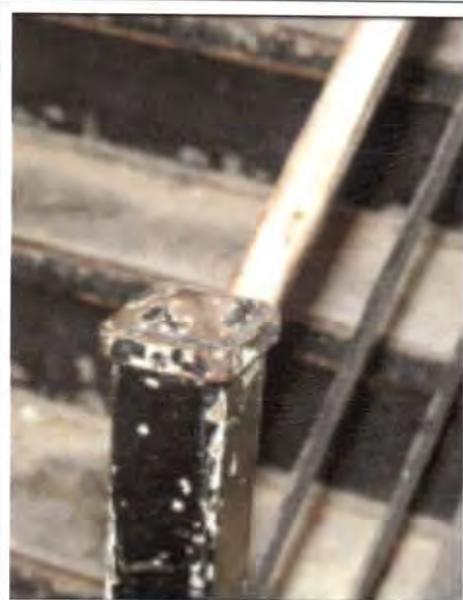
FIGURE 12.5 A metal railing before abatement.

Railings include the railing caps, banisters, posts and spindles (balusters), and newel posts that can be removed and replaced (see Figure 12.5). Railings may or may not be part of a stair system. Affected components should be removed as described in Section B. New lead-free components should be installed in a professional manner using standard carpentry practices. Metal railings and other grillwork can be removed and taken off-site for contained abrasive blasting or other forms of paint removal, then reinstalled after repainting. See Section II.C.3, above, regarding lead-containing factory-applied primers.

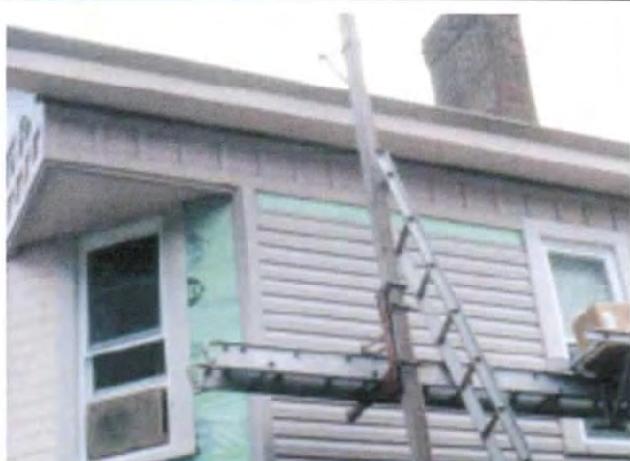
FIGURE 12.6 Installation of replacement siding.

Many materials are used on a dwelling's exterior walls. Materials of concern are generally painted wood or brick. Under most conditions, deteriorated siding identified as a lead hazard will be abated through enclosure without removing the original material. However, in restoration or historically significant projects, it may be replaced. Siding is now available that closely resembles wood. If the siding is to be replaced, the affected siding should be removed. Care must be taken to avoid contamination of soil walkways, window air conditioners, and the building interior (see Figures 12.6 and 12.7).

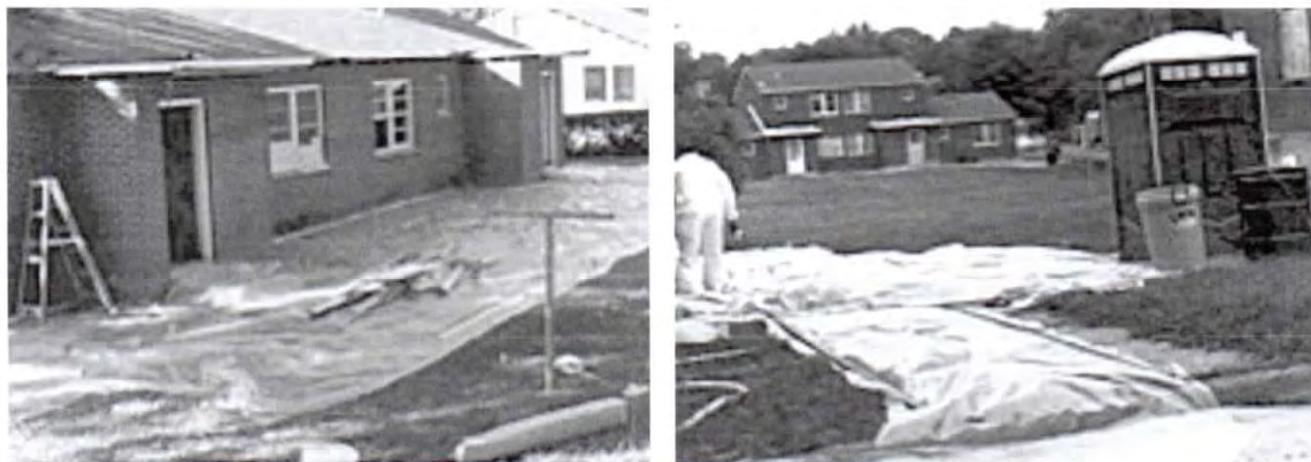
FIGURE 12.8 Line surfaces with plastic in the work area (left) and pathways (right)

Building component replacement and demolition generate a considerable amount of waste material. Lead-contaminated building components and demolition debris should be handled carefully (see Chapter 10). Bulk debris such as doors, windows, and trim should be wrapped in durable puncture resistant plastic sheeting and sealed with tape. Smaller debris should be swept into heavy duty plastic bags after spraying. Exterior ground surfaces must also be protected. Outside storage needs to be secure and protect the ground (see Figure 12.8)

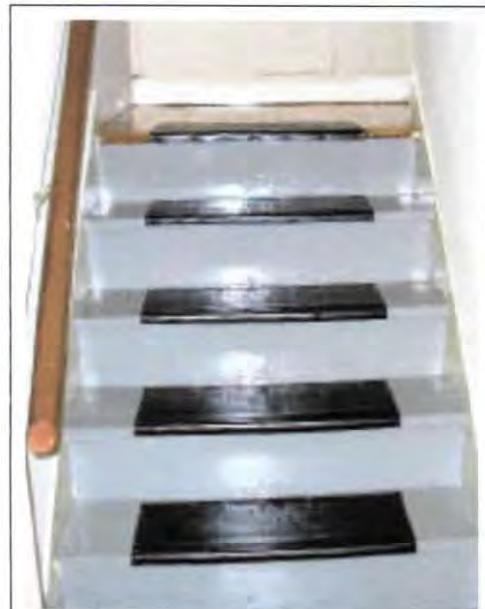
FIGURE 12.11 Enclosed stairs.

Plywood can be used to cover step risers and squared-off treads. Plywood is also useful as additional protection, supplementing the vinyl covers mentioned above. Precast concrete steps will have to be drilled, screwed, and glued to anchor the covers in place.

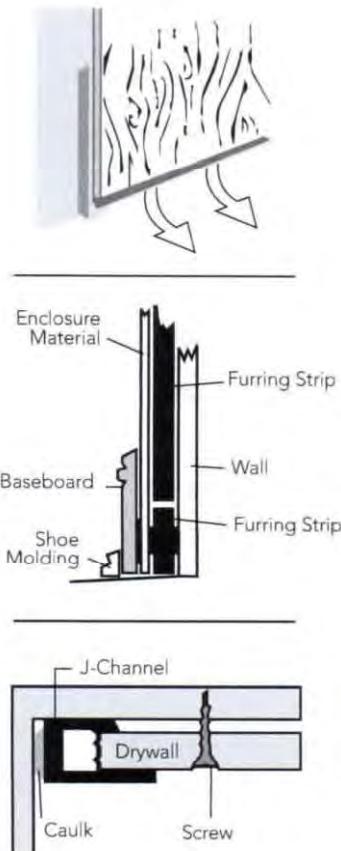
FIGURE 12.12 Seal All Seams for Enclosure.

- ◆ Back-caulk all the seams that aren't taped and spackled. Use a high quality adhesive caulk.
- ◆ Use a "J-channel" where drywall meets a finished surface. A J-channel is a final strip attached to the rough edge of drywall to make a finished edge. It's called a "J-channel" because of its shape. Caulk the outside edge so it seals with the finished surface. Screw the drywall in place.

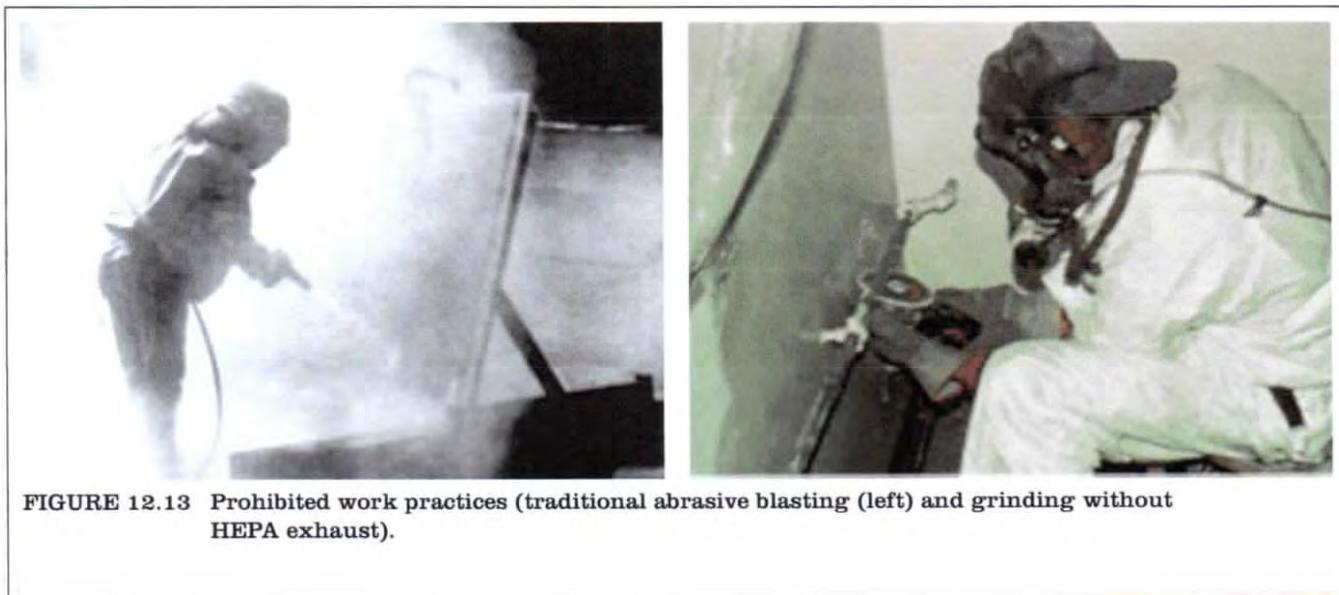
FIGURE 12.13 Prohibited work practices (traditional abrasive blasting (left) and grinding without HEPA exhaust).

Machine sanding or grinding is prohibited (regardless of the grit used) because of the large volume of leaded-dust generated (see Figure 12.13). As a result of these methods, workers have been exposed to extremely high leaded-dust levels, and blood-lead levels in resident children have increased (Amitai, 1991; Farfel, 1990; Jacobs, 1991b). However, machine sanding with a HEPA abatement exhaust tool is permitted and is discussed further below. Extensive dry hand sanding is not recommended, but wet sanding can be done if no electrical outlets are nearby. Limited dry sanding or scraping near electrical circuits is permitted.

Traditional abrasive blasting or sandblasting is prohibited in residential structures, regardless of whether the abrasive material is recycled or if the area is fully contained. These methods

produce widespread dust contamination; full containment is nearly impossible to maintain and guarantee in a residential environment. Abrasive blasting should only be done using HEPA vacuum local exhaust equipment, discussed below.

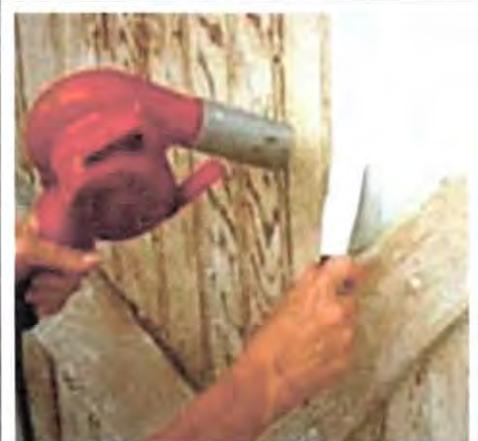
FIGURE 12.14 Using a heat gun to remove paint is labor-intensive.

Open flame burning is prohibited, so removal methods using heat are limited to electric powered flameless heat guns (see Figure 12.14).

While there is little risk that dangerous levels of lead fumes will be produced at temperatures below 1100°F, significant airborne particulate lead is generated by the accompanying scraping of the paint. Also, significant amounts of potentially harmful organic vapors can be released from the action of the heat upon the paint, even at temperatures below 1100 °F. For this reason, air-purifying respirators should be outfitted with both a HEPA-filtered cartridge and an organic vapor cartridge. Organic vapor cartridges may not be available for some powered air-purifying respirators.

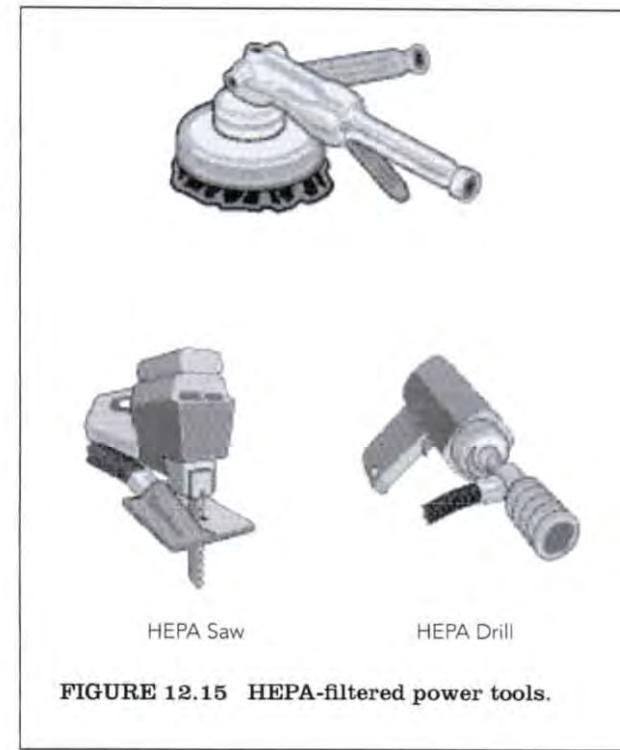
FIGURE 12.15 HEPA-filtered power tools.

HEPA sanding uses traditional electric sanders, such as disc sanders or orbital or vibrating sanders, equipped with specially designed shrouds or containment systems that are placed under a partial vacuum (also known as local exhaust ventilation). All exhaust air is passed through a HEPA filter (often using an ordinary HEPA vacuum) to reduce the amount of airborne particulate lead (see Figure 12.15). The HEPA vacuum must be correctly sized to provide adequate airflow to permit the system to operate properly. If hoses are longer than normal, a larger HEPA vacuum may be needed to handle the increased pressure drop.

There are two main types of HEPA sanders. The first uses a flexible shroud to surround the sanding head, with the HEPA vacuum hose attached to the shroud. The shroud must be

in constant contact with the surface to be effective. If the shroud extends beyond the surface being sanded, large amounts of particulate lead will be released into the air. In addition, this configuration makes it impossible to sand to the edge of protruding surfaces, such as baseboards or window and door casings.

The second type of HEPA sander pierces the sandpaper with holes through which the vacuum draws the dust. This allows the instrument to be used to the edge of protruding surfaces. However, care must be exercised to keep the sandpaper flat on the surface. Neither one of these methods is completely effective; respirators are always recommended. Worker fatigue can also prevent the worker from holding the tool flush with the surface, making it necessary to provide frequent breaks or rotate workers.

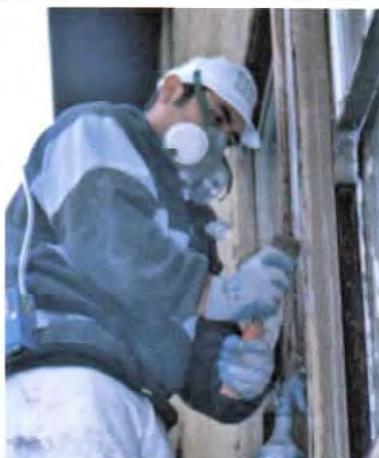
FIGURE 12.16 Wet scraping (left)

Wet scraping can be performed by using a spray bottle or sponge attached to a paint scraper (see Figure 12.16 and 12.17). Wet scraping is often used to remove loose and flaking paint before paint film stabilization or encapsulation. If wet scraping is employed as an abatement technique, a more durable covering than new paint is needed. Working a few square feet at a time, the worker should mist

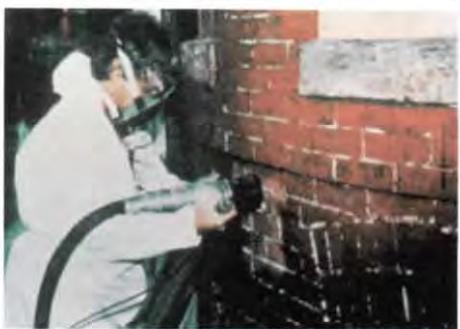
FIGURE 12.18 Vacuum blasting is not often used on housing.

HEPA vacuum blasting is simply abrasive blasting with a shroud under a vacuum that is attached to the blast head. All exhaust air is passed through a HEPA filter, using a properly sized HEPA vacuum system. Vacuum blasting is appropriate for metal, brick, concrete, and other masonry surfaces. To date, attempts to use the process on wood, plaster, and other soft materials have

Various blasting media can be used (e.g., aluminum oxide, metal shot, walnut shells) depending on the type of substrate. Blast heads, usually a brush-type arrangement, come in various sizes and shapes. The blast head must remain in continuous contact with the surface to avoid dispersal of both the blast medium and particulate lead (see figure 12.18). The equipment can be outfitted with a device that separates the blast media from the paint, effectively recycling the blast material, and dramatically reducing the volume of waste. This is particularly important because the blast material should be disposed of very carefully (see Chapter 10).

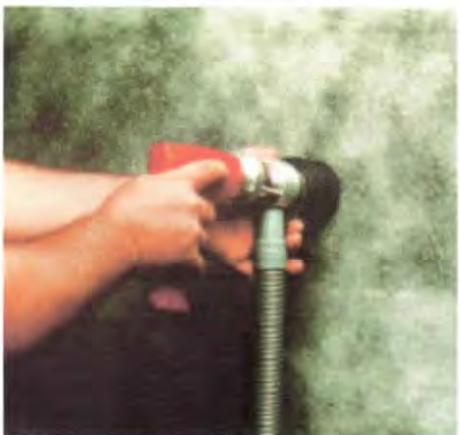
FIGURE 12.19 Needle Gun with HEPA Exhaust Ventilation.

The HEPA vacuum needle gun is similar to vacuum blasting in concept but avoids the use of a blast medium (see Figure 12.19). In the vacuum needle gun, metal needles rapidly pound against the painted surface, dislodging the paint. The HEPA vacuum, which is connected to the gun head, draws paint chips and dust into the vacuum, minimizing the dispersion of the particulate.

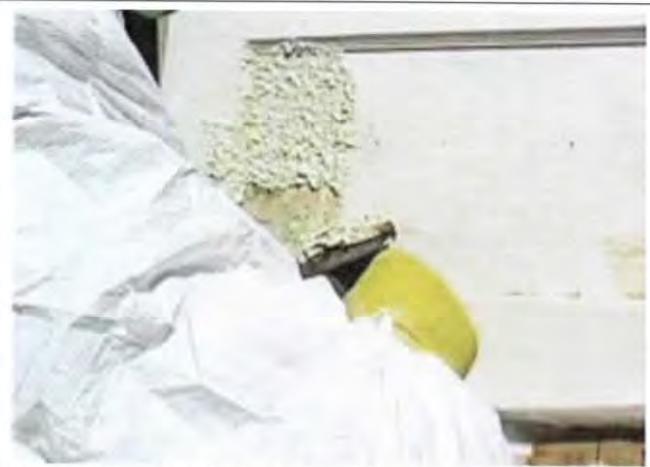
FIGURE 12.20 Workers should wear protective clothing when using chemicals.

Other drawbacks to chemical removal include high cost and potential harm to workers from splashes and chemical burns if proper gloves, face shields, and clothing are not provided and used (see Figure 12.20).

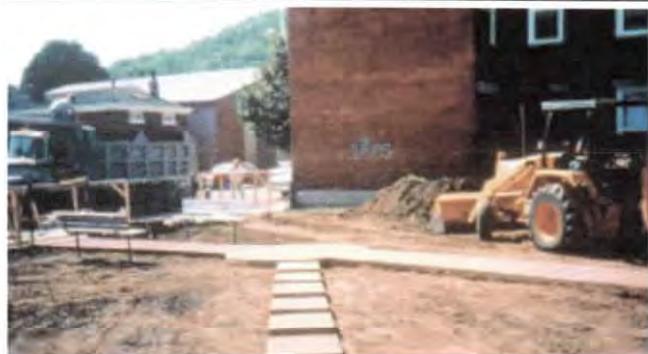
FIGURE 12.22 Replacing resident pathway after soil removal.

9. **Soil Replacement and Cleanup** – Prior to soil replacement, all walks, driveways, lanes, and streets adjacent to the excavation area should be cleaned of all contaminated soil (see Figure 12.22). All loose soil should be scraped, washed, and swept from the above-mentioned surfaces. No clean soil should be placed down until all contamination has been removed from these areas.

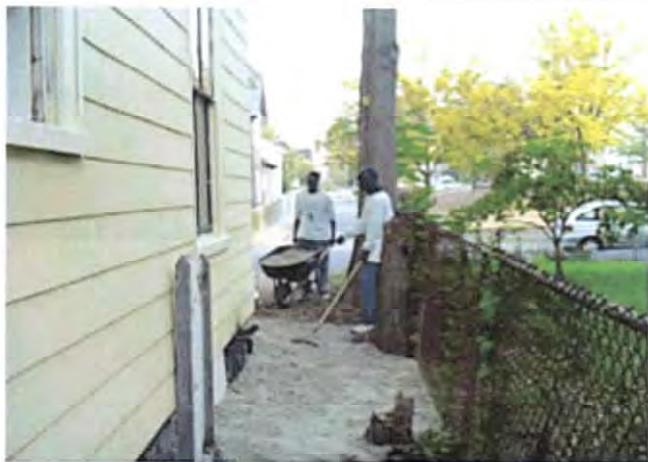
FIGURE 12.23 Preparing to pave high traffic area.

If contaminated soil is present in high-traffic areas, the soil can be covered by a high-quality concrete or asphalt (see Figure 12.23). In this case, contaminated soil need not be removed before paving. Normal precautions associated with thermal expansion or contraction and traffic load should be considered. Hard surfaces are not appropriate in play areas where falls are possible from slides, jungle gyms, etc. The Consumer Product Safety Commission has developed recommendations for fall surfaces in public play areas (e.g., addressing the need for impact attenuating protective surfacing under and around equipment, installation and maintenance procedures, and general hazards presented by protrusions, etc. CPSC, 2008; www.cpsc.gov/CPSCPUB/PUBS/325.pdf).
