**Environmental Review for Activity/Project that is Categorically
Excluded Subject to Section 58.5
Pursuant to 24 CFR 58.35(a)**

Project Name: Revitalización Fachadas Arquitectónicas e Históricas en el Centro Urbano (PR-CRP-000775)

Responsible Entity: Puerto Rico Department of Housing (PRDOH)

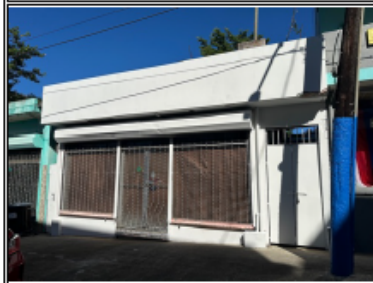
Property 01

- Paint the window's storm protection the same color as building (only the mechanism cover).
- Clean the mosaic and paint it in a similar color to the original.
- Clean and paint all electrical conduit, rolling door, including its components, side entrance metal door.
- Repair cement plaster prior to painting applications

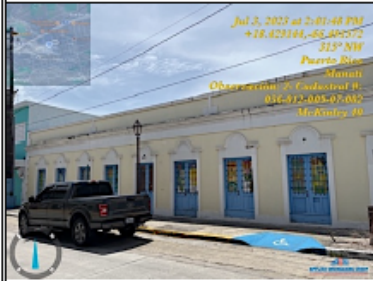
Property 02

- Remove the adhesives on windows and replace them with a frosted tint.
 - Remove all the vegetation present.
 - Clean and paint plaster on moldings and columns.
 - Repair double doors. Security grills to remain.
 - Paint any exposed pipes on the façade.
 - Paint the side facade
- Organize all exposed cable wiring, remove when is not in use.

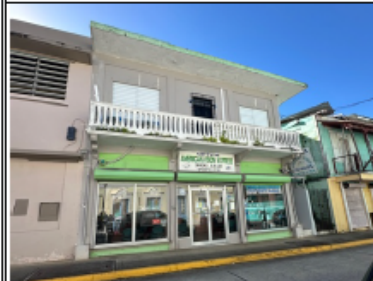
Property 03

- Remove all existing vegetation.
- Remove all non-compliant signage.
- Clean and repair plaster prior to painting application.
- Paint all exposed conduits the same color as the façade.
- Paint side façade.
- Repair all exposed facades.

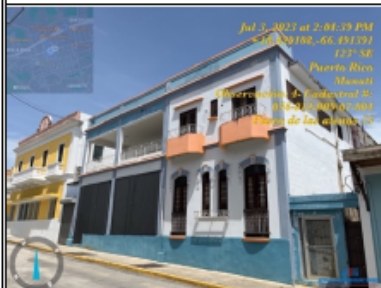
Property 04

- Replace damaged commercial type door.
- Install absent Luminaires.
- Fabricate architectural railings to original, paint and install.
- Repair the damaged exposed reinforcing steel.
- Repair all exposed facades.

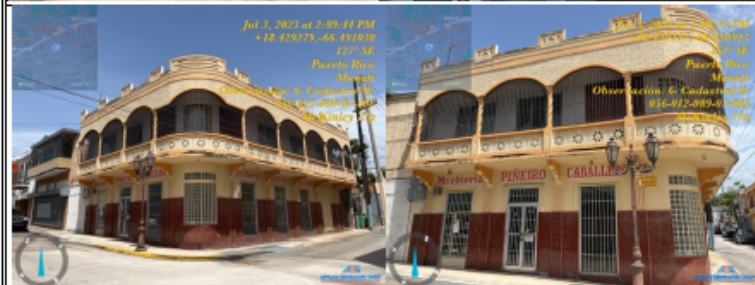
Property 06

- Clean and protect the ceramic tiles (mosaic).
- Repair concrete plaster prior to paint application.
- Repair pipes for storm drains.
- Remove vegetation.
- Install and/or replace lighting fixtures that are the same as existing ones (size up to 20%).
- Cover empty light fixture boxes, dimples and surface imperfections in wall left by unused light fixtures.
- Protect the "Mueblería Piñeiro Caballero" sign. Replicate if damaged.
- Repair exposed reinforcing steel.
- Paint steel gates (including lattices and wood finishes).
- Replace all damaged glass door (commercial type aluminum).
- Verify wall skylight (glass blocks) condition and replace if required, with same model.

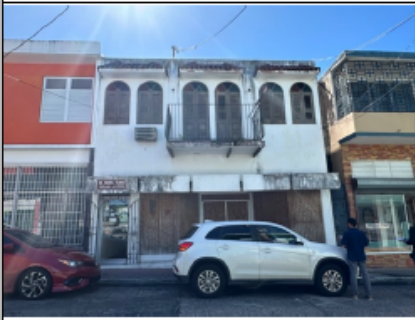
Property 07

- Remove all signage that is non-compliant.
- Install the decorative beam on the balcony.
- Repair water damage on eaves and façade.
- Repair doors and commercial windows on the main/front façade.
- Install luminaire where missing.
- Restore or replace all damaged doors on the second floor.
- Remove a/c unit, coordinate with owner.
- Replace the side steel gate.

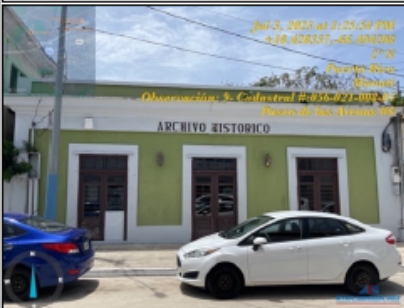
Property 08

- Repair the panel on the central door, replace the door if necessary.
- Clean and repair moldings and concrete plaster finish prior to the application of paint.
- Remove vegetation.
- Remove lettering for "Archivo Histórico".
- Organize the electrical infrastructure. Paint any exposed pipes or conduits on the façade.

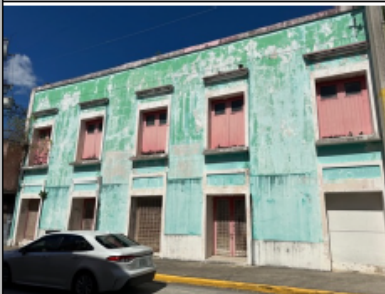
Property 09

- Replace all doors on the second floor with aluminum doors.
- Replace all damaged doors and crystal windows on the first level.
- Install metal railings on the second floor.
- Remove all non-compliant signage.
- Organize electrical conduits and attached to façade plane.
- Paint side wall.
- Clean and repair prior to painting application.

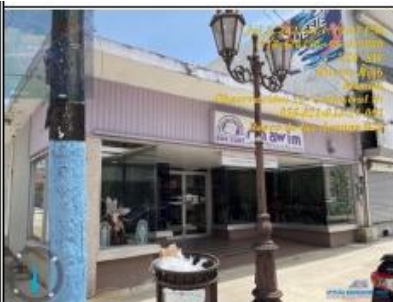
Property 10

- Clean the existing ceramic tiles.
- Repair the wooden fascia.
- Protect bookstore sign.
- Paint all pipes and conduits the same color as the façade.
- Paint all street exposed facades.

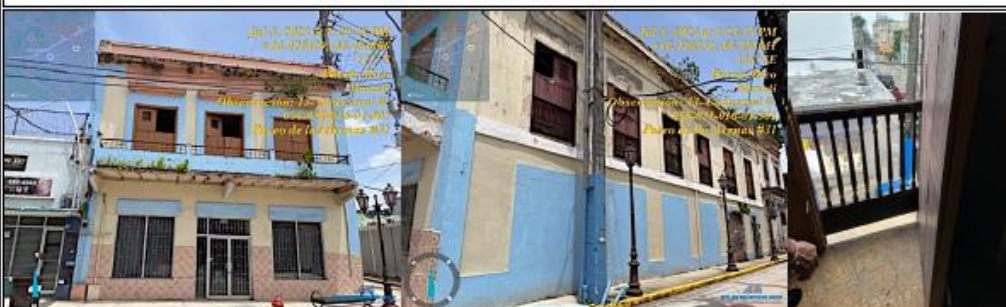
Property 11

- Reduce the wide opening of fenestration on the first floor in the frontal façade, incorporate side strips and the architrave lintel.
- Restore wooden elements of guardrails.
- Remove the ceramic tiles on the main façade.
- Repair all damaged doors on the second floor (install missing sills). The doors will be the same as the existing ones.
- Recuperate the fenestration doors opening and install doors on the west side façade. The doors will be the same or similar.

- Clean and treat all metal all metal railings before paint application.
- Install decorative brackets beam under the balcony.
- Repair the side facade.
- Repair exposed bricks with cured limestone-based material.
- Fabricate and install cornices on the door fenestration, second floor.
- Repair cornices that are in deteriorated condition.
- Cleaning and repair of the plaster finishes prior to the application of paint on all exposed facades.
- Replace all damaged doors on the first floor (storefront).

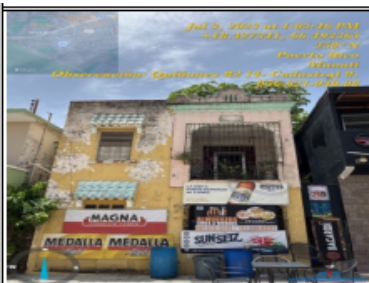
Property 12

- Remove vegetation.
- Remove the wooden garage door and install aluminum jealousies window (equal to the second floor).
- Install steel grills on the balcony on the first floor inside arch soffit.
- Replicate stucco finish where it is present.
- Replace doors and windows with the same existing typology.
- Remove all non-compliant signage.

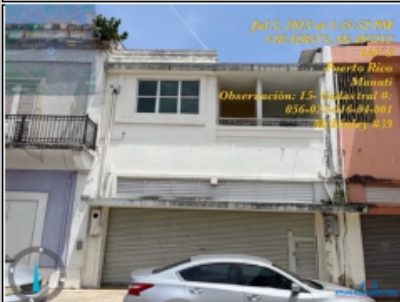
Property 13

- Repair damage caused by humid conditions.
- Recover windows fenestration original size and install new window (equal as existing).
- Remove all the vegetation.
- Organize the electrical infrastructure, dispose conduits that are not in use.
- Replace damaged garage door.

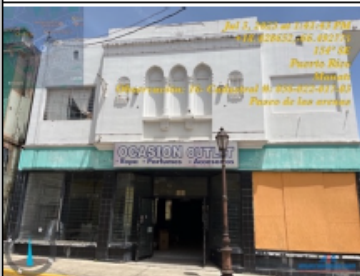
Property 14:

- Faded paint and humidity stains are present.
- Electrical conduits and meters are exposed.
- The signage does not follow Historic District parameters.
- Ceramic tiles painted black do not contribute to the style original design (ceramic mosaics) which can be seen at the corner.

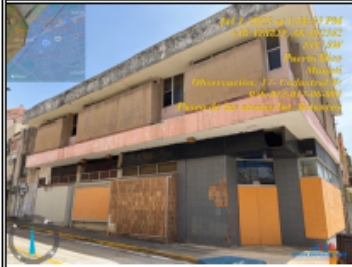
Property 15

- Return the commercial front to its original position.
- Replace all windows and doors that are in deteriorated condition on the main/front façade.
- Remove all tiles from facades.
- Replace all damaged exterior light fixtures.

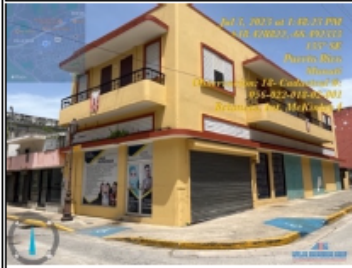
Property 16

- Remove signage that is not in compliance with the provisions of local codes.
- Remove all the vegetation present.
- Review and repair existing storm drains according to conditions.
- Repair the window's clerestory.
- Clean and repair the plaster finish prior to the application of paint.
- Clean and paint the missing ceramic tiles.
- Repair chain link fence.

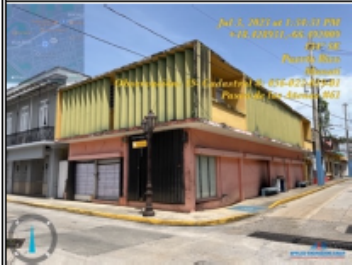
Property 17

- Install two (2) solid wooden doors (absent on the second floor) with transparent acrylic panels.
- Install smaller aluminum jealousies windows on the second floor.
- Install acrylic glass on commercial doors on the first floor.
- Install absent sunscreen member on the main façade.
- Encapsulate the existing mosaic, by smooth plaster finish and paint.
- Replace damaged metal brackets for wooden sunscreen elements.

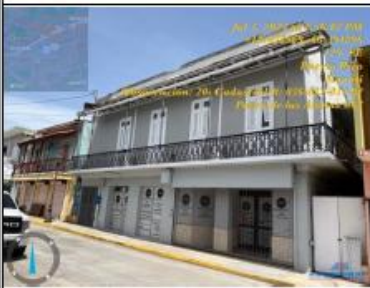
Property 18

- Repair the existing cornice, only where it previously existed.
- Repair door that are in deteriorated condition on the second level.
- Remove signage that is not in compliance with the provisions of local codes.
- Repair only the deteriorated area that is in poor condition, including the roof of the balcony with zinc panels and wood beams support structure.
- Restore the deteriorated balcony's wooden handrails.
- Restore lateral steel gates.

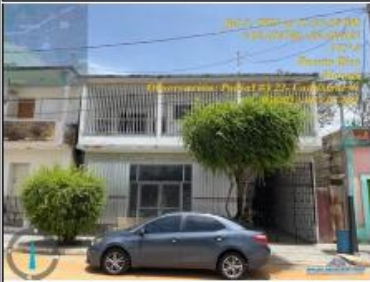
Property 19

- Clean and restore ceramic tiles. Remove the "graffiti" present in mosaic.
- Remove and replace steel gates on the first floor (interior and exterior).
- Remove all the vegetation.
- Repair damage by humid conditions on 2nd floor.

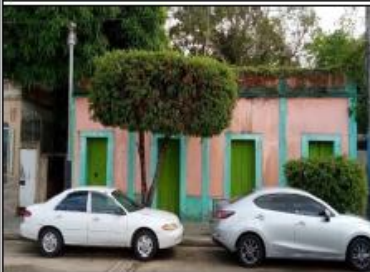
Property 20

- Repair and patchwork are needed.
- Replace wooden panels on doors that are in poor conditions or have missing parts. If the repairments are not feasible, full replacement shall be equal to existing doors.
- Organize the electrical infrastructure.
- Install new steel solid plate on gate sides.
- Remove all the vegetation.

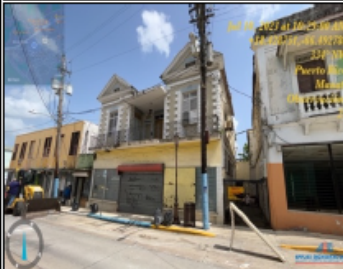
Property 24

- The ceramic tiles shall be removed.
- Install wooden doors and windows with jealousies on the second level. Repair or replace the doors, which shall be equal in typology to existing ones on the second level.
- Cleaning and repair of the plaster finish prior to painting application.
- Replace the windows on the main/front façade – due to their conditions, typology must be equal as existing ones.
- Remove air condition unit console, coordinate with owner.
- Organize the electrical infrastructure.
- Paint the storm rolling doors mechanism housing of the same as the façade.

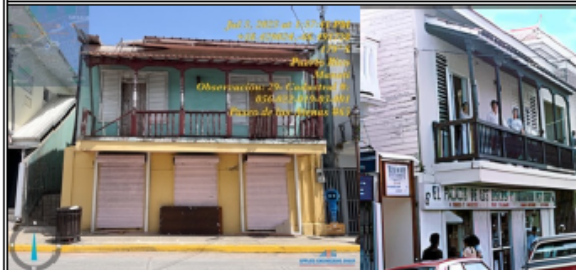
Property 25

- Restore the wooden balcony.
- Install two new double doors on the second floor.
- Preserve lighting fixture to remain.
- Repair the damaged balcony roof.
- Review and replace all doors on the first level (storefront).
- Paint the windows on the second floor, if conditions require it, replace it with equal typology.

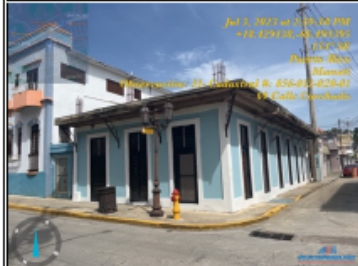
Property 26

- Repair the wooden elements of the projected eave.
- Install and luminaires fixtures (where missing and existing ones).
- Remove the exposed roof steel rods on the second floor.
- Apply the same paint color over the door fenestration that its height is smaller than the rest, to visually equalize all door openings.

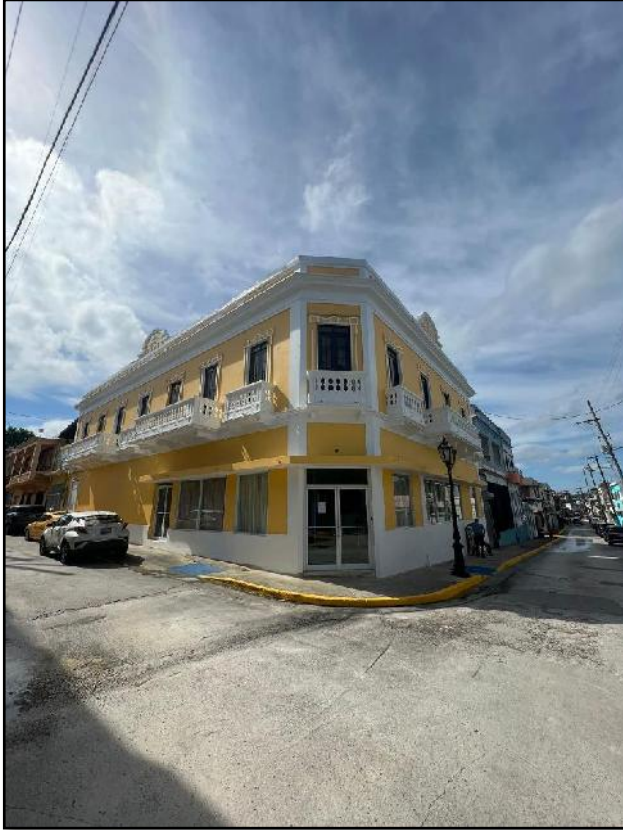
#75 McKinley St.
2nd Floor Exterior Front Facade
Balcony White Concrete Decorative Block
Painted with LBP

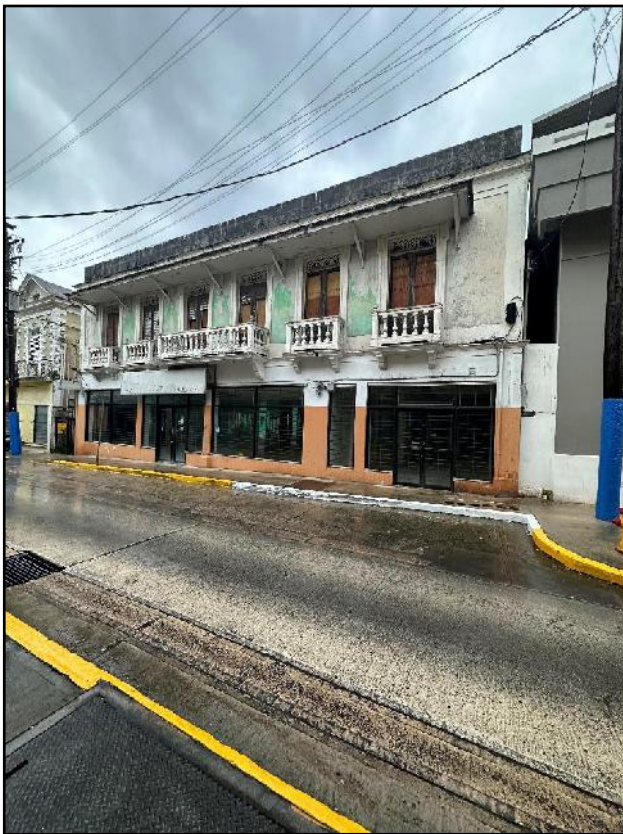
#30 McKinley St.
1st Floor Exterior Front Facade
White & Brown Painted Ceramic
Tiles on Walls and Column. White
Balcony Ceiling and Joist Painted
with LBP

2nd Floor Exterior Front Facade
White Wood Wall and Concrete
Column, Concrete White and Green
Walls; Balconies Wood Door Frames,
and Concrete White Decorative
Columns Painted with LBP

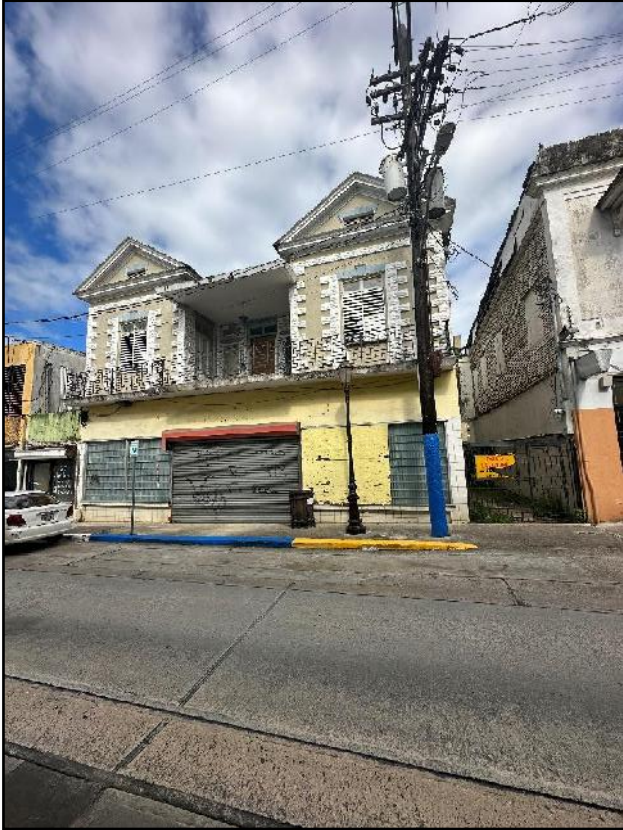
#28 McKinley St.
1st Floor Exterior Front Facade
Lower Walls Ceramic Tiles Painted
with LBP

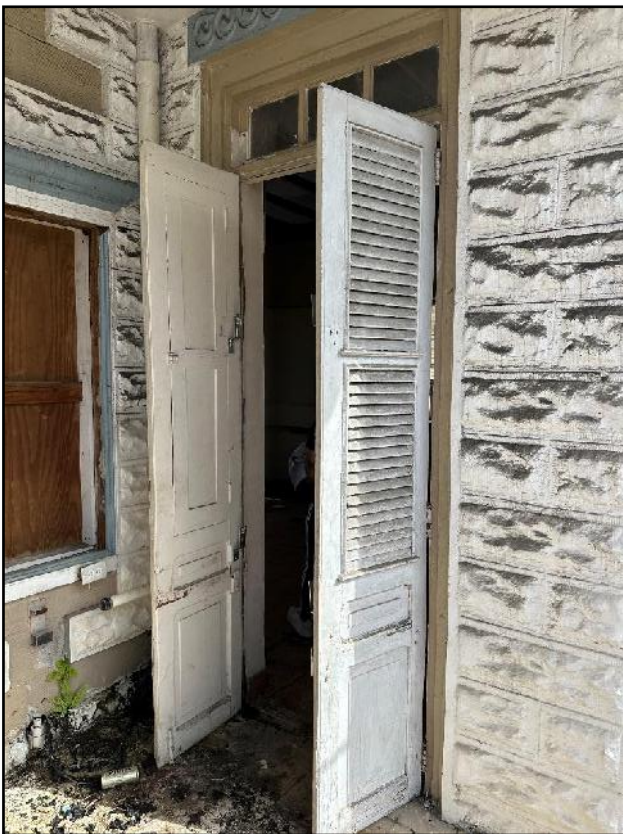
#28 McKinley St.
2nd Floor Exterior Front Facade
Balcony White Decorative Fascia
White Wood Door and Frame Painted
with LBP

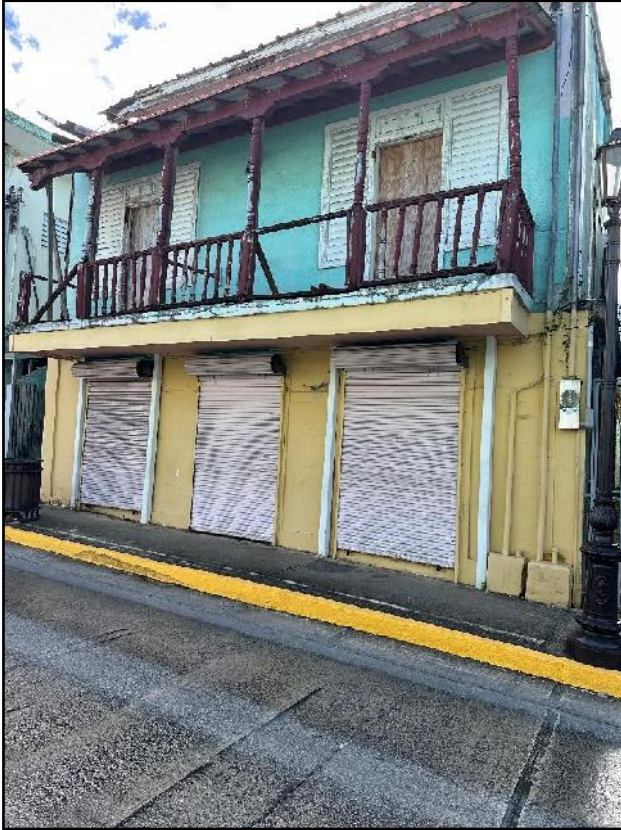
#65 McKinley St.

1st Floor Exterior Front Facade

2nd Floor Exterior Front Facade

White Window Trims Painted with LBP

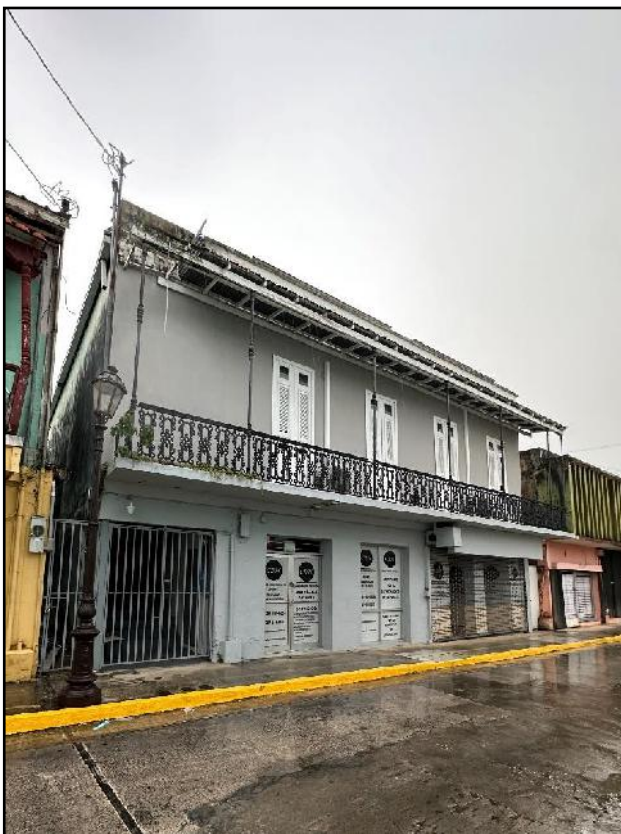
#63 McKinley St.

1st Floor Exterior Front Facade

Gray Wall & Concrete Column
Black Metal Railing & Columns
Painted with LBP

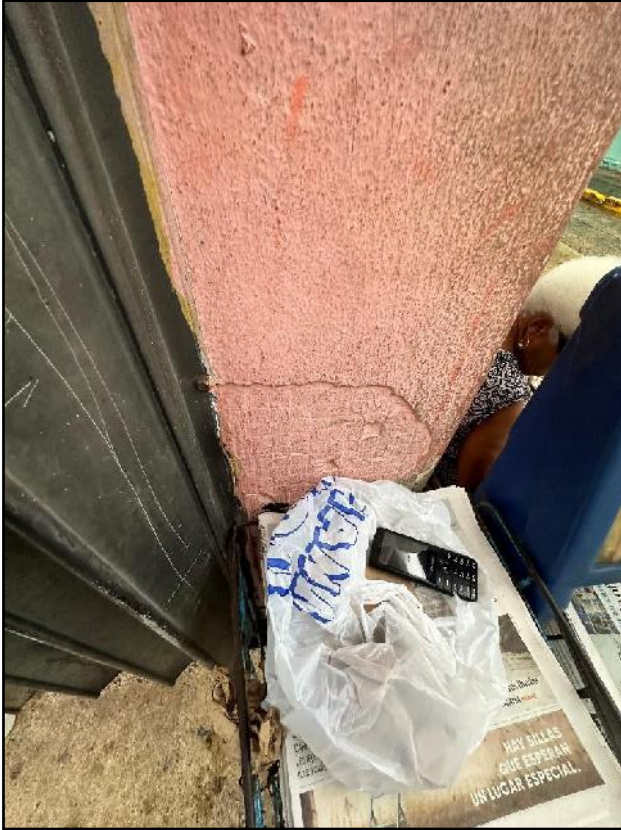
#61 McKinley St.

1st Floor Exterior Front Facade
Peach Column Ceramic Tiles Painted
with LBP

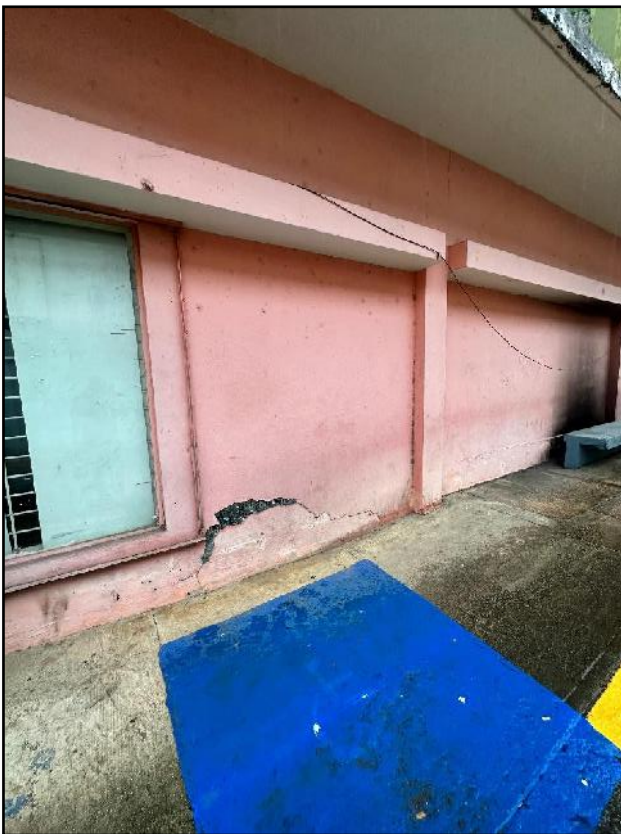
#61 McKinley St.

1st Floor Exterior Front Facade
Black Ceramic Tiles Under Pink Wall
Painted with LBP

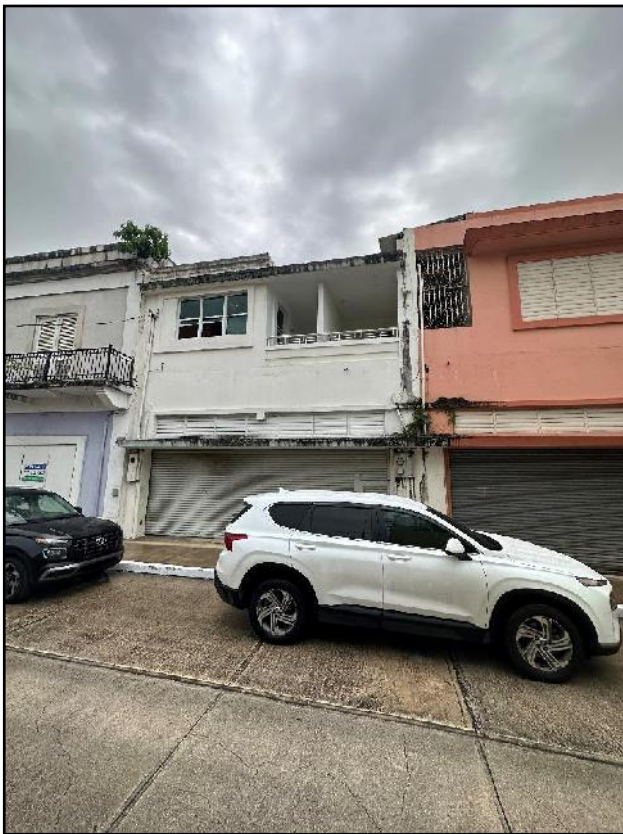
#39 McKinley St.
1st Floor Exterior Front Facade
White Ceramic Tiles Painted with LBP

2nd Floor Exterior Front Facade
White Concrete Walls Painted with LBP

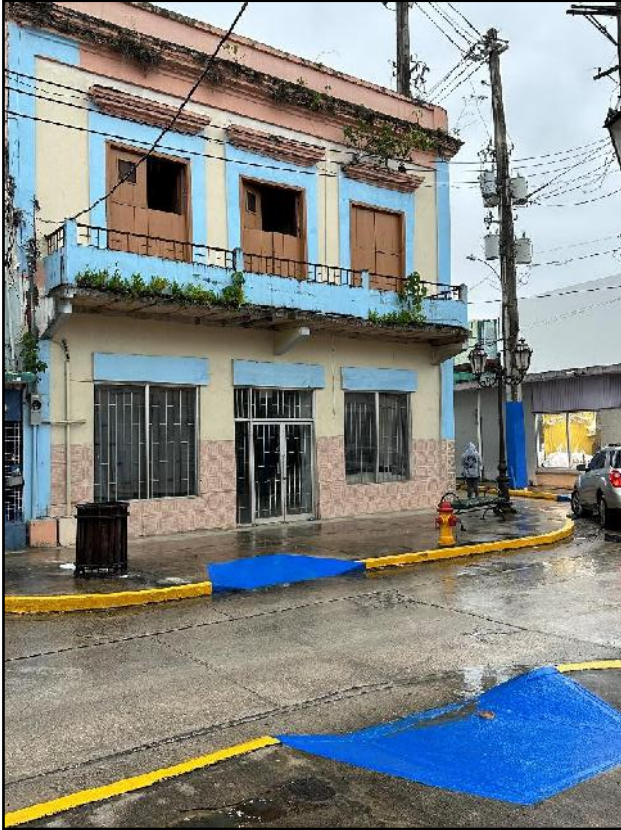
#31 McKinley St.

1st Floor Exterior Front Facade
Wall & Column Brown Ceramic Tiles
Painted with LBP

2nd Floor Exterior Front Facade
Brown Doors & Frames Painted with LBP

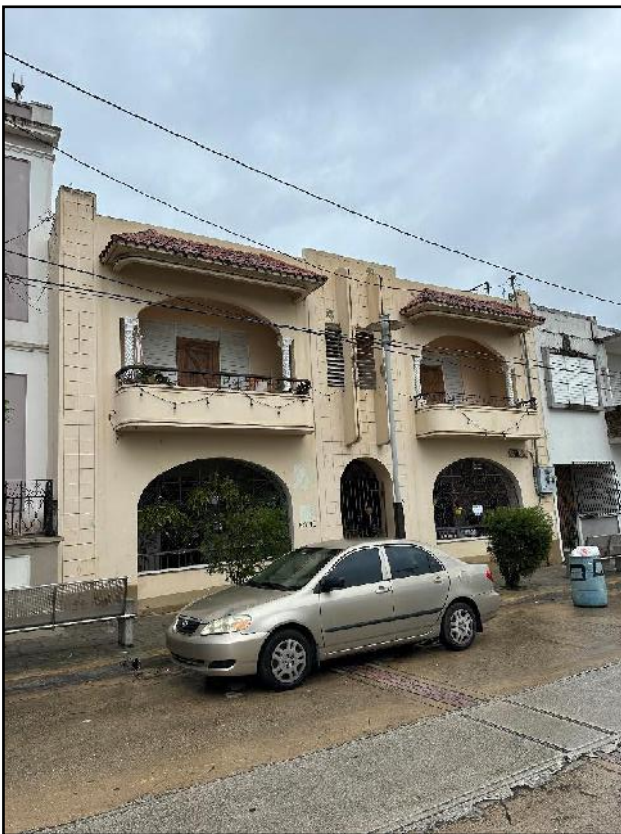
#13 Padial St.

1st Floor Exterior Front Facade
Cream Wall and Brown Baseboard
Balcony Cream Walls & Arc Painted
with LBP

2nd Floor, Right Balcony
Cream Walls and Arc & White
Decorative Columns Painted with LBP

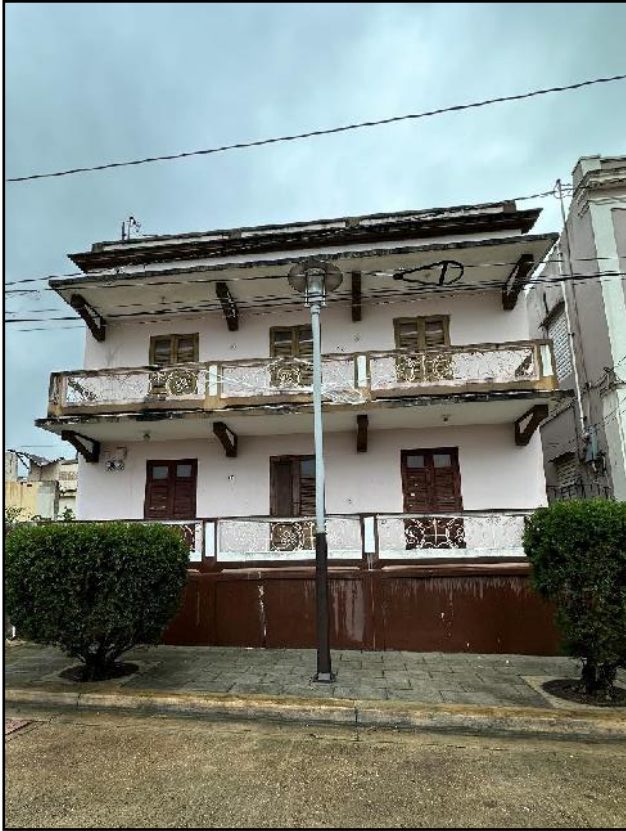
#17 Padial St.

1st Floor Exterior Front Facade
Pink Wall & Brown Baseboard
Painted with LBP

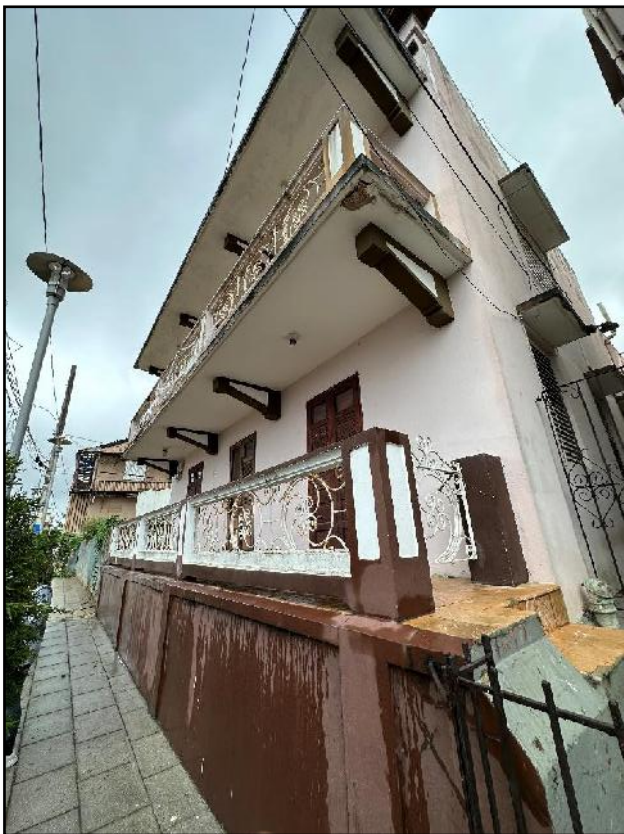
#17 Padial St.

1st Floor Balcony
Brown Lower Column and Ceiling
Joist, White Ceiling & Gray Side
Baseboard Painted with LBP

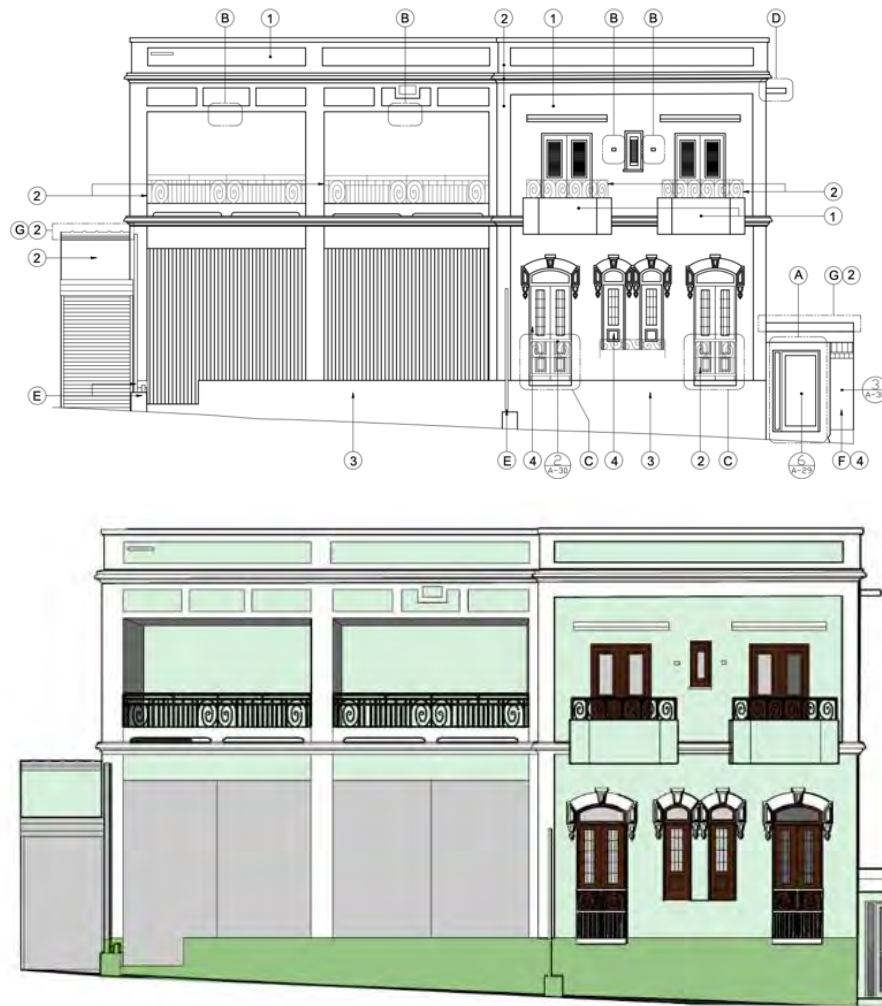
Proposal View
Property No. 04
73 Paseo de las Atenas Street
Plan Sheet No. A-4

- Replace damaged commercial type door.
- Install absent Luminaires.
- Fabricate architectural railings to original, paint and install.
- Repair the damaged exposed reinforcing steel.
- Repair all exposed facades.

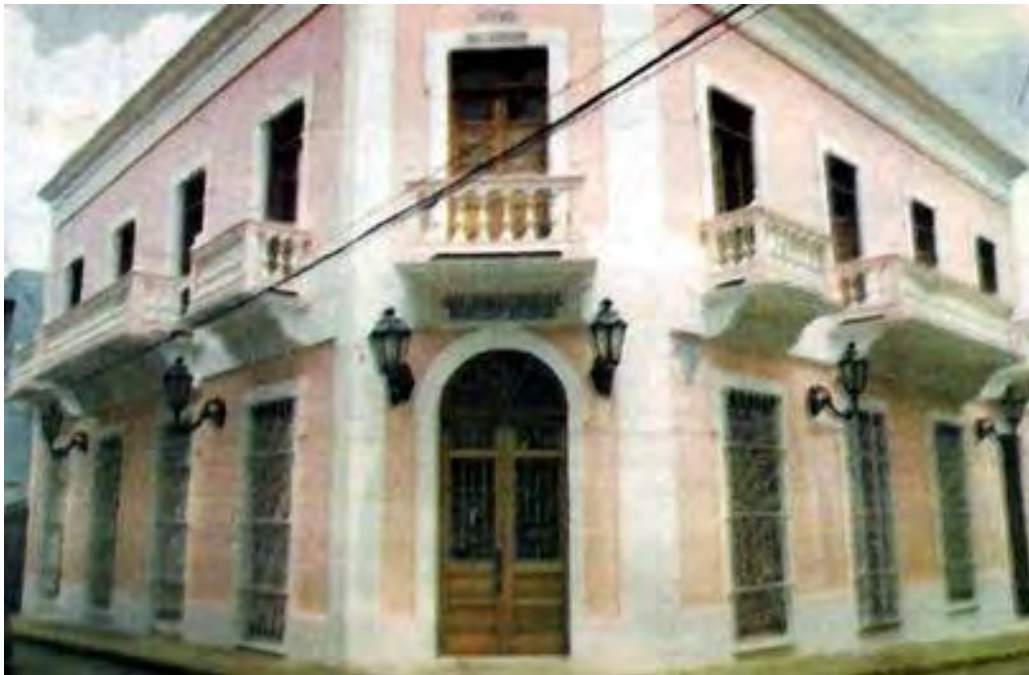
Figure 01c. Antiguo Casino

| <p>Property Façade Description</p> <p>Style: Puerto Rico Late 19th-early 20th Century. Two stories property. Reinforce concrete. (See Figure 01c).</p> <p>Character Defining Features</p> <p>Main/front facade- First Level</p> <p>Commercial. The façade is parallel aligned with the sidewalk line. The original Main/front facade- First Level facade was the same as the second level in respect to the fenestration locations. It was altered, to install commercial, double metal doors and full glass windows. The main entrance is a chamfered corner.</p> | | | |

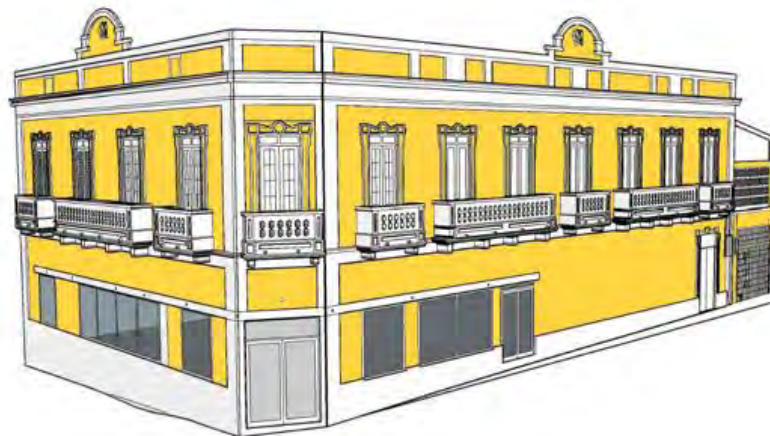
Proposal View
Property No. 05
75 Paseo de las Atenas Street
Plan Sheet No. A-5

| Property Undertaking Existing Conditions: <ul style="list-style-type: none"> • The property is well kept in good conditions and integrity. Proposed Scope of Work (SOW) <ul style="list-style-type: none"> • Repair the cornice. • Install Luminaries where its missing. • Remove air condensing unit, coordinate with owner. | |

- Rehabilitation Project Guidelines apply.
- Clean and approved Historic District paint choice to be applied.

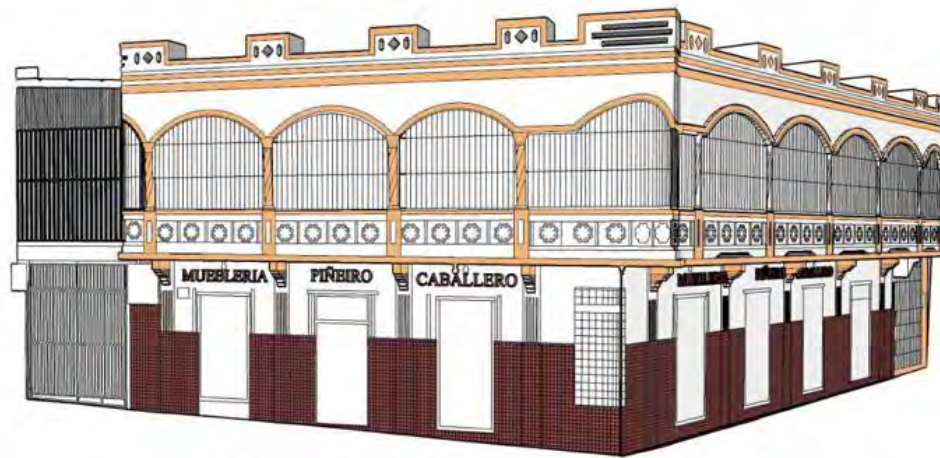
Proposal View
Property No. 06
77 Paseo de las Atenas Street
Plan Sheet No. A-6

- Clean and protect the ceramic tiles (mosaic).
- Repair concrete plaster prior to paint application.
- Repair pipes for storm drains.
- Remove vegetation.
- Install and/or replace lighting fixtures that are the same as existing ones (size up to 20%).
- Cover empty light fixture boxes, dimples and surface imperfections in wall left by unused light fixtures.
- Protect the "Mueblería Piñeiro Caballero" sign. Replicate if damaged.
- Repair exposed reinforcing steel.
- Paint steel gates (including lattices and wood finishes).
- Replace all damaged glass door (commercial type aluminum).
- Verify wall skylight (glass blocks) condition and replace if required, with same model.

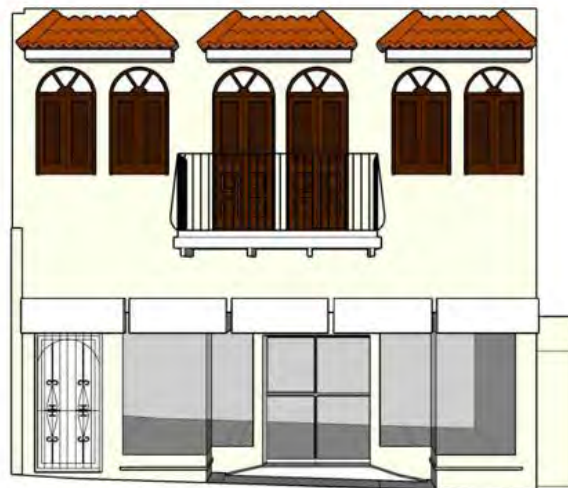
Proposal View
Property No. 07
79 Paseo de las Atenas Street
Plan Sheet No. A-7

| <p>Property Undertaking</p> <p>Existing Conditions:</p> <ul style="list-style-type: none"> Faded paint and humidity stains are present. Exposed A/C box type unit under the left side window. The property is in good conditions and integrity. <p>Proposed Scope of Work (SOW)</p> <ul style="list-style-type: none"> Remove all signage that is non-compliant. Install the decorative beam on the balcony. Repair water damage on eaves and facade. Repair doors and commercial windows on the main/front facade. Install luminaire where missing. Restore or replace all damaged doors on the second floor. Remove a/c unit, coordinate with owner. Replace the side steel gate. <p>Rehabilitation Standards for Non-Contributing Buildings</p> <ul style="list-style-type: none"> Rehabilitation and Storefront Project Guidelines apply. Cleaning and approved Historic District paint choice to be applied. Doors and windows shall be restored and only need to be replaced with the same design. | | |

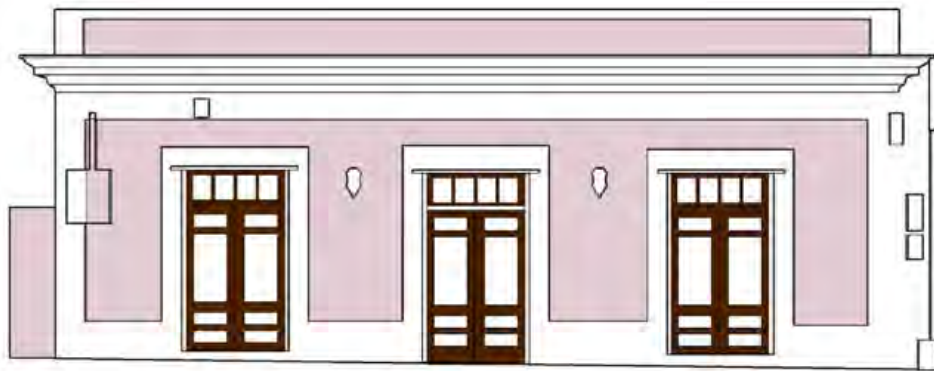
Proposal View
Property No. 08
06 Paseo de las Atenas Street
Plan Sheet No. A-8

- Repair the panel on the central door, replace the door if necessary.
- Clean and repair moldings and concrete plaster finish prior to the application of paint.
- Remove vegetation.
- Remove lettering for "Archivo Histórico".
- Organize the electrical infrastructure. Paint any exposed pipes or conduits on the façade.

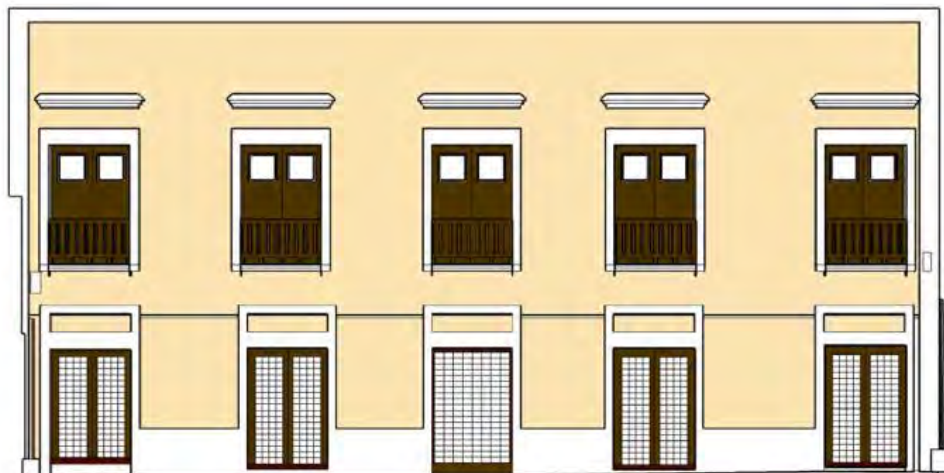
Proposal View
Property No. 09
18 Paseo de las Atenas Street
Plan Sheet No. A-9

| Property Undertaking Existing Conditions: <ul style="list-style-type: none"> Faded paint and humidity stains with vegetation are present with missing surface plaster finish is clear within some areas. The electrical, telephone and meter infrastructure conduits are exposed at one of the sides of the facade. <p>Proposed Scope of Work (SOW)</p> <ul style="list-style-type: none"> Replace all doors on the second floor with aluminum doors. Replace all damaged doors and crystal windows on the first level. Install metal railings on the second floor. Remove all non-compliant signage. Organize electrical conduits and attached to façade plane. Paint side wall. Clean and repair prior to painting application. | | |

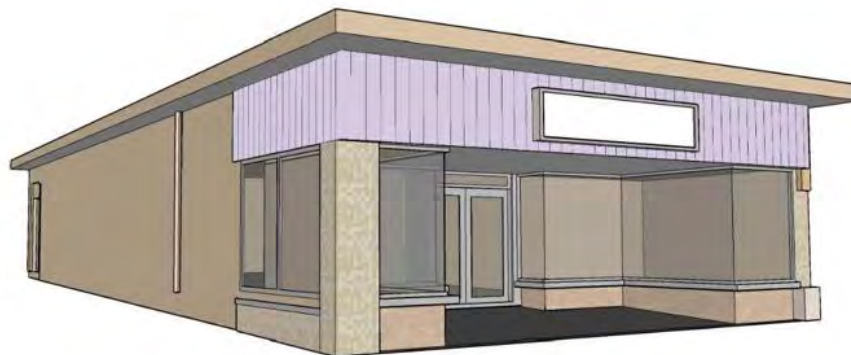
Proposal View
Property No. 10
20 Paseo de las Atenas Street
Plan Sheet No. A-10

- Clean the existing ceramic tiles.
- Repair the wooden fascia.
- Protect bookstore sign.
- Paint all pipes and conduits the same color as the façade.
- Paint all street exposed facades.

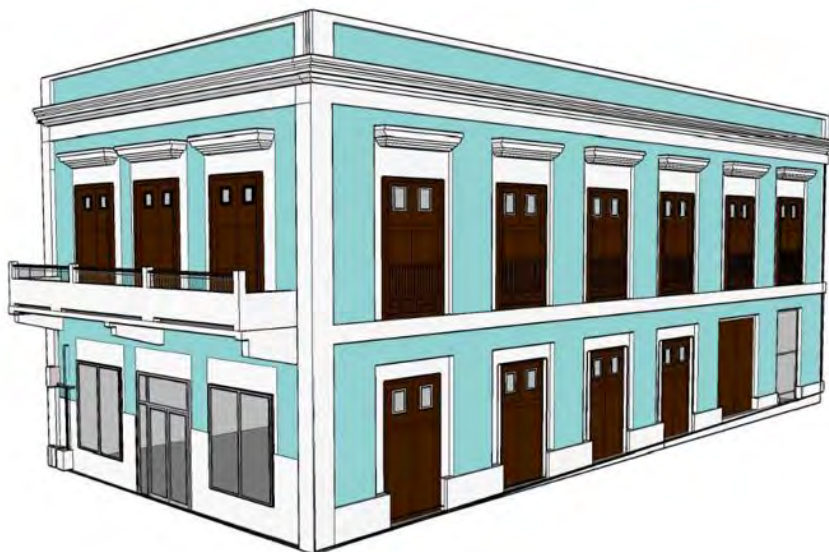
Proposal View
Property No. 11
31 Paseo de las Atenas Street
Plan Sheet No. A-11

- Replace all damaged doors on the first floor (storefront).

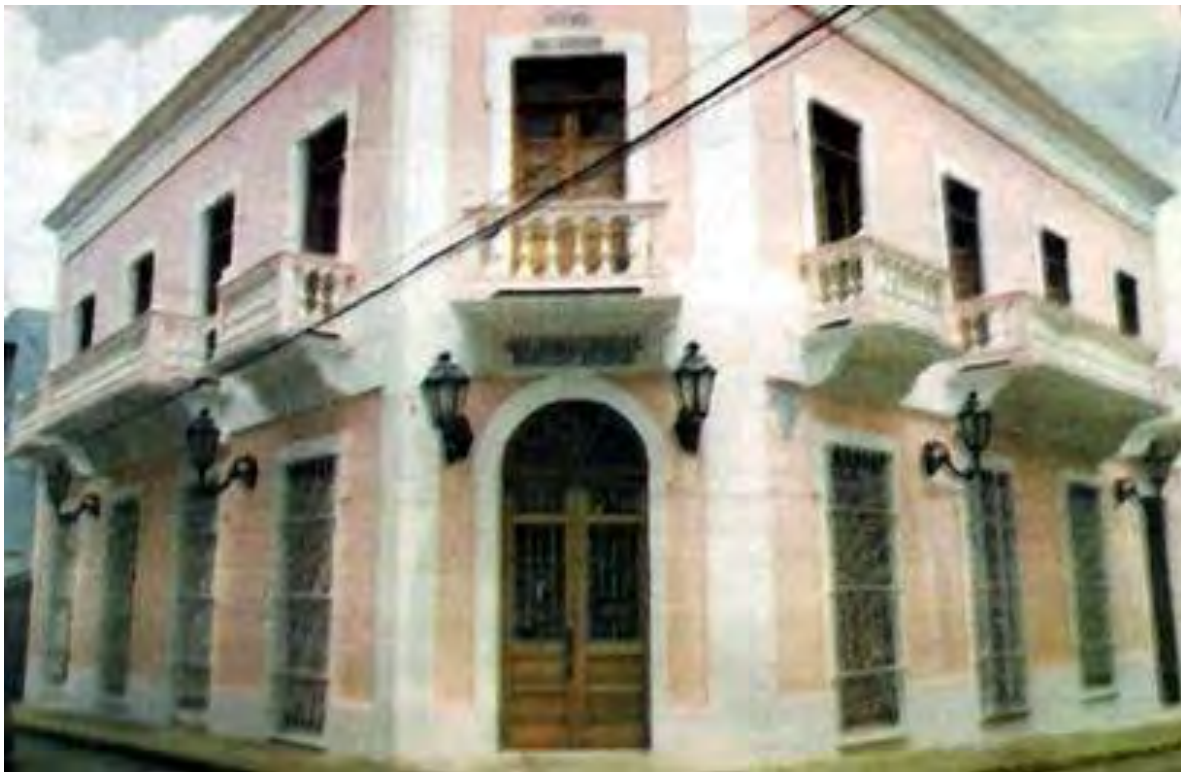
Figure 19. Antiguo Casino, ca.1924.
 #75 Mckinley Street, Manatí, Puerto Rico
 APE project property.

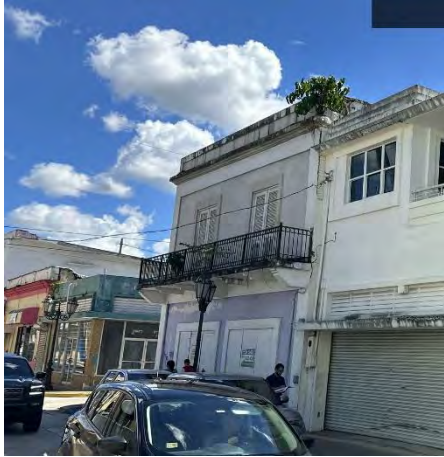
Figure 23a. (Partial Photo #66). South-East view. McKinley Street. Creole Style. Rubble and concrete interventions. Two levels. Projected balcony with steel railings and cantilevered brackets. Visual APE. (Not included in project). Contributing and non-eligible property.

For contributing properties within the project Visual APE, but not included in the proposal, refers to Figure 23a to 23f.

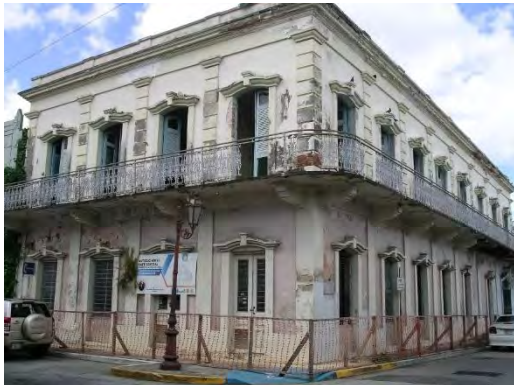
Figure 25b. (Photo #48). Spanish Neoclassical Style, 1900. North view. McKinley Street. Two levels, projected continuous balcony with iron handrails, cornice and parapet. Doors fenestrations with broken pediments on top, and side strips. Rubble and concrete interventions. Visual APE. Contributing and eligible. (Not included in the project).

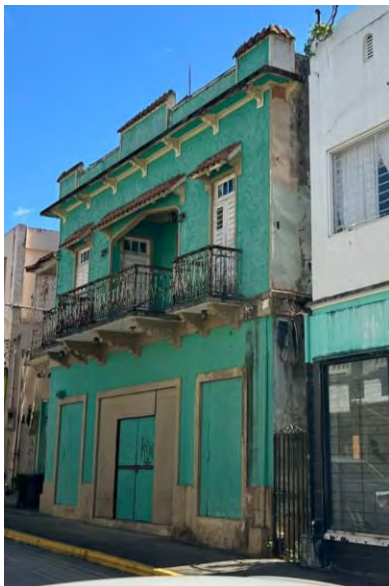
Figure 25c. (Partial Photo #61). South-East view. McKinley Street. Spanish Revival, 1920. Two levels projected separated balconies, cornice with ornamental console brackets, concrete property. Contributing, non-eligible. Visual APE. (Not included in project).

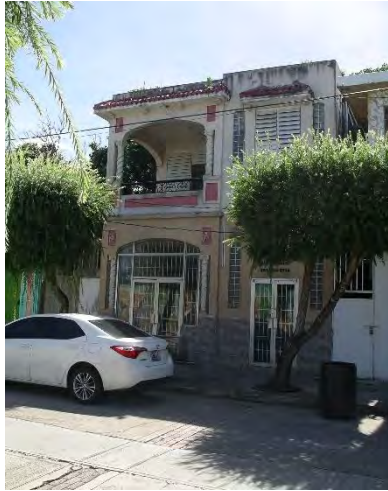
Figure 25d. (Partial Photo #05). South-West view, Padial Street. Spanish Revival Style. 1920. Two levels, concrete property with balcony on the second floor. Facades shows elliptical arch flanked by double columns. Contributing and eligible. Visual APE. (Not included in project).

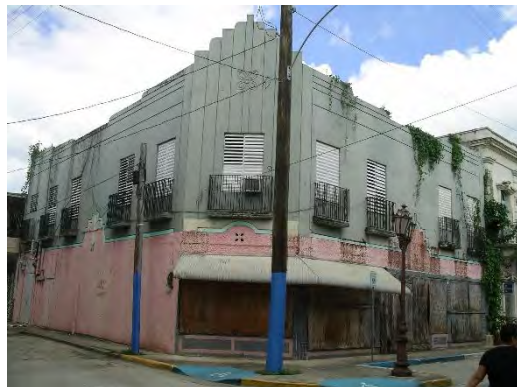
Figure 25e. North-east view. Mckinley Street. Late Art deco Style, 1940. Two levels concrete property, with special emphasis oriented towards the corner. Contributing and non-eligible. Visual APE. (Not included in project).

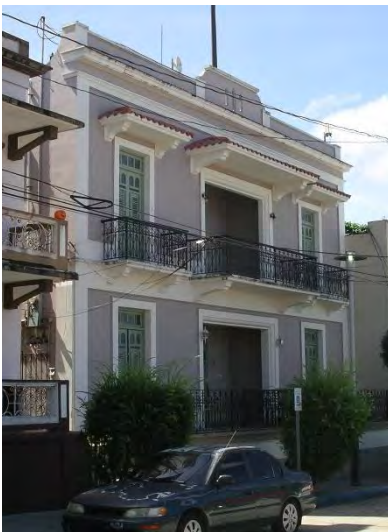
Figure 25f. (Partial Photo #12). South-West view, Padial Street. Creole with Spanish Revival influences Style. 1920. Two levels, concrete property with projected and separated balconies on the second floor. Raised parapet towards the center emphasizing on the main entrance axis with cornice and eaves over each door fenestrations. Contributing and eligible. Visual APE. (Not included in project).

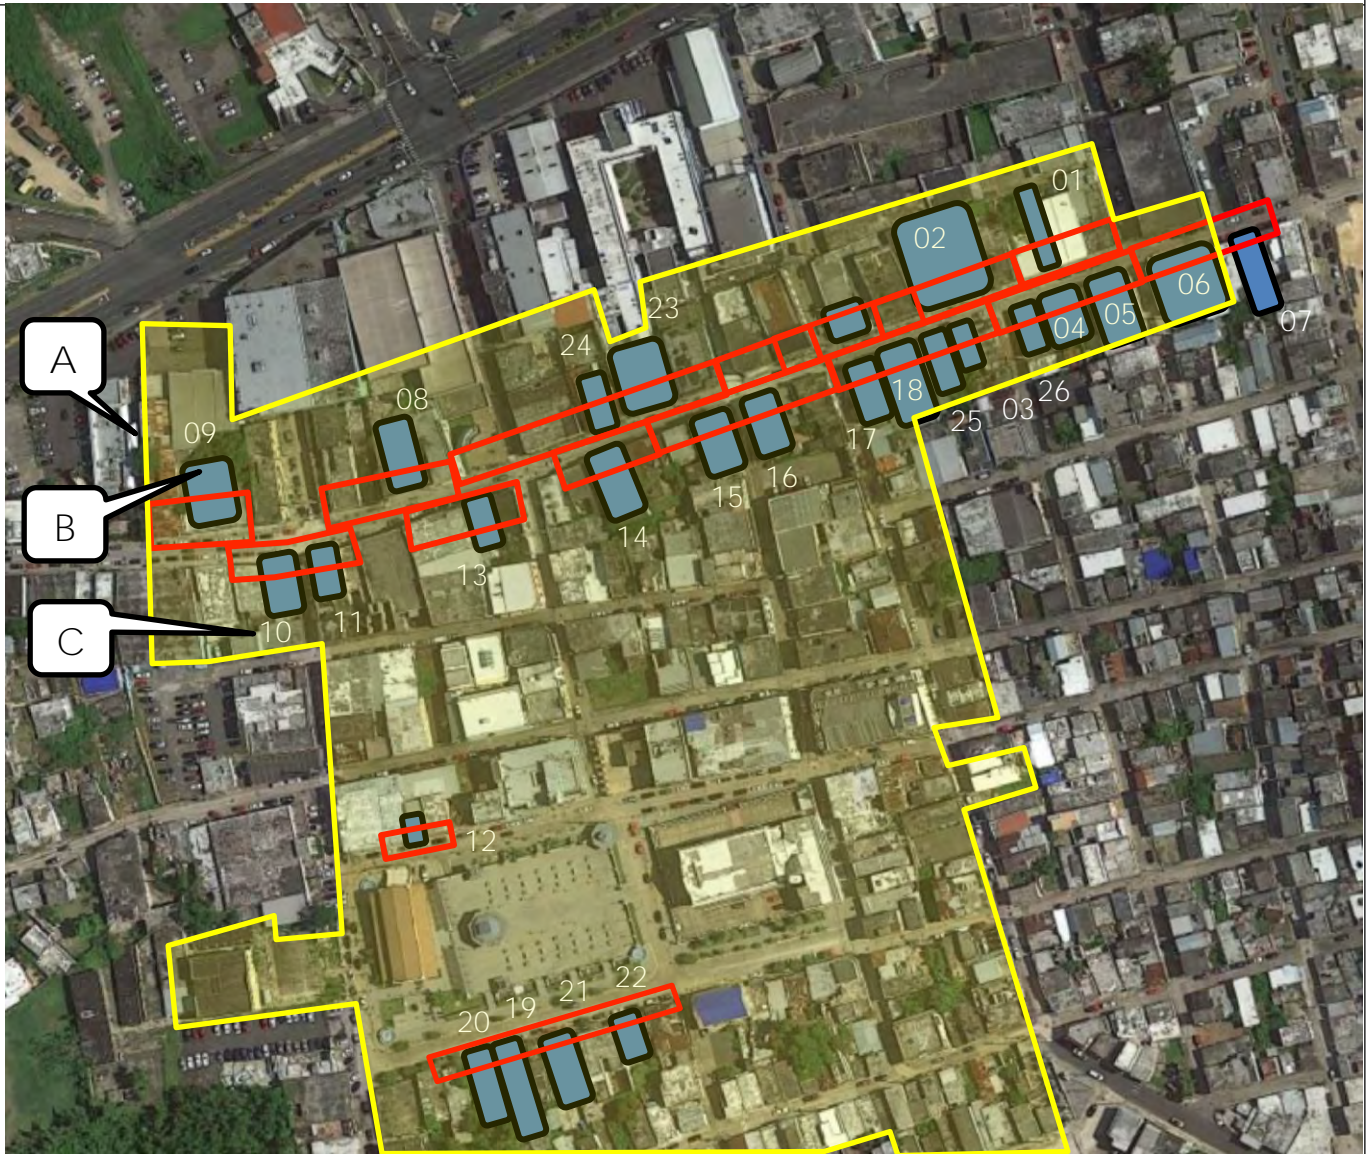
Project (Parcel) Location – Area of Potential Effect Map (Aerial Photo). Not to Scale.
