**Environmental Review for Activity/Project that is Categorically
Excluded Subject to Section 58.5
Pursuant to 24 CFR 58.35(a)**

Project Name: Revitalización Fachadas Arquitectónicas e Históricas en el Centro Urbano (PR-CRP-000775)

Responsible Entity: Puerto Rico Department of Housing (PRDOH)

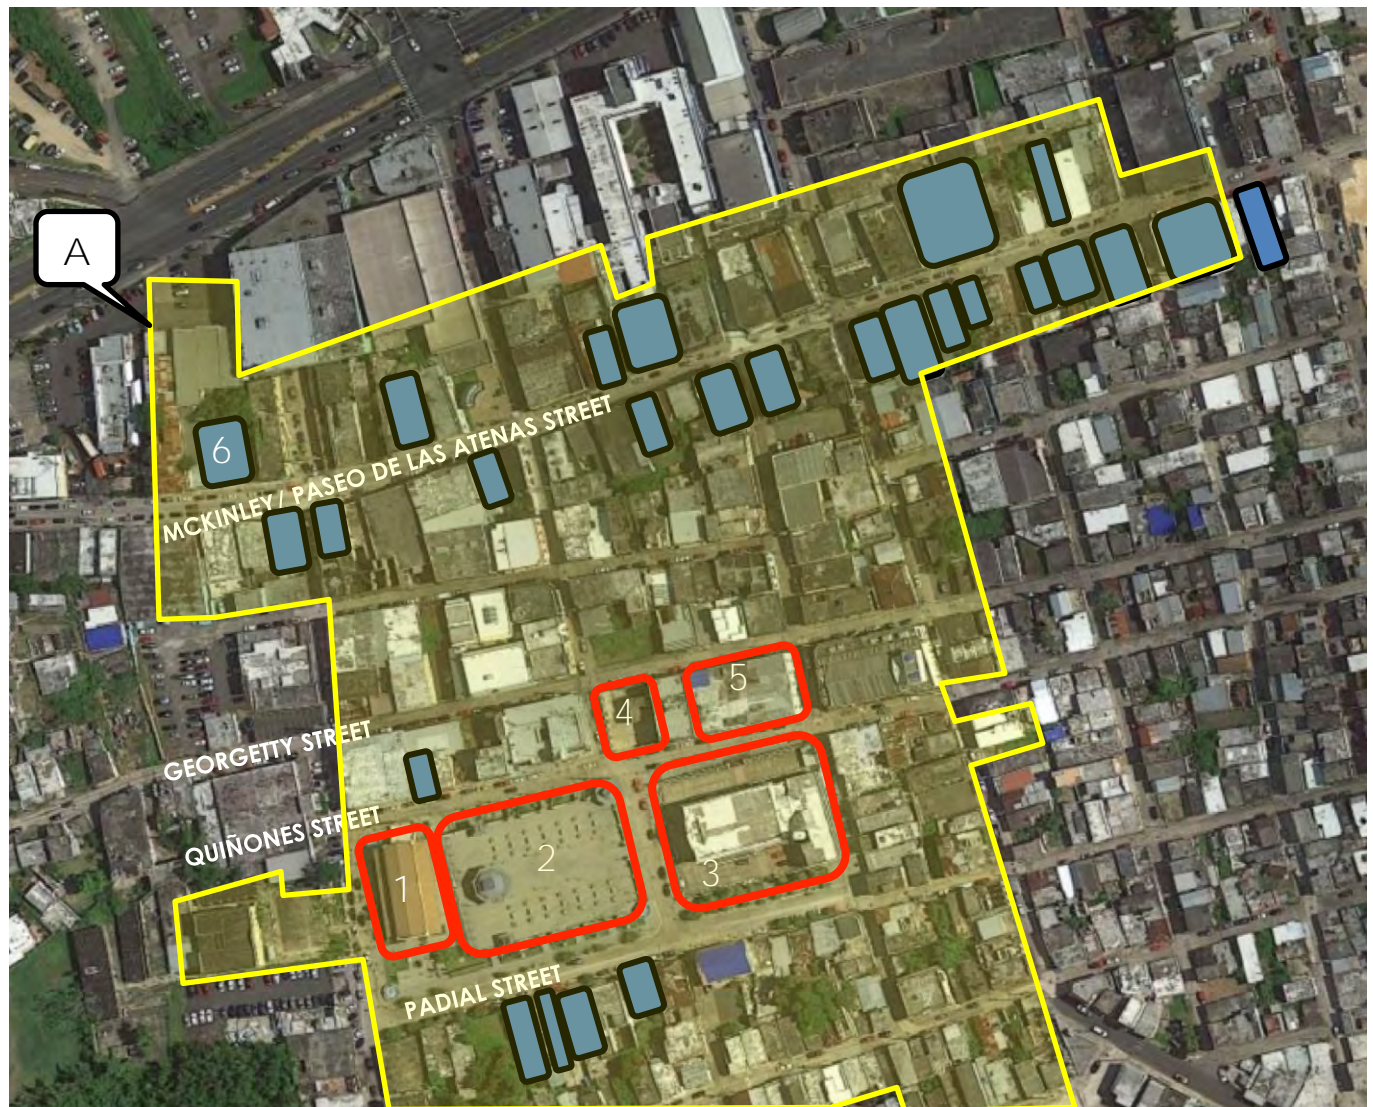
Project Parcel Location with Previous Recorded Historic Properties- Aerial Map
Not to Scale.

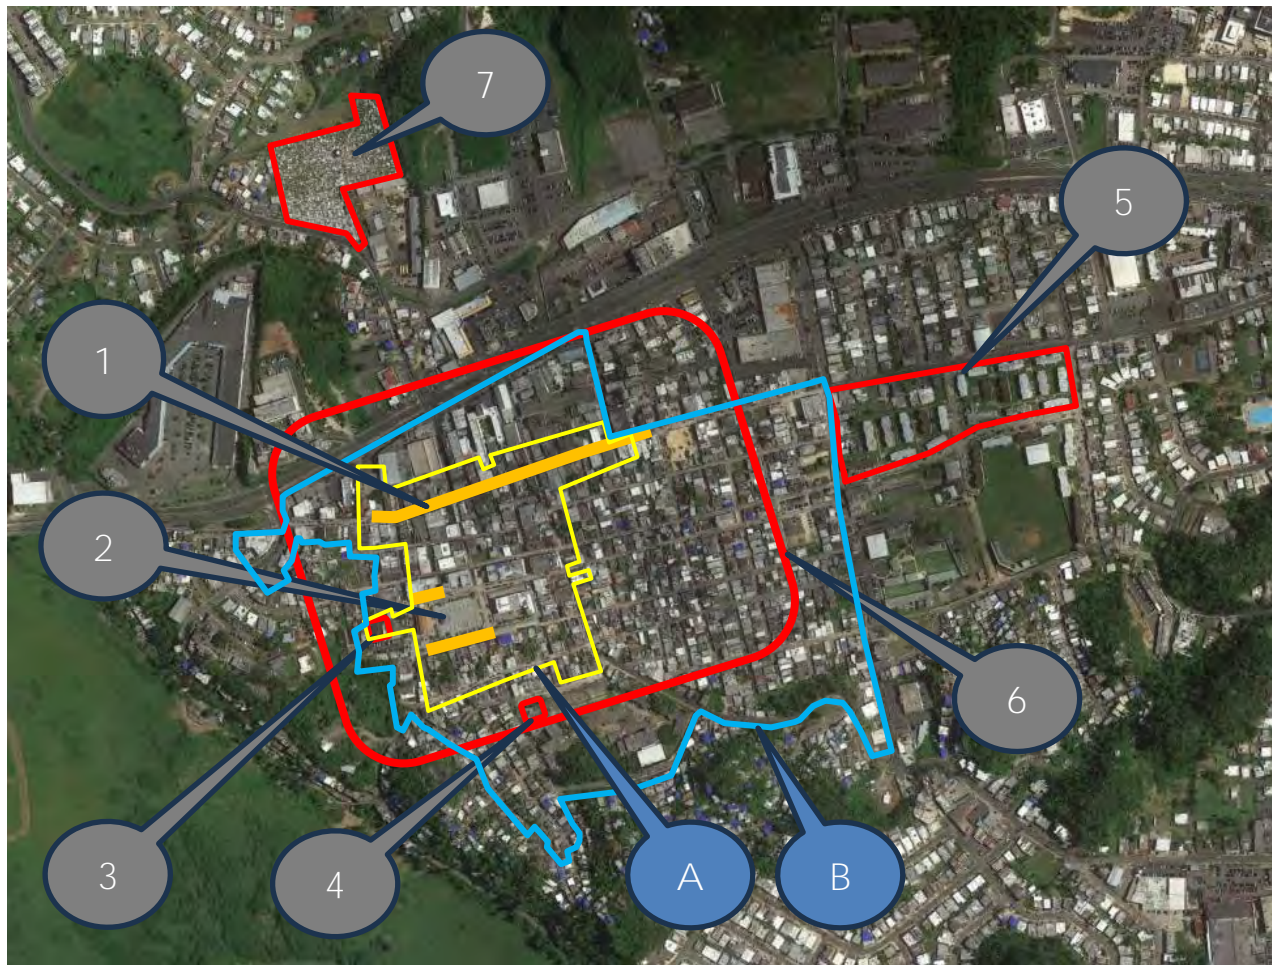
Historic properties listed or eligible determined by PRSHPO
Source: Google Earth.

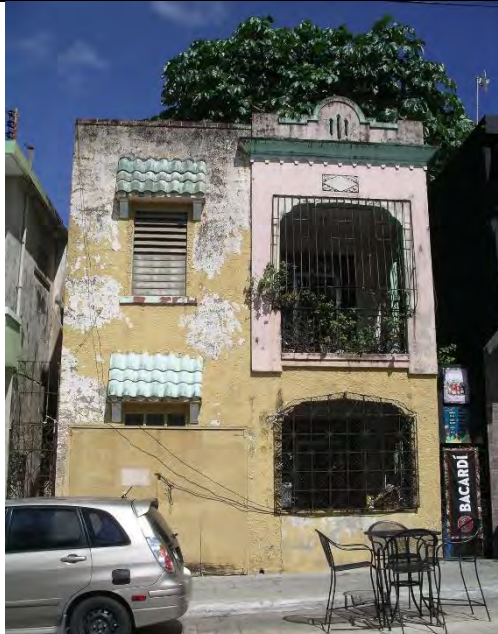
Photo: #01

Description: North view. #2 Quiñones Street, Manatí, Puerto Rico.
Direct APE Contributing property.

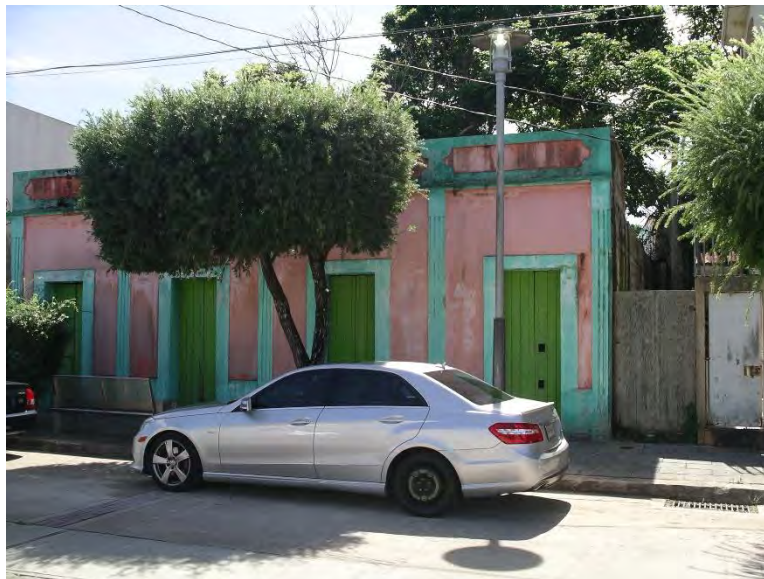
Photo: #04

Description: South view. #7 Padial Street Manatí, Puerto Rico. Direct APE Contributing property.

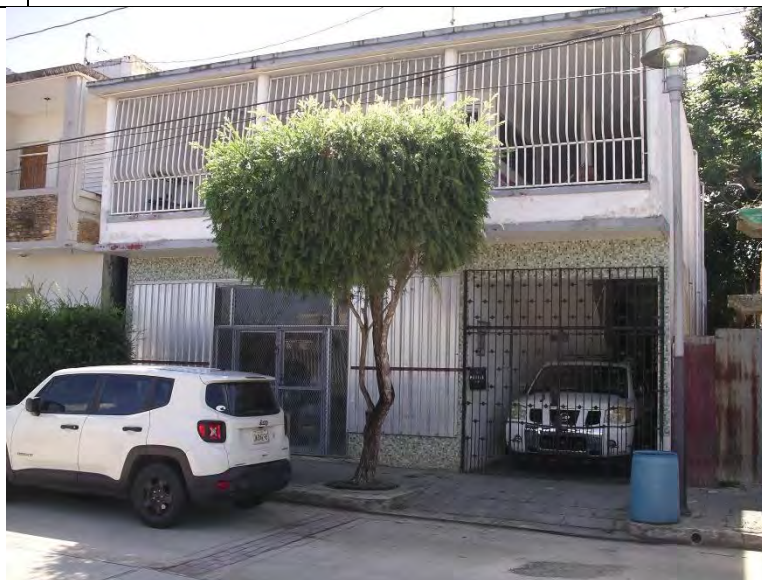
Photo: #06

Description: South view. # 9 Padial Street, Manatí, Puerto Rico. Direct APE Contributing property.

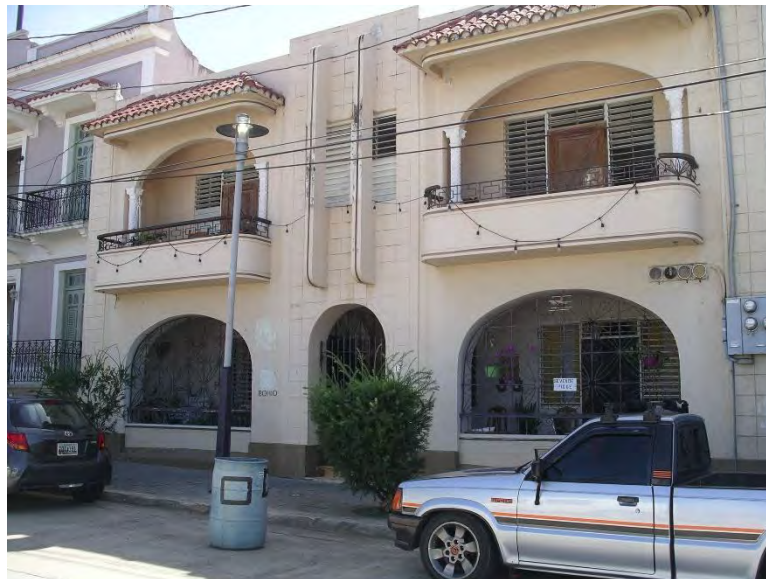
Photo: #08

Description: South view. # 13 Padial Street Manatí, Puerto Rico. Direct APE Contributing property.

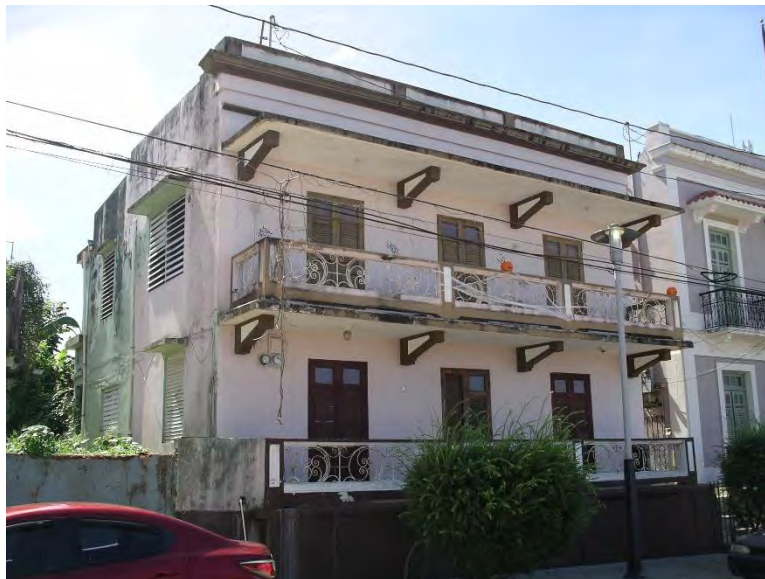
Photo: #10

Description: South view. # 17 Padial Street Manatí, Puerto Rico. Direct
APE Contributing property.

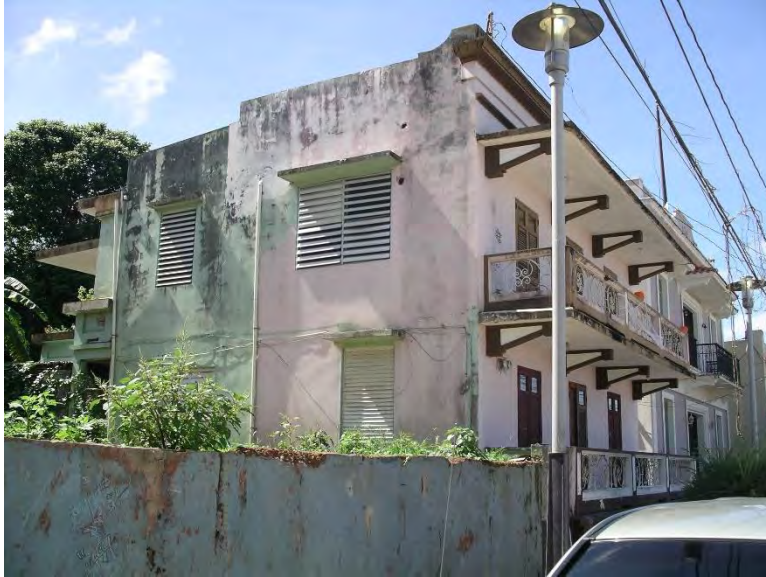
Photo: #11

Description: South-West view. # 17 Padial Street Manatí, Puerto Rico.
Direct APE Contributing property.

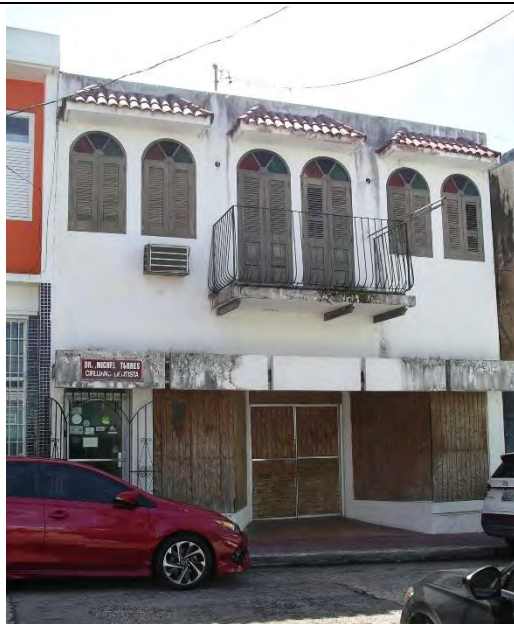
Photo: #16

Description: South view. # 79 Paseo de la Atenas Street, Manatí, Puerto Rico. Direct APE Contributing property.

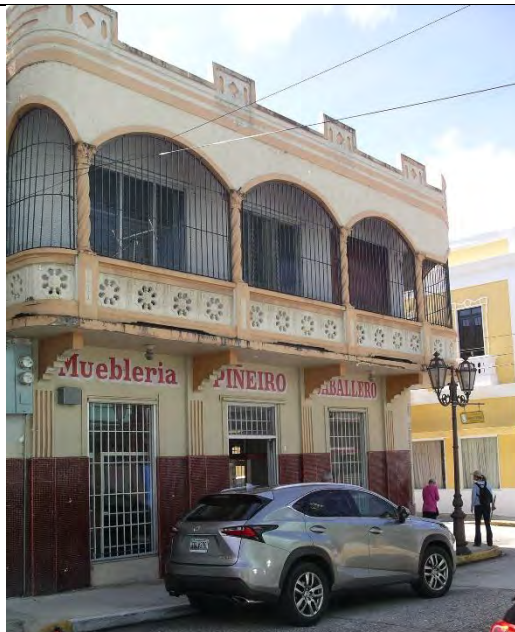
Photo: #18

Description: South view. # 75 McKinley Street, Manatí, Puerto Rico. Direct APE, Contributing property.

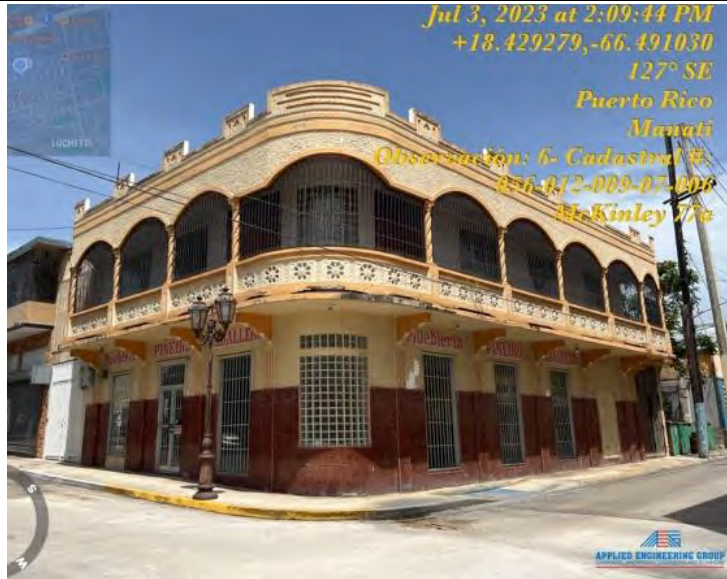
Photo: #19

Description: South-East view. # 75 McKinley Street, Manatí, Puerto Rico. Direct APE, Contributing property.

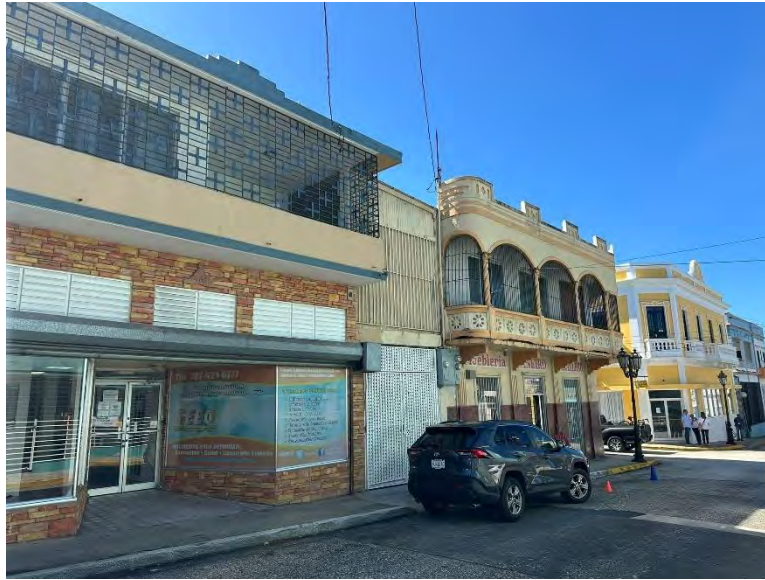
Photo: #20

Description: North view. # 75 McKinley Street, Manatí, Puerto Rico. Direct APE Contributing property

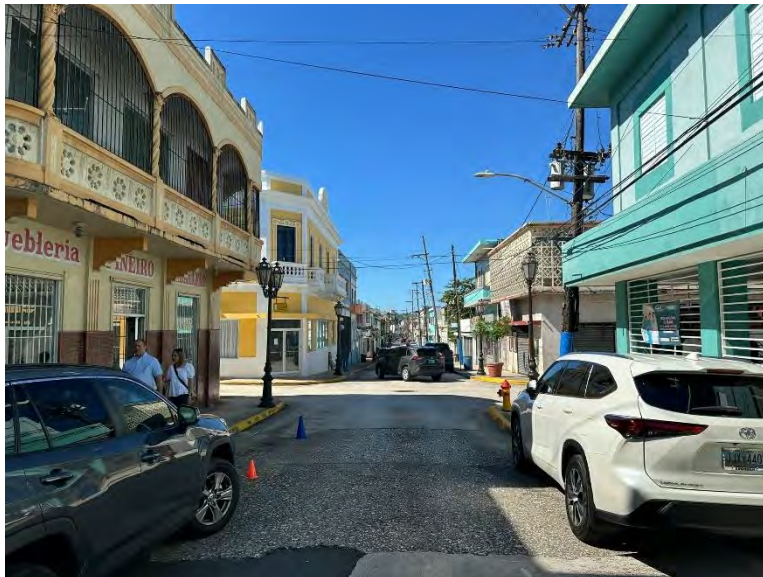
Photo: #21

Description: South-West view. # 75 McKinley Street, Manatí, Puerto Rico. Visual/Indirect APE.

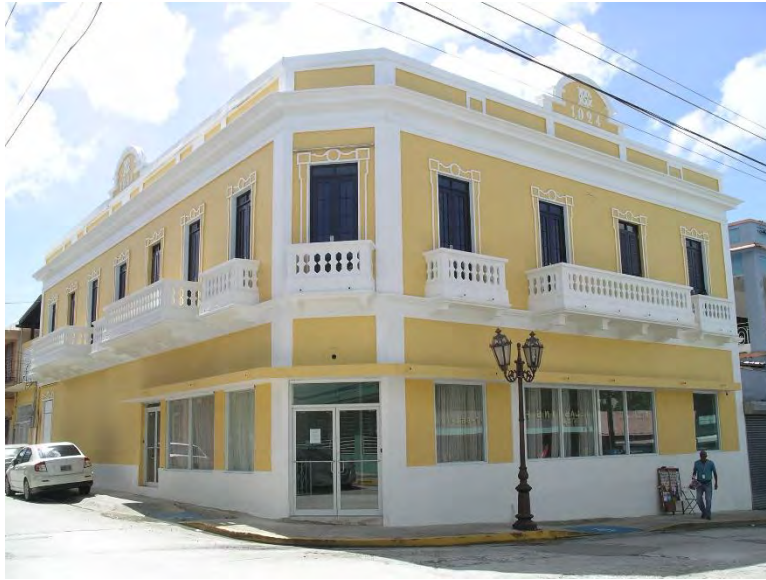
Photo: #22

Description: West view. McKinley/Paseo de las Atenas Street, Manatí, Puerto Rico. Visual/Indirect APE.

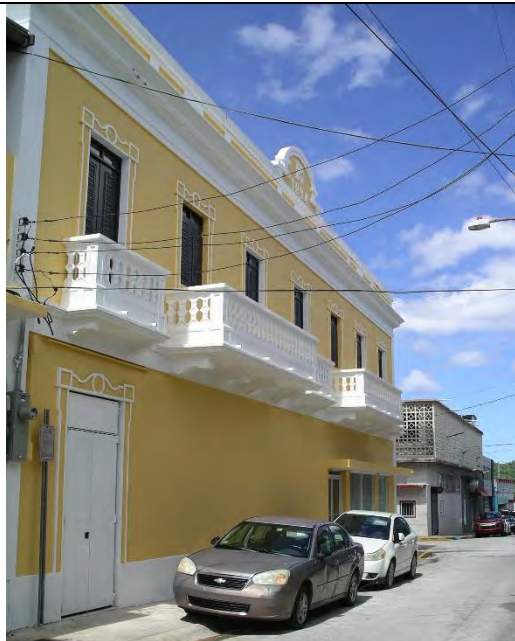
Photo: #23

Description: : South view. # 75 McKinley Street, Manatí, Puerto Rico.
Direct APE Contributing property.

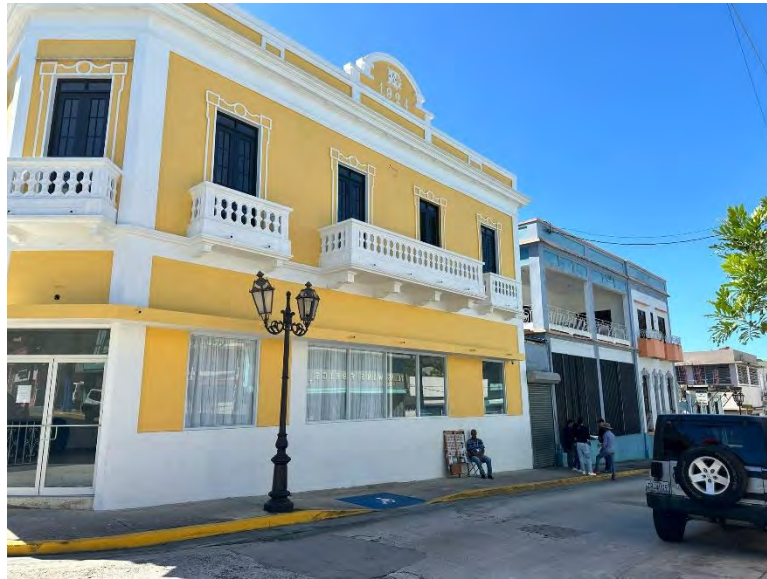
Photo: #24

Description: North view. # 75 McKinley Street, Manatí, Puerto Rico.
Direct APE, Contributing property

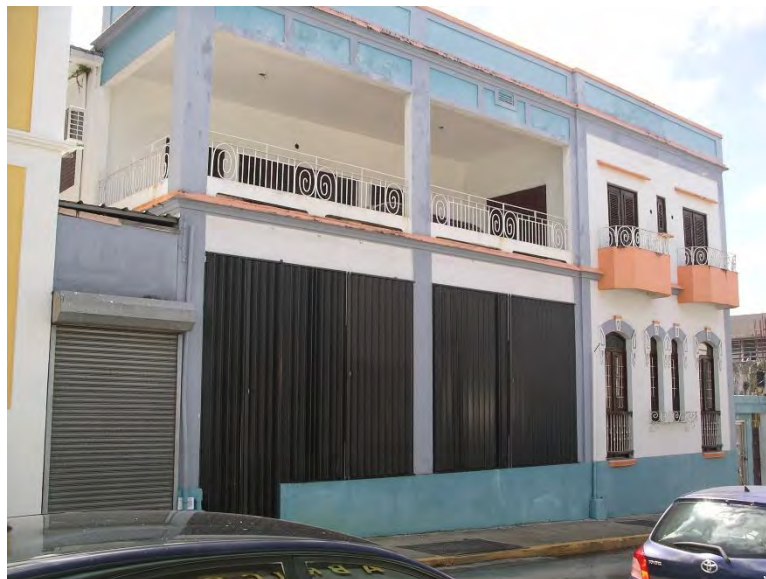
Photo: #25

Description: West view. # 75 McKinley/Paseo de las Atenas Street, Manatí, Puerto Rico. Visual/Indirect APE.

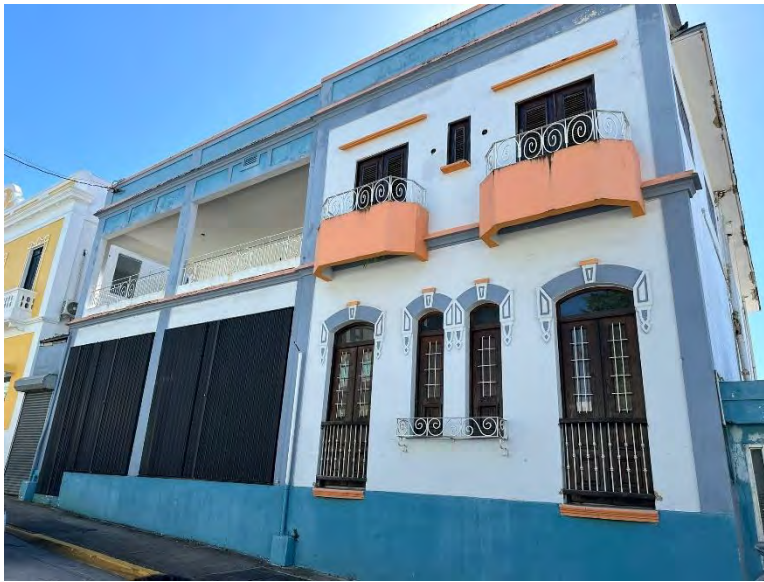
Photo: #26

Description: South view. # 73 McKinley/Paseo de las Atenas Street, Manatí, Puerto Rico. Direct APE Contributing property.

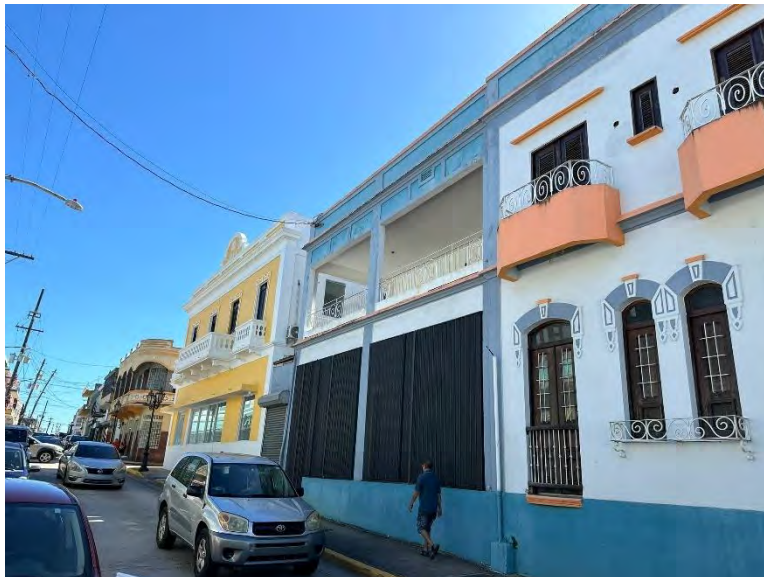
Photo: #27

Description: South view. # 73 McKinley/Paseo de las Atenas Street, Manatí, Puerto Rico. Direct APE Contributing property.

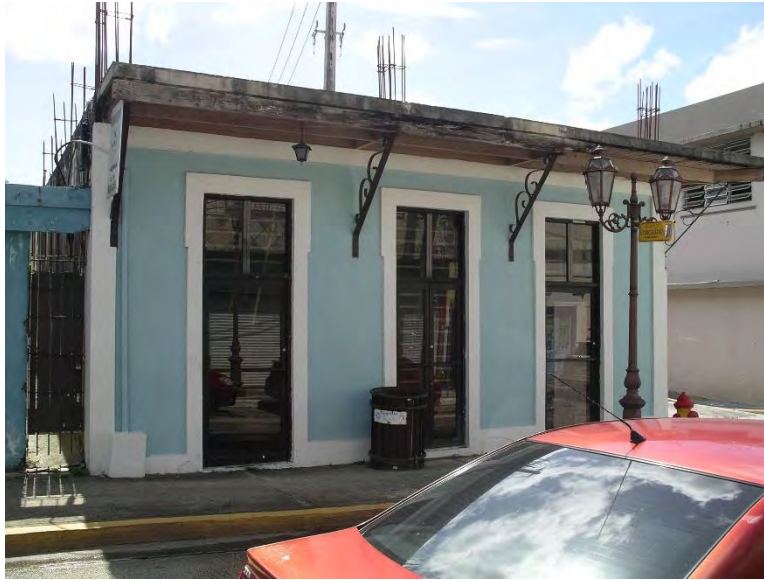
Photo: # 28

Description: South-East view. # 73 McKinley/Paseo de las Atenas Street, Manatí, Puerto Rico. Visual/Indirect APE.

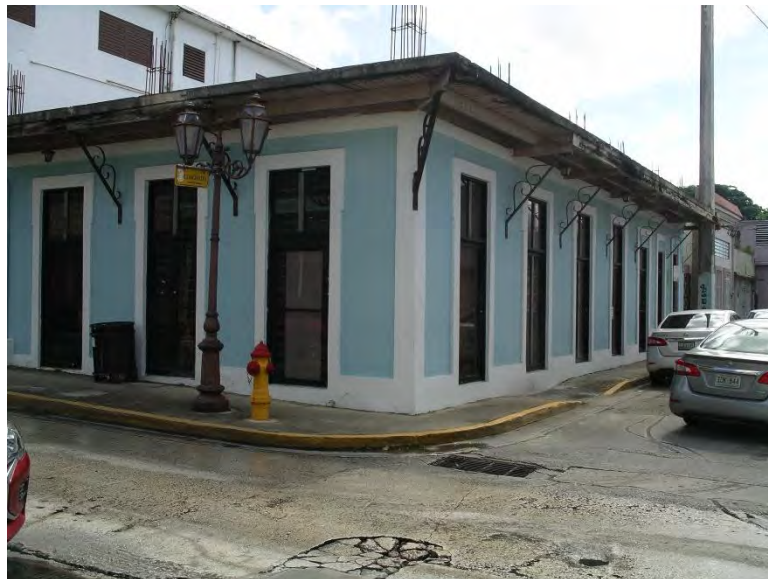
Photo: #29

Description: South view. #69 Paseo de las Atenas and Corchado Street Manatí, Puerto Rico. Direct APE Contributing property.

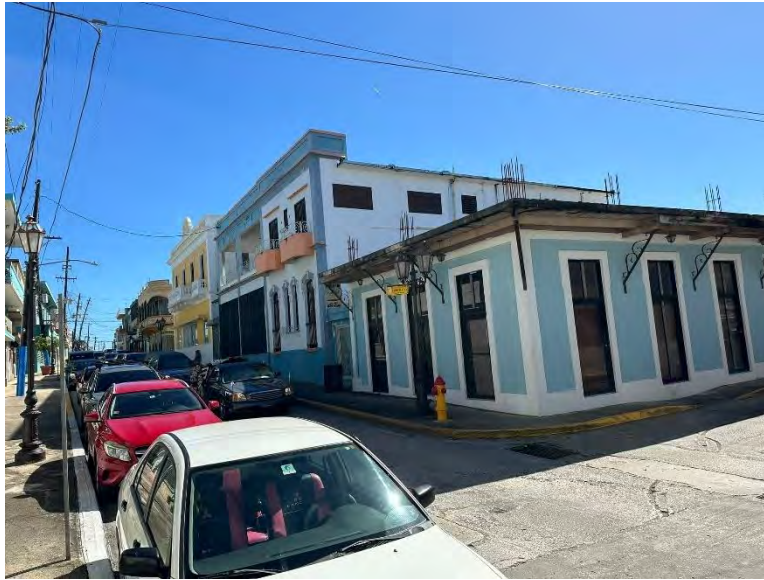
Photo: #30

Description: South-East view. #69 Paseo de las Atenas and Corchado Street Manatí, Puerto Rico. Direct APE, Contributing property.

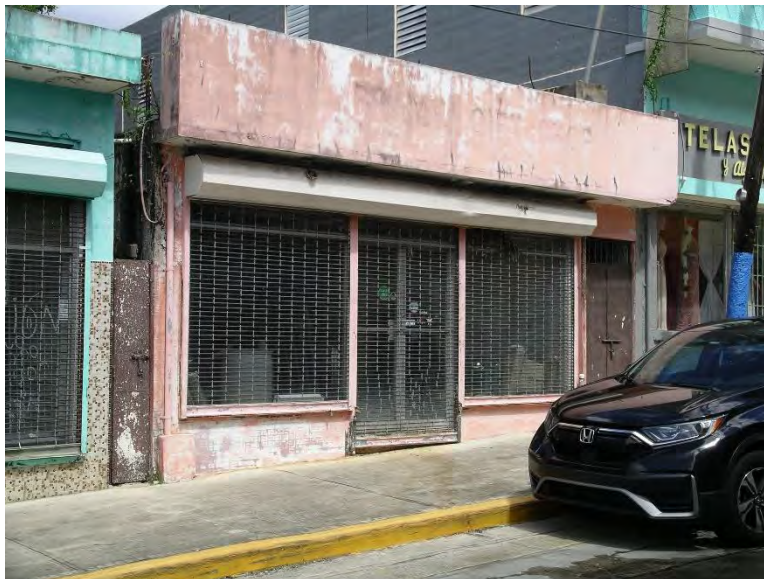
Photo: #31

Description: South-East view. # 69 McKinley/Paseo de las Atenas Street, Manatí, Puerto Rico. Visual/Indirect APE.

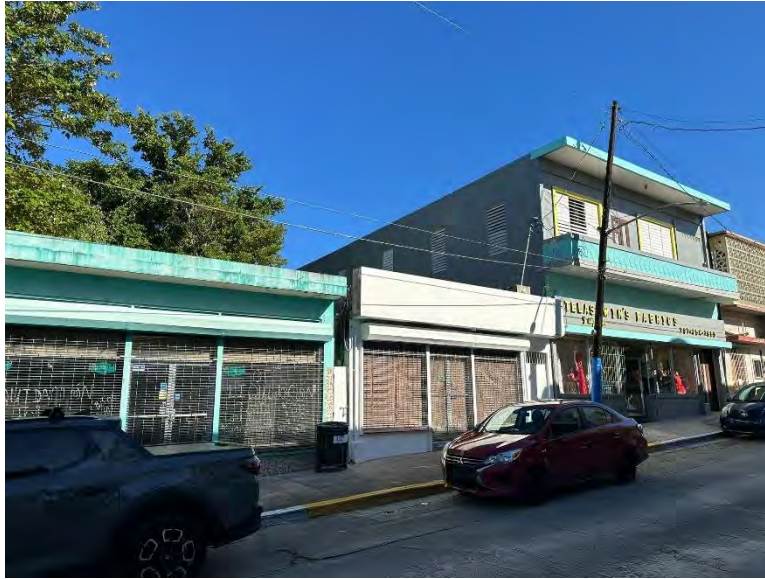
Photo: #32

Description: North view. #46 McKinley/Paseo de las Atenas Street, Manatí, Puerto Rico. Direct APE Contributing property.

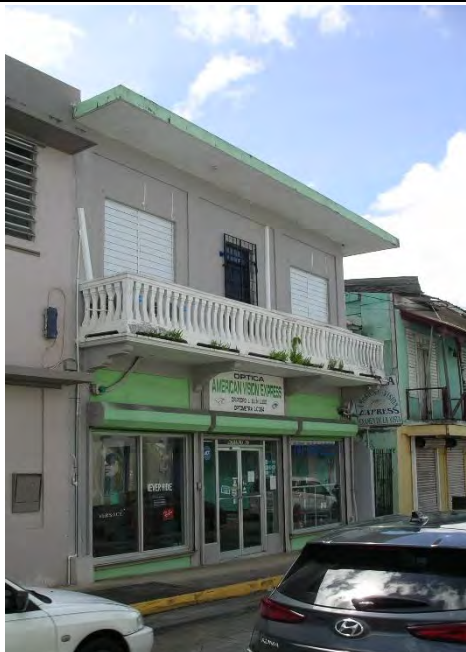
Photo: #33

Description: North-East view. #46 McKinley/Paseo de las Atenas Street, Manatí, Puerto Rico. Visual/Indirect APE.

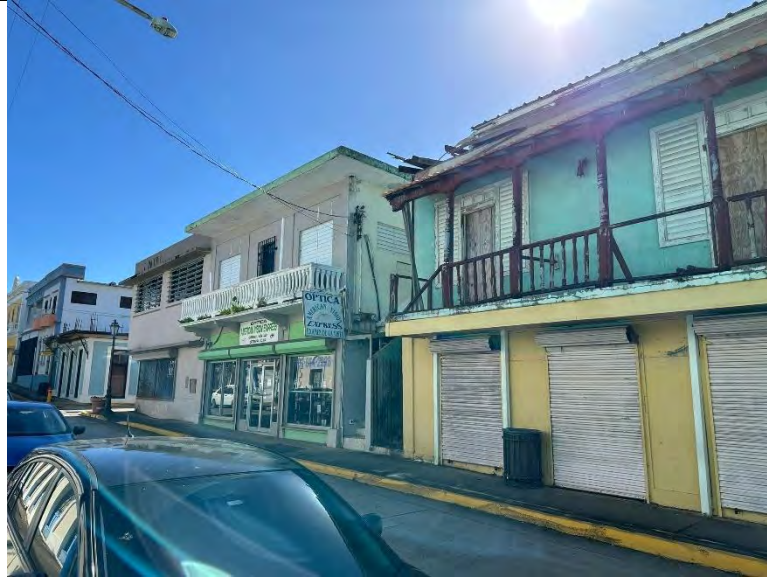
Photo: #34

Description: South-West view. #67 McKinley/Paseo de las Atenas Street, Manatí, Puerto Rico. Direct APE Contributing property.

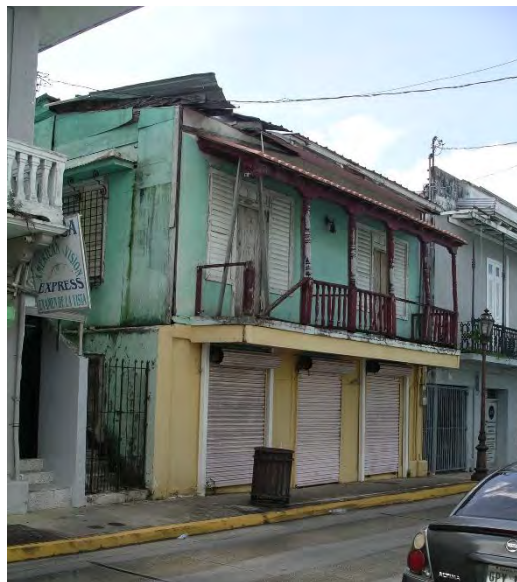
Photo: #35

Description: South-East view. # 67 McKinley/Paseo de las Atenas Street, Manatí, Puerto Rico. Visual/Indirect APE.

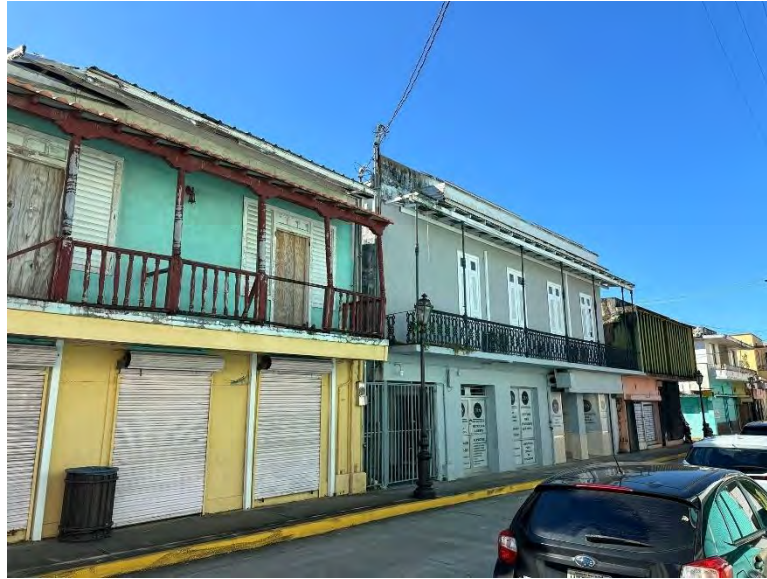
Photo: #36

Description: South-West view. # 65 McKinley/Paseo de las Atenas Street, Puerto Rico. Direct APE Contributing property.

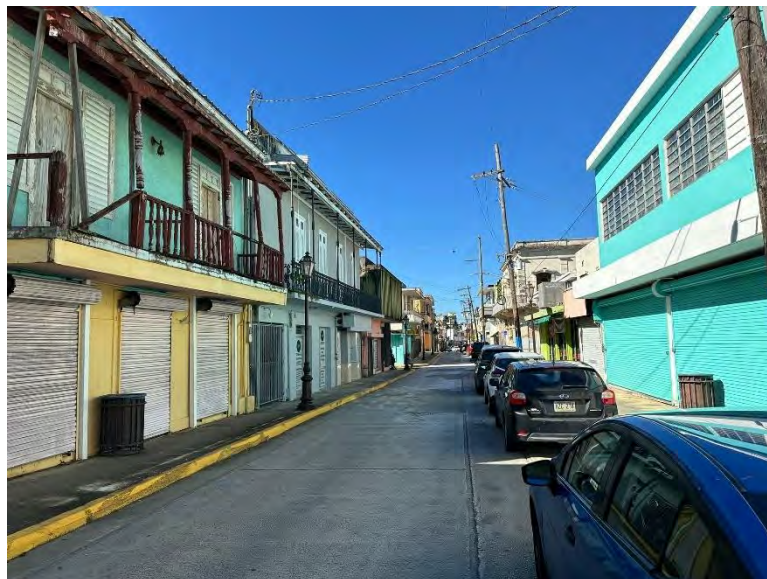
Photo: #37

Description: South-West view. # 65 McKinley/Paseo de las Atenas Street Manatí, Puerto Rico. Visual/Indirect APE.

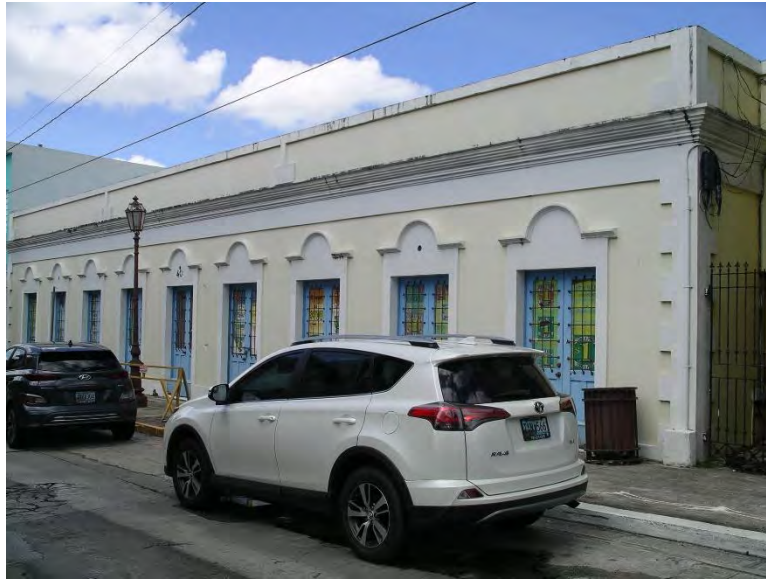
Photo: #38

Description: West view. McKinley/Paseo de las Atenas Street Manatí, Puerto Rico. Visual/Indirect APE.

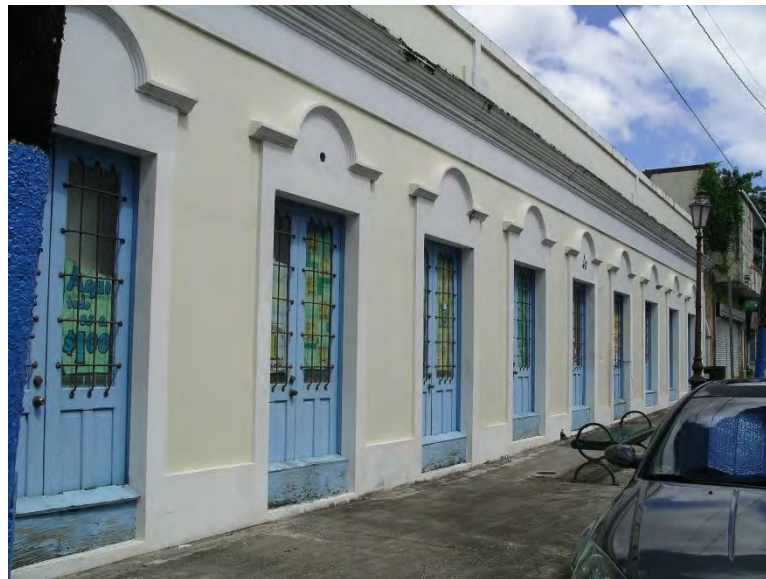
Photo: #39

Description: North-West view. # 40 McKinley/Paseo de las Atenas Street, Manatí, Puerto Rico. Direct APE Contributing property.

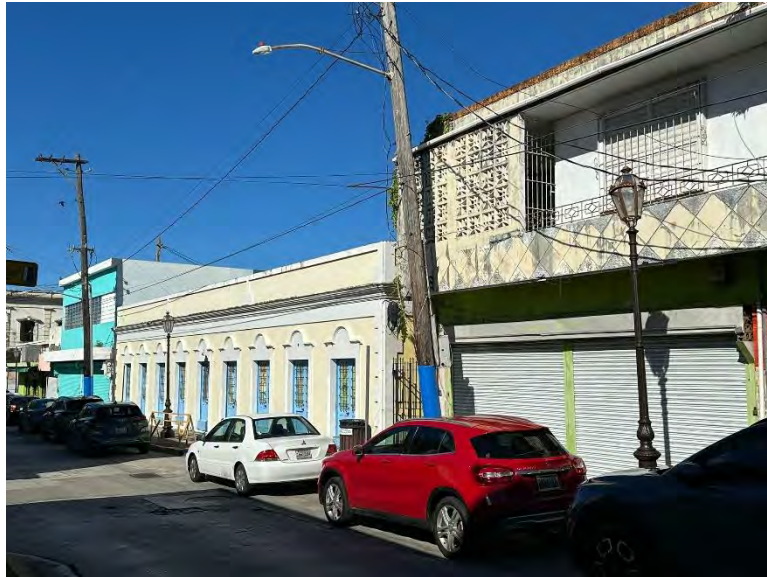
Photo: #40

Description: North-East view. # 40 McKinley/Paseo de las Atenas Street, Manatí, Puerto Rico. Direct APE Contributing property.

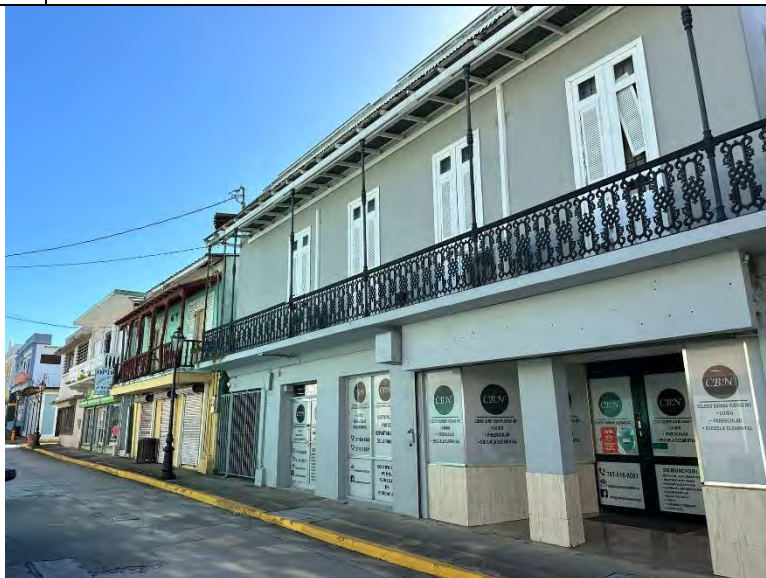
Photo: #41

Description: North-West view. # 40 McKinley/Paseo de las Atenas Street, Manatí, Puerto Rico. Visual/Indirect APE.

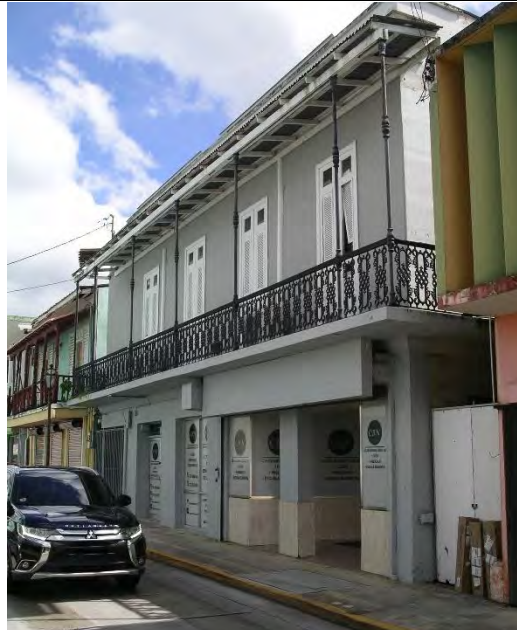
Photo: #42

Description: South-East view. # 63 McKinley/Paseo de las Atenas Street Manatí, Puerto Rico. Visual/Indirect APE.

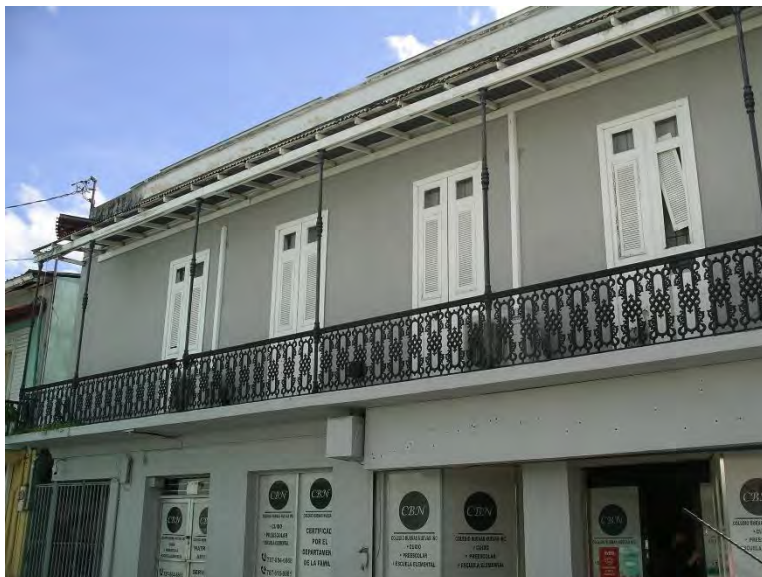
Photo: #43

Description: South-East view. # 63 McKinley/Paseo de las Atenas Street Manatí, Puerto Rico. Direct APE Contributing property.

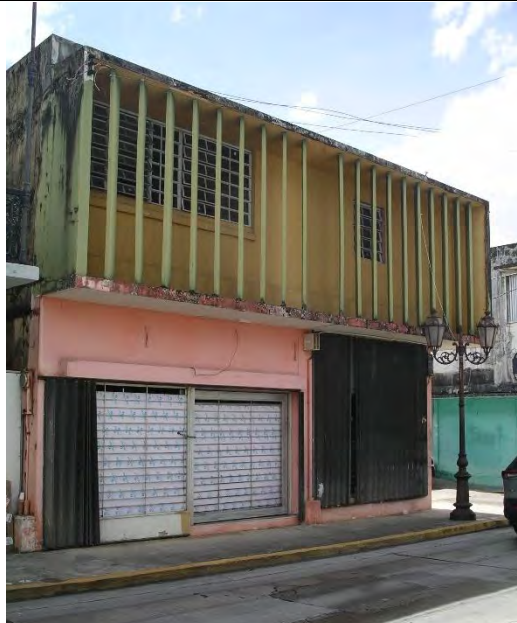
Photo: #44

Description: South-East view. # 63 McKinley/Paseo de las Atenas Street Manatí, Puerto Rico. Direct APE Contributing property.

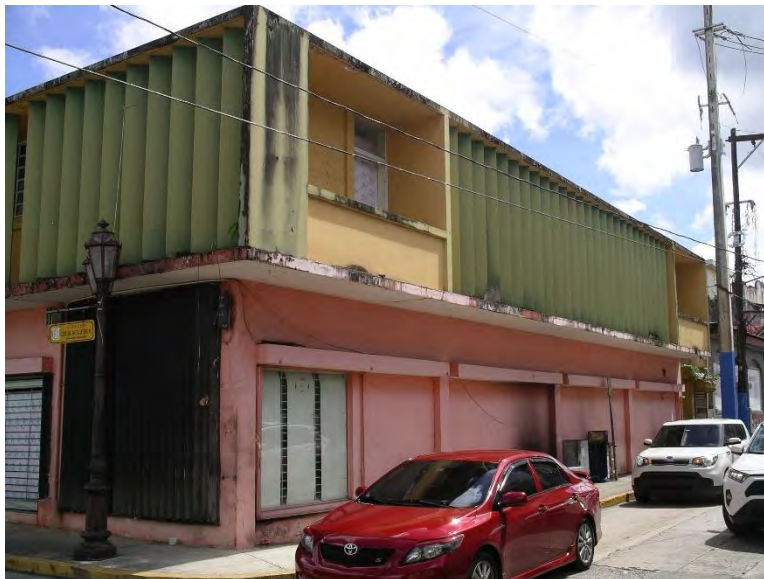
Photo: #45

Description: South-West view. # 61 McKinley/Paseo de las Atenas Street, Manatí, Puerto Rico. Direct APE Contributing property.

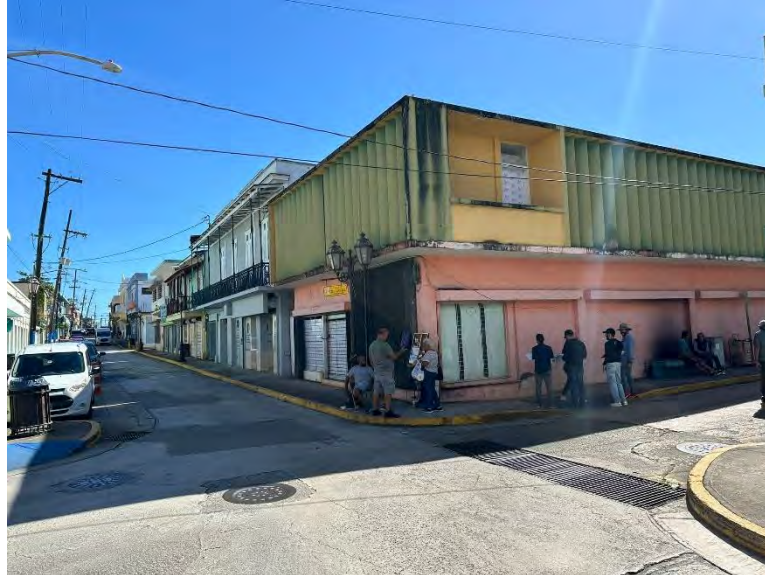
Photo: #46

Description: South-East view. # 61 McKinley/Paseo de las Atenas Street, Manatí, Puerto Rico. Direct APE Contributing property.

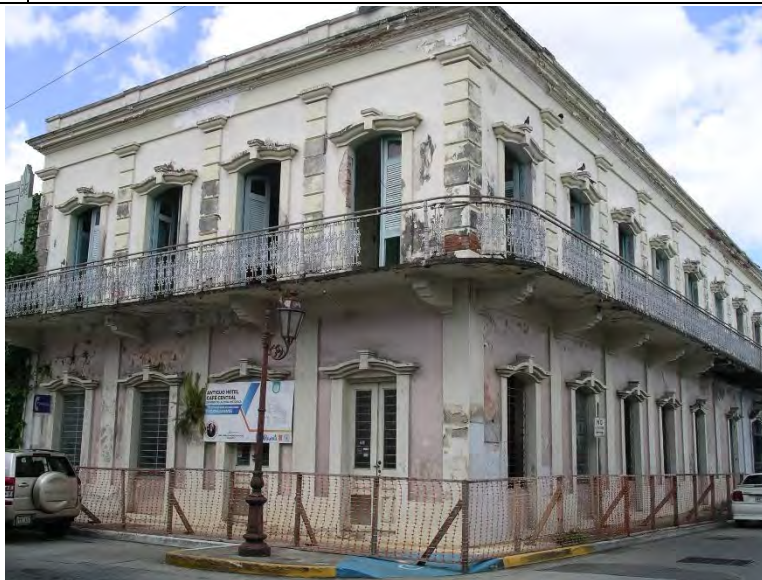
Photo: #47

Description: South-East view. # 61 McKinley/Paseo de las Atenas Street, Manatí, Puerto Rico. Visual/Indirect APE.

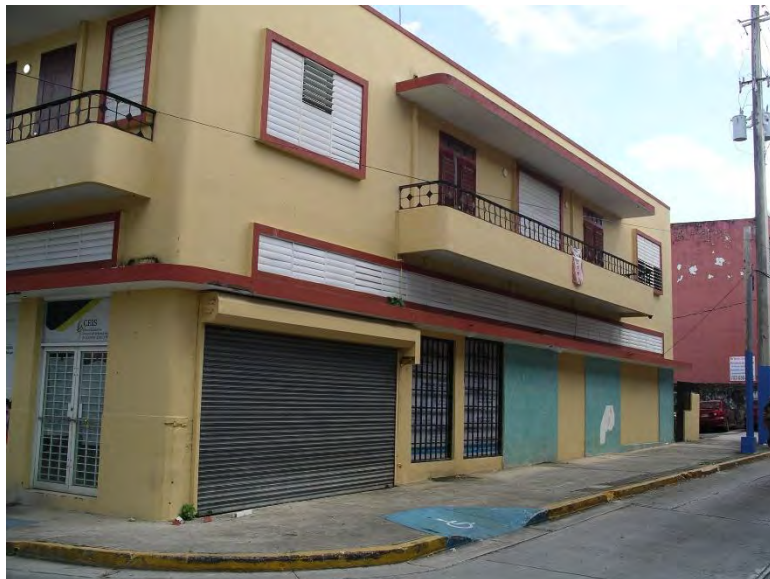
Photo: #49

Description: South-East view. # 4 Betances and McKinley Streets, Manatí, Puerto Rico. Direct APE Contributing property.

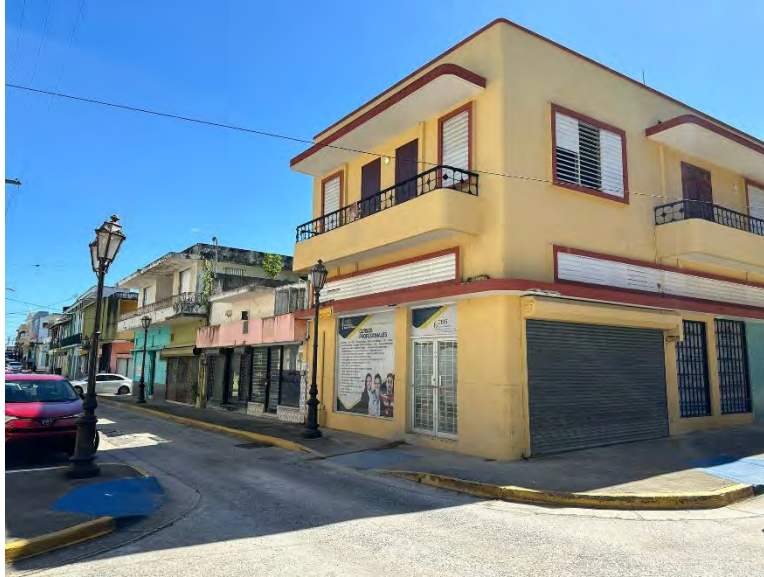
Photo: #50

Description: South-East view. # 4 Betances and McKinley Streets, Manatí, Puerto Rico. Direct APE Contributing property.

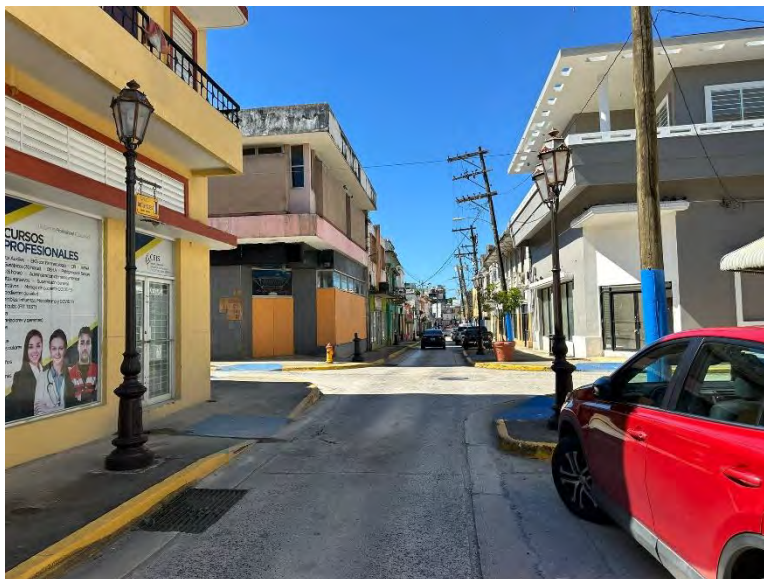
Photo: #51

Description: South-East view. # 4 Betances and McKinley Streets, Manatí, Puerto Rico. Visual/Indirect APE.

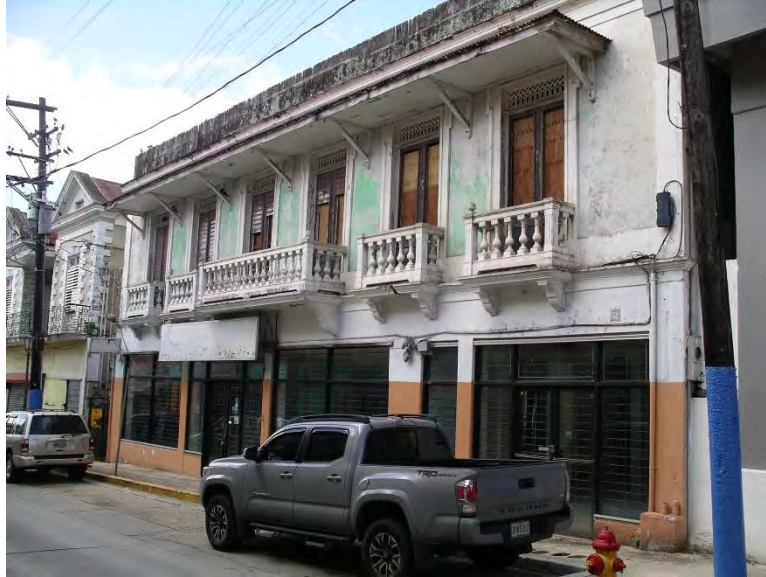
Photo: #52

Description: East view. McKinley/Paseo de las Atenas Street, Manatí, Puerto Rico. Visual/Indirect APE.

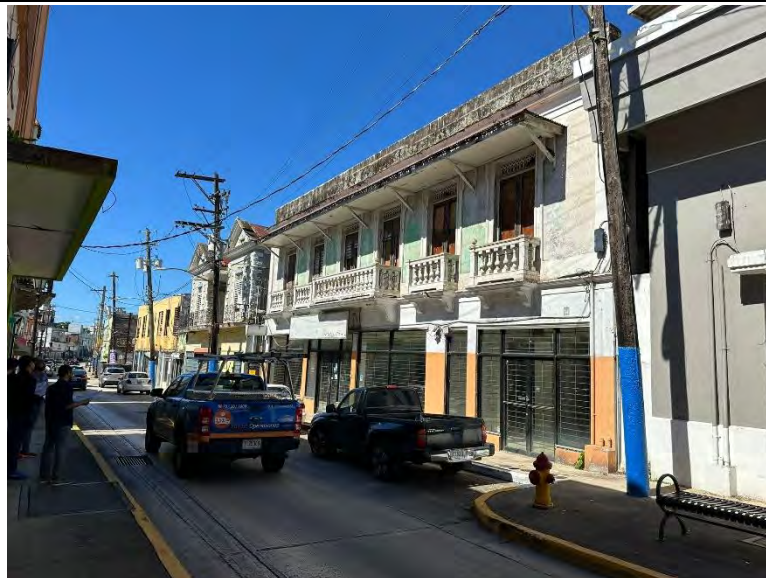
Photo: #53

Description: North-west view. #30 McKinley/Paseo de las Atenas Street Manatí, Puerto Rico. Direct APE Contributing property.

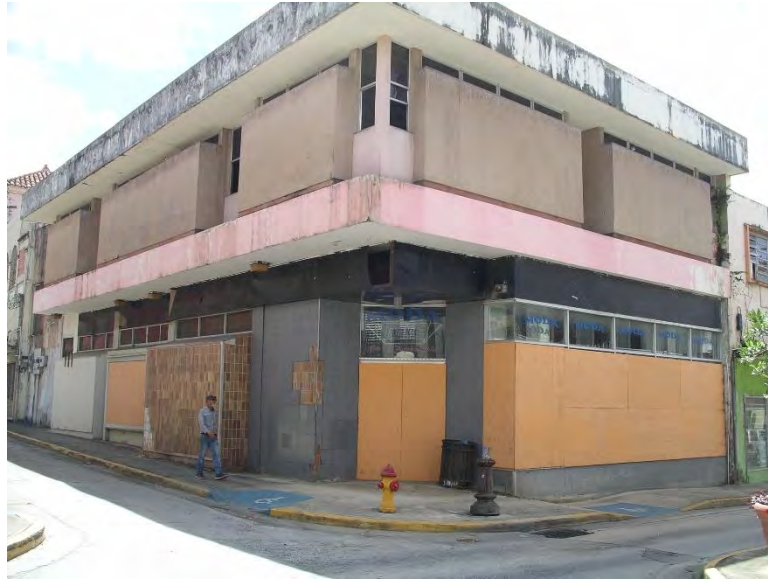
Photo: #54

Description: West view. McKinley/Paseo de las Atenas Street Manatí, Puerto Rico. Visual/Indirect APE.

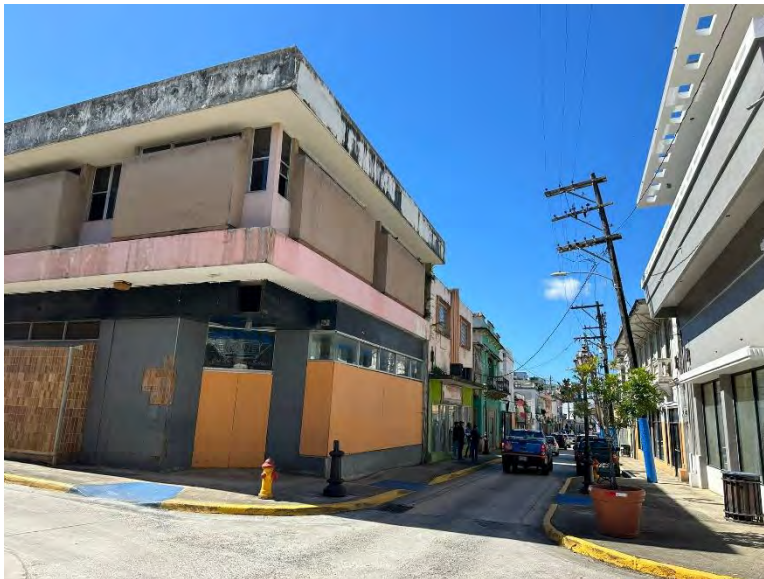
Photo: #55

Description: South-West view. Paseo de las Atenas and R. Betances Street, Manatí, Puerto Rico. Direct APE. Non-Contributing property.

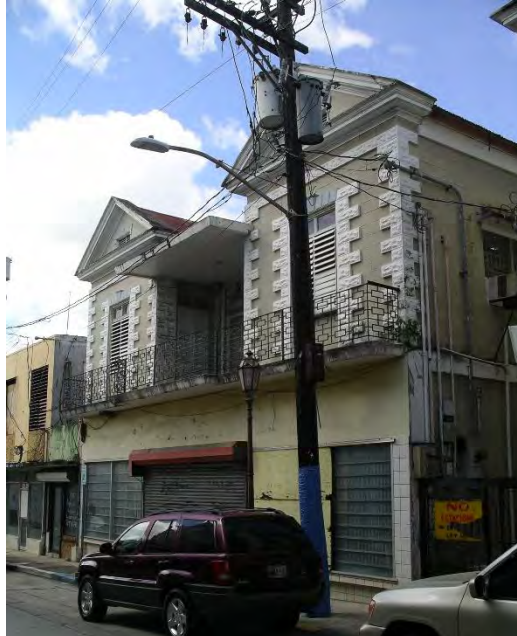
Photo: #56

Description: West view. McKinley/Paseo de las Atenas Street Manatí, Puerto Rico. Visual/Indirect APE.
