**Environmental Review for Activity/Project that is Categorically
Excluded Subject to Section 58.5
Pursuant to 24 CFR 58.35(a)**

Project Name: Revitalización Fachadas Arquitectónicas e Históricas en el Centro Urbano (PR-CRP-000775)

Responsible Entity: Puerto Rico Department of Housing (PRDOH)

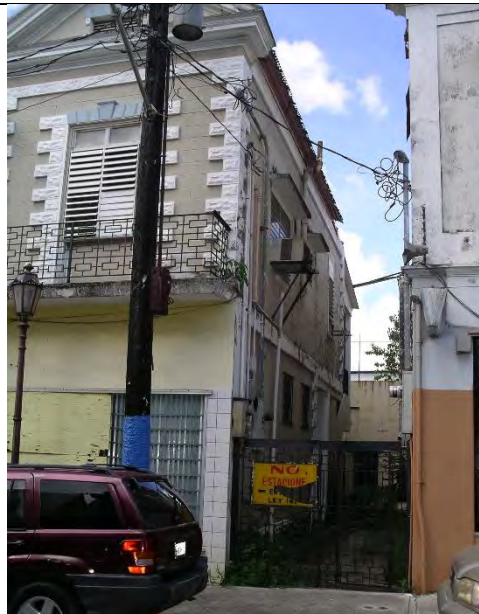
Photo: #57

Description: North view. #28 Paseo de las Atenas Manatí, Puerto Rico.
Direct APE, Contributing property.

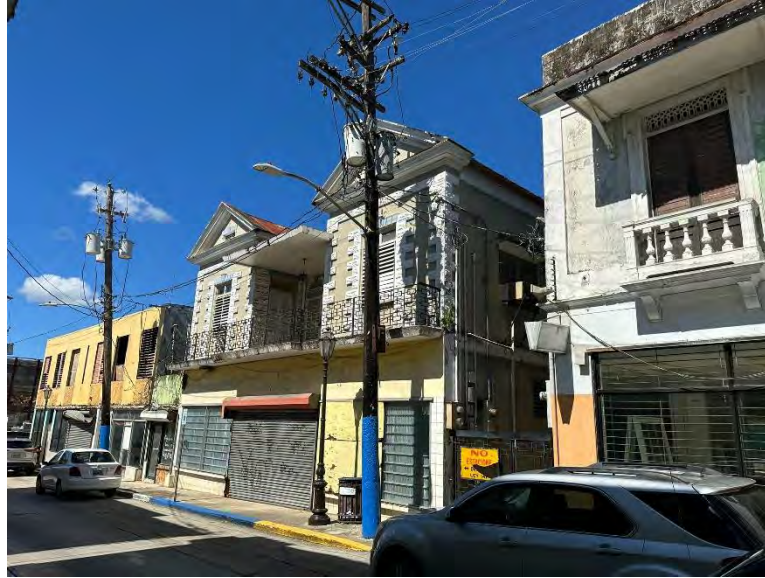
Photo: #58

Description: North view. #28 Paseo de las Atenas Manatí, Puerto Rico.
Direct APE, Contributing property.

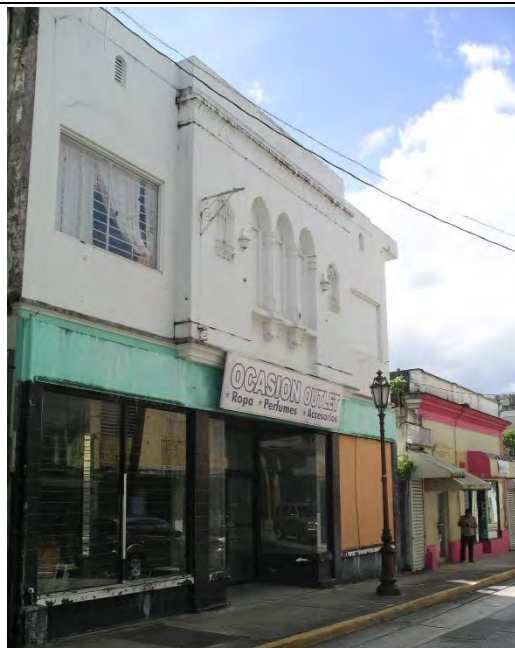
Photo: #60

Description: South-West view. #47 McKinley/Paseo de las Atenas Street, Manatí, Puerto Rico. Direct APE Contributing property.

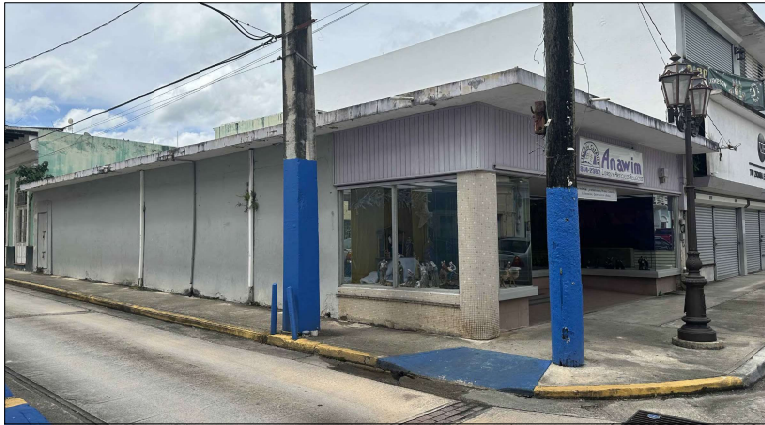
EXISTING CONDITIONS FACADES AS-BUILT - PROPERTY NO. 10
SCALE: 1/4" = 1'-0"

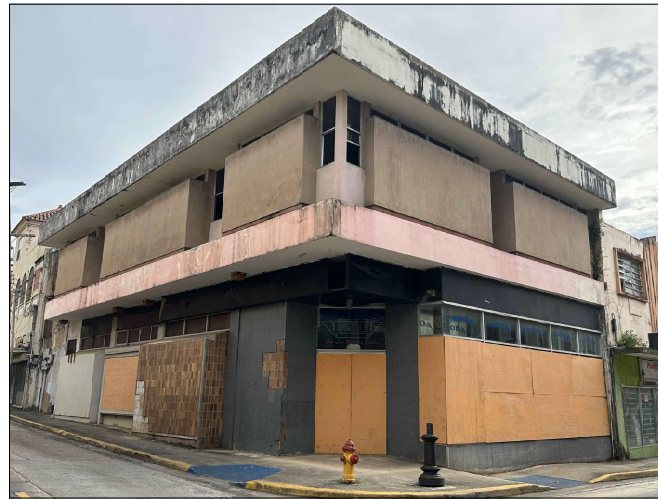
EXISTING CONDITIONS FACADES AS-BUILT - PROPERTY NO. 15
SCALE: 1/4" = 1'-0"

ELEVATION 15A

| SCHEDULE | | | |
|---|---|---|---|
| A. | COMMERCIAL WINDOW | 21 | ALUMINUM FRAME AND GLASS |
| B. | GUILLOTINE WINDOW | 4 | ALUMINUM FRAME AND GLASS |

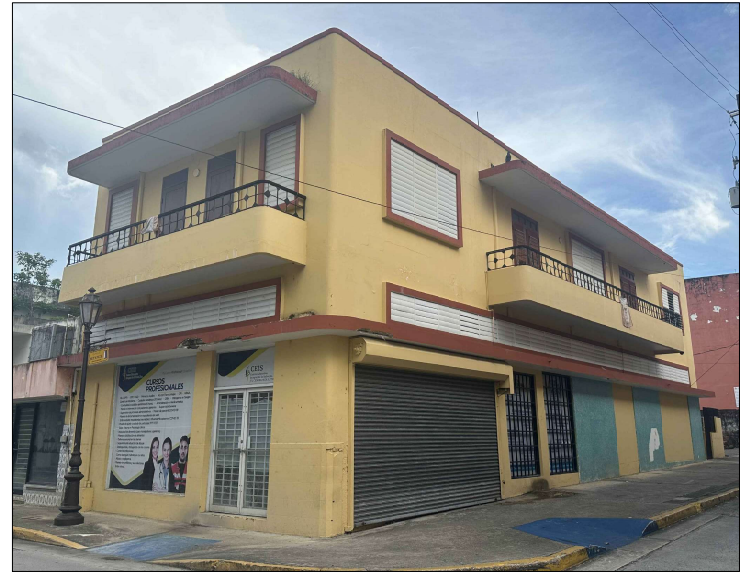
EXISTING CONDITIONS FACADES AS-BUILT - PROPERTY NO. 16
SCALE: 1/4" = 1'-0"

ELEVATION 16A

- OBSERVATIONS:
- DAMAGED ALUMINUM WINDOWS
 - VEGETATION PRESENT
 - DAMAGED CERAMIC TILES
 - EXPOSED CONDUITS
 - NON-COMPLIANT SIGNAGE

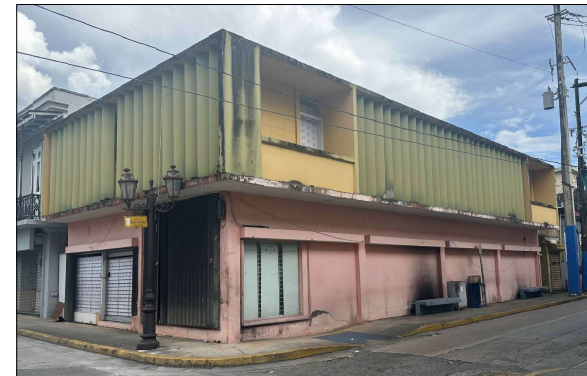
EXISTING CONDITIONS FACADES AS-BUILT - PROPERTY NO. 17
SCALE: 1/4" = 1'-0"

ELEVATION 17B

1. MISSING SUNSCREEN
2. MISSING MISSING CRYSTALS FROM ROLLING DOOR
3. ENCAPSULATED CERAMIC TILES
4. MISSING DOORS
5. MISSING WINDOWS

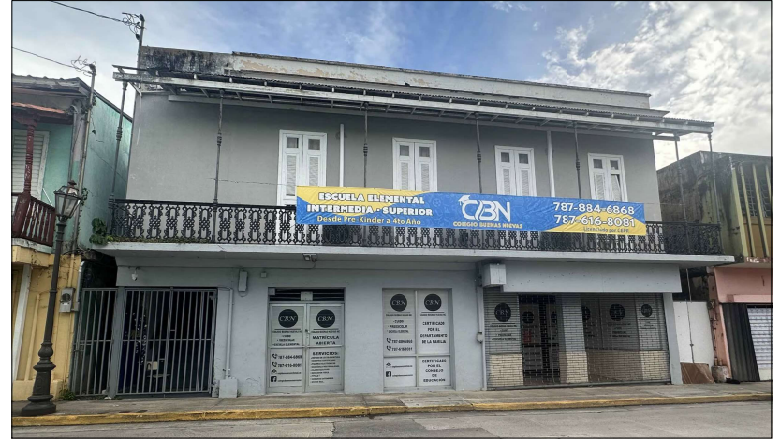
EXISTING CONDITIONS FACADES AS-BUILT - PROPERTY NO. 18
SCALE: 3/16" = 1'-0"

1. NON-COMPLIANT SIGNAGE
2. ALUMINUM BALCONY CEILING DAMAGED
3. PLASTER IN BAD CONDITIONS
4. DAMAGED MOLDINGS
5. VEGETATION PRESENT
6. EXPOSED CONDUITS
7. WOODEN BALCONY ELEMENTS DAMAGED
8. DAMAGED WOODEN DOOR
9. CERAMIC TILES

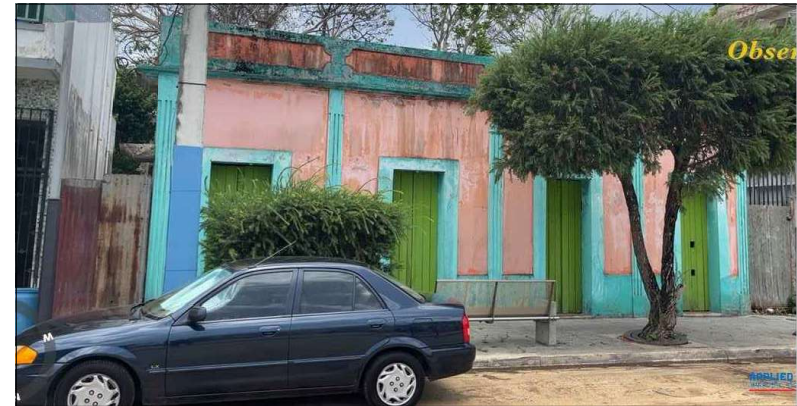
EXISTING CONDITIONS FACADES AS-BUILT - PROPERTY NO. 20
SCALE: 1/4" = 1'-0"

1. DAMAGED WOODEN PANELS
2. ZINC SHEETS AT LATERALS
3. WATER DAMAGE PLASTER

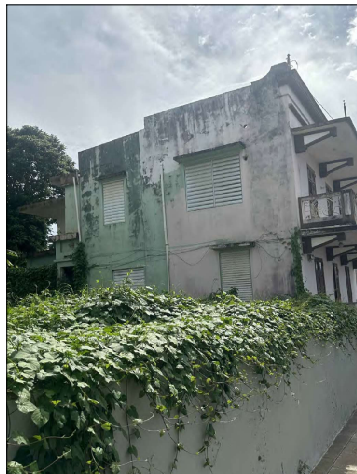
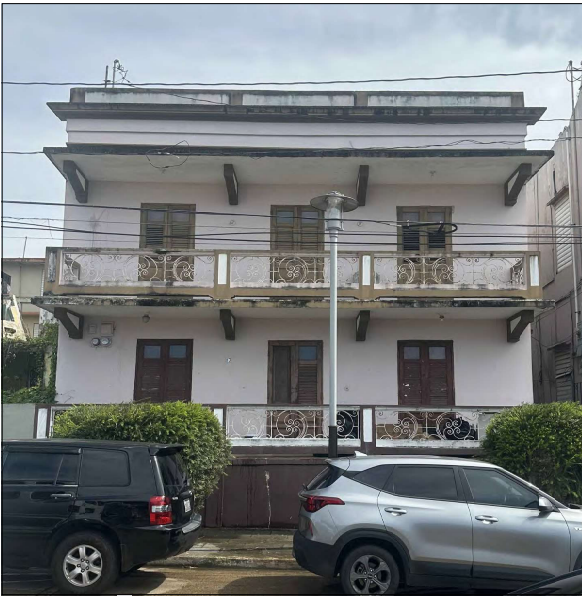
EXISTING CONDITIONS FACADES AS-BUILT - PROPERTY NO. 22
SCALE: 3/16" = 1'-0"

ELEVATION 22B

ELEVATION 22A

1. MISSING LIGHT FIXTURES
2. WATER DAMAGE
3. WOODEN DOORS PANELS DAMAGED
4. MISSING CONCRETE EAVE IN LATERAL FACADE

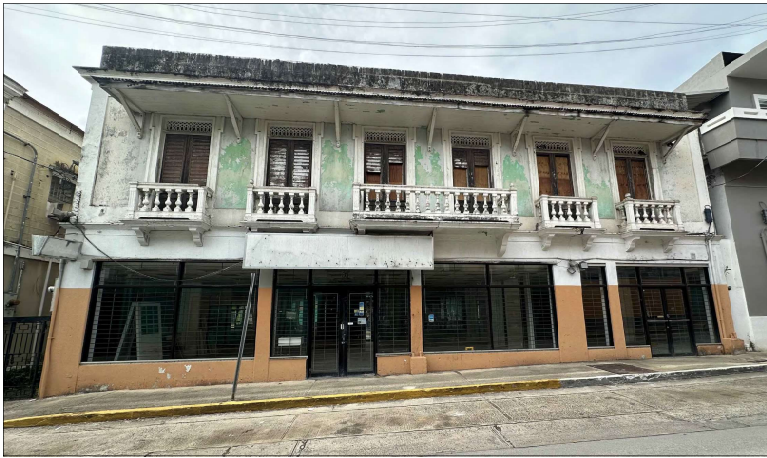
EXISTING CONDITIONS FACADES AS-BUILT - PROPERTY NO. 23
SCALE: 3/16" = 1'-0"

23 ELEVATION 23 23

DETAIL CERAMIC TILE
SCALE: NTS

1. NON - COMPLIANT SIGNAGES
2. EXPOSED CONDUITS
3. DAMAGED DOORS AND WINDOWS
4. PAINTED CERAMIC TILES

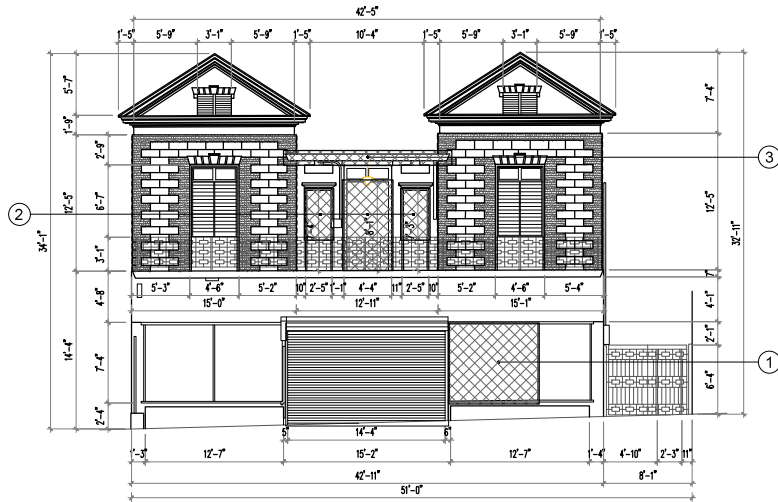
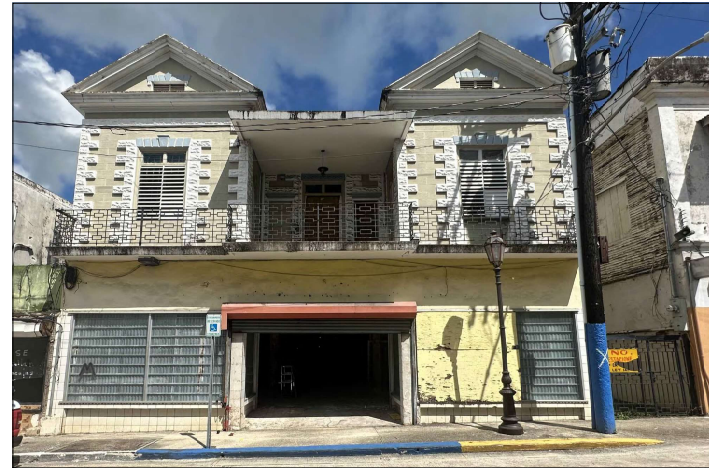
EXISTING CONDITIONS FACADES AS-BUILT - PROPERTY NO. 24
SCALE: 3/16" = 1'-0"

ELEVATION 24A

ELEVATION 24B

1. MISSING ALUMINUM AND CRYSTAL WINDOW
2. MISSING DOORS AND WINDOWS ON THE LEVEL
3. WATER DAMAGED PAINT
4. EXPOSED A/C UNIT

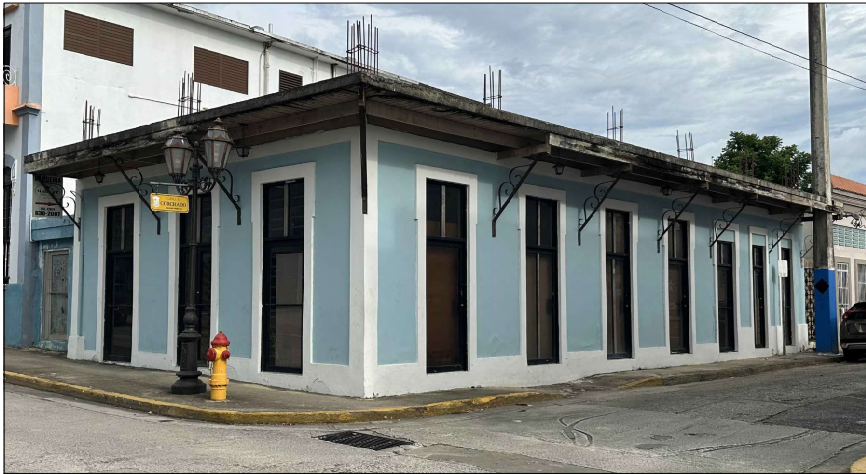
EXISTING CONDITIONS FACADES AS-BUILT - PROPERTY NO. 26
SCALE: 1/4" = 1'-0"

ELEVATION 26A

1. EXPOSED REINFORCING STEEL AT THE CEILING
2. DAMAGED WOODEN ELEMENTS CORNING THE EAVE
3. MISSING LIGHTING FIXTURES

1. EXPOSED REINFORCING STEEL AT THE CEILING
2. DAMAGED WOODEN ELEMENTS CORNING THE EAVE
3. MISSING LIGHTING FIXTURES
4. DOOR FENESTRATION NOT COMPLETELY OPENED

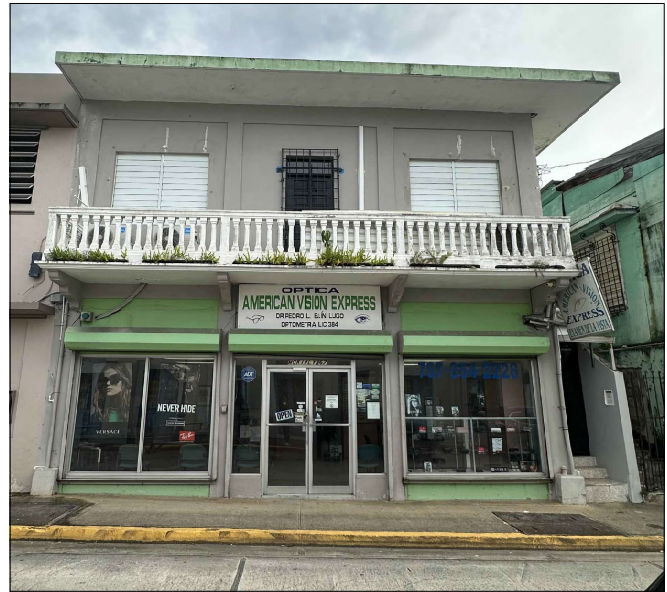
1. REMOVE THE SIGNS "OPTICA AMERICA VISION EXPRESS" AND REPAIR ANY DAMAGED PLASTER

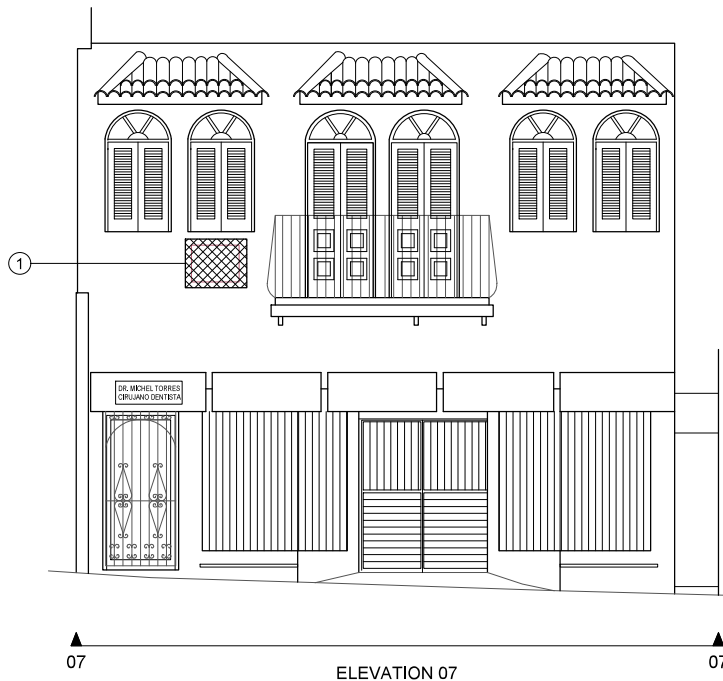
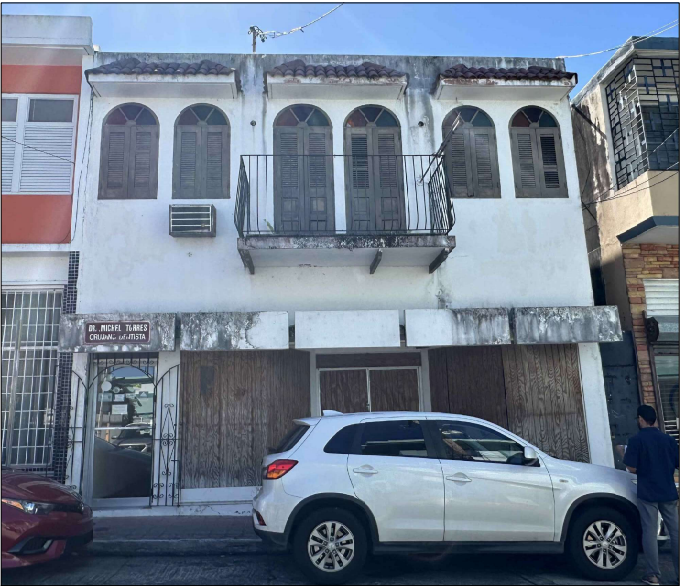
1. REMOVE THE AIR CONDITIONER FORM THE FRONT FACADE, SEAL THE OPENING AND RE-PLASTER

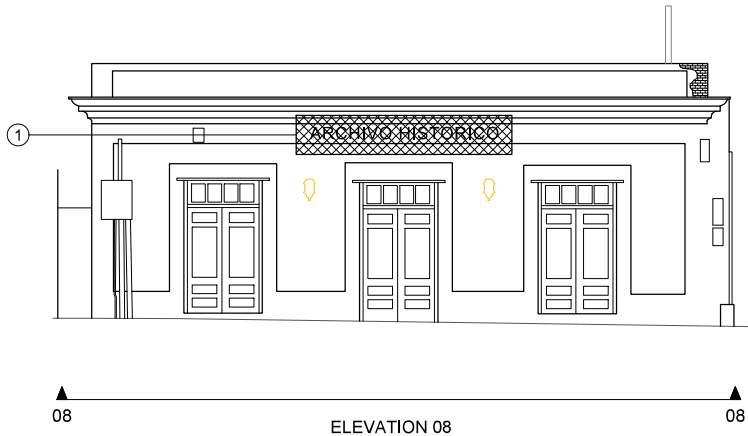
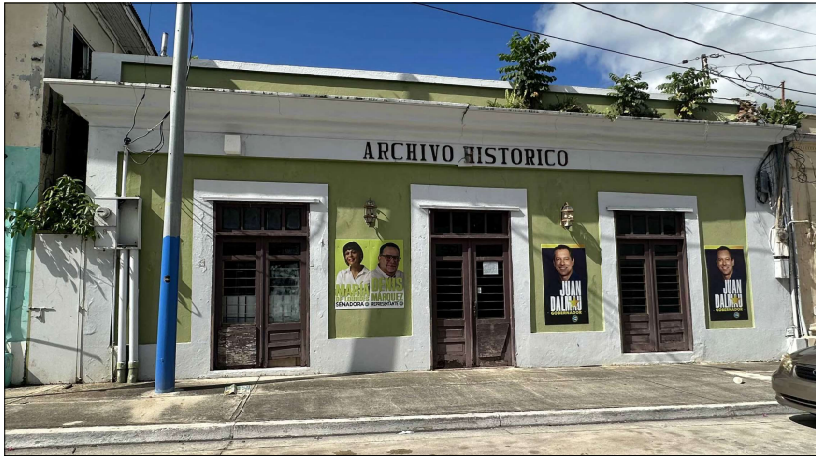
DEMOLITION PLAN - PROPERTY NO. 08
SCALE: 1/4" = 1'-0"

| FACADES | | | | |
|---|---|---|--|---|
| #6 MCKINLEY/PASEO DE LAS ATENAS, MANATÍ, PUERTO RICO. | 056-021-008-05-901 | LAT: 18.42880840, LON: -66.49419283 | THE FACADES REQUIRES REPAIRATION AND PAINTING. DAMAGE PARAPET, ROTULATIONS LETTERS AND DOOR, VEGETATION PRESENT. | PUERTO RICO LATE XIX - EARLY XX / COLONIAL. |

LETTERING REMOVAL

1. REMOVE THE LETTERS FOR "ARCHIVO HISTORICO" AND REPAIR ANY AFFECTED PLASTER

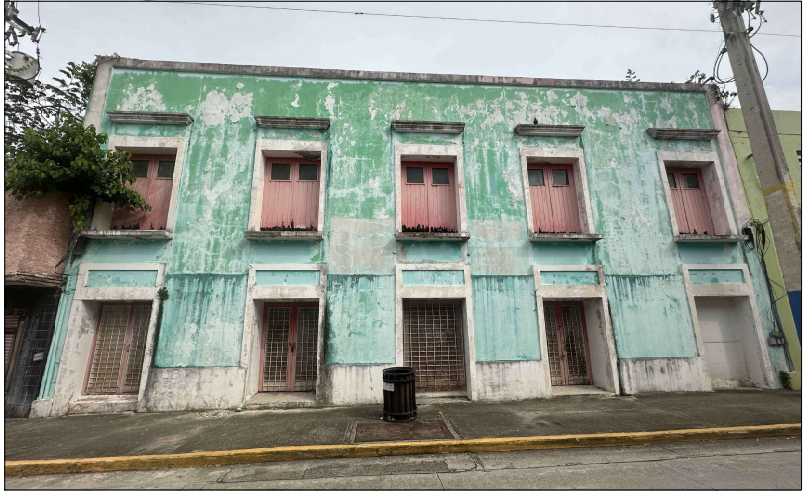
ELEVATION 09

- REMOVE THE WOOD PANEL INSTALLED IN THE OPENING OF THE FIRST DOOR FROM THE RIGHT AND REPAIR ANY AFFECTED PLASTER COORDINATE WITH NEW DOOR INSTALLATION

| FACADES | | | | |
|---|---|---|---|---|
| #18 MCKINLEY/ PASEO DE LAS ATENAS, MANATÍ, PUERTO RICO. | 056-021-008-12-001 | LAT: 18.42867503, LON: -66.49350178 | THE FACADES REQUIRES REPAIR AND PAINTING. MISSING SILLS AND DOOR. VEGETATION PRESENT. | PUERTO RICO VERNACULAR (PUERTO RICO LATE XIX - EARLY XX - COMMERCIAL BUILDING/WAREHOUSE). |

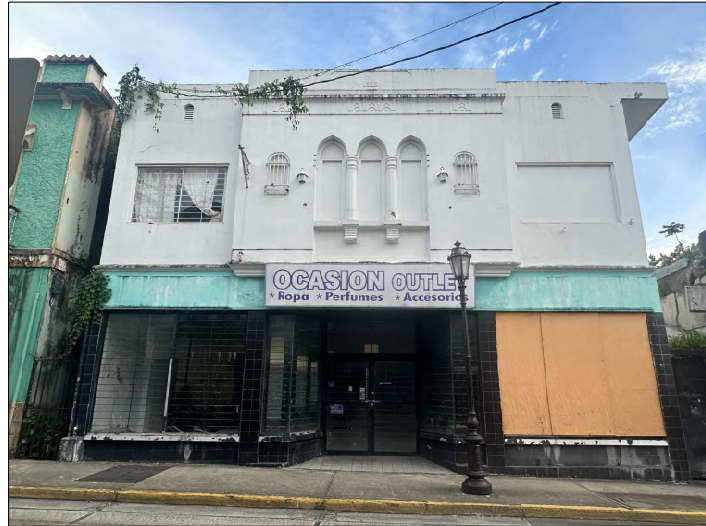
DEMOLITION PLAN - PROPERTY NO. 14
SCALE: 1/4" = 1'-0"

14 PLAN VIEW 01 14

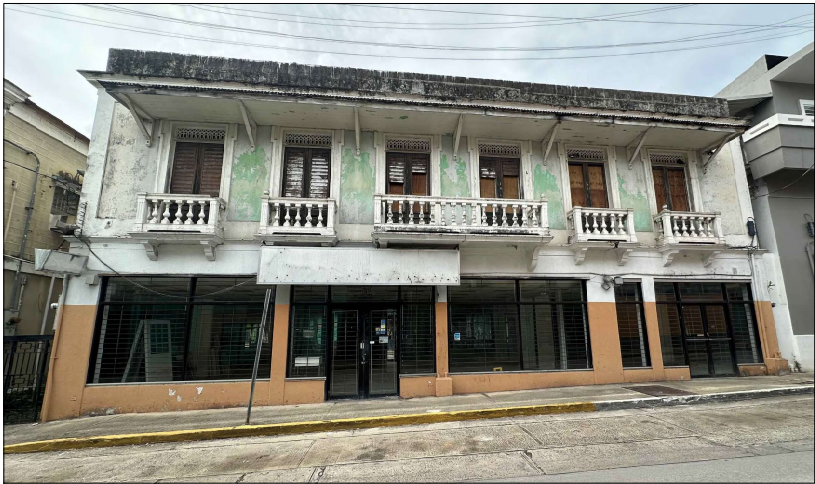
DEMOLITION PLAN - PROPERTY NO. 23
SCALE: 3/16" = 1'-0"

1. REMOVE ALL THE SIGNS ON THE FRONTAL FACADE AND REPAIR ANY AFFECTED PLASTER

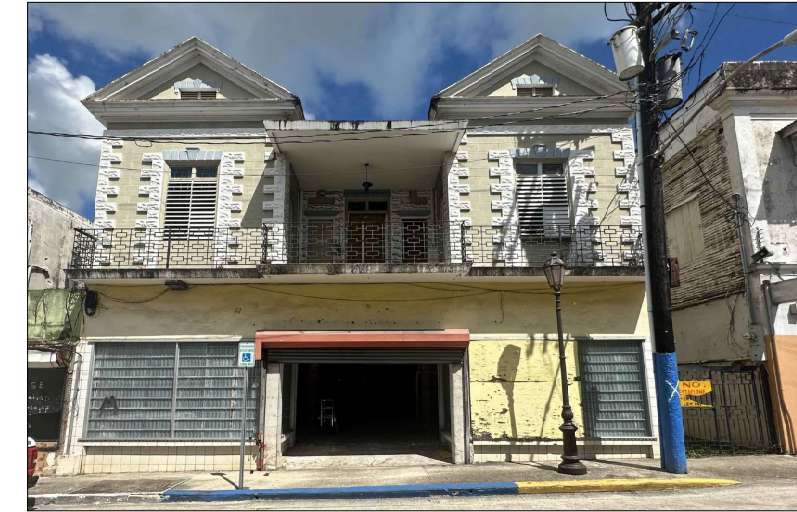
1. REMOVE THE WINDOWS FROM THE SECOND FLOOR, REPAIR WALLS AND PLASTER
2. REMOVE WOODEN PANELS COVERING OPENINGS, REPAIR WALLS AND PLASTER
3. REMOVE DAMAGED AIR CONDITIONING UNITS AND HARDWARE, SEAL OPENINGS AND PLASTER

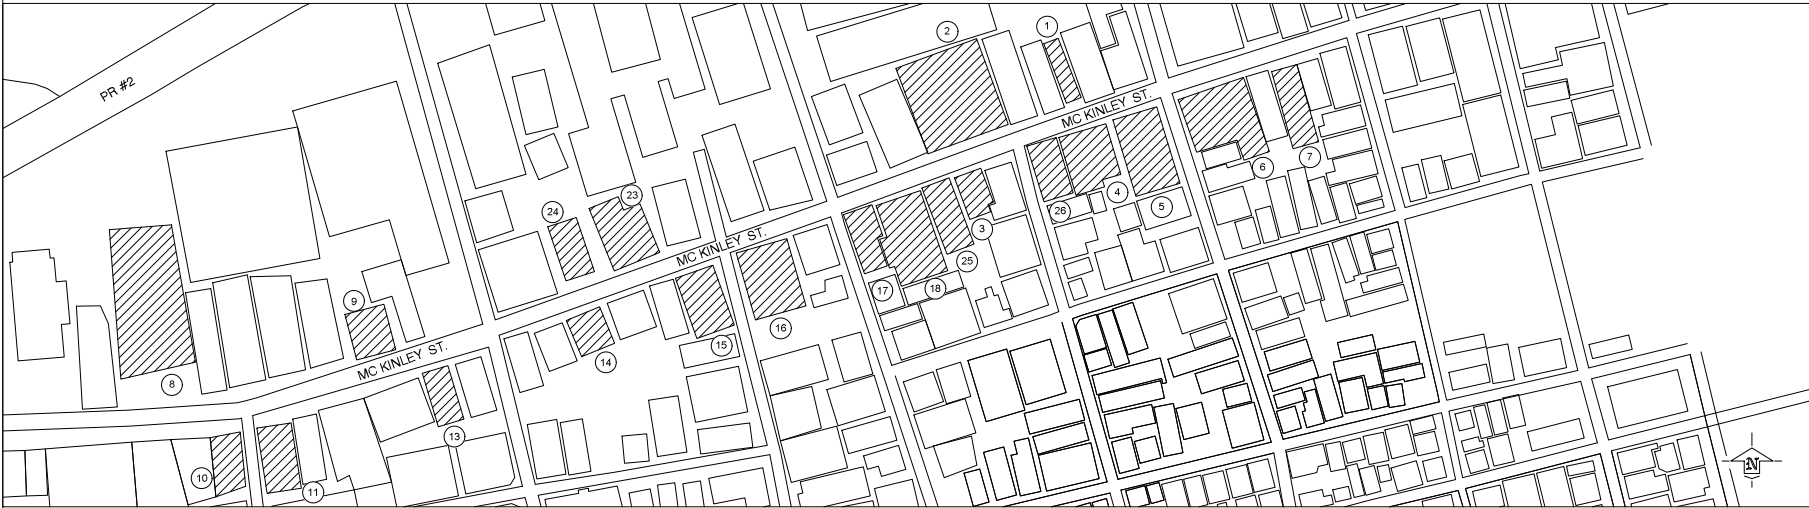
PROPOSED FACADES/STOREFRONT IMPROVEMENT - SITE PLAN VIEW
SCALE: 1/750

- ① SEE DWG SHEET A-1: PROPERTY NO. 1 - #46 PASEO DE LAS ATENAS
② SEE DWG SHEET A-2: PROPERTY NO. 2 - #40 MCKINLEY/PASEO DE LAS ATENAS
③ SEE DWG SHEET A-3: PROPERTY NO. 3 - #67 MCKINLEY/PASEO DE LAS ATENAS
④ SEE DWG SHEET A-4: PROPERTY NO. 4 - #73 PASEO DE LAS ATENAS
⑤ SEE DWG SHEET A-5 & A-5.1: PROPERTY NO. 5 - #75 MCKINLEY
⑥ SEE DWG SHEET A-6 & A-6.1: PROPERTY NO. 6 - #77A MCKINLEY/PASEO DE LAS ATENAS
⑦ SEE DWG SHEET A-7: PROPERTY NO. 7 - #79 MCKINLEY/PASEO DE LAS ATENAS
⑧ SEE DWG SHEET A-8: PROPERTY NO. 8 - #6 MCKINLEY/PASEO DE LAS ATENAS
⑨ SEE DWG SHEET A-9: PROPERTY NO. 9 - #18 MCKINLEY/PASEO DE LAS ATENAS
⑩ SEE DWG SHEET A-10: PROPERTY NO. 10 - #20 PASEO DE LAS ATENAS AND BALDORIO
⑪ SEE DWG SHEET A-11 & A-11.1: PROPERTY NO. 11 - #21 MCKINLEY/PASEO DE LAS ATENAS AND BALDORIO
⑫ SEE DWG SHEET A-12: PROPERTY NO. 12 - #2 QUINONES
⑬ SEE DWG SHEET A-13: PROPERTY NO. 13 - #14 MCKINLEY/PASEO DE LAS ATENAS

⑭ SEE DWG SHEET A-14: PROPERTY NO. 14 - #47 MCKINLEY/PASEO DE LAS ATENAS
⑮ SEE DWG SHEET A-15 & A-15.1: PROPERTY NO. 15 - MCKINLEY/PASEO DE LAS ATENAS AND R, BETANCES
⑯ SEE DWG SHEET A-16 & A-16.1: PROPERTY NO. 16 - MCKINLEY #4, ESQ. BETANCES
⑰ SEE DWG SHEET A-17 & A-17.1: PROPERTY NO. 17 - #61 MCKINLEY/PASEO DE LAS ATENAS AND CORCHADO
⑱ SEE DWG SHEET A-18: PROPERTY NO. 18 - #63 MCKINLEY/PASEO DE LAS ATENAS
⑲ SEE DWG SHEET A-19: PROPERTY NO. 19 - #9 PADIAL
⑳ SEE DWG SHEET A-20: PROPERTY NO. 20 - #7 PADIAL
㉑ SEE DWG SHEET A-21: PROPERTY NO. 21 - #13 PADIAL
㉒ SEE DWG SHEET A-22: PROPERTY NO. 22 - #17 PADIAL
㉓ SEE DWG SHEET A-23: PROPERTY NO. 23 - #30 MCKINLEY/PASEO DE LAS ATENAS
㉔ SEE DWG SHEET A-24: PROPERTY NO. 24 - #28 MCKINLEY/PASEO DE LAS ATENAS
㉕ SEE DWG SHEET A-25: PROPERTY NO. 25 - #65 MCKINLEY/PASEO DE LAS ATENAS
㉖ SEE DWG SHEET A-26 & A-26.1: PROPERTY NO. 26 - #69 MCKINLEY/PASEO DE LAS ATENAS AND CORCHADO

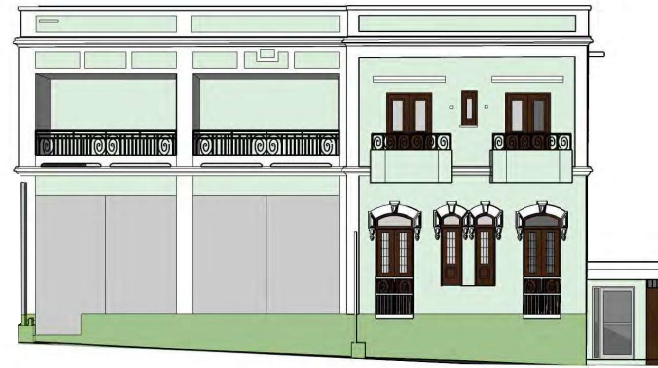
- REPLACE DAMAGED COMMERCIAL TYPE DOOR. (REFER TO ITEM # 1 ON DOOR SCHEDULE - SHEET # A-27).
- INSTALL ABSENT LUMINAIRES.
- FABRICATE ARCHITECTURAL RAILINGS TO ORIGINAL, PAINT AND INSTALL.
- REPAIR THE DAMAGED EXPOSED REINFORCING STEEL.
- REPAIR ALL EXPOSED FACADES.

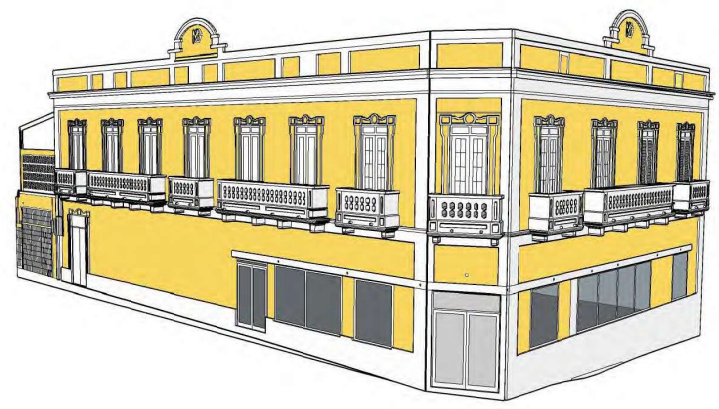
ELEVATION 05C

- A. REPAIR THE CORNICE.
- B. INSTALL LUMINARIES WHERE ITS MISSING.
- C. REMOVE AIR CONDENSING UNIT, COORDINATE WITH OWNER.

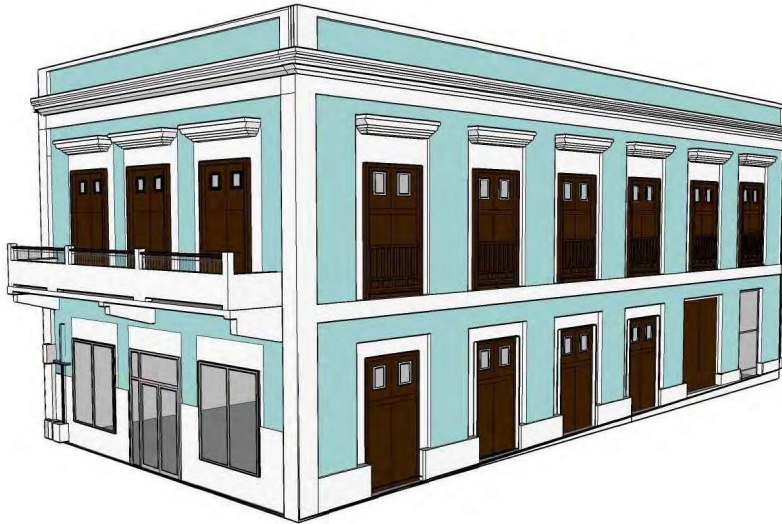
PROPOSED SCOPE OF WORK:

- REDUCE THE WIDE OPENING OF FENESTRATION ON THE FIRST FLOOR IN THE FRONTAL FACADE, INCORPORATE SIDE STRIPS AND THE ARCHITRAVE LINTEL.
- RESTORE WOODEN ELEMENTS OF GUARDRAILS.

- REMOVE THE CERAMIC TILES ON THE MAIN FACADE.
- REPAIR ALL DAMAGED DOORS ON THE SECOND FLOOR (INSTALL MISSING SILLS). THE DOORS WILL BE THE SAME AS THE EXISTING ONES.

- CLEAN AND TREAT ALL METAL RAILINGS BEFORE PAINT APPLICATION.
- INSTALL DECORATIVE BRACKETS BEAMS UNDER THE BALCONY.
- REPAIR THE SIDE FACADES.
- REPAIR OF EXPOSED BRICKS WITH CURED LIMESTONE-BASED MATERIAL.

- FABRICATE AND INSTALL CORNICES ON THE DOOR FENESTRATION, SECOND FLOOR.
- REPAIR CORNICES THAT ARE IN DETERIORATED CONDITION.
- CLEANING AND REPAIR OF THE PLASTER FINISHES PRIOR TO THE APPLICATION OF PAINT ON ALL EXPOSED FACADES.

- REPLACE ALL DAMAGED DOORS ON THE FIRST FLOOR (STOREFRONT). (REFER TO ITEM #8 ON DOOR SCHEDULE - SHEET # A-27).

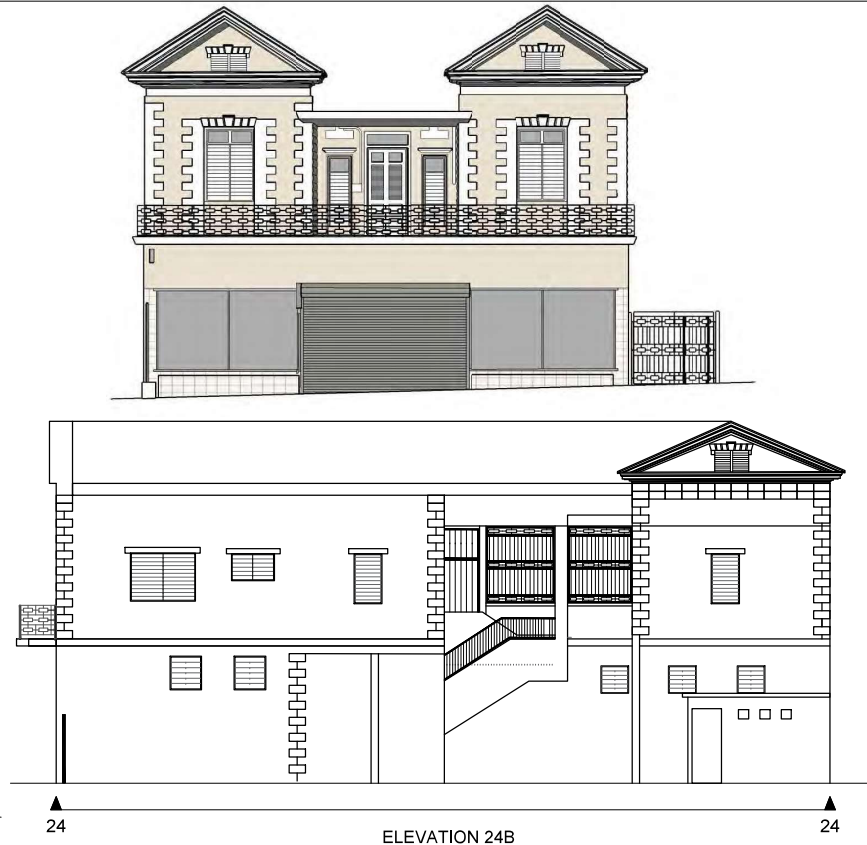
PROPOSED FACADE/STOREFRONT IMPROVEMENT - PROPERTY NO. 24
SCALE: 1/4" = 1'-0"

- THE CERAMIC TILES SHALL BE REMOVED.
- INSTALL WOODEN DOORS AND WINDOWS WITH JALOUSIES ON THE SECOND LEVEL. REPAIR OR REPLACE THE DOORS, WHICH SHALL BE EQUAL IN TYPOLOGY TO EXISTING ONES ON THE SECOND LEVEL. (REFER TO ITEM #18 DOOR SCHEDULE - SHEET # A-27) (REFER TO ITEM #16, #17 WINDOW SCHEDULE - SHEET # A-27).
- CLEANING AND REPAIR OF THE PLASTER FINISH PRIOR TO PAINTING APPLICATION. (REFER TO ITEM #15 ON WINDOW SCHEDULE - SHEET # A-27).
- REPLACE THE WINDOWS ON THE MAIN/FRONT FACADE - DUE TO THEIR CONDITIONS, TYPOLOGY MUST BE EQUAL AS EXISTING ONES.
- REMOVE AIR CONDITION UNIT CONSOLE, COORDINATE WITH OWNER.
- ORGANIZE THE ELECTRICAL INFRASTRUCTURE.
- PAINT THE STORM ROLLING DOORS MECHANISM HOUSING OF THE SAME AS THE FACADE.

- PAINT FACADE SW 7571 OR SIMILAR
- PAINT EAVES, MOLDINGS ARCHITECTURAL GATE AND GRILLS SW 9541 OR SIMILAR
- PAINT ROLL-UP SHUTTERS PPG0993-7 OR SIMILAR
- PAINT RAILINGS SW 6258 OR SIMILAR
- SEE CLEANING AND SURFACE PREPARATIONS PRIOR TO PAINT APPLICATION.
- CLEANING AND REPAIR OF THE PLASTERED FINISH PRIOR TO THE APPLICATION OF PAINT ON ALL FACADE'S SURFACES

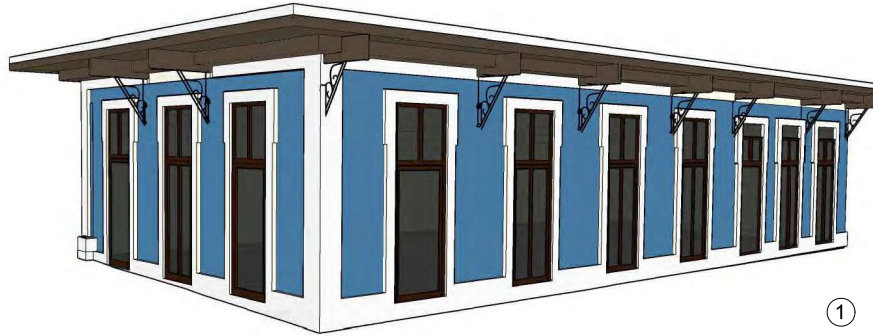
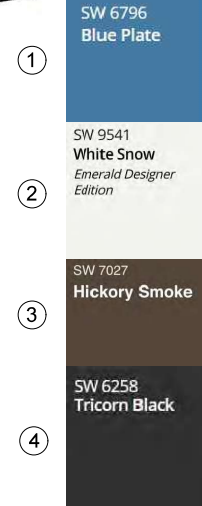
| FACADES | | | |
|---|---|---|---|
| #69 MCKINLEY/ PASEO DE LAS ATENAS AND CORCHADO STREET, MANATÍ, PUERTO RICO. | 056-012-020-01-001 | LAT: 18.42903477, LON: -66.49140009 | PUERTO RICO LATE XIX - EARLY - XX COMMERCIAL BUILDING / WAREHOUSE). |

- REPAIR THE WOODEN ELEMENTS OF THE PROJECTED EAVE.
- INSTALL LUMINAIRES FIXTURES (WHERE MISSING AND EXISTING ONES).
- REMOVE THE EXPOSED ROOF STEEL RODS ON THE SECOND FLOOR.
- APPLY THE SAME PAINT COLOR OVER THE DOOR FENESTRATION THAT ITS HEIGHT IS SMALLER THAN THE REST, TO VISUALLY EQUALIZE ALL DOOR OPENINGS.

- PAINT FACADE SW 6796 OR SIMILAR
- PAINT DOOR FRAMES SW 9541 OR SIMILAR
- PAINT EAVE WOODEN ELEMENT SW 7027 OR SIMILAR
- PAINT METAL BRACKETS SW 6258
- REPLICATE WITH PAINT (SW 6258) HEADER OF THREE DOORS
- SEE CLEANING AND SURFACE PREPARATIONS PRIOR TO PAINT APPLICATION. CLEANING AND REPAIR OF THE PLASTERED FINISH PRIOR TO THE APPLICATION OF PAINT ON ALL FACADES

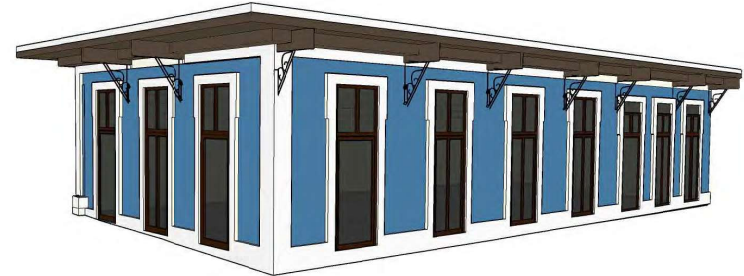
DRAW. SHEET
A-26

- REPAIR THE WOODEN ELEMENTS OF THE PROJECTED EAVE.
- INSTALL LUMINAIRES FIXTURES (WHERE MISSING AND EXISTING ONES).
- REMOVE THE EXPOSED ROOF STEEL RODS ON THE SECOND FLOOR.
- APPLY THE SAME PAINT COLOR OVER THE DOOR FENESTRATION THAT ITS HEIGHT IS SMALLER THAN THE REST, TO VISUALLY EQUALIZE ALL DOOR OPENINGS.

- PAINT FACADE SW 6796 OR SIMILAR
- PAINT DOOR FRAMES SW 9541 OR SIMILAR
- PAINT EAVE WOODEN ELEMENT SW 7027 OR SIMILAR
- PAINT METAL BRACKETS SW 6258
- REPLICATE WITH PAINT (SW 6258) HEADER OF THREE DOORS
- SEE CLEANING AND SURFACE PREPARATIONS PRIOR TO PAINT APPLICATION. CLEANING AND REPAIR OF THE PLASTERED FINISH PRIOR TO THE APPLICATION OF PAINT ON ALL FACADES
