Environmental Assessment Determinations and Compliance Findings for HUD-assisted Projects 24 CFR Part 58

Project Name: MEJORAS A LA INFRAESTRUCTURA DE LA URBANIZACIÓN MAYAGÜEZ TERRACE (PR-CRP-000855)

Responsible Entity: Puerto Rico Department of Housing

Grant Recipient (if different from Responsible Entity): Municipal Government of Mayagüez

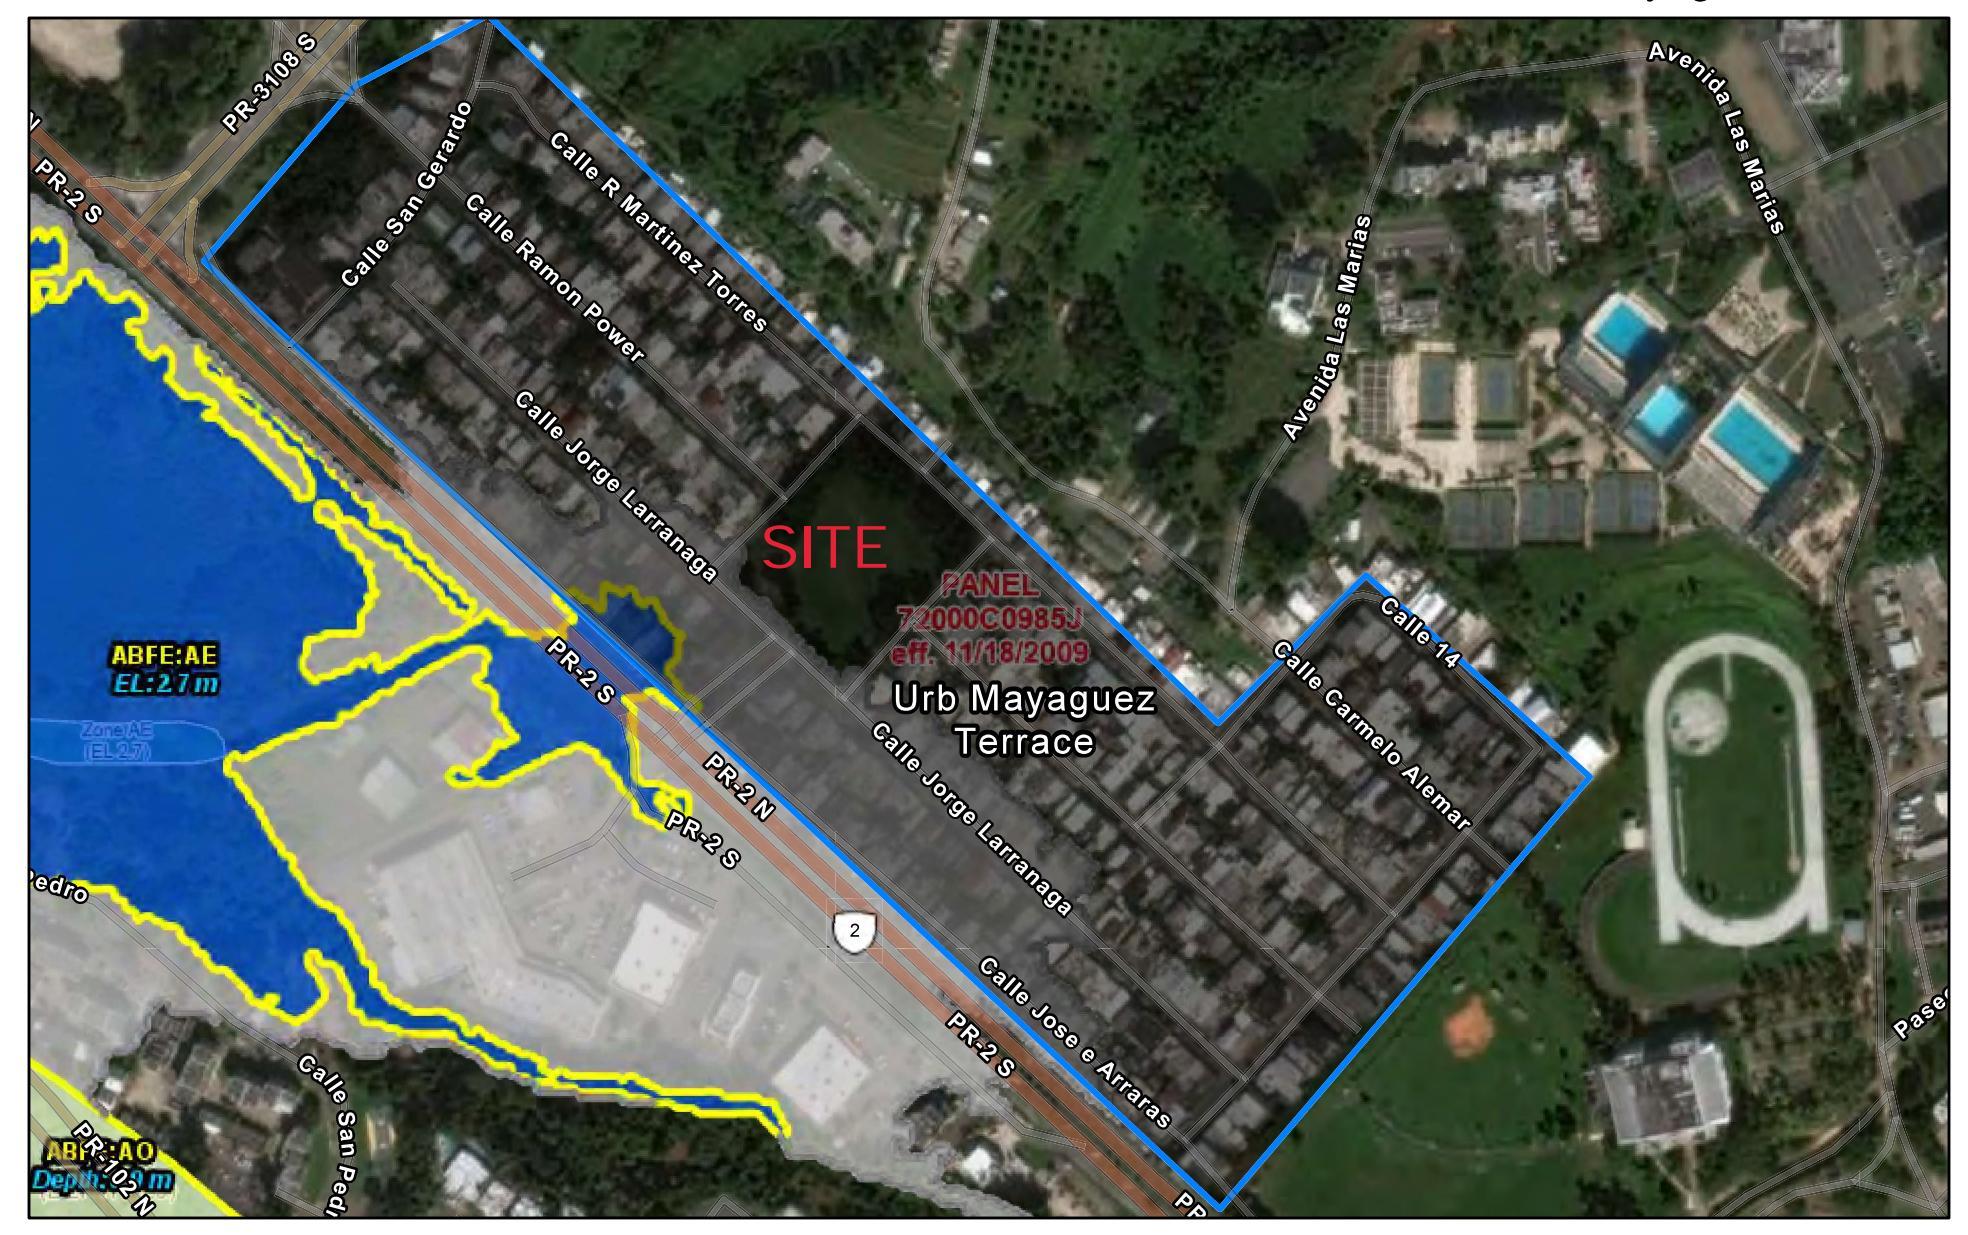
PR-CRP-000855 Mejoras a la infraestructura de la Urbanización Mayagüez Terrace

National Flood Hazard Layer FIRMette

Flood Insurance Flood Disaster Protection Act of 1973 and National Flood Insurance Reform Act of 1994 [42 USC 4001-4128 and 42 USC 5154a]	Yes No	The Project site is not in the 100-year Special Flood Hazard Area (SFHA), as indicated on the Federal Emergency Management Agency (FEMA) Flood Insurance Rate Map (FIRM) per Floodplain Insurance Maps 72000C0985J, effective date November 18, 2009. Although flood insurance is recommended, it is not required. All areas within the Commonwealth of Puerto Rico are eligible for NFIP policies. Flood Insurance is required when a project involves repairs, rehabilitation, or construction of an insurable structure in the 100-year floodplain. The structures are only insurable on the project site. The topic complies with the regulation. See Exhibit 4 for FIRMette.

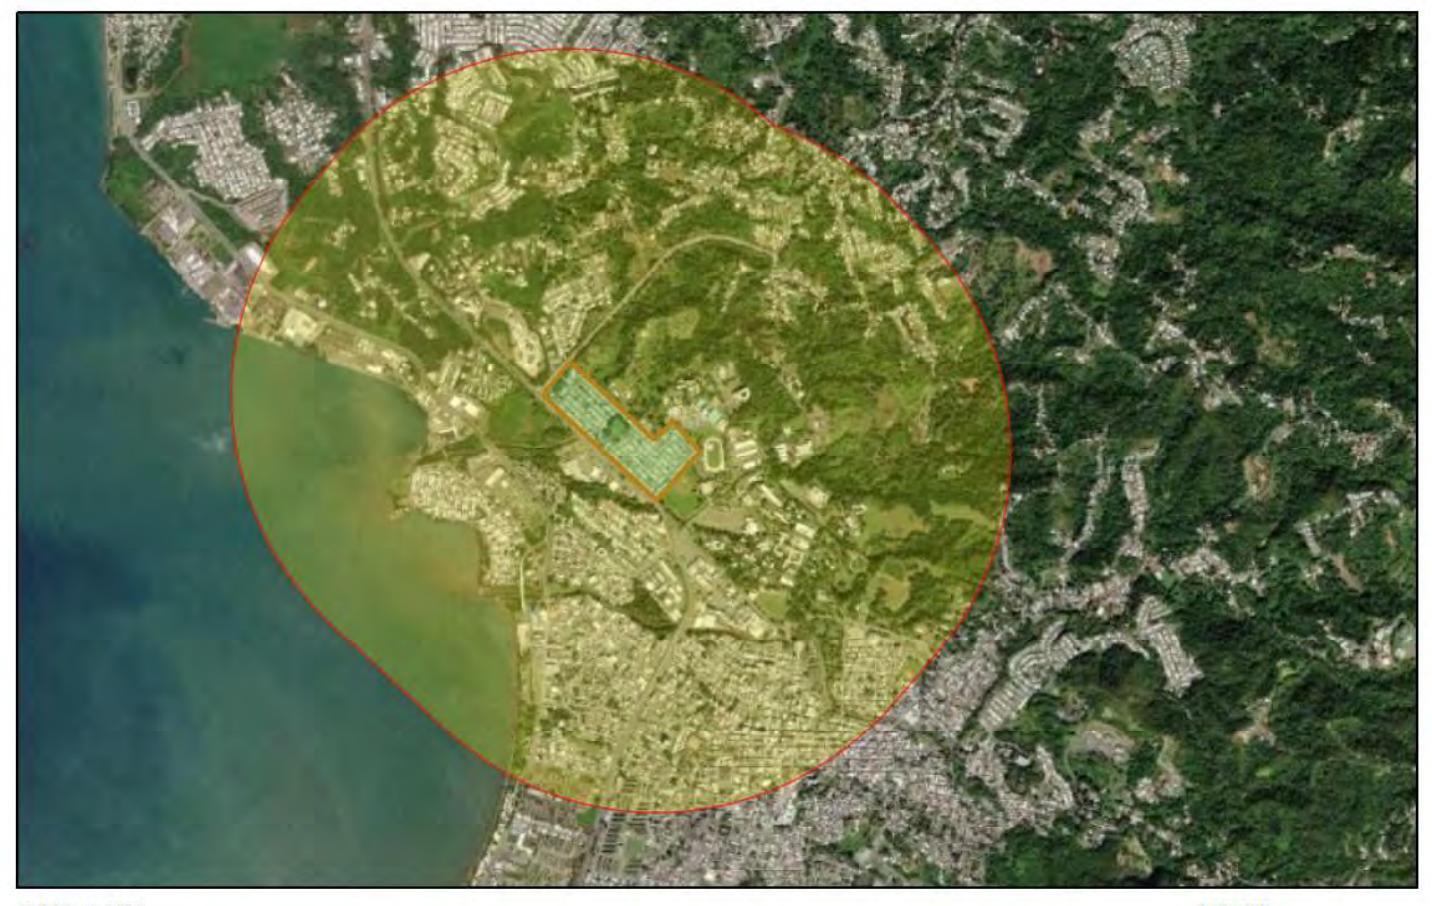
Puerto Rico Nonattainment/Maintenance Status for Each County by Year for All Criteria Pollutants

You are here: EPA Home > Green Book > >National Area and County-Level Multi-Pollutant Information >Puerto Rico Nonattainment/Maintenance Status for Each County by Year for All Criteria Pollutants

Explosive and Flammable		
Hazards 24 CFR Part 51 Subpart C	Yes No	The proposed project for the Mayagüez Terrace Urban Sector does not include a hazardous facility that mainly stores, handles, or processes flammable or combustible chemicals such as bulk fuel storage. Planned activities at the project area do not include the installation of storage tanks. The project will not introduce new residents, employees, or clients during the daytime hours who could be exposed to any explosive or flammable hazards. Examination of the aerial views and street views shows no ground storage tanks within the acceptable separation distance. Thus, the project is in compliance with explosive and flammable hazard requirements. Refer to Exhibit 9 for Explosive and Flammable Map.
Farmlands Protection Farmland Protection Policy Act of 1981, particularly sections 1504(b) and 1541; 7 CFR Part 658	Yes No	The Project is located on farmland classified as Not Prime Farmland. The Mayagüez Terrace Urban Sector project does not include any activities that could convert agricultural land to non-agricultural use, such as new construction, acquisition of undeveloped land, or conversion of farmlands of statewide importance. The scope of the project includes improvements to infrastructure, such as the reconstruction of sidewalks and ramps to comply with ADA regulations, street improvements, construction of waste container areas, replacement of street lighting, installation of street signage, improvements to the stormwater systems, and enhancements to the university of Puerto Rico Mayagüez Campus. Examination of the project site and review of the relevant maps confirm that the project area does not impact prime farmland. The project is compliance with the Farmland Protection Policy Act of 1981, particularly sections 1504(b) and 1541; 7 CFR Part 658. Refer to Exhibit 10.
