Environmental Assessment

Determinations and Compliance Findings for HUD-assisted Projects 24 CFR Part 58

Project ID: PR-RGRW-04551

Project Name: Ana M Ramos

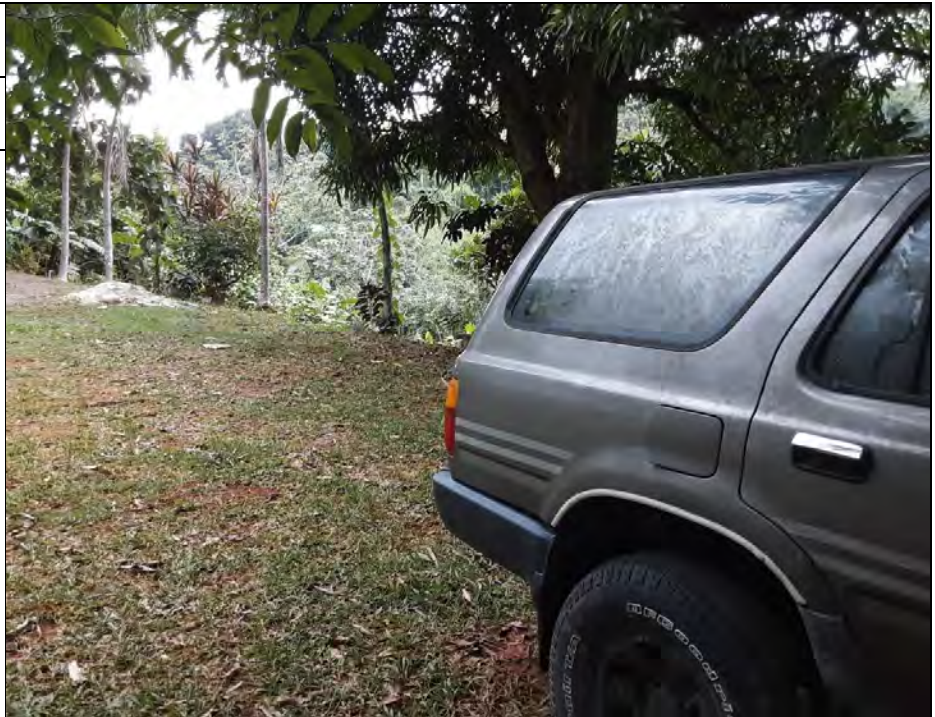
Photo #: 03	Date: 09/25/ 2023
Photo Direction: South	
Description: Overview from the north corner of the project location for a greenhouse 48x20x15ft with the ground covered with gravel and the picture showing the area's vegetation, the landform, construction materials, and an abandoned vehicle.

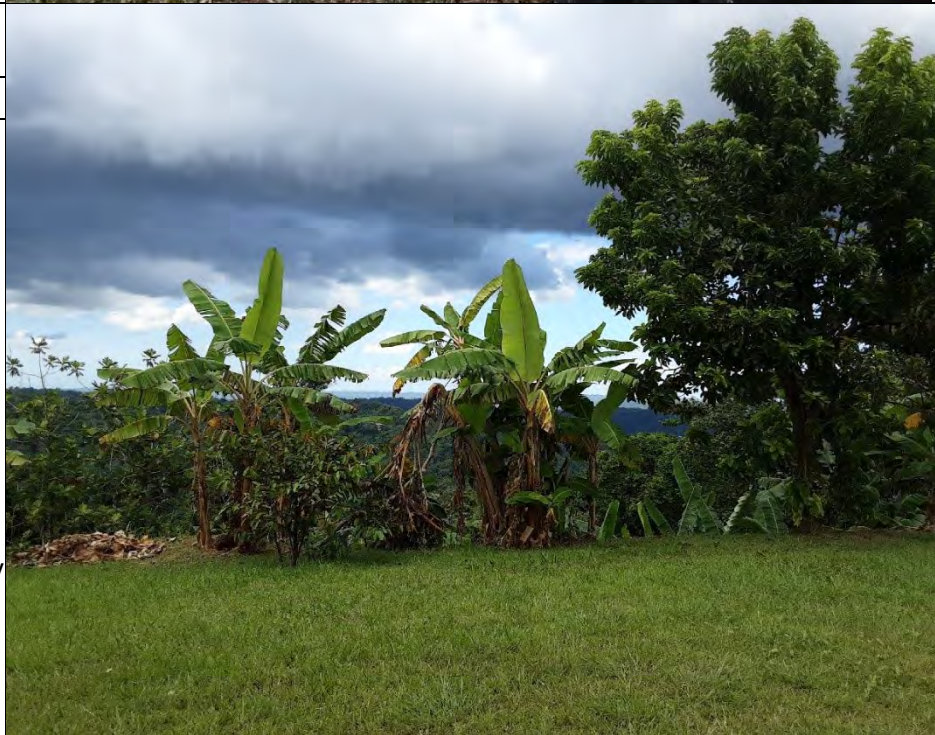
Photo #: 04	Date: 09/25/2023
Photo Direction: North	
Description: Overview from the center of the project location for a freight container 40x8x9.5ft to use as a warehouse. The applicant has two options for the base: (a) over five (5) concrete beams placed every 8ft or (b) over galvanized pipes welded together every 8ft covering 40x20ft (20ft = 4ft on the front side (to the community road), 8ft will be covered by the freight container, and 8ft will be on the back.

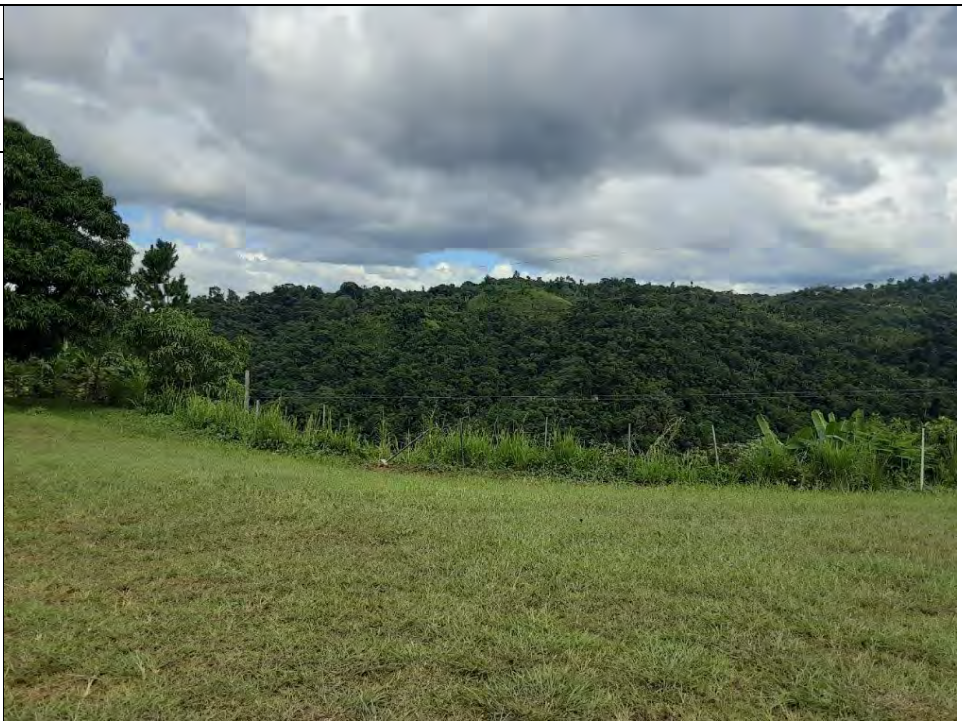
<p>Photo #: 05</p>	<p>Date: 09/25/2023</p>

<p>Photo Direction: East</p>		
<p>Description: Overview from the center of the project location for a freight container 40x8x9.5ft to use as a warehouse and shows the area's vegetation and the landform.</p>		
<p>Photo #: 06</p>	<p>Date: 09/25/ 2023</p>

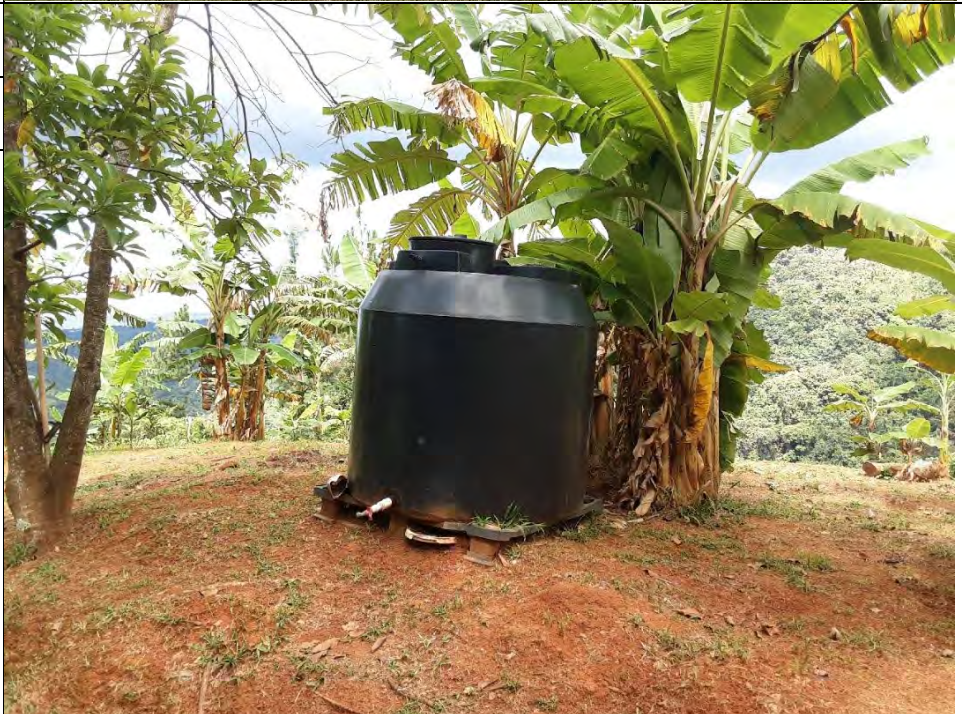
<p>Photo Direction: Northeast</p>		
<p>Description: Overview of a 600-gallon cistern currently in use; the applicant plans to move it closer to the greenhouse (see Photo #10) and a 1000-gallon cistern will be placed in this location.</p>

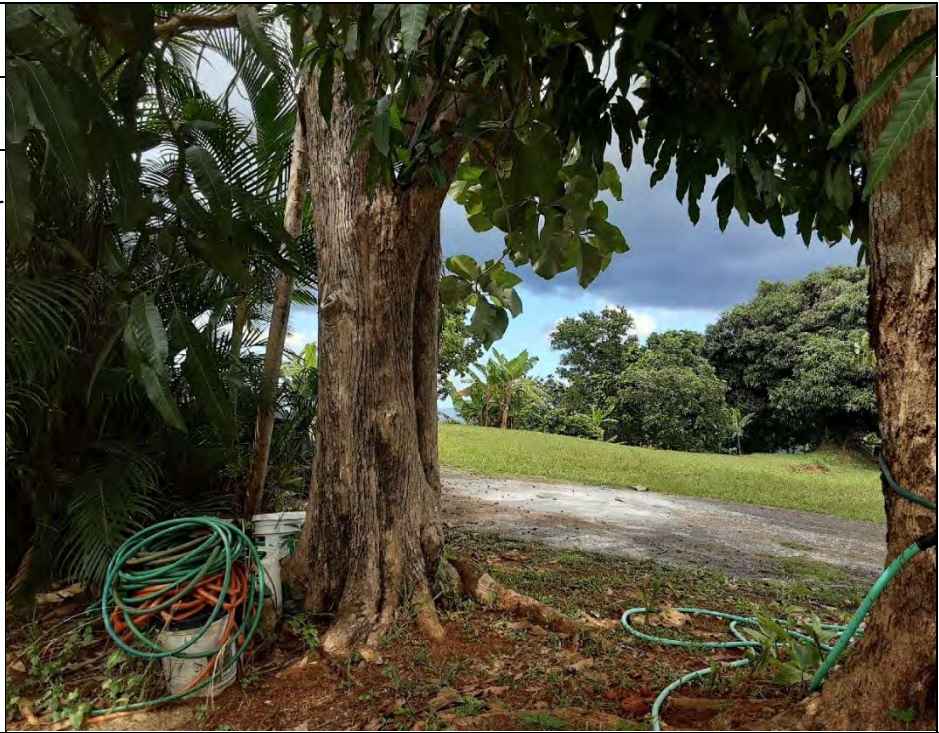
Photo #: 07	Date: 09/25/2023
Photo Direction: North	
Description: Overview from the center of the area where the applicant plans to install one of the 1000-gallon cisterns and shows the site location for the warehouse 40x8x9.5ft.

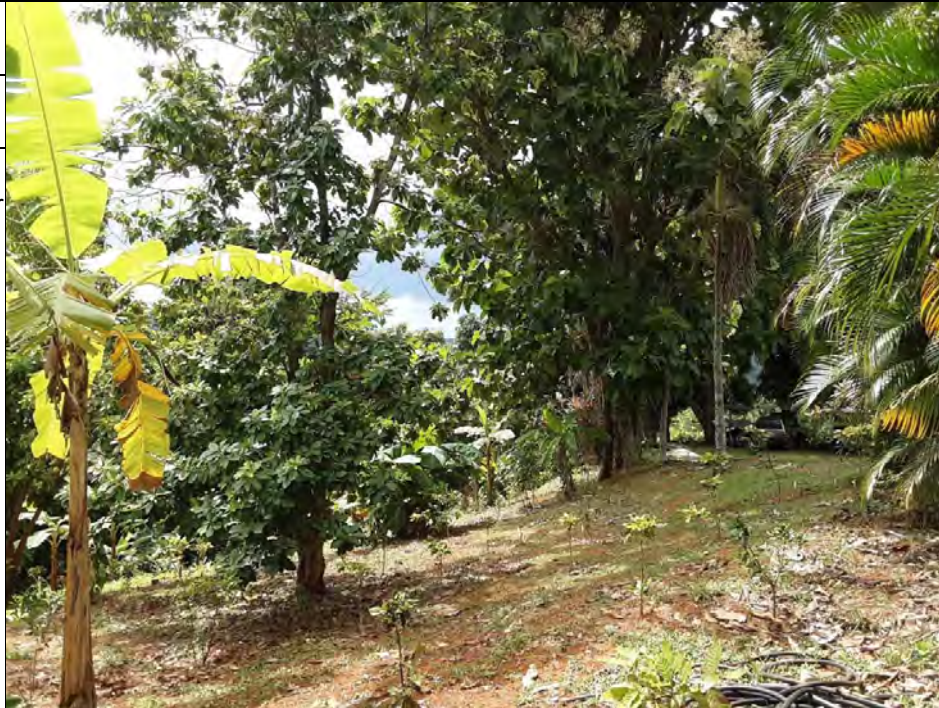
Photo #: 08	Date: 09/25/ 2023
Photo Direction: West	
Description: Overview from the center of the area where the applicant plans to install one of the 1000-gallon cisterns and shows the area's vegetation and the landform.

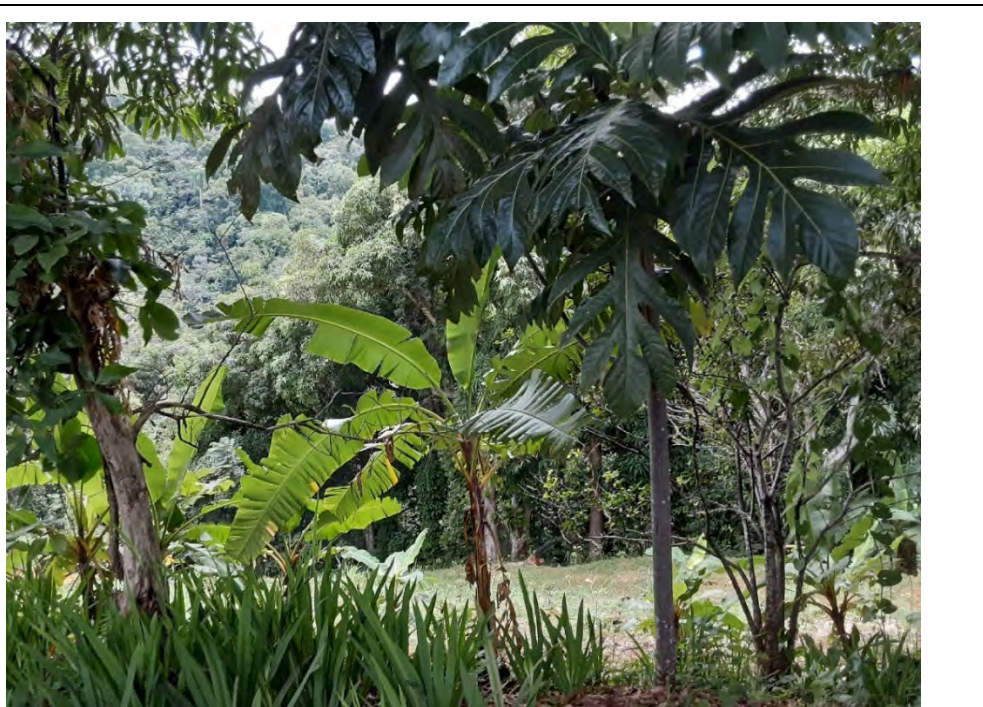
<p>Photo #: 10</p>	<p>Date: 09/25/ 2023</p>

<p>Photo Direction: West</p>		
<p>Description: Overview of the general direction of where the spring water is found. Near foreground is the future destination of the relocated 600-gallon cistern.</p>

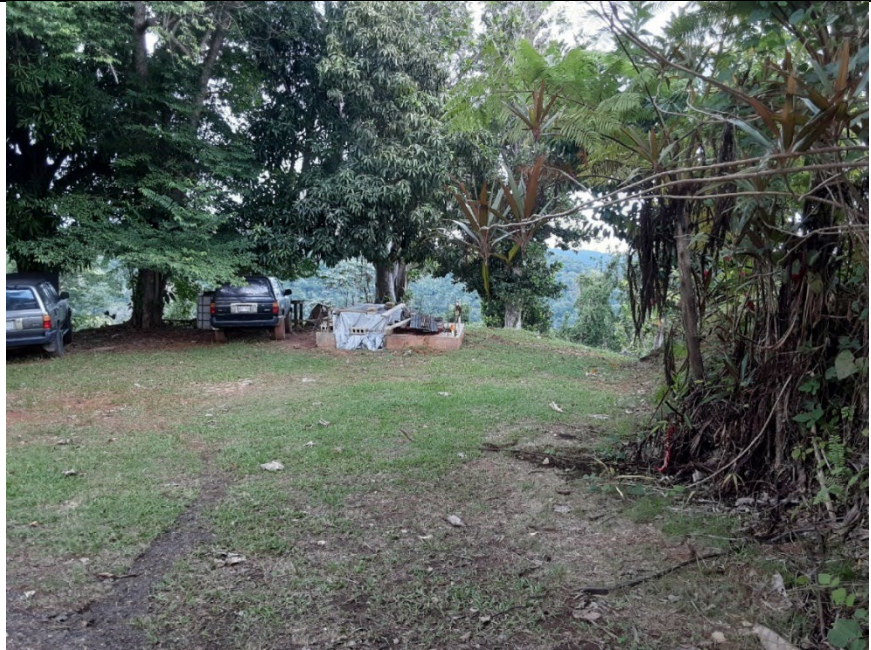
Photo #: 01	Date: 09/25/2023
Photo Direction: Northwest	
Description: Overview of the project location for a greenhouse 48x20x15ft with the ground covered with gravel and the picture showing the two abandoned vehicles, the bathroom under construction, the area's vegetation, and the landform. The applicant mentioned the area might need grading and pruning of the trees.

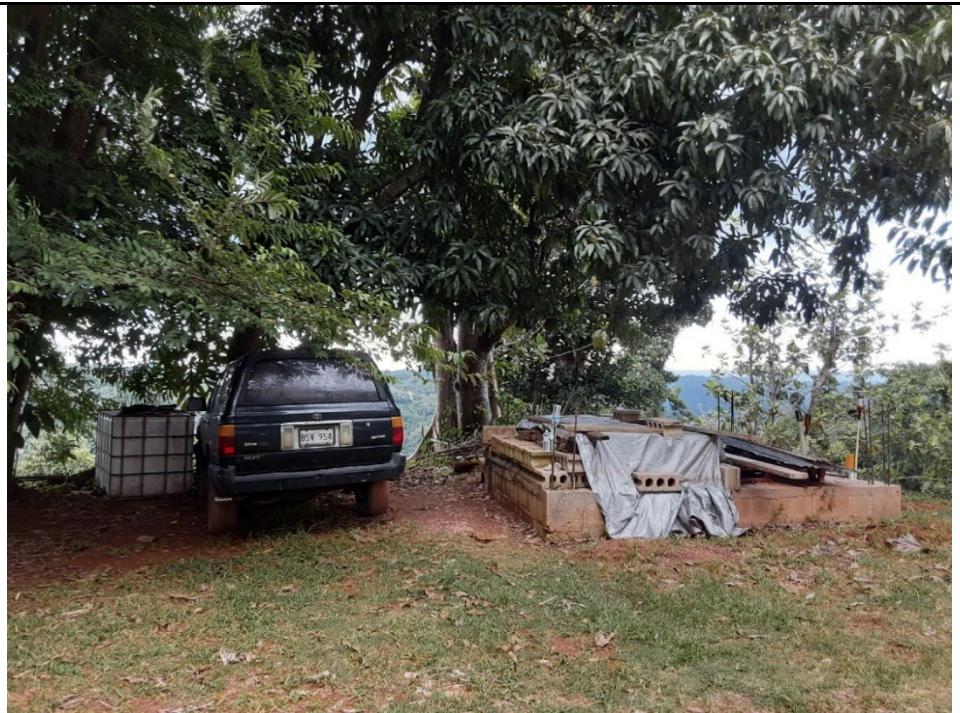
Photo #: 02	Date: 09/25/2023
Photo Direction: North	
Description: Overview from the center of the project location for a greenhouse 48x20x15ft with the ground covered with gravel and the picture showing a 275-gallon cistern, an abandoned vehicle, the bathroom under construction, the area's vegetation, and the landform.

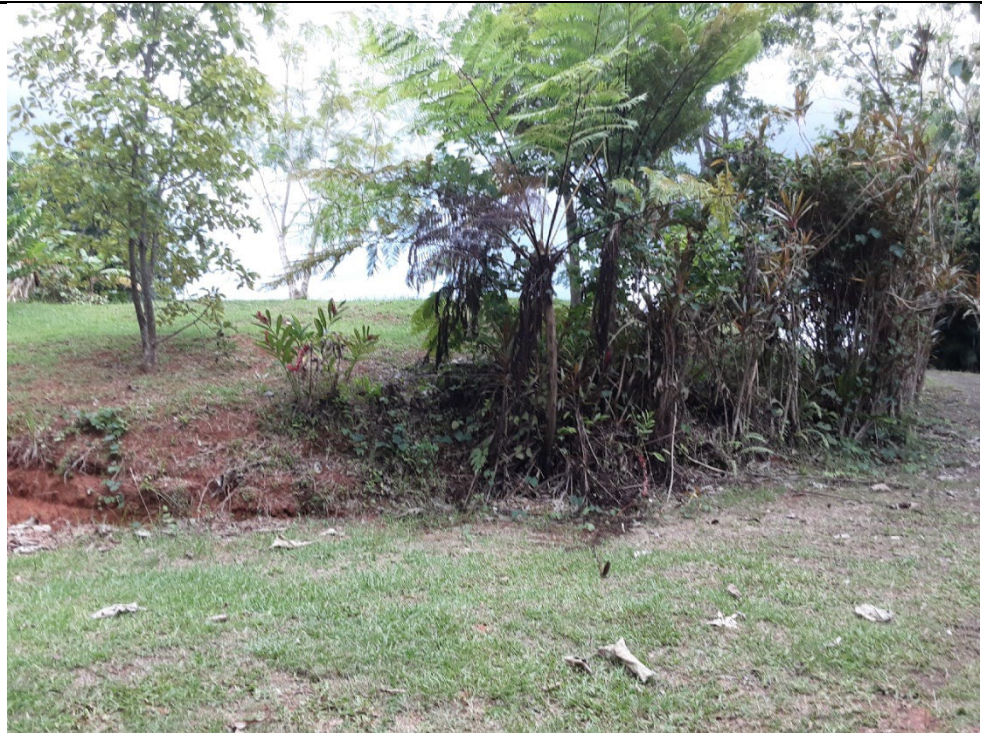
Photo #: 03	Date: 09/25/ 2023
Photo Direction: East	
Description: Overview from the center of the project location for a greenhouse 48x20x15ft with the ground covered with gravel and the picture showing the area's vegetation and the landform towards the site location for the warehouse.

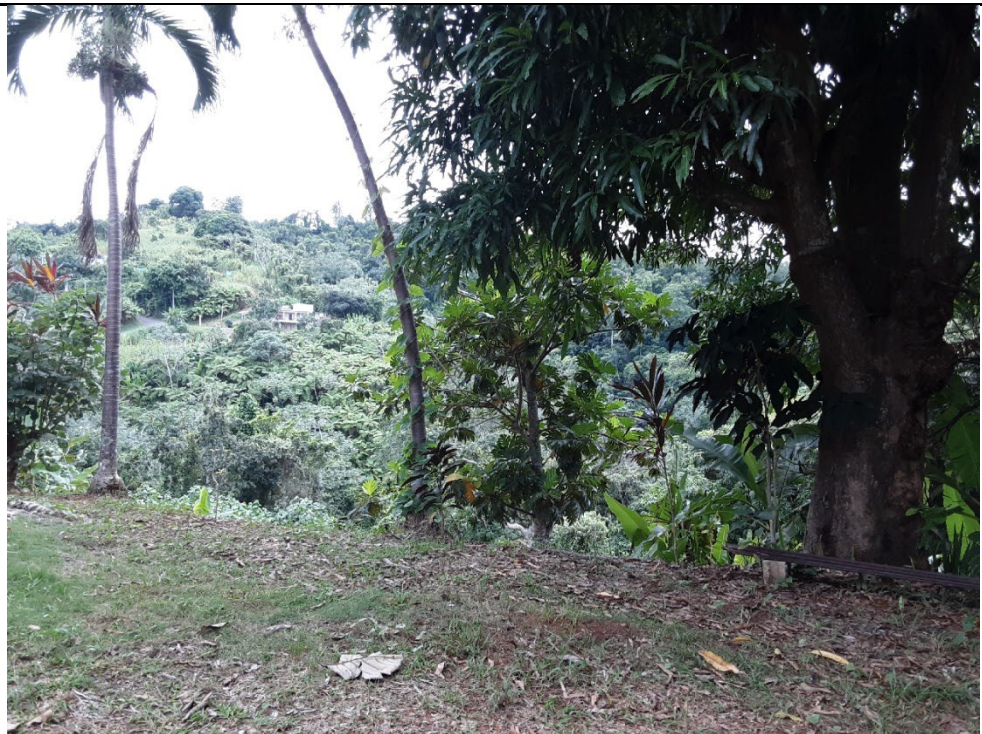
Photo #: 04	Date: 09/25/ 2023
Photo Direction: South	
Description: Overview from the center of the project location for a greenhouse 48x20x15ft with the ground covered with gravel and the picture showing the area's vegetation and the landform.

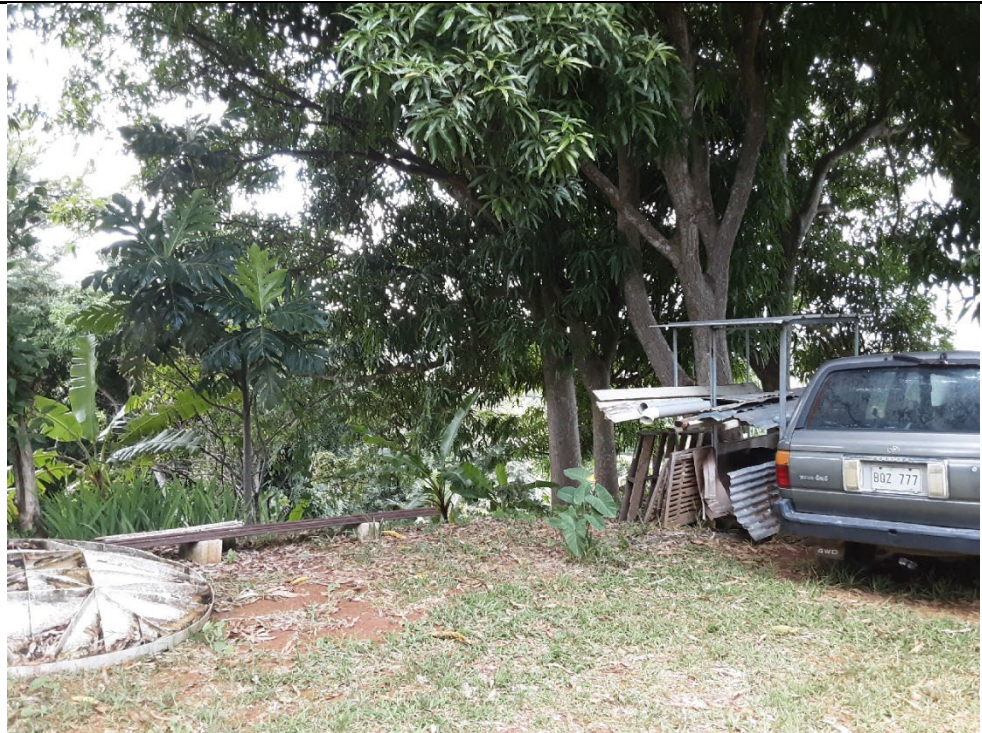
Photo #: 05	Date: 09/25/ 2023
Photo Direction: West	
Description: Overview from the center of the project location for a greenhouse 48x20x15ft with the ground covered with gravel and the picture showing the area's vegetation, the landform, a satellite dish, construction materials, and an abandoned vehicle.

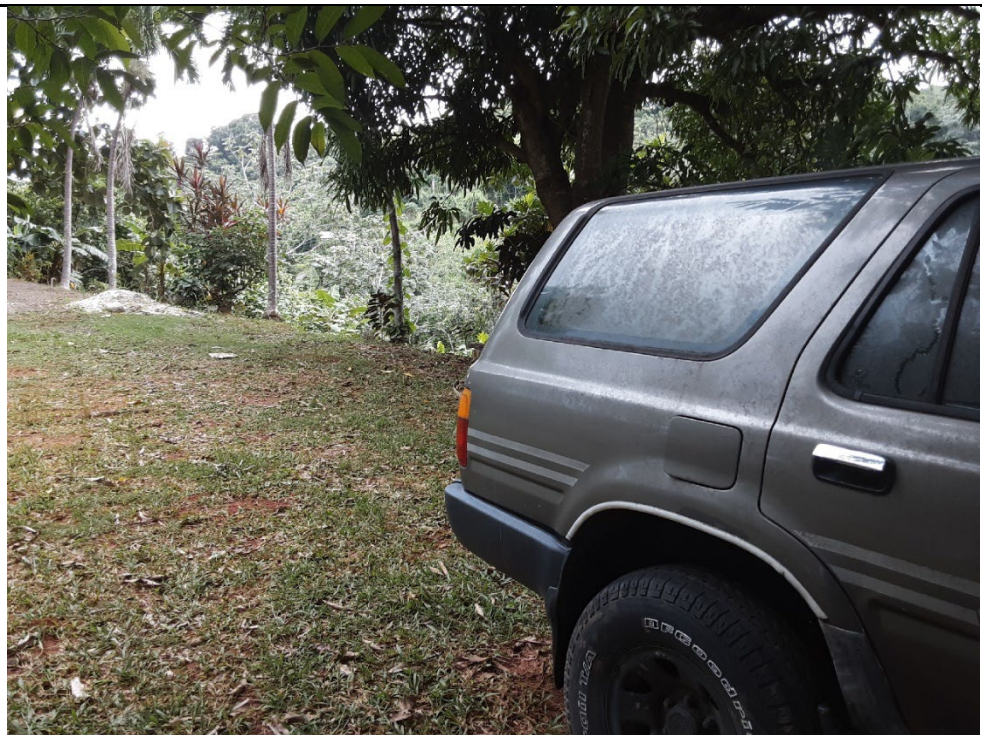
Photo #: 06	Date: 09/25/ 2023
Photo Direction: South	
Description: Overview from the north corner of the project location for a greenhouse 48x20x15ft with the ground covered with gravel and the picture showing the area's vegetation, the landform, construction materials, and an abandoned vehicle.

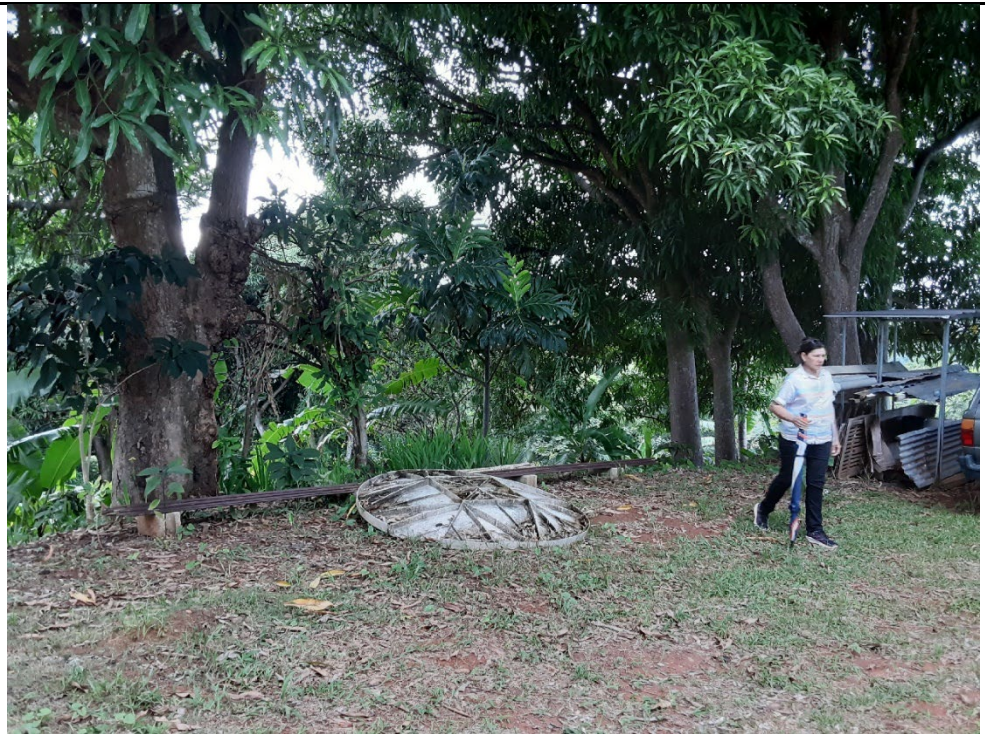
Photo #: 07	Date: 09/25/ 2023
Photo Direction: West	
Description: Overview from the east corner of the project location for a greenhouse 48x20x15ft with the ground covered with gravel and the picture showing the area's vegetation, the landform, a satellite disk, construction materials, an abandoned vehicle, and the applicant.

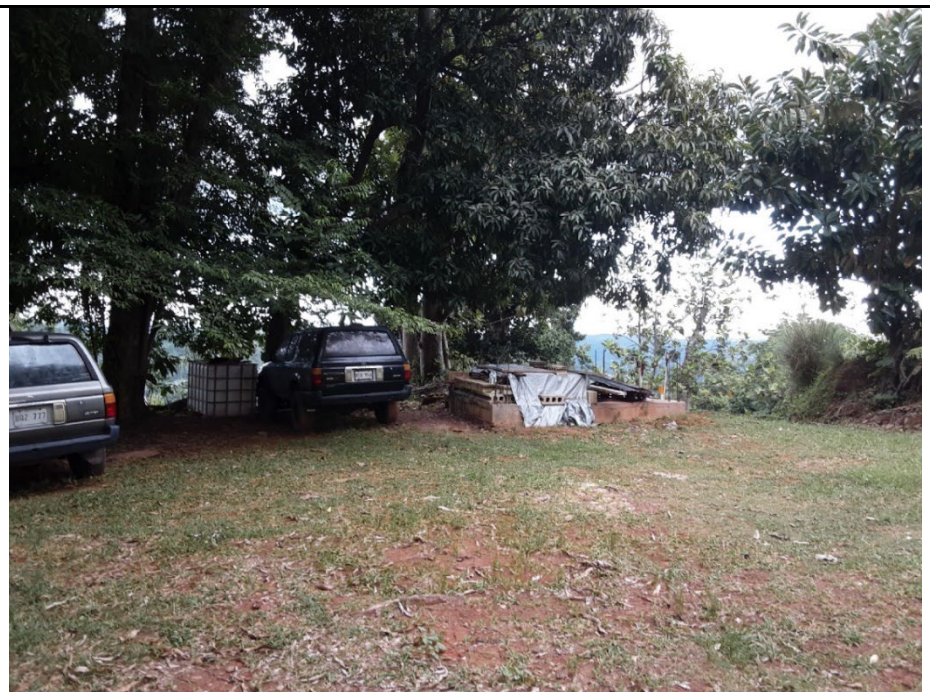
Photo #: 08	Date: 09/25/2023
Photo Direction: North	
Description: Overview from the south corner of the project location for a greenhouse 48x20x15ft with the ground covered with gravel and the picture showing the two abandoned vehicles, a 275-gallon cistern, the bathroom under construction, the area's vegetation, and the landform.

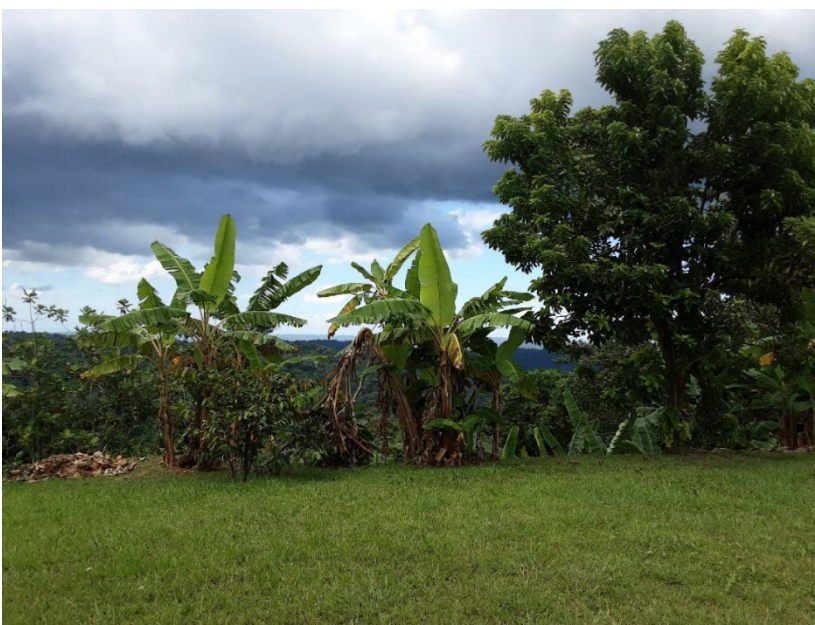
Photo #: 10	Date: 09/25/2023

Photo Direction: North		
Description: Overview from the center of the project location for a freight container 40x8x9.5ft to use as a warehouse. The applicant has two options for the base: (a) over five (5) concrete beams placed every 8ft or (b) over galvanized pipes welded together every 8ft covering 40x20ft (20ft = 4ft on the front side (to the community road), 8ft will be covered by the freight container, and 8ft will be on the back (to the greenhouse and the rest of the farm)).

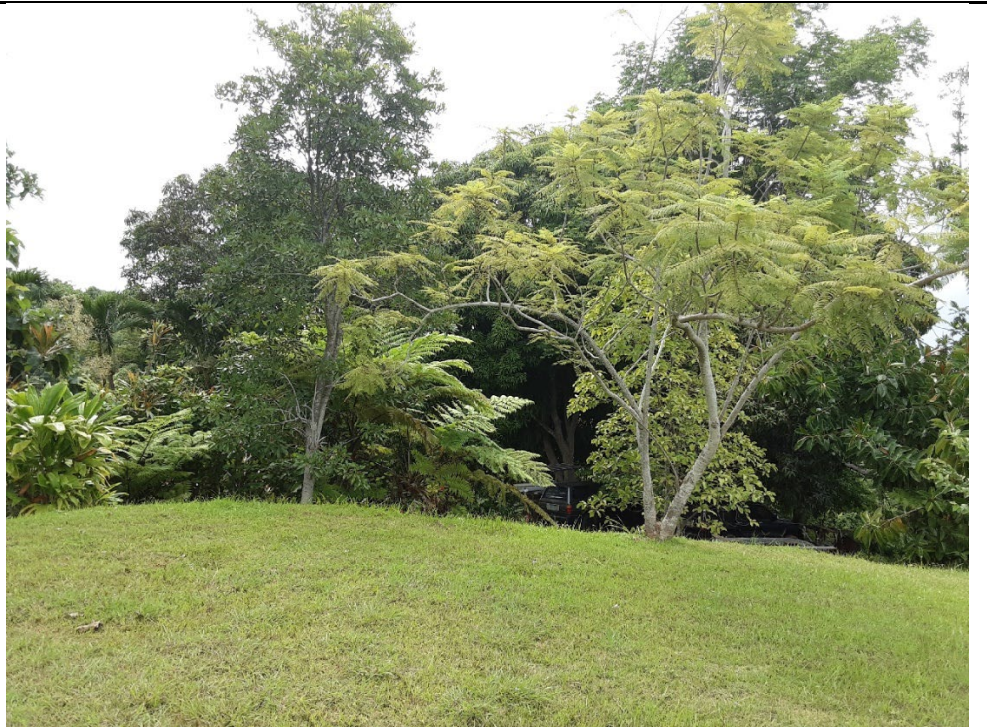
Photo #: 13	Date: 09/25/2023
Photo Direction: West	
Description: Overview from the center of the project location for a freight container 40x8x9.5ft to use as a warehouse which shows the area's vegetation and the landform.

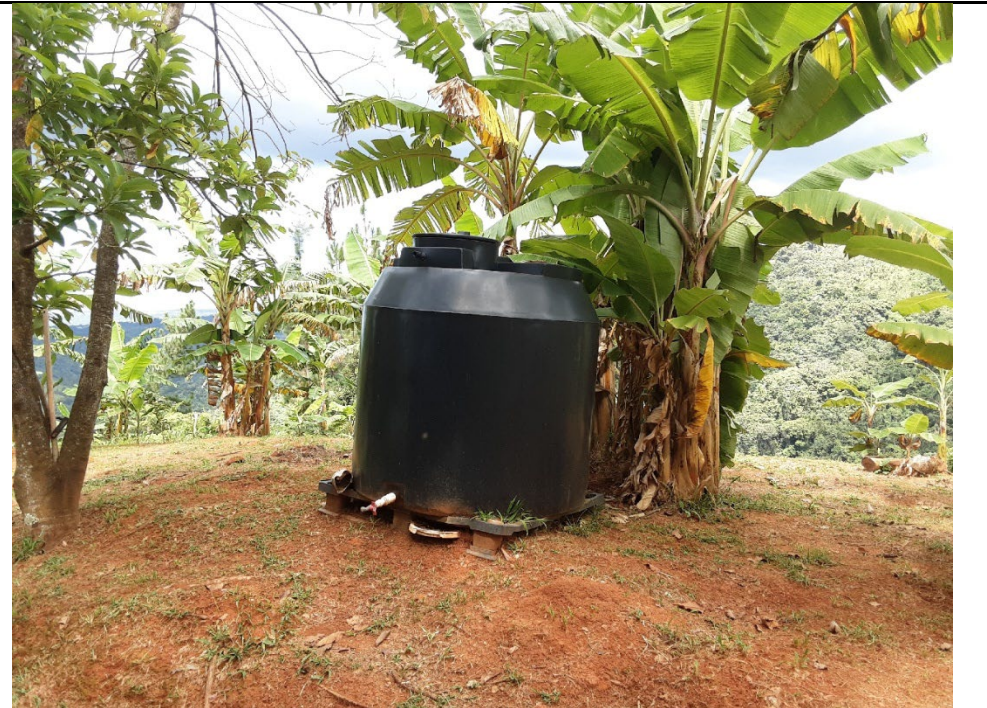
Photo #: 14	Date: 09/25/2023
Photo Direction: Northeast	
Description: Overview of a 600-gallon cistern in use; the applicant plans to move it closer to the freight container and a 1000-gallon cistern will be placed in this location.

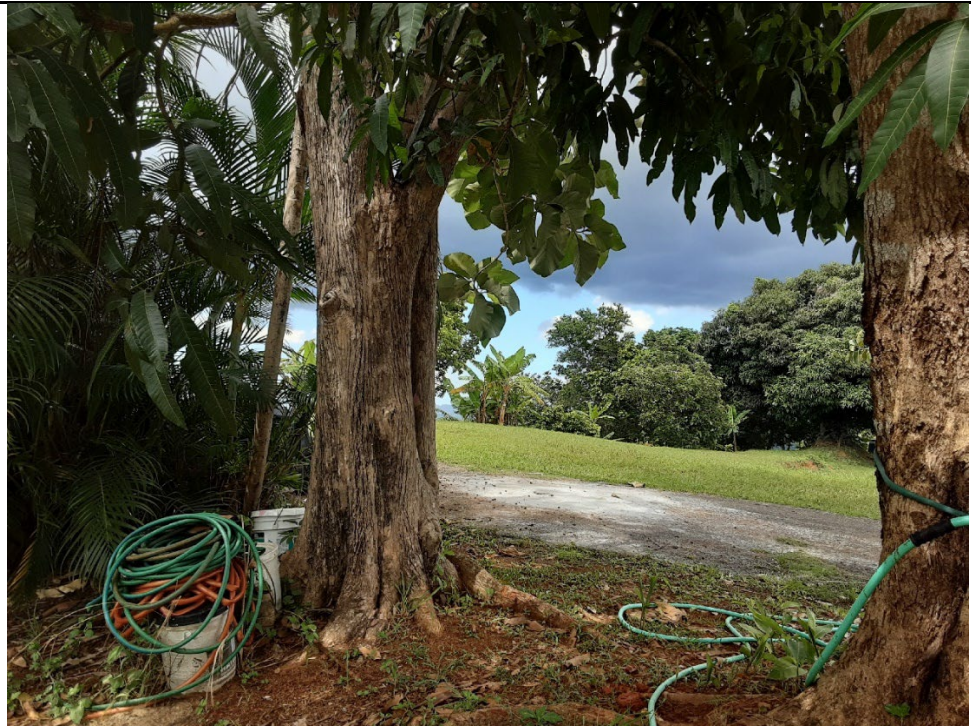
Photo #: 15	Date: 09/25/2023
Photo Direction: North	
Description: Overview from the center of the area where the applicant plans to install one of the 1000-gallon cisterns and shows the site location for the warehouse 40x8x9.5ft.

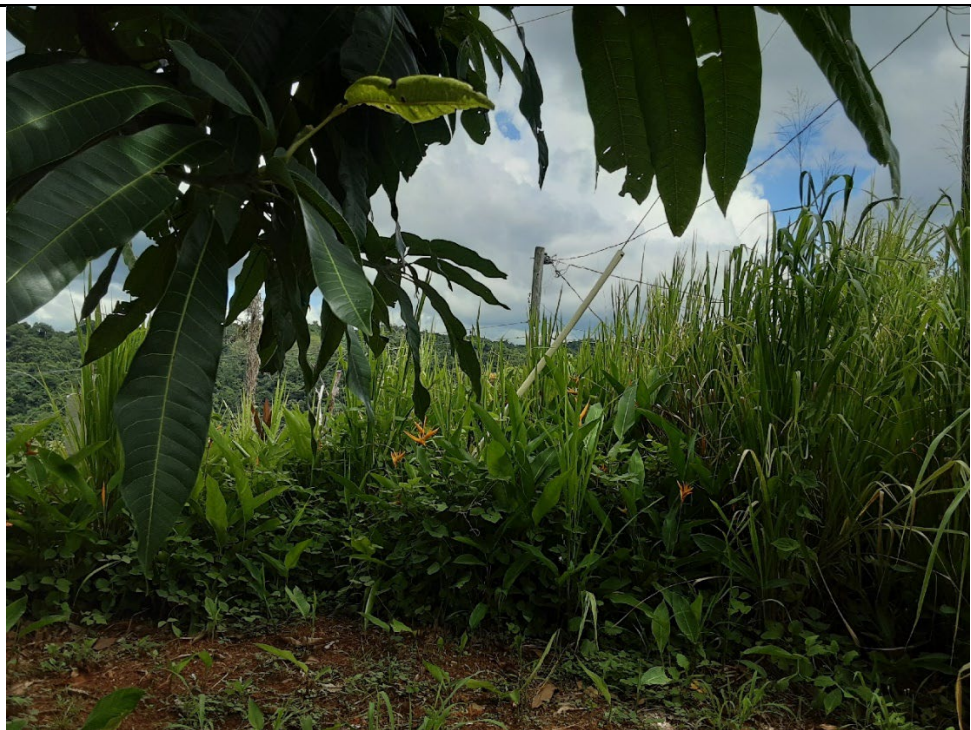
Photo #: 16	Date: 09/25/2023
Photo Direction: East	
Description: Overview from the center of the area where the applicant plans to install one of the 1000-gallon cisterns which shows the area's vegetation and the landform.

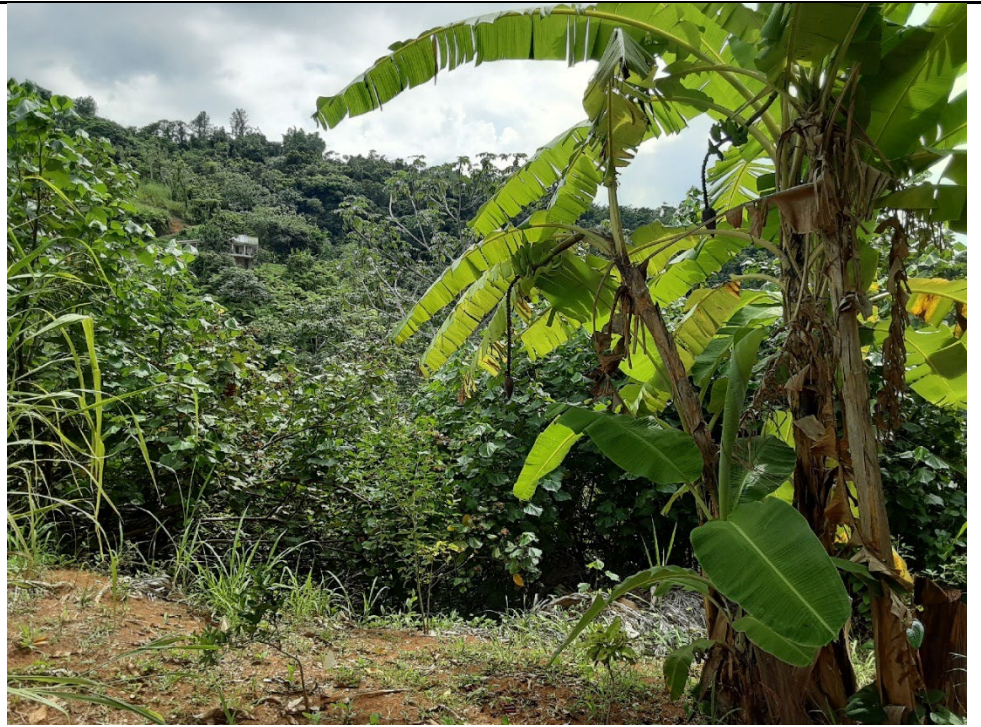
Photo #: 17	Date: 09/25/2023
Photo Direction: South	
Description: Overview from the center of the area where the applicant plans to install one of the 1000-gallon cisterns which shows the area's vegetation and the landform.

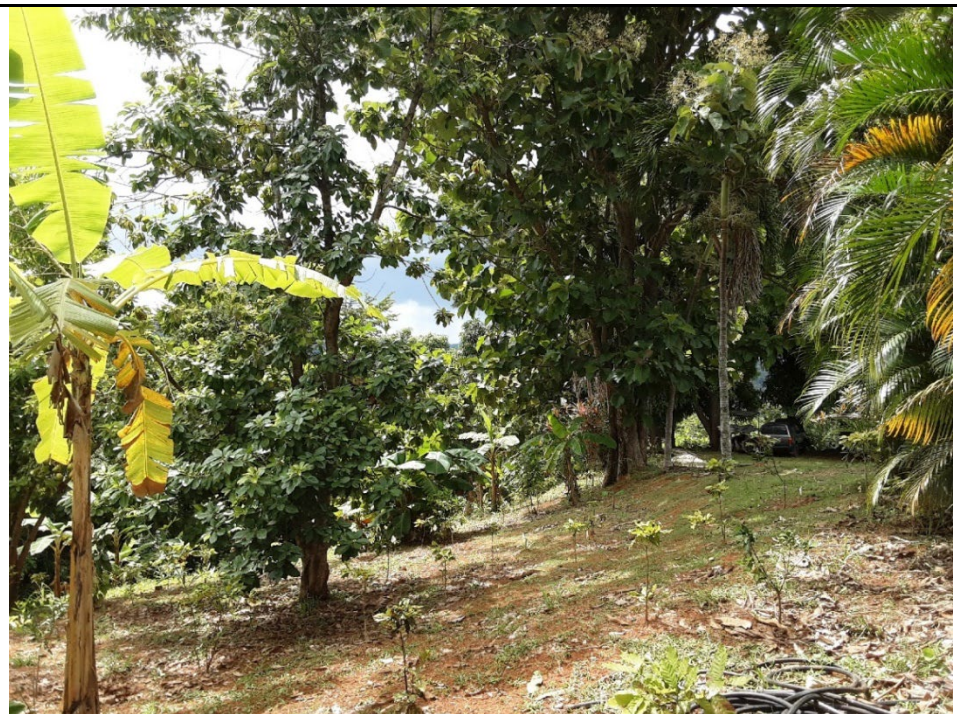
Photo #: 18	Date: 09/25/2023
Photo Direction: West	
Description: Overview from the center of the area where the applicant plans to install one of the 1000-gallon cisterns which shows the area's vegetation and the landform.

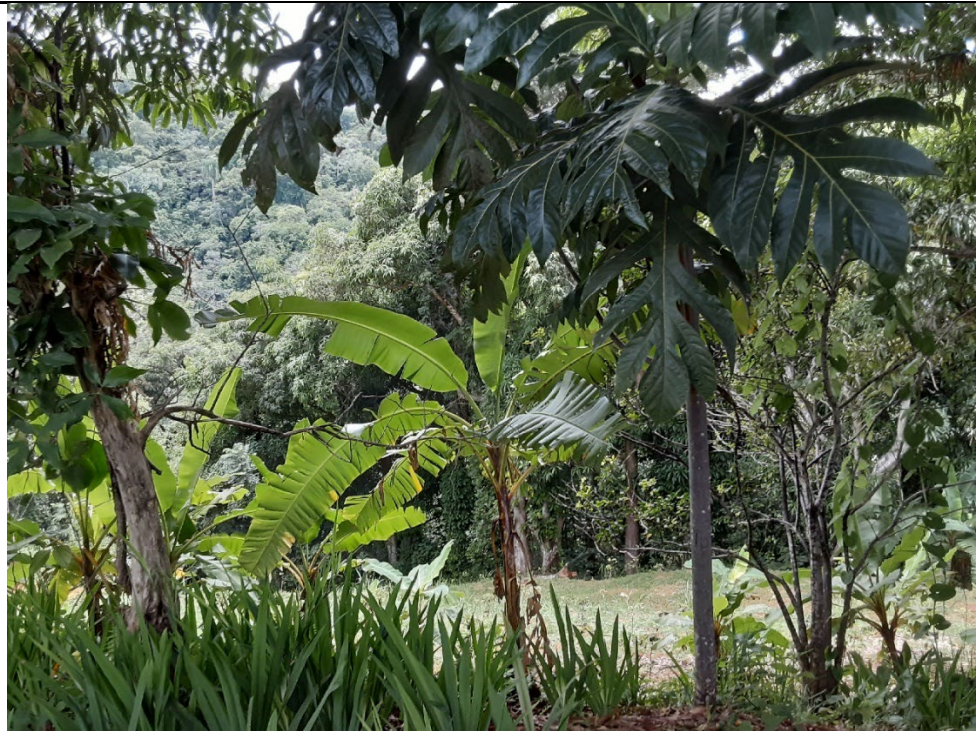
Photo #: 19	Date: 09/25/2023
Photo Direction: West	
Description: Overview of the general direction of where the spring water is found.

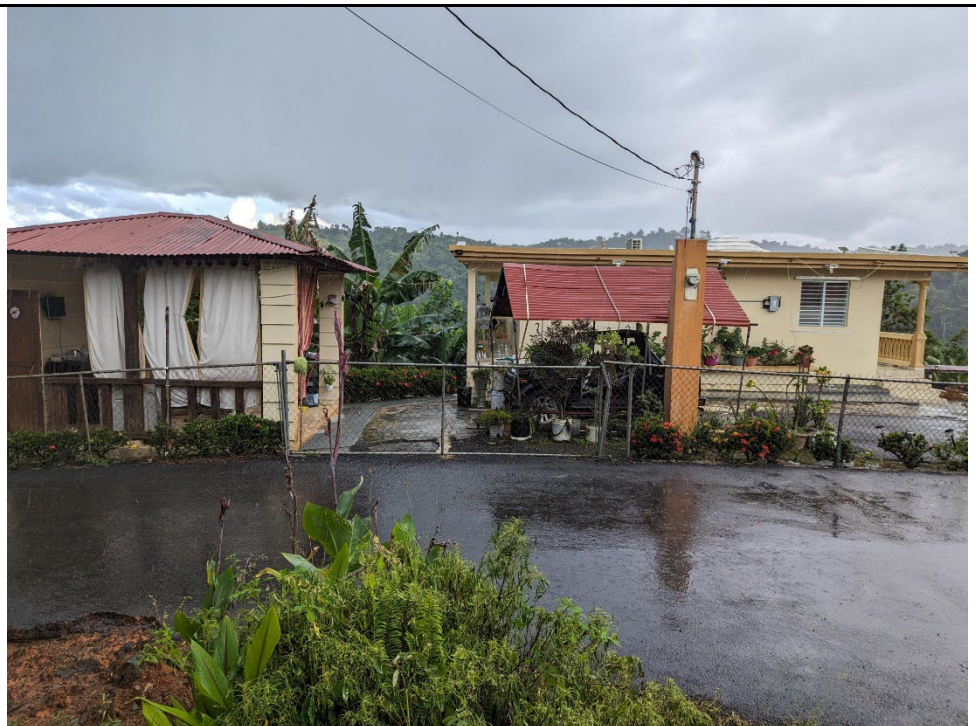
Photo #: 20	Date: 09/25/2023
Photo Direction: Southeast	
Description: Overview of the structures built around the 1990s that might have a direct view of the project location, especially the warehouse.
