Environmental Assessment

Project ID: PR-RGRW-03945

Project Name: Johnny Torres Gonzalez

Responsible Entity: Puerto Rico Department of Housing

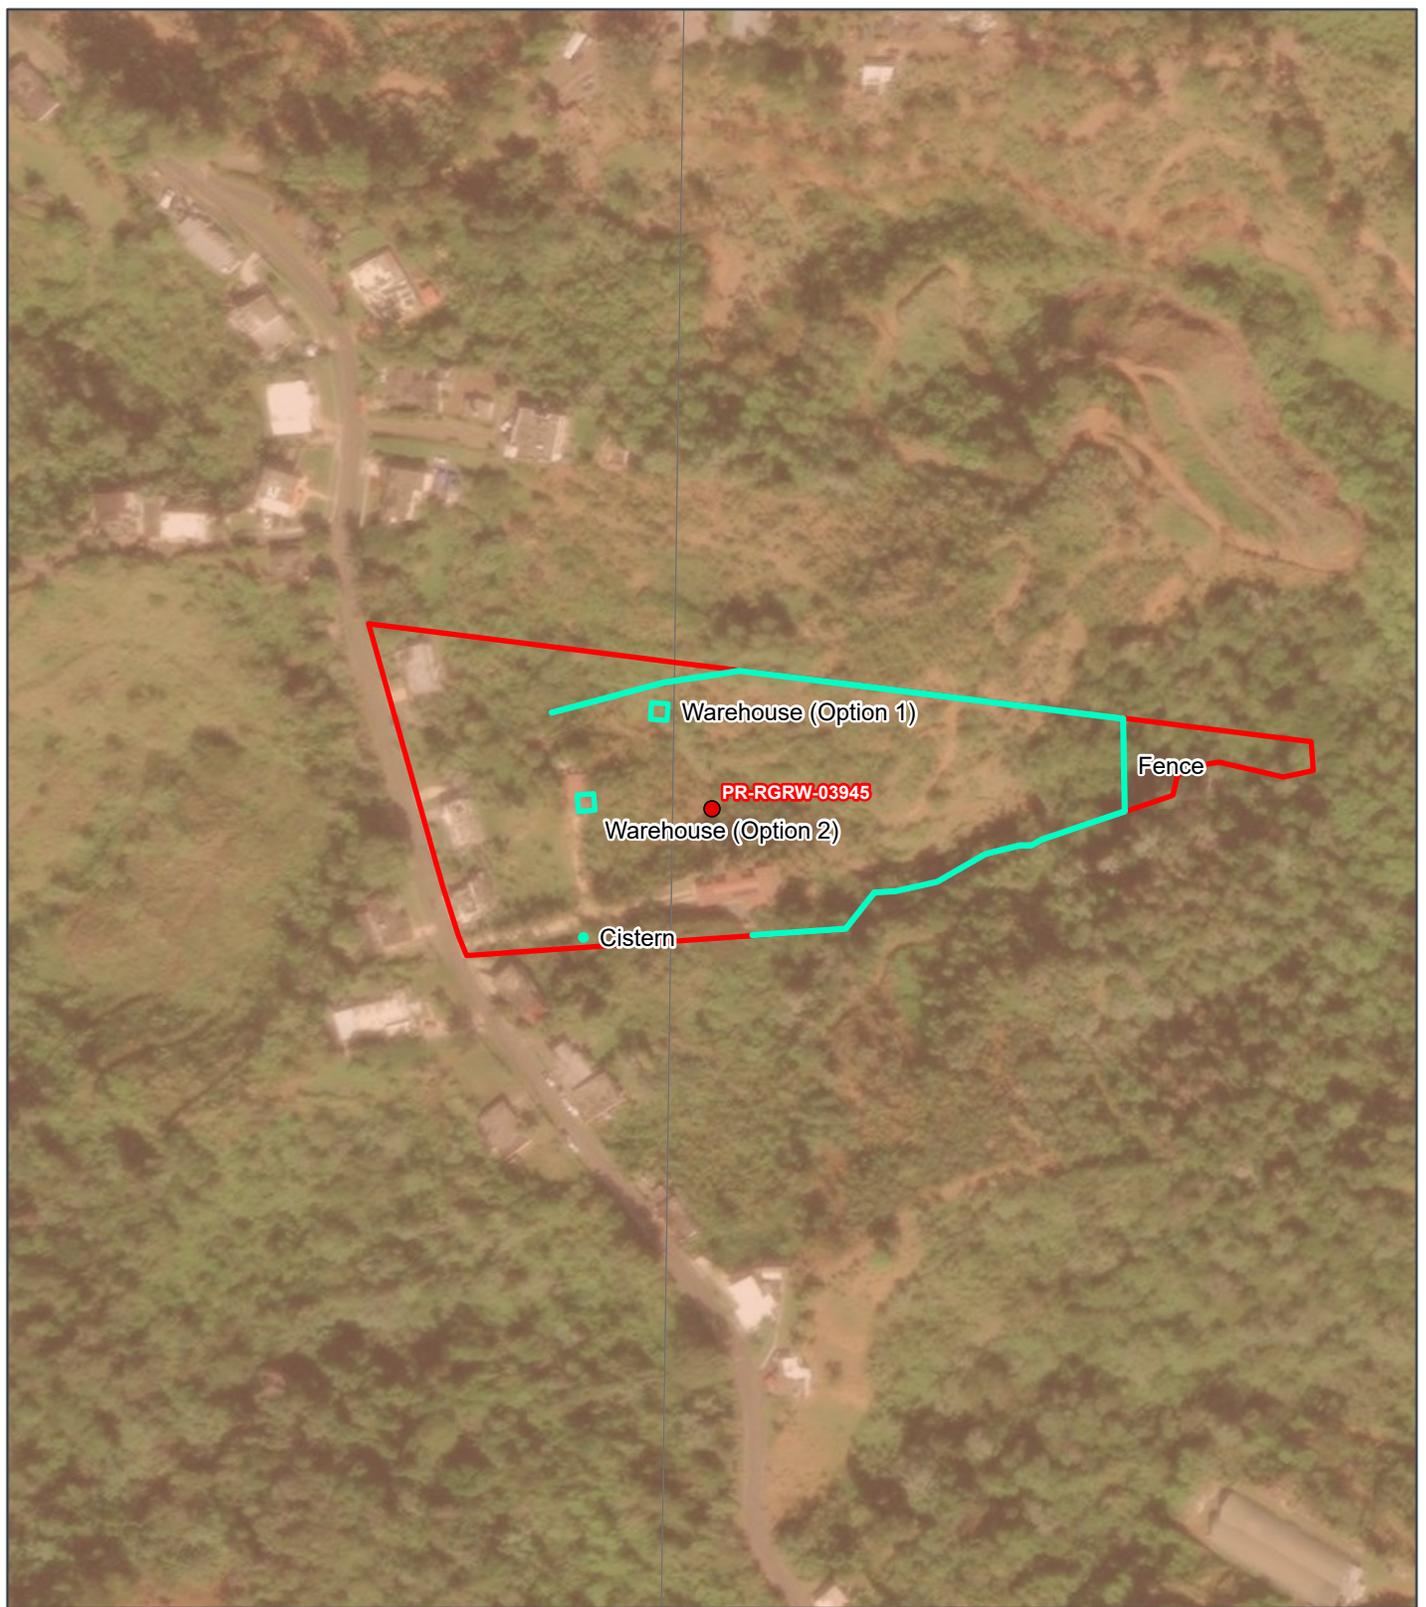
**Figure A-3:
USGS Landslide Map**

<p>Soil Suitability/ Slope/ Erosion/ Drainage/ Storm Water Runoff</p>	<p>2</p>	<p>The soil is currently being used for agriculture purposes, including cultivation and harvest of coffee plants. Soil suitability will be assessed prior to construction and will be addressed during local permitting processes. Contractors will be required to use best management practices during construction to control erosion and prevent runoff.</p> <p>Landslide data from the U.S. Geological Survey (USGS) indicates less than 25 landslides per square kilometer for the project area (see Appendix A, Figure 3- USGS Landslide Map).</p> <p>Under the USEPA National Pollutant Discharge Elimination System (NPDES) Program requirements, any project with a disturbance area equal to or greater than 1 acre requires a USEPA Construction General Permit, NPDES Permit, and formal Stormwater Pollution Prevention Plan (SWPPP). The total disturbance area for this project is less than 1 acre and does not meet this threshold; therefore, these requirements do not apply.</p>

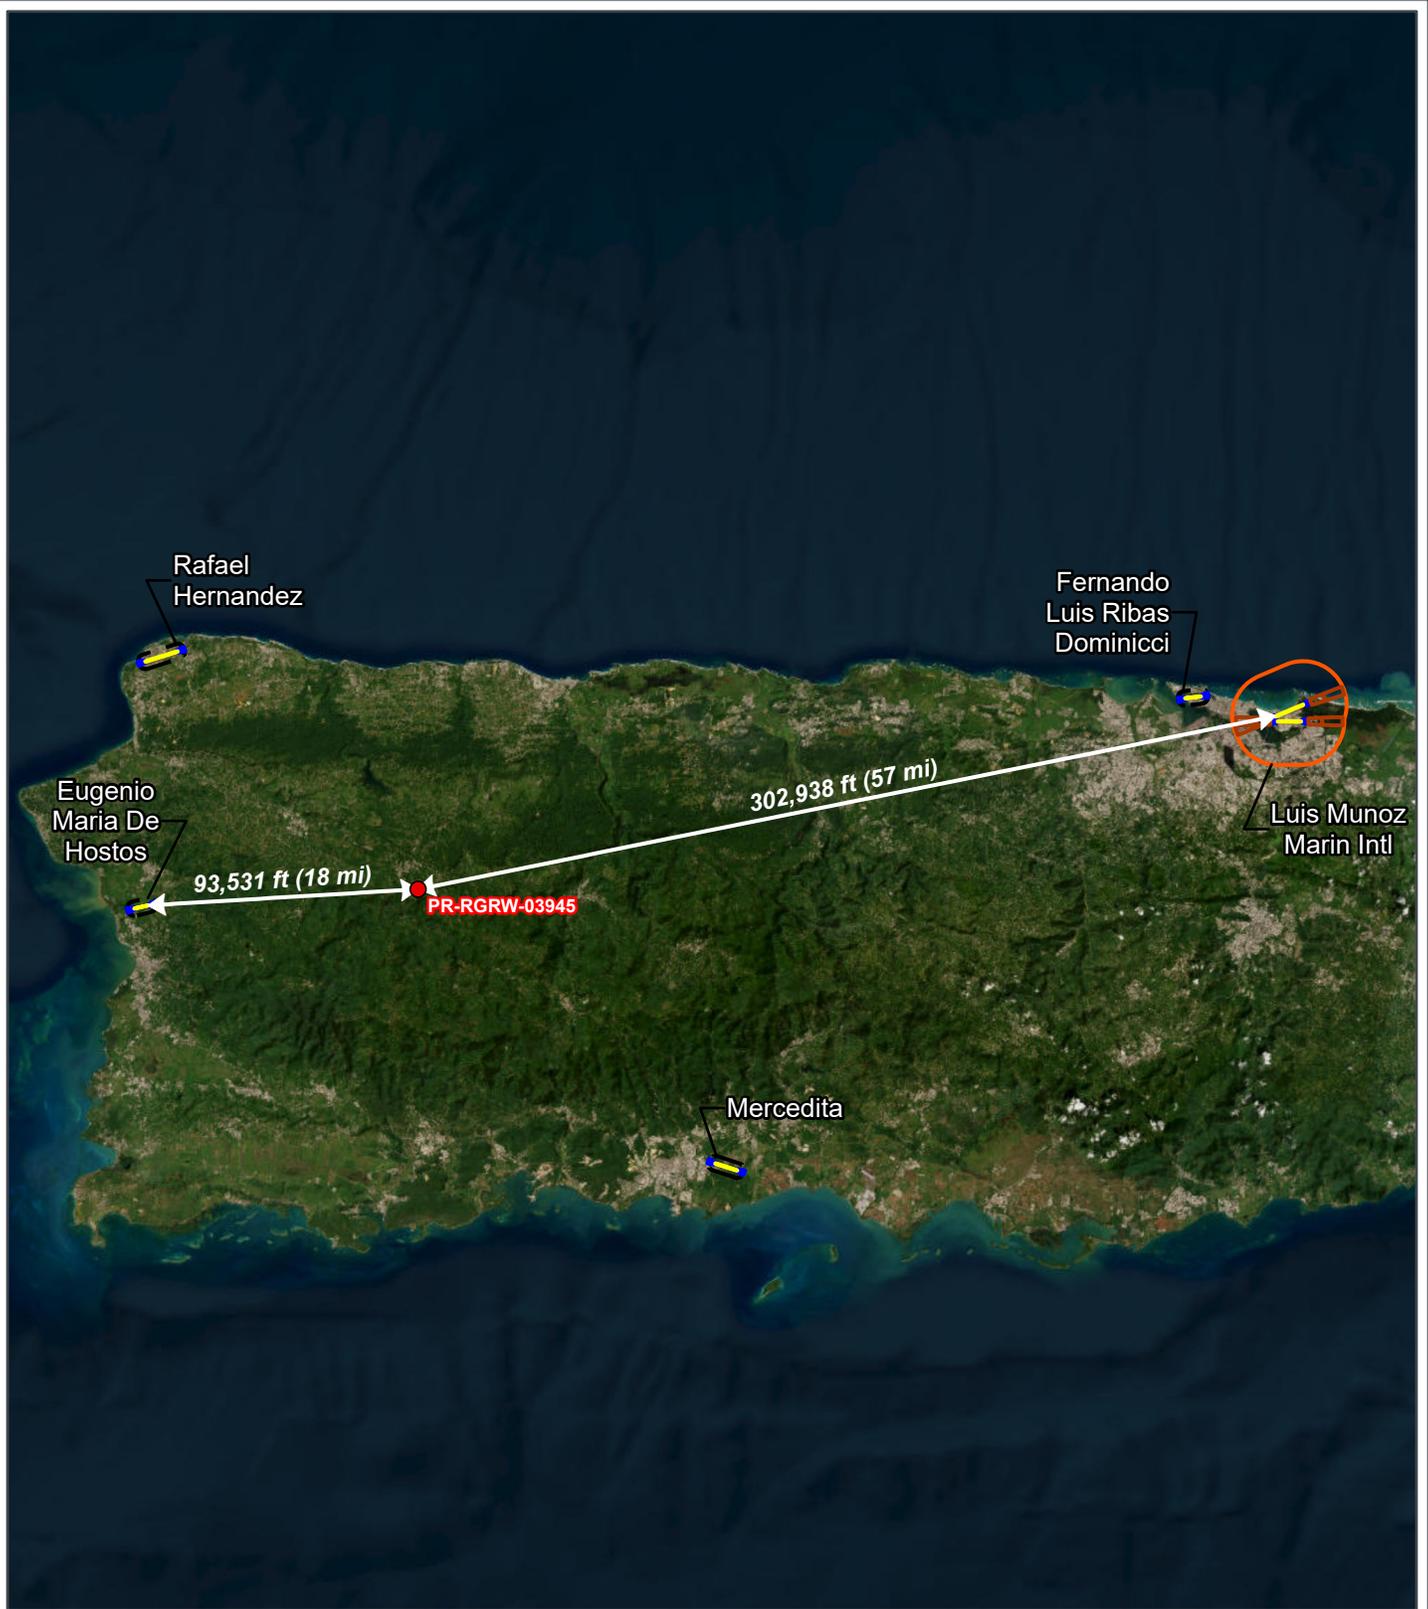
**Figure B 1-1:
Airport Hazards Map**

The project site is not within 2,500 feet of a civil primary or commercial service airport or within 15,000 ft of a military airport. The nearest civil primary or commercial service airport, Eugenio Maria de Hostos, is located 93,531 feet (18 miles) from the project site. The nearest military airport, Luis Munoz Marin International Airport, is located [302,938 feet (57 miles) from the project site. The project is in compliance with this section. No further evaluation is required. The project is in compliance with airport hazards requirements.

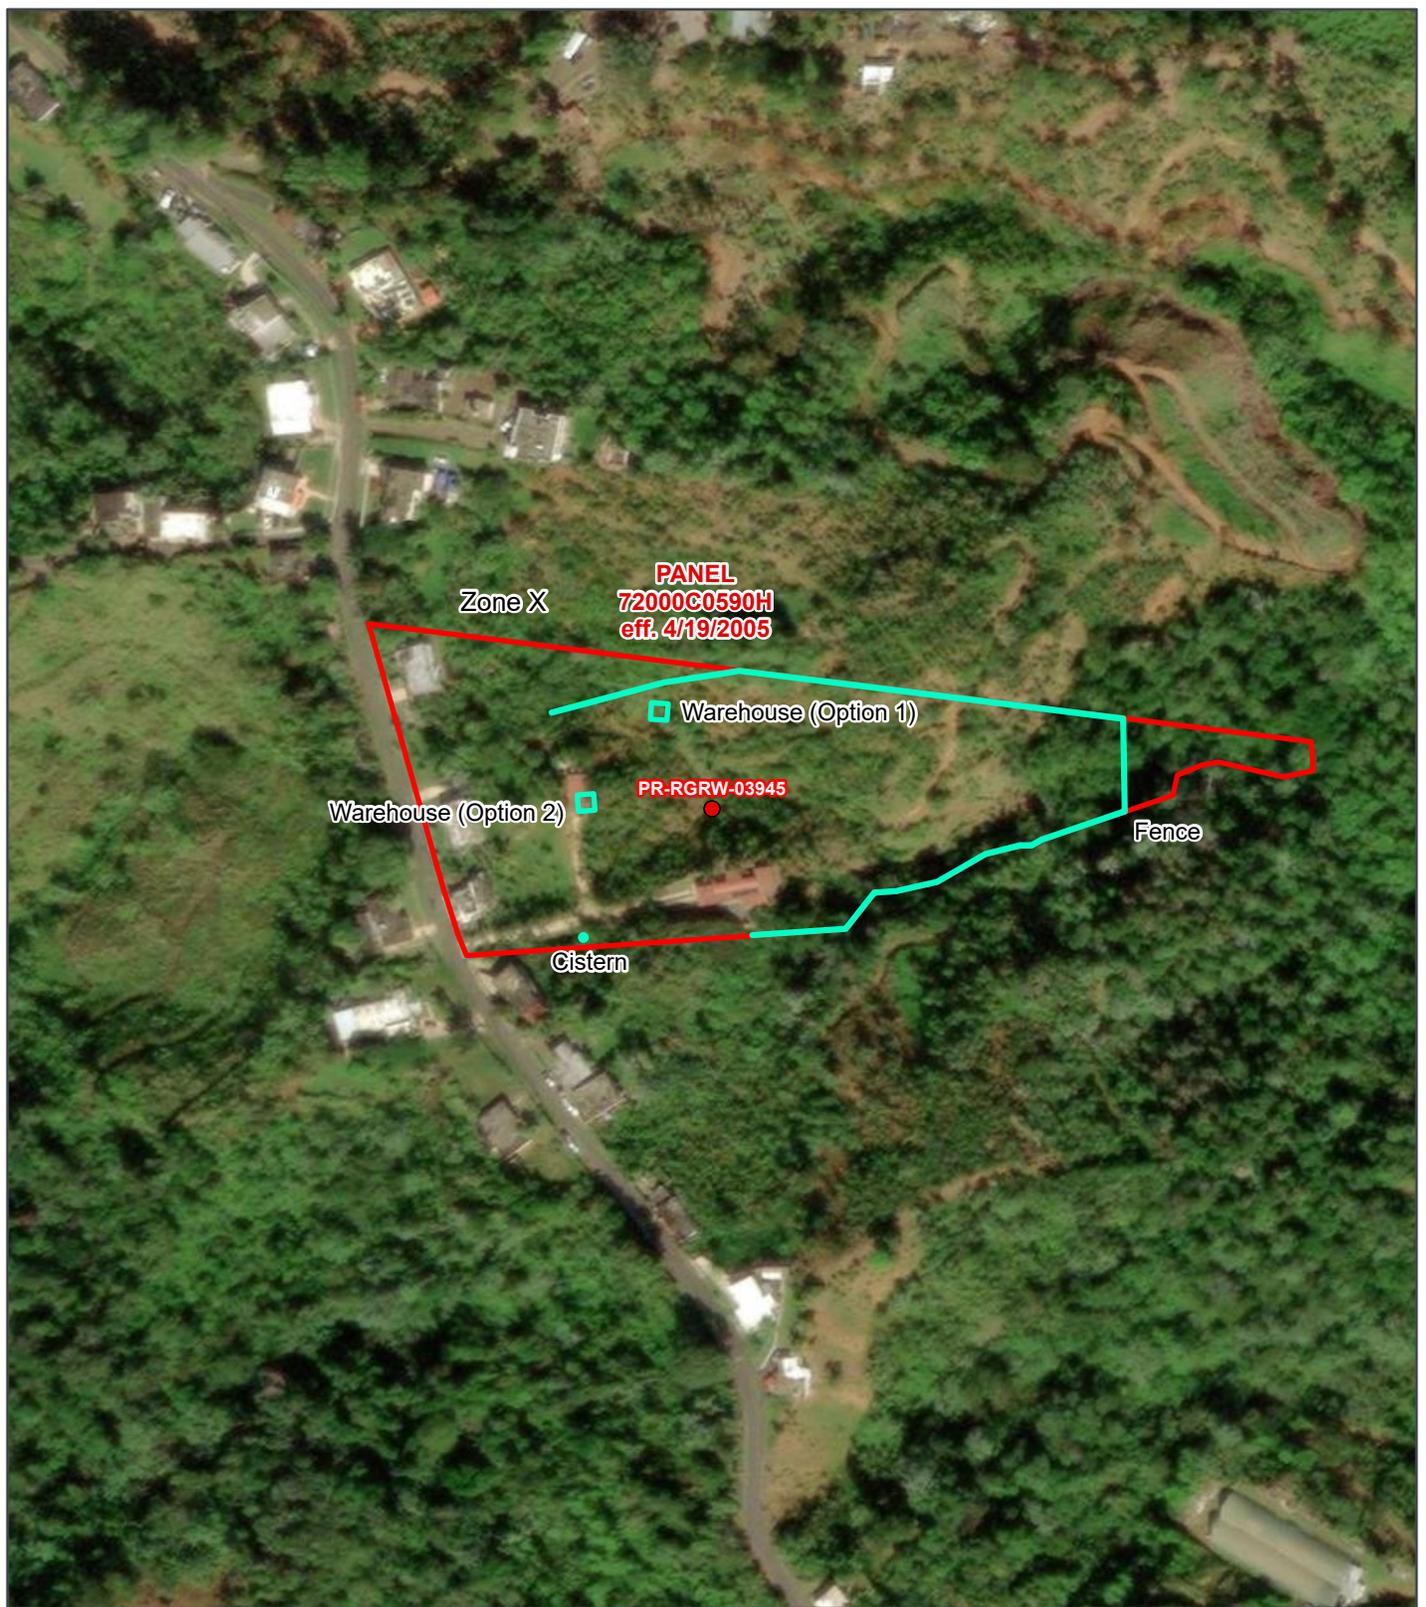
Figure B 3-1: Flood Insurance Rate Map (FIRM)

A review of the FEMA Flood Insurance Rate Map (FIRM), Community Panel 72000C0590H (effective date 4/19/2005), shows the project site is in Flood Zone X, which is not in a Special Flood Hazard Area (SFHA). Flood insurance is not required. The project is in compliance with this section. No further evaluation is required. The project is in compliance with the Flood Disaster Protection Act and National Flood Insurance Reform Act.

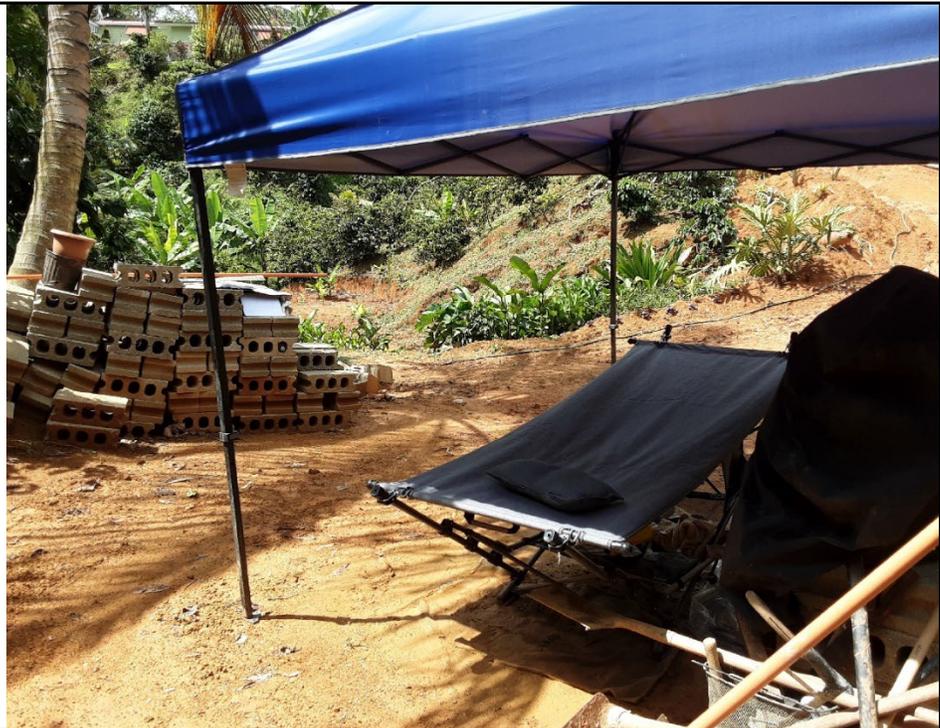
Photo #: 01	Date: 05/26/ 2023
Photo Direction: Southwest	
Description: This picture is an overview taken from the northeast corner of the Option 1 site location for an 18ft x 18ft galvanized roof and associated concrete pad. The picture shows construction materials and existing site conditions and surrounding vegetation.

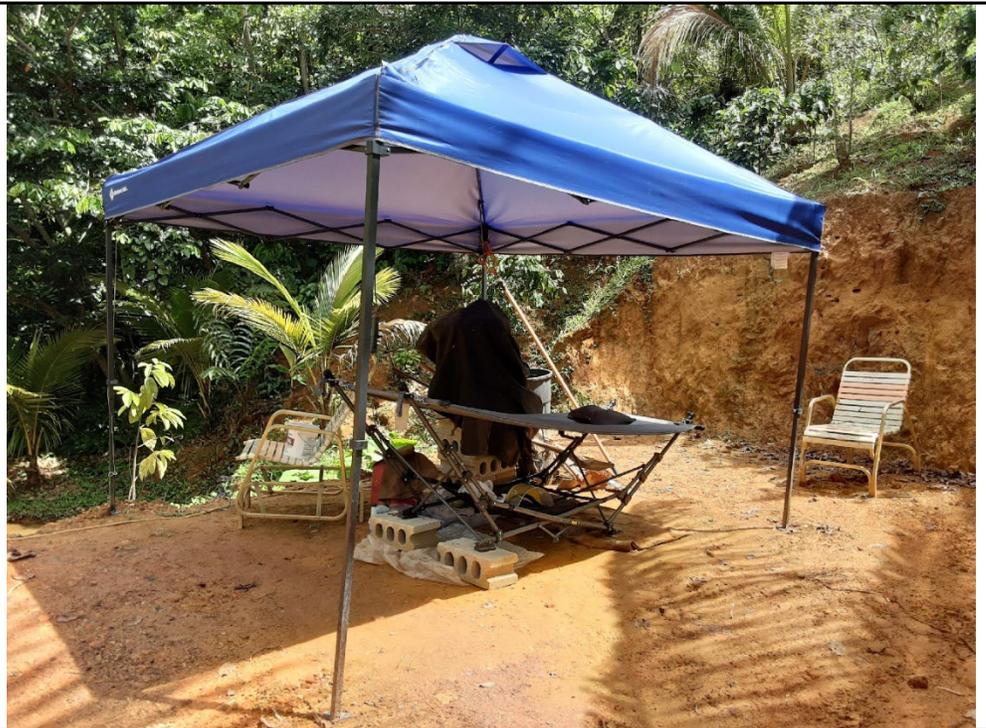
Photo #: 03	Date: 05/26/ 2023
-----------------------	--------------------------------

Photo Direction:
Northeast

Description:
This picture is an overview taken from the southwest corner of the Option 1 site location for an 18ft x 18ft galvanized roof and associated concrete pad. The picture shows existing site conditions and surrounding vegetation.

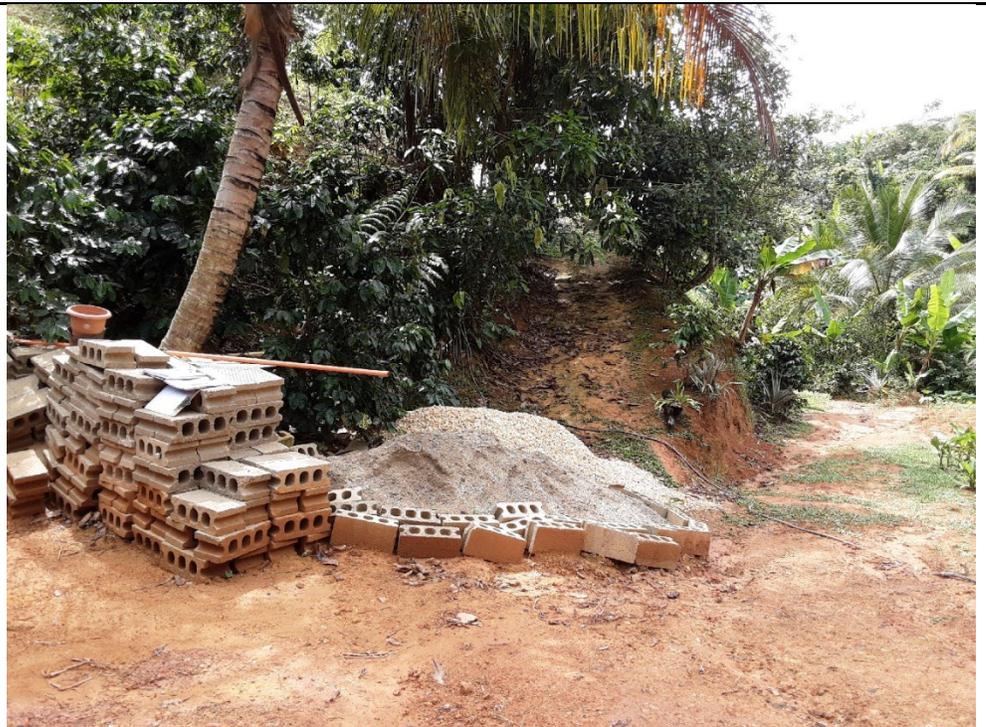
Photo #: 04	Date: 05/26/ 2023
-----------------------	--------------------------------

Photo Direction:
Southeast

Description:
This picture is an overview of Option 1 site location for an 18ft x 18ft galvanized roof and associated concrete pad. The picture shows construction materials and existing site conditions and surrounding vegetation.

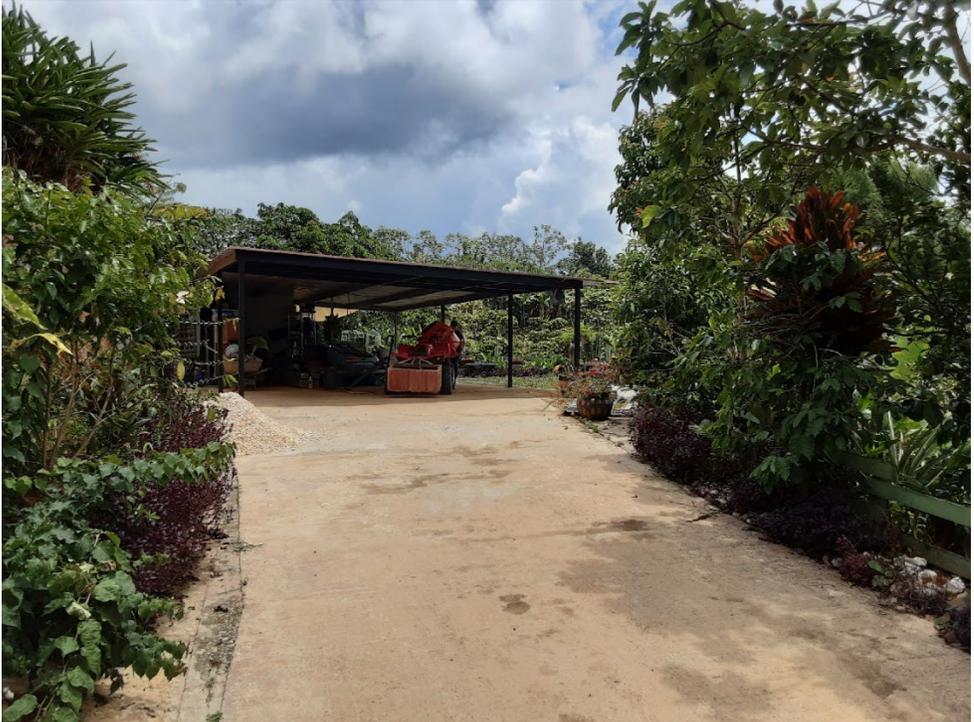
Photo #: 05	Date: 05/26/ 2023

Photo Direction: North		
Description: This picture is an overview of the Option 2 location showing existing site conditions and surrounding vegetation. If selected, the existing roof will be replaced and reinforced.

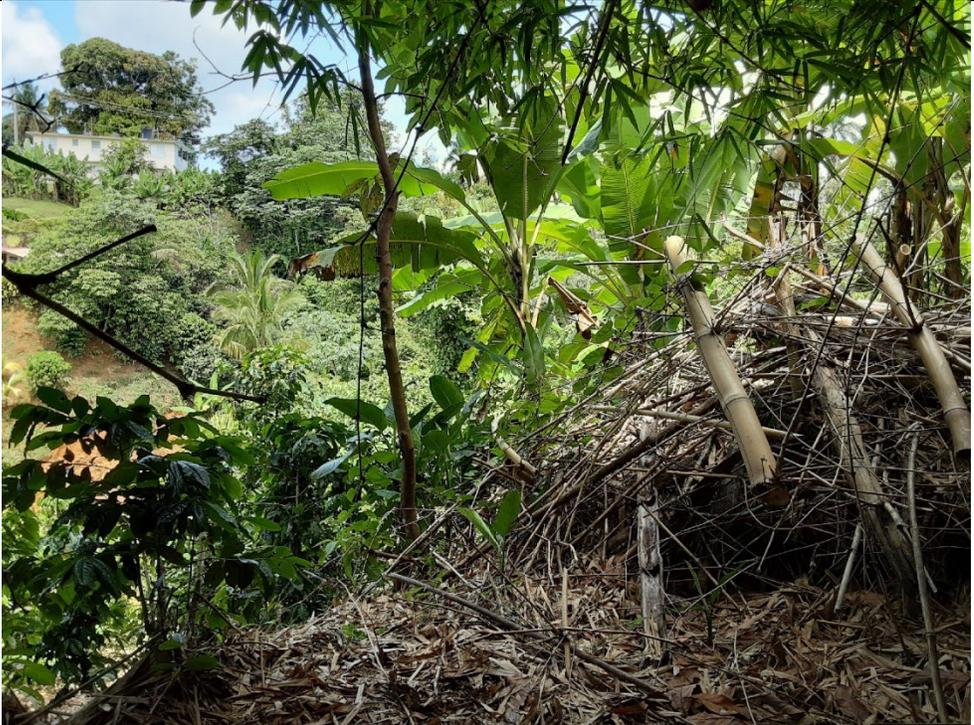
Photo Direction: Northwest		
Description: This picture was taken from the beginning of the proposed northeast to northwest fence location showing existing vegetation. The wall will use barbed wire with metal posts and would be approximately 1 ft deep.

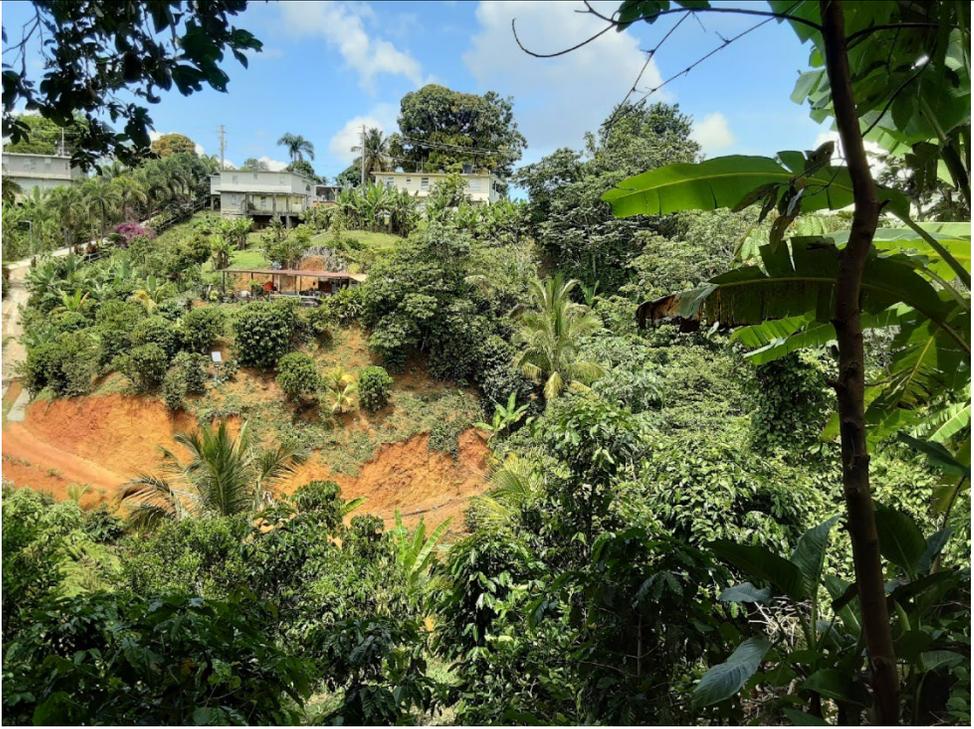
Photo Direction: Northwest		
Description: This picture was taken from the beginning of the proposed northeast to northwest fence location, showing the surrounding vegetation and an overview of the property. The fence will use barbed wire with metal posts and will be approximate 1 ft deep.

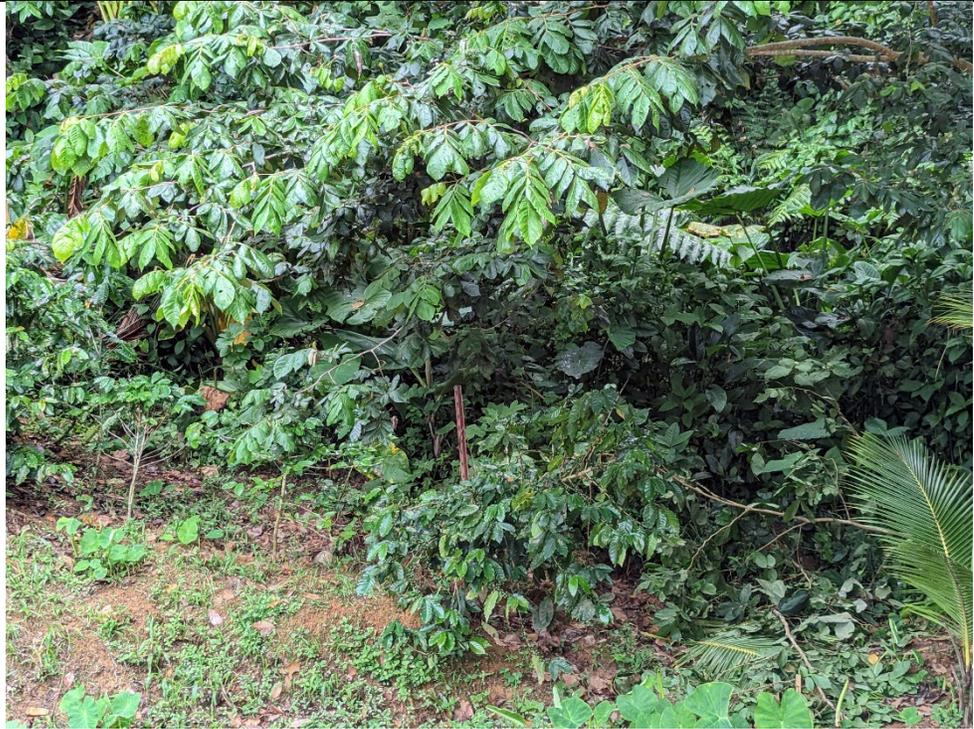
Photo Direction: North		
Description: This picture was taken from a midway point of the proposed northeast to northwest fence location showing existing vegetation and one of the posts marking the property line. The fence will use barbed wire with metal posts and will be approximate 1 ft deep.

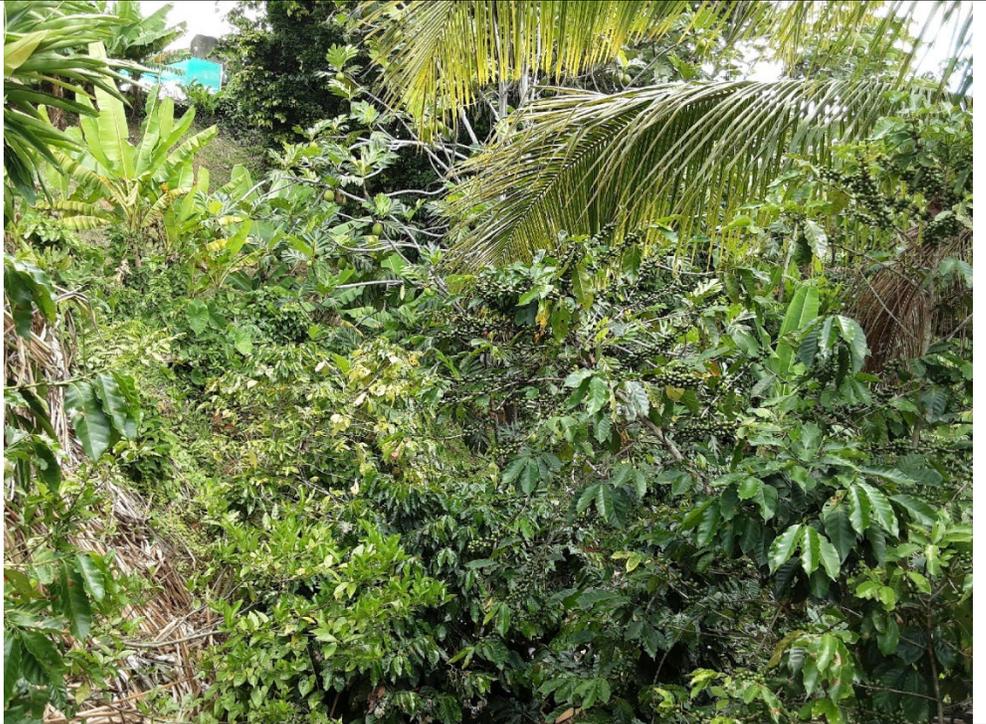
Photo Direction: Northwest		
Description: This picture was taken from an endpoint of the proposed northeast to northwest location showing representative vegetation. The fence will use barbed wire with metal posts and will be approximate 1 ft deep.

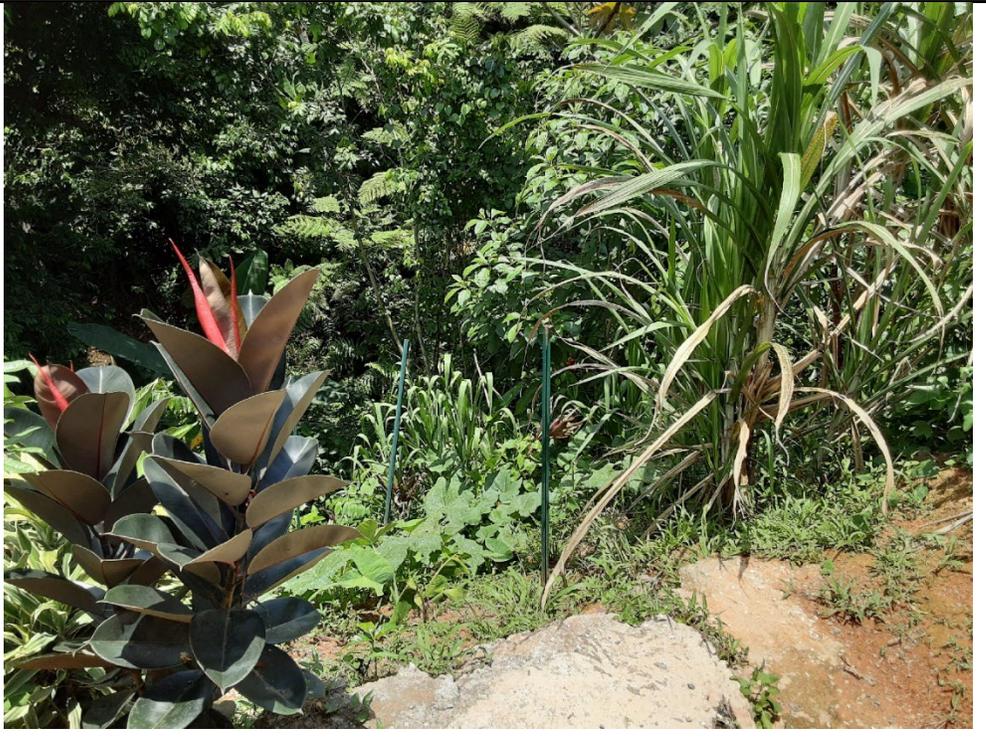
Photo Direction: Southeast		
Description: This picture was taken from the beginning of the proposed southwest to the southeast fence location, showing the existing vegetation and the metal post that will be used to secure the barbed wire.

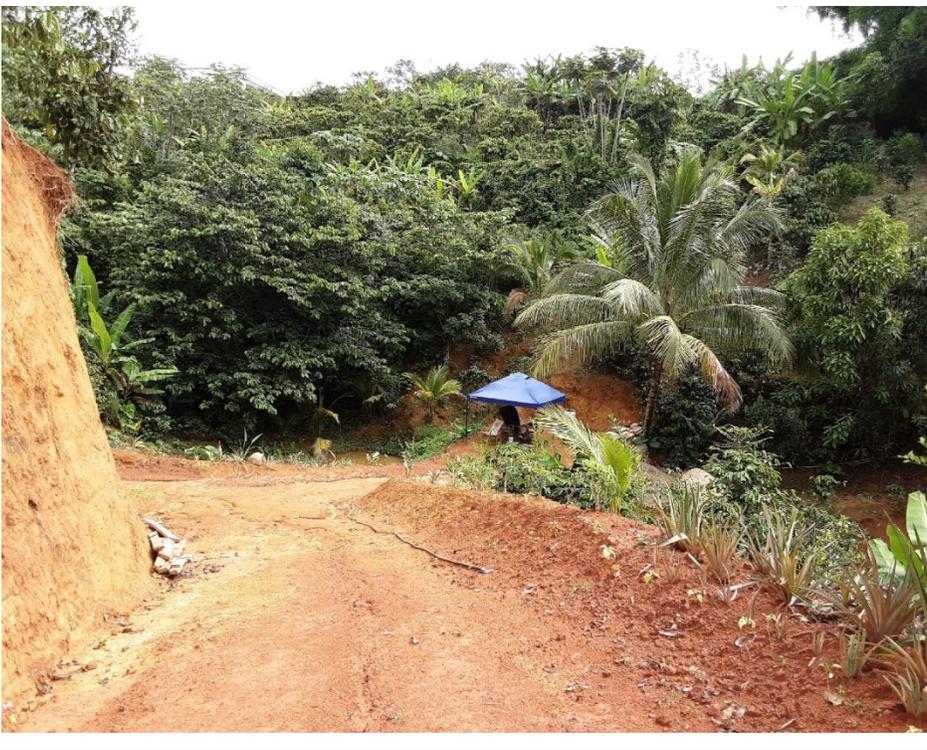
<p>Photo Direction: North</p>		
<p>Description: This picture is an overview of option 1 for the project location for a galvanized roof 18x18ft (ReGrow funds) taken from the dirt access road showing the area's vegetation and a partial view of a tarp where the galvanized roof will be. The applicant will turn the galvanized roof into a warehouse with his funds.</p>		
<p>Photo #: 02</p>	<p>Date: 05/26/ 2023</p>

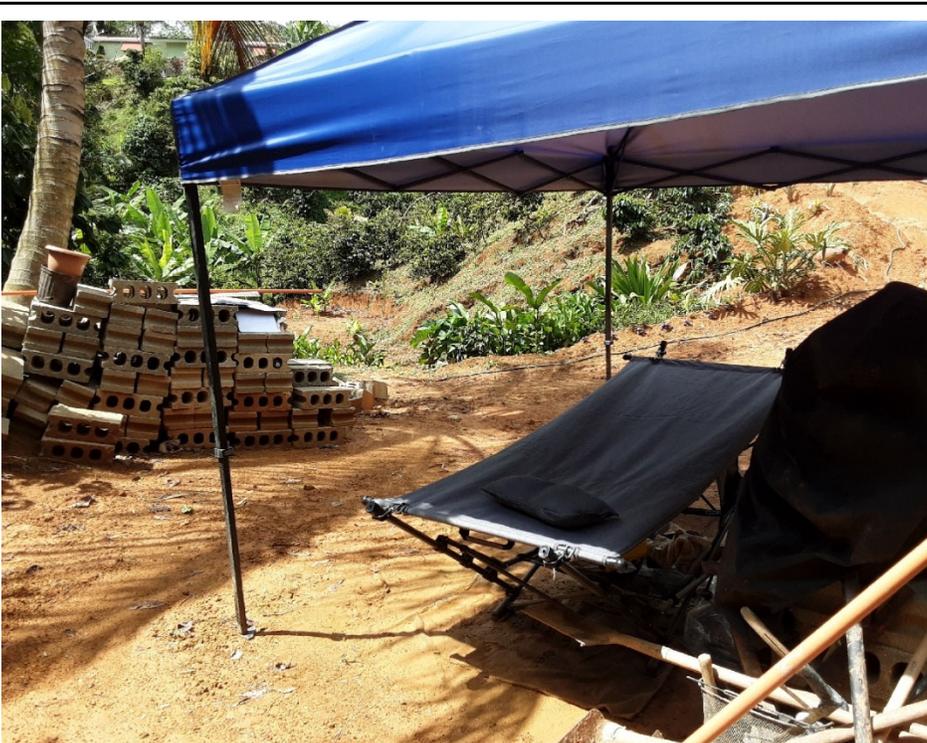
<p>Photo Direction: Southwest</p>		
<p>Description: This picture is an overview taken from the northeast corner of the option one site location for a galvanized roof of 18x18ft, which will be developed into a warehouse. The picture shows a concrete block, a partial view of the tarp with equipment inside, and vegetation.</p>

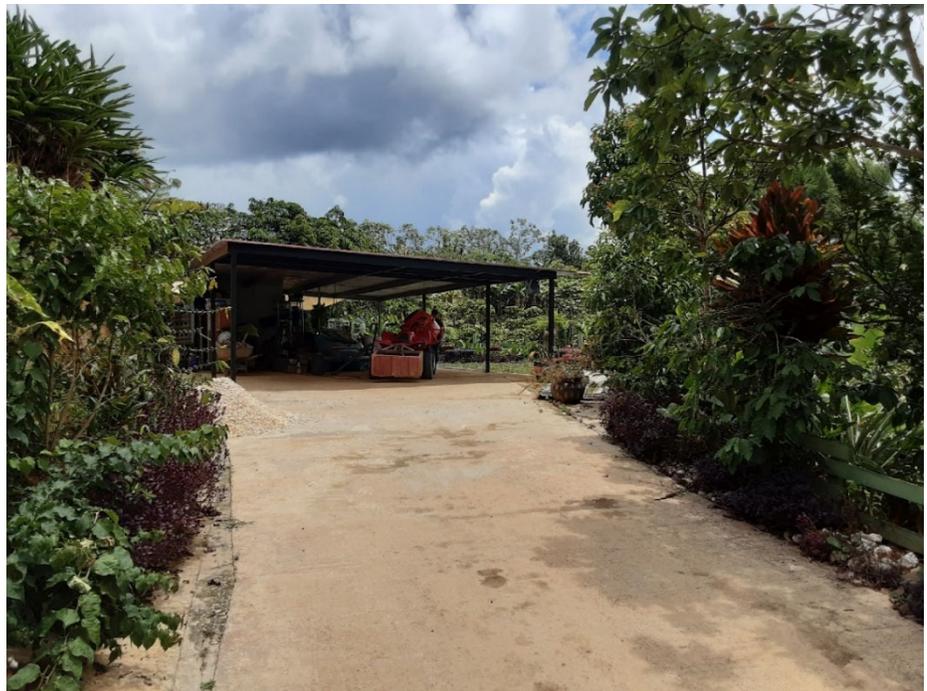
This picture is an overview of the second option for a galvanized roof 18x18ft taken from the concrete access road to an existing structure. The galvanized roof will be replaced and reinforced on this structure with ReGrow funds if this option is selected.

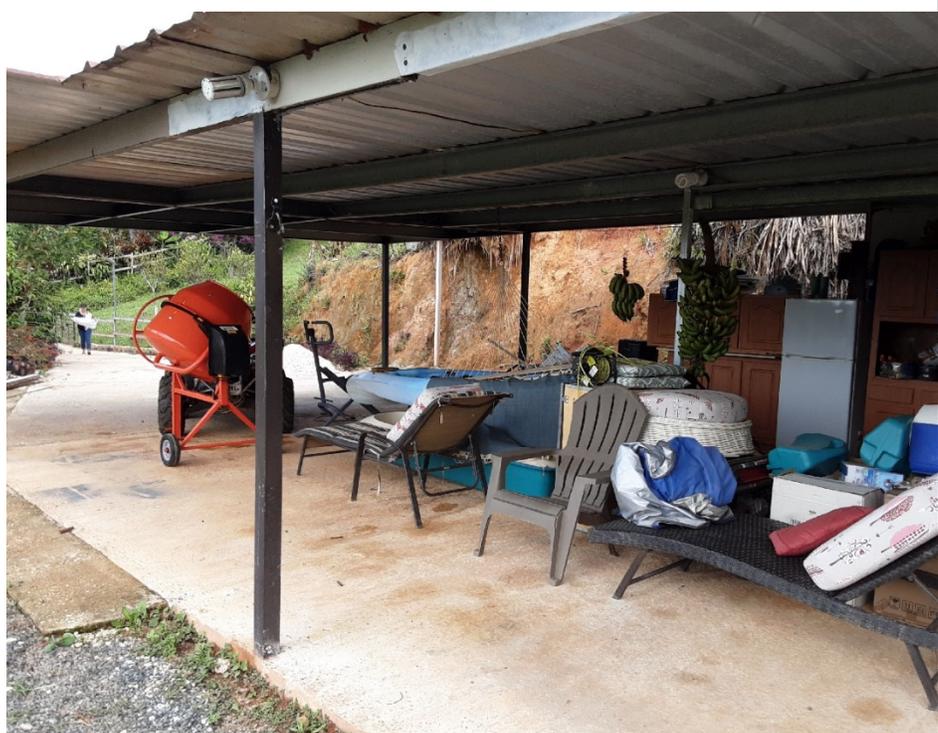
This picture is an overview of the second option for a galvanized roof 18x18ft replacement and reinforcement, taken from the northeast corner showing a partial view of the structure and the inside.

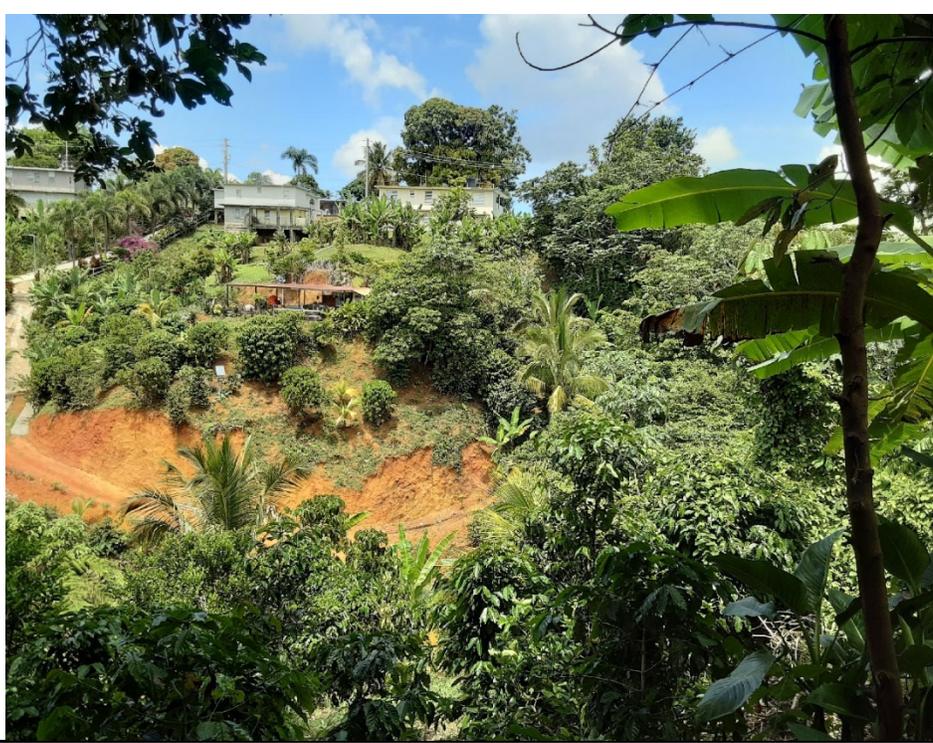
<p>Photo Direction: Northwest</p>		
<p>Description: This picture was taken from the beginning of where the northeast to northwest fence will be located, showing the vegetation and the property. The fence will use barbed wire with metal posts and is going to be 1 ft deep approximately.</p>		
<p>Photo #: 06</p>	<p>Date: 05/26/ 2023</p>

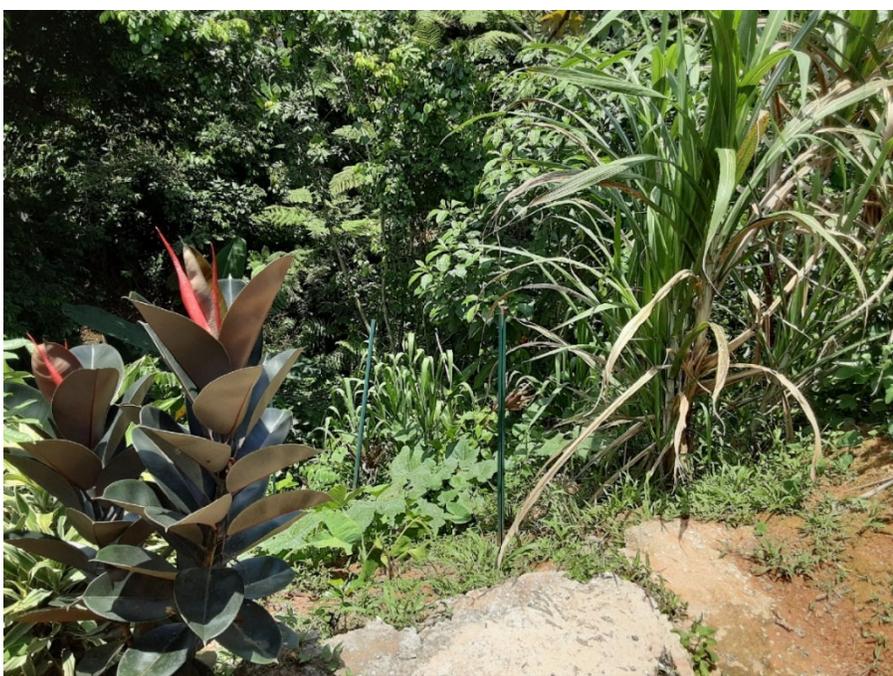
<p>Photo #: 07</p>	<p>Date: 05/26/ 2023</p>

<p>Photo Direction: Southeast</p>		
<p>Description: This picture was taken from the beginning of where the southwest to the southeast fence will be located, showing the vegetation and the metal post that will be used with barbed wire, 1 ft deep approximately.</p>		
<p>Photo #: 08</p>	<p>Date: 05/26/ 2023</p>

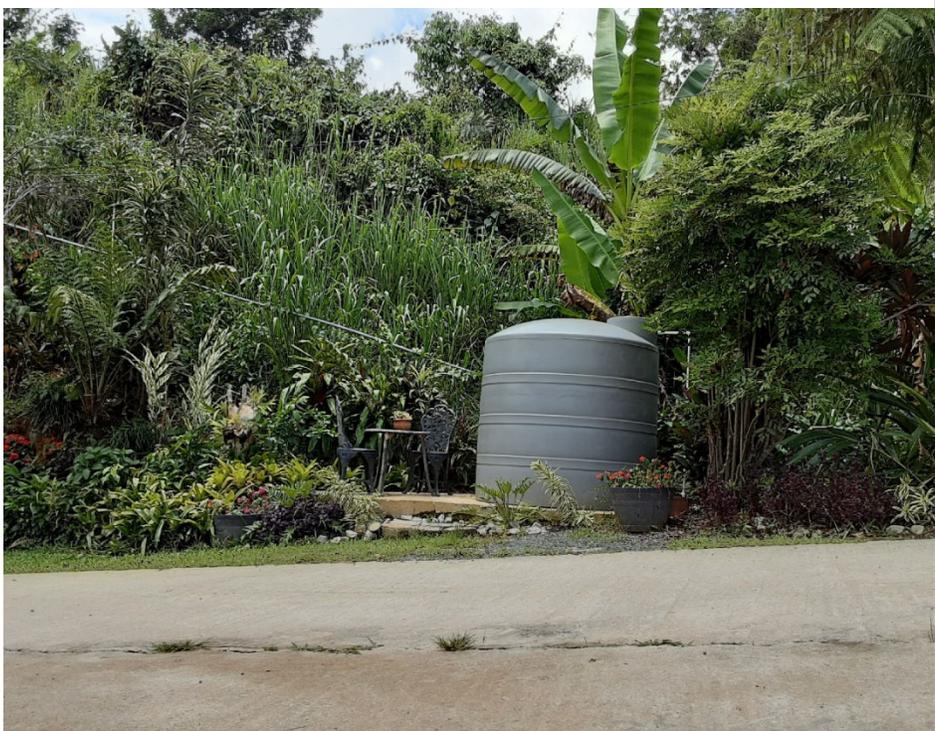
<p>Photo Direction: South</p>		
<p>Description: This picture overviews the site location for a cistern right next to the existing one (left), which was bought by the previous owner and will be placed on an existing concrete platform. This cistern will help with the crops with an above-ground irrigation system (not funded by ReGrow).</p>

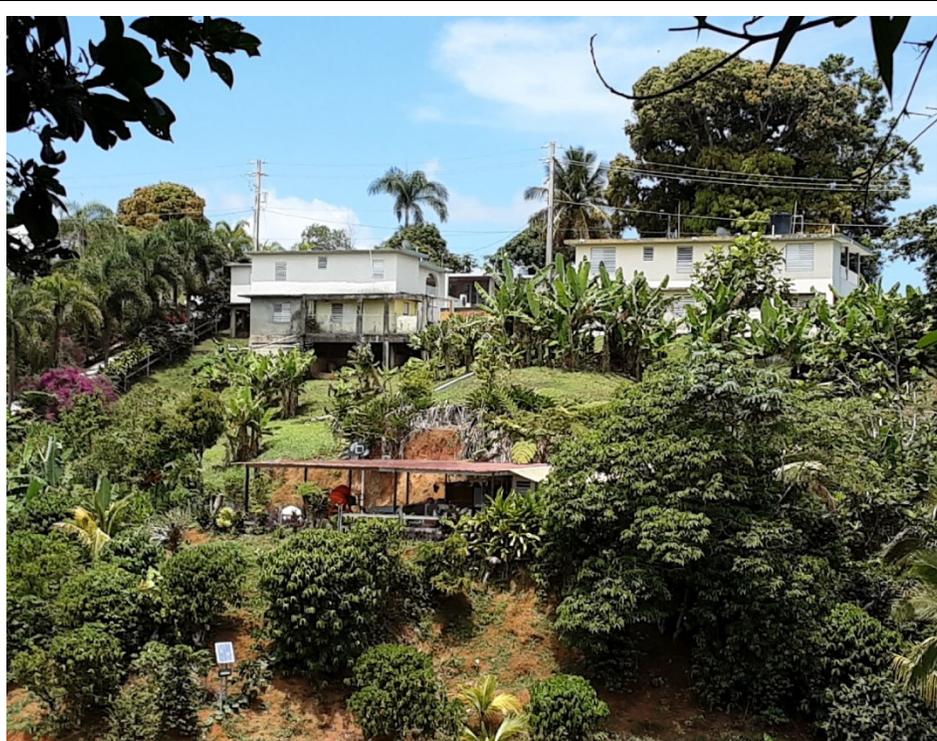
<p>Photo #: 09</p>	<p>Date: 05/26/ 2023</p>

<p>Photo Direction: West</p>		
<p>Description: Overview of two properties directly viewing the project location, built around the 1970s/1980s. These residences don't belong to the applicant or are part of his property (please check the blueprint provided by the applicant).</p>		
<p>Photo #: 10</p>	<p>Date: 05/26/ 2023</p>

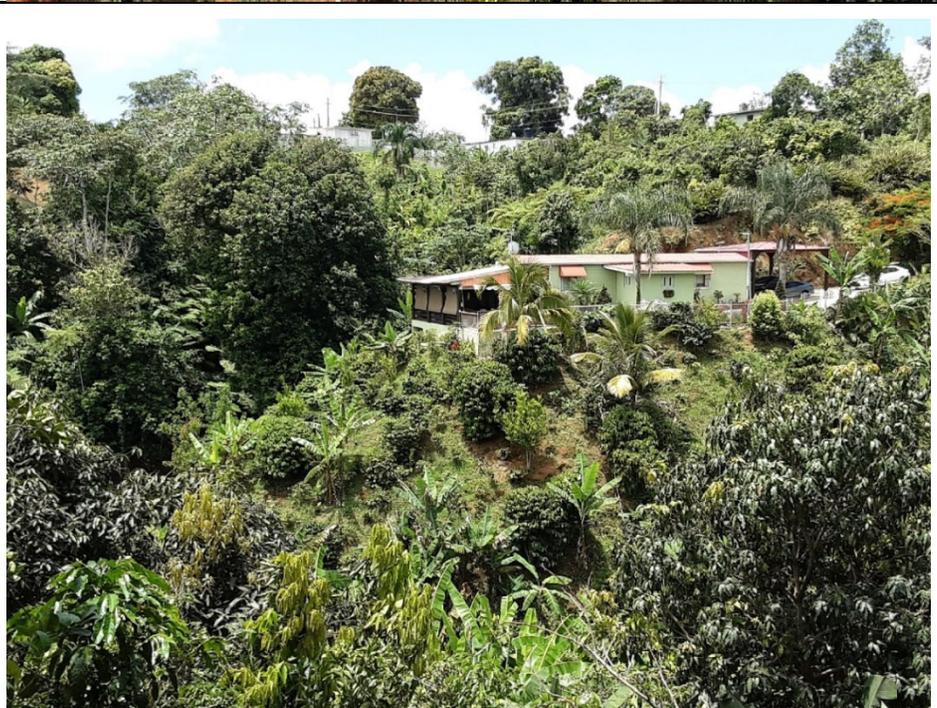
<p>Photo Direction: Southeast</p>		
<p>Description: This picture is an overview of the property showing the areas where the coffee will be planted; the applicant mentioned the areas where there are no plantains on the hillside are where coffee will be grown. Coffee must be 8 to 9 inches deep on the ground.</p>

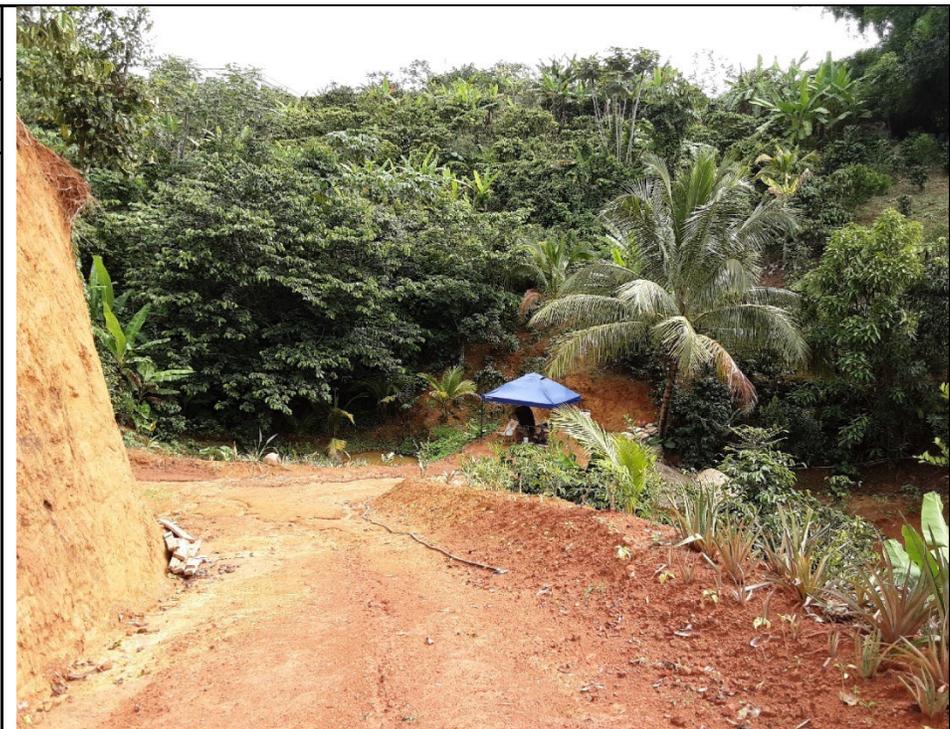
Photo #: 02	Date: 05/26/ 2023
Photo Direction: Southwest	
Description: This picture is an overview taken from the northeast corner of the option one site location for a galvanized roof of 18x18ft, which will be developed into a warehouse. The picture shows a concrete block, a partial view of the carp with equipment inside, and vegetation.

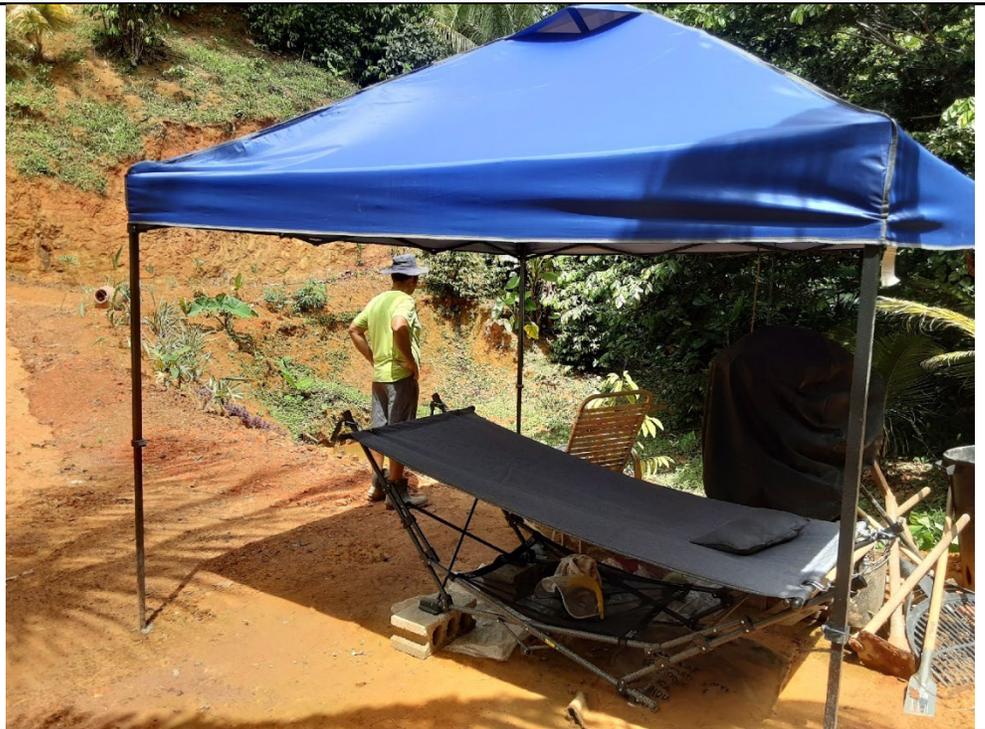
Photo #: 04	Date: 05/26/ 2023
Photo Direction: Northeast	
Description: This picture is an overview taken from the southwest corner of option one site location for a galvanized roof of 18x18ft, which will be developed into a warehouse, showing the vegetation and the carp with the equipment inside.
