Environmental Assessment

Project ID: PR-RGRW-03945

Project Name: Johnny Torres Gonzalez

Responsible Entity: Puerto Rico Department of Housing

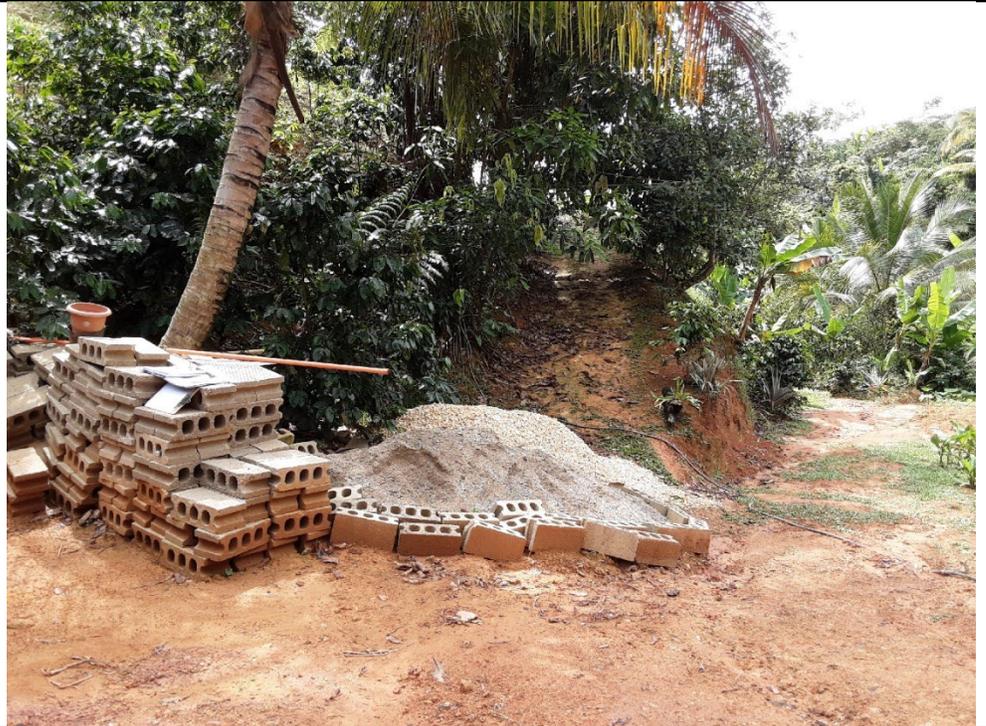
Photo #: 06	Date: 05/26/ 2023
Photo Direction: North	
Description: This picture was taken from the center of the project location option one for a galvanized roof 18x18ft (ReGrow funds), which will later be developed into a warehouse with the applicant's funds; it shows equipment, a partial view of the carp, and vegetation.

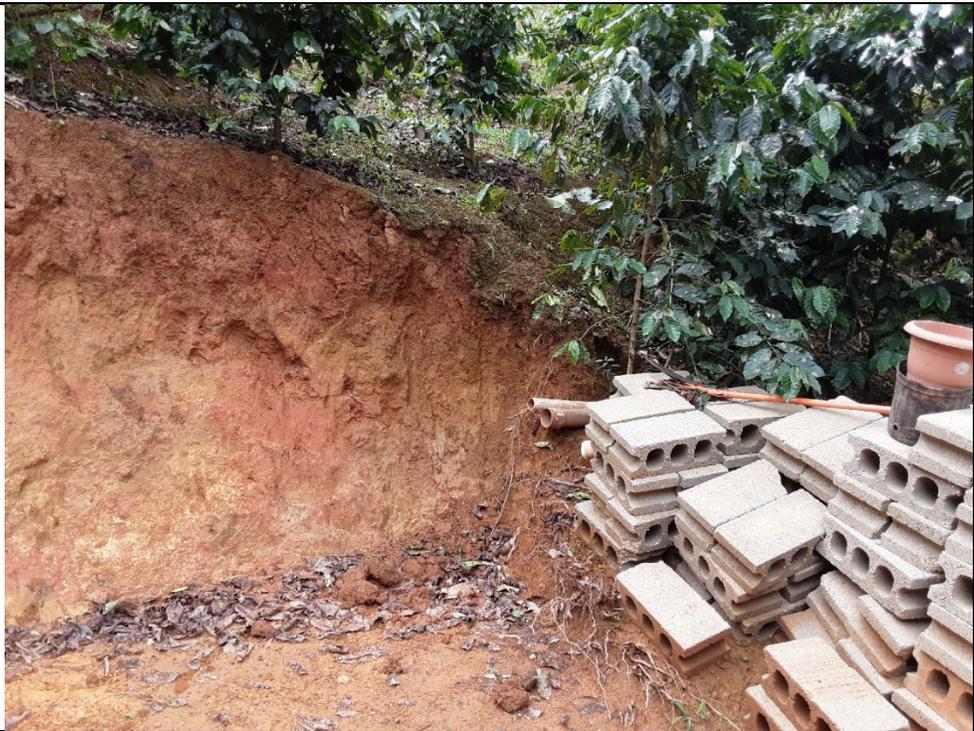
Photo #: 08	Date: 05/26/ 2023
Photo Direction: South	
Description: This picture was taken from the center of the project location option one for a galvanized roof 18x18ft (ReGrow funds), which will later be developed into a warehouse with the applicant's funds; it shows a partial view of construction materials, the applicant, and vegetation.

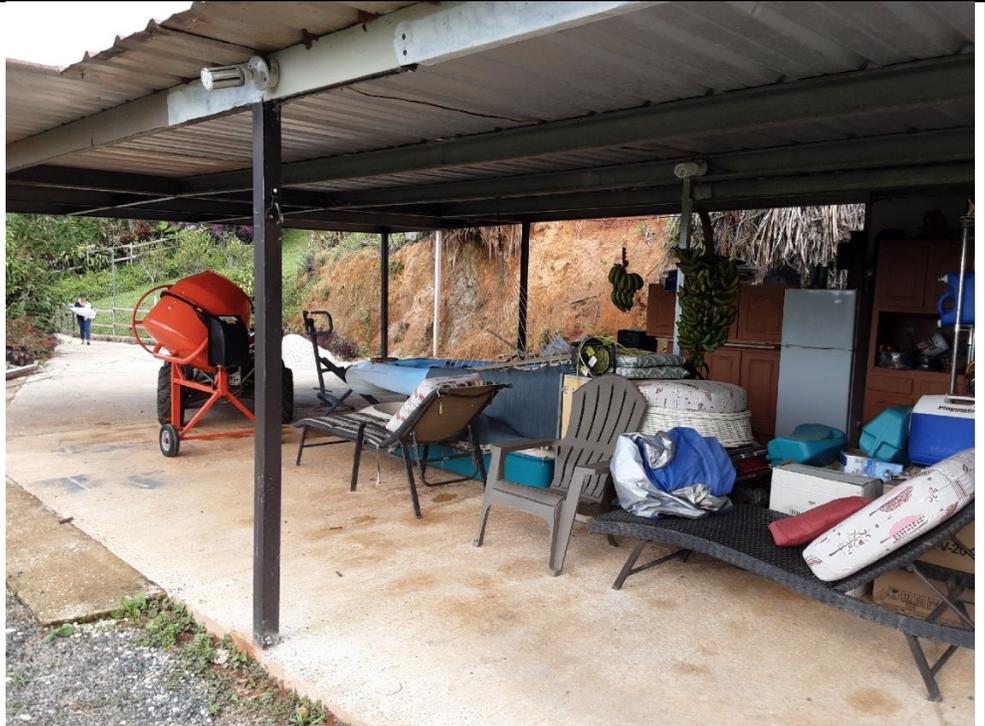
Photo #: 12	Date: 05/26/ 2023
Photo Direction: Northwest	
Description: This picture is an overview of the second option for a galvanized roof 18x18ft replacement and reinforcement, taken from the southeast corner showing a partial view of the structure and the inside.

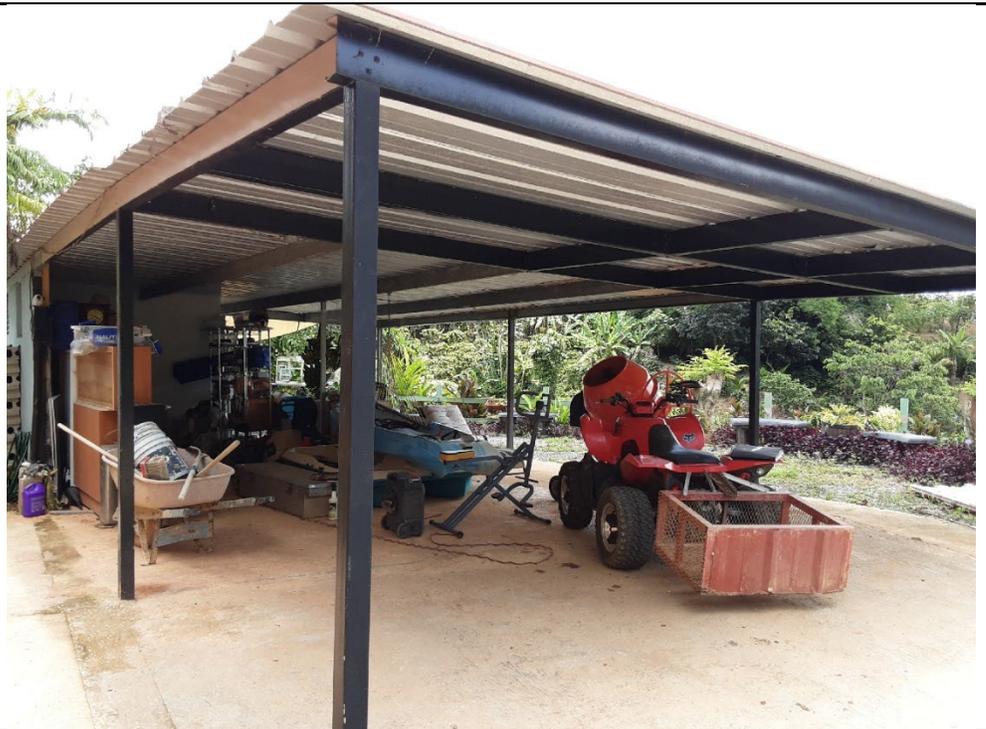
Photo #: 14	Date: 05/26/ 2023
Photo Direction: Southeast	
Description: This picture is an overview of the second option for a galvanized roof 18x18ft replacement and reinforcement, taken from the northwest corner, showing a partial view of a small warehouse at the back of option 2, construction materials, and an empty gas tank.

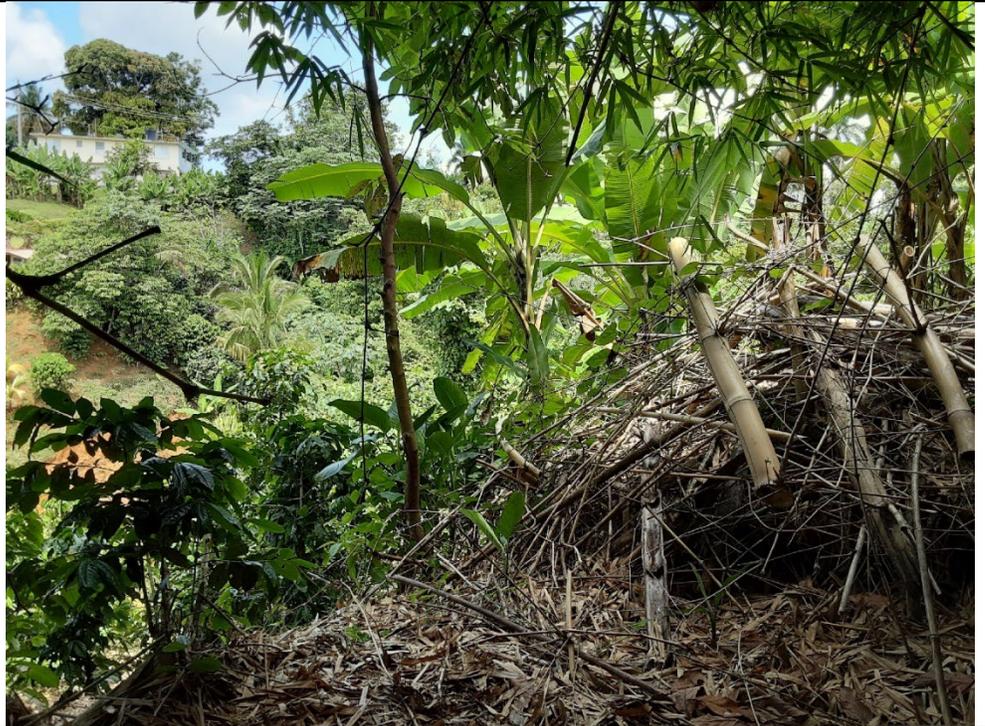
Photo #: 16	Date: 05/26/ 2023
Photo Direction: Northwest	
Description: This picture was taken from the beginning of where the northeast to northwest fence will be located, showing the vegetation and the property. The fence will use barbed wire with metal posts and is going to be 1 ft deep approximately.

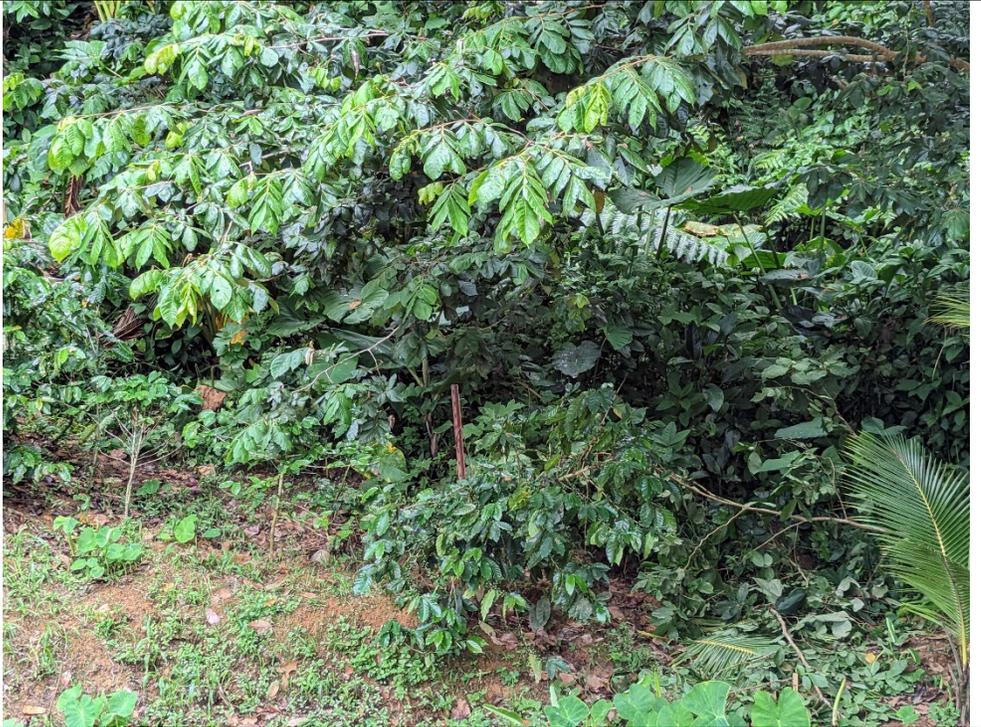
Photo Direction: North		
Description: This picture was taken from a middle point where the northeast to northwest fence will run. The fence will be a barbed wire with metal posts and is going to be 1 ft deep approximately. The picture shows one of the posts marking the property line.

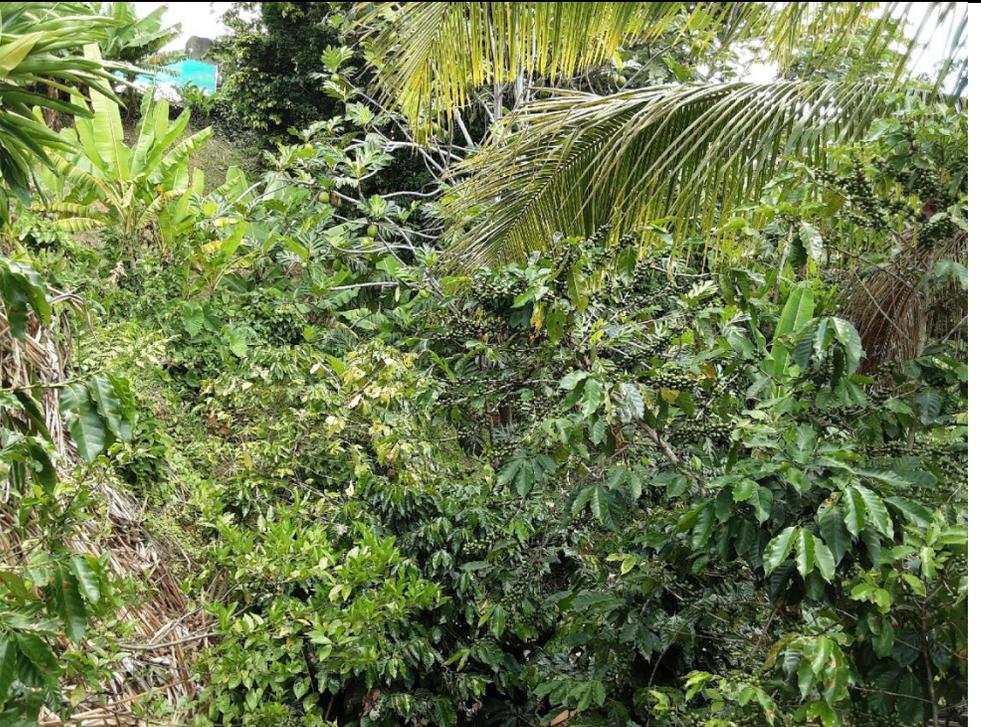
Photo Direction: Northwest		
Description: This picture was taken from an endpoint where the northeast to northwest fence will run. The fence will be a barbed wire with metal posts and is going to be 1 ft deep approximately.

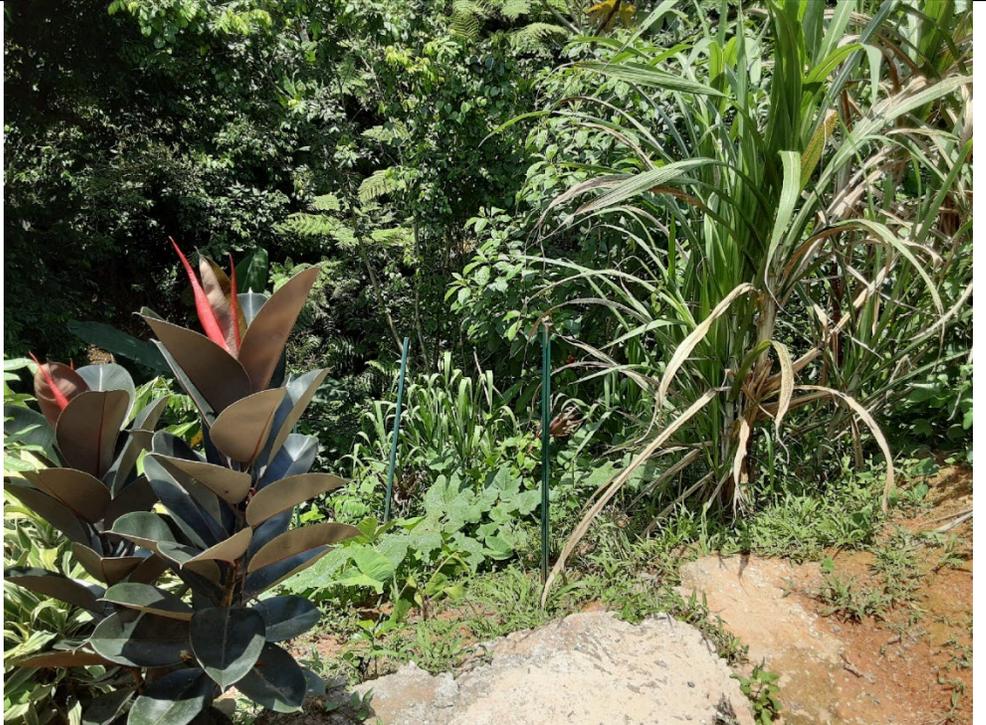
Photo Direction: Southeast		
Description: This picture was taken from the beginning of where the southwest to the southeast fence will be located, showing the vegetation and the metal post that will be used with barbed wire, 1 ft deep approximately.

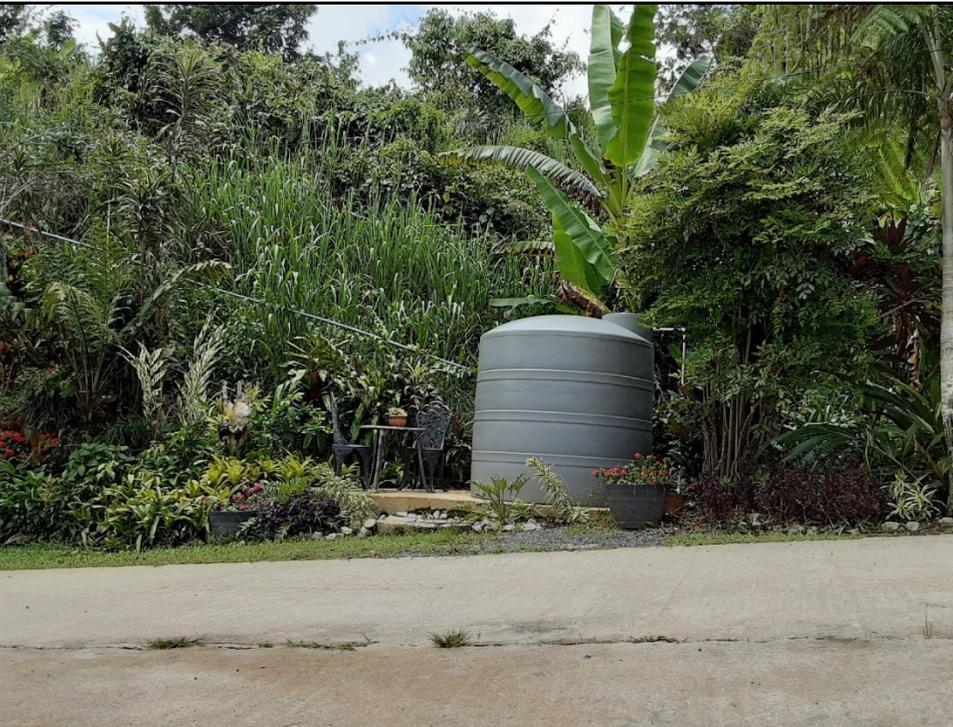
Photo Direction: South		
Description: This picture overviews the site location for a cistern right next to the existing one (left), which was bought by the previous owner and will be placed on an existing concrete platform. This cistern will help with the crops with an above-ground irrigation system (not funded by ReGrow).

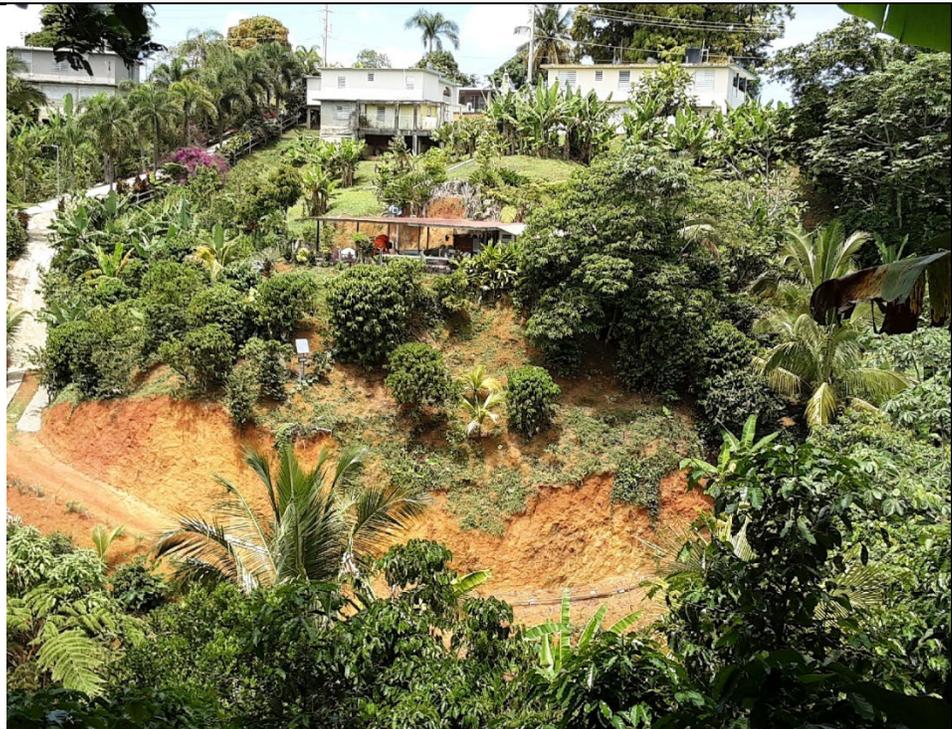
Photo #: 21	Date: 05/26/ 2023
Photo Direction: West	
Description: This picture is an overview of the property showing the areas where the coffee will be planted; the applicant mentioned the areas where there is no vegetation on the hillside are where coffee will be grown. Coffee must be 8 to 9 inches deep on the ground.

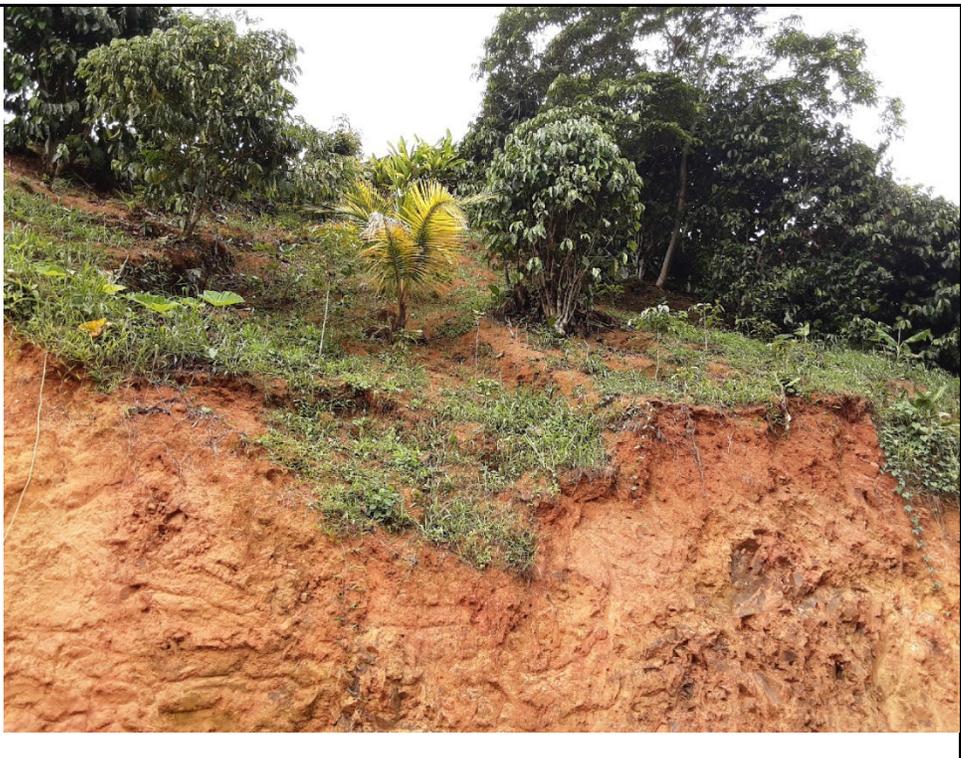
Photo #: 22	Date: 05/26/ 2023
Photo Direction: Northwest	
Description: This picture is an overview of the property showing a closer look of the areas where the coffee will be planted; the applicant mentioned the areas where there is no vegetation on the hillside are where coffee will be grown. Coffee must be 8 to 9 inches deep on the ground.

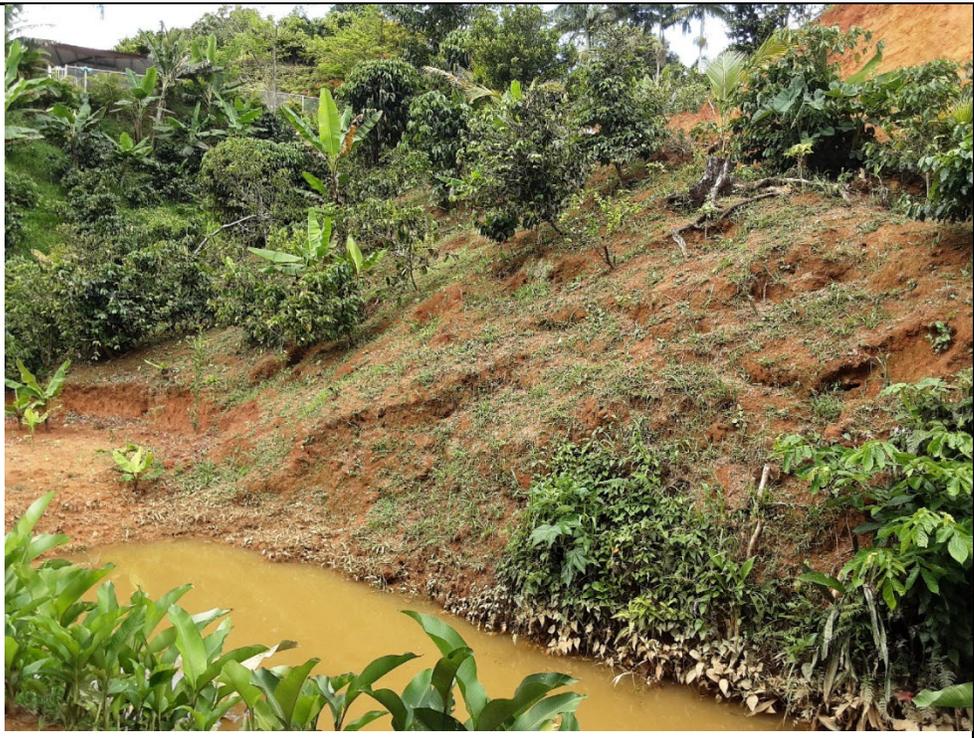
Photo #: 23	Date: 05/26/ 2023
Photo Direction: Southeast	
Description: This picture is an overview of the property showing the areas where the coffee will be planted and an artificial pond; the applicant mentioned the areas where there is no vegetation on the hillside are where coffee will be grown. Coffee must be 8 to 9 inches deep on the ground.

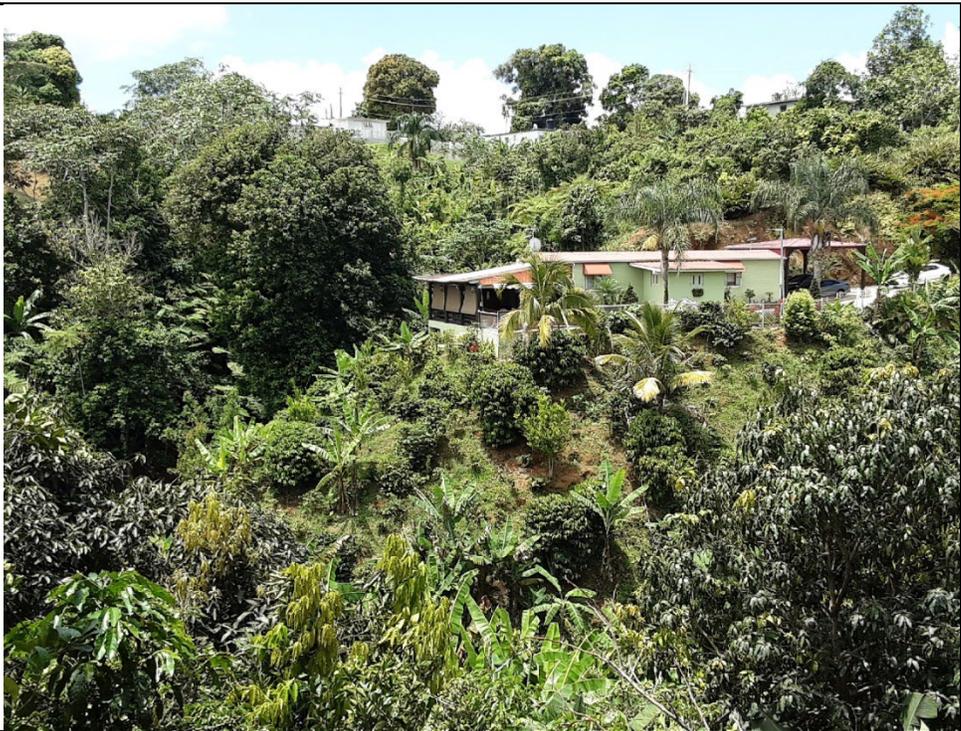
Photo #: 25	Date: 05/26/ 2023
Photo Direction: Southeast	
Description: This picture is an overview of the property showing the areas where the coffee will be planted; the applicant mentioned the areas where there are no plantains on the hillside are where coffee will be grown. Coffee must be 8 to 9 inches deep on the ground.
