Environmental Assessment

Project ID: PR-RGRW-01037

Project Name: Montuno, LLC

The proposed project, which includes the installation of a water well and the purchase of equipment, is located on a 50.44-acre parcel (Cadastral Numbers 244-000-004-49-000 and 244-000-004-39) at Carretera 590 Km. 4.2 Interior, Barrio Bauta Abajo, Sector La Francia, Orocovis, Puerto Rico 00720 (see Appendix A, **Figure 1**- Site Location and **Figure 2**- Site Vicinity). This property is in a rural area in the western portion of Orocovis Municipio. Access to the project area is provided via an unpaved road at the southern portion of the parcel.

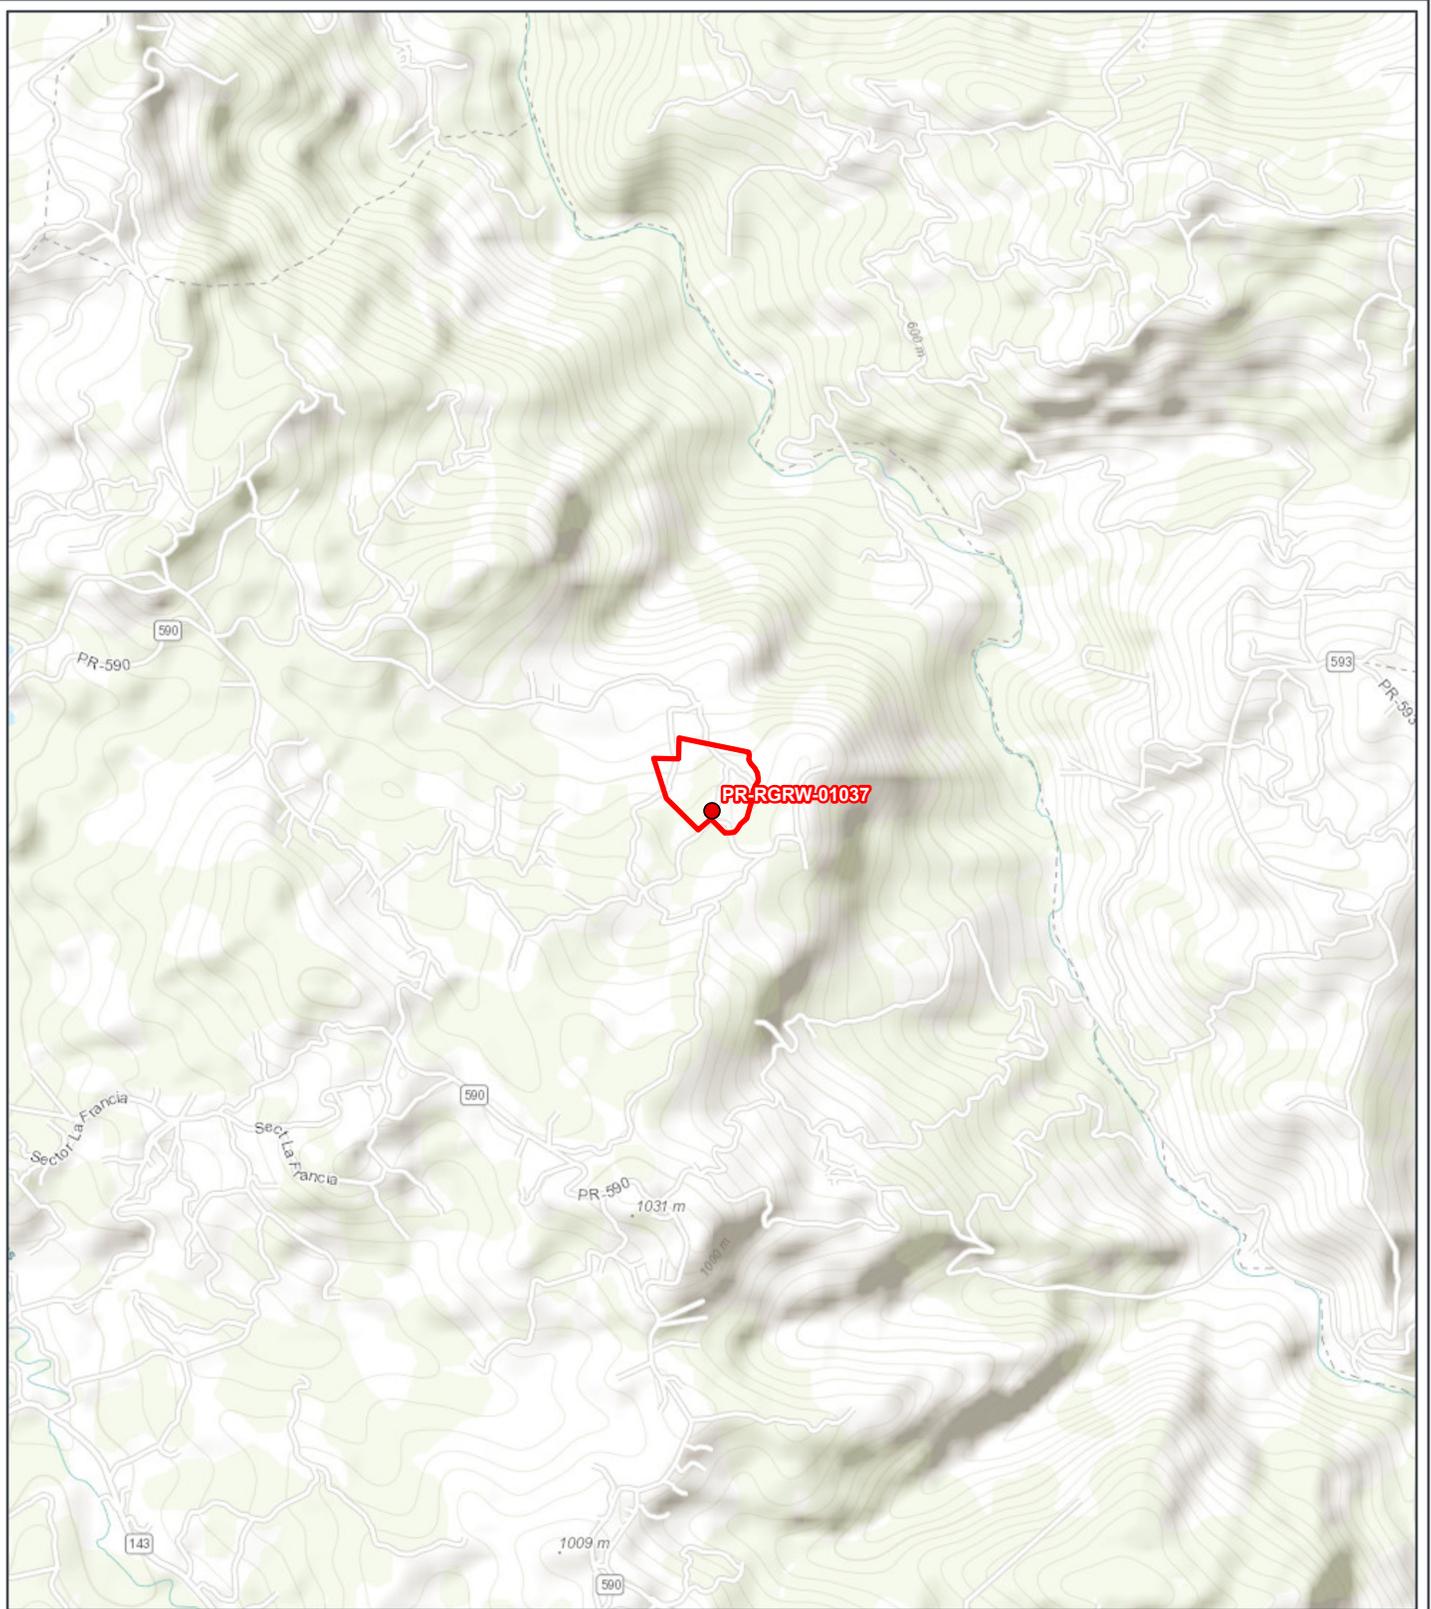
**Figure A-1:
Site Location**

Figure 1
Site Location Map

The applicant has identified two locations for project activities related to the Intended Use of Grant Funds that are being evaluated under this Environmental Assessment (EA), also shown on Figures 1 and 2:

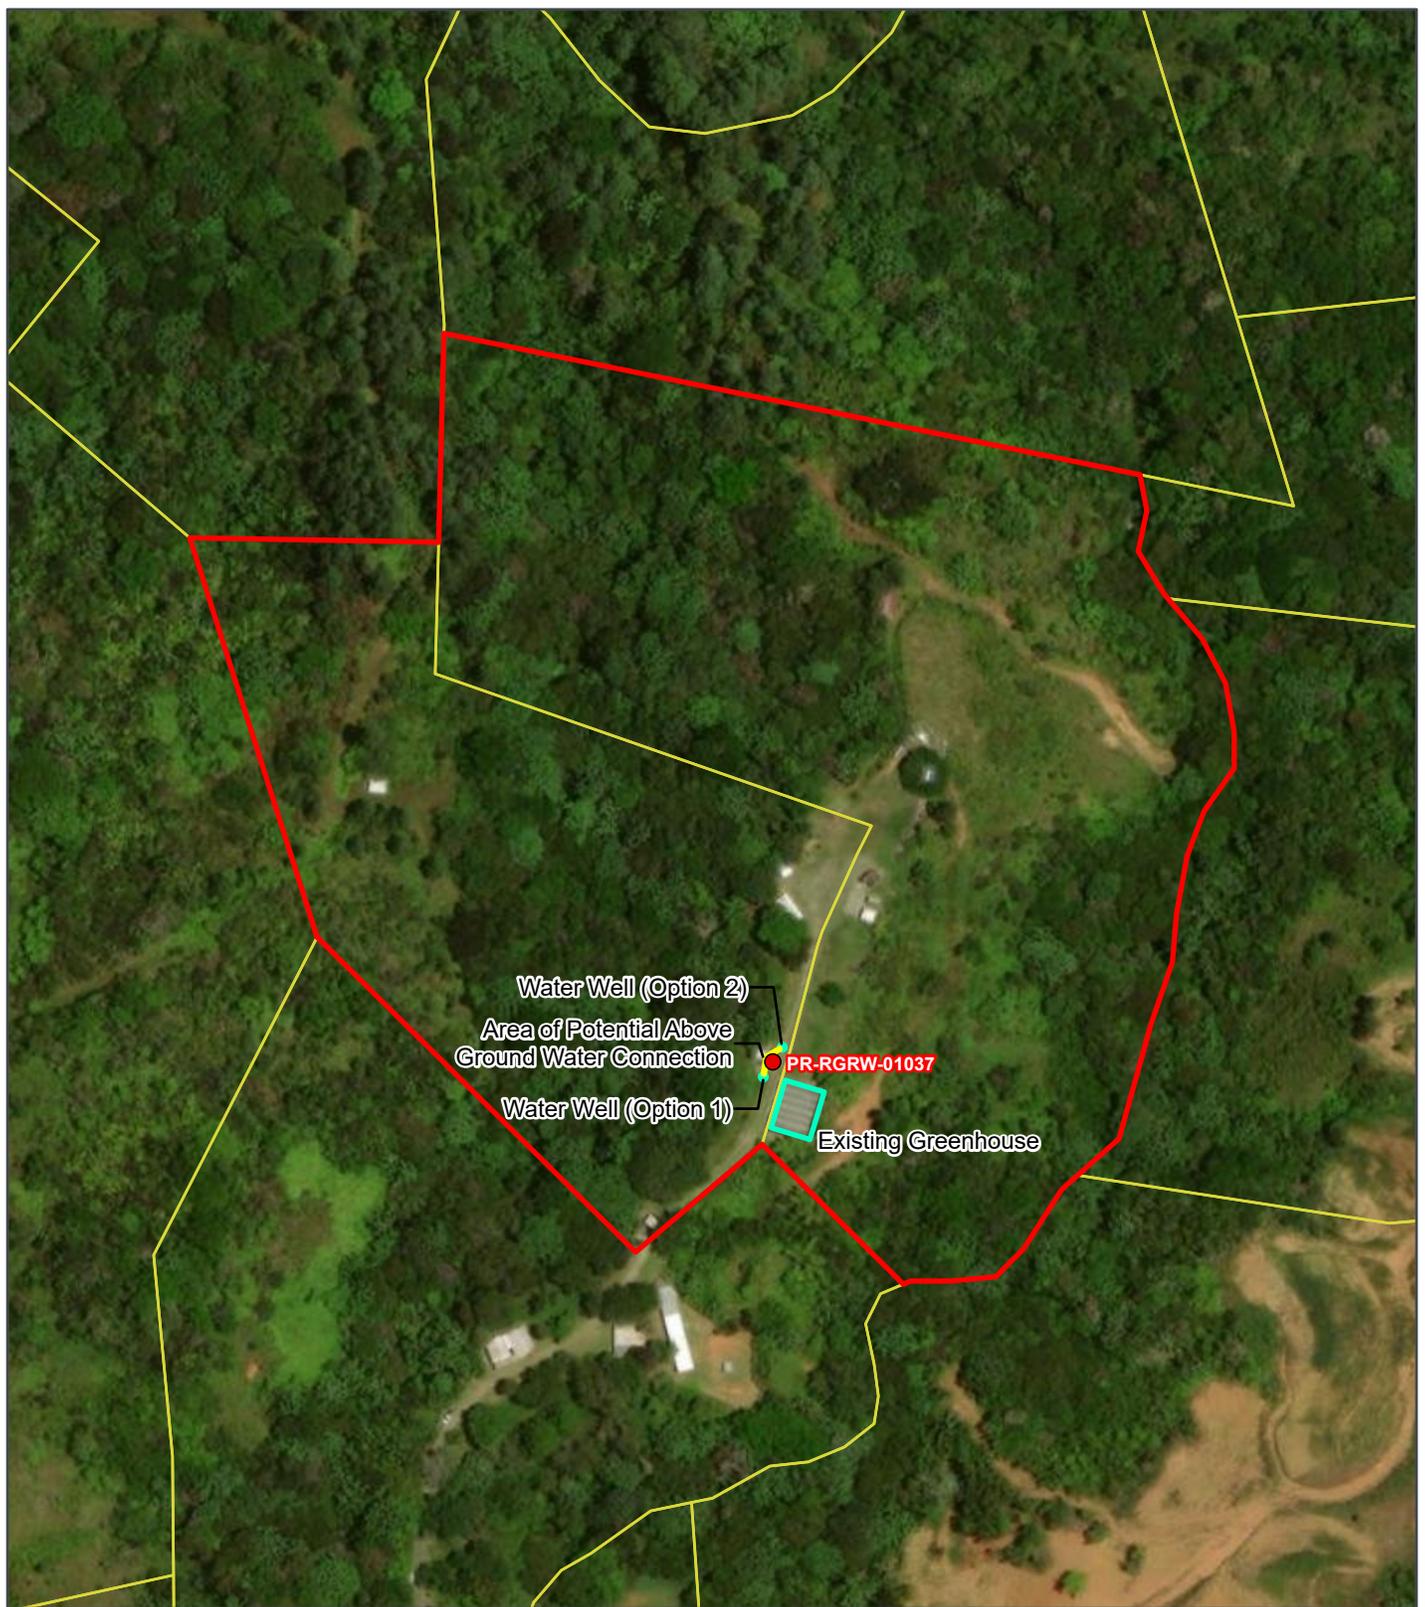
**Figure A-2:
Site Vicinity**

Figure 2
Site Vicinity Map

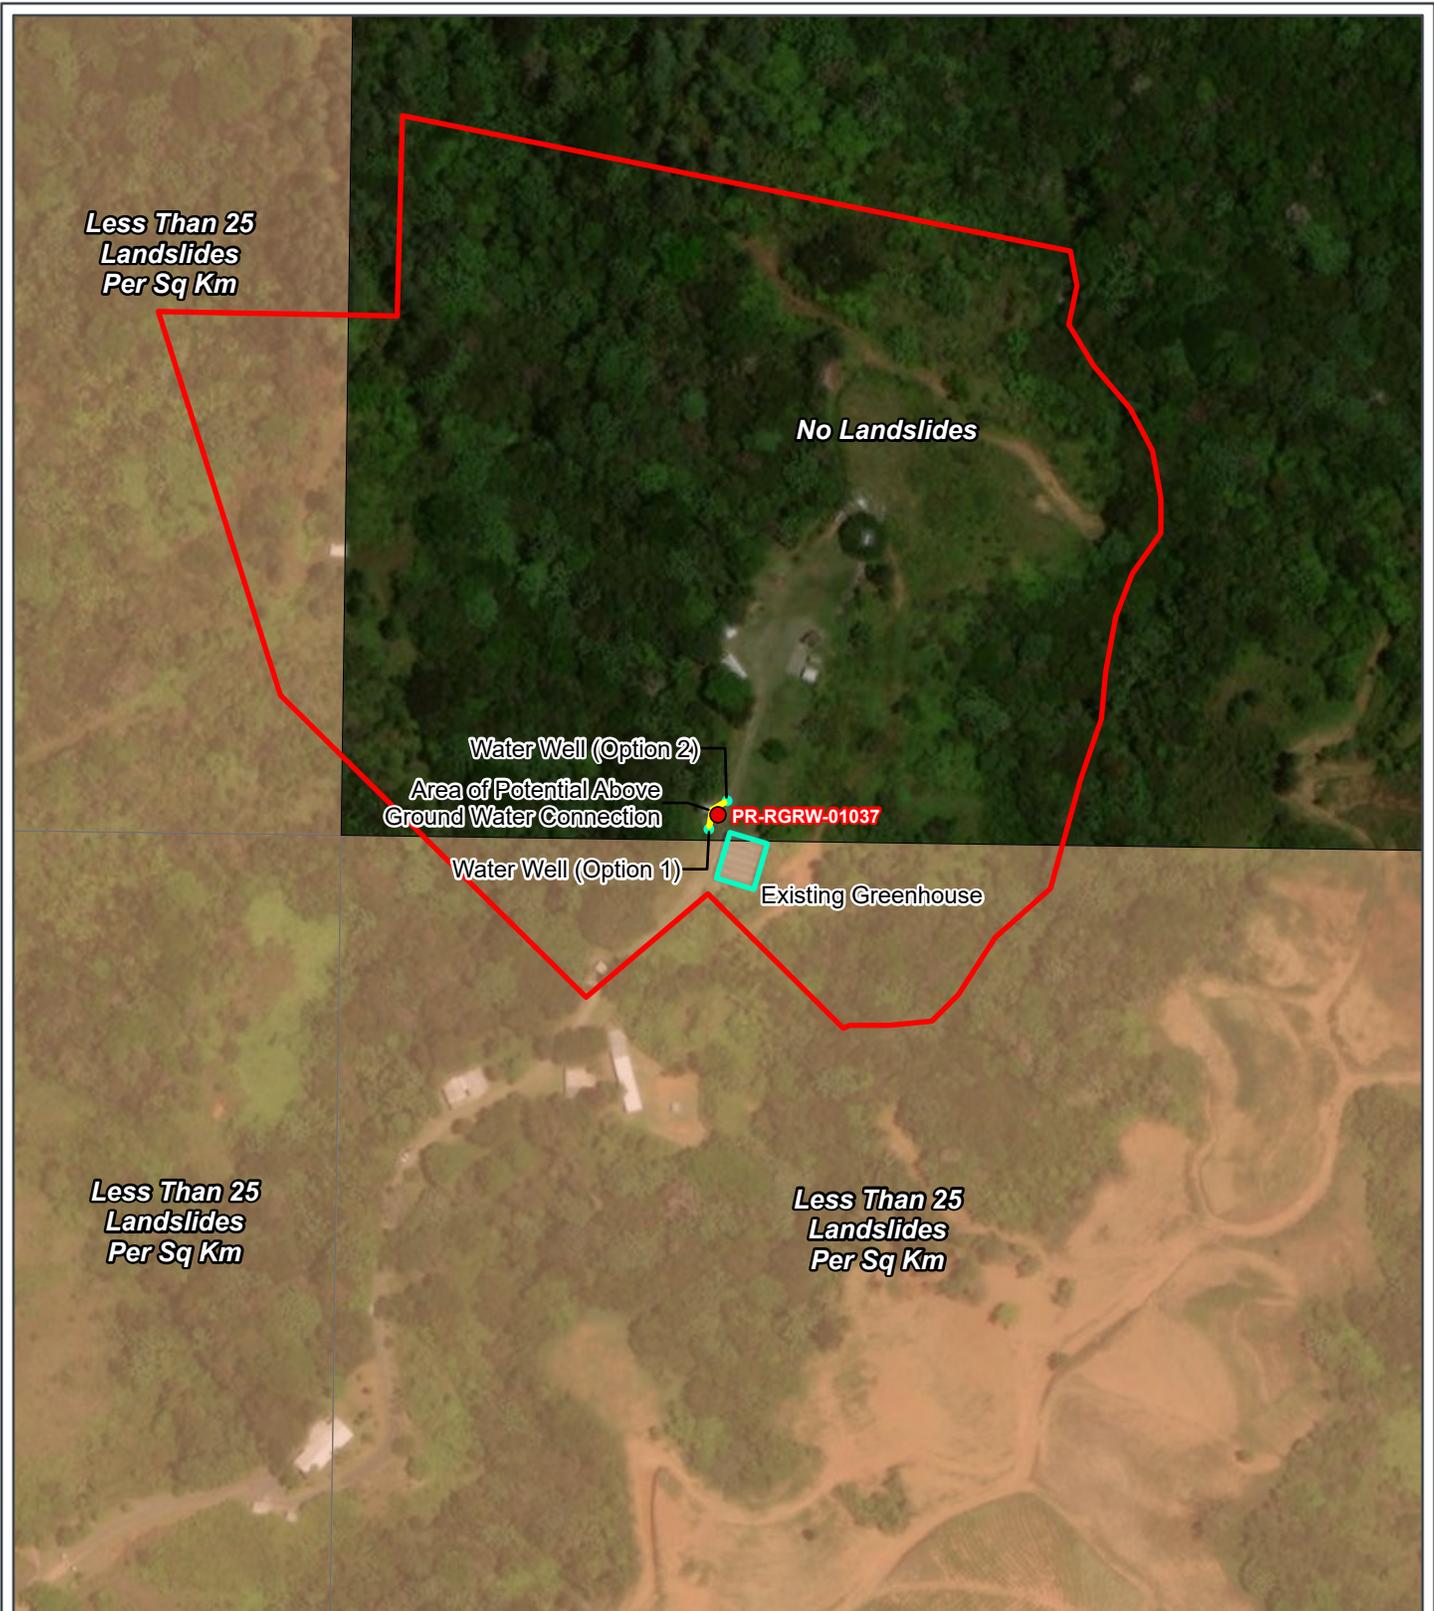
**Figure A-3:
USGS Landslide Map**

Figure 3
USGS Landslide Map

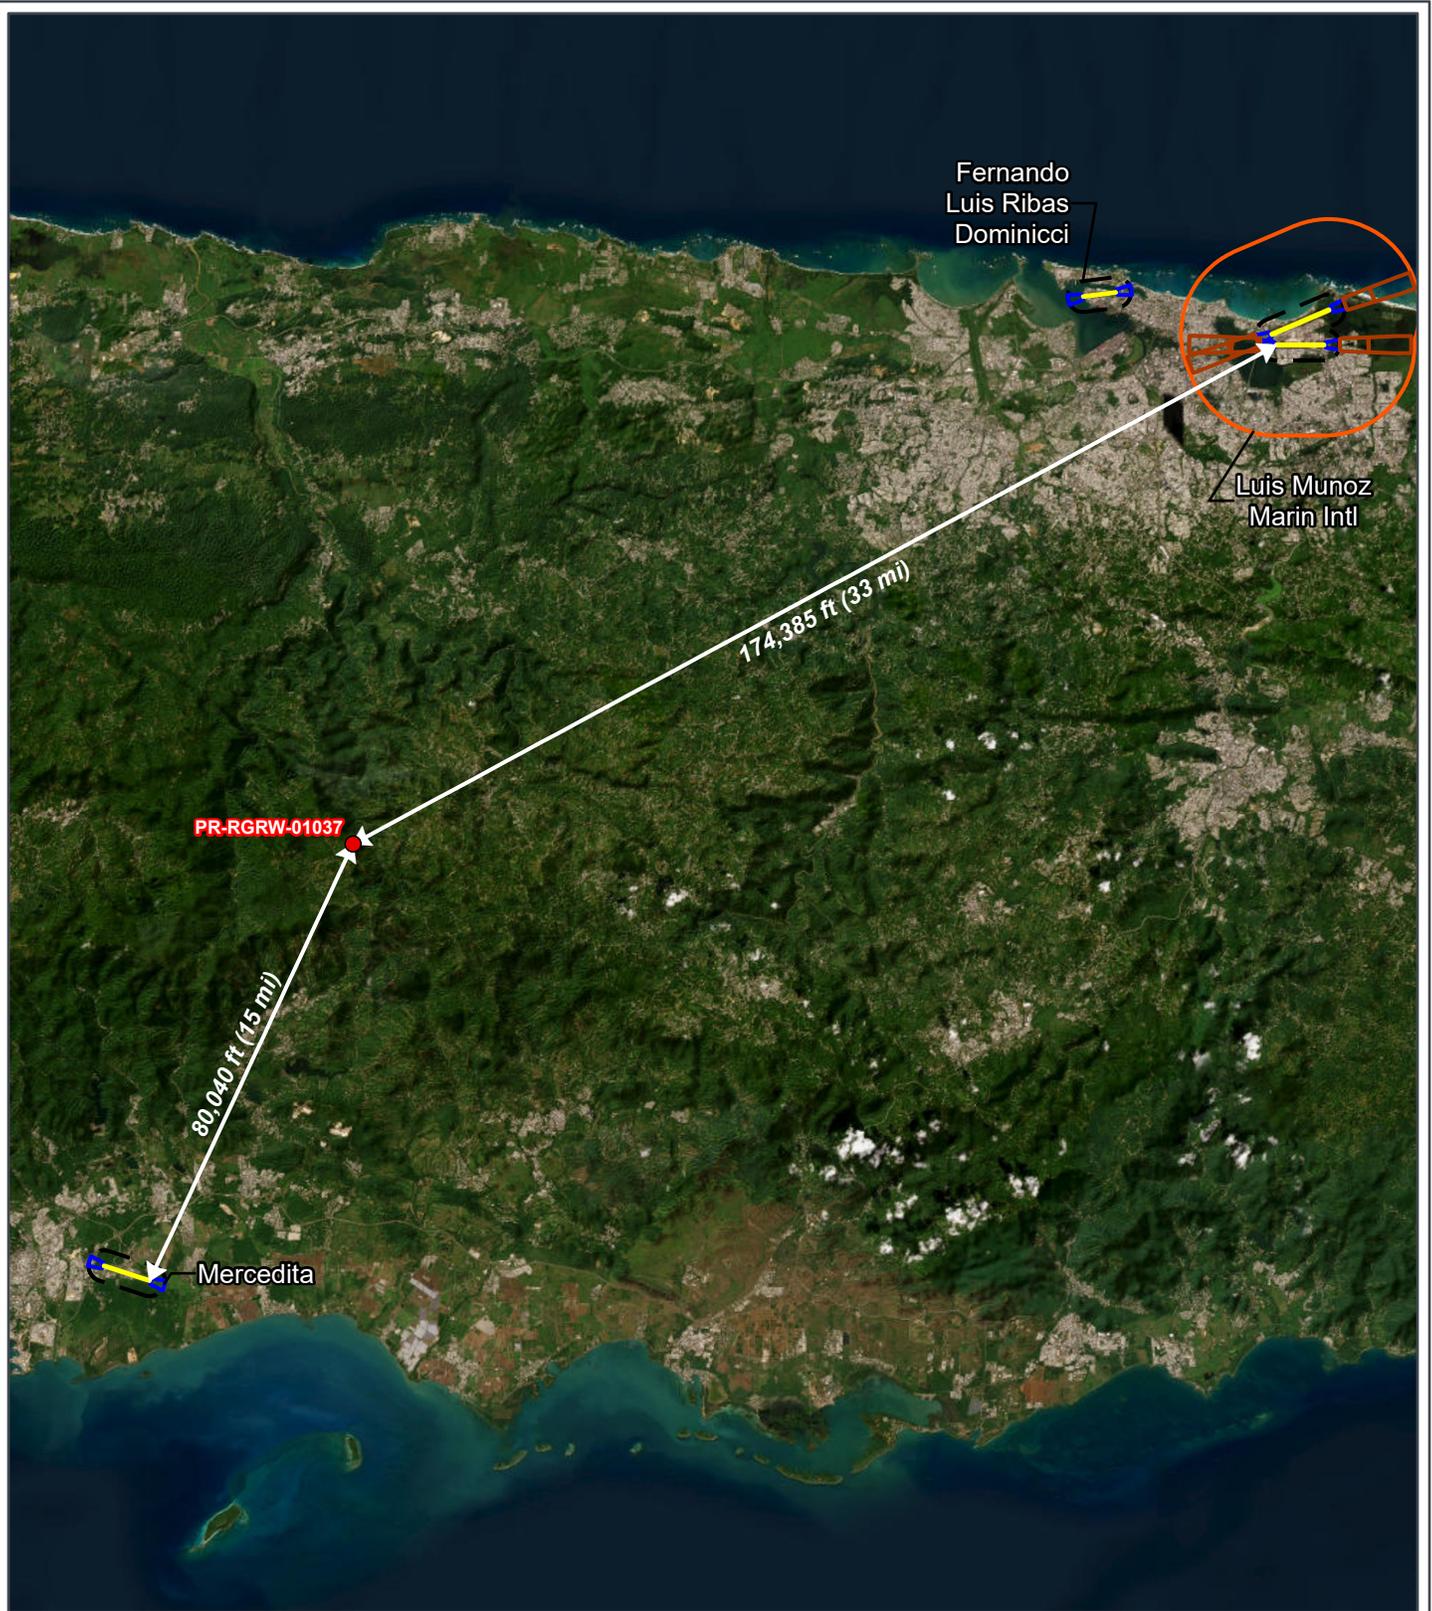
**Figure B 1-1:
Airport Hazards Map**

The project sites are not within 2,500 feet of a civil primary or commercial service airport or within 15,000 feet of a military airport. The nearest civil primary or commercial service airport, Mercedita, is located 80,040 feet (15 miles) south of the project sites. The nearest military airport, Luis Munoz Marin International Airport, is located 174,385 feet (33 miles) northeast of the project sites. No further evaluation is required. The project is in compliance with airport hazards requirements.

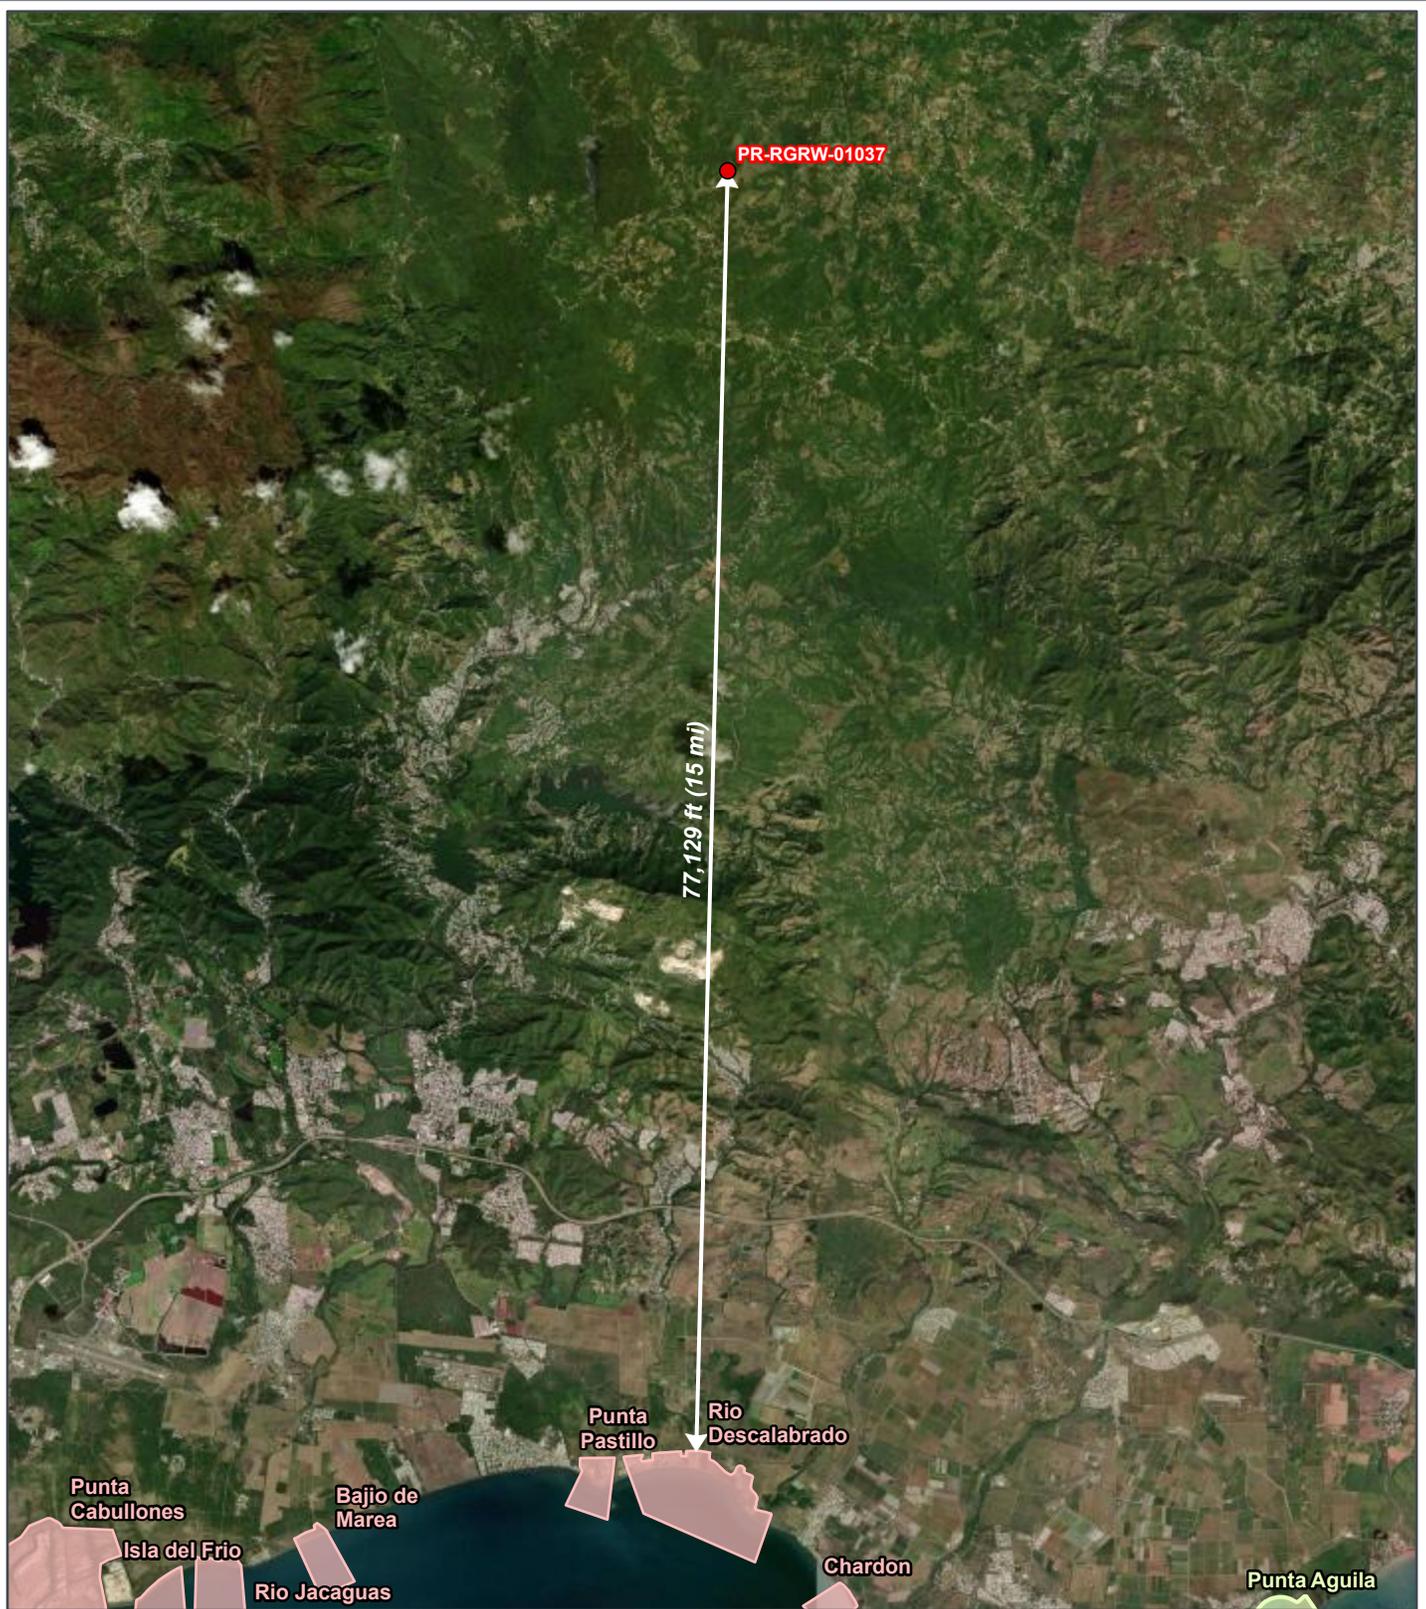
Figure B 2-1: Coastal Barrier Resources Map

The project sites are not located in a Coastal Barrier Resource Systems Unit (CBRS) or Otherwise Protected Area (OPA). There are no CBRS units in Orocovis. The closest CBRS unit, Rio Descalabrado, is located 77,129 feet (15 miles) south of the project sites. No further evaluation is required. The project is in compliance with the Coastal Barrier Resources Act.

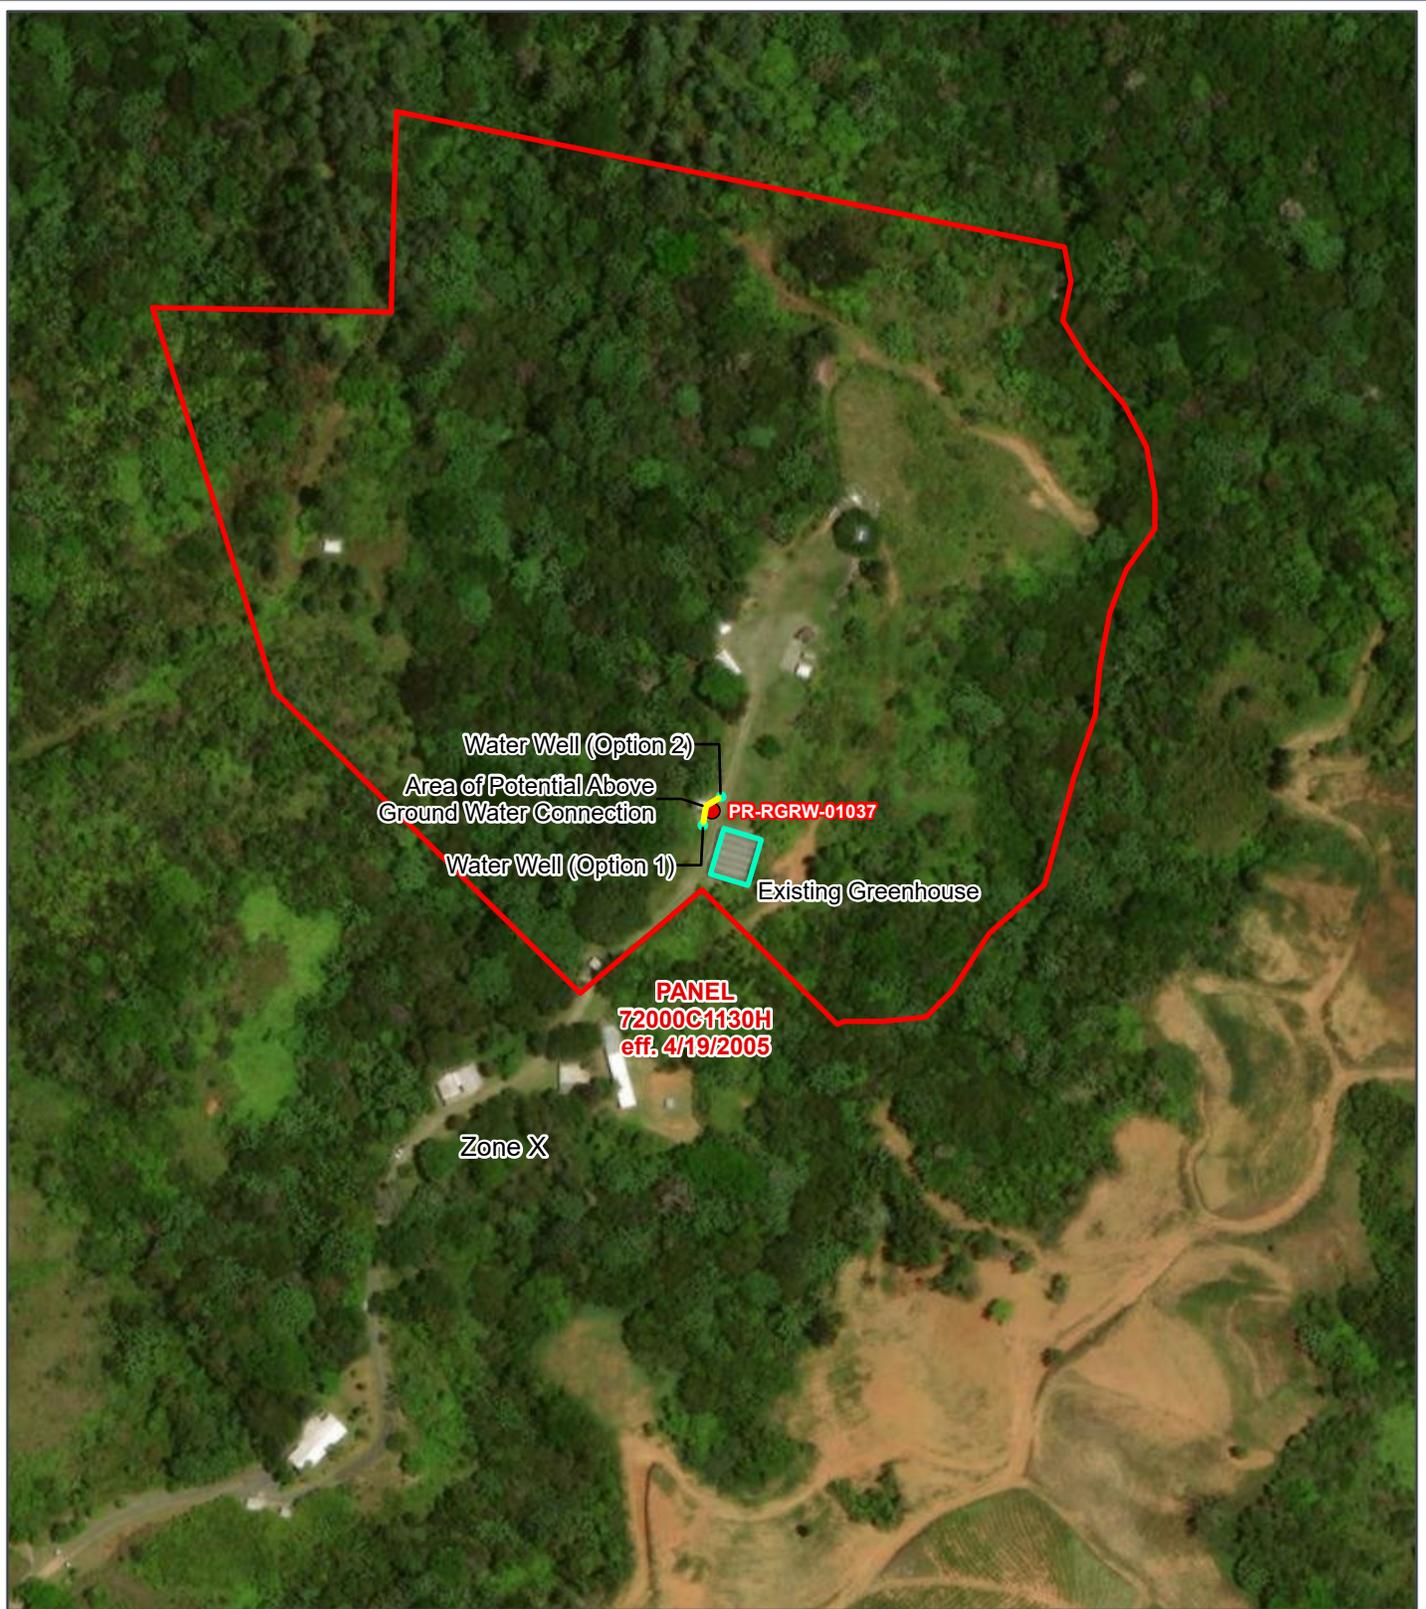
Figure B 3-1: Flood Insurance Rate Map (FIRM)

A review of the FEMA Flood Insurance Rate Map (FIRM), Community Panel 72000C1130H (effective date 4/19/2005), shows the project sites are in Flood Zone X, which is not in a Special Flood Hazard Area (SFHA). Flood insurance is not required. No further evaluation is required. The project is in compliance with the Flood Disaster Protection Act and National Flood Insurance Reform Act.

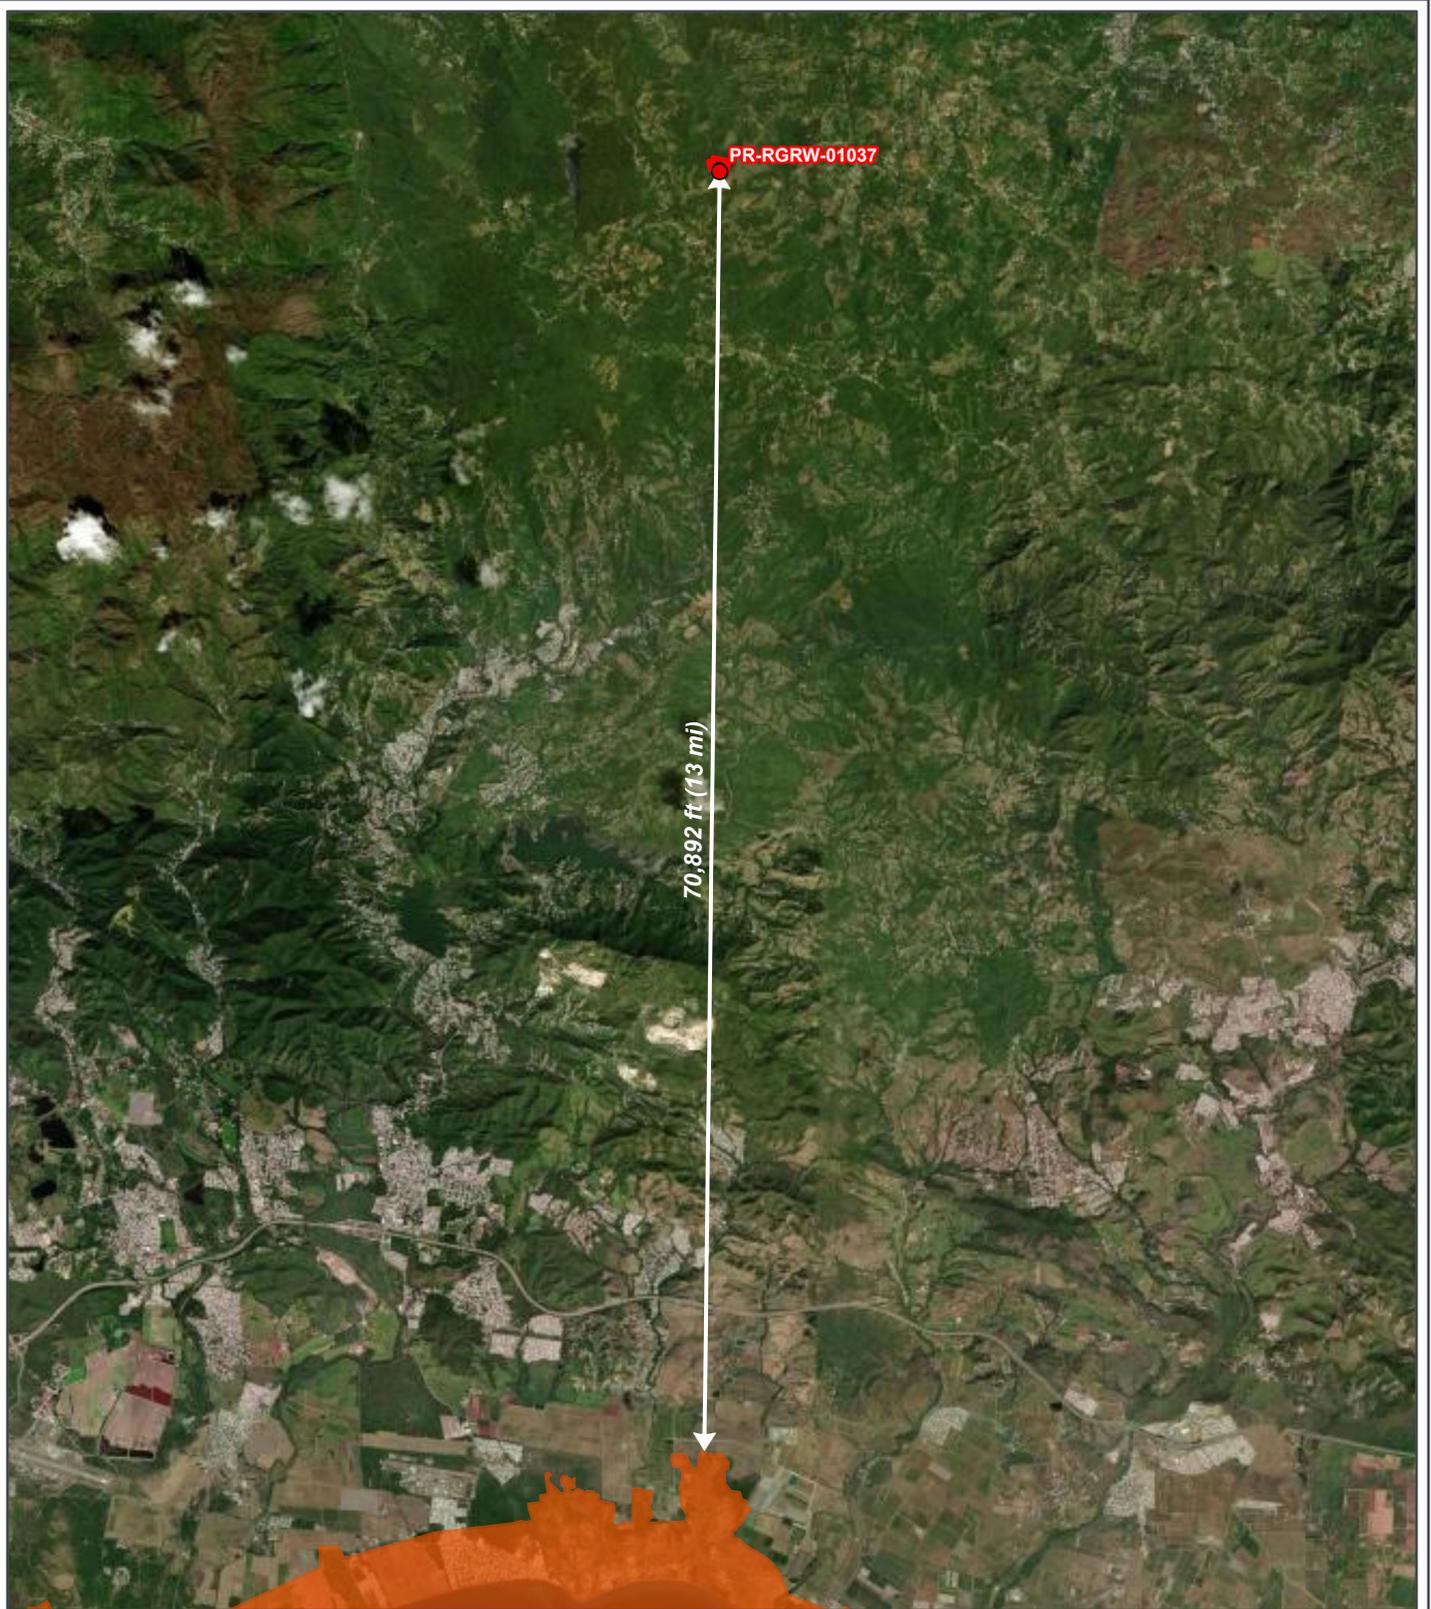
Figure B 5-1: Coastal Zone Management Map

The project sites are not located within the Puerto Rico Coastal Management Zone. The closest coastal zone area is located 70,892 feet (13 miles) south the project sites. No further evaluation is required. The project is in compliance with the Coastal Zone Management Act.

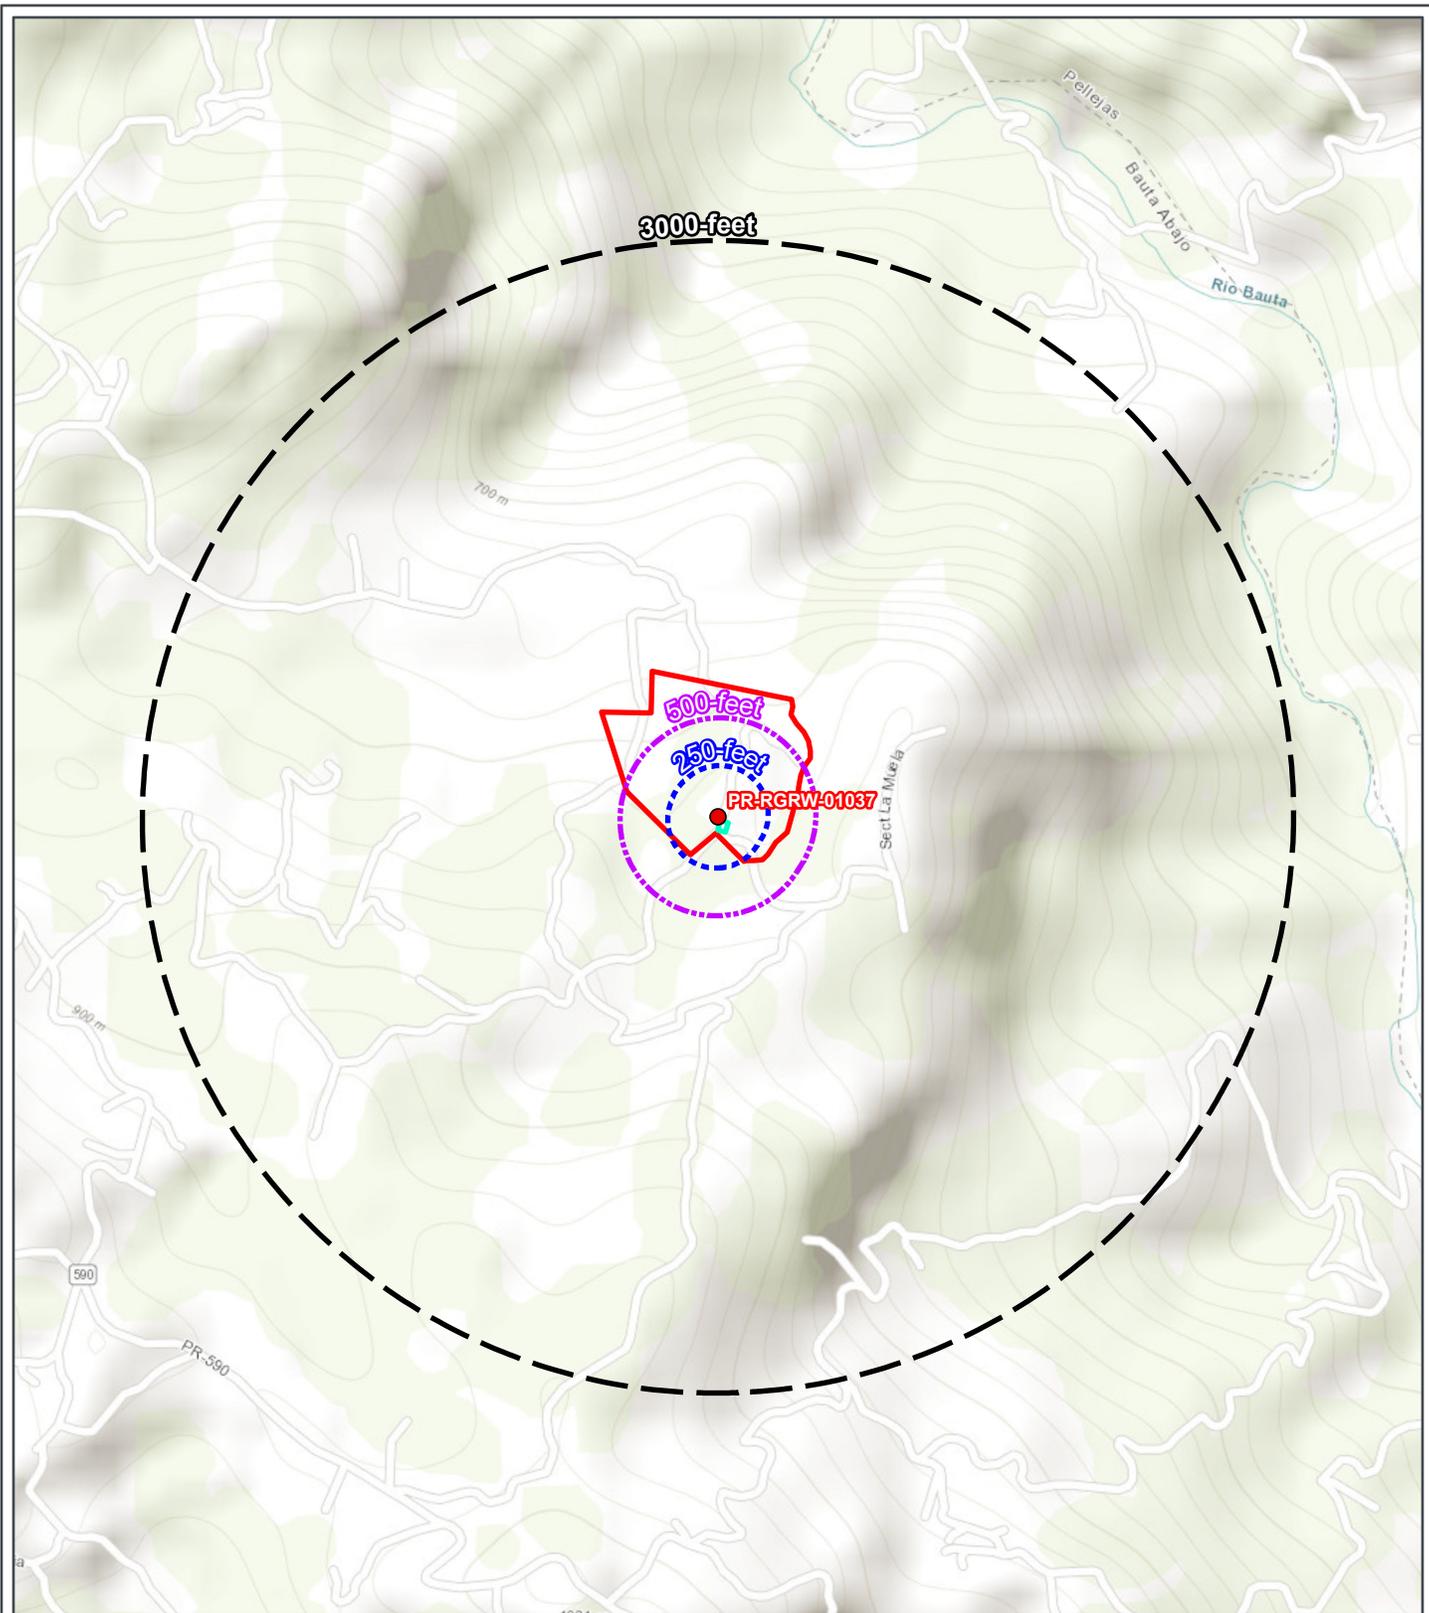
**Figure B 6-1:
Contamination and
Toxic Substances Map**

hazardous or radioactive substances in or within 3,000 feet of the project area that could affect the health and safety of project occupants or conflict with the intended use of the property. The project is in compliance with contamination and toxic substances requirements.

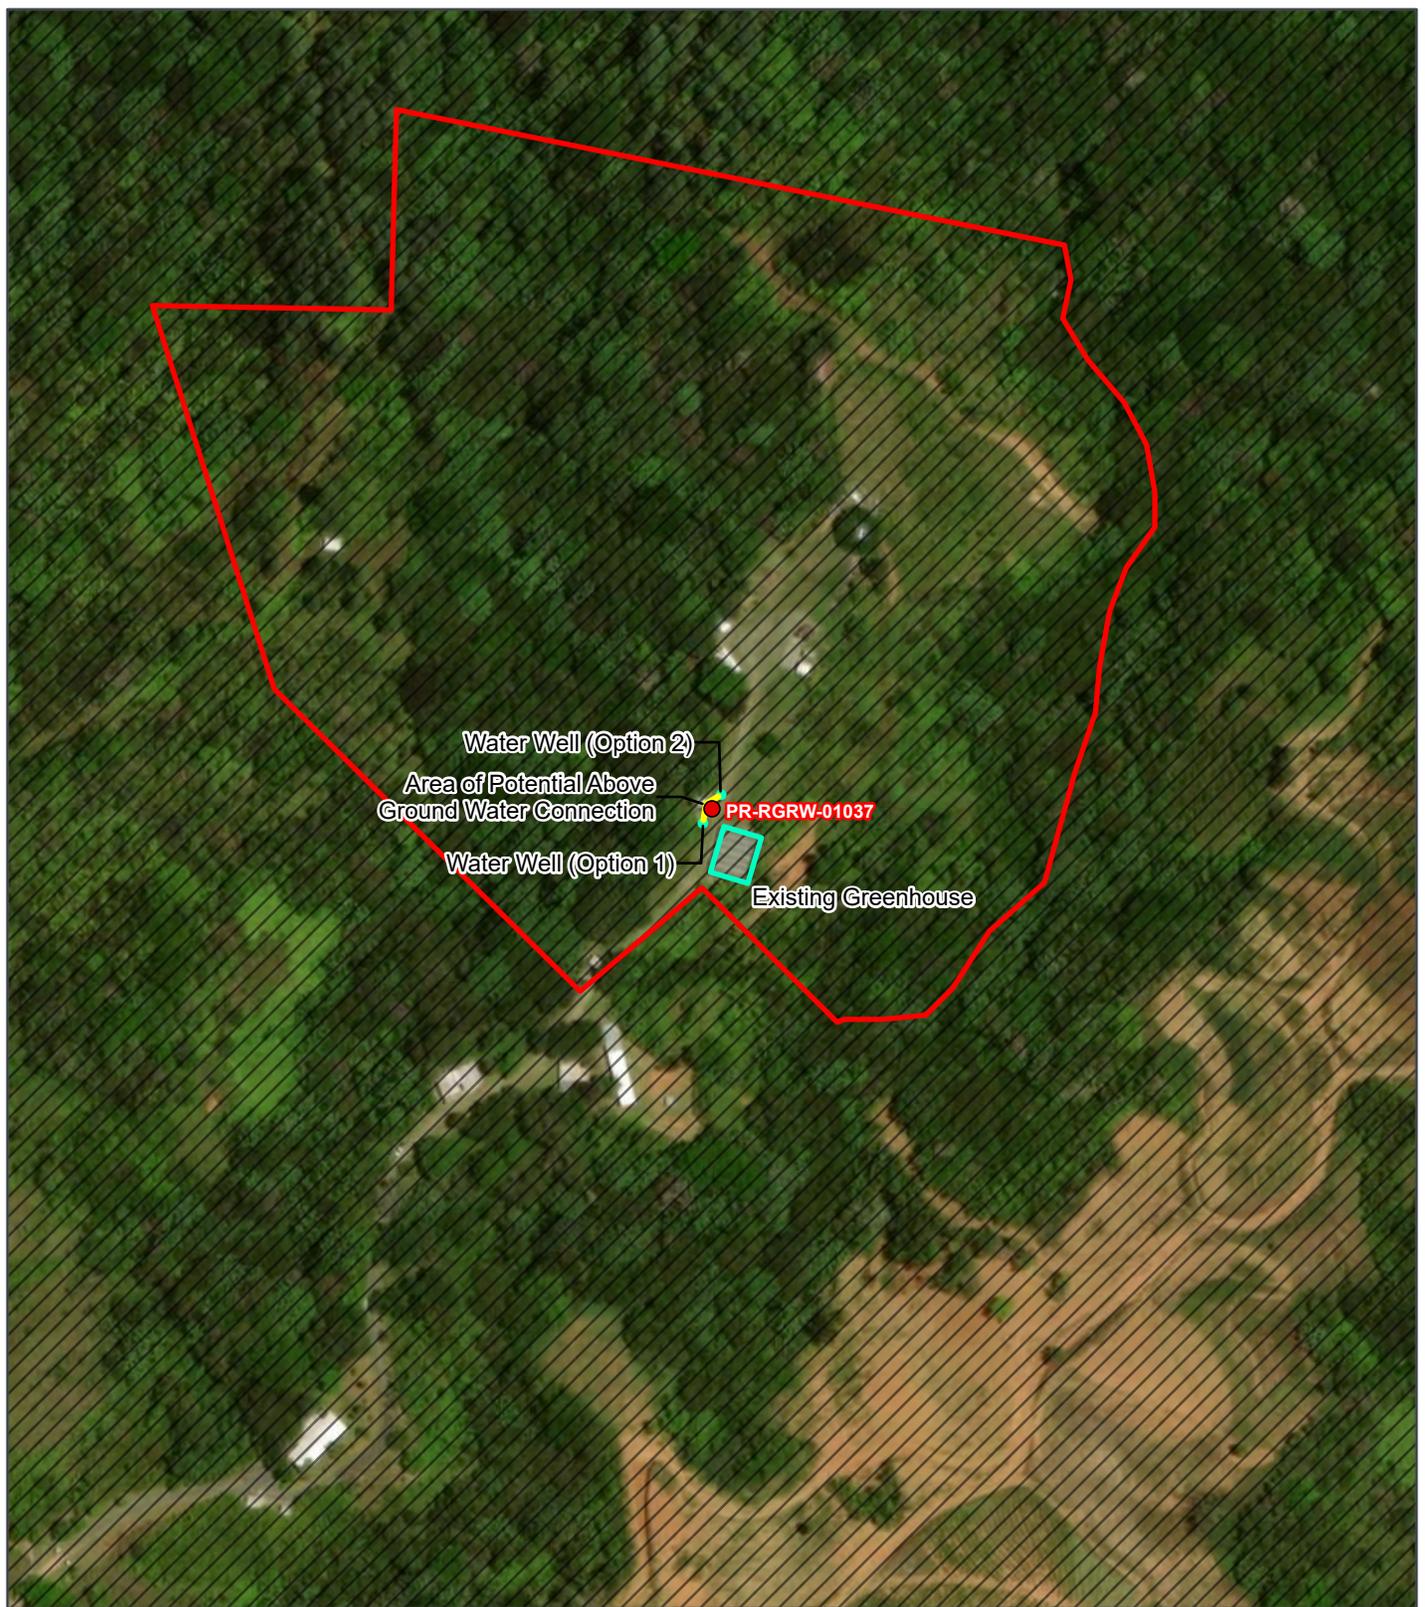
**Figure B 9-1:
Prime Farmland Map**

This project does not include any activities that could potentially convert agricultural land to non-agricultural use. No prime farmland or farmlands of statewide importance are within the project area. Although the project includes new construction, the project is exempt from review under the Farmland Protection Policy Act (FFPA) as the project is limited to construction of on-farm structures needed for farm operations. No further review is required. The project is in compliance with the Farmland Protection Policy Act.
