Environmental Assessment

Project ID: PR-RGRW-01037

Project Name: Montuno, LLC

The proposed project, which includes the installation of a water well and the purchase of equipment, is located on a 50.44-acre parcel (Cadastral Numbers 244-000-004-49-000 and 244-000-004-39) at Carretera 590 Km. 4.2 Interior, Barrio Bauta Abajo, Sector La Francia, Orocovis, Puerto Rico 00720 (see Appendix A, **Figure 1**- Site Location and **Figure 2**- Site Vicinity). This property is in a rural area in the western portion of Orocovis Municipio. Access to the project area is provided via an unpaved road at the southern portion of the parcel.

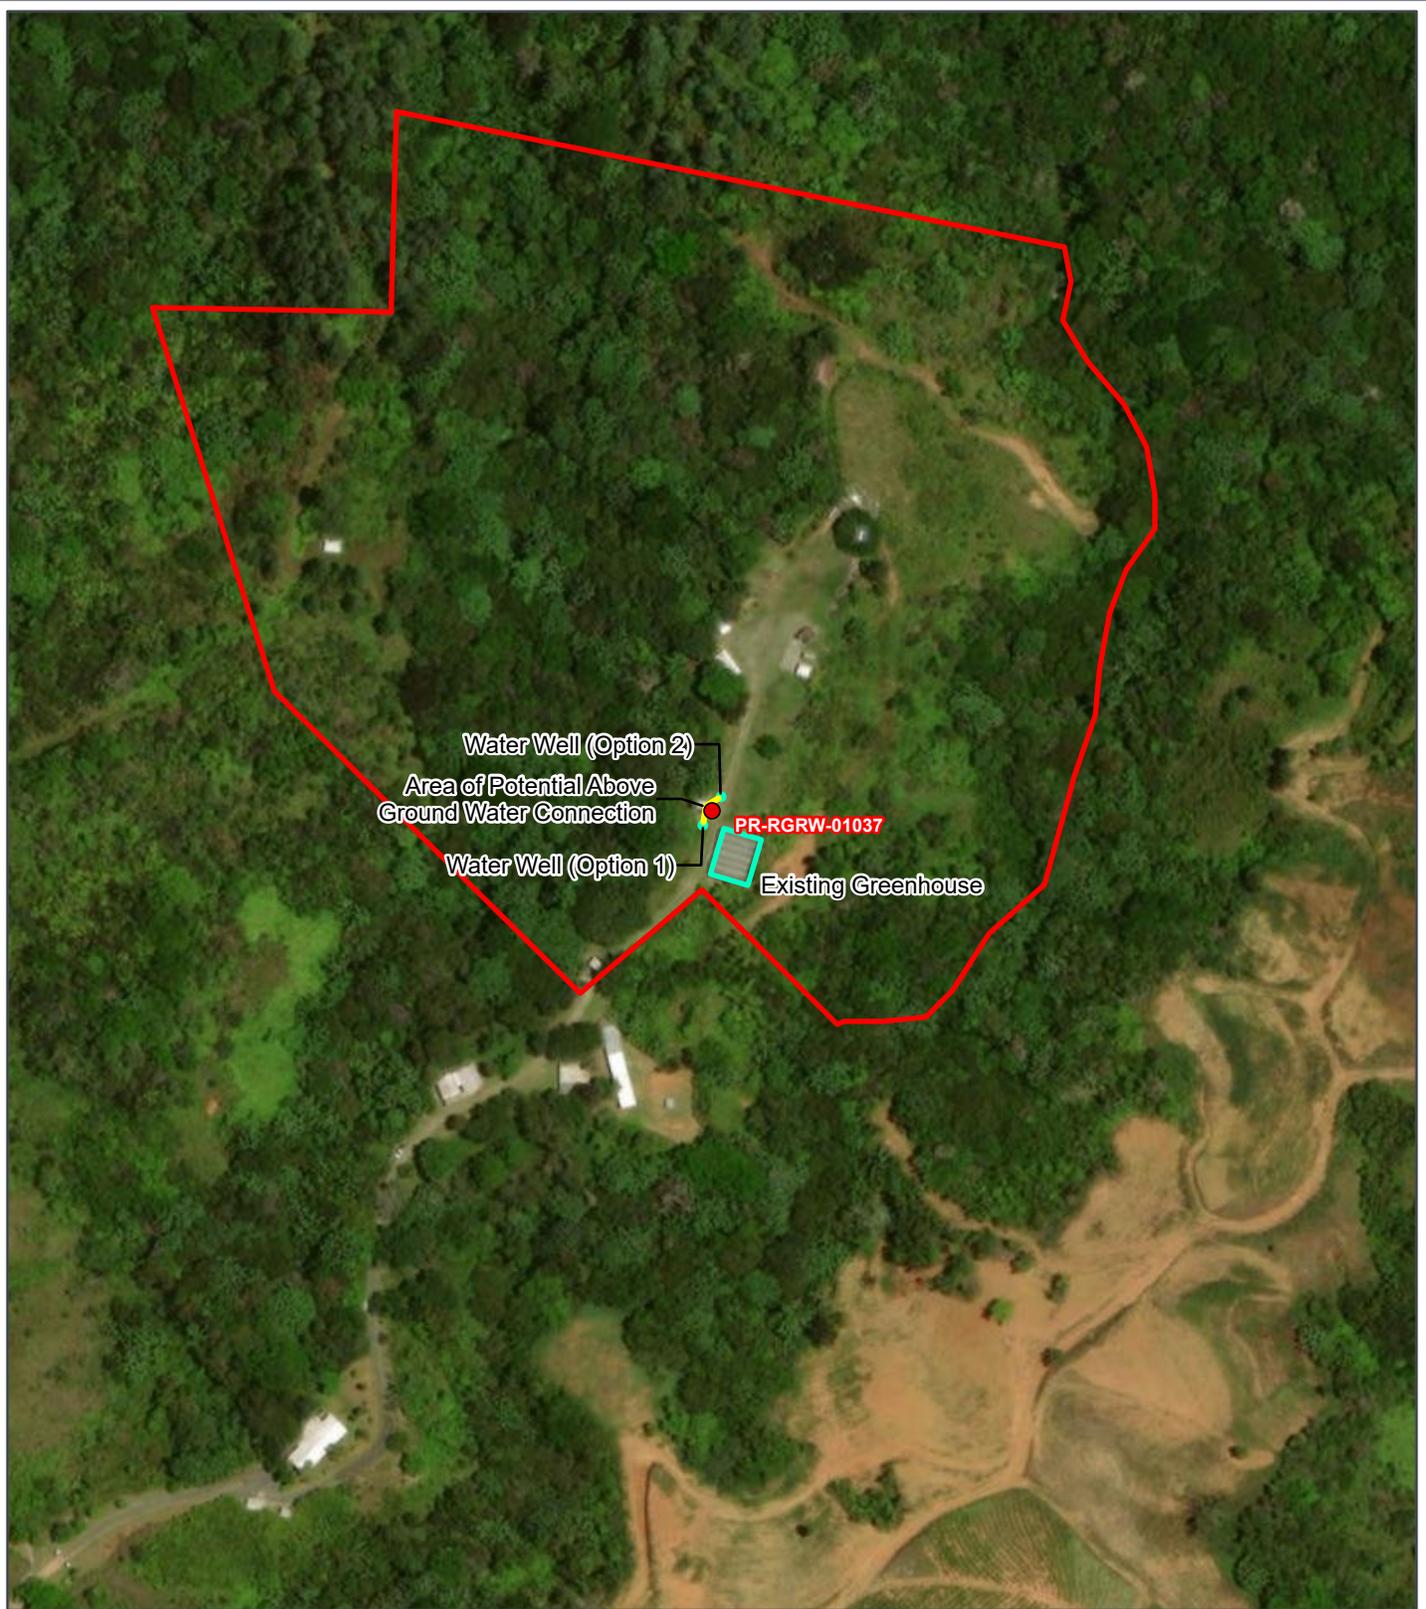
**Figure B 10-1:
Advisory Base Flood
Elevation For 100-Year
Floodplain Map**

The FEMA FIRM, Community Panel 72000C1130H (effective date 4/19/2005), shows the project sites are in Flood Zone X. An Advisory Base Flood Elevation (ABFE) map was developed by FEMA for this FIRM, which shows the project sites are in Flood Zone X. The project is not located in the 100-year floodplain or ABFE special flood hazard area; therefore, no further action is required. The project is in compliance with Executive Order 11988.

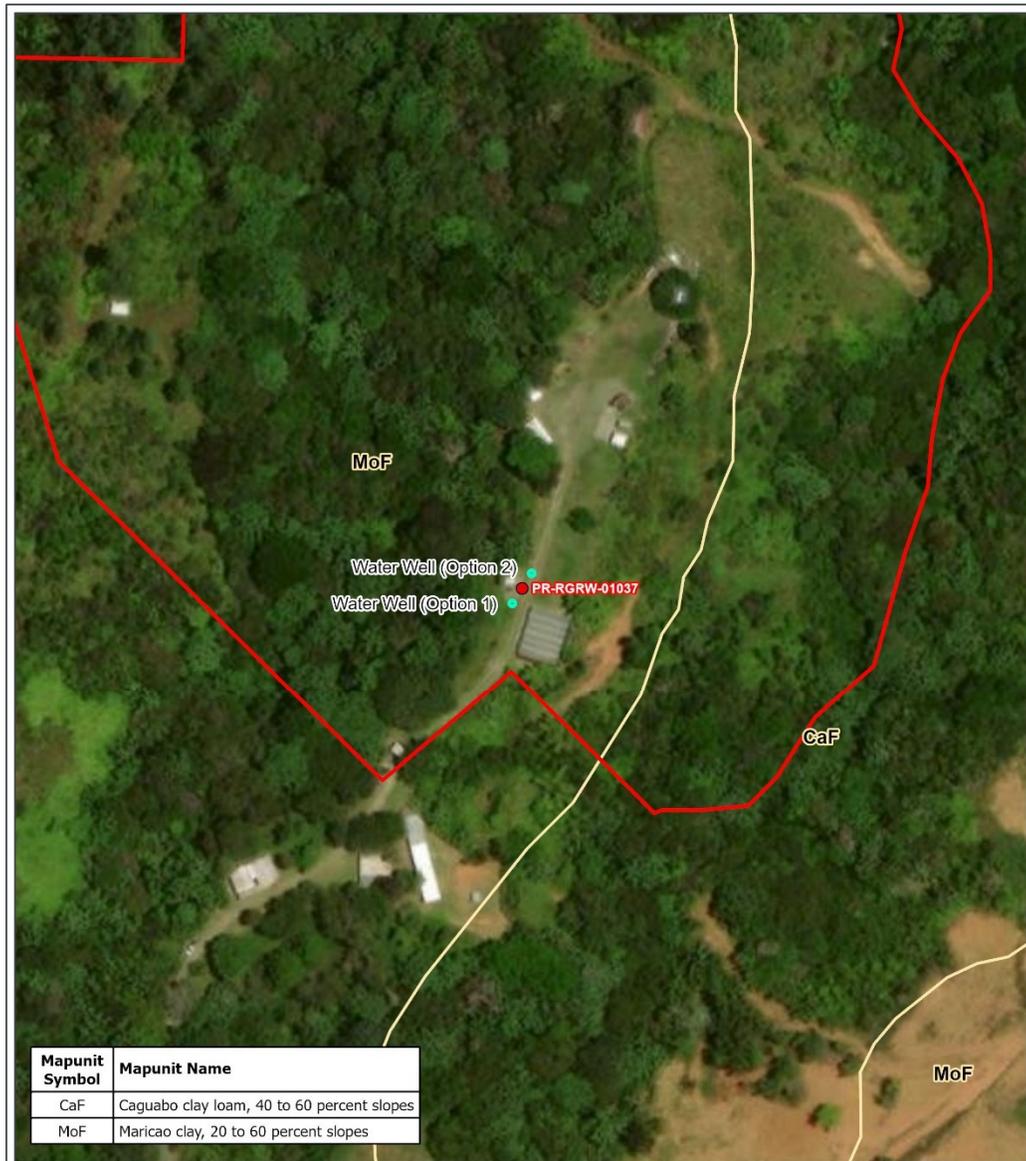
Project (Parcel) Location – Soils Map

Mapunit Symbol	Mapunit Name
CaF	Caguabo clay loam, 40 to 60 percent slopes
MoF	Maricao clay, 20 to 60 percent slopes

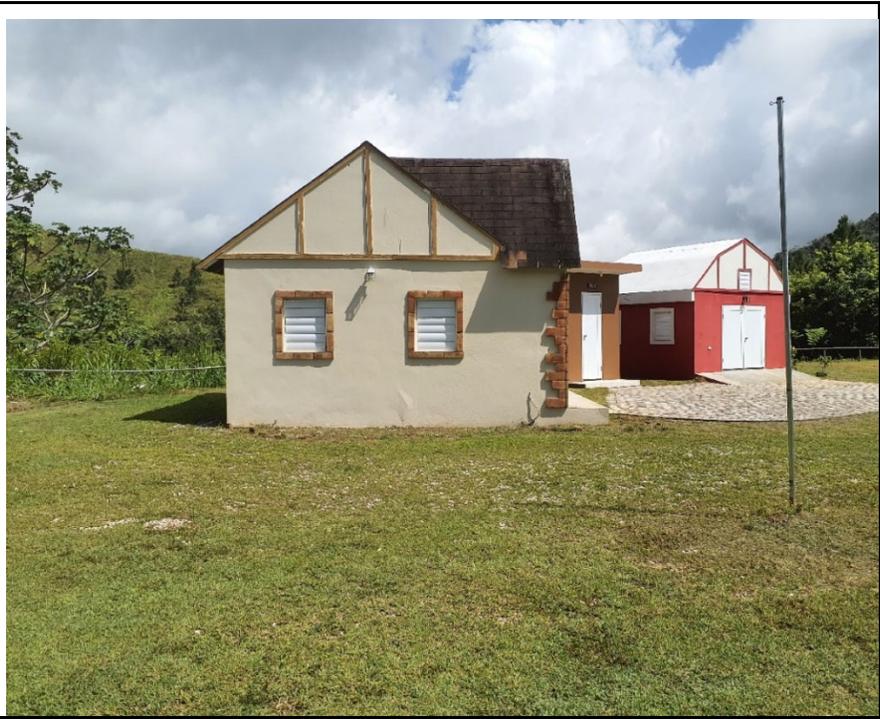
Photo #:	Date:
02	8/30/23

This photo presents a view to the north from the general area of the proposed well and includes features depicted in other photos. White PVC pipes in the foreground and background indicate existing water connections near the proposed well.

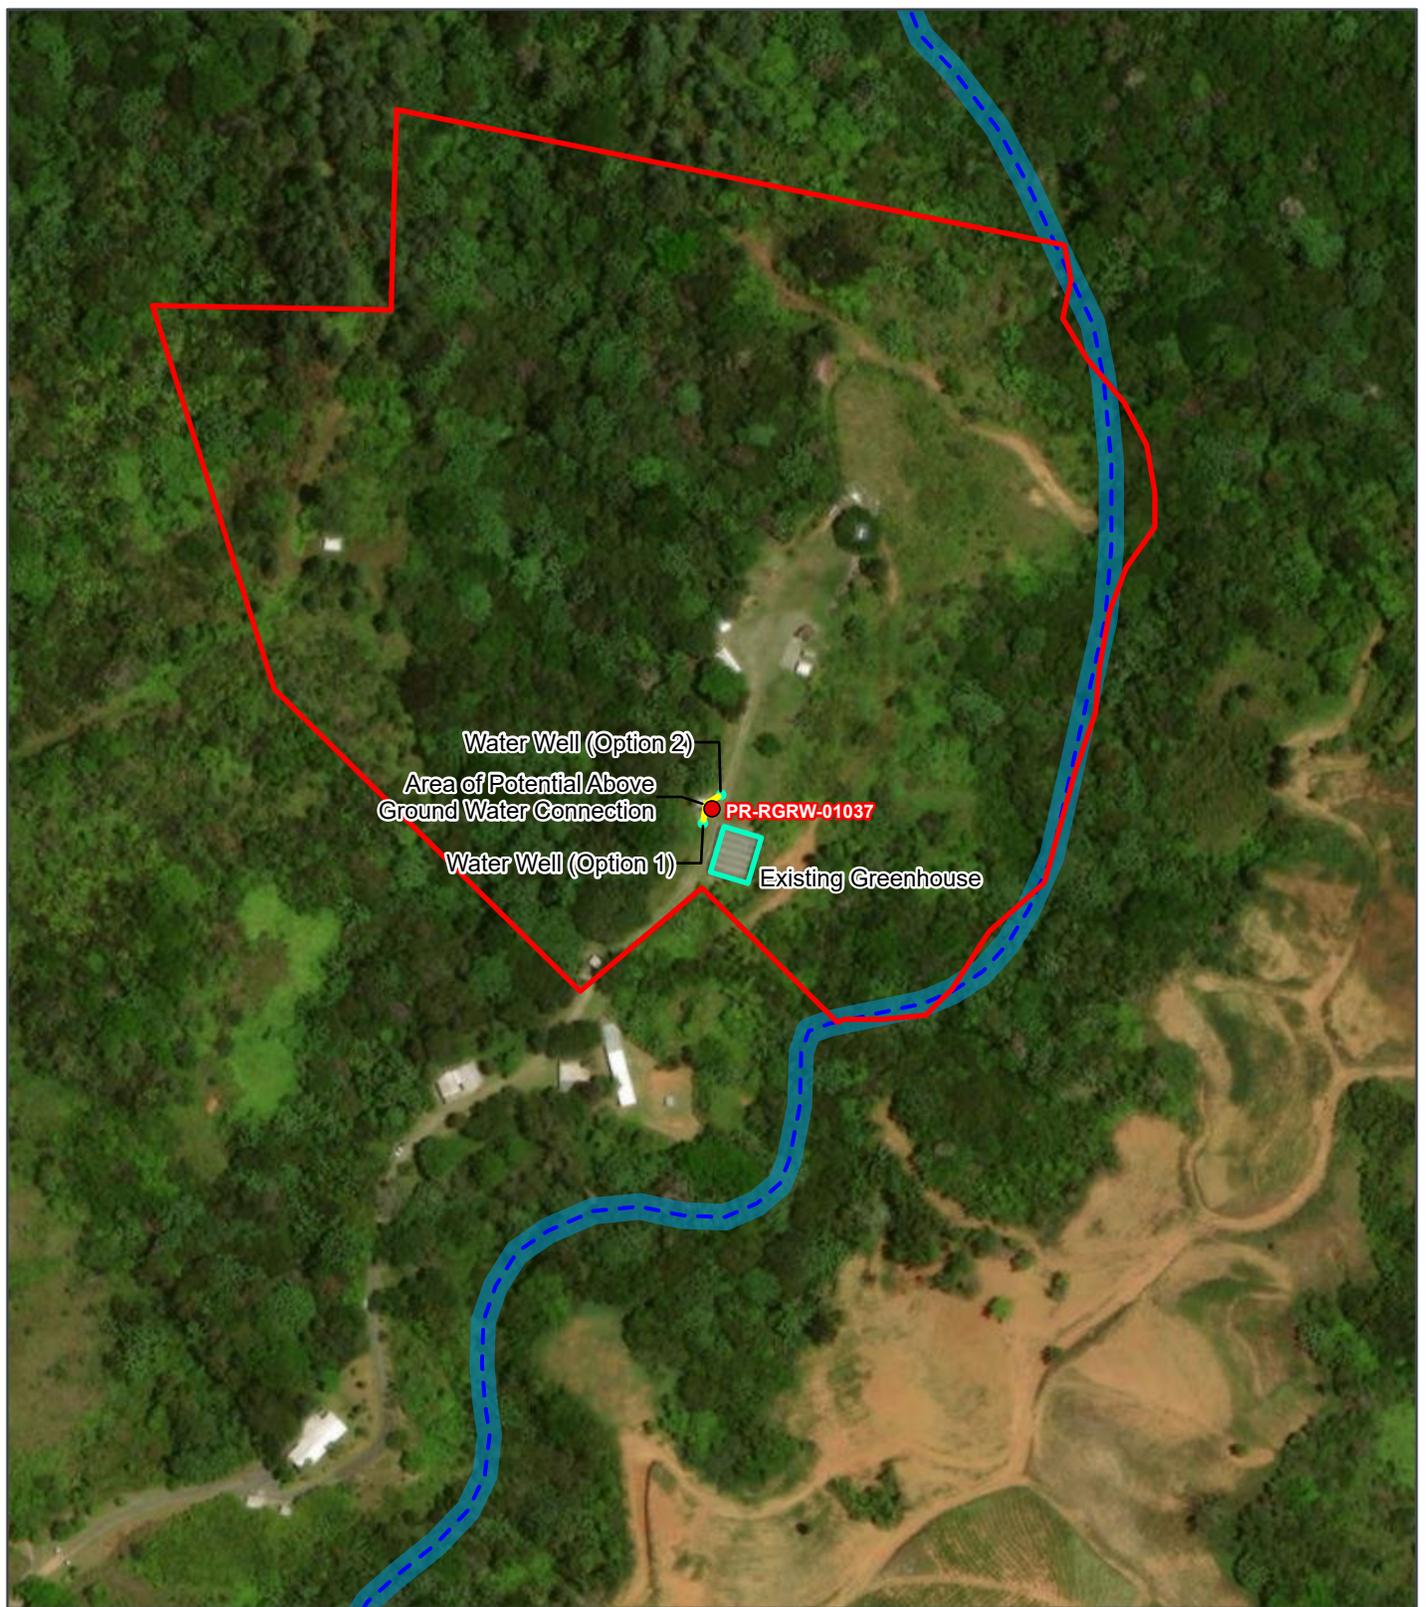
**Figure B 12-1:
Wetlands Protection
Map**

The project sites were reviewed for wetlands using the USFWS Wetland Inventory Mapper and a visual confirmation during the field site inspection. A riverine wetland is located approximately 373 feet east of Water Well Site Option 1 at its closest point, and will not be affected by project activities if best management practices, such as silt fencing and erosion control, are implemented during any ground-disturbing activities. No further evaluation is required. The project is in compliance with Executive Order 11990.

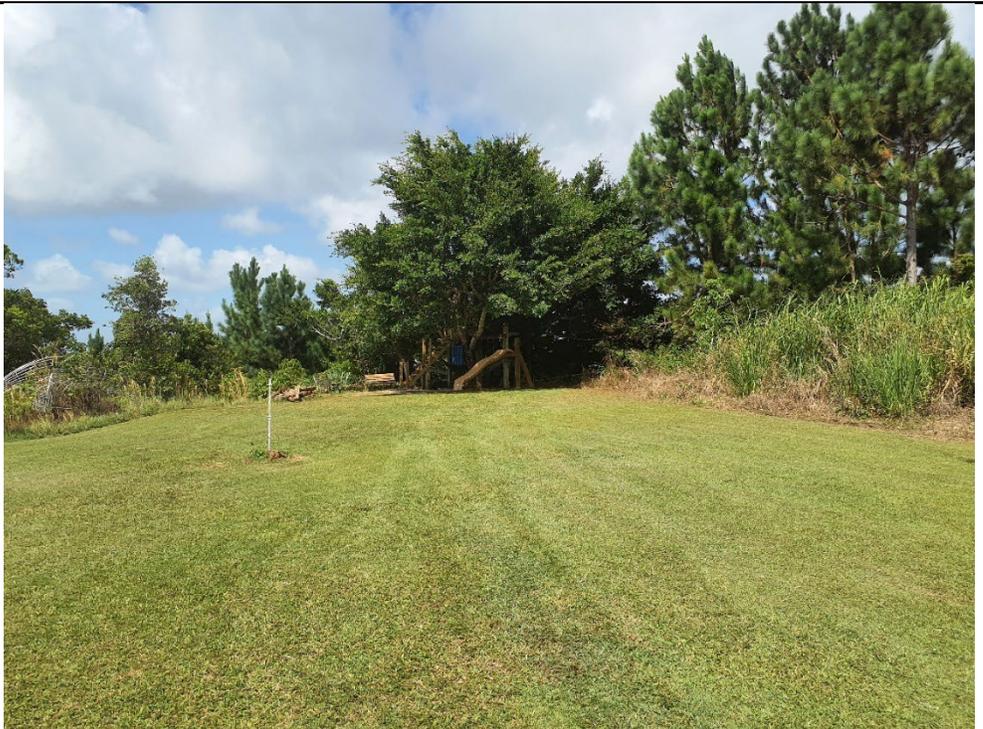
Photo #: 01	Date: 8/30/23

Photo Direction: North		
Description: This photo shows a playground/treeho use located to the north of the proposed water well. All structures in the vicinity were constructed after the applicant purchased the property in 1999.

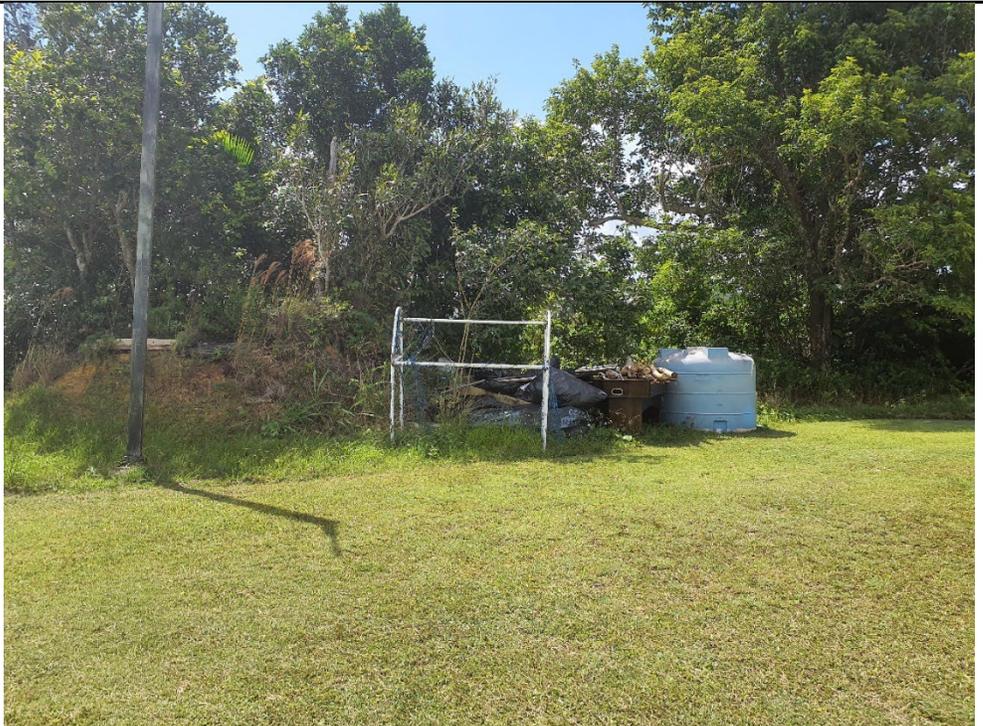
Photo #: 02	Date: 8/30/23

Photo Direction: West		
Description: This photo shows miscellaneous debris and a stored/discarded water tank located to the north of the proposed water well.

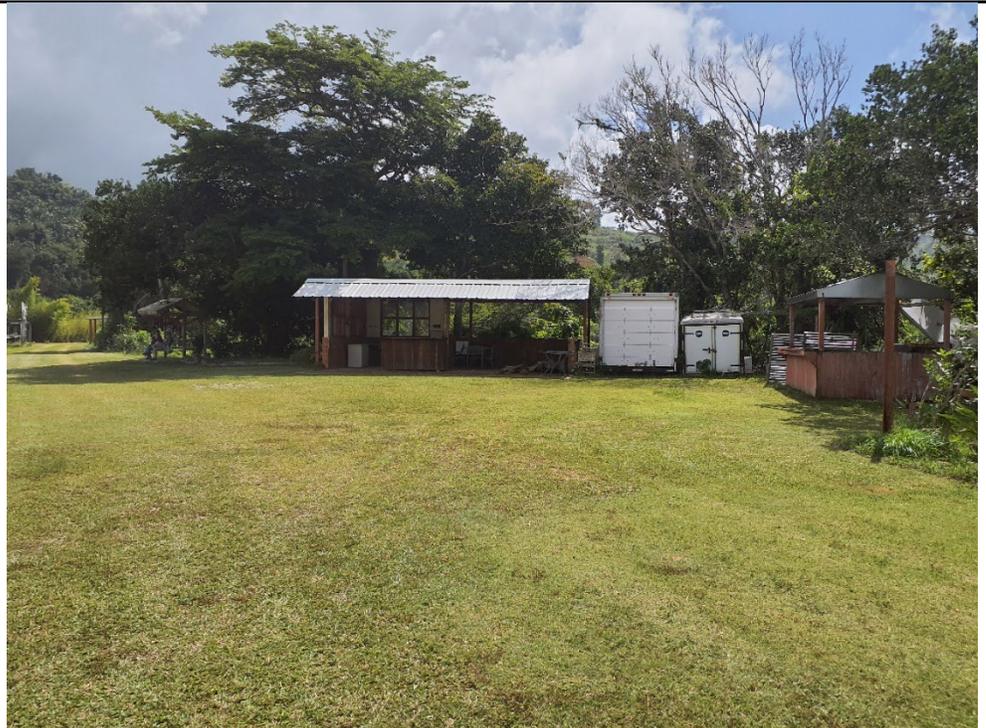
Photo #: 03	Date: 8/30/23
Photo Direction: South	
Description: This photo shows medium and small pavilion structures currently used for storage of construction materials and two trailers, located to the north of the proposed water well. All structures in the vicinity were constructed after the applicant purchased the property in 1999.

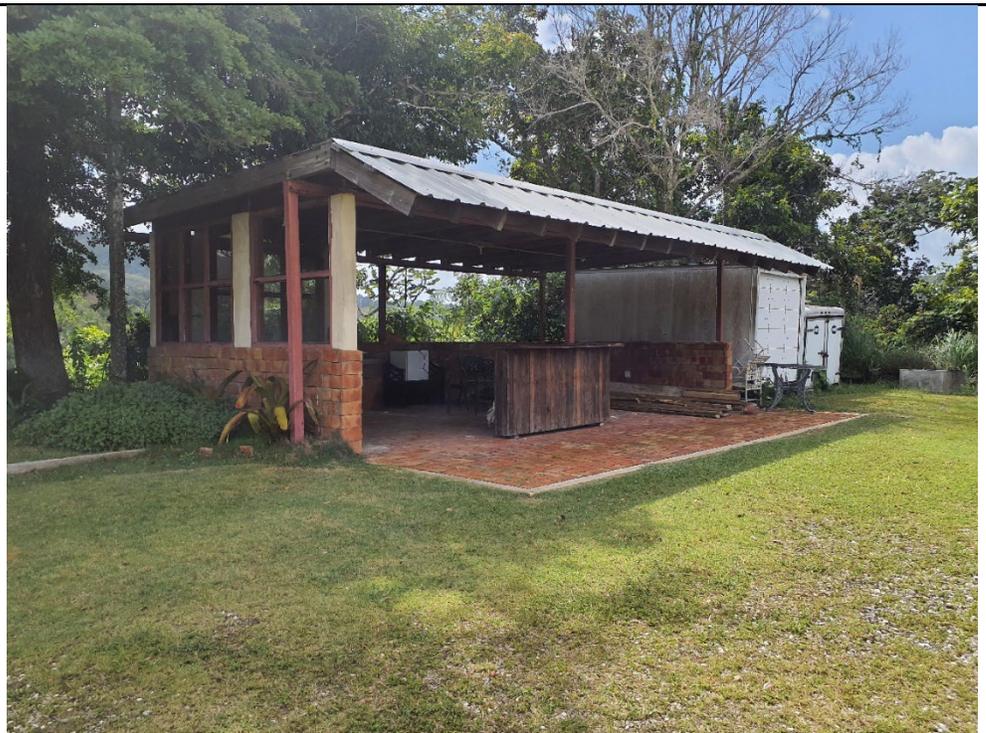
Photo #: 05	Date: 8/30/23
-----------------------	-------------------------

Description:
This photo shows a medium pavilion structure and two trailers located to the north of the proposed water well. These can also be seen in the background of Photo #03. All structures in the vicinity were constructed after the applicant purchased the property in 1999.

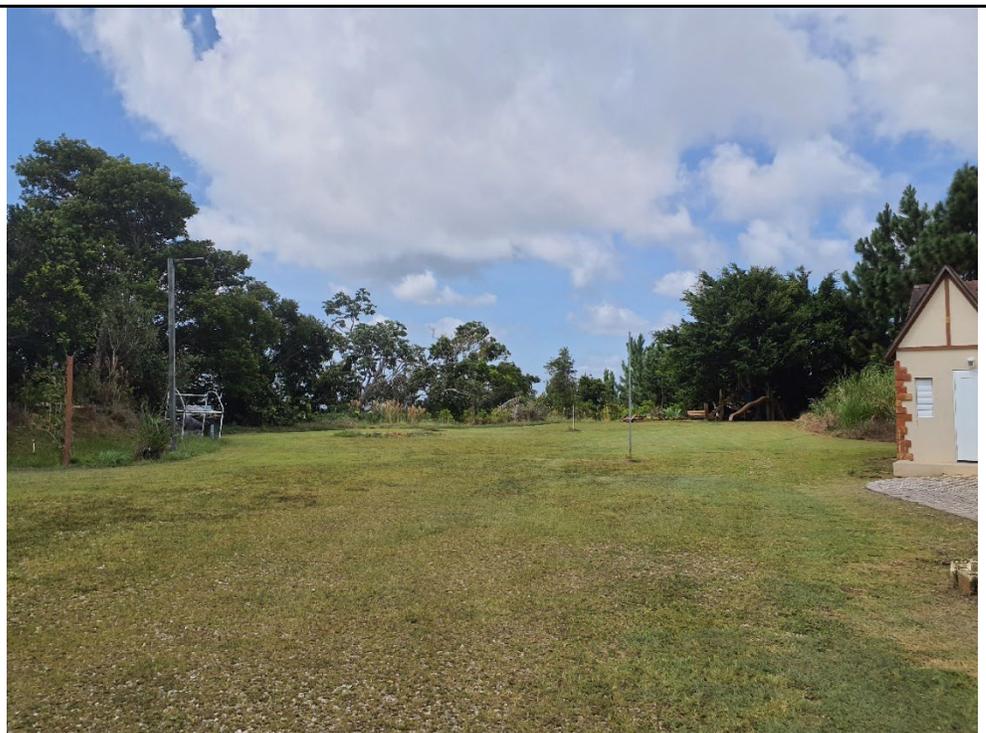
Photo #: 06	Date: 8/30/23
-----------------------	-------------------------

Description:
This photo shows a general view of the northern area that was documented in Photos 01 through 04. The small cottage structure on the right side of the frame is the same as the one shown in Photo #04.

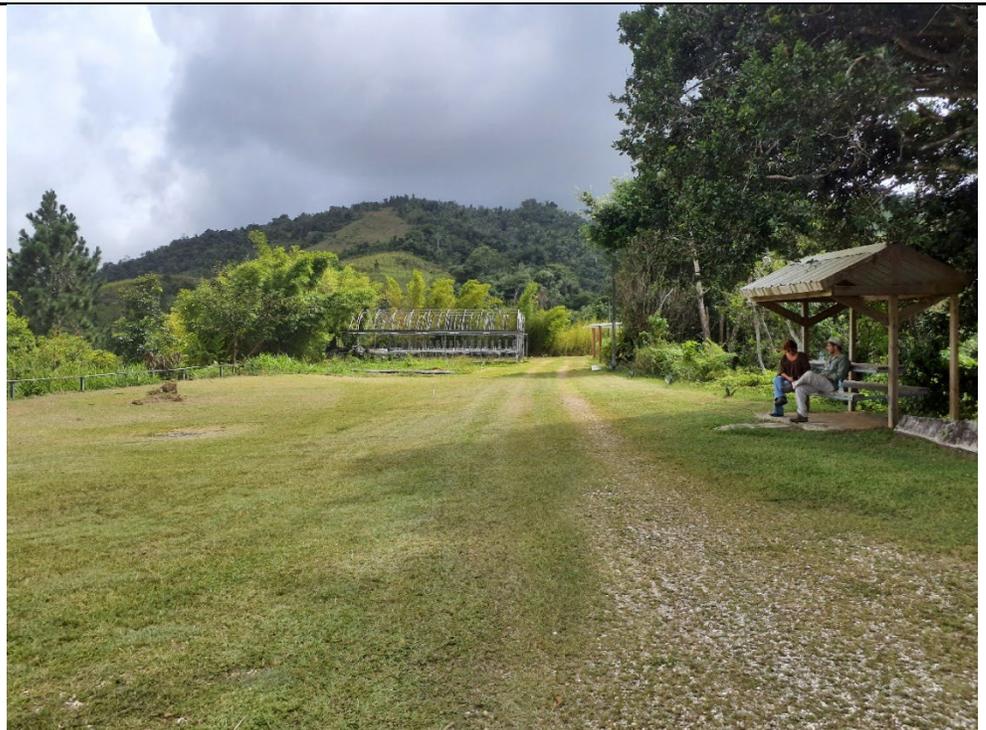
Photo #: 07	Date: 8/30/23
Photo Direction: South	
Description: This photo depicts a small, covered bench area in the foreground (right of frame) and the greenhouse structure near the proposed well in the background.

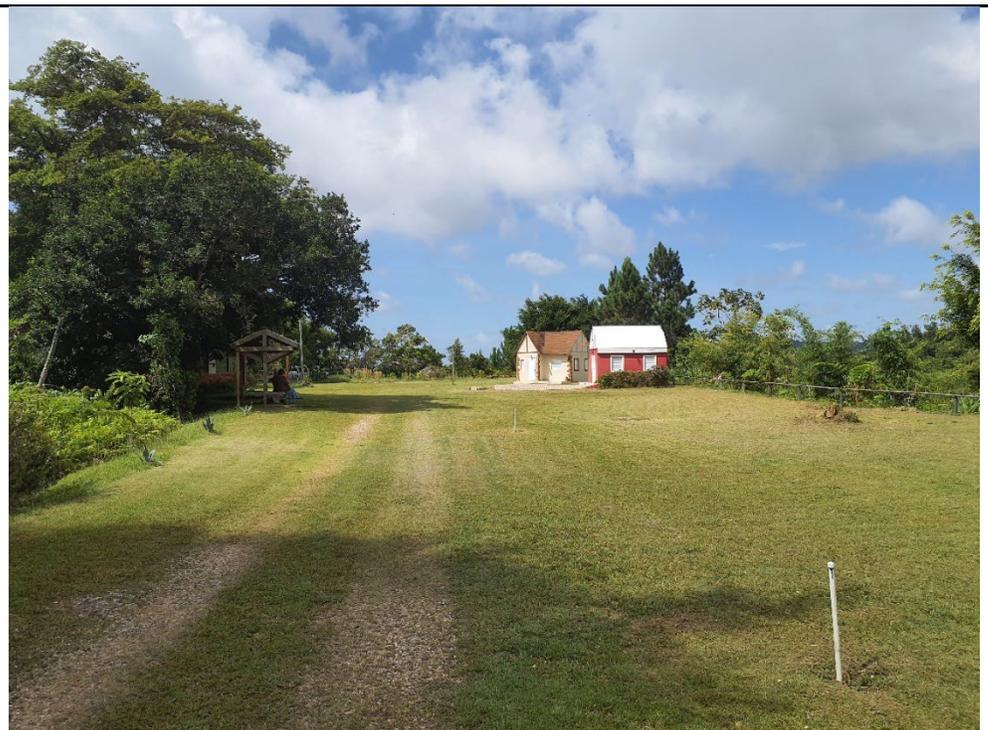
Photo #: 09	Date: 8/30/23
-----------------------	-------------------------

Description:
This photo presents a view to the north from the general area of the proposed well and includes features depicted in other photos. White PVC pipes in the foreground and background indicate existing water connections near the proposed well.

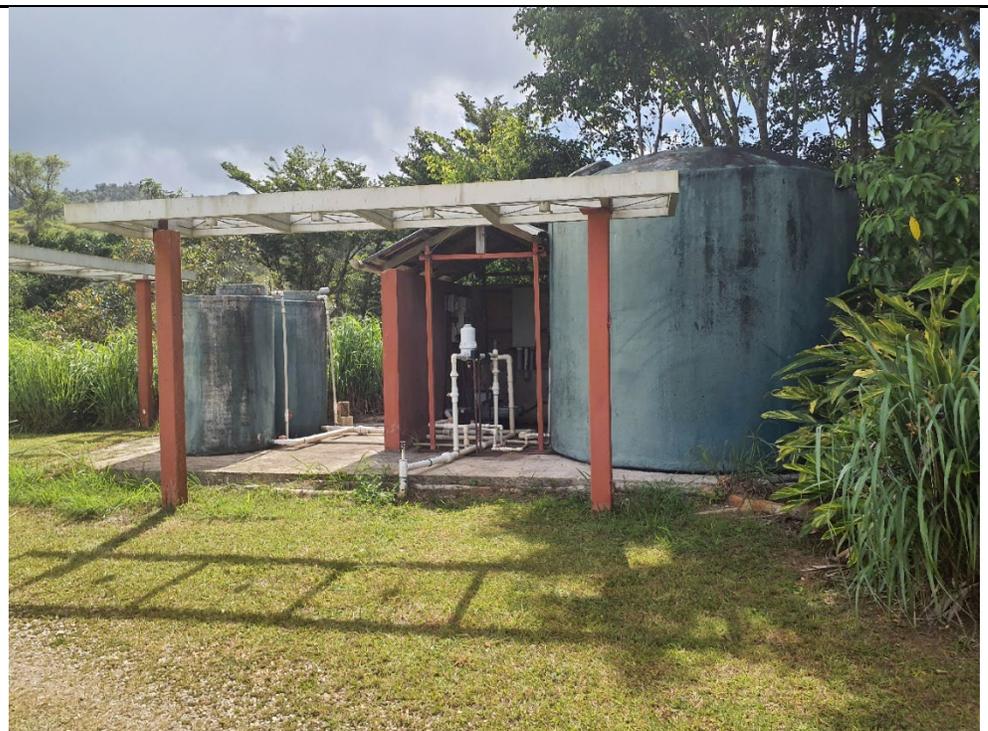
Photo #: 10	Date: 8/30/23
-----------------------	-------------------------

Description:
This photo shows surface water tanks and PVC piping near the preferred and alternate locations for the proposed well. This infrastructure will be used to facilitate pumping and storage of water from the proposed well.

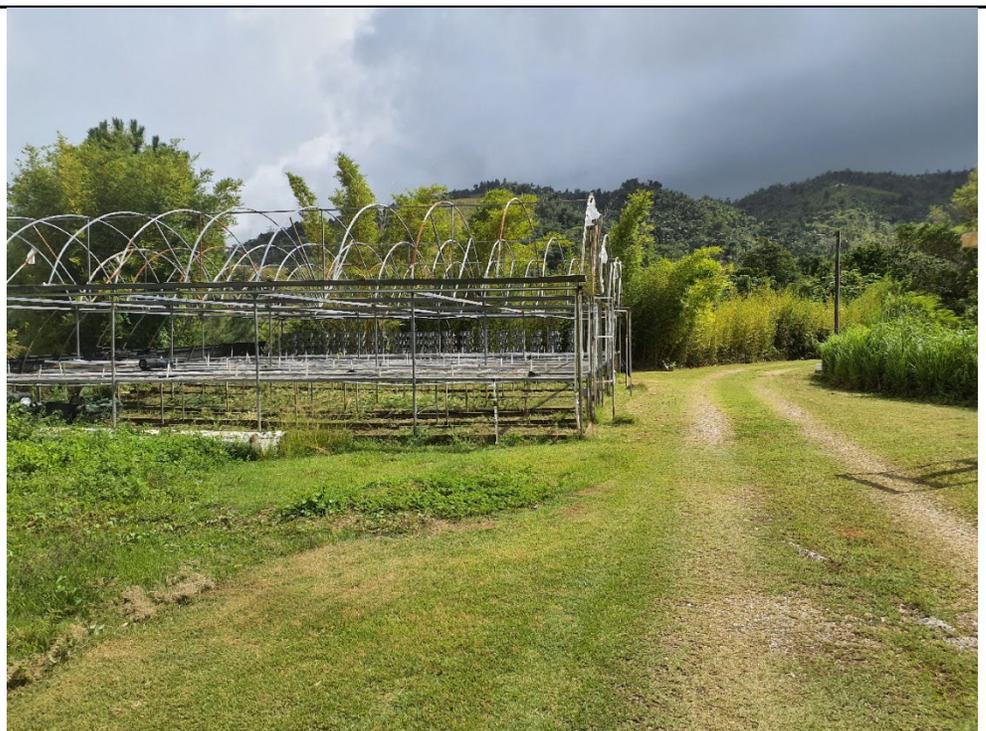
Photo #: 12	Date: 8/30/23
Photo Direction: South	
Description: This photo shows the existing greenhouse structure as seen from the vicinity of the preferred and alternate locations for the proposed well. Existing PVC water pipe runs underground toward the greenhouse.
