**Environmental Review for Activity/Project that is
Categorically Excluded Subject to Section 58.5
Pursuant to 24 CFR 58.35(a)**

Project Name: PR-RGRW-01465-W-RE

HEROS Number: 900000010368931

This project (PR-RGRW-01465-W-RE) entails the award of a grant to Orlando A Vazquez Vazquez DBA Finca, an agricultural business, at Carretera 770 KM 4.2 Int., Bo Canabon Sec. La Torre, Barranquitas, PR 00794. Tax ID Number: 220-088-201-13-000. Coordinates (18.222314, -66.329820). This project had an original CENST review which included the purchase of Ford 150 pickup for project cost of \$49,995.00. See attached CENST environmental review. This review includes a scope item previously considered as an EA level of review (hydroponic infrastructure) which is now evaluated as CEST level of review in accordance with FR-6492-N-01 with a project cost of \$37,691.46. The proposed project includes construction of a hydroponic greenhouse. The proposed hydroponic greenhouse is 2,000 square feet (sq ft) (100 feet [ft] by 20 ft) with a maximum height of approximately 13 ft. The greenhouse will be secured by approximately 18 arches that will be backfilled with cement and installed no deeper than 24 inche

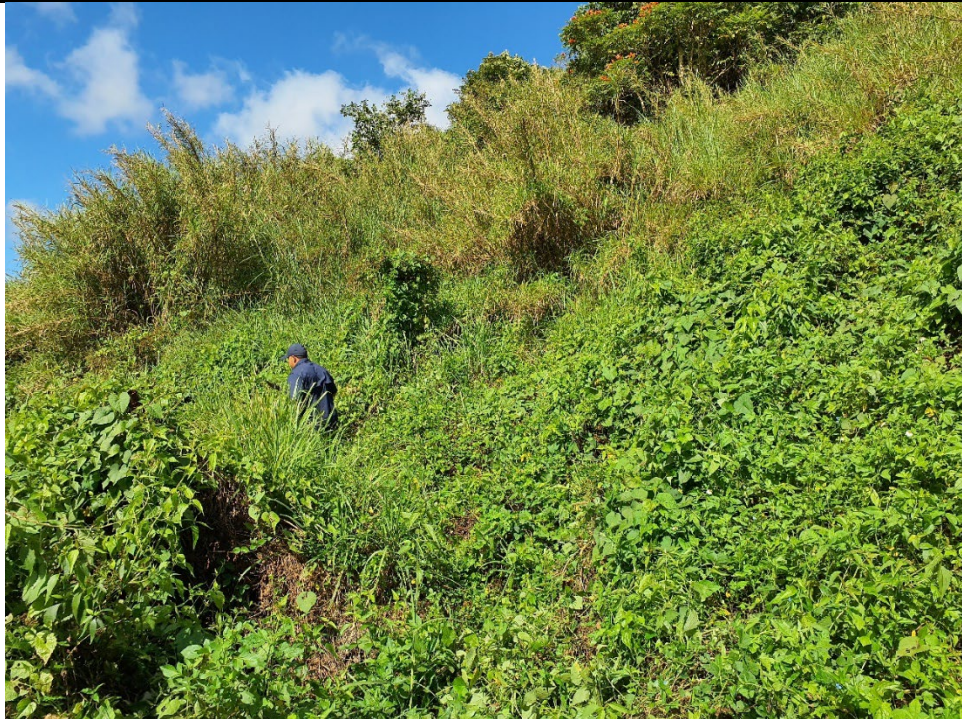
Photo #: 02	Date: 02/13/24

Photo Direction: Southwest		
Description: This photo was taken from the approximate northeast corner of the proposed location for a 100' x 20' x 13' greenhouse, facing approximate southwest corner of proposed location. The area is flatter than it appears along proposed greenhouse location, but the vegetation is overgrown.

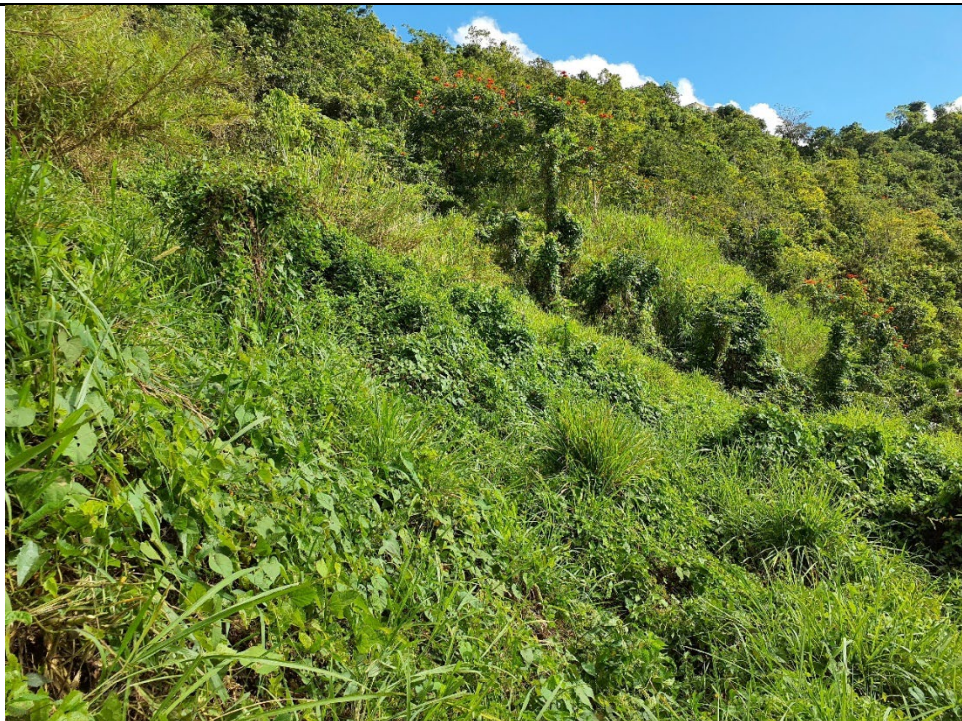
Photo #: 03	Date: 02/13/24

Photo Direction: Northeast		
Description: This photo was taken from the approximate southwest corner of the proposed location for a 100' x 20' x 13' greenhouse, facing approximate northeast corner of proposed location. The area is flatter than it appears along proposed greenhouse location, but the vegetation is overgrown.

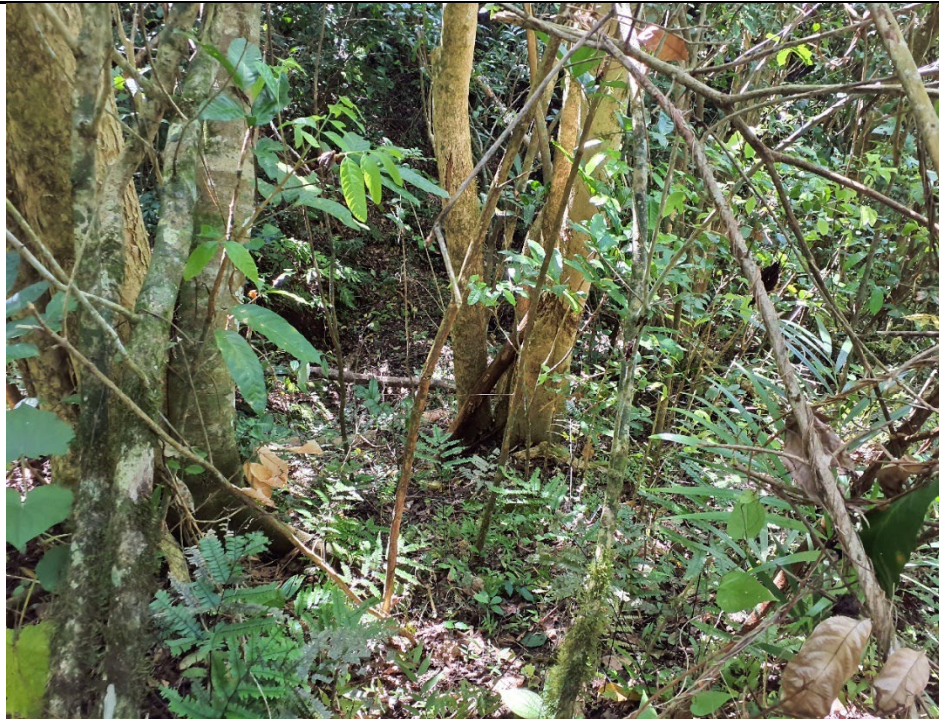
Photo #: 04	Date: 02/13/24

Photo Direction: Southeast		
Description: This photo shows the location of an intermittent stream that flows northeast to southwest along the eastern property boundary. The stream was damp/no flowing water during site inspection and was difficult to access for closer inspection, due to its steep grade. This view is facing southeast.

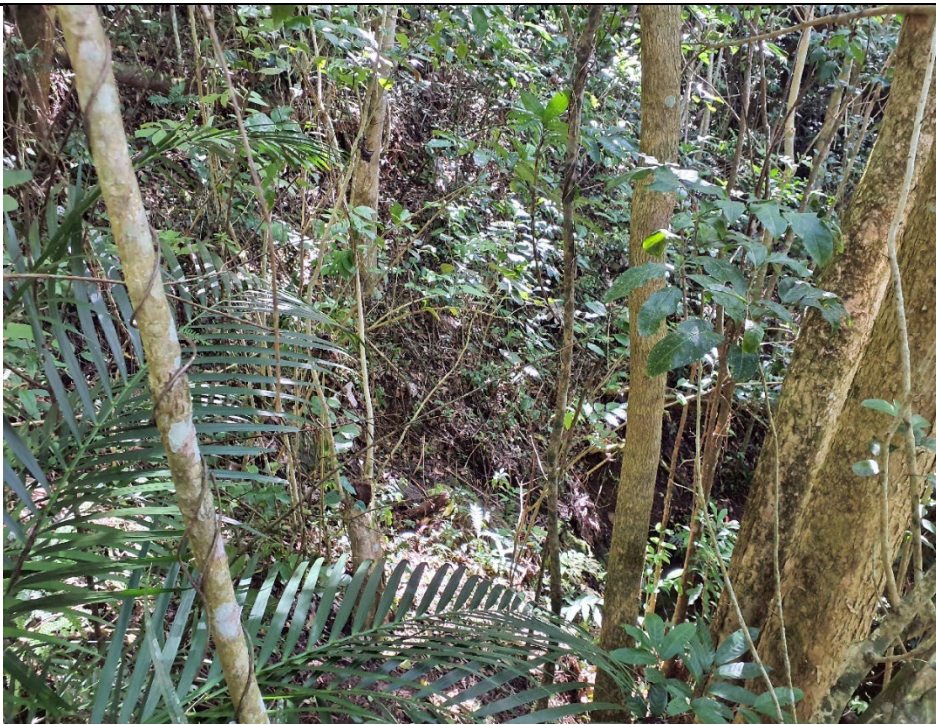
Photo #: 05	Date: 02/13/24
Photo Direction: South	
Description: This photo shows the location of an intermittent stream that flows from northeast to southwest along the eastern boundary of the property. The stream was damp/no flowing water during site inspection and was difficult to access for closer inspection, due to its steep grade. This view is facing downhill/downstream.

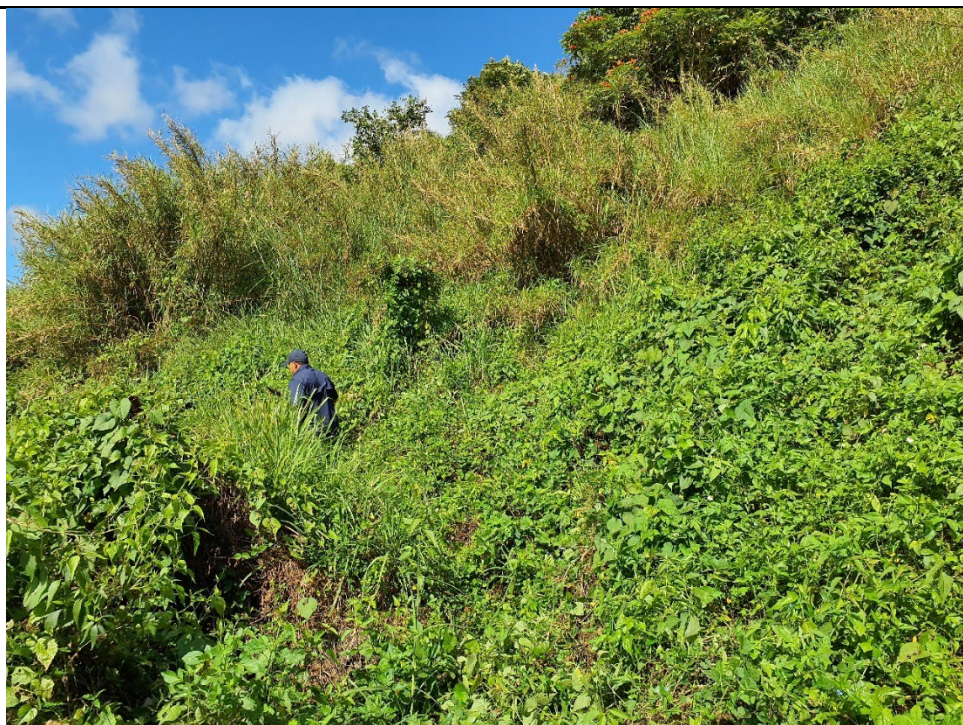
Photo #: 02	Date: 02/13/24

Photo Direction: Southwest		
Description: This photo was taken from the approximate northeast corner of the proposed location for a 100' x 20' x 13' greenhouse, facing approximate southwest corner of proposed location. The area is flatter than it appears along proposed greenhouse location, but the vegetation is overgrown.

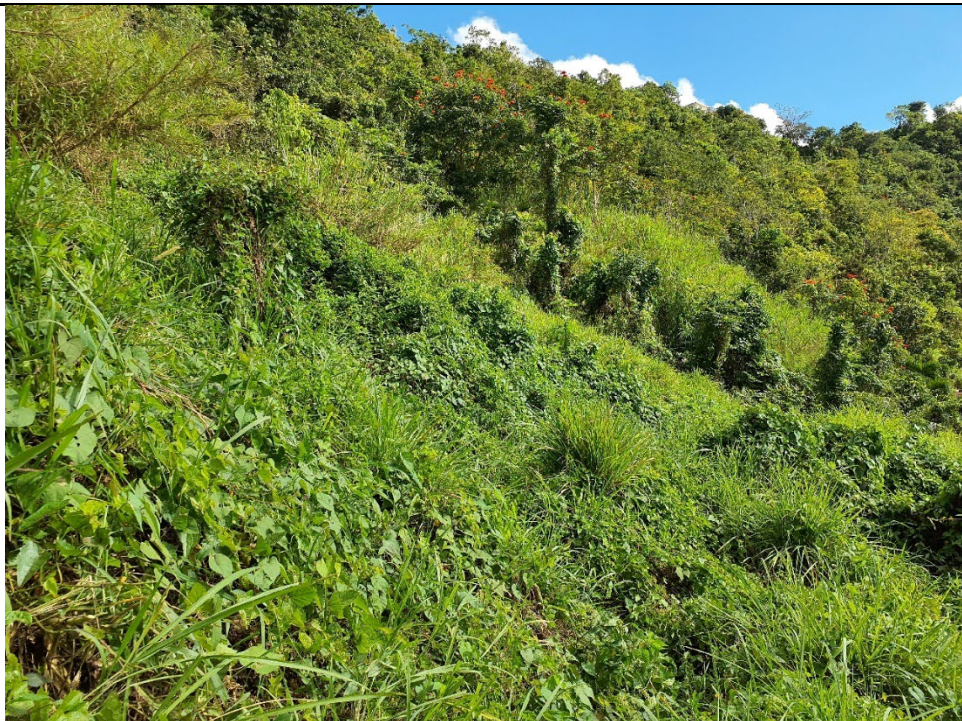
Photo #: 03	Date: 02/13/24

Photo Direction: Northeast		
Description: This photo was taken from the approximate southwest corner of the proposed location for a 100' x 20' x 13' greenhouse, facing approximate northeast corner of proposed location. The area is flatter than it appears along proposed greenhouse location, but the vegetation is overgrown.

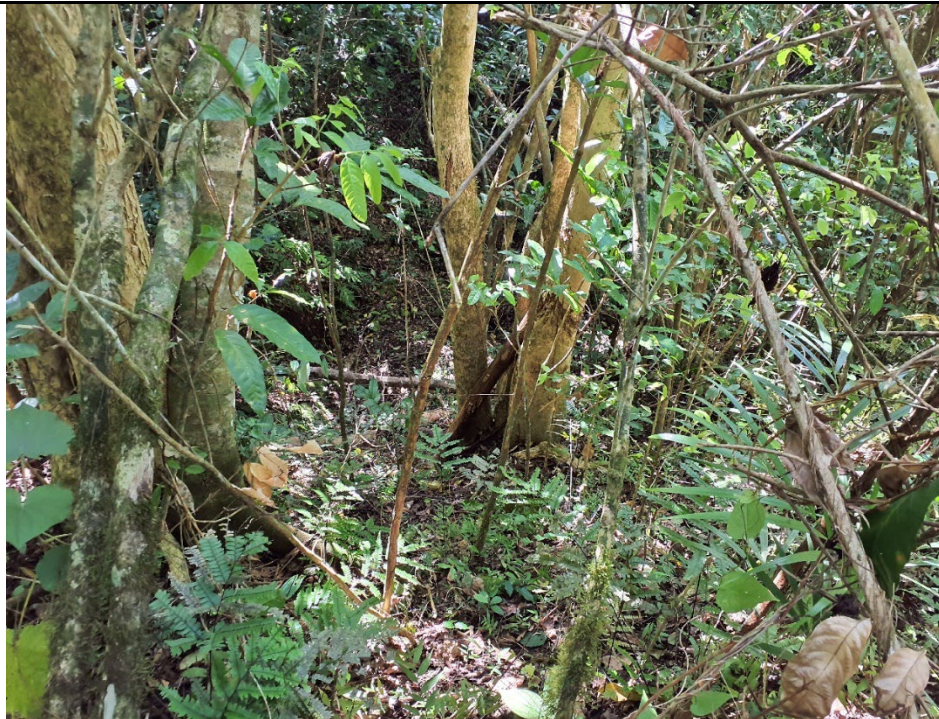
Photo #: 04	Date: 02/13/24

Photo Direction: Southeast		
Description: This photo shows the location of an intermittent stream that flows northeast to southwest along the eastern property boundary. The stream was damp/no flowing water during site inspection and was difficult to access for closer inspection, due to its steep grade. This view is facing southeast.

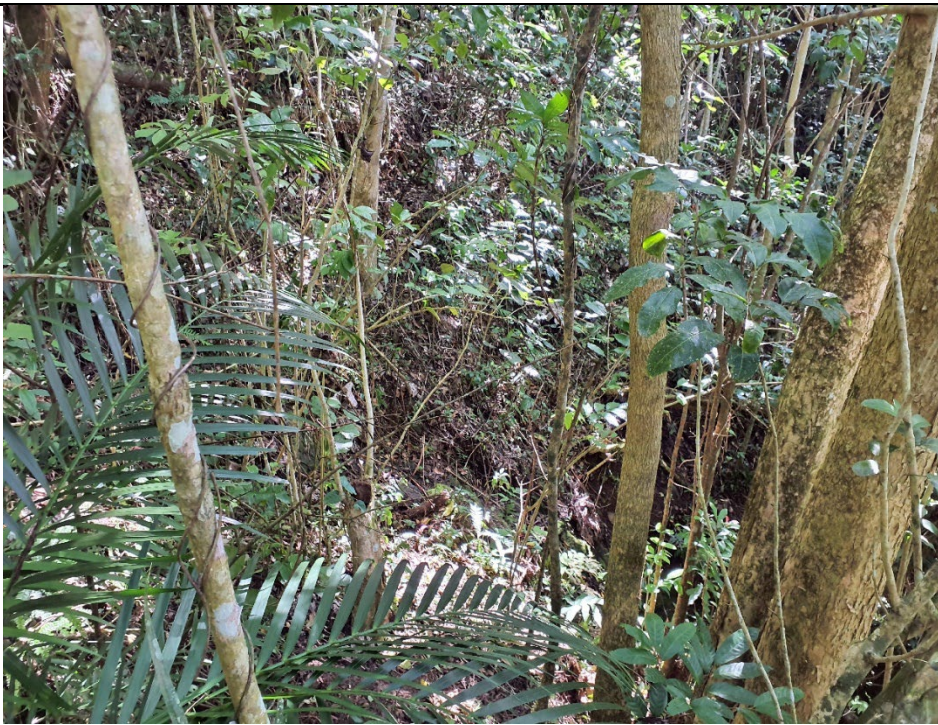
Photo #: 05	Date: 02/13/24
Photo Direction: South	
Description: This photo shows the location of an intermittent stream that flows from northeast to southwest along the eastern boundary of the property. The stream was damp/no flowing water during site inspection and was difficult to access for closer inspection, due to its steep grade. This view is facing downhill/downstream.

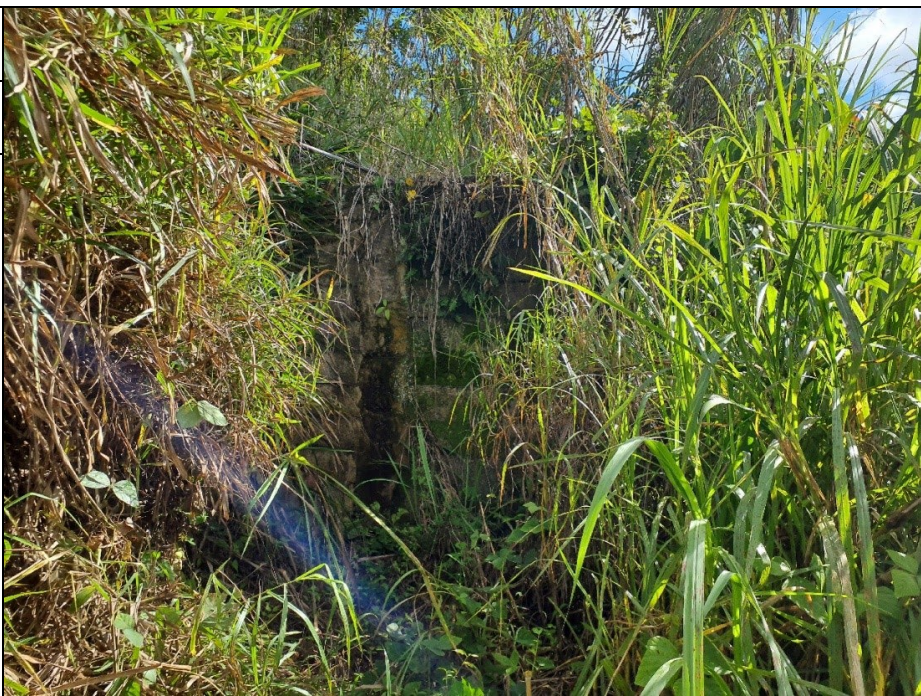
Photo #: 03	Date: 02/13/24

Photo Direction: Northeast		
Description: This shows a pre-existing cinder block water tank with overgrown surrounding vegetation which the applicant intends to clean up and use for future water collection for greenhouse. This will be done in the future with personal funds and is not part of the current project scope.
