Environmental Assessment

Project ID: PR-RGRW-01960

Project Name: RLR4U Inc.

The proposed project includes the purchase of a tractor and a van plus the applicable van refrigeration unit, the purchase of various farm equipment, and the purchase of roofing materials, galvanized tubes, and PVC pipes to construct an open-air garage for the applicant's agricultural vehicles. The equipment that will be purchased by the applicant as listed in the Intended Use of Grant Funds falls under the "categorically excluded, not subject to (CENST)" category under HUD guidelines (24 CFR 58.35(b)(4)). This Environmental Assessment (EA) also encompasses the CENST review requirements for the equipment.

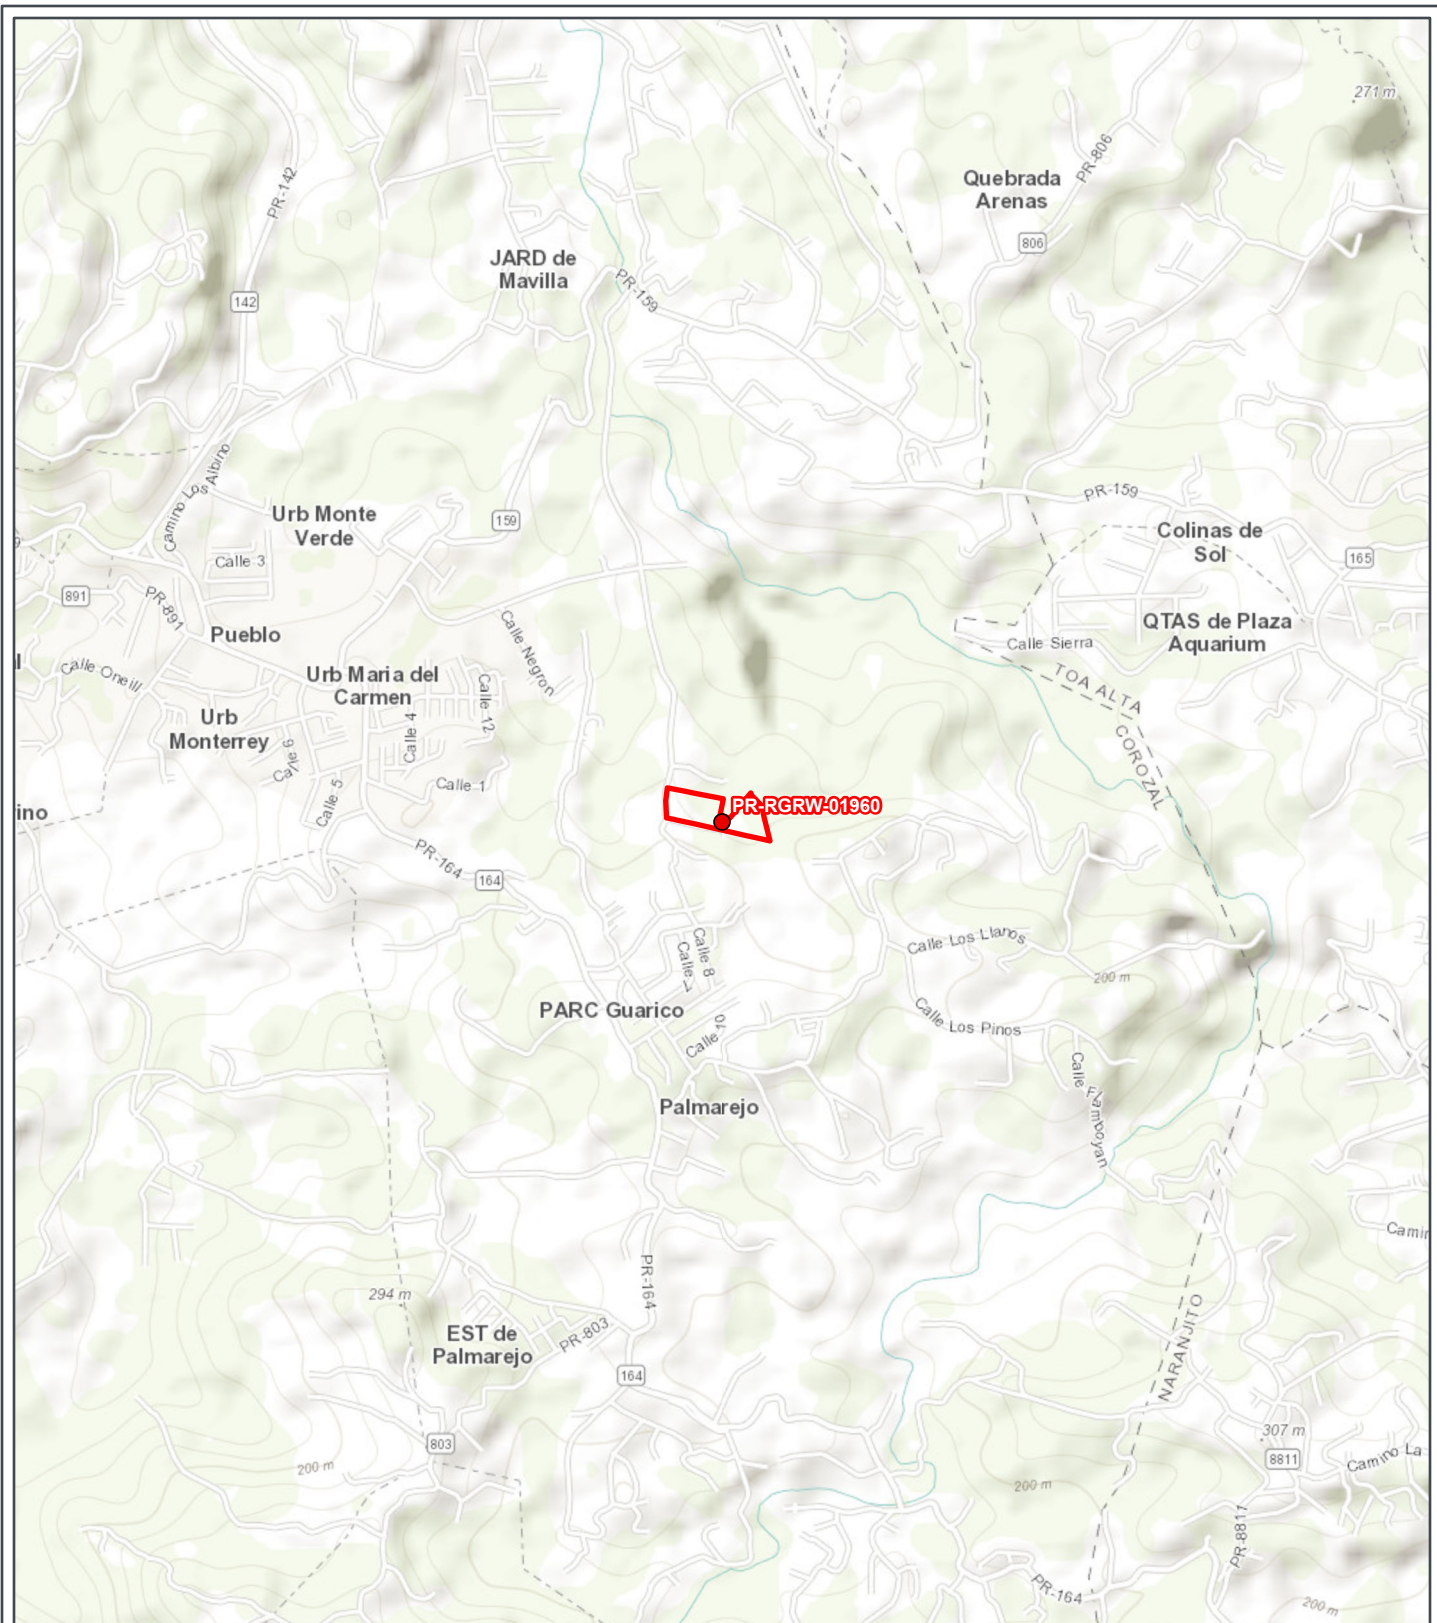
**Figure A-1:
Site Location**

Figure 1
Site Location Map

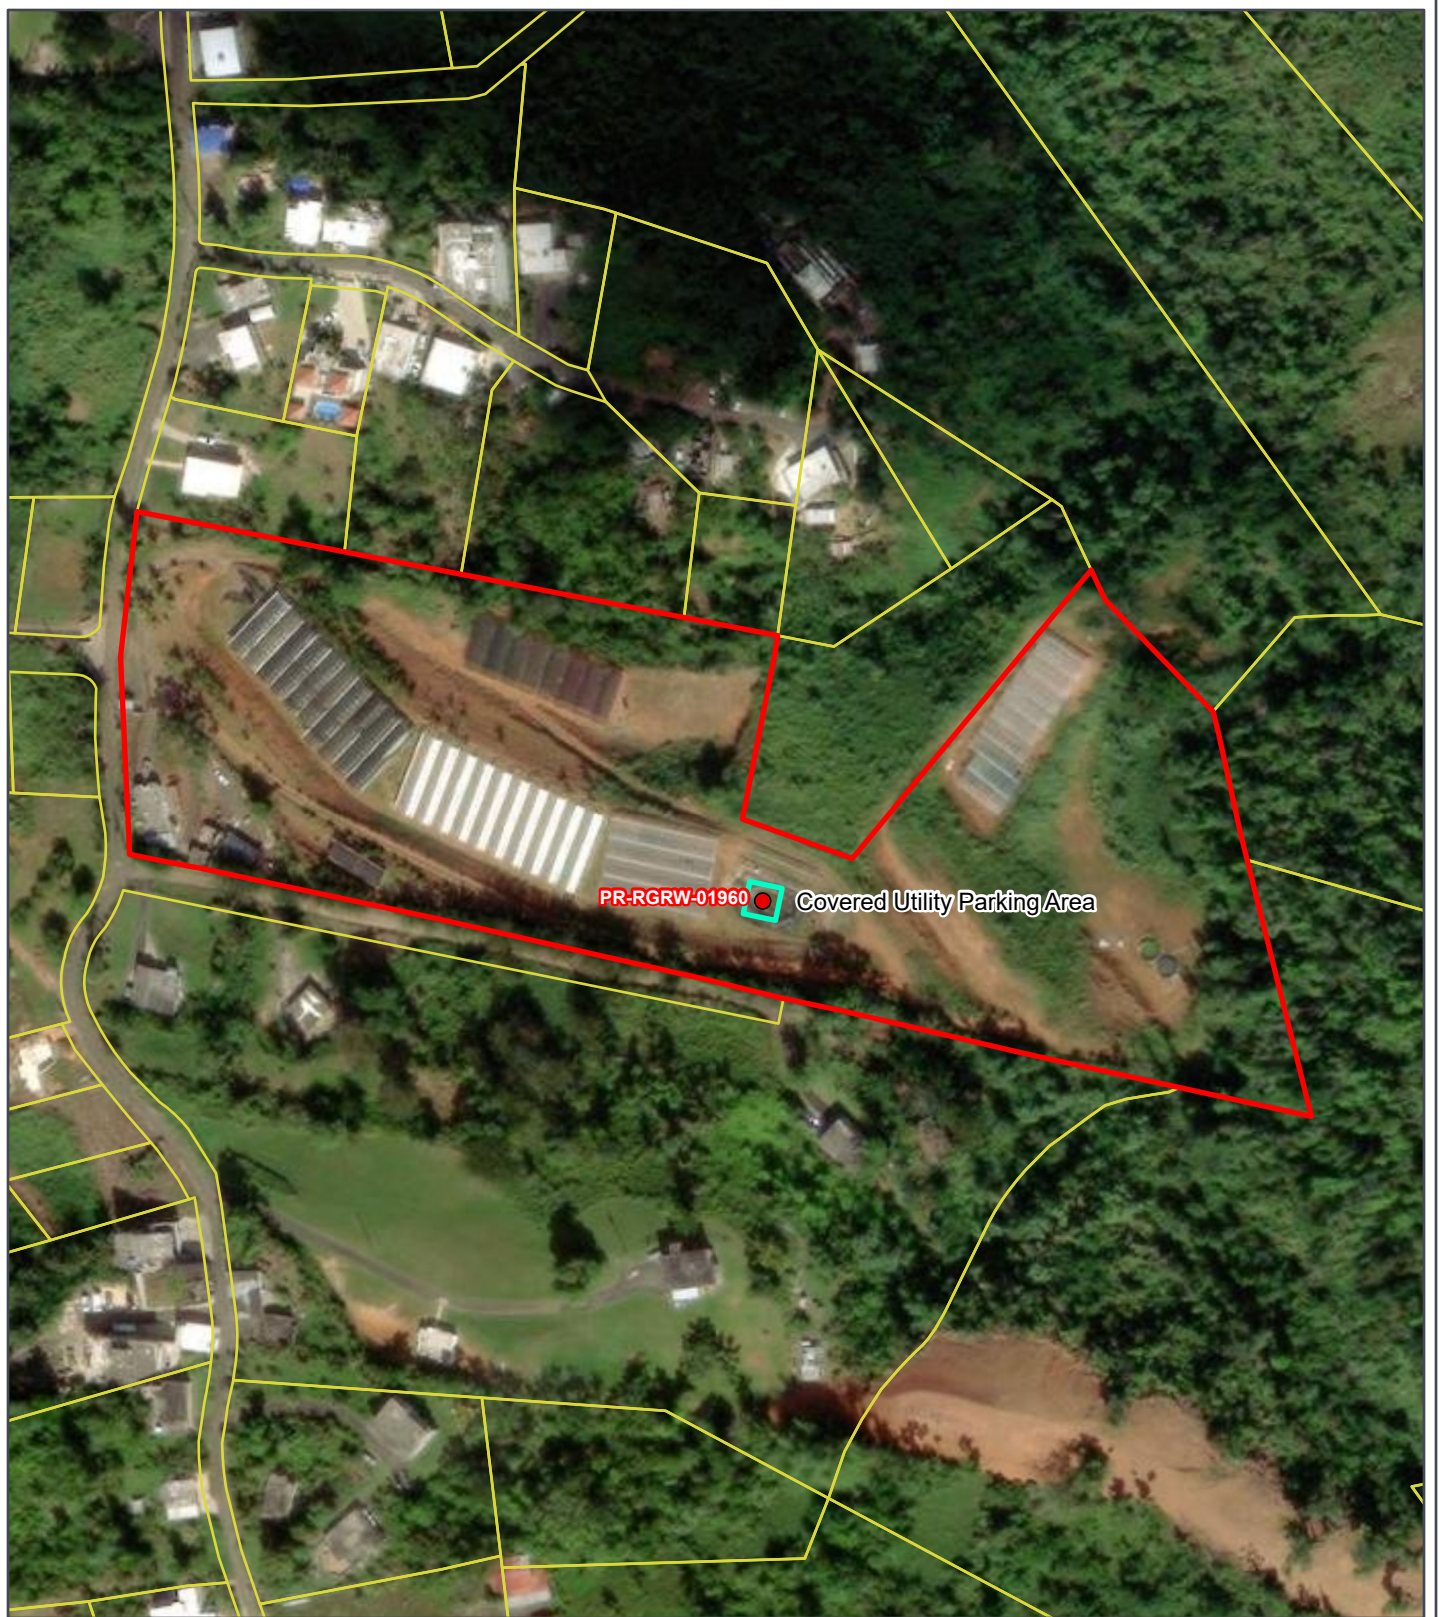
**Figure A-2:
Site Vicinity**

Figure 2
Site Vicinity Map

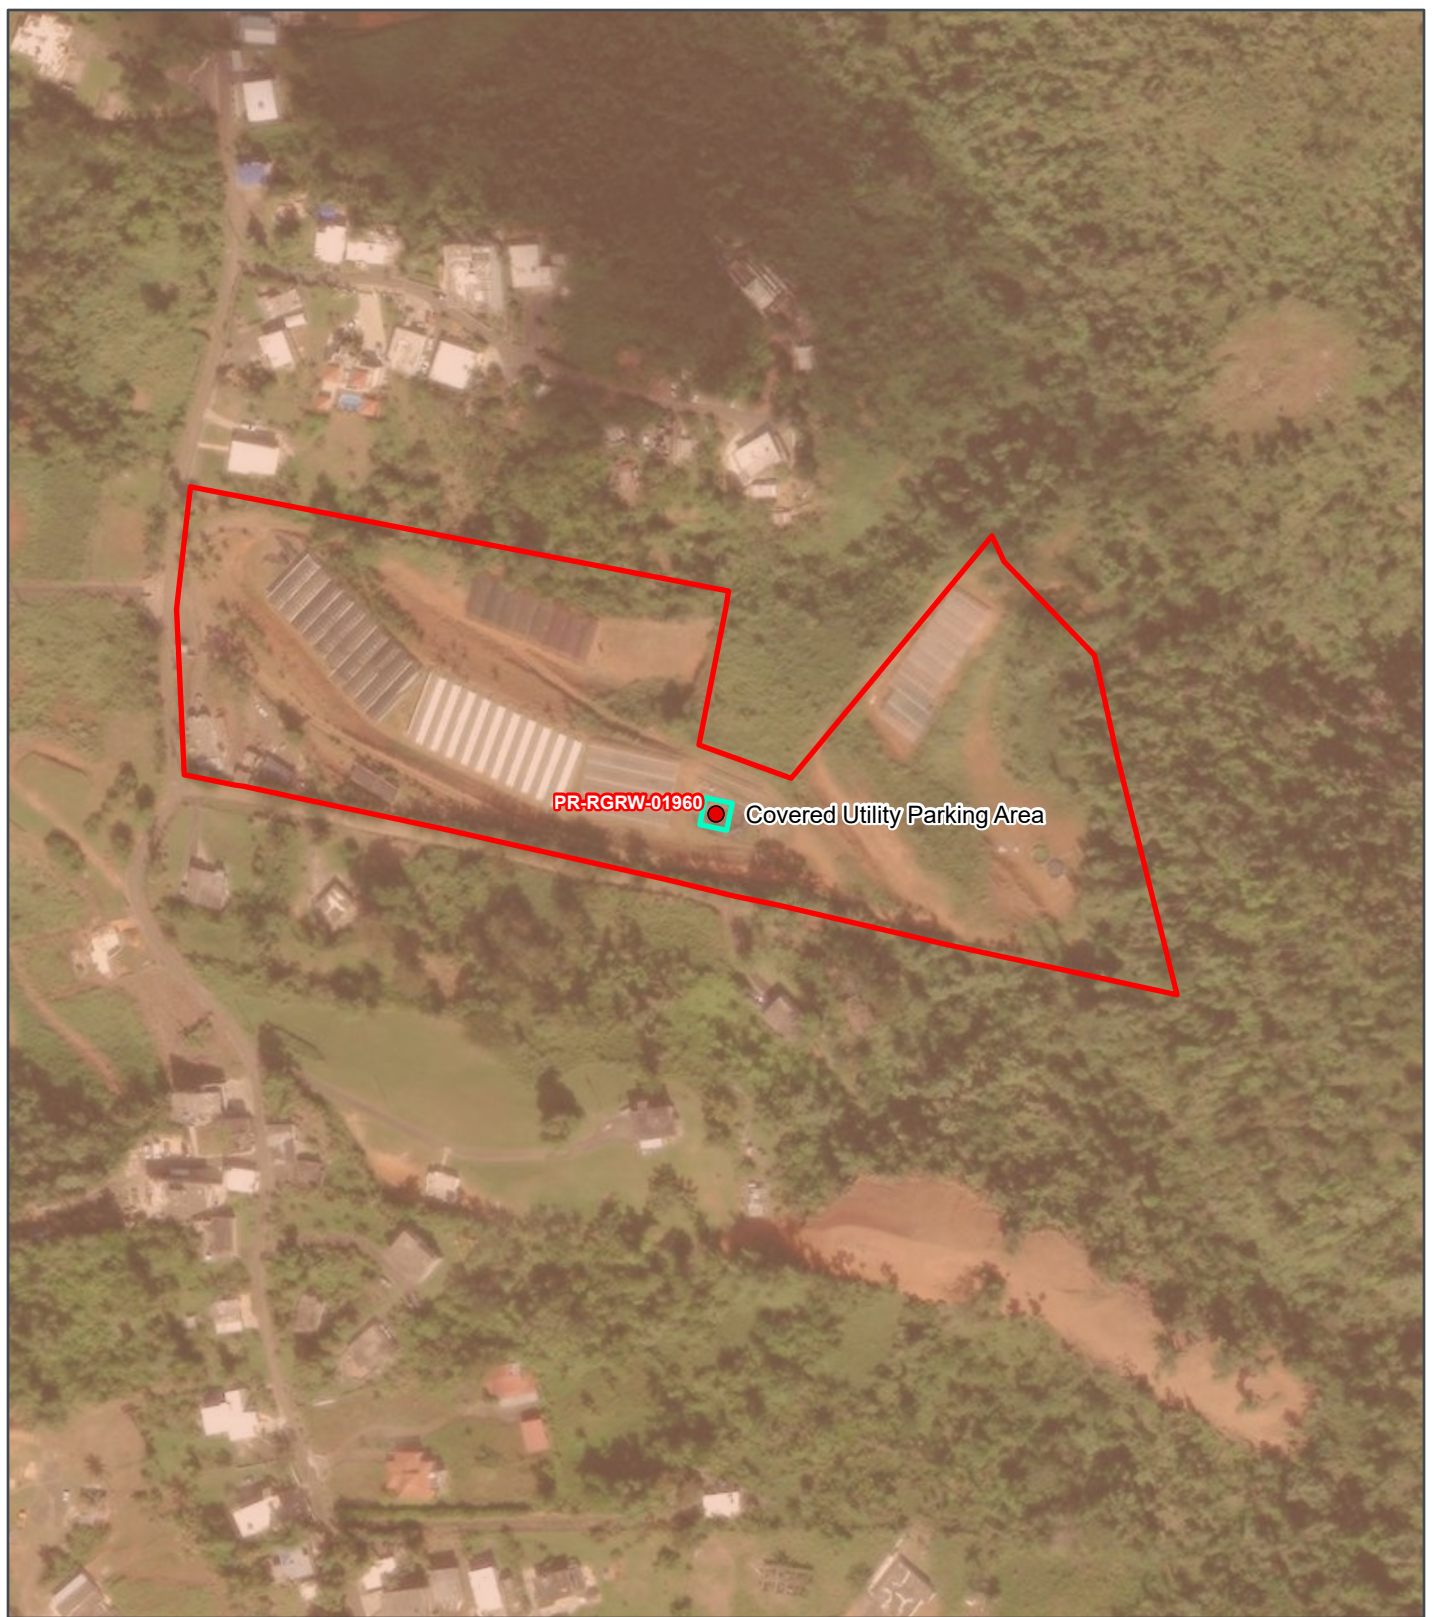
**Figure A-3:
USGS Landslide Map**

for the project area (see Appendix A, Figure 3- USGS Landslide Map). Department of Natural and Environmental Resources (DNER) authorization may be required for any extraction, removal, excavation, and dredging of the components of the earth's crust.
Hazards and Nuisances including Site Safety and Noise	2	Contractors will be required to provide health and safety plans and monitoring during construction. Noise levels will temporarily increase during construction; however, program activities are limited to the existing farm property and will not elevate ambient noise levels long-term. Contractors will be required to comply with the applicable local noise ordinances. Noise impacts will be mitigated by restricting construction activities to daylight hours. Additionally, the project does not include housing to where inhabitants would be affected.
Energy Consumption	2	The project will not result in significant additional energy consumption as it involves only the construction of an open-air garage on an existing farm and will not require any expansion to existing power facilities.

Figure 3
USGS Landslide Map

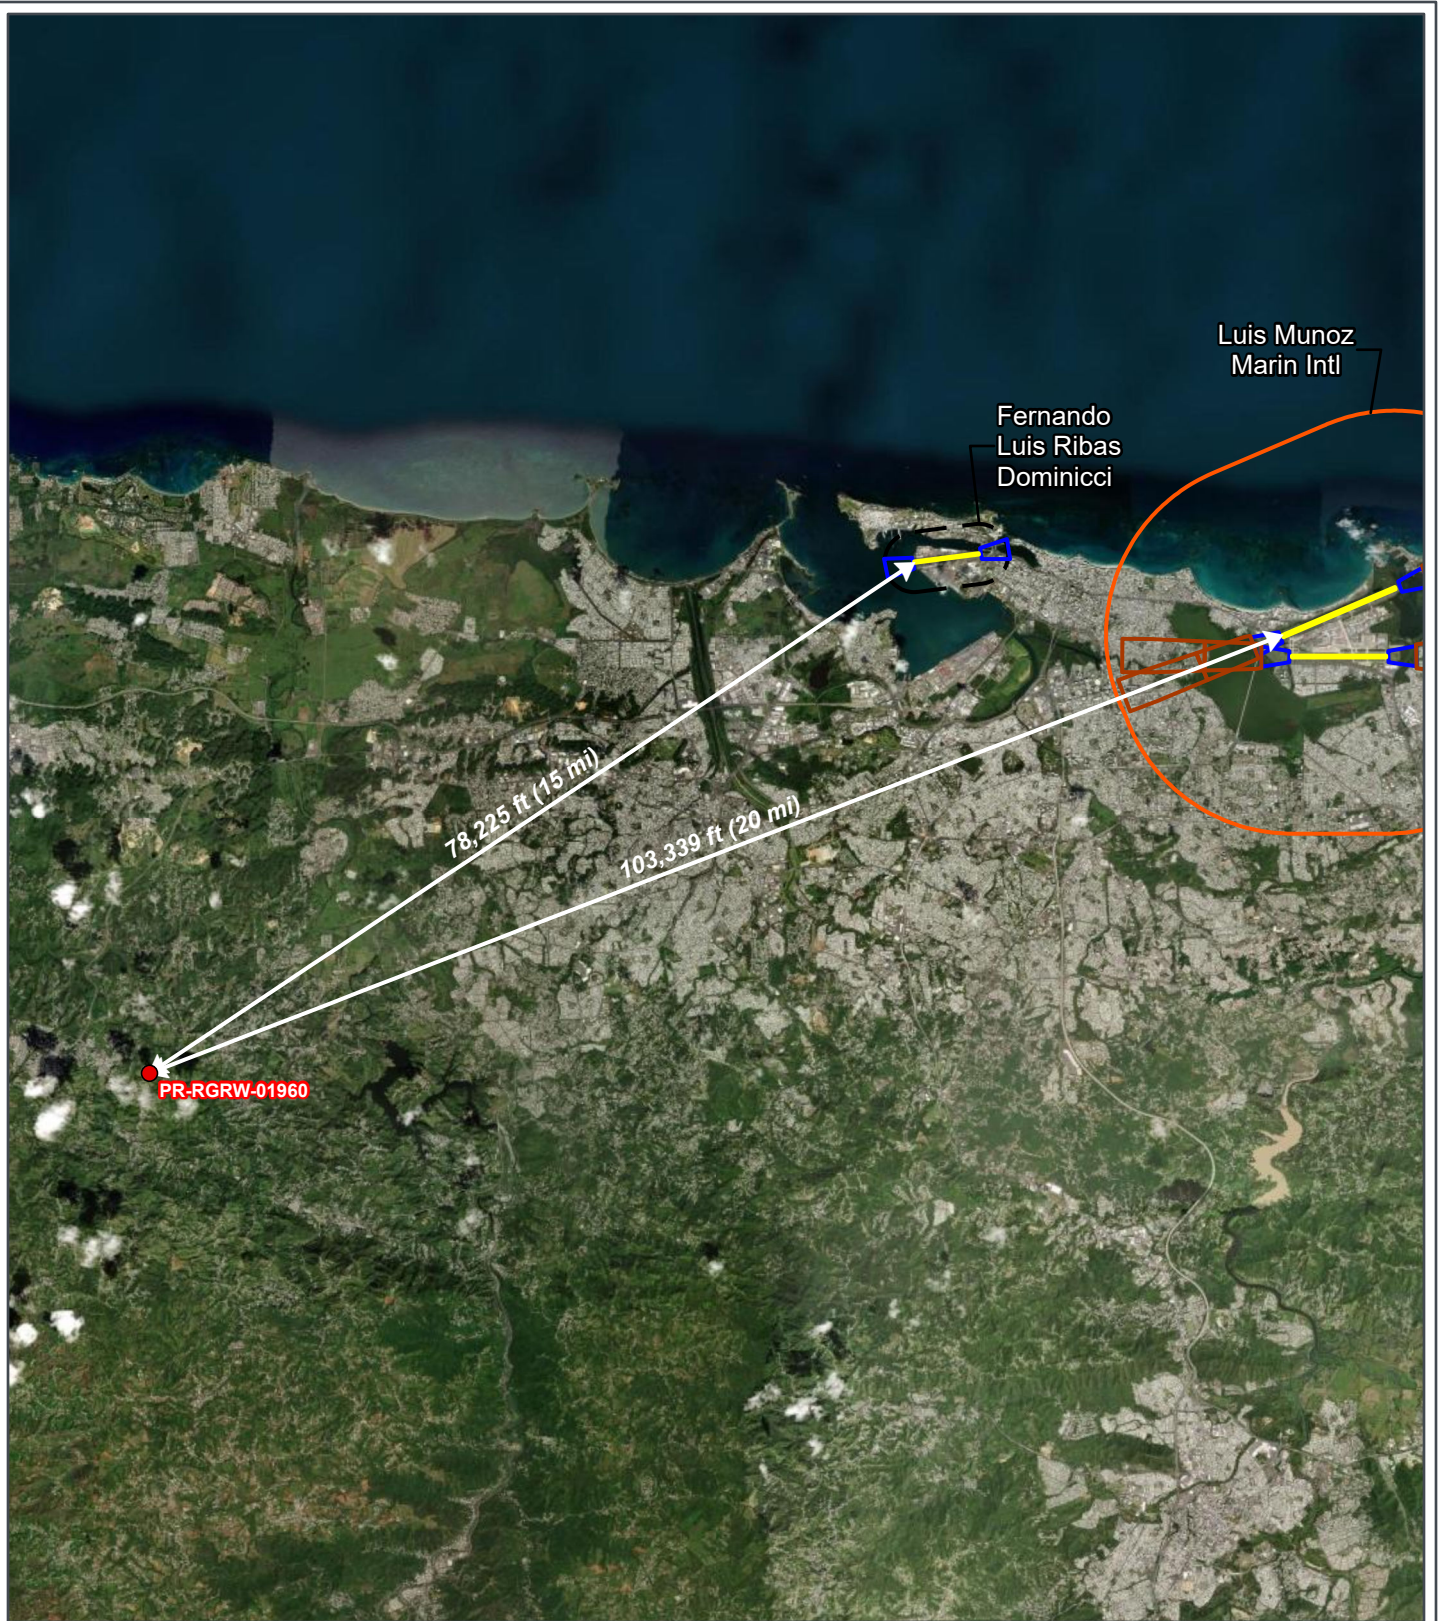
**Figure B 1-1:
Airport Hazards Map**

The project site is not within 2,500 feet (ft) of a civil primary or commercial service airport or within 15,000 ft of a military airport. The nearest civil primary or commercial service airport, Fernando Luis Ribas Dominicci, is located 78,225 ft (15 miles) from the project site. The nearest military airport, Luis Munoz Marin International Airport, is located 103,339 ft (20 miles) from the project site. Project activities are therefore an exempt activity. No further evaluation is required. The project is in compliance with airport hazards requirements.

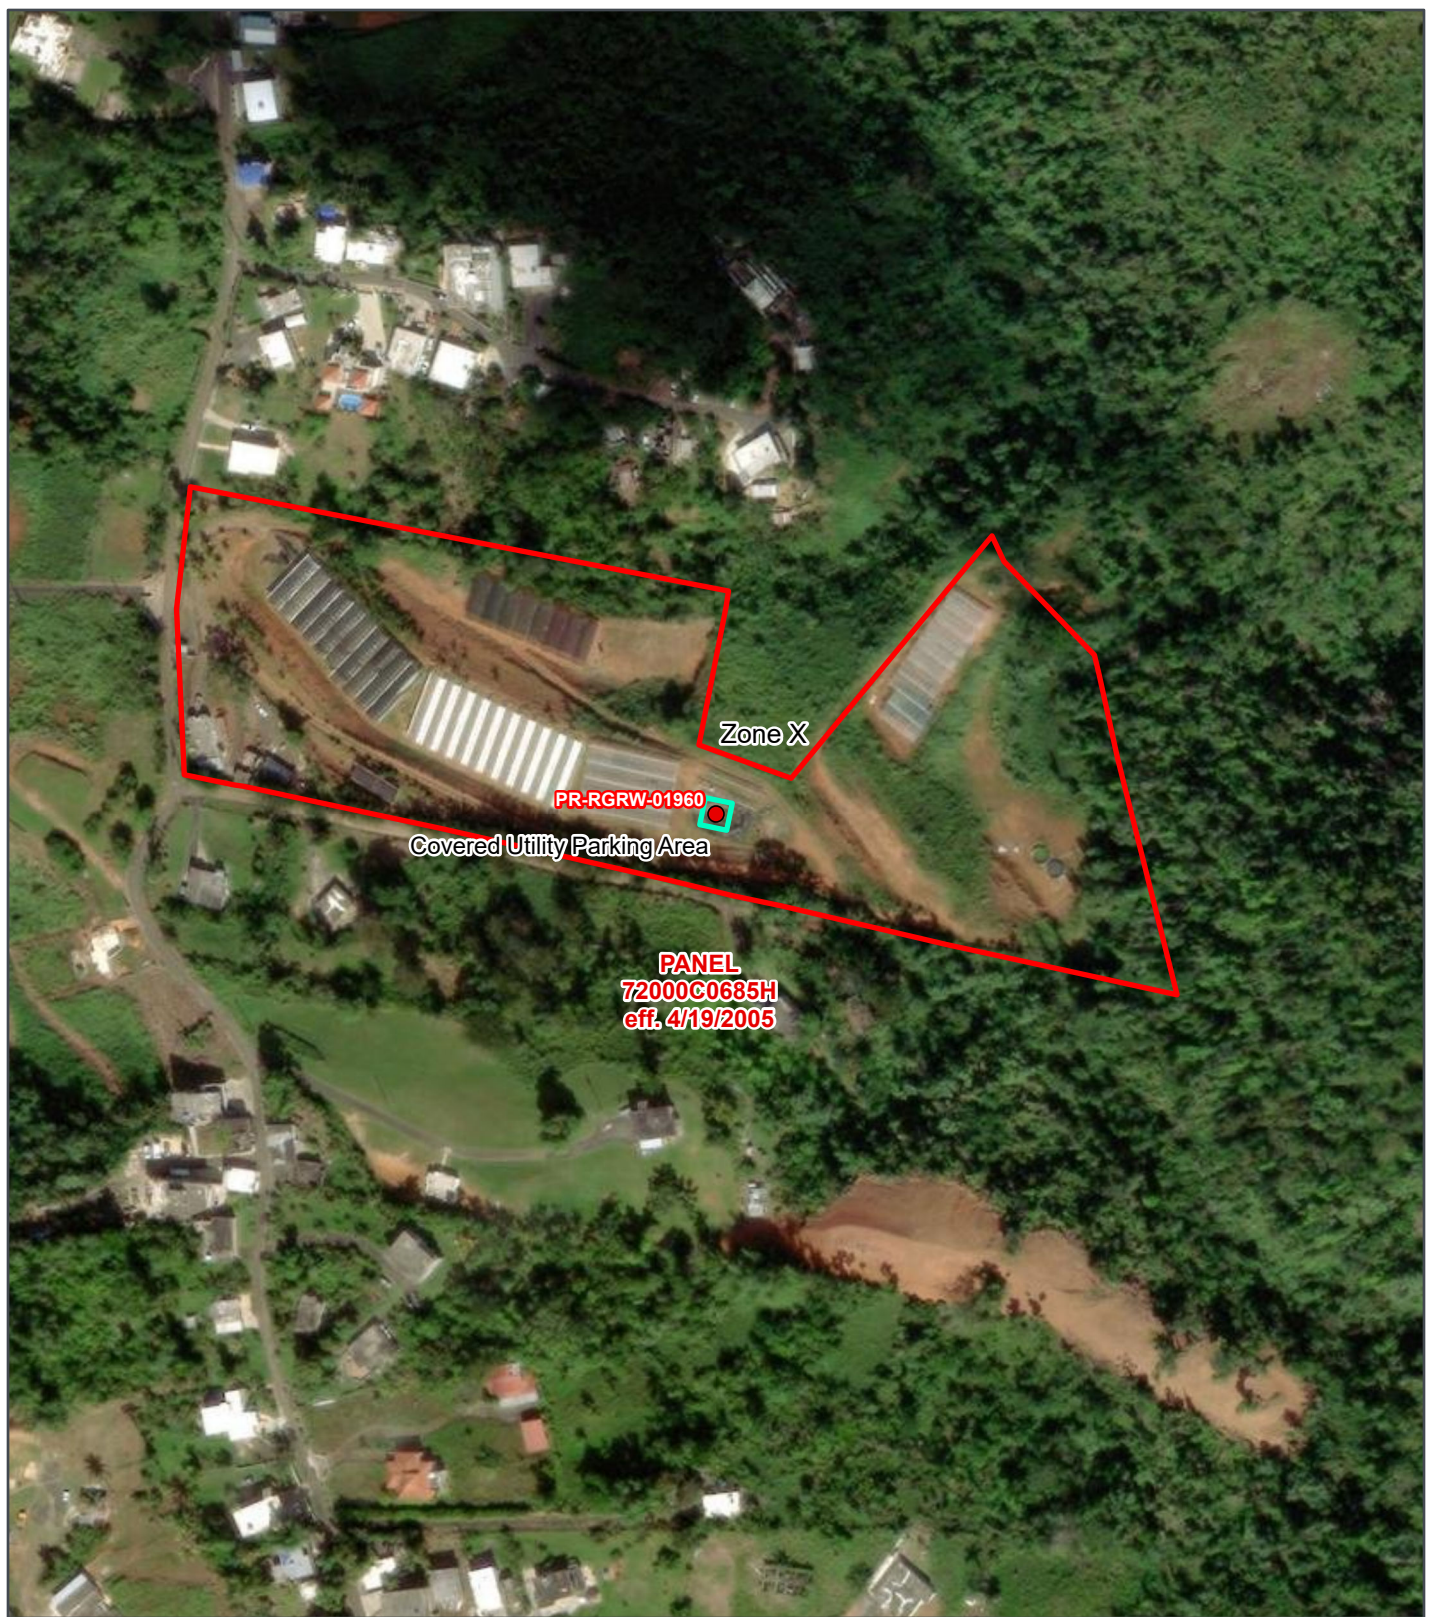
Figure B 3-1: Flood Insurance Rate Map (FIRM)

A review of the FEMA Flood Insurance Rate Map (FIRM), Community Panel 72000C0320J (effective date 11/18/2009), shows the project site is in Flood Zone X, which is not in a Special Flood Hazard Area (SFHA). Flood insurance is not required. The project is in compliance with this section. No further evaluation is required.

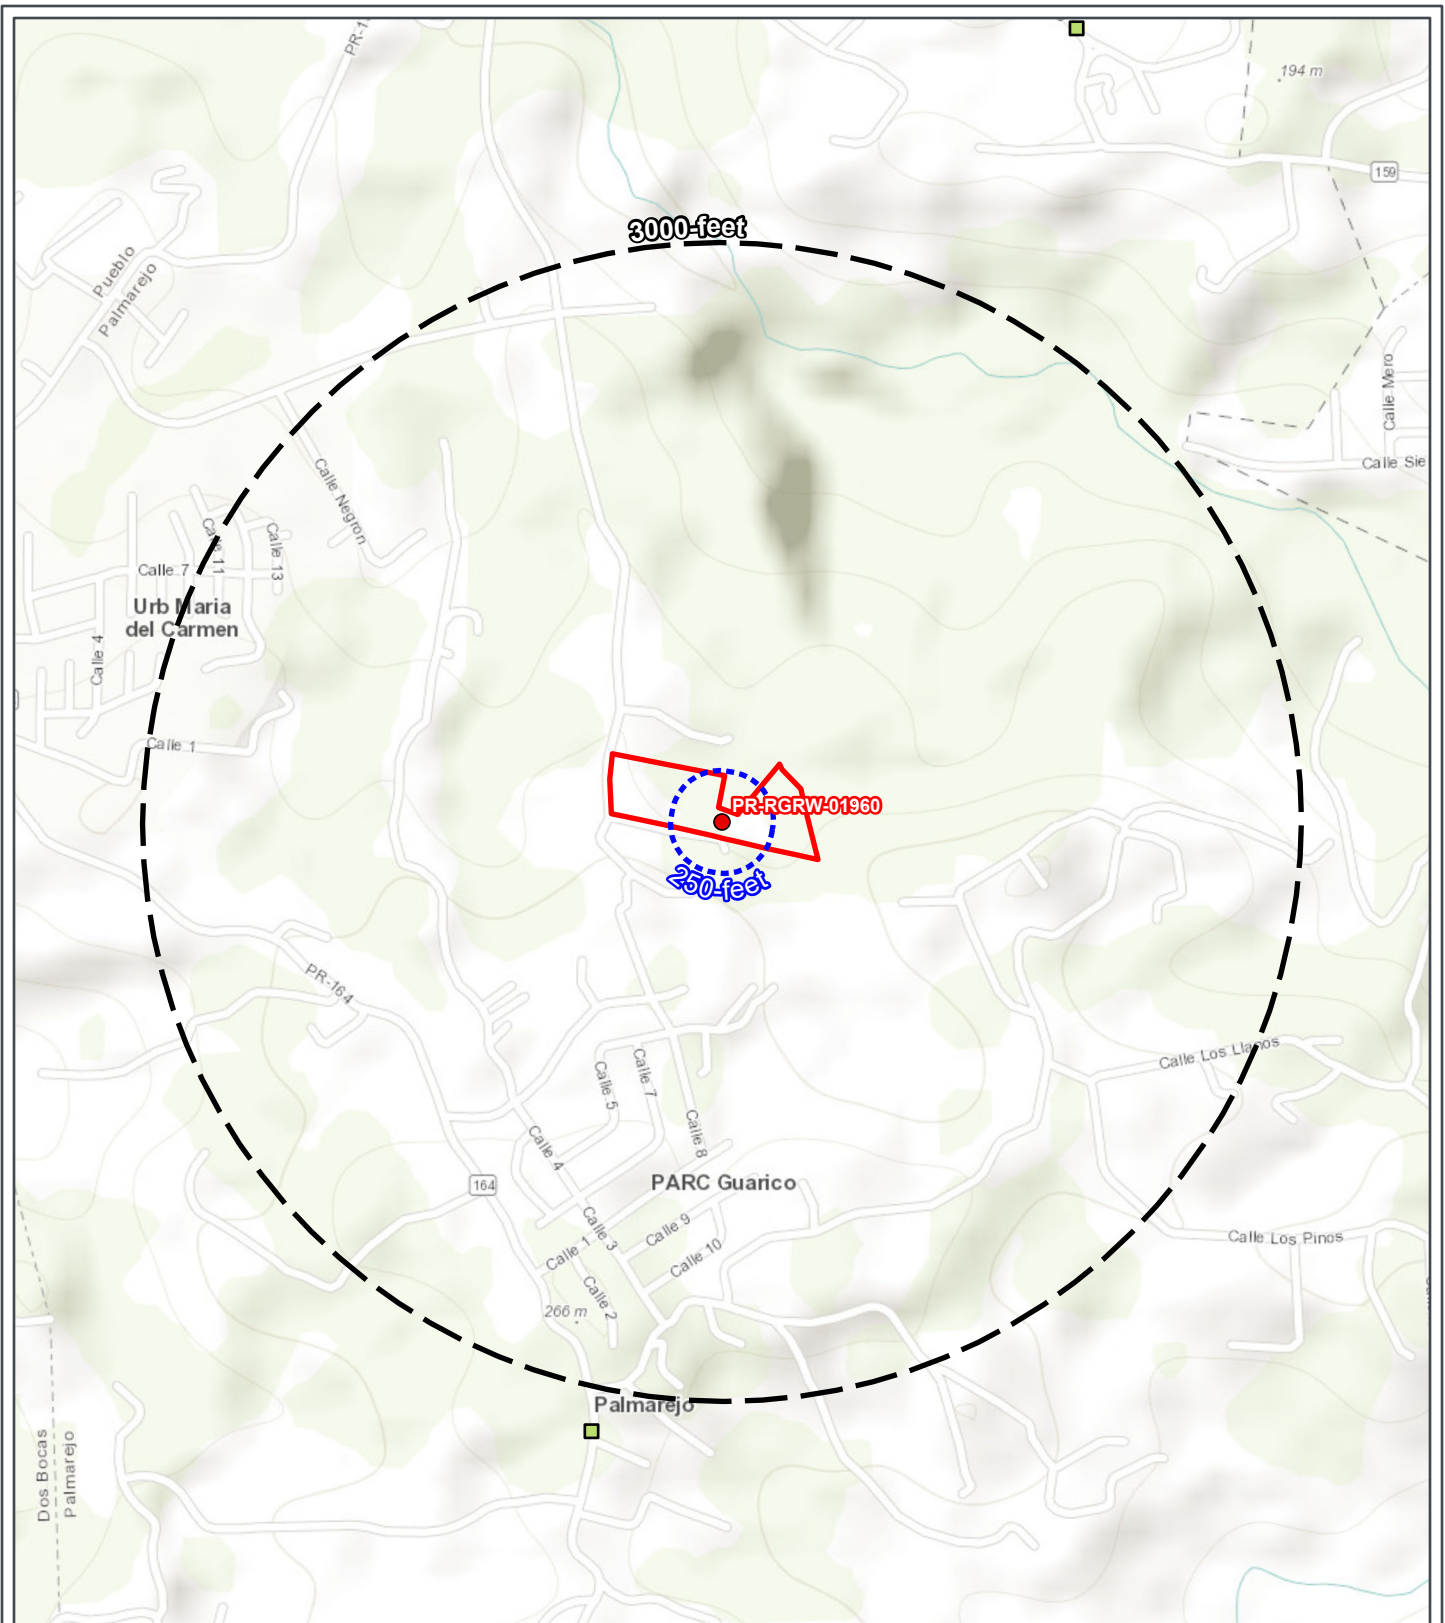
**Figure B 6-1:
Contamination and
Toxic Substances Map**

The project site was evaluated for potential contamination by conducting a field site inspection on 06/14/2023 to identify any onsite hazards including, but not limited to, soil staining, above ground storage tanks, signs of underground storage tanks, odors, hazardous debris etc. The site inspection did not identify any onsite hazards that could not be resolved with mitigation.

action and/or further investigation. The desktop review did not find any of the above-listed toxic, hazardous or radioactive substances in or within 3,000 feet of the project area that could affect the health and safety of project occupants or conflict with the intended use of the property. The project is in compliance with contamination and toxic substances requirements.

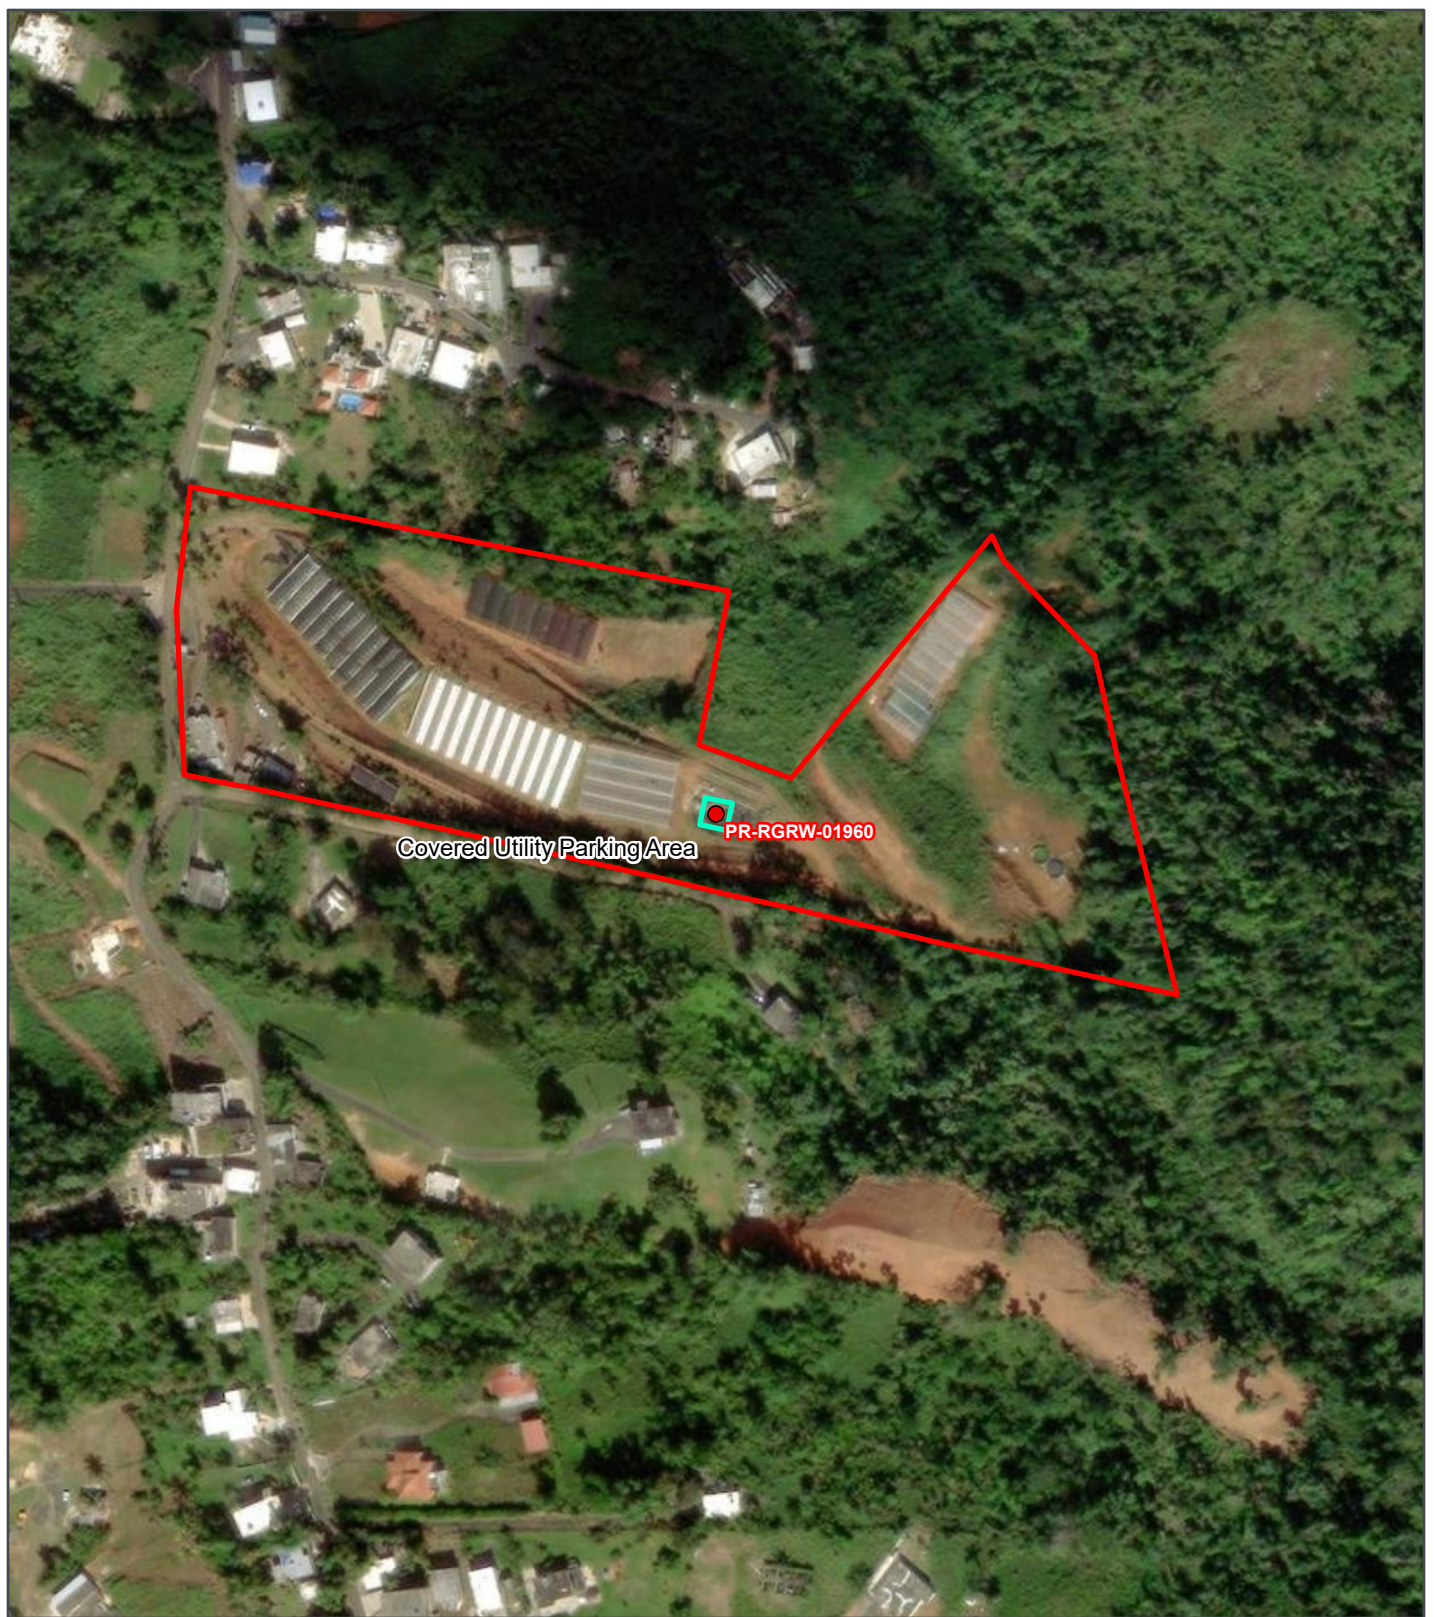
**Figure B 10-1:
Advisory Base Flood
Elevation For 100-Year
Floodplain Map**

A review of the Advisory Base Flood Elevation (ABFE) map, Community Panel 72000C0320J (effective date 11/18/2009), shows the project site is in Flood Zone X. The project is not located in the 100-year floodplain or ABFE special flood hazard area; therefore, no further action is required.

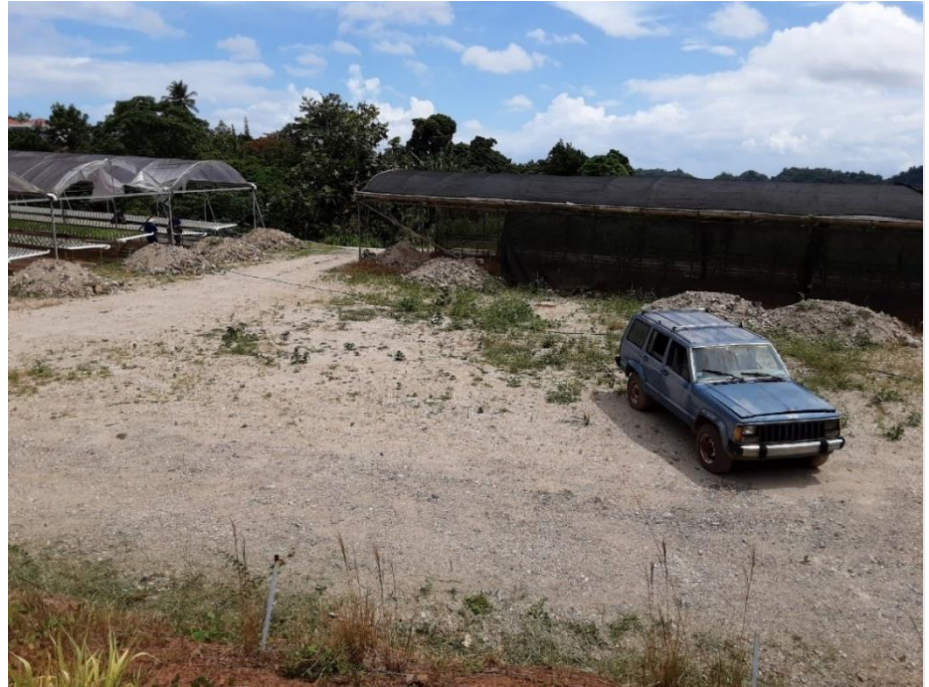
Description: Overview of the site location for a covered utility parking area 30x30 ft. The roof will have an inclination from 10 ft (east) to 8.5 ft (west) to help direct the rainwater out of the area where the greenhouses are being cultivated. This picture shows a partial view of a greenhouse being cultivated, an abandoned car, and another greenhouse.

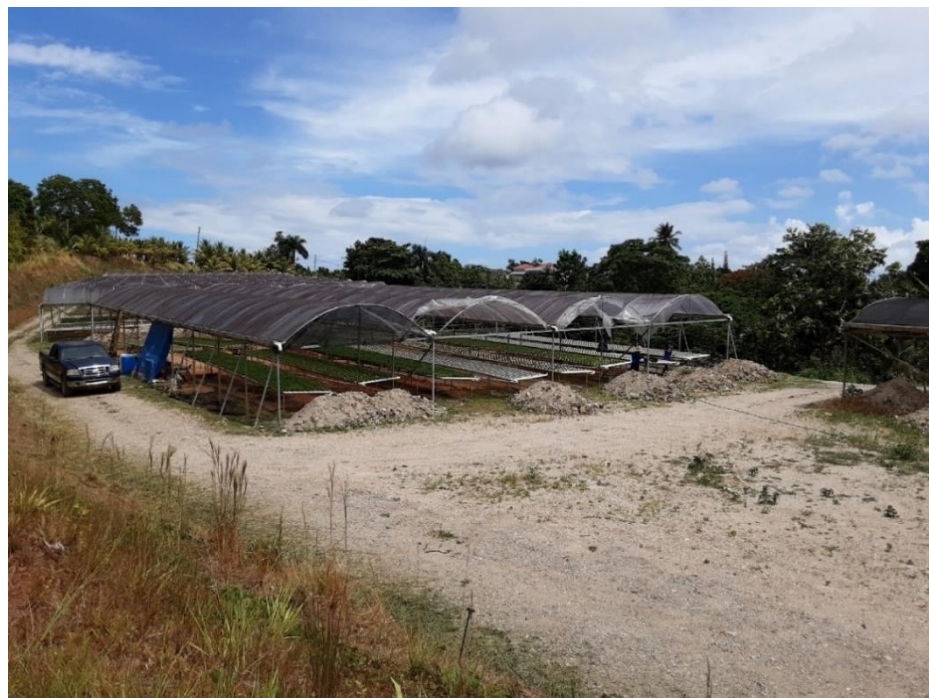
Description: This picture is an overview of the property where the project location for a covered utility parking area 30x30 ft, 10 to 8.5 ft. This picture shows the farm vehicle, the greenhouses with the hydroponic systems, a partial view of the site location, and the corner of another greenhouse.

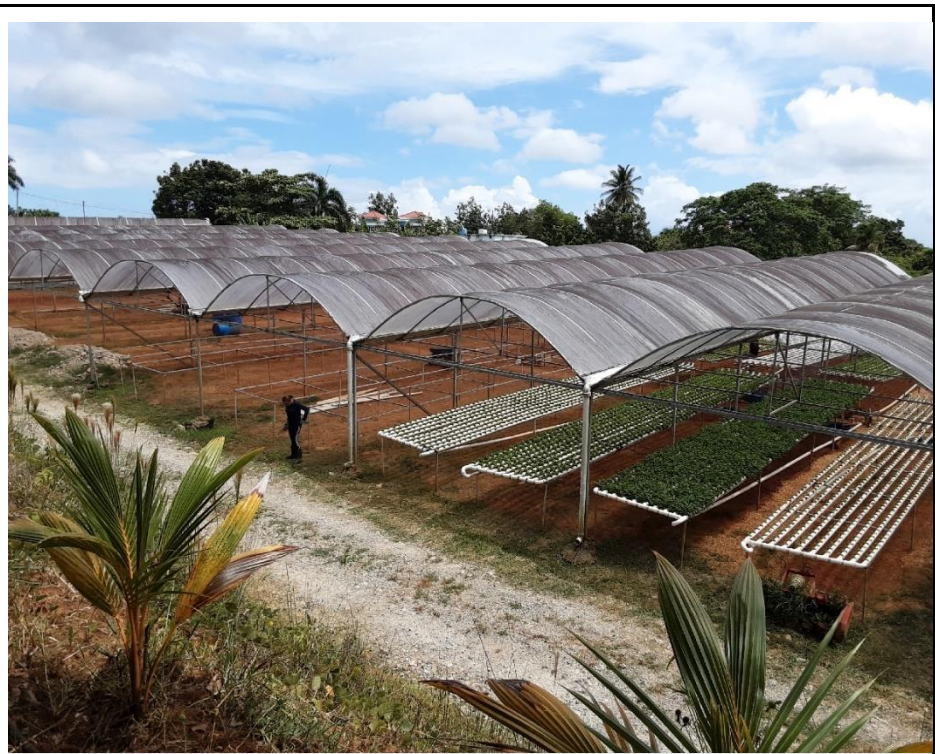
This picture overviews the greenhouses with the hydroponics systems, east of the project location. Part of the greenhouses are being prepared or transformed into hydroponics.

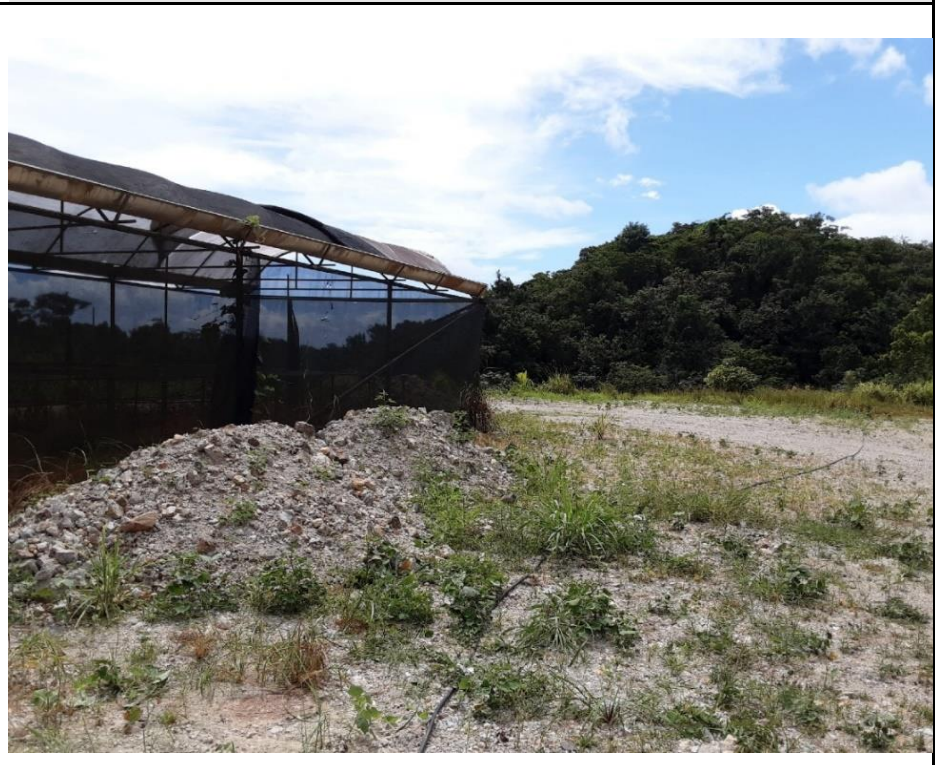
Description: Overview of the project location for a covered utility parking area 30x30 ft with a height of 10 ft getting an inclination of 8.5 ft taken from the center, showing a greenhouse with construction materials at the side. The pile of rocks will be spread inside the greenhouses to create a floor and cover the dirt to limit the creation of potholes.

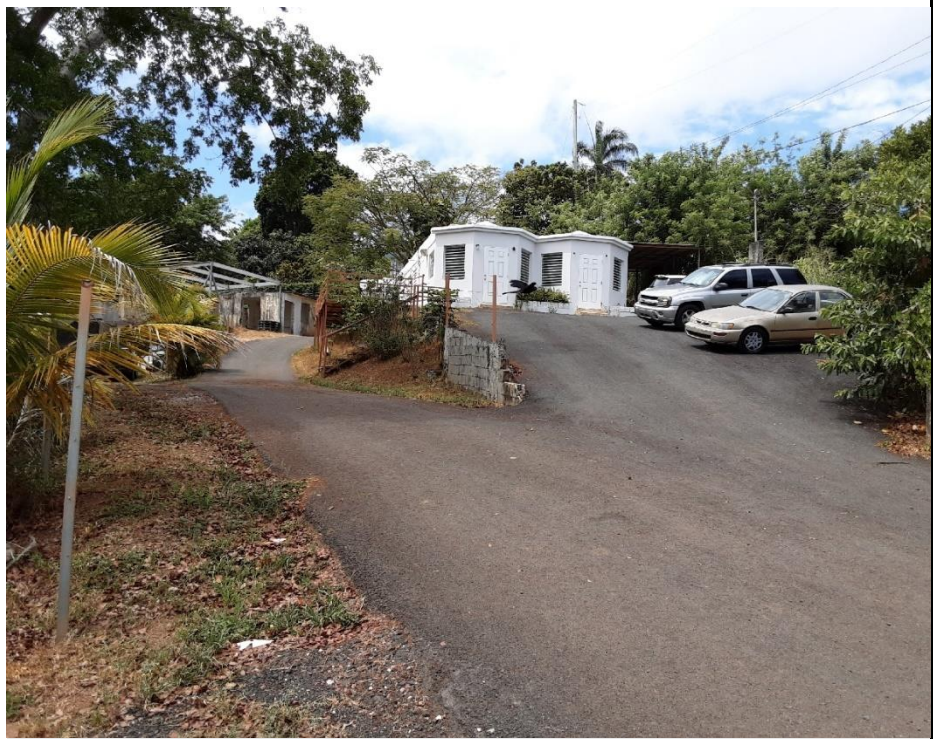
The structure on the left side of this picture was severely damaged by Hurricane Maria in 2017 and the structure to the right was fixed and transformed into a warehouse where the product is packed to be sold. Both structures were built in 1991 per the owner, however aerials suggest ca.1995 for the warehouse and ca. 1967 for the abandoned house.
