Environmental Assessment

Project ID: PR-RGRW-01960

Project Name: RLR4U Inc.

The proposed project includes the purchase of a tractor and a van plus the applicable van refrigeration unit, the purchase of various farm equipment, and the purchase of roofing materials, galvanized tubes, and PVC pipes to construct an open-air garage for the applicant's agricultural vehicles. The equipment that will be purchased by the applicant as listed in the Intended Use of Grant Funds falls under the "categorically excluded, not subject to (CENST)" category under HUD guidelines (24 CFR 58.35(b)(4)). This Environmental Assessment (EA) also encompasses the CENST review requirements for the equipment.

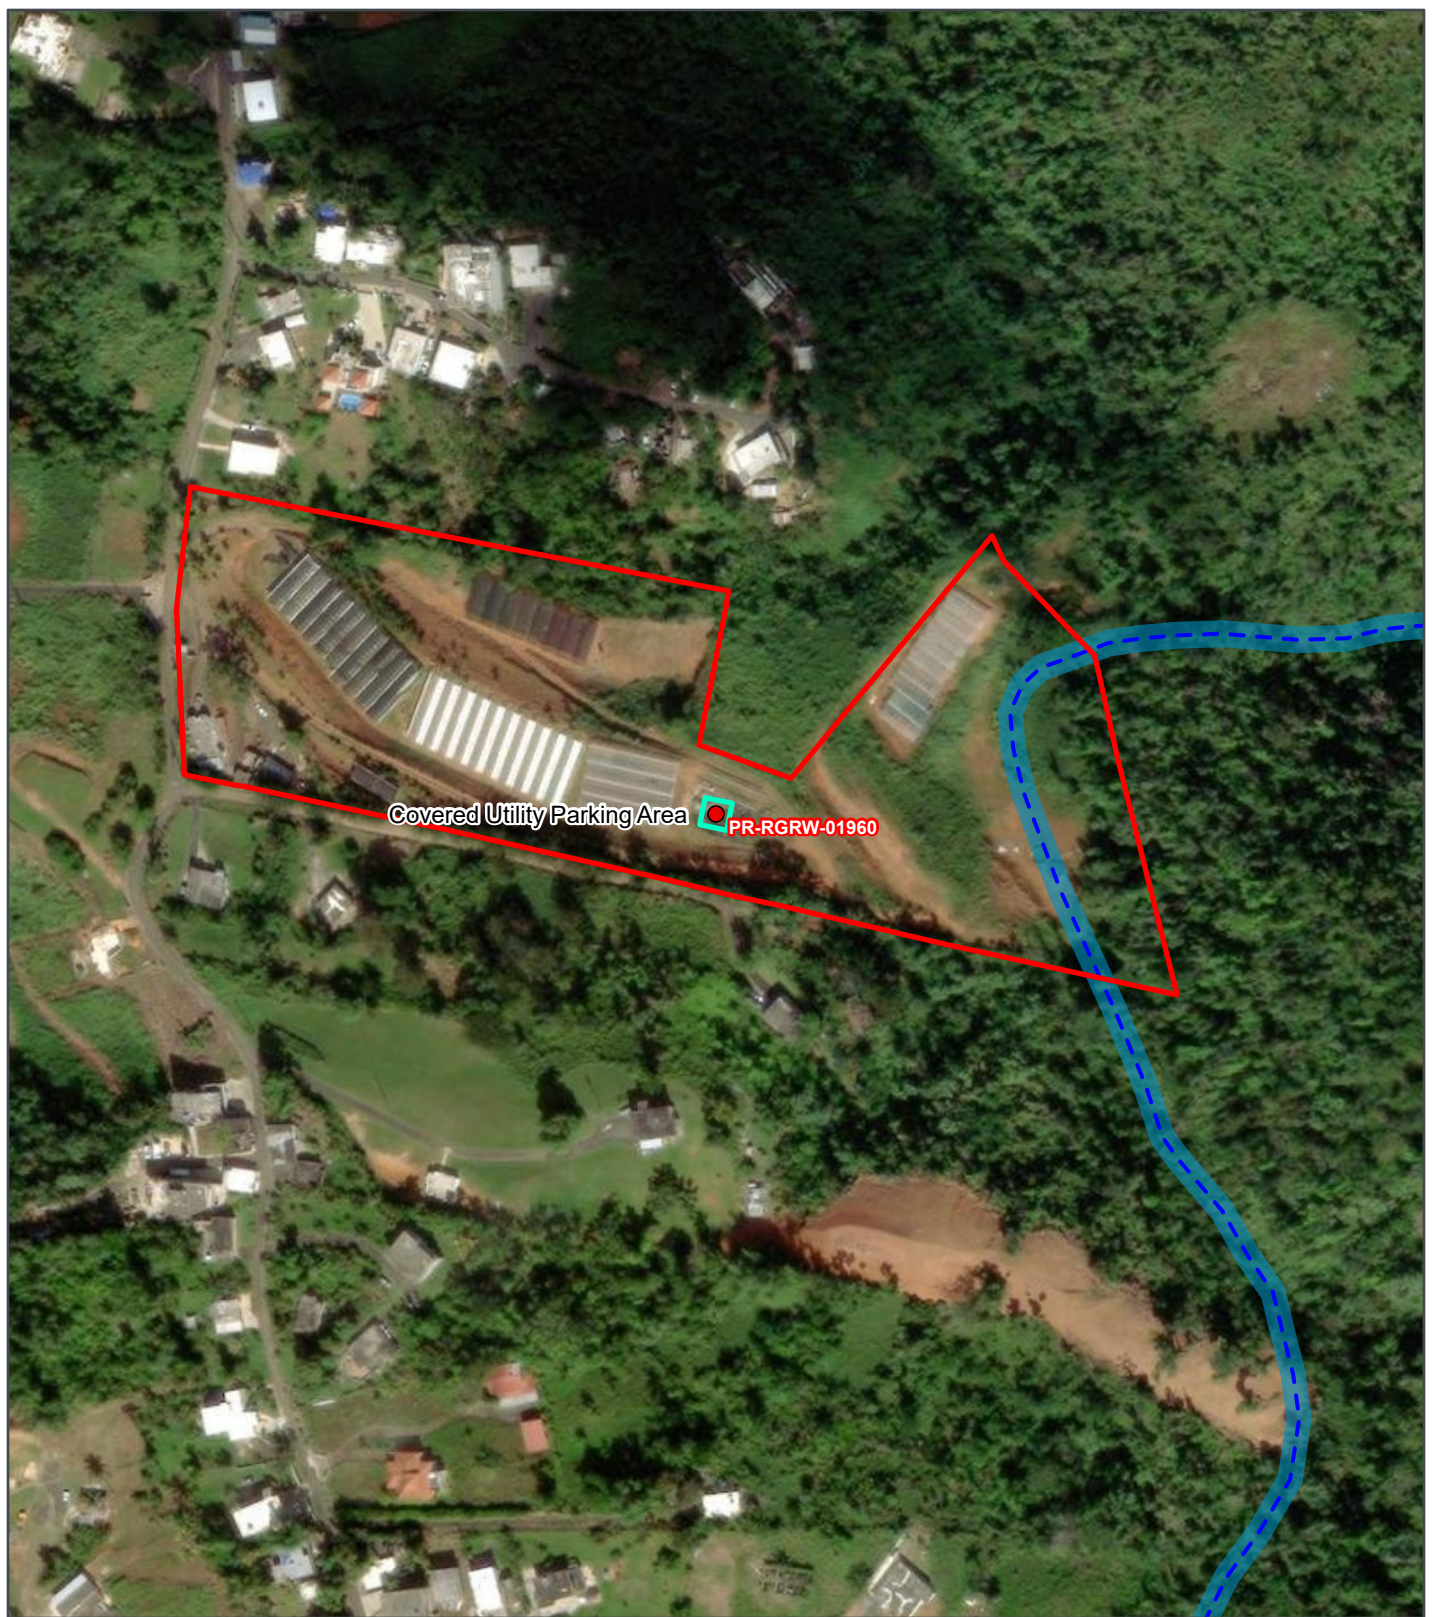
**Figure B 14-1:
Wetlands Protection
Map**

The project site was reviewed for wetlands using the USFWS Wetland Inventory Mapper and a visual confirmation during the field site inspection. No wetlands were determined to be present on site. The site inspection identified a stream about 320 feet east northeast, but it will not be impacted by the project if BMPs, such as silt fencing and erosion control, are implemented during any ground-disturbing activities. No further evaluation is required. The project is in compliance with Executive Order 11990.

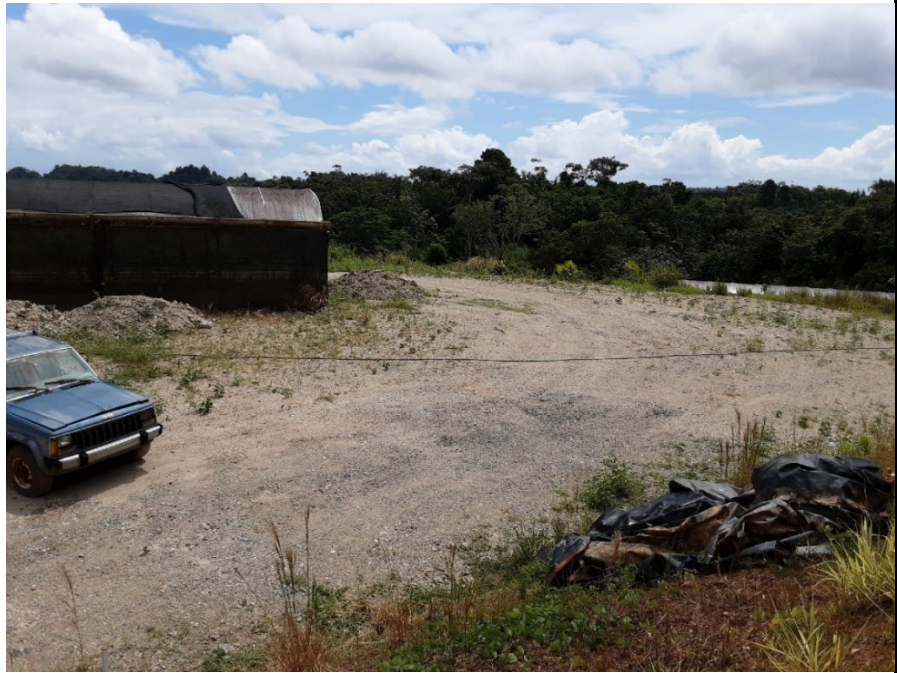
Photo #: 01	Date: 06/16/ 2023
Photo Direction: Northeast	
Description: This picture is an overview of the property where the project location for a covered utility parking area 30x30ft. The roof will have an inclination from 10ft to 8.5ft to help the rainwater to run from east to west and not towards the greenhouses. This picture shows a partial view of an abandoned car, a partial view of a greenhouse, the road, and the area's vegetation.

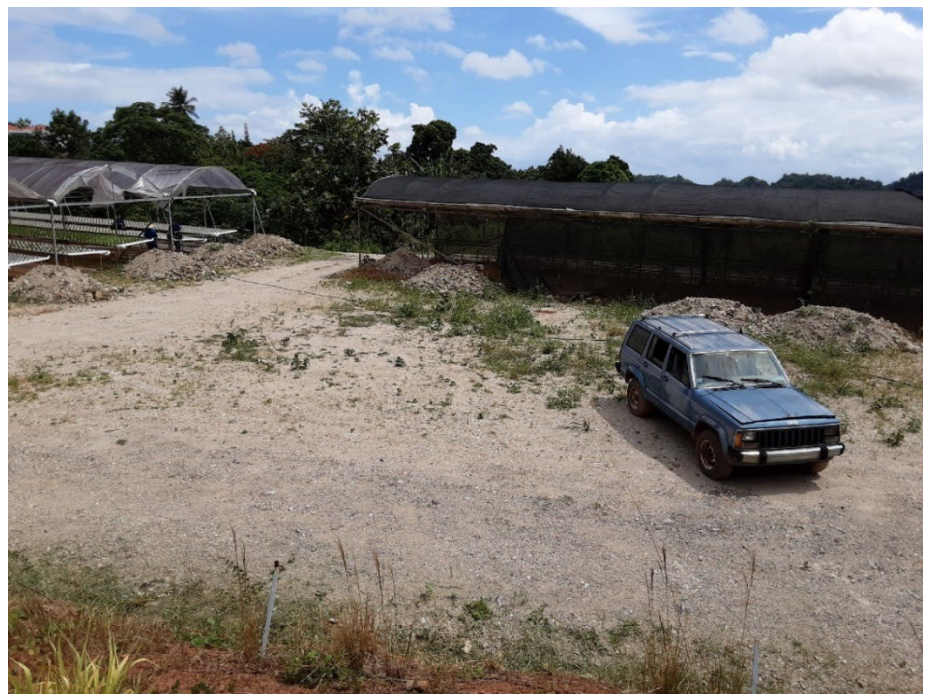
Photo #: 02	Date: 06/16/ 2023
Photo Direction: North	
Description: This picture is an overview of the site location project for a covered utility parking area 30x30f. The roof will have an inclination from 10ft (east) to 8.5ft (west) to help direct the rainwater out of the area where the greenhouses are being cultivated. This picture shows a partial view of a greenhouse being cultivated, an abandoned car, and another greenhouse.

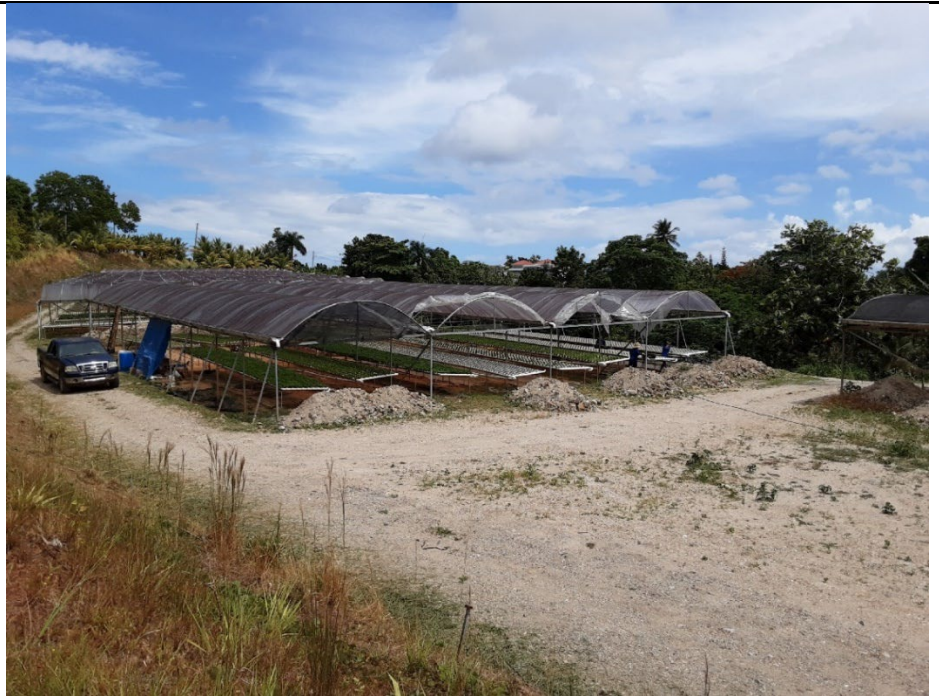
Photo #: 03	Date: 06/16/ 2023
Photo Direction: Northwest	
Description: This picture is an overview of the property where the project location for a covered utility parking area 30x30ft, 10 to 8.5ft. This picture shows the farm vehicle, the greenhouses with the hydroponic systems, a partial view of the site location, and the corner of another greenhouse.

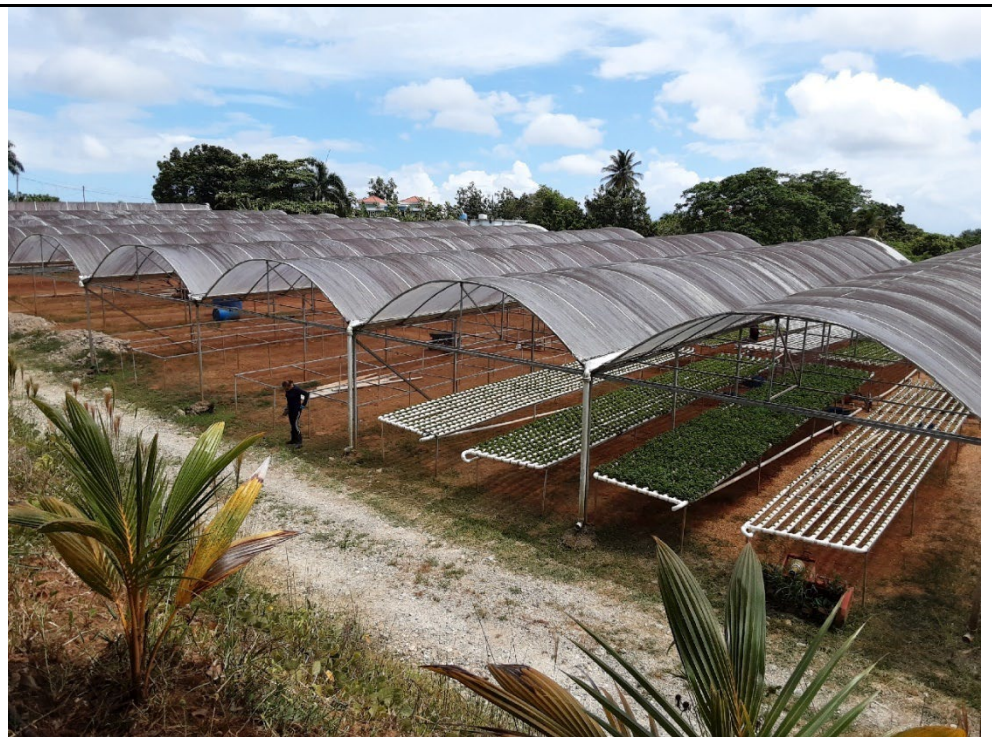
Photo #: 04	Date: 06/16/ 2023
Photo Direction: Northwest	
Description: This picture overviews the greenhouses with the hydroponics systems, east of the project location. Part of the greenhouses are being prepare or transform into hydroponics.

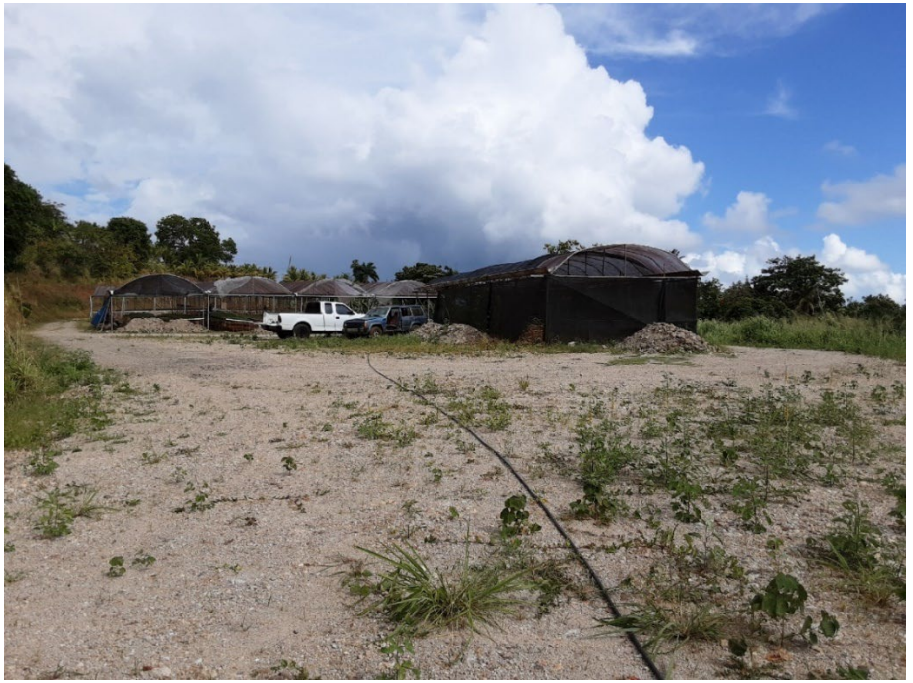
Photo #: 05	Date: 06/16/ 2023

Photo Direction: Northwest		
Description: This picture is an overview of the project location for a covered utility parking area 30x30ft with a height of 10ft getting an inclination of 8.5ft to help direct the rainwater out of the greenhouses that are being cultivated. The picture also presents two vehicles (one from an employee and an abandoned car) next to another greenhouse, and the area's vegetation.

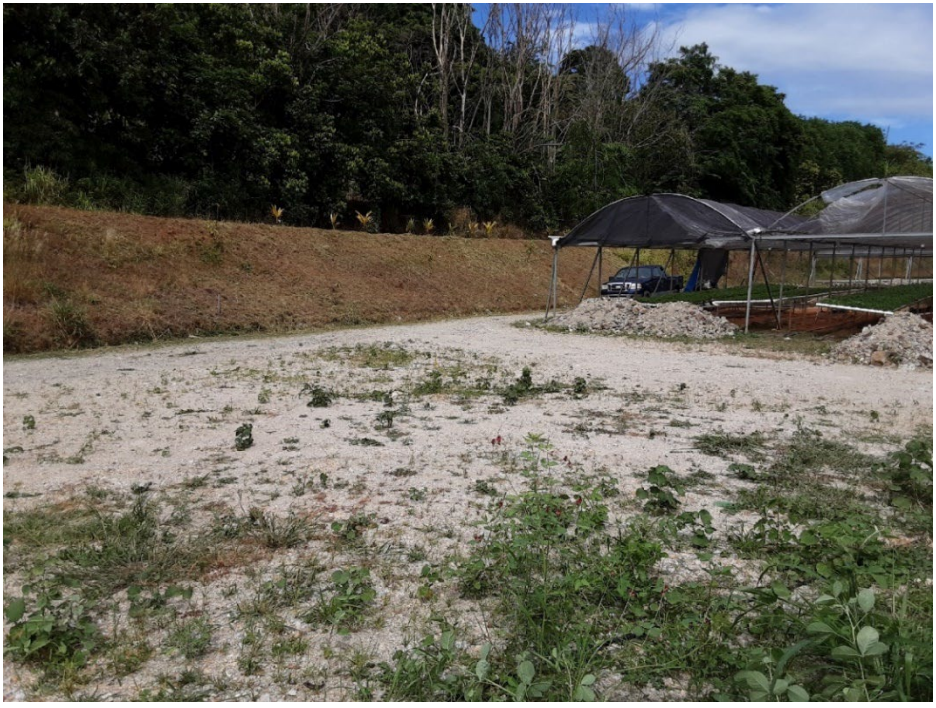
Photo #: 07	Date: 06/16/ 2023

Photo Direction: Southwest		
Description: This picture is an overview of the project location for a covered utility parking area 30x30ft with a height of 10ft getting an inclination of 8.5ft taken from the northeast corner showing the area's vegetation, the farm's vehicle, and the greenhouses with the hydroponics being cultivated.

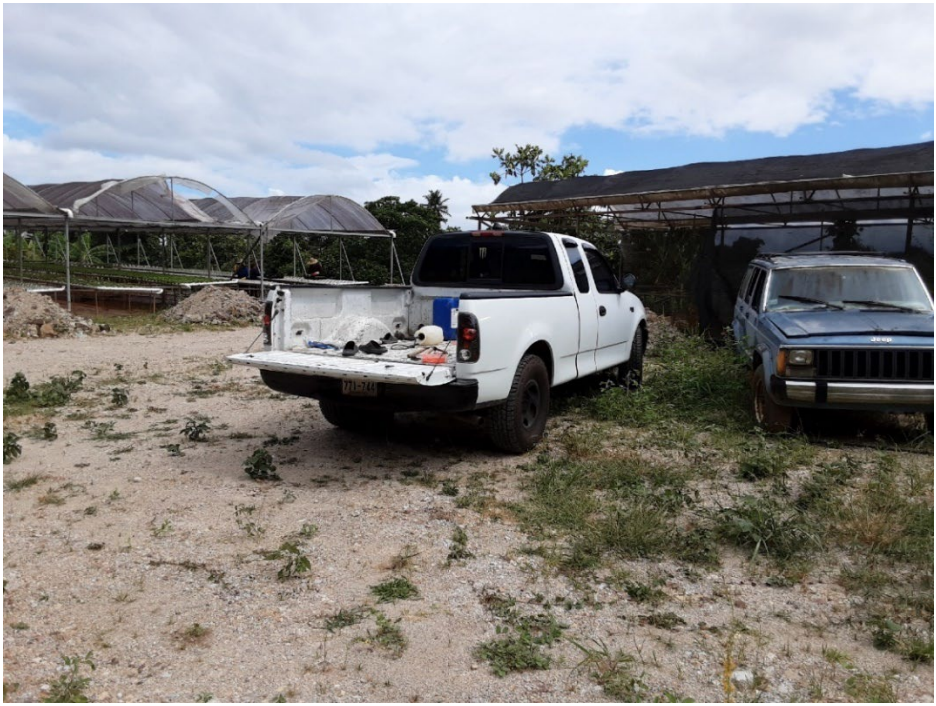
Photo #: 08	Date: 06/16/ 2023

Photo Direction: Northwest		
Description: This picture is an overview of the project location for a covered utility parking area 30x30ft with a height of 10ft getting an inclination of 8.5ft taken from the southeast corner showing the greenhouses being cultivated using hydroponics, a vehicle from an employee, and an abandoned vehicle.

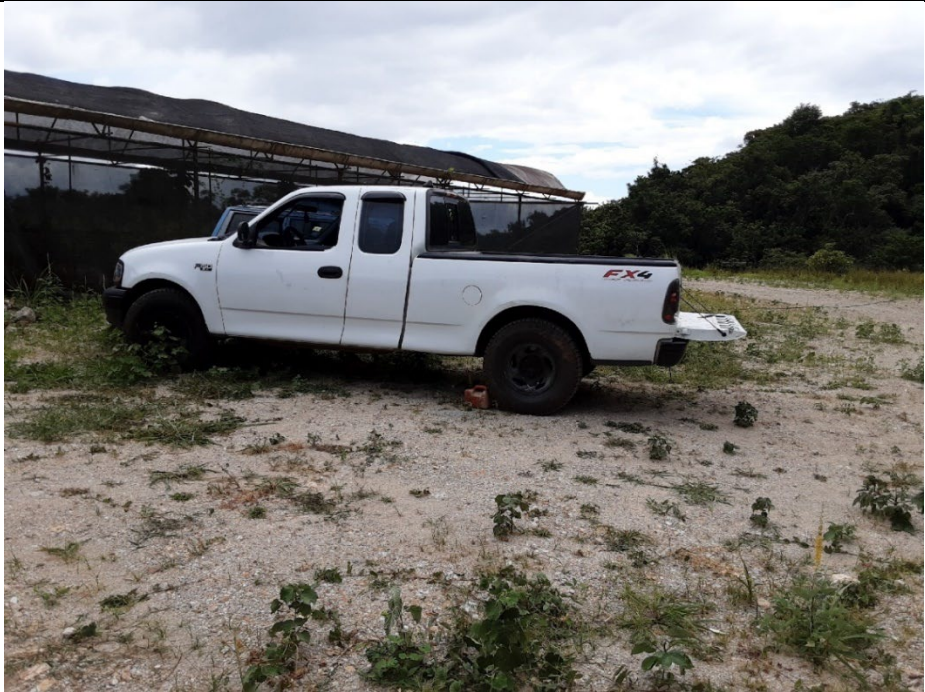
Photo #: 09	Date: 06/16/ 2023

Photo Direction: Northeast		
Description: This picture is an overview of the project location for a covered utility parking area 30x30ft with a height of 10ft getting an inclination of 8.5ft taken from the southeast corner showing the greenhouses being cultivated using hydroponics, a vehicle from an employee, and an abandoned vehicle.

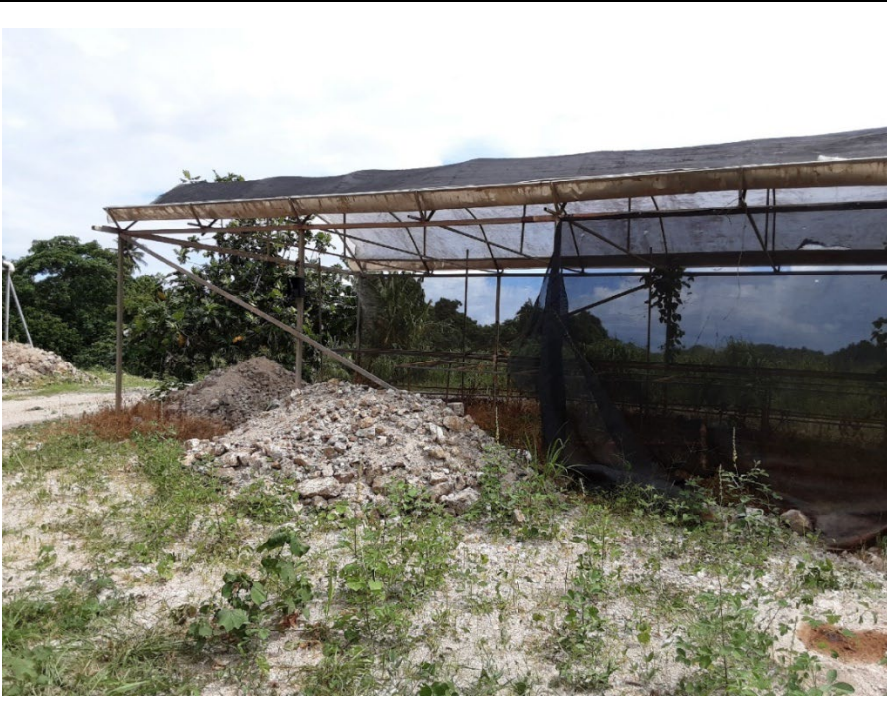
Photo #: 10	Date: 06/16/ 2023

Photo Direction: North		
Description: This picture is an overview of the project location for a covered utility parking area 30x30ft with a height of 10ft getting an inclination of 8.5ft taken from the center, showing a greenhouse with construction materials at the side. The pile of crushed rocks is going to be scattered inside the greenhouses to create some sort of floor and cover the dirt to limit the creation of potholes.

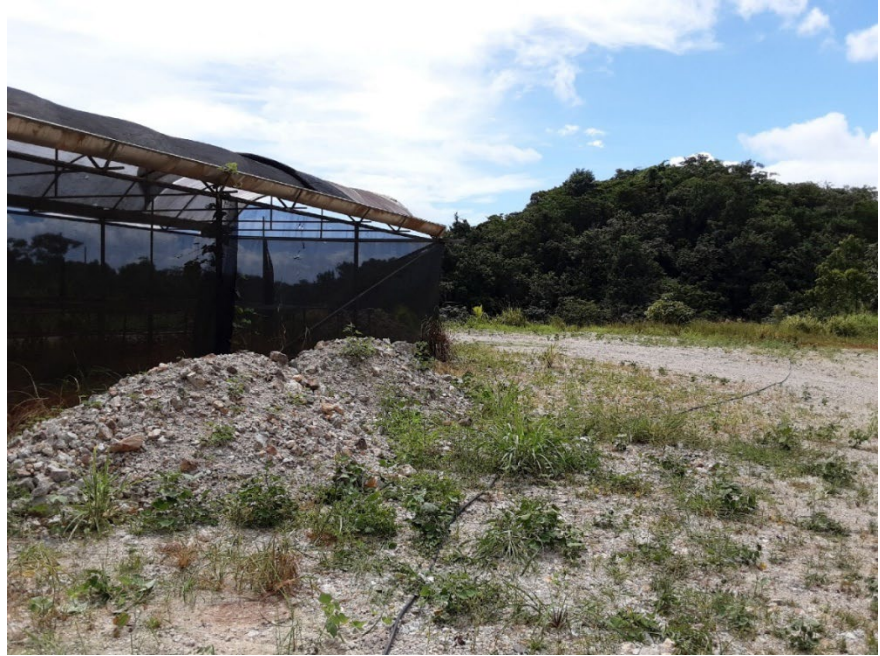
Photo #: 11	Date: 06/16/ 2023

Photo Direction: East		
Description: This picture is an overview of the project location for a covered utility parking area 30x30ft with a height of 10ft getting an inclination of 8.5ft taken from the center, showing a greenhouse with construction materials at the side. The pile of crushed rocks is going to be scattered inside the greenhouses to create some sort of floor and cover the dirt to limit the creation of potholes, and the area's vegetation closer to the river.

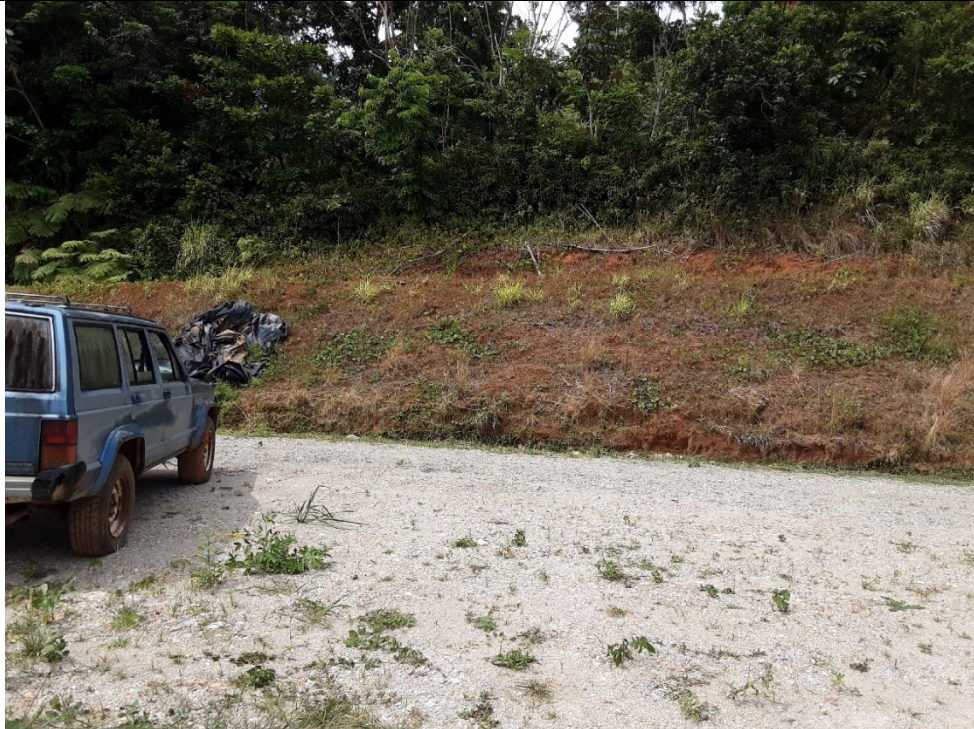
Photo #: 12	Date: 06/16/ 2023

Photo Direction: South		
Description: This picture is an overview of the project location for a covered utility parking area 30x30ft with a height of 10ft getting an inclination of 8.5ft taken from the center, showing an abandoned vehicle the applicant will remove and the area's vegetation.

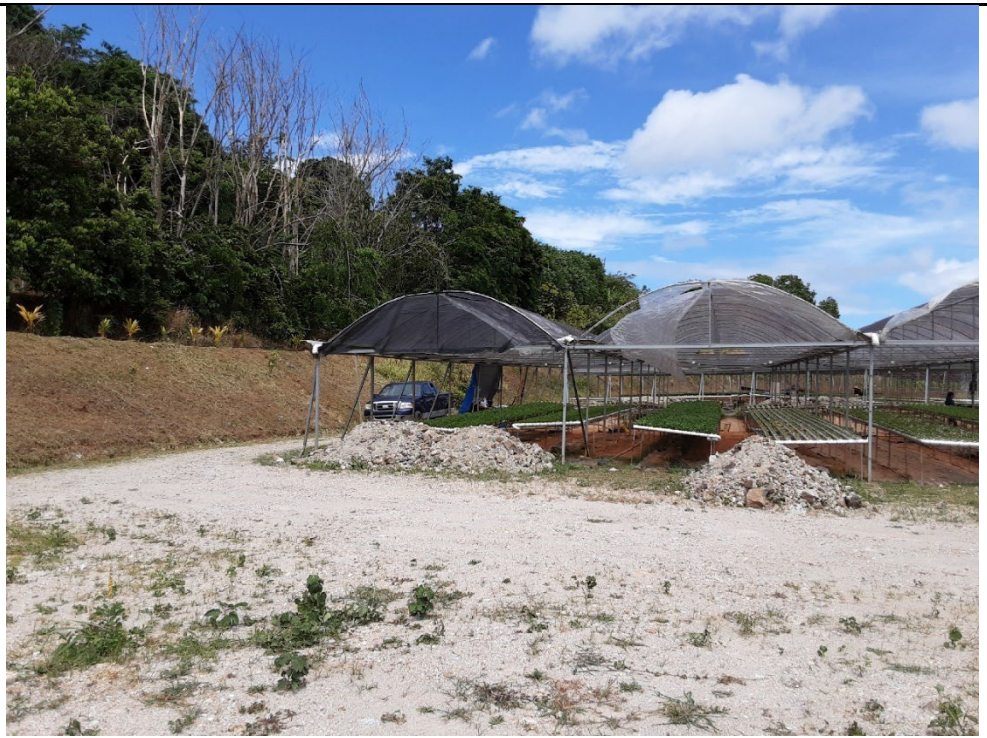
Description:
This picture is an overview of the project location for a covered utility parking area 30x30ft with a height of 10ft getting an inclination of 8.5ft taken from the center, showing the greenhouses with the hydroponic system and the area's vegetation.

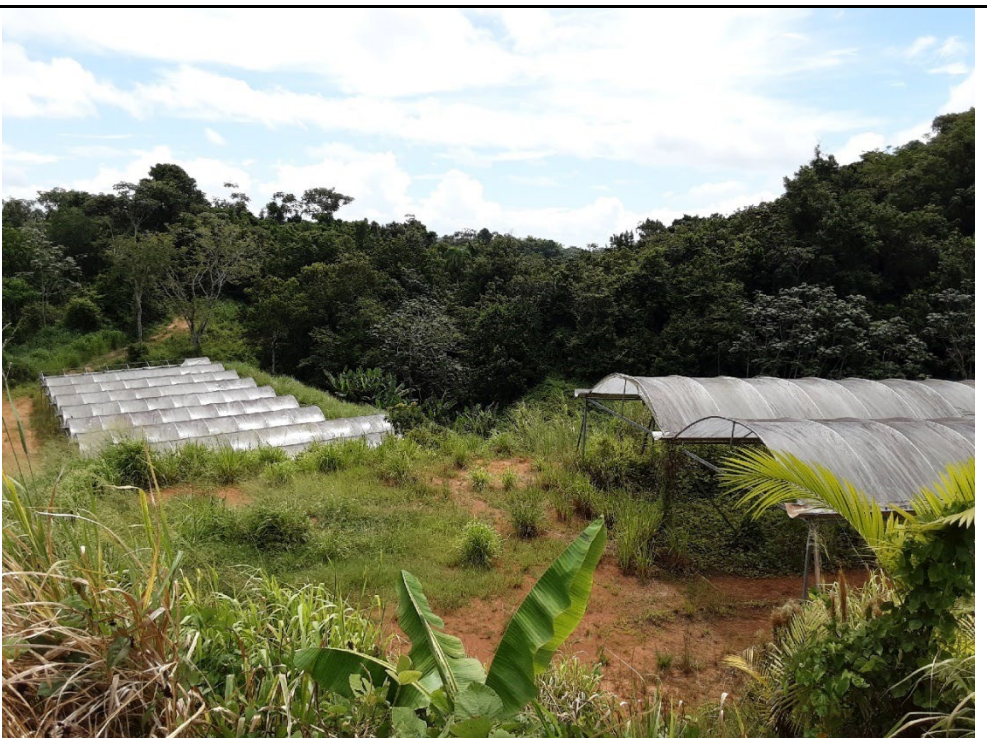
Photo #: 14	Date: 06/16/ 2023
-----------------------	--------------------------------

Description:
This picture is an overview of another section of the property where the applicant cultivates, and it also overlooks the area where an unnamed stream is located (not seen in the picture).

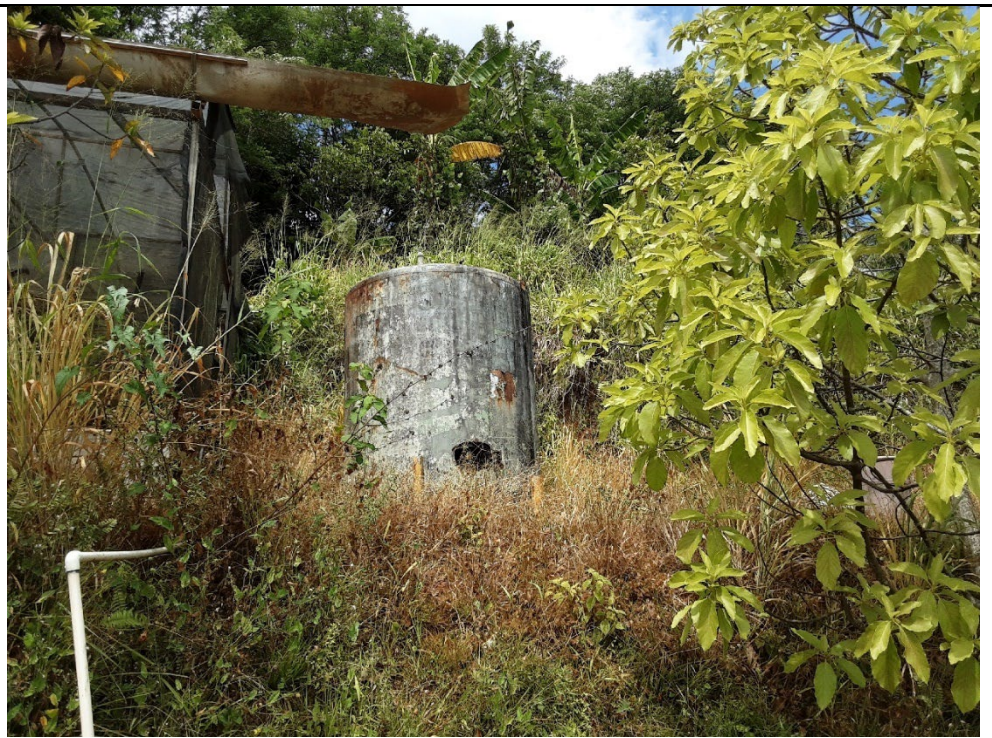
Photo #: 15	Date: 06/16/ 2023
Photo Direction: South	
Description: This picture presents a 5000-gallon cistern the applicant is fixing to be able to store rainwater for the crops, this is a future project funded by the applicant.

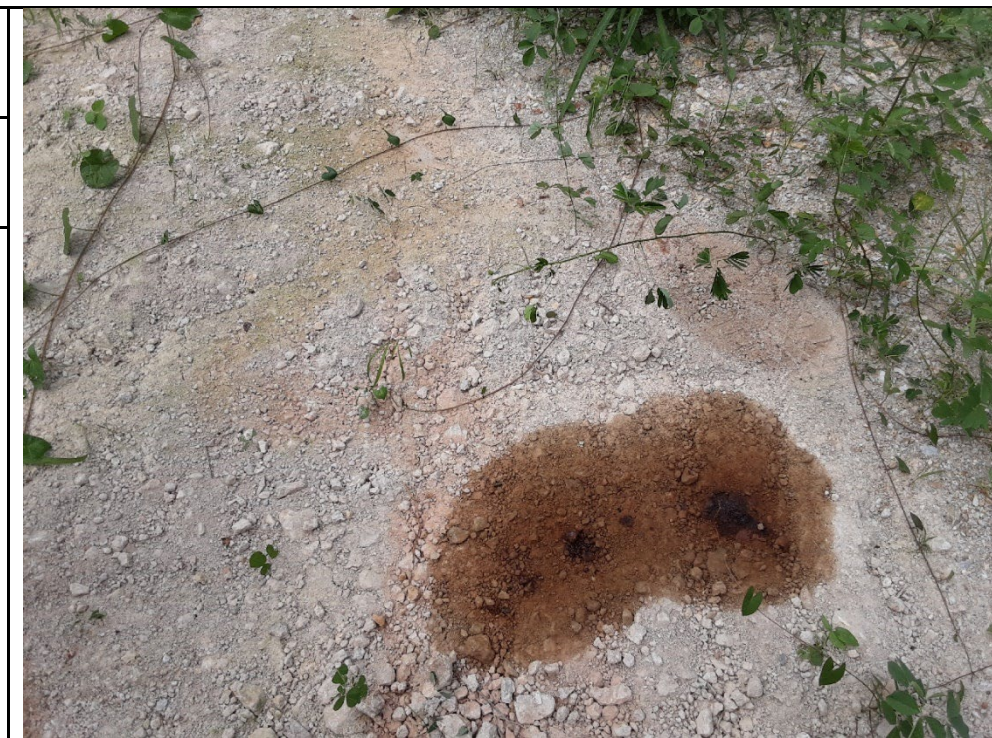
Photo #: 16	Date: 06/16/ 2023
Photo Direction: Close-up, facing down.	
Description: This picture overlooks a soil stain that was uncovered when the applicant moved the abandoned vehicle to provide a better view when taking the pictures. The applicant is going to remove the abandoned vehicle from the property.
