Environmental Assessment

Determinations and Compliance Findings for HUD-assisted Projects

Project Name: Hidropónicos María - PR-RGRW-00325

Responsible Entity: Puerto Rico Department of Housing

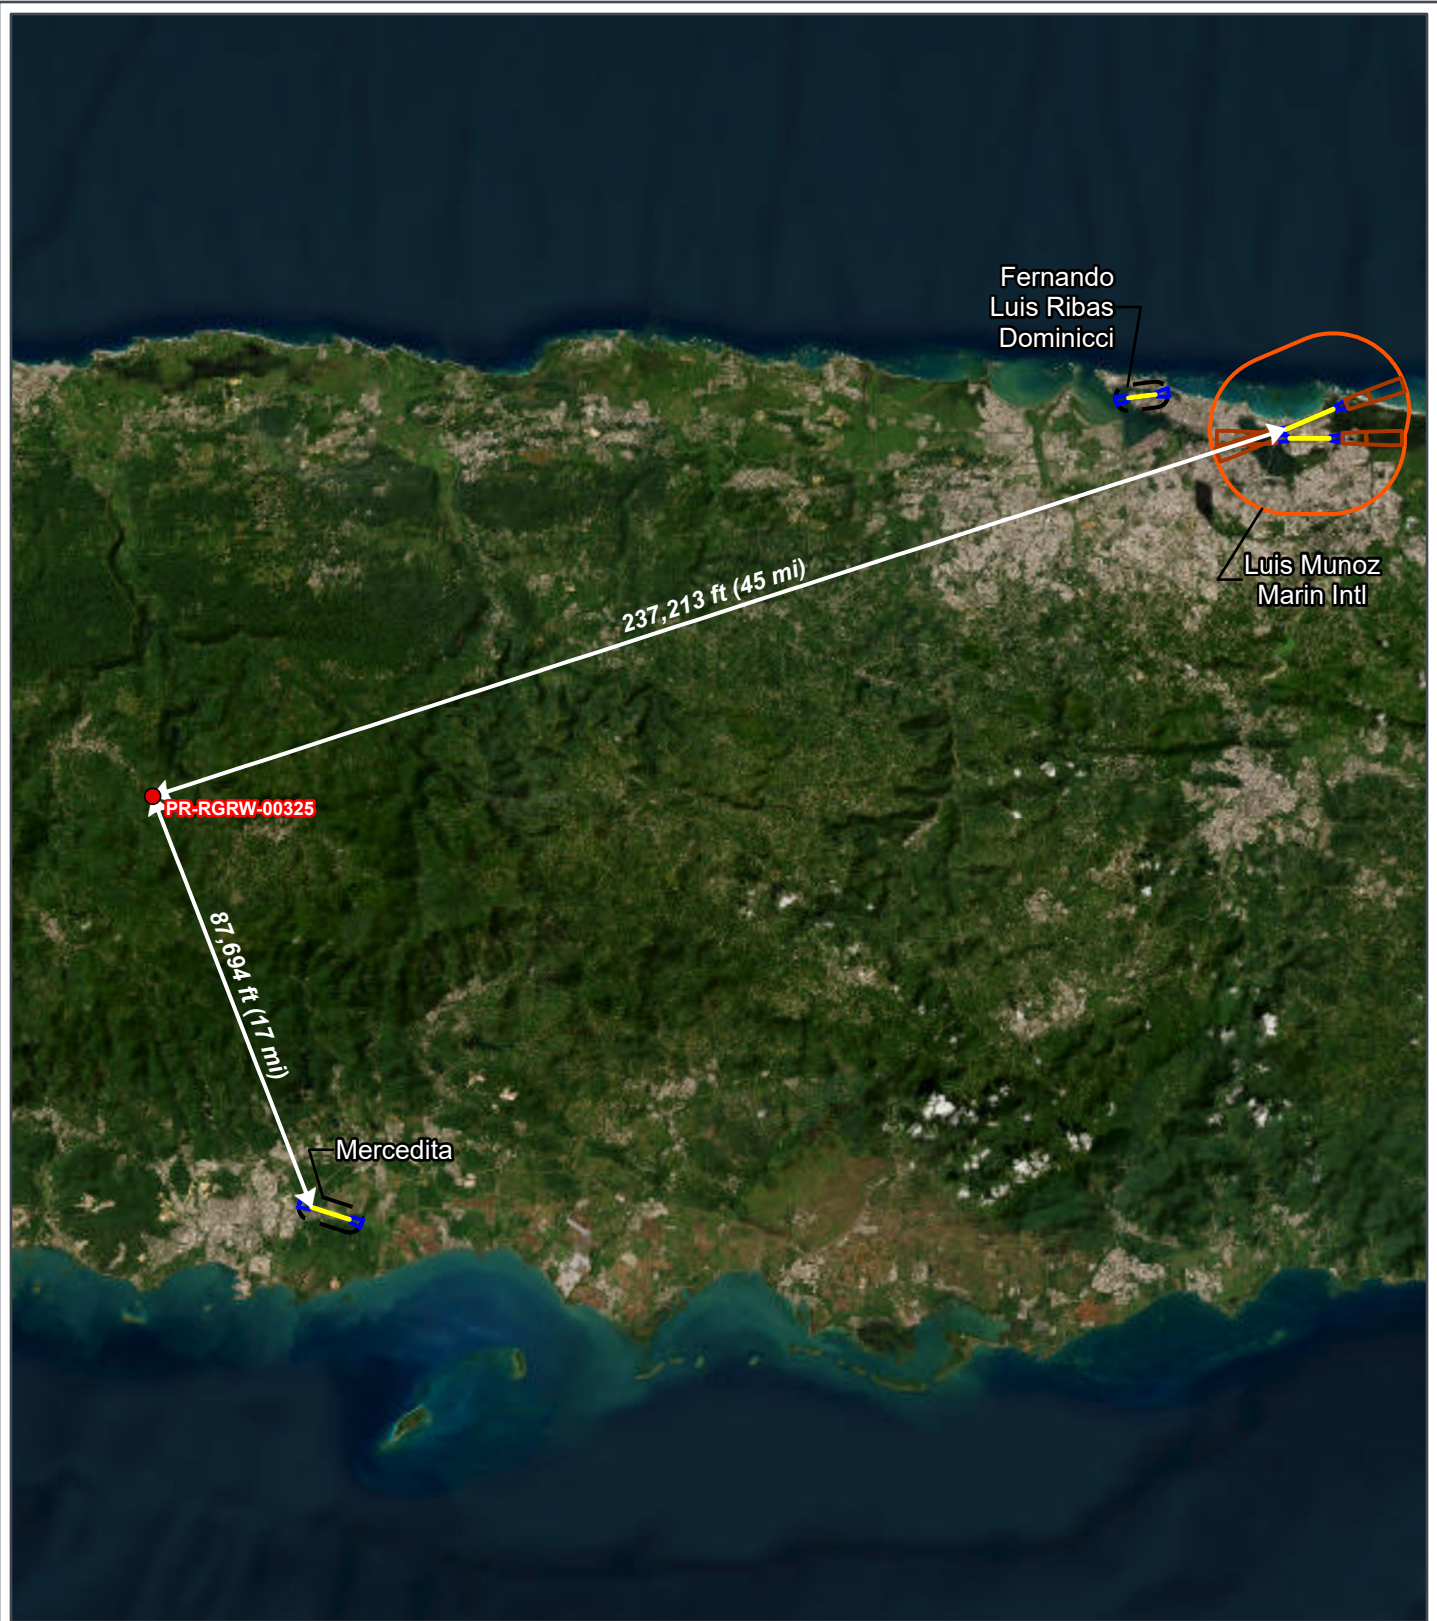
**Figure B 1-1:
Airport Hazards Map**

The project site is not within 2,500 feet of a civil primary or commercial service airport or within 15,000 feet of a military airport. The nearest civil primary or commercial service airport, Mercedita International Airport, is located 17 miles from the project site. The nearest military airport, Luis Muñoz Marín International Airport, is located 45 miles from the project site.

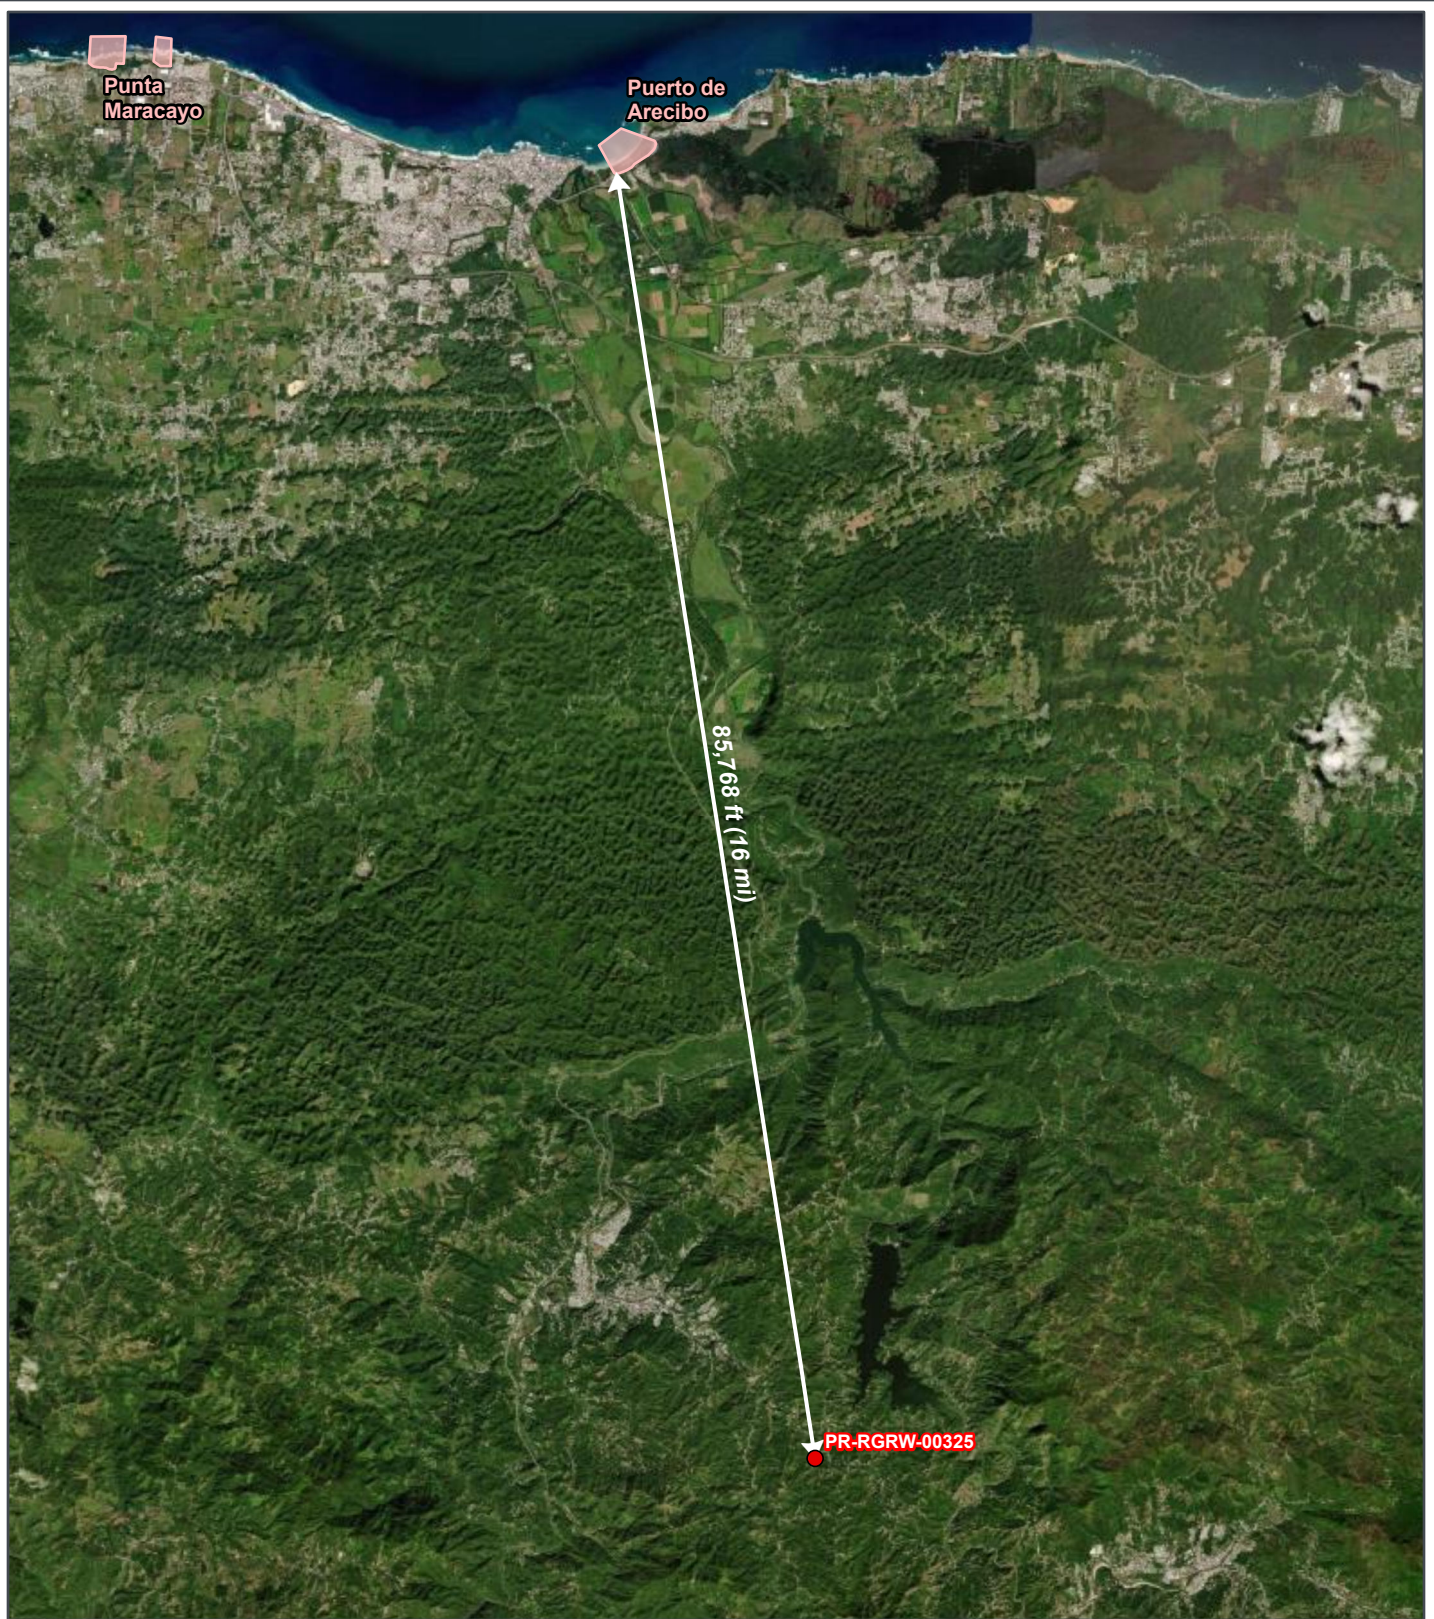
Figure B 2-1: Coastal Barrier Resources Map

The project site is not located in a Coastal Barrier Resource Systems Unit (CBRS) or Otherwise Protected Area (OPA). There are no CBRS units in Utuado Municipio. The closest CBRS unit, Puerto de Arecibo, is located 16 miles from the project site.

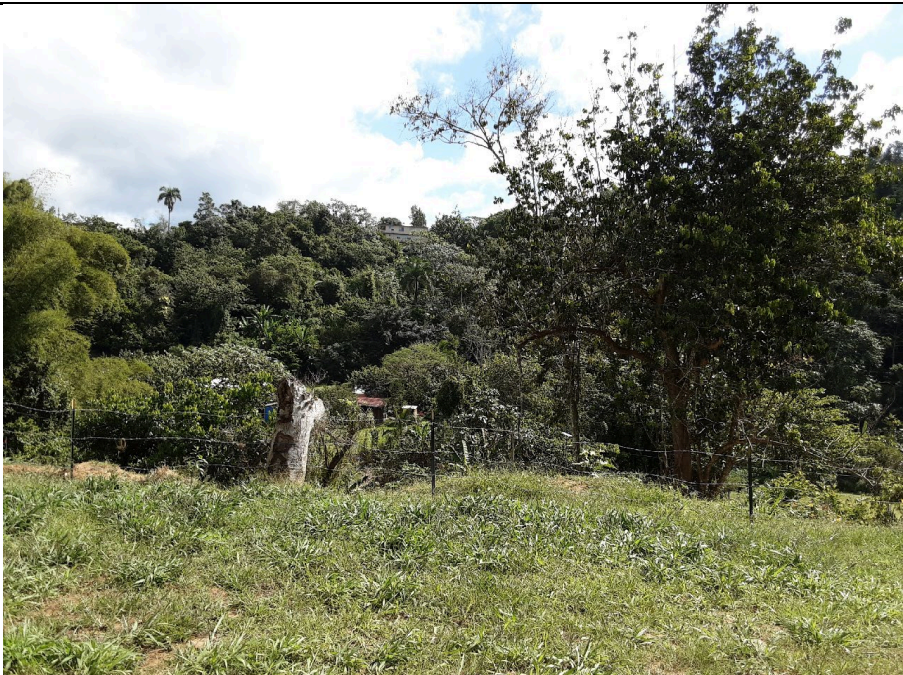
Photo #: 08	Date: 02/24/ 2023

Photo Direction: South		
Description: This picture shows the south overview of the Option 1 site taken from the center of the location, presenting the Barrio Viví Arriba community.

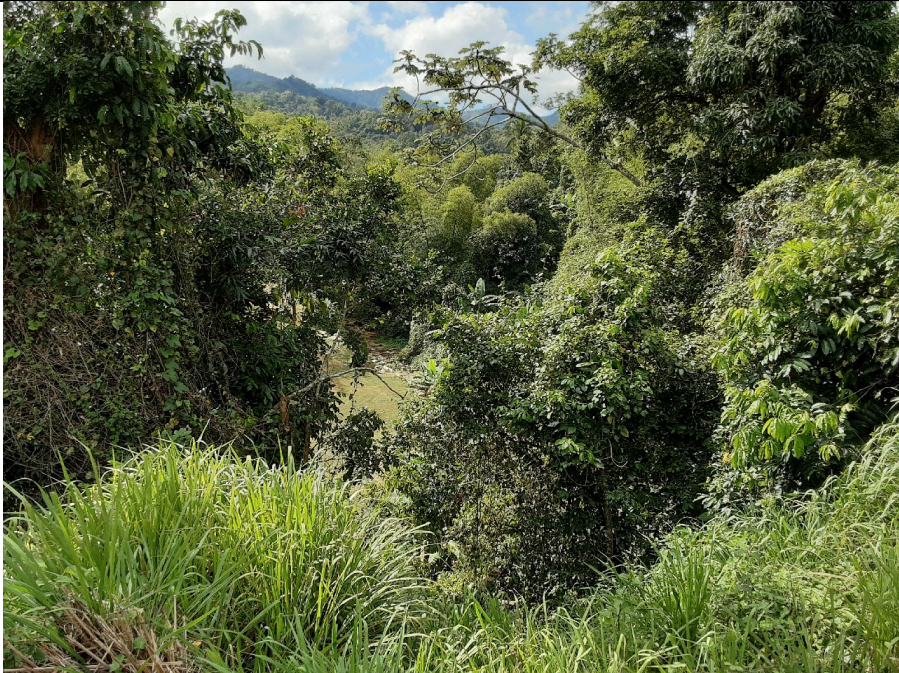
Photo #: 11	Date: 02/24/ 2023

Photo Direction: Southeast		
Description: This picture is an overview of an unnamed stream to the South of the property taken from the area of Option 1.

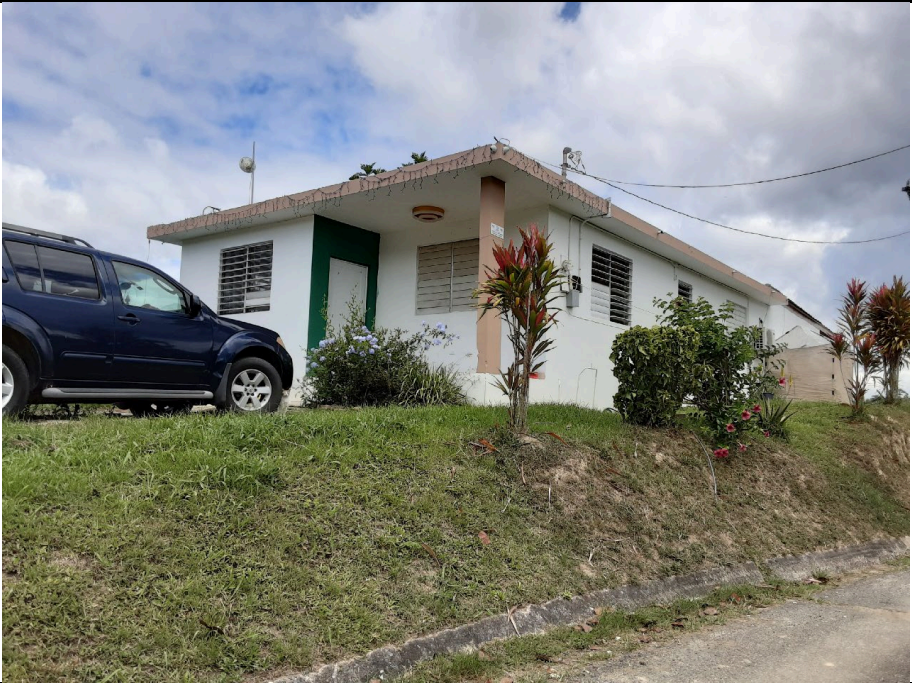
Photo #: 26	Date: 02/24/ 2023

Photo Direction: North		
Description: This is an overview of the applicant's residence in the southern area of the property.

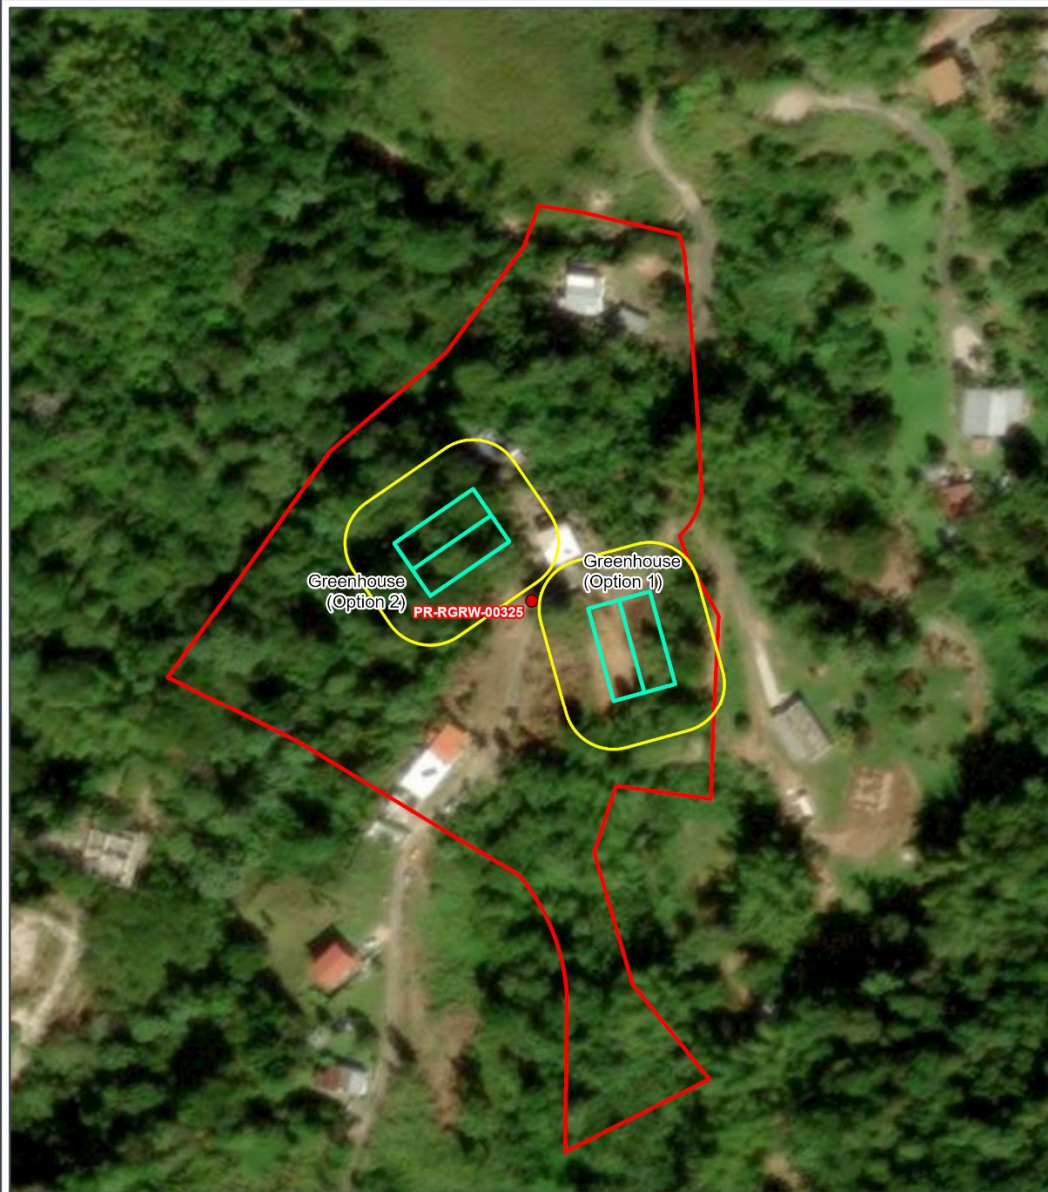
Project (Parcel) Location – Area of Potential Effect Map (Aerial)

Project Location Area of Potential Effects (APE) Map

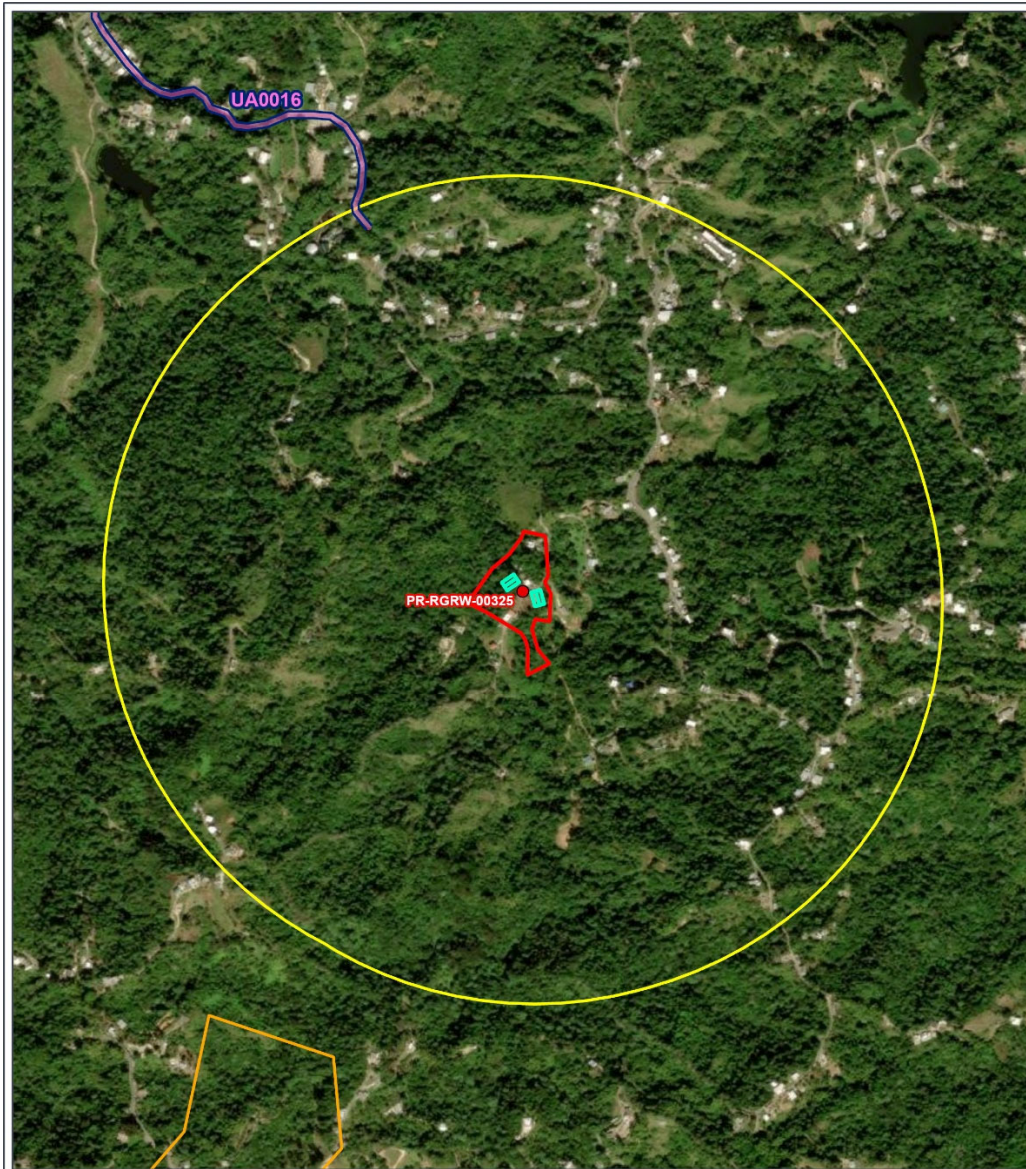
Project (Parcel) Location with Previous Investigations - Aerial Map

Previous Investigation Map

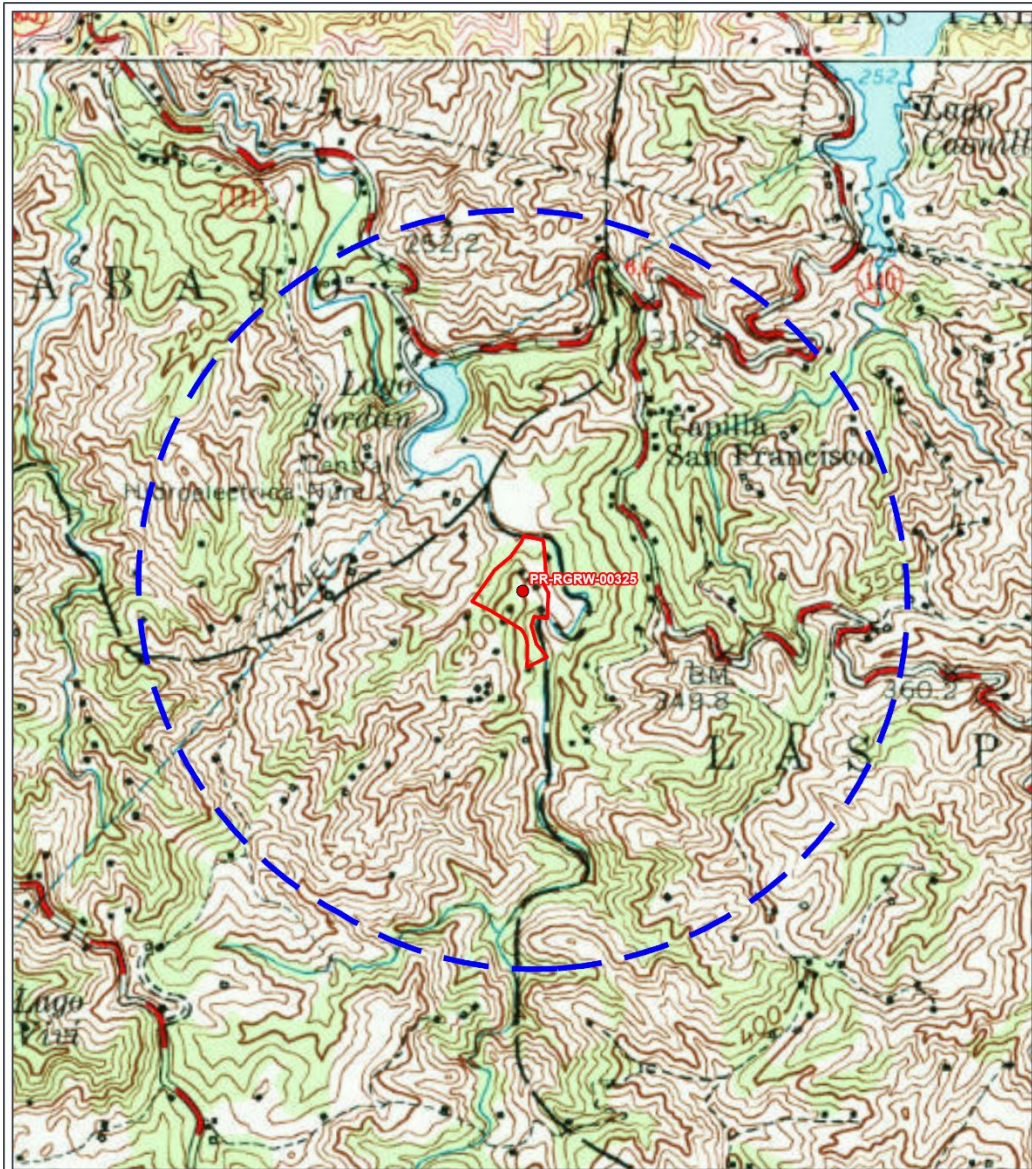
**Project (Parcel) Location with Previously Recorded Cultural Resources
USGS Topographic Map**

<p>REGROW PROGRAM</p> <p>Previously Recorded Cultural Resources Map</p> <p>Applicant ID: PR-RGRW-00325</p>  	<ul style="list-style-type: none"> ● Site Site Parcel Buffer (0.5-mile) ▲ Archaeological Site ★ Historic Area Point ◆ JP Historical Sites ● National Register of Historic Places ● National Historic Landmark 	<ul style="list-style-type: none"> National Register of Historic Places Historic Community Historic District Arroyo Historic Zone Caguas Historic Zone Coamo Historic Zone Guayama Historic Zone Manati Historic Zone Miramar Historic Zone Ponce Historic Zone San German Historic Zone San Juan Historic Zone Vega Baja Historic Zone Traditional Urban Centers 	<p>140 Kilómetro 21 Interior 0 Las Palmas Utuado, Puerto Rico 00641</p> <p>Parcel ID: 215-034-182-03</p> <p>Parcel Center: 66.666845°W 18.237487°N</p> <p>Base Map: ESRI ArcGIS Online, accessed March 2023 Updated: 3/6/2023</p> <p>Layout: Cultural Resources Aprx: 72428_ReGrowTier2Maps</p>	<p style="text-align: center;">N</p>   <p style="text-align: center;">1:12,000</p> <p style="text-align: center;">Puerto Rico</p>

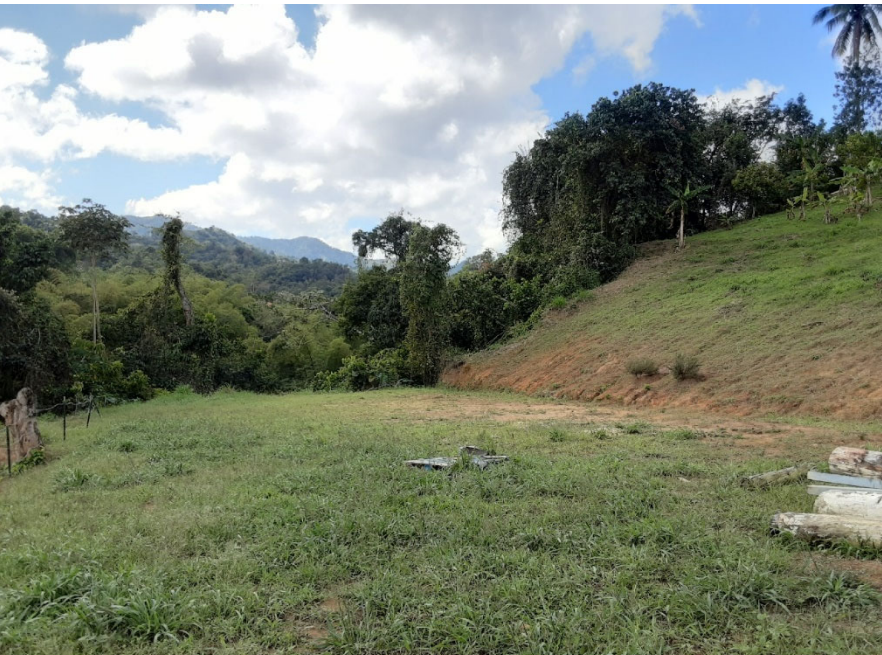
<p>Photo #:01</p>	<p>Date: 02/24/2023</p>

<p>Photo Direction: Southwest</p>		
<p>Description: Overview from northeast corner of the Greenhouse Option 1, facing southwest.</p>
