# Environmental Assessment Determinations and Compliance Findings for HUD-assisted Projects 24 CFR Part 58

Project ID: PR-RGRW-01540

Project Name: SEMILLA VIVA LLC

### **Description of the Proposed Project** [24 CFR 58.32; 40 CFR 1508.25]:

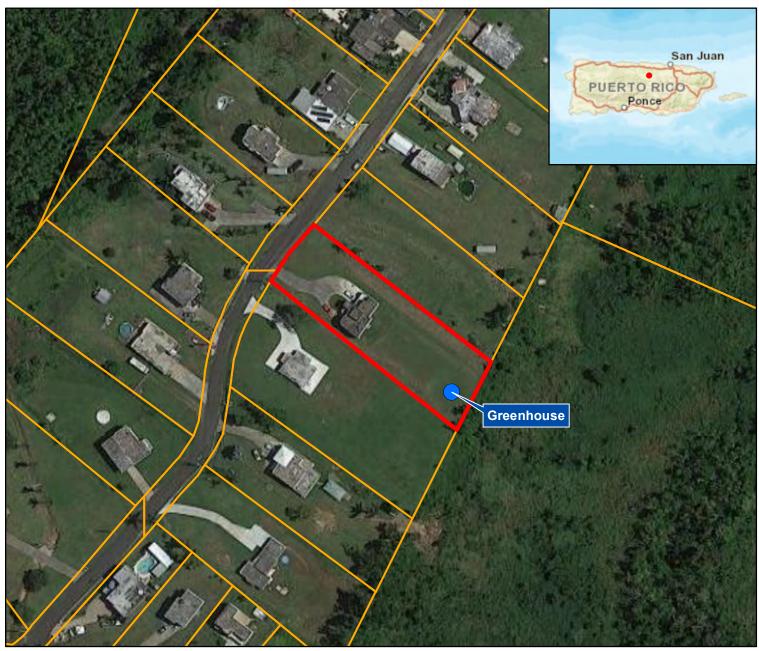
Figure 1

A site Map is included in Figure 1, illustrating the location of the greenhouse on the property. Photos of the locations are included in the Section 106 documentation, Appendix 1.

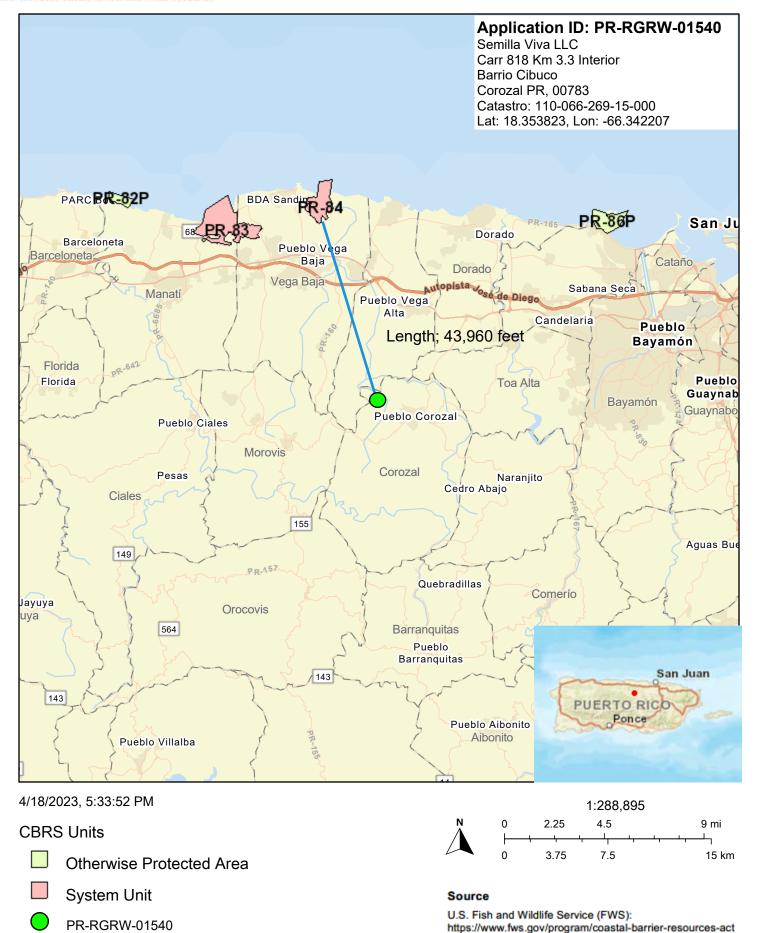
# Figure 3 PR-RGRW-01540 CBRS

Compliance Factors: Statutes, Executive Orders, and Regulations listed at 24 CFR §58.5 and §58.6	Are formal compliance steps or mitigation required?	Compliance determinations
STATUTES, EXECUTIVE ORDERS,	AND REGULATI	ONS LISTED AT 24 CFR 58.6
Airport Hazards  24 CFR Part 51 Subpart D	Yes No	This project consists only of the purchase and installation of a 40 x 8 feet Greenery Container and will have no impact on any Airports. This topic is in compliance with the HUD's Airport Hazard regulations without further evaluation. The site is located 92,181 feet from the nearest civil airport, Fernando Luis Ribas Dominicci Airport in San Juan. See the attached Airport map Runway Protection Zone, Figure 2.
Coastal Barrier Resources  Coastal Barrier Resources Act, as amended by the Coastal Barrier Improvement Act of 1990 [16 USC 3501]	Yes No	This project is not located in a CBRS Unit. The project is located 43,960 feet southeast of the nearest Coastal Barrier Resource System, PR-84. Therefore, this project has no potential to impact a CBRS Unit and is in compliance with the Coastal Barrier Resources Act. See the attached CBRS map, Figure 3.

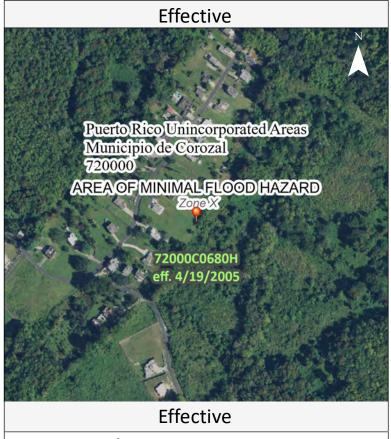
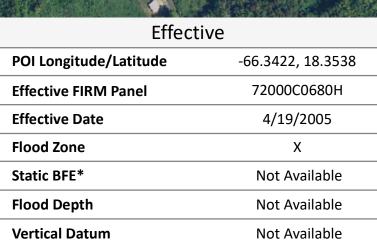
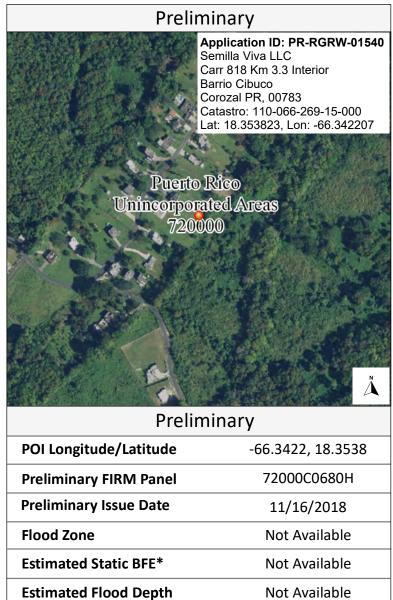
Flood Insurance  Flood Disaster Protection Act of 1973 and National Flood Insurance Reform Act of 1994 [42 USC 4001-4128 and 42 USC 5154a]	Yes No	The project is located in a Zone X, Panel 72000C0680H, 4/19/2005 on the FEMA FIRM. The project does not require flood insurance or is excepted from flood insurance. See attached Flood Map, Figure 4 and Figure 4.1.

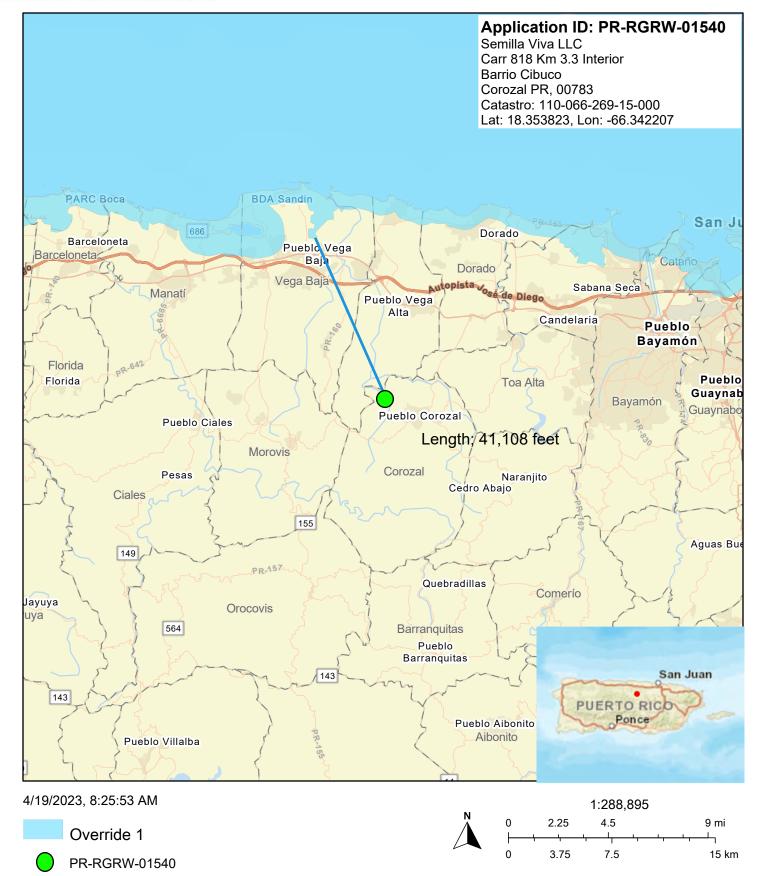
# Figure 5 PR-RGRW-01540 CZM

Clean Air  Clean Air Act, as amended, particularly section 176(c) & (d); 40 CFR Parts 6, 51, 93	Yes No	This project consists only of the purchase and installation of a 40 x 8 feet Greenery Container for an agricultural site and is not located in a nonattainment municipality of Puerto Rico (Arecibo, Bayamón, Cataño, Guaynabo, Salinas, San Juan, Toa Baja). The installation and operation of this project will have no impact and is in compliance with the Clean Air Act without further evaluation. See attached published list of Puerto Rico Nonattainment/Maintenance Status for each country by year for all criteria pollutants in Appendix 2.
Coastal Zone Management Coastal Zone Management Act, sections 307(c) & (d)	Yes No	The project is located 41,108 feet from the nearest Coastal Zone Management area and does not affect a Coastal Zone as defined in the state Coastal Management Plan. This project activity classifies as new construction. The project is in compliance with the Coastal Zone Management Act. See the attached CZMA map, Figure 5.

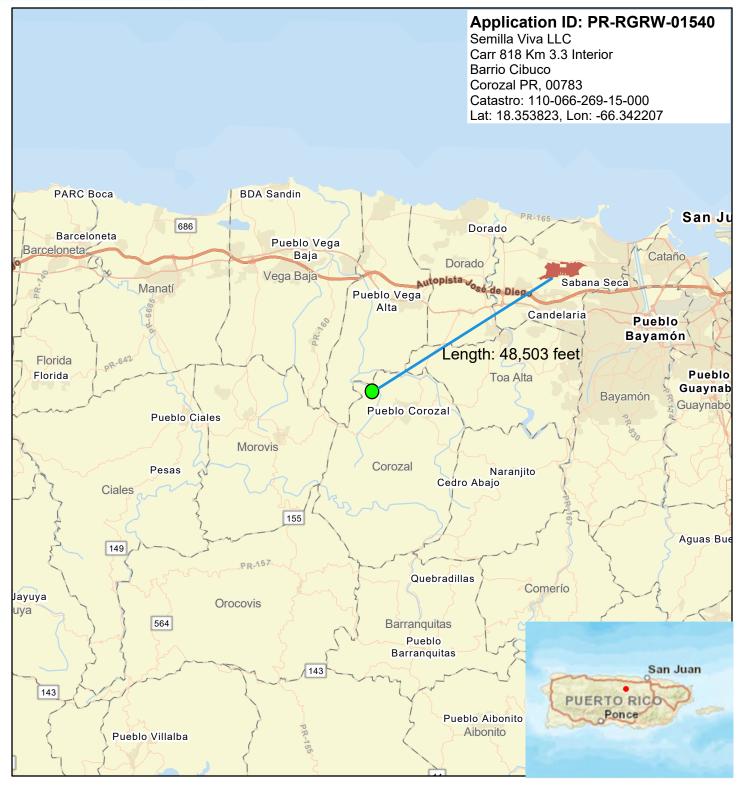
# Figure 7 PR-RGRW-01540 Endangered Species

The sites of concern are not located proximate (within 500 ft) of the project location. Based on EPA Enforcement and Compliance History Online there is no violations reported.  The project is in compliance with contamination and toxic substances requirements. See attached Toxics Map, Figure 6.
Endangered Species Act of 1973, particularly section 7; 50 CFR Part 402	Yes No	This project will have No Effect on listed species due to the nature of the activities involved in the project. The project is 48,503 feet from the nearest final endangered species critical habitat. The scope of work includes continued agricultural use of the property with no intention to cut down trees. Additionally, the project has no critical habitats in the area. If a Puerto Rican Boa is found in the project activity site, work shall cease until the Boa moves off on its own. If the Boa does not move off, the Construction Manager shall contact the Puerto Rico Department of Natural and Environmental Resources and ask for them to relocate the Boa. As established by the USFWS Puerto Rican Boa Conservation Measures Guideline.  https://ipac.ecosphere.fws.gov/guideline/design/population/156/office/41430.pdf This project is in compliance with the Endangered Species Act. See attached Endangered Species map, Figure 7.

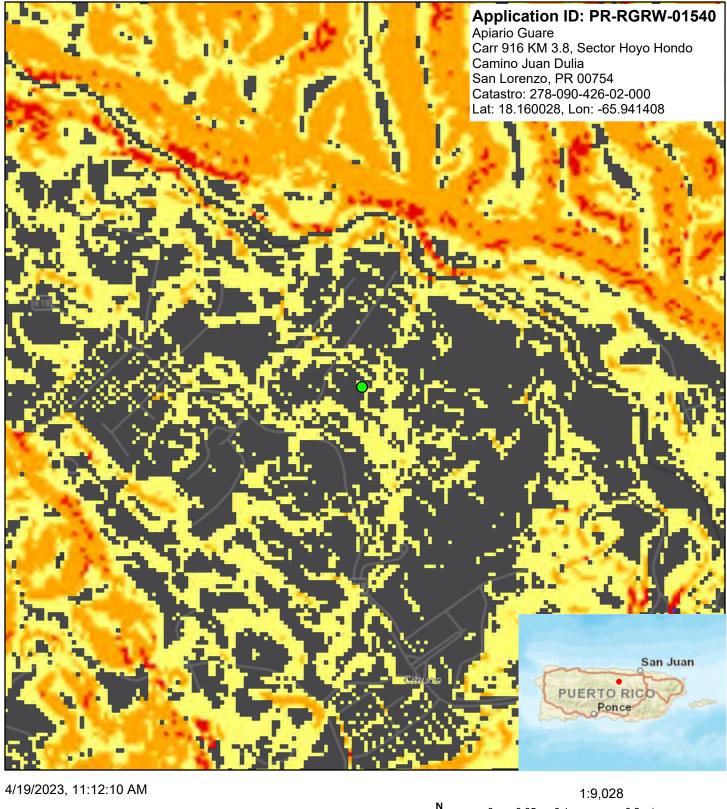
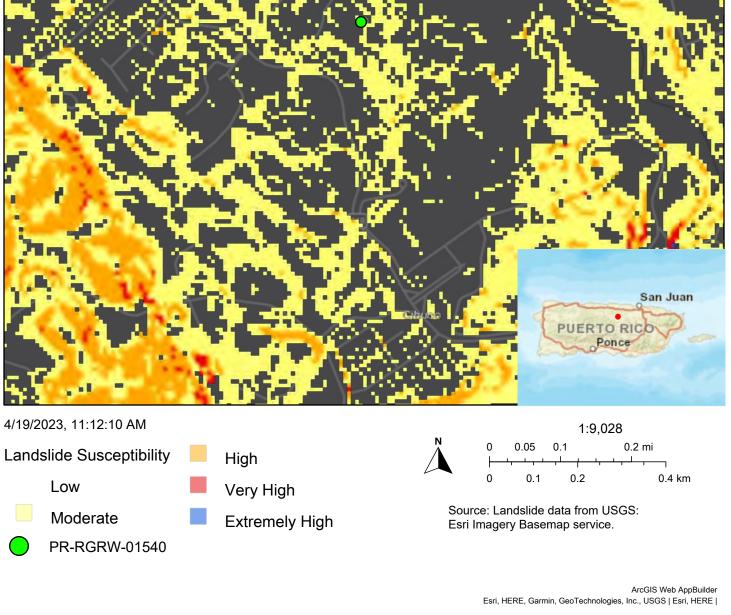
### Figure 13 Landslide

Environmental	Impact	
Assessment Factor	Code	Impact Evaluation
LAND DEVELOP	MENT	
Conformance with Plans / Compatible Land Use and Zoning / Scale and Urban Design	2	The proposed action is continued agricultural use of property which is compatible with a zoning code of R.b (Low Intensity Residential) and existing land use of SRC (Rustic Land). There is no urban design associated with this rural, agricultural site.
Soil Suitability/ Slope/ Erosion/ Drainage/ Storm Water Runoff	2	The soil is currently being used for agriculture purposes. There is no change in land use since the land will continue to be used to agriculture purposes. The landslide data indicates low to moderate landslide susceptibility, and no erosion is expected to occur from this project. The project will not affect the drainage in the area. There will be little to no additional runoff associated with the project. See Landslide Susceptibility Map, Figure 13.

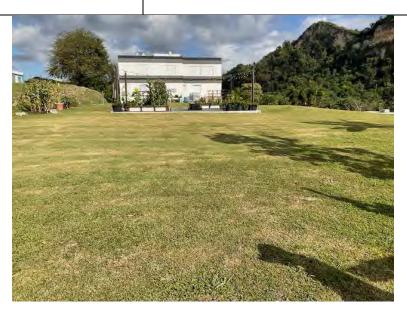
Photo #: 2

**Description (include direction):** Area where the new greenhouse will be placed, looking southeast.

On March 27, 2023, we visually inspected the project area. The project will be developed in the backyard of a residence. The property is covered with grass, and although visibility is poor what we could observe is that apart from the existing greenhouse there is no structure in the area where the new greenhouse will be placed. The land to the southwest is at a higher level and the land to the southeast is lower than the RGRW-01540 project area. Surface stone is observed on these plots.
