## **Environmental Review for Activity/Project that is Categorically Excluded Subject to Section 58.5**

**Project Name:** PR-ESP-00356 Farmacia Summit Hills

The subject property is a commercial building located in San Juan, PR serving as a pharmacy. The project is located at 1727 Avenida Jesús T. Pinero, San Juan PR 00920, Latitude: 18.397422, Longitude: -66.099655. A Site Map is included in Figure 1 in Appendix 1, illustrating the location of the building. The area is characterized by being urban, near commercial buildings and family residences. The road with access to the building is Ave. Jesús T. Piñero (PR-17).

A field visit was conducted on March 7, 2025, to document existing conditions of the project site. The Field Visit Report is included in Appendix 2. The project scope includes the installation of a photovoltaic (solar) panel system on the existing commercial building's roof and appurtenant storage system (batteries) on the western lateral wall, with all improvements limited to the roof, floors, and walls of the existing structure. The batteries will be installed at the back wall of the building. The size of the proposed system will be to cover the annual consumption:

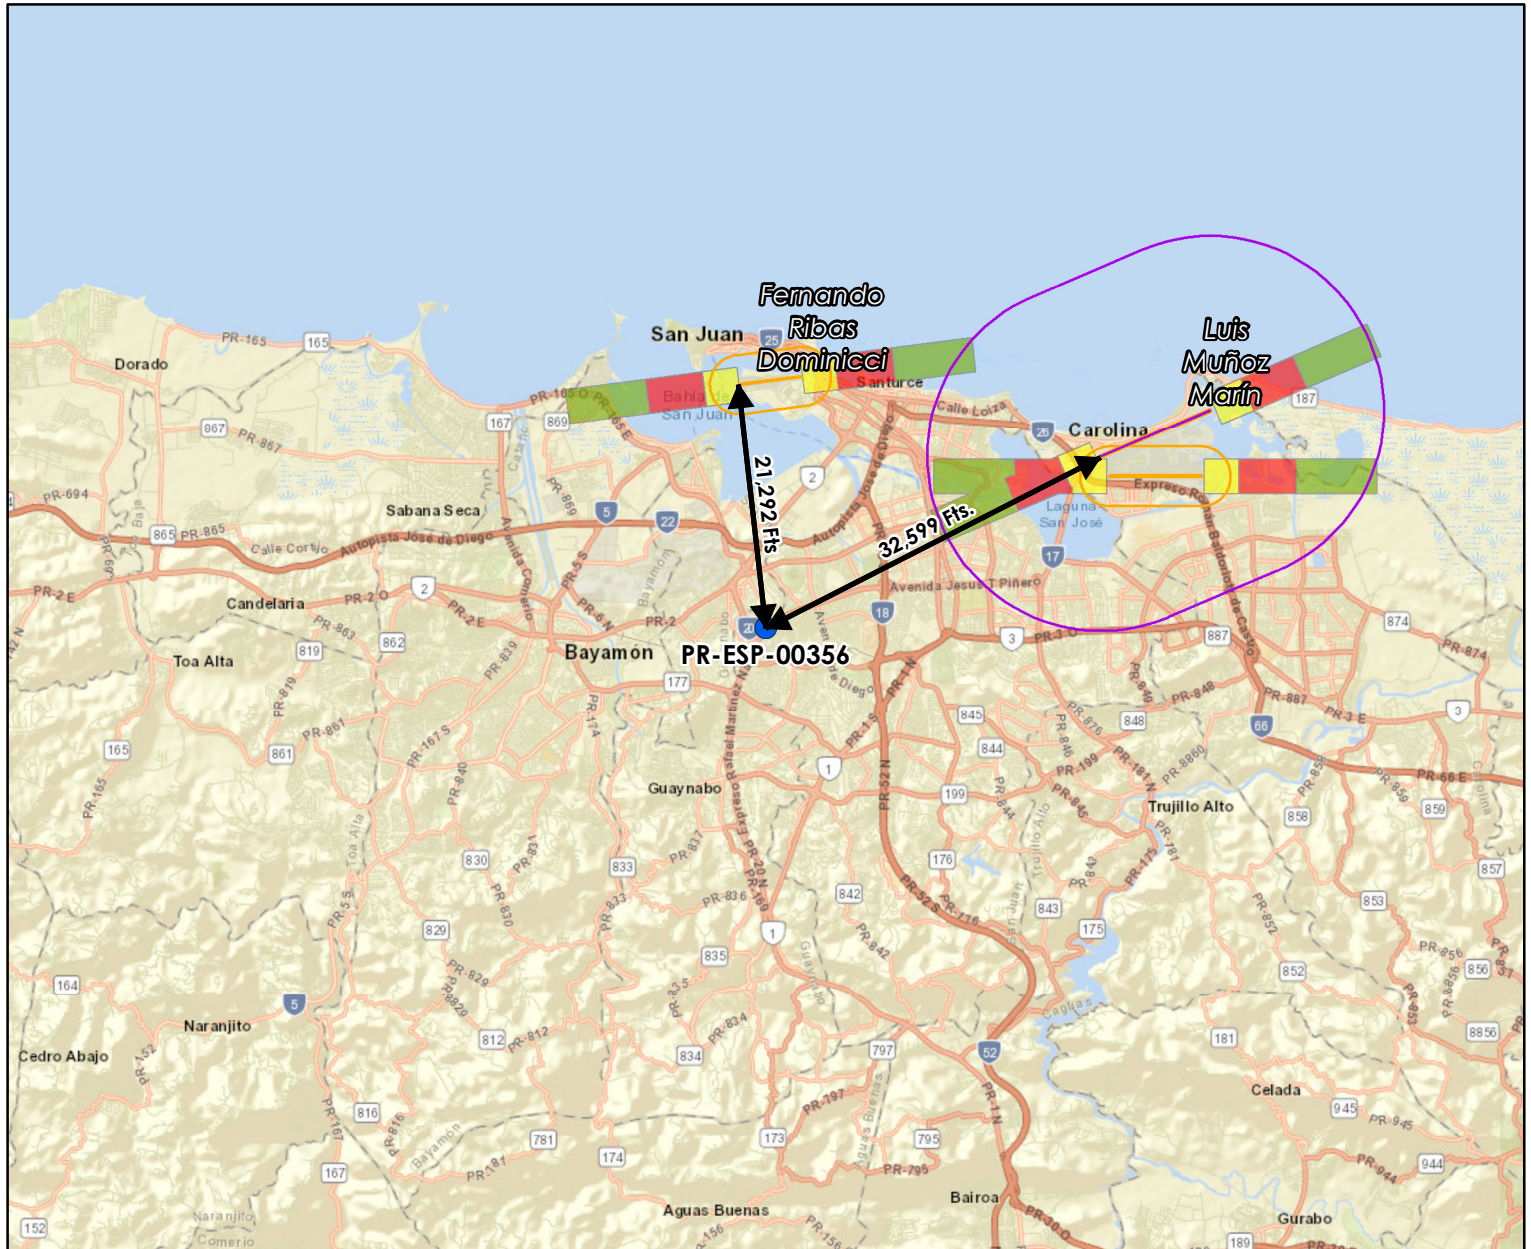
- PR-ESP-00356
- SJU Military Runway
- SJU Civil Runway
- Military Airport Buffer (15,000 Fts.)
- Civil Airport Buffer (2,500 Fts.)
- Accident Potential Zone**
- APZ 1
- APZ 2
- Clear Zone

| <b>Compliance Factors:</b><br>Statutes, Executive Orders,<br>and Regulations listed at 24<br>CFR §58.5 and §58.6 | Are formal<br>compliance<br>steps or<br>mitigation<br>required? | Compliance determinations |
|---|---|---|
| <b>Airport Hazards</b><br><br>24 CFR Part 51 Subpart D | Yes    No<br><input type="checkbox"/> <input checked="" type="checkbox"/> | The site is located 21,292 feet from the nearest civil airport, Fernando Ribas Dominicci in San Juan and 32,599 feet from the nearest military airport, Luis Muñoz Marín International Airport in San Juan. This topic is in compliance with HUD's Airport Hazard Regulations without further evaluation.<br><br>Refer to Airports Map Zone, Figure 2 included in Appendix 1. |
